Shetland Islands Council

Sixth Biennial Flood Report November 2007

To
The Scottish Government

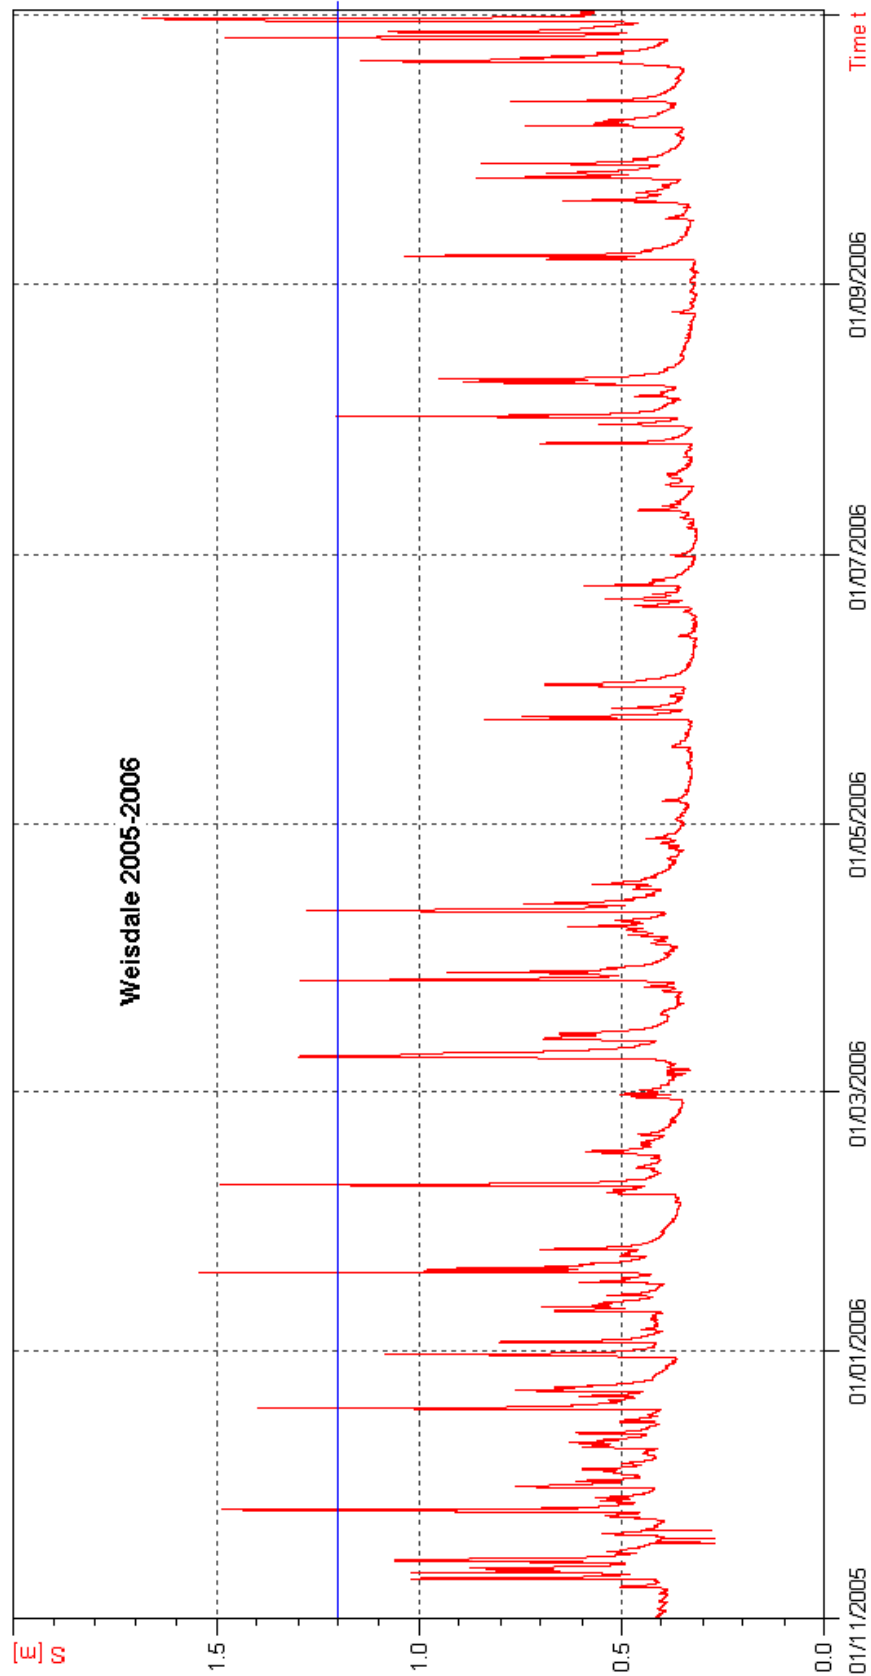
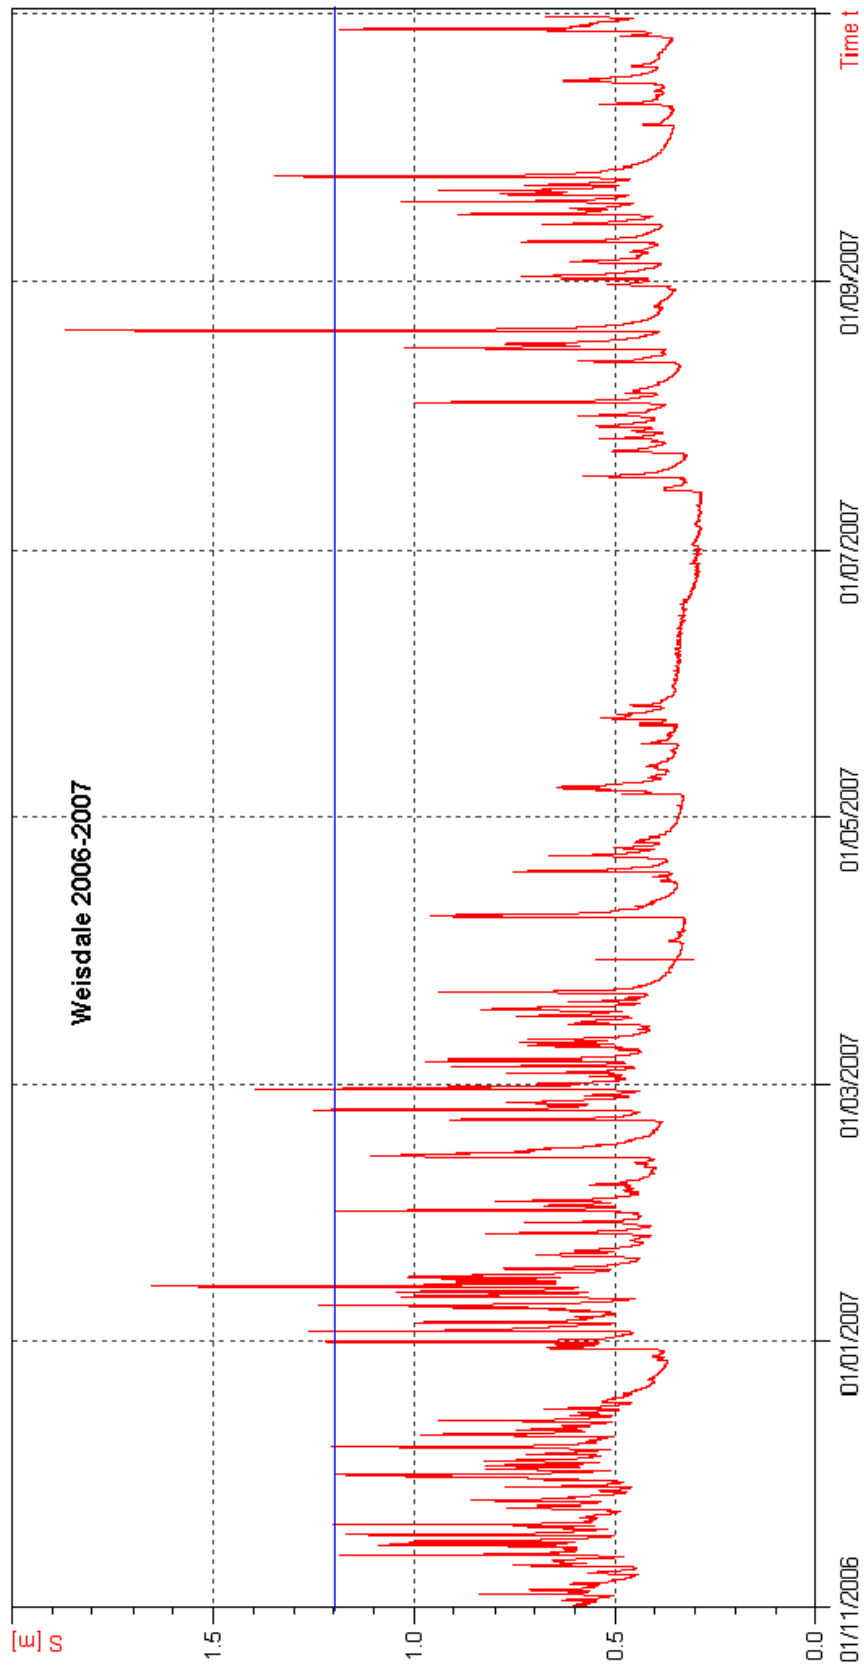
Appendix 2: Weisdale Burn sample river level data

electronic sensors used to measure the water levels with readings logged electronically every 15 minutes. **Appendix 2** shows sample river level data for the previous two years. The flood watch threshold of 1.200m is shown in blue and it can be seen from this that water levels in the burn exceed this limit quite regularly. **Appendix 3** gives a graphical representation of this information over the previous 5-year period. The highest peak recorded over the previous 2-year period was 1.868m on 20th August 2007. This was the second highest water level since records began on this stretch of water.
