# Former Warehouse

72 Commercial Road, Lerwick

HNP Engineers Former Workshop  
Commercial Rd, Lerwick, Shetland ZE1 0NJ, UK

Surveyed by Ewen Balfour on 10 Nov 2025

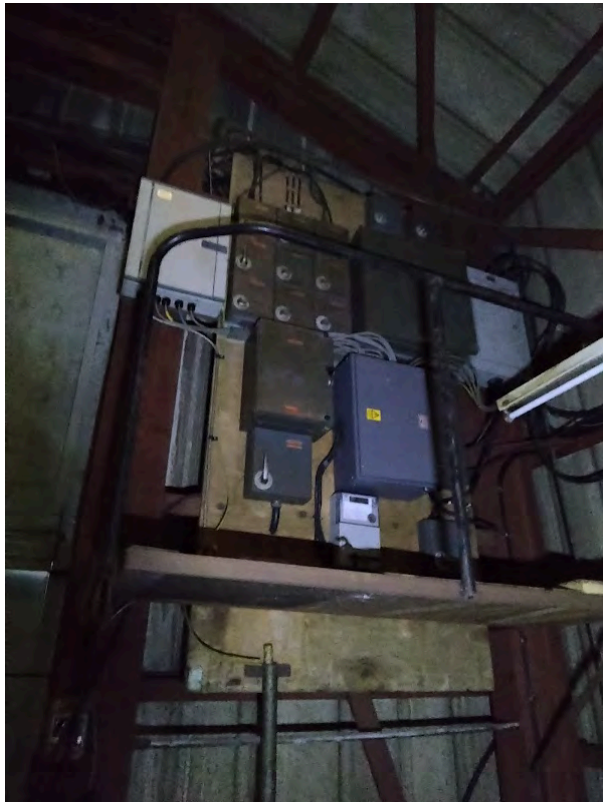
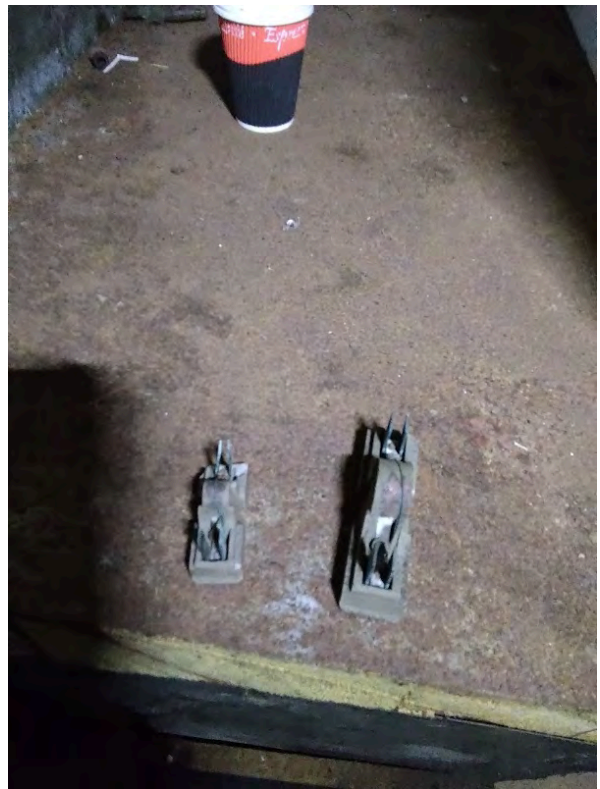
[014] 0-Ground floor > Workshop > Electrical items > Consumer unit	
Building Name	HNP Engineers Former Workshop
Building Address	Commercial Rd, Lerwick, Shetland ZE1 0NJ, UK
Extent	As Seen
Sample Number	No Sample Taken
Notes	<i>Flashguards within Switchgear inaccessible</i>

### Material Assessment Score 7

Asbestos Type	Presumed	3	Product Type	Textiles	2
Condition	Medium Damage	2	Treatment	Composite Materials	0
Fibre Release	<b>Medium</b>		Action Required	B: Encapsulation

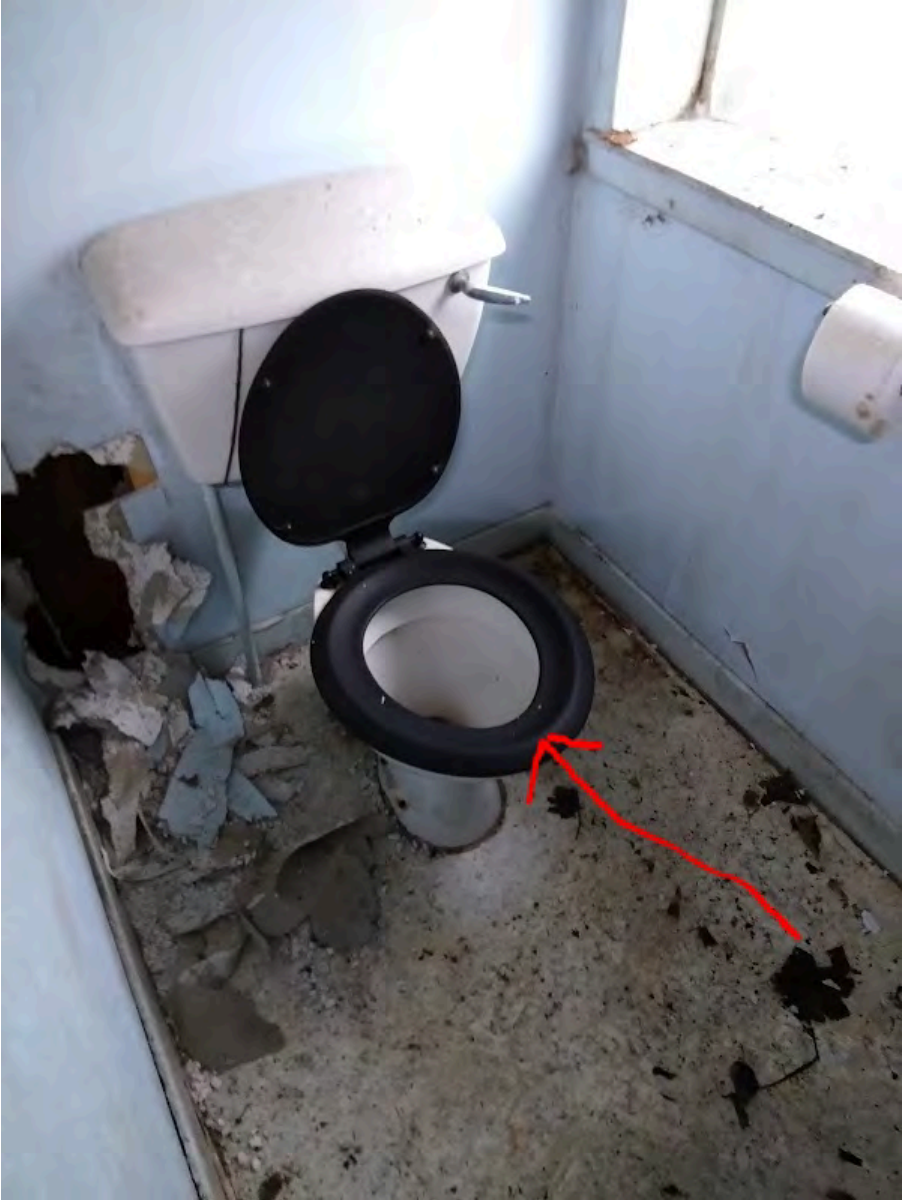
[024] 1-First floor > WC > Sanitary, kitchen items > Toilet seat					
Building Name	HNP Engineers Former Workshop				
Building Address	Commercial Rd, Lerwick, Shetland ZE1 0NJ, UK				
Extent	As Seen				
Sample Number	No Sample Taken				
Notes	<i>Ladies WC First Floor</i>

Material Assessment Score 4					
Asbestos Type	Presumed	3	Product Type	Reinforced Composites	1
Condition	Good Condition	0	Treatment	Composite Materials	0
Fibre Release	Very Low		Action Required	D: Must Remove *Escalated

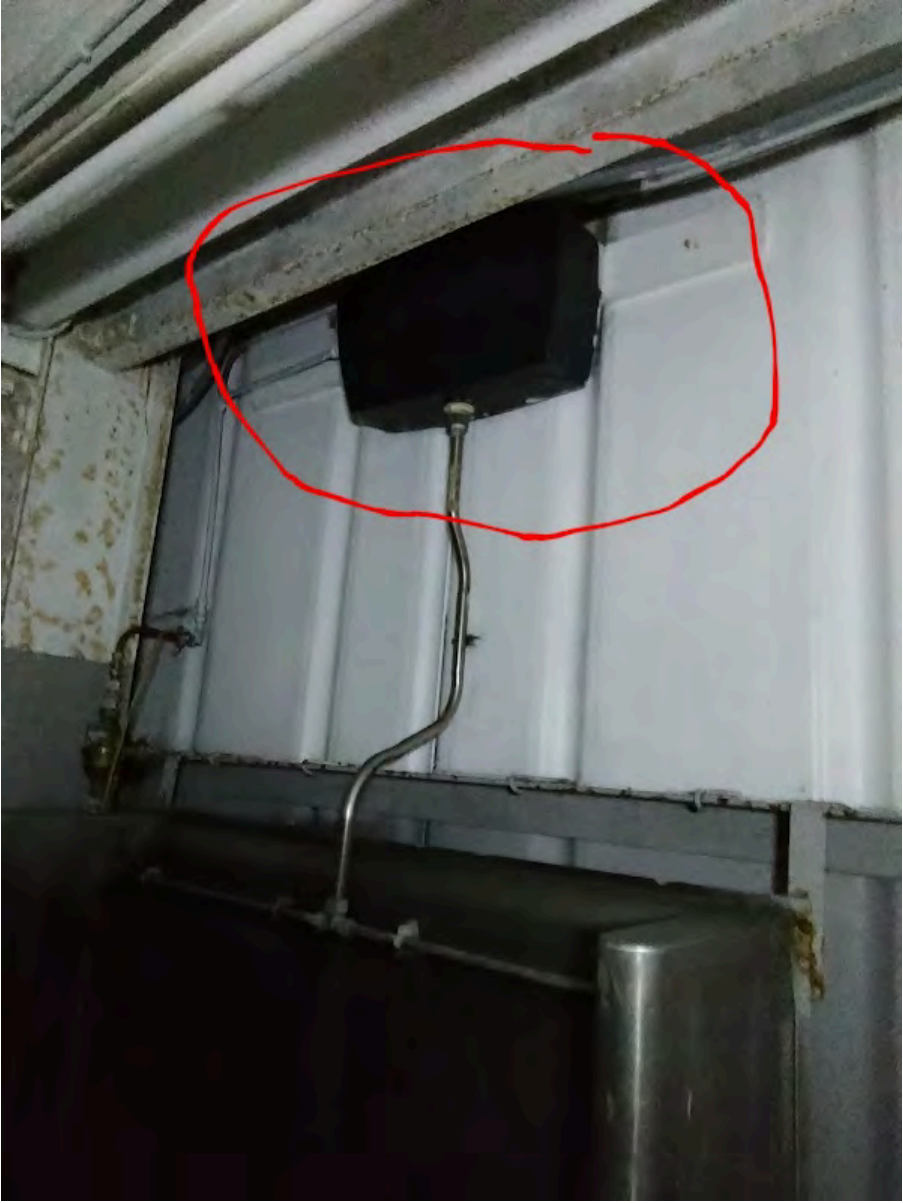
<b>[026] 0-Ground floor &gt; WC &gt; Sanitary, kitchen items &gt; Toilet cistern</b>					
Building Name	HNP Engineers Former Workshop				
Building Address	Commercial Rd, Lerwick, Shetland ZE1 0NJ, UK				
Extent	Measured 1.0 Item				
Sample Number	No Sample Taken				
Notes	<i>Male WC</i>

<b>Material Assessment Score 5</b>					
Asbestos Type	Presumed	3	Product Type	Reinforced Composites	1
Condition	Low Damage	1	Treatment	Composite Materials	0
Fibre Release	<i>Low</i>		Action Required	C: Monitor Biannually

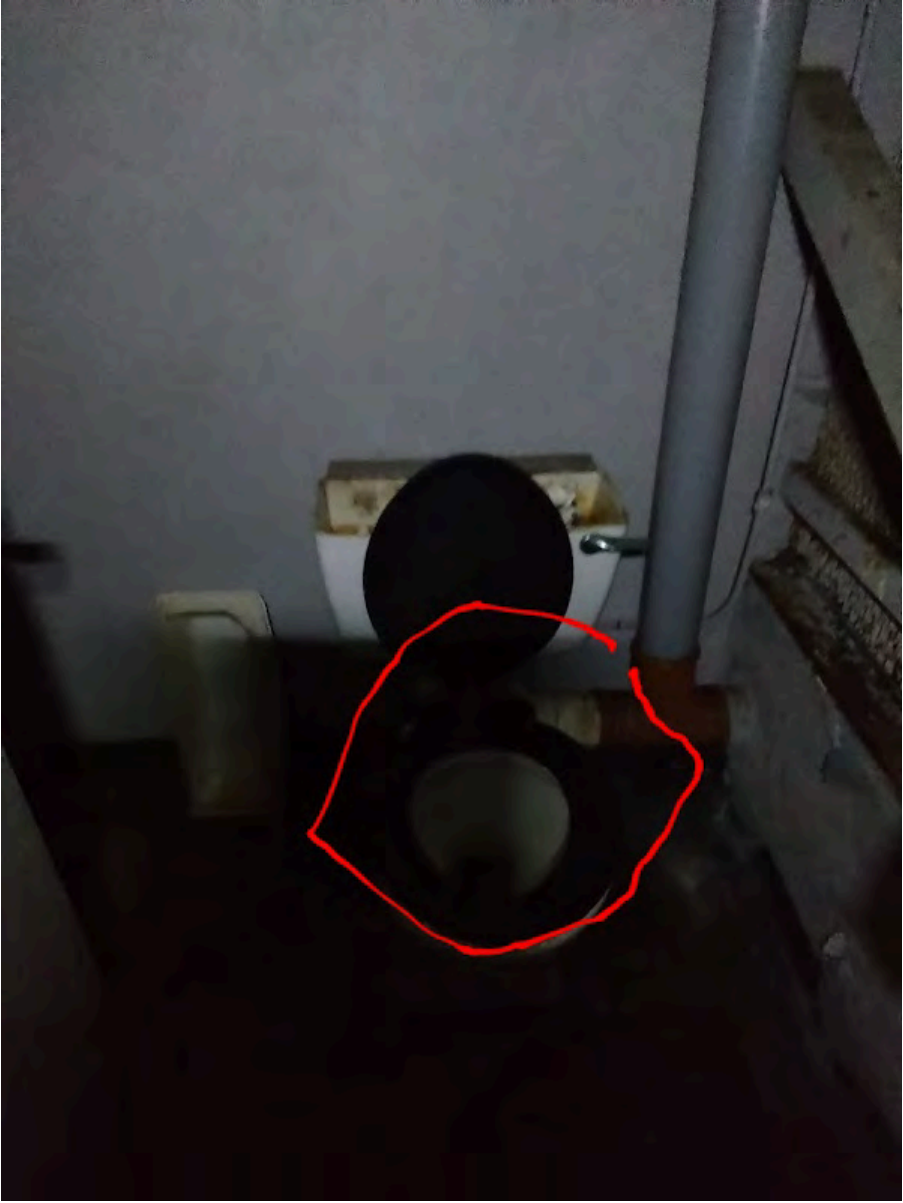
[027] 0-Ground floor > WC > Sanitary, kitchen items > Toilet seat					
Building Name	HNP Engineers Former Workshop				
Building Address	Commercial Rd, Lerwick, Shetland ZE1 0NJ, UK				
Extent	Measured 1.0 Item				
Sample Number	No Sample Taken				
Notes	<i>Male WC Ground Floor</i>

Material Assessment Score 5					
Asbestos Type	Presumed	3	Product Type	Reinforced Composites	1
Condition	Low Damage	1	Treatment	Composite Materials	0
Fibre Release	Low		Action Required	C: Monitor Biannually

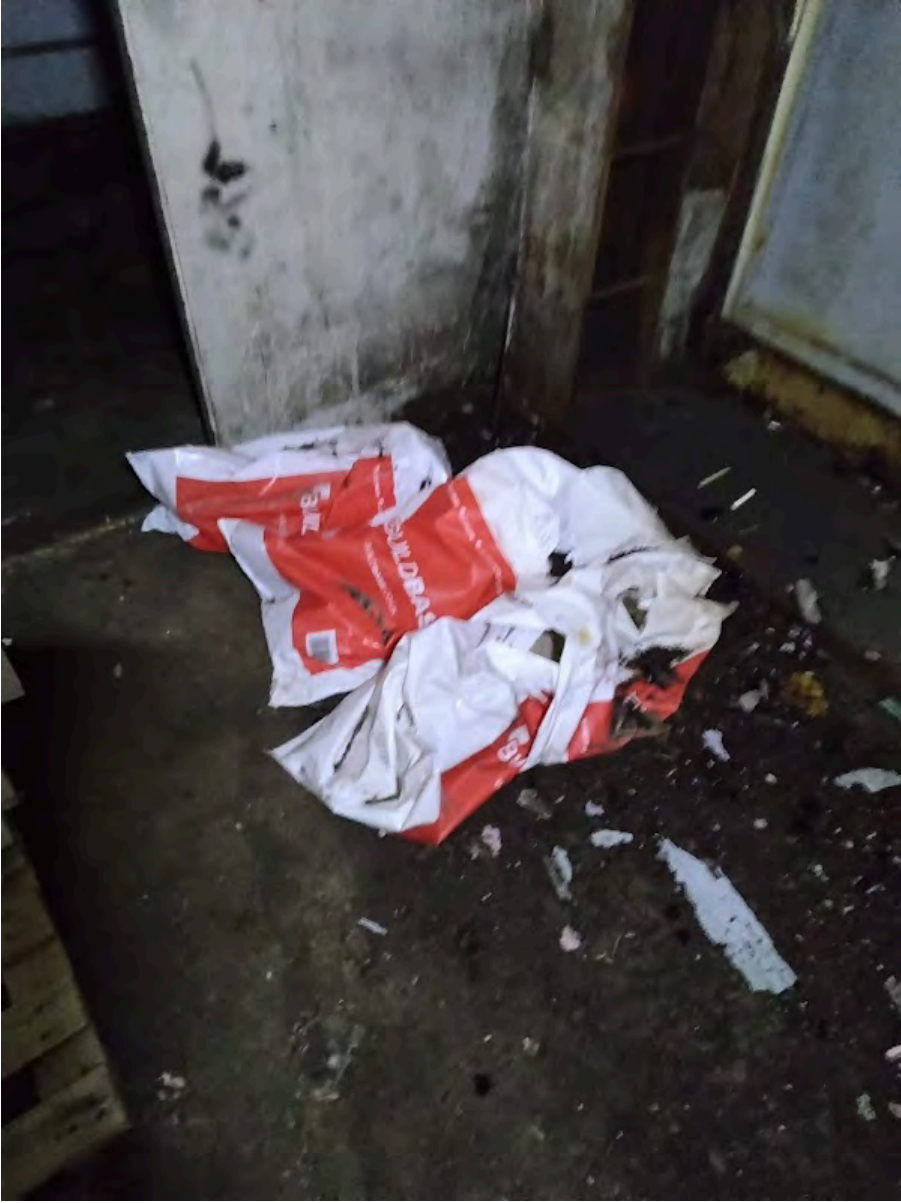
[029] 0-Ground floor > Workshop > Roof covering > Debris					
Building Name	HNP Engineers Former Workshop				
Building Address	Commercial Rd, Lerwick, Shetland ZE1 0NJ, UK				
Extent	As Seen				
Sample Number	No Sample Taken				
Notes	<i>Bagged debris</i>

Material Assessment Score 8					
Asbestos Type	Presumed	3	Product Type	Reinforced Composites	1
Condition	High Damage	3	Treatment	Cement Sheets	1
Fibre Release	<b>Medium</b>		Action Required	B: Encapsulation

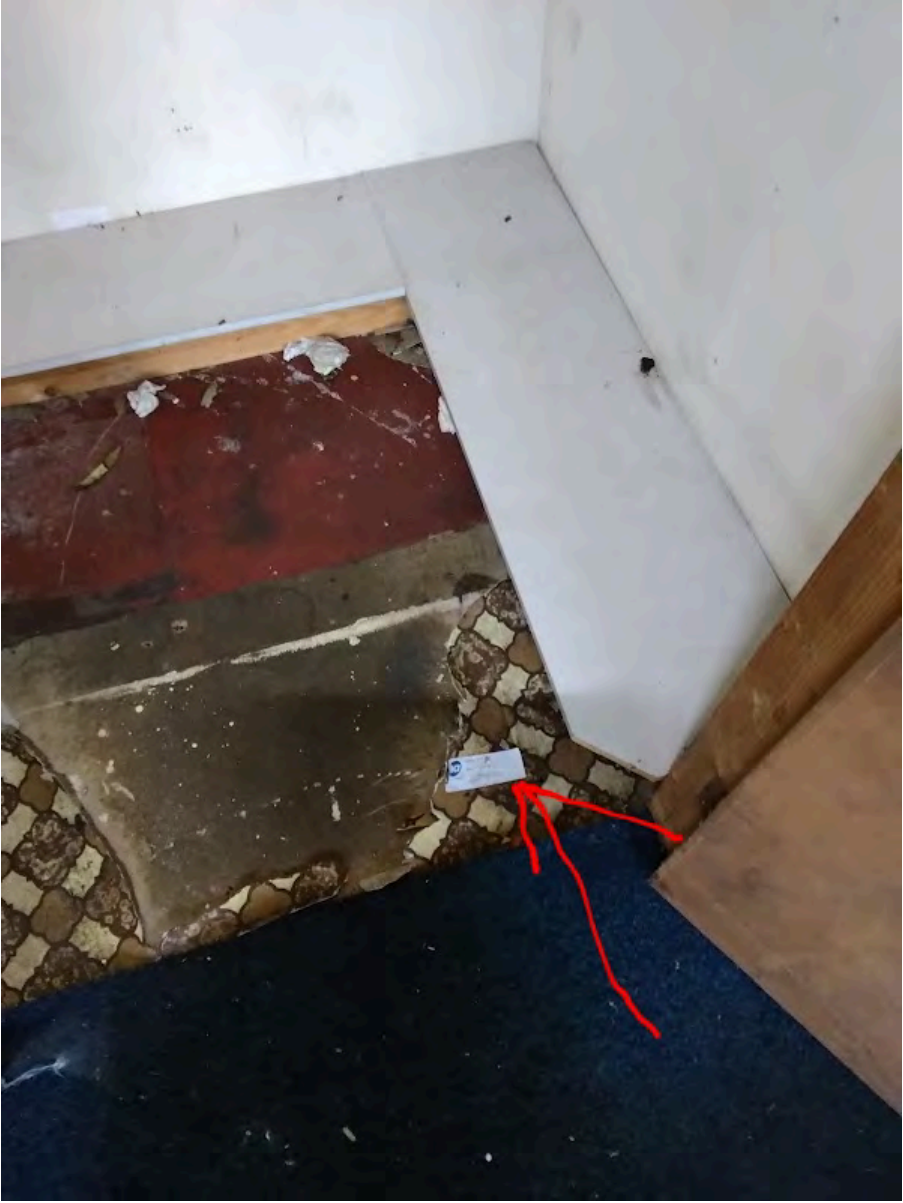
[001] 1-First floor > Office 1 > Flooring > Vinyl sheet floor					
Building Name	HNP Engineers Former Workshop				
Building Address	Commercial Rd, Lerwick, Shetland ZE1 0NJ, UK				
Extent	Measured 25.0 Square Metres				
Sample Number	As 001 (Ref: 001/6041)				
Notes	<i>Patterned brown floor vinyl</i>

Material Assessment Score 4					
Asbestos Type	Chrysotile	1	Product Type	Reinforced Composites	1
Condition	Medium Damage	2	Treatment	Composite Materials	0
Fibre Release	Very Low		Action Required	D: Must Remove *Escalated

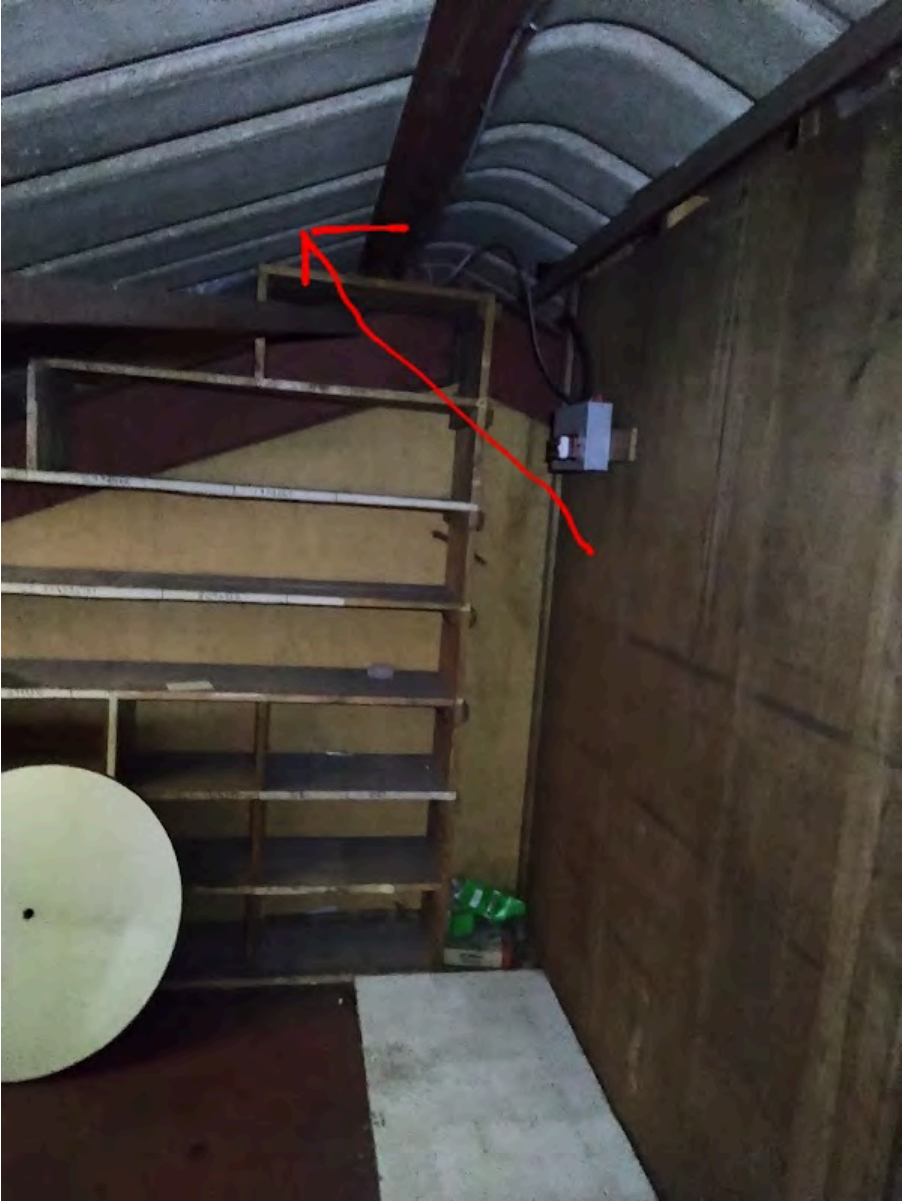
[002] 2-Second floor > Store 5 > Roof covering > Liner sheet					
Building Name	HNP Engineers Former Workshop				
Building Address	Commercial Rd, Lerwick, Shetland ZE1 0NJ, UK				
Extent	Measured 30.0 Square Metres				
Sample Number	As 002 (Ref: 002/6041)				
Notes	<i>Liner sheet to roof</i>

Material Assessment Score 4					
Asbestos Type	Chrysotile	1	Product Type	Reinforced Composites	1
Condition	Low Damage	1	Treatment	Cement Sheets	1
Fibre Release	Very Low		Action Required	D: Monitor Annually

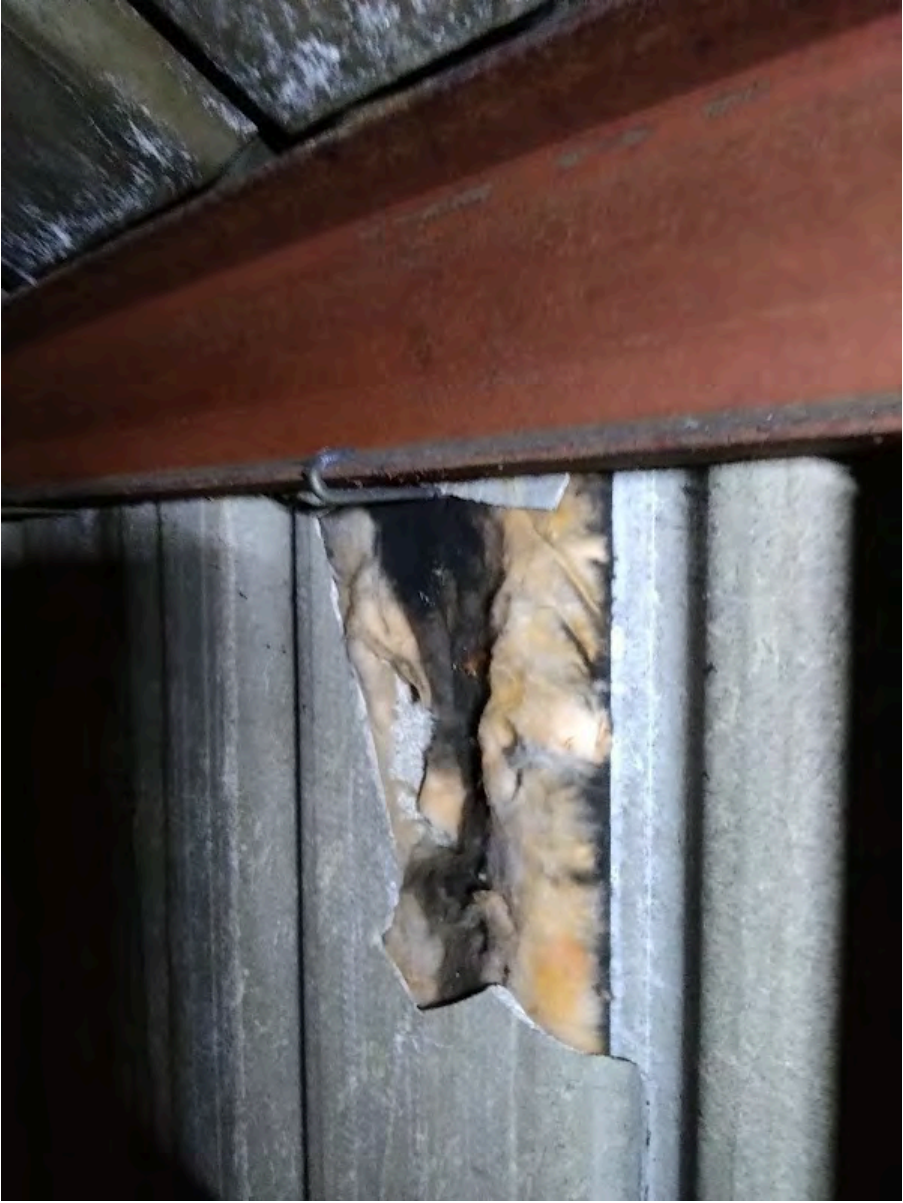
[003] 1-First floor > Main Store > Wall covering > Wall cladding					
Building Name	HNP Engineers Former Workshop				
Building Address	Commercial Rd, Lerwick, Shetland ZE1 0NJ, UK				
Extent	Measured 100.0 Square Metres				
Sample Number	As 003 (Ref: 003/6041)				
Notes	<i>Cement fibre wall sheeting</i>

Material Assessment Score 4					
Asbestos Type	Chrysotile	1	Product Type	Reinforced Composites	1
Condition	Low Damage	1	Treatment	Cement Sheets	1
Fibre Release	Very Low		Action Required	D: Monitor Annually

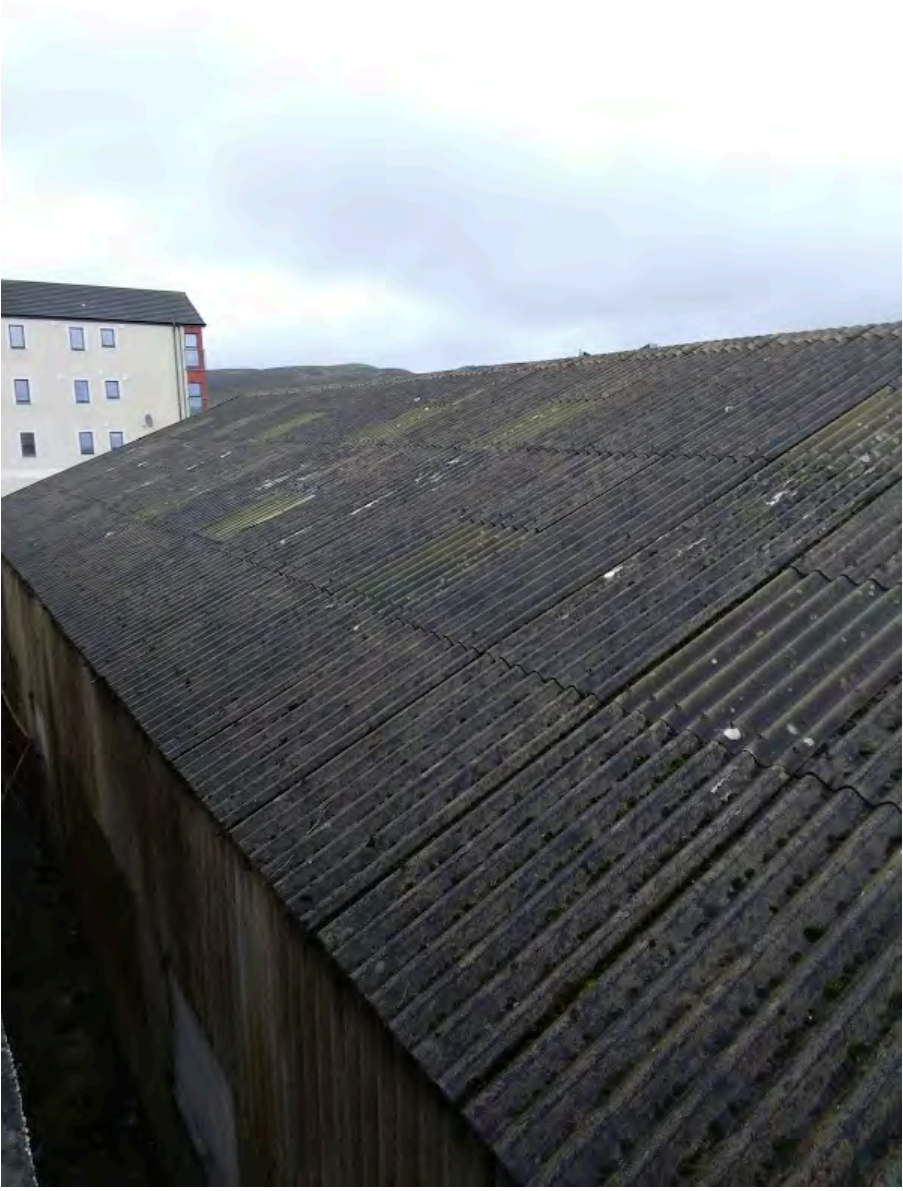
<b>[004] 1-First floor &gt; Main Store &gt; Roof covering &gt; Corrugated roof sheets</b>					
Building Name	HNP Engineers Former Workshop				
Building Address	Commercial Rd, Lerwick, Shetland ZE1 0NJ, UK				
Extent	Measured 200.0 Square Metres				
Sample Number	As 004 (Ref: 004/6041)				
Notes	<i>Cement fibre roof sheet</i>

<b>Material Assessment Score 4</b>					
Asbestos Type	Chrysotile	1	Product Type	Reinforced Composites	1
Condition	Low Damage	1	Treatment	Cement Sheets	1
Fibre Release	<i>Very Low</i>		Action Required	D: Monitor Annually

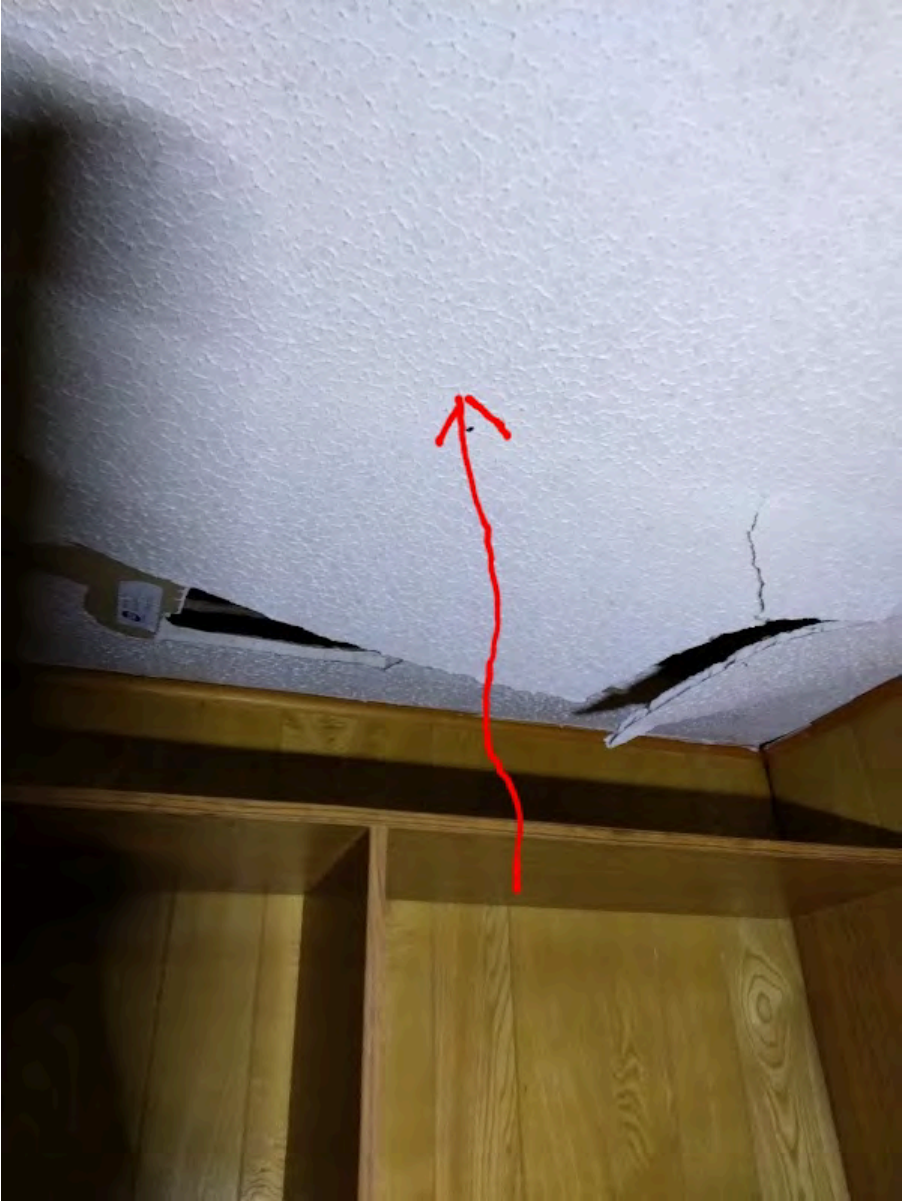
[005] 1-First floor > Shop Office > Ceilings > Textured coating to ceilings					
Building Name	HNP Engineers Former Workshop				
Building Address	Commercial Rd, Lerwick, Shetland ZE1 0NJ, UK				
Extent	Measured 15.0 Square Metres				
Sample Number	As 005 (Ref: 005/6041)				
Notes	<i>Artex finish</i>

Material Assessment Score 3					
Asbestos Type	Chrysotile	1	Product Type	Reinforced Composites	1
Condition	Low Damage	1	Treatment	Composite Materials	0
Fibre Release	<i>Very Low</i>		Action Required	D: Monitor Annually

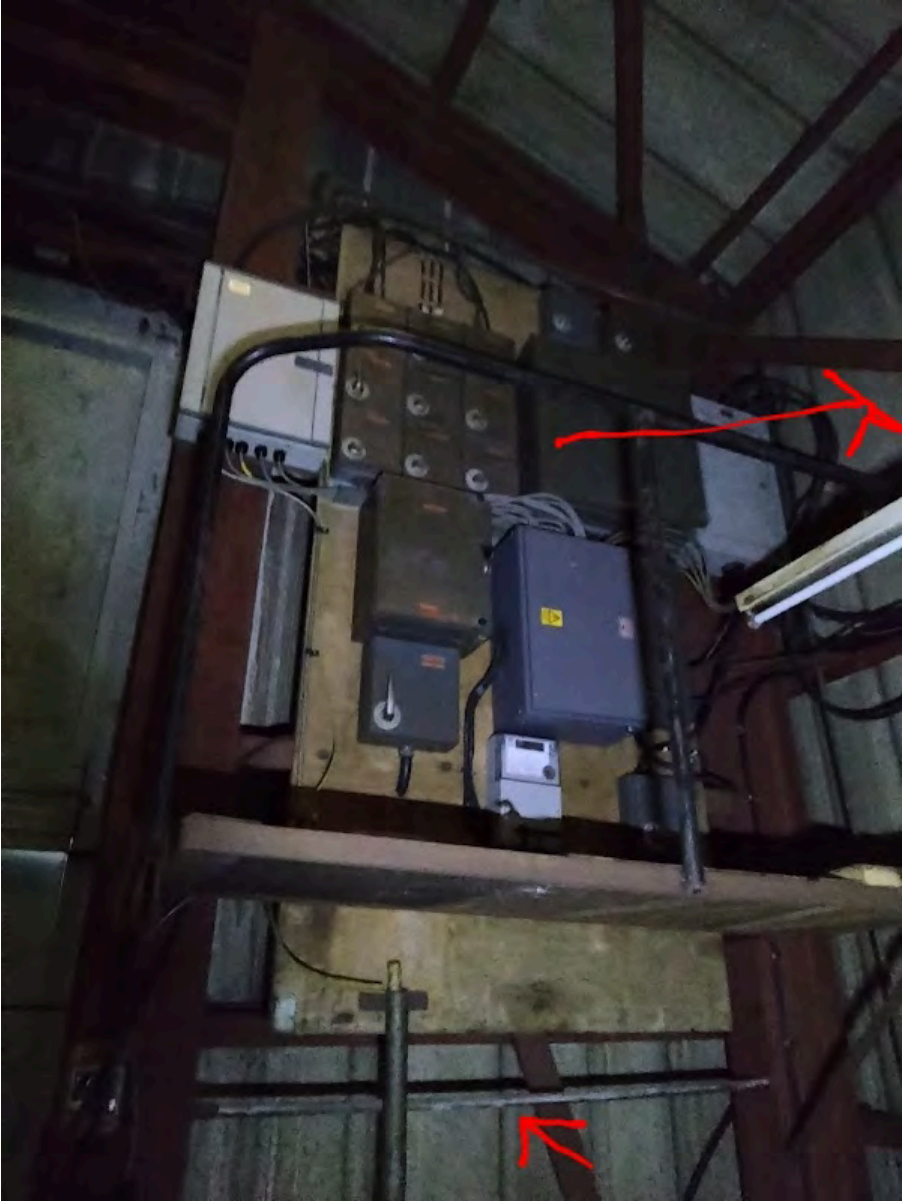
[007] 0-Ground floor > Workshop > Wall covering > Wall cladding					
Building Name	HNP Engineers Former Workshop				
Building Address	Commercial Rd, Lerwick, Shetland ZE1 0NJ, UK				
Extent	Measured 480.0 Square Metres				
Sample Number	As 007 (Ref: 007/6041)				
Notes	<a href="#">Cement Fibre wall lining sheet</a>

Material Assessment Score 5					
Asbestos Type	Chrysotile	1	Product Type	Reinforced Composites	1
Condition	Medium Damage	2	Treatment	Cement Sheets	1
Fibre Release	Low		Action Required	C: Monitor Biannually

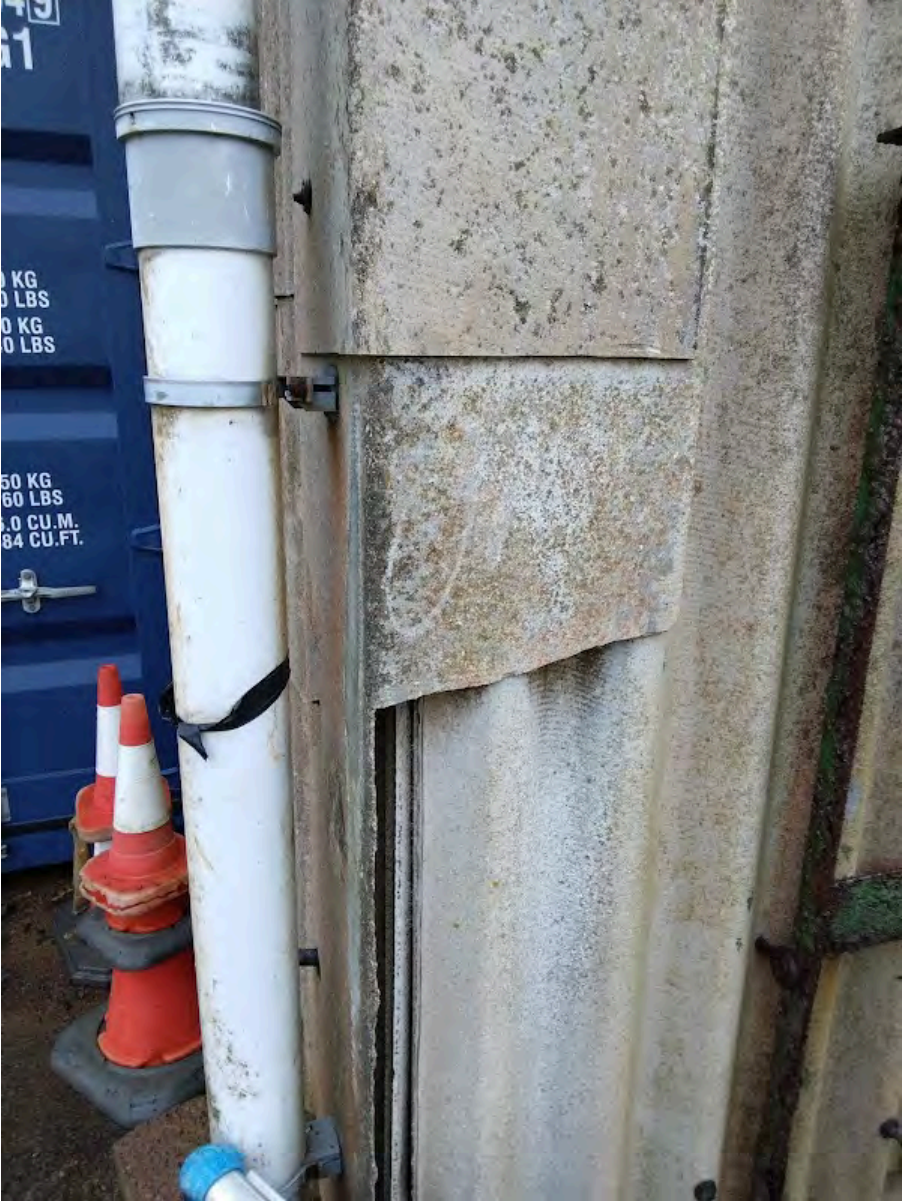
[008] External > Corners > Roof covering > Ridging					
Building Name	HNP Engineers Former Workshop				
Building Address	Commercial Rd, Lerwick, Shetland ZE1 0NJ, UK				
Extent	Measured 40.0 Linear Metres				
Sample Number	As 008 (Ref: 008/6041)				
Notes	<i>Corner flashing vertical</i>

Material Assessment Score 5					
Asbestos Type	Chrysotile	1	Product Type	Reinforced Composites	1
Condition	Medium Damage	2	Treatment	Cement Sheets	1
Fibre Release	Low		Action Required	C: Monitor Biannually

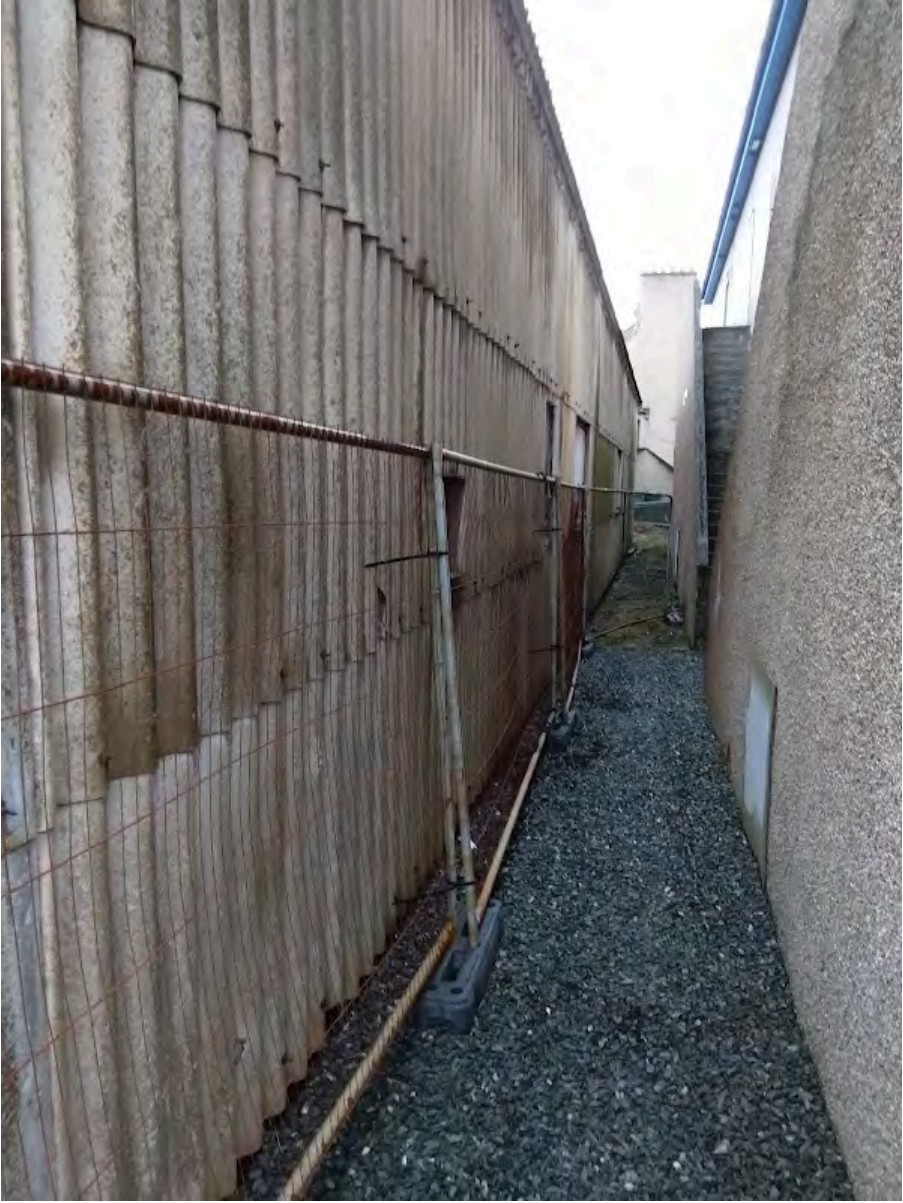
<b>[009] External &gt; Walls &gt; Roof covering &gt; Corrugated roof sheets</b>					
Building Name	HNP Engineers Former Workshop				
Building Address	Commercial Rd, Lerwick, Shetland ZE1 0NJ, UK				
Extent	Measured 480.0 Square Metres				
Sample Number	As 009 (Ref: 009/6041)				
Notes	<a href="#">Cement Fibre sheeting to Walls</a>

<b>Material Assessment Score 5</b>					
Asbestos Type	Chrysotile	1	Product Type	Reinforced Composites	1
Condition	Medium Damage	2	Treatment	Cement Sheets	1
Fibre Release	Low		Action Required	C: Monitor Biannually

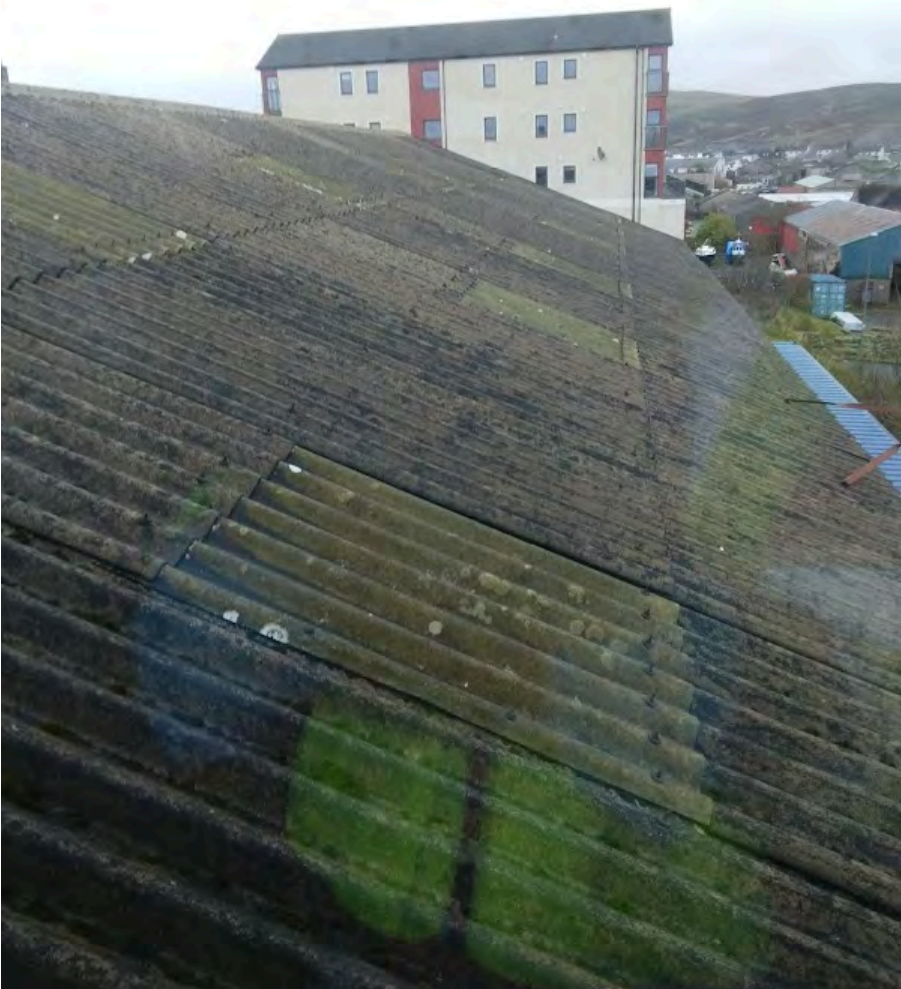
[012] External > Roof > Roof covering > Corrugated roof sheets					
Building Name	HNP Engineers Former Workshop				
Building Address	Commercial Rd, Lerwick, Shetland ZE1 0NJ, UK				
Extent	Measured 300.0 Square Metres				
Sample Number	As 012 (Ref: 012/6041)				
Notes	<i>Cement Fibre sheeting</i>

Material Assessment Score 5					
Asbestos Type	Chrysotile	1	Product Type	Reinforced Composites	1
Condition	Medium Damage	2	Treatment	Cement Sheets	1
Fibre Release	Low		Action Required	C: Monitor Biannually

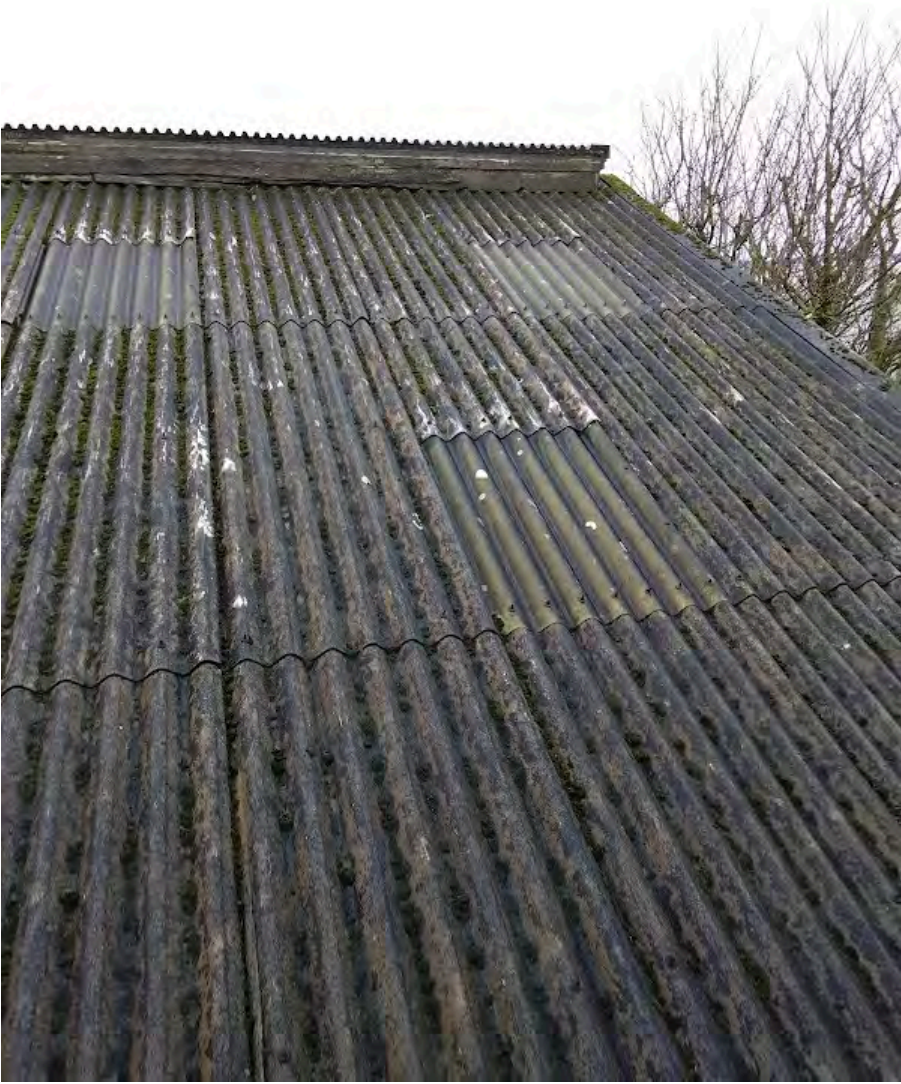
[013] External > Roof > Roof covering > Corrugated roof sheets					
Building Name	HNP Engineers Former Workshop				
Building Address	Commercial Rd, Lerwick, Shetland ZE1 0NJ, UK				
Extent	Measured 300.0 Square Metres				
Sample Number	As 013 (Ref: 013/6041)				
Notes	<i>Cement Fibre roof sheet</i>

Material Assessment Score 5					
Asbestos Type	Chrysotile	1	Product Type	Reinforced Composites	1
Condition	Medium Damage	2	Treatment	Cement Sheets	1
Fibre Release	Low		Action Required	C: Monitor Biannually

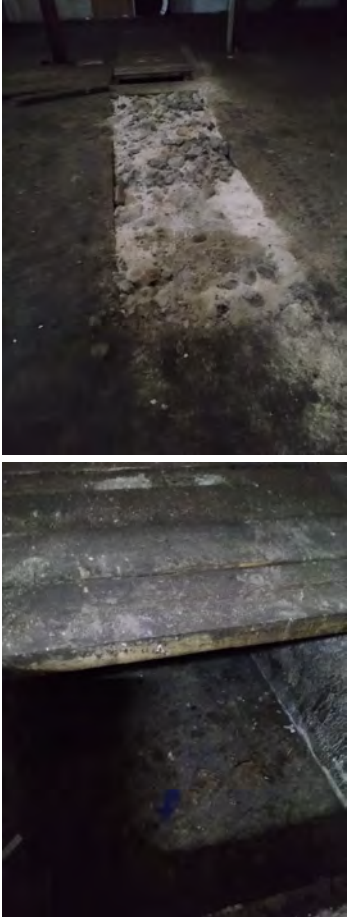
Excluded Area	Photo
<p>[032] 0-Ground floor &gt; Inspection pits Room <i>Inspection pits are filled/partially filled and could not be inspected</i></p>

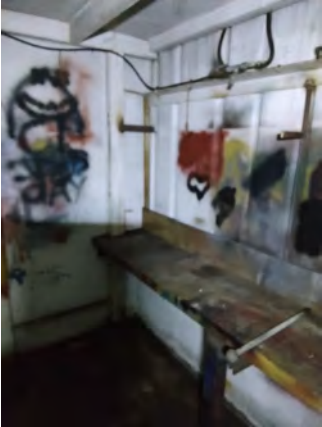
Non Asbestos Area/Item	Justification	Photo
[015] 0-Ground floor > Paint Store Room <a href="#">Paint Store</a>	<i>No Asbestos Detected</i> Area inspected in detail and no suspected asbestos containing materials identified.

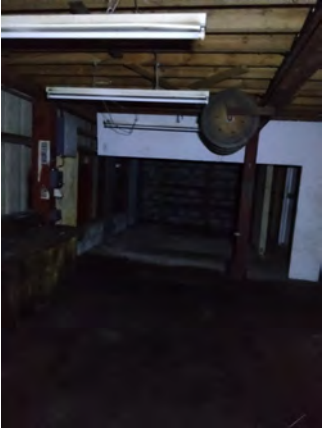
[016] 0-Ground floor > Store 4 Room <a href="#">Store 4</a>	<i>No Asbestos Detected</i> Area inspected in detail and no suspected asbestos containing materials identified.

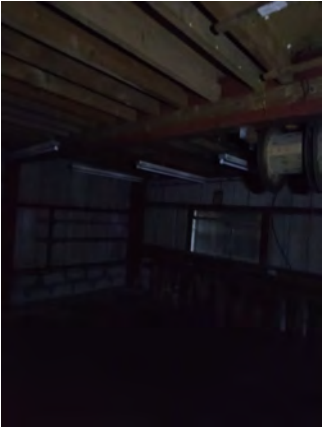
[017] 0-Ground floor > Store 3 Room <a href="#">Store 3</a>	<i>No Asbestos Detected</i> Area inspected in detail and no suspected asbestos containing materials identified.

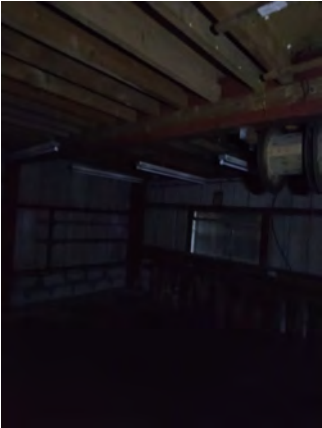
[018] 0-Ground floor > Store 2 Room <a href="#">Store 2</a>	<i>No Asbestos Detected</i> Area inspected in detail and no suspected asbestos containing materials identified.

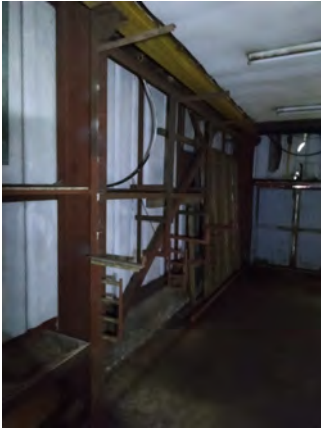
<p>[019] 0-Ground floor &gt; Metal Store Room</p> <p><i>Metal Store</i></p>	<p><i>No Asbestos Detected</i></p> <p>Area inspected in detail and no suspected asbestos containing materials identified.</p>

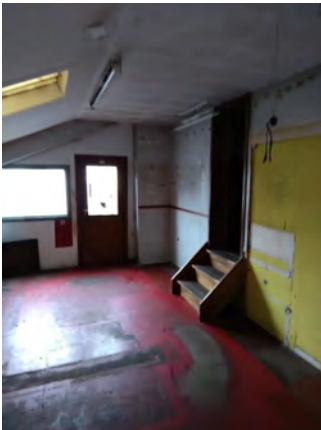
<p>[020] 1-First floor &gt; Shop Room</p> <p><i>Shop</i></p>	<p><i>No Asbestos Detected</i></p> <p>Area inspected in detail and no suspected asbestos containing materials identified.</p>

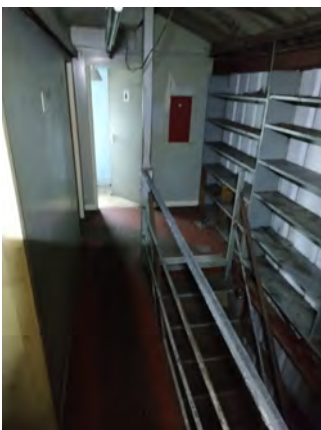
<p>[021] 1-First floor &gt; Landing Room</p> <p><i>Landing</i></p>	<p><i>No Asbestos Detected</i></p> <p>Area inspected in detail and no suspected asbestos containing materials identified.</p>

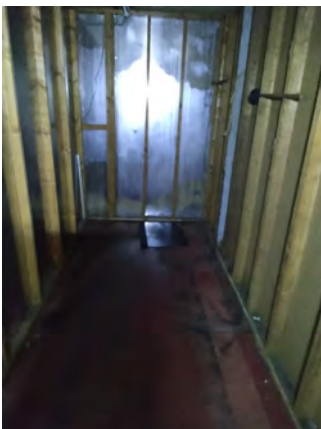
<p>[022] 1-First floor &gt; Store Room</p> <p><i>FF Store</i></p>	<p><i>No Asbestos Detected</i></p> <p>Area inspected in detail and no suspected asbestos containing materials identified.</p>

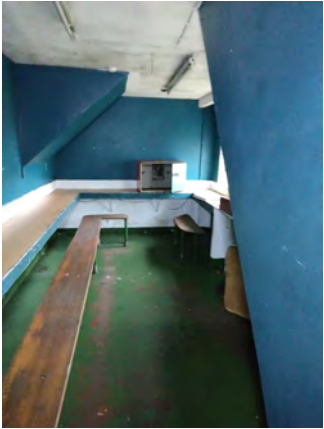
<p>[023] 1-First floor &gt; Canteen Room <i>Canteen</i></p>	<p><i>No Asbestos Detected</i> Area inspected in detail and no suspected asbestos containing materials identified.</p>

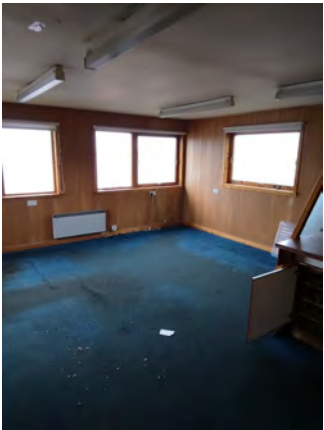
<p>[025] 2-Second floor &gt; Office 2 Room <i>Office 2 2nd Floor</i></p>	<p><i>No Asbestos Detected</i> Area inspected in detail and no suspected asbestos containing materials identified.</p>

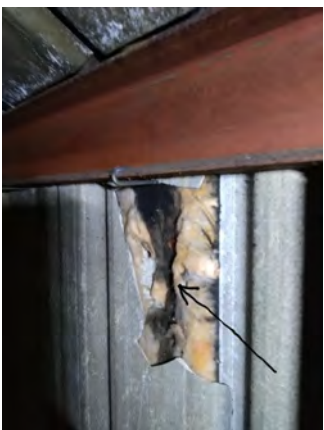
<p>[031] All floors &gt; Cavity insulation Area <i>All cavity insulation viewed is either Rockwool or Glassfibre</i></p>	<p><i>No Asbestos Detected</i> Knowledge of Product - Manufactured from a known non-asbestos product.</p>

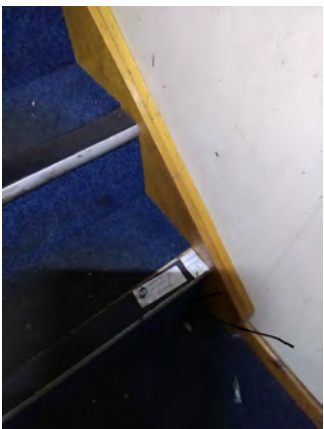
<p>[006] 1-First floor &gt; Main Office Other item Stair nosings <i>Vinyl stair nosing</i></p>	<p><i>No Asbestos Detected</i> Lab Results Sample 006</p>

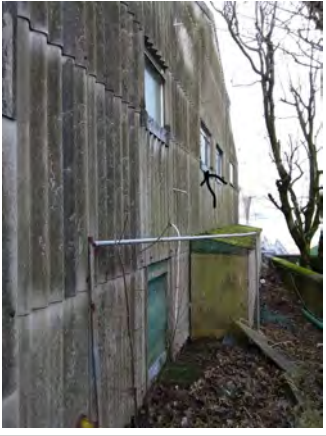
<p>[010] External &gt; Windows  Mastic  To window frames  <i>Linseed putty to frames</i></p>	<p><i>No Asbestos Detected</i>  Lab Results  Sample 010</p>

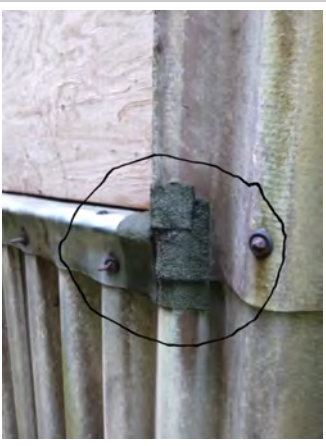
<p>[011] External &gt; Windows  Windows  Bitumen Felt flashing  <i>Felt flashing window sills</i></p>	<p><i>No Asbestos Detected</i>  Lab Results  Sample 011</p>

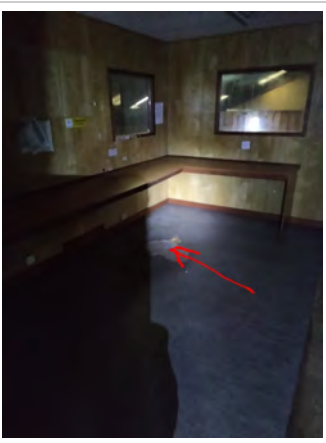
<p>[028] 1-First floor &gt; All rooms  Flooring  Vinyl sheet floor  <i>Though first floor - Grey</i></p>	<p><i>No Asbestos Detected</i>  Lab Results  Sample 028</p>
