## **Reinspection of Management Asbestos Survey Report**

Inspection Date(s): 19<sup>th</sup> May 2025

Site Address: 12 Scalloway Road  
Lerwick, Shetland

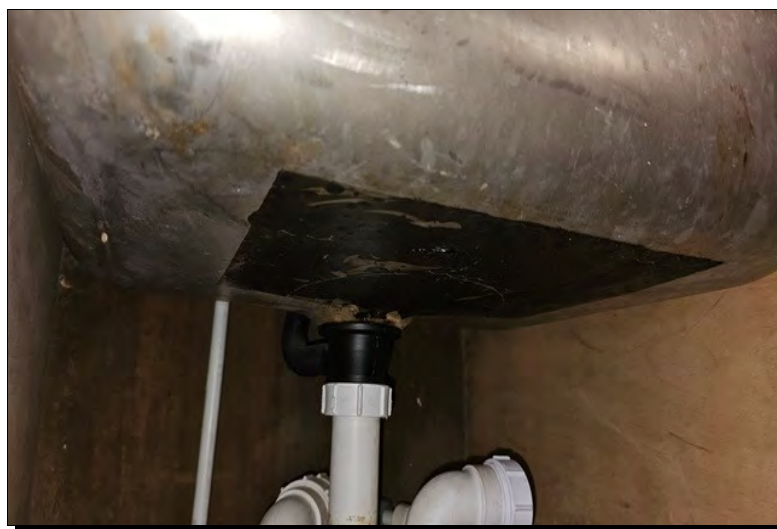
Photo Reference: 1

| Floor/<br>Loc ID: | Location Description: | Surface: | Material Description/type: | Size: | Sample<br>Reference: | Associate<br>Sample: | Material Assessment | | | | Material Risk<br>Assessment:<br>Algorithm: | Next<br>Inspection<br>date | Action / Recommendation |
|---|---|---|---|---|---|---|---|---|---|---|---|---|---|
| Ground<br>03 | Kitchen | Fitting | Bitumen sink pad beneath<br>drainer only | x1 | 01 | | Chrysotile | Bitumen | Low damage | Sealed | 4 | 19/05/2027 | Monitor, label and<br>manage |

**Analysis Result:** Chrysotile **Material:** Bitumen  
**Condition:** Low damage **Surface Treatment:** Sealed

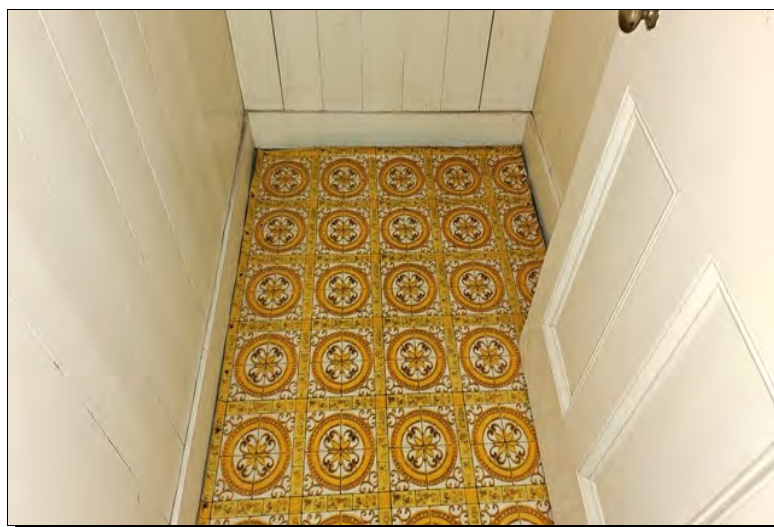
Photo Reference: 3

| Floor/<br>Loc ID: | Location Description: | Surface: | Material Description/type: | Size: | Sample<br>Reference: | Associate<br>Sample: | Material Assessment | | | | Material Risk<br>Assessment:<br>Algorithm: | Next<br>Inspection<br>date | Action / Recommendation |
|---|---|---|---|---|---|---|---|---|---|---|---|---|---|
| Ground<br>07 | Store Room | Floor | Paper lining beneath lino | 1.5 sq m | 03 | | Chrysotile | Paper | Low Damage | Sealed | 5 | 19/05/2027 | Monitor, label and<br>manage |

**Analysis Result:** Chrysotile **Material:** Paper  
**Condition:** Low Damage **Surface Treatment:** Sealed

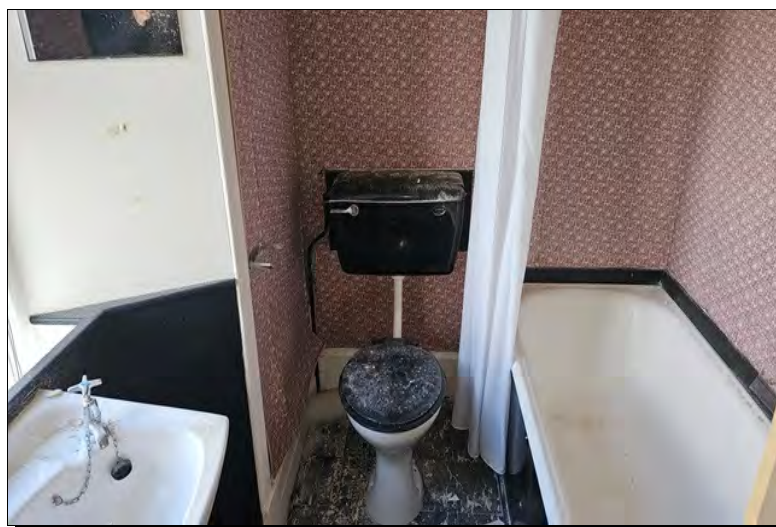
Photo Reference: 5

| Floor:/<br>Loc ID: | Location Description: | Surface: | Material Description/type: | Size: | Sample<br>Reference: | Associate<br>Sample: | Material Assessment | | | | Material Risk<br>Assessment:<br>Algorithm: | Next<br>Inspection<br>date | Action / Recommendation |
|---|---|---|---|---|---|---|---|---|---|---|---|---|---|
| First<br>15 | Bathroom | Fitting | Black toilet cistern | x1 | 05 | | Amosite | Resin | Low damage | Sealed | 5 | 19/05/2027 | Monitor, label and manage |

**Analysis Result:** Amosite **Material:** Resin  
**Condition:** Low damage **Surface Treatment:** Sealed

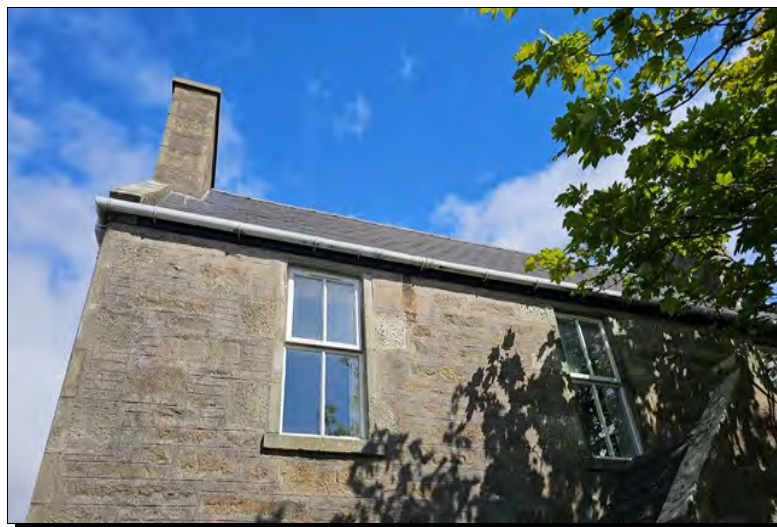
Photo Reference: 8

| Floor:/<br>Loc ID: | Location Description: | Surface: | Material Description/type: | Size: | Sample<br>Reference: | Associate<br>Sample: | Material Assessment | | | | Material Risk<br>Assessment:<br>Algorithm: | Next<br>Inspection<br>date | Action / Recommendation |
|---|---|---|---|---|---|---|---|---|---|---|---|---|---|
| 18 | External Elements | Fitting | Roof tiles to main building | 140 sq m | 08 | | Chrysotile | Cement | Low damage | Sealed | 4 | 19/05/2027 | Monitor, label and manage |

**Analysis Result:** Chrysotile **Material:** Cement  
**Condition:** Low damage **Surface Treatment:** Sealed

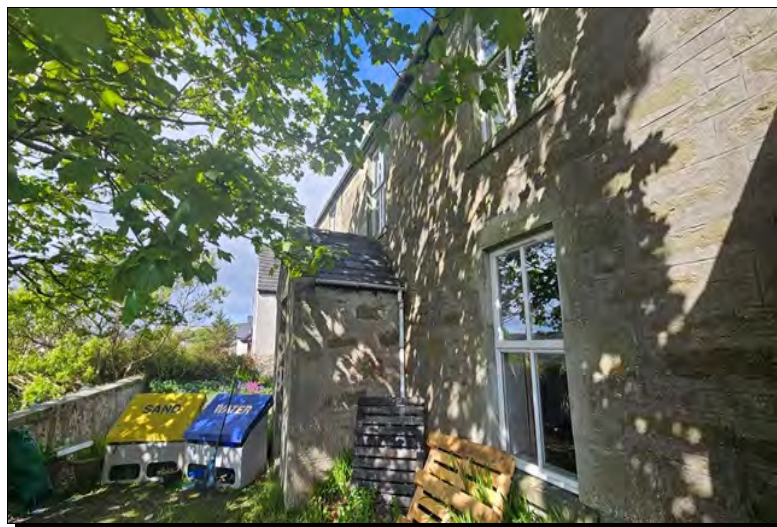
Photo Reference: 9

| Floor:/<br>Loc ID: | Location Description: | Surface: | Material Description/type: | Size: | Sample<br>Reference: | Associate<br>Sample: | Material Assessment | | | | Material Risk<br>Assessment:<br>Algorithm: | Next<br>Inspection<br>date | Action / Recommendation |
|---|---|---|---|---|---|---|---|---|---|---|---|---|---|
| 18 | External Elements | Fitting | Roof tiles above entrance<br>vestibule | 3 sq m | CR | 08 | Chrysotile | Cement | Low damage | Sealed | 4 | 19/05/2027 | Monitor, label and<br>manage |

**Analysis Result:** Chrysotile **Material:** Cement  
**Condition:** Low damage **Surface Treatment:** Sealed
