Intended for
Viking Energy Wind Farm LLP

Date
November 2020

VIKING WIND FARM PLANNING MONITORING OFFICER AUDIT REPORT 001

| Audit Date | 28 th October 2020 |

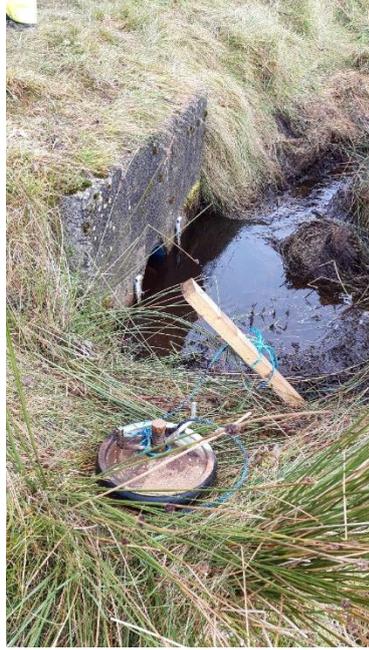
The PMO inspected the drainage channel on the northern side of the road between Culverts 2 and 5 and observed the culvert outflow points on the southern side of the road. Plugs attached to wooden stakes were observed adjacent to each culvert outflow, with each of these noted to be open during the audit (refer to Appendix 1, Photo 1,). The Environmental Advisor explained that the plugs were used to allow drainage originating from the development site to be diverted to Culvert 4, which is the main discharge point to the loch.

It was highlighted by the Environmental Advisor that repairs were required to the grout on the underside of Culvert 3, to prevent drainage run-off flowing underneath the culvert pipe following an incident on 24th October 2020 which resulted in silt flowing into the Sandwater Loch. Ramboll was provided with a copy of the incident report that was prepared by the Principal Contractor evidence that the incident was subsequently reported to SEPA by email on 27th October 2020. A member of site personnel was observed attending to this repair on the day of the audit and SSE confirmed via email that this task had commenced, with the northern side of the road completed on 30th October 2020, and the southern side (i.e. the side of the loch) scheduled for completion by Monday 2nd November 2020.

Photo 1. Plug attached to wooden stake at Culvert 3

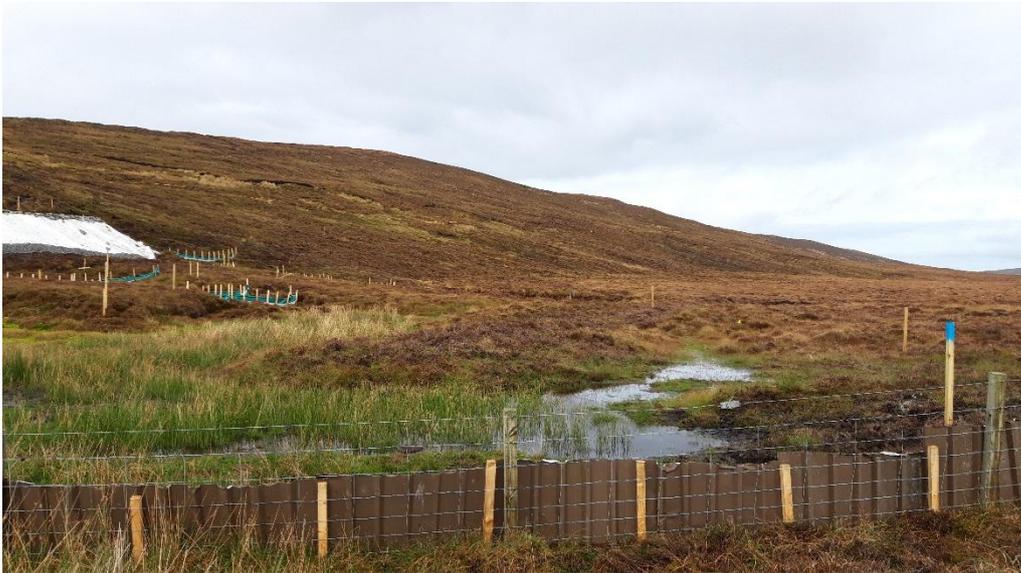
A waterlogged area of the proposed route of the new Sandwater Road was observed between Culverts 2 and 3. It was highlighted by the Environmental Advisor that this is an area where water accumulates. Additional shuttering was observed to have been installed along the fence line between this area and the drainage ditch along the north side of Sandwater Road, in response to the heavy rainfall event (refer to Appendix 1, Photo 2).

Photo 2. Shuttering along field edge between Culvert 2 and 3 where waterlogged ground is present

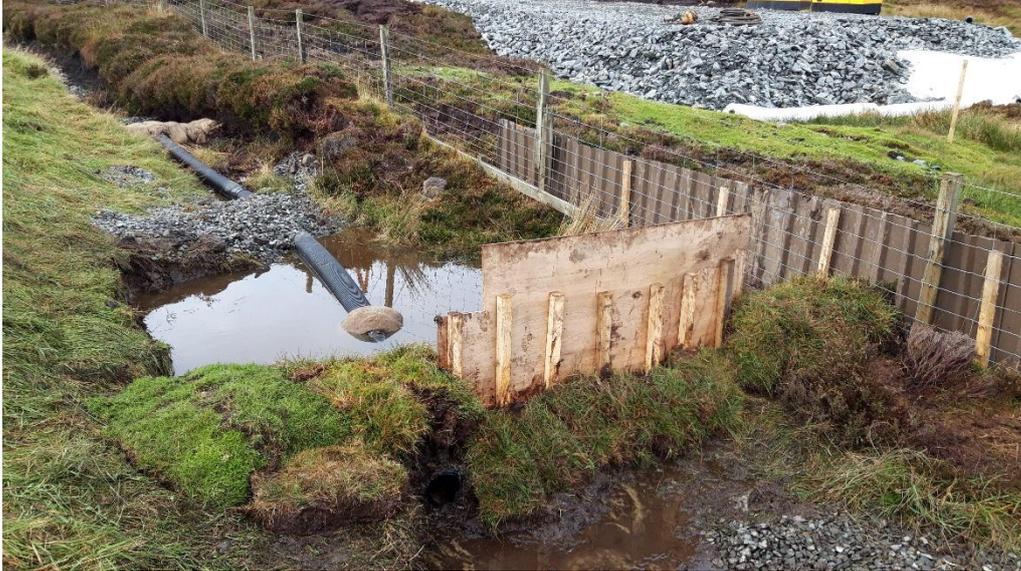
An area of ponded water was observed in the drainage ditch west of the access track (refer to Appendix 1, Photo 3). It was reported by the Environmental Advisor that water had previously

been observed to be 'bubbling' at the surface, following the aforementioned rainfall event, and was thought to be a groundwater spring. The 'bubbling' was not occurring during the PMO audit. It was reported that a pump will be used to divert the pooled surface water back to the settlement ponds located below the compound at the temporary access point on Sandwater Road. The PMO observed that a length of pipe had been installed in this area so that drainage run-off did not flow into the pooled water area, as well as wooden shuttering. This appeared to be providing an effective barrier with the down gradient drainage ditch (refer to Appendix 1, Photos 3 and 4). The separation of the development run-off in the ditch and the 'clean' groundwater is in accordance with measures set out in Section 10.2 of the CEMP.

Photo 3. View of ponded groundwater due to be pumped back to settlement pond.

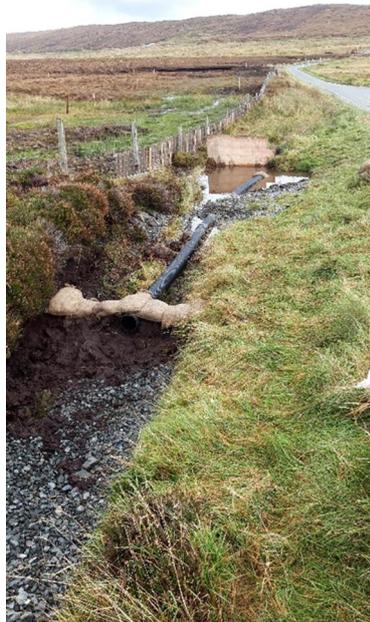
Photo 4. View of pipe placed in drainage channel to allow surface run-off to by-pass ponded groundwater.

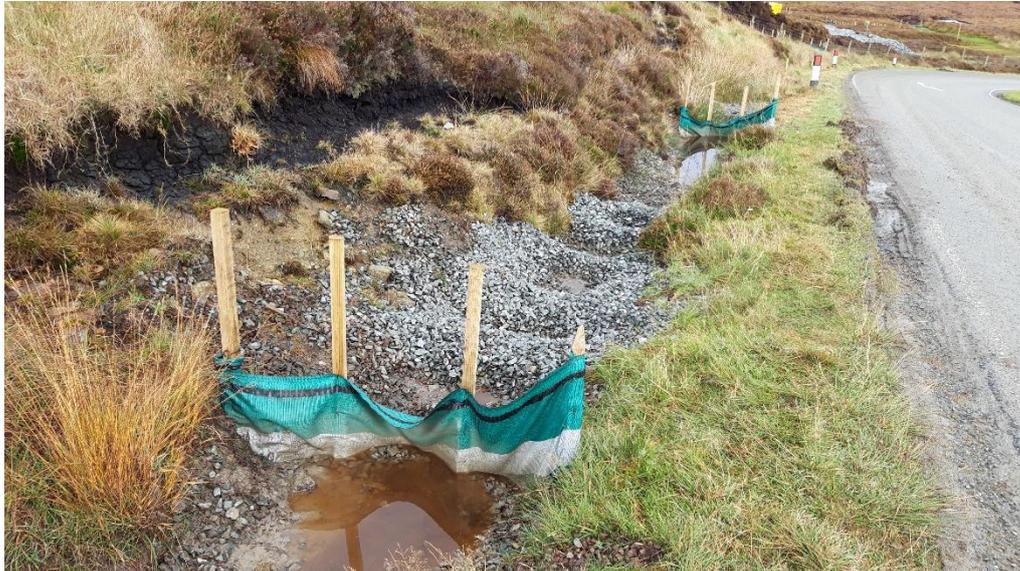
Photo 5. Example of silt fences and clean stone in place to aid drainage in ditch to south of construction area on Sandwater Road

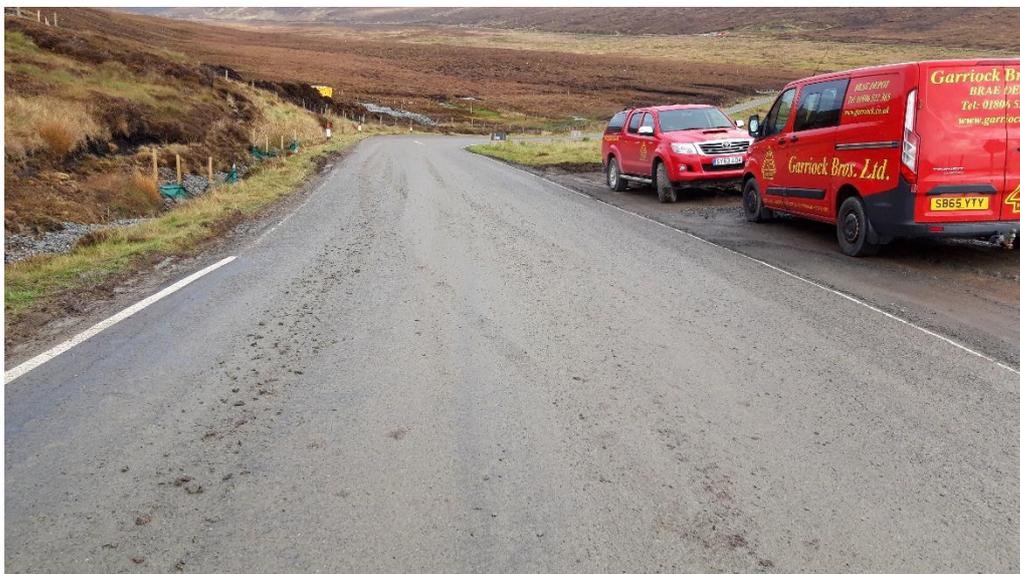
Silt and mud were observed by the PMO on the road leading from the access point to the temporary Sandwater Road compound at the top of the hill, expected to be as a result of lorry movements entering and leaving the site (refer to Appendix 1, Photo 6). A wheel wash was not present on site, nor was a road sweeper. Condition 28 of the planning consent sets out the requirement for road cleaning to address the presence of mud, silt or debris on the road network. It is stated in Section 18.2 of the CEMP that a road sweeper will be employed where required and that a wheel wash will be installed at each of the construction compounds. The Environmental Advisor stated that the Principal Contractor had arranged for these items to be delivered to site. Following the audit, the PMO received confirmation that these had been received at the site on 29th October 2020. Monitoring of the road network will be undertaken by the Principal Contractor foremen, ECoW and SSE Environmental team on a daily basis.

Photo 6. Mud observed on road at the temporary access point to Sandwater Road compound

| Issue | Auditor Comments | Required Action | Action Owner | Status |
|---|--|--|---|---|
| Materials Storage and Handling | <p>Silt and mud were observed on the road adjacent to the Sandwater Road temporary construction access. A wheel wash had not yet been set up at this construction compound and a road sweeper was not readily available.</p> <p>The presence of silt and mud on the road network presents a potential risk to the water environment, including the nearby Sandwater Loch. A Corrective Action was raised.</p> <p>HGVs entering and leaving this area were observed to be sheeted to minimise dust generation.</p> <p>The PMO received confirmation that a wheel wash and road sweeper have been received at the site on 29th October.</p> | <p>No further actions required.</p> <p>Road network around access points will be reviewed as part of the next audit.</p> | N/A | Green |

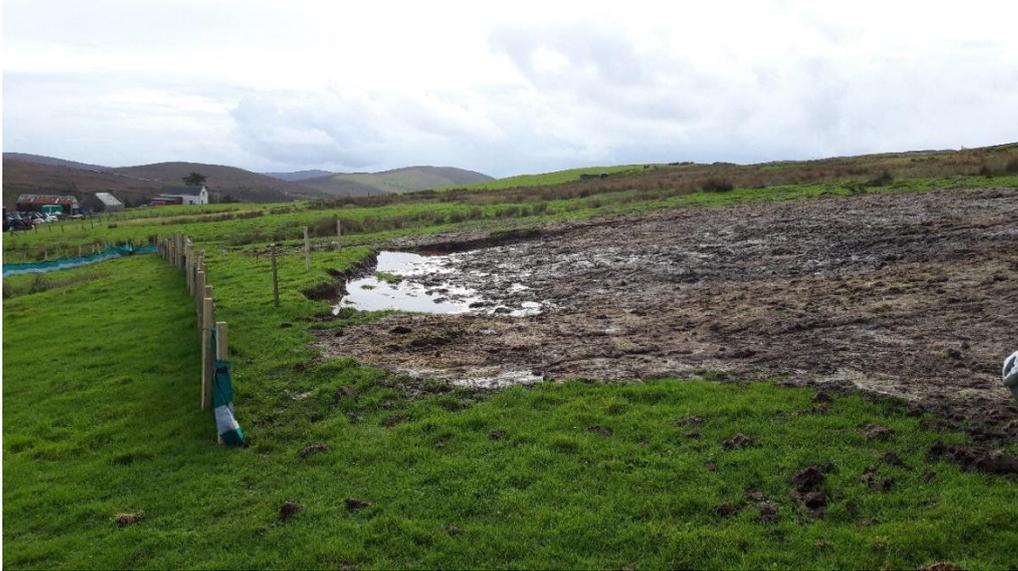
An incident report was prepared by Tulloch Developments Ltd (Principal Contractor for construction of the Kergord Access Track). A copy of the report was provided by the ECoW to Ramboll for review following the site audit. At the time of the incident, a new culvert was installed beneath the Kergord Access Track to direct surface water away from the work area and silt fences were already in place downstream of the culvert. It is reported the discoloured water was caused by a combination of surface run-off from exposed mineral sediment on the northern side of the track and flow through the bedding of the culvert.

Photo 7. Area of temporary settlement pond downgradient of Kergord Access Track, in the vicinity of Burn of Weisdale tributary.

- The excavation of an additional settlement pond (refer to Appendix 1, photo 7).
- The erection of additional silt fences downstream of the access track (refer to Appendix 1, photo 8).
- Four check dams comprising clean stone were added to the impacted tributary to aid filtration of run-off (refer to Appendix 1, photo 9).

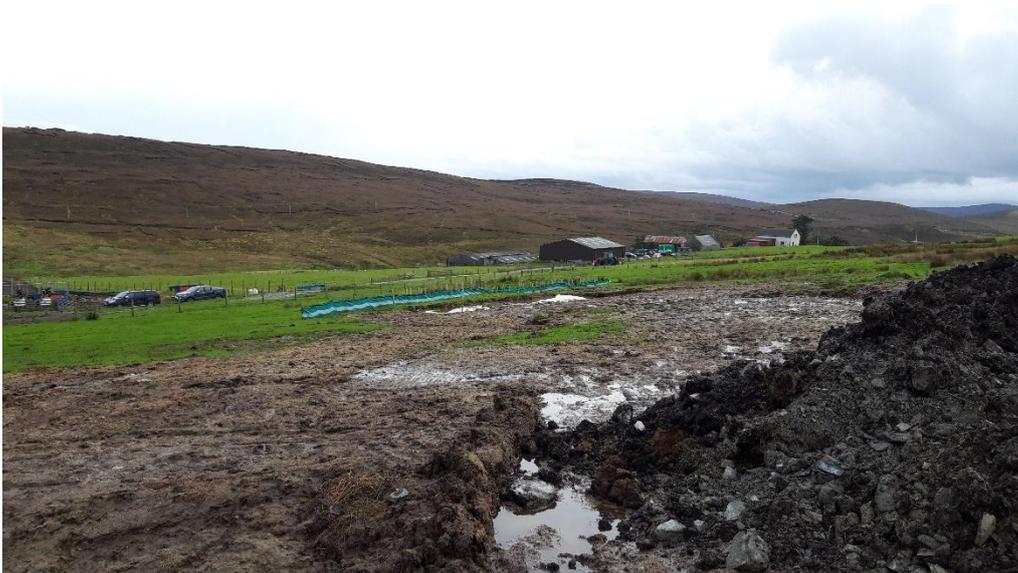
Photo 8. View of silt fencing beyond settlement pond, downgradient of the Kergord Access Track.

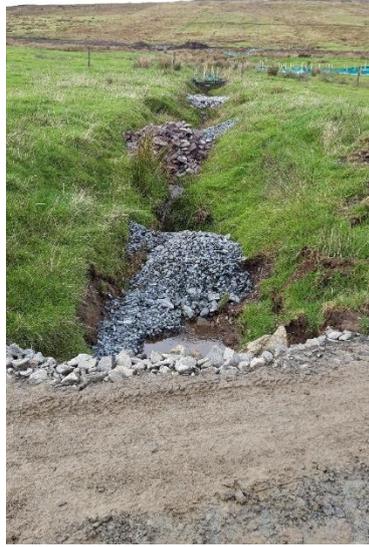
At the time of the audit the surface water in the tributary, both upgradient and downgradient of the crossing point was noted by the PMO to be clear.

Photo 9. View of Burn of Weisdale tributary containing silt fencing and stone check dams following incident on 1st October 2020.

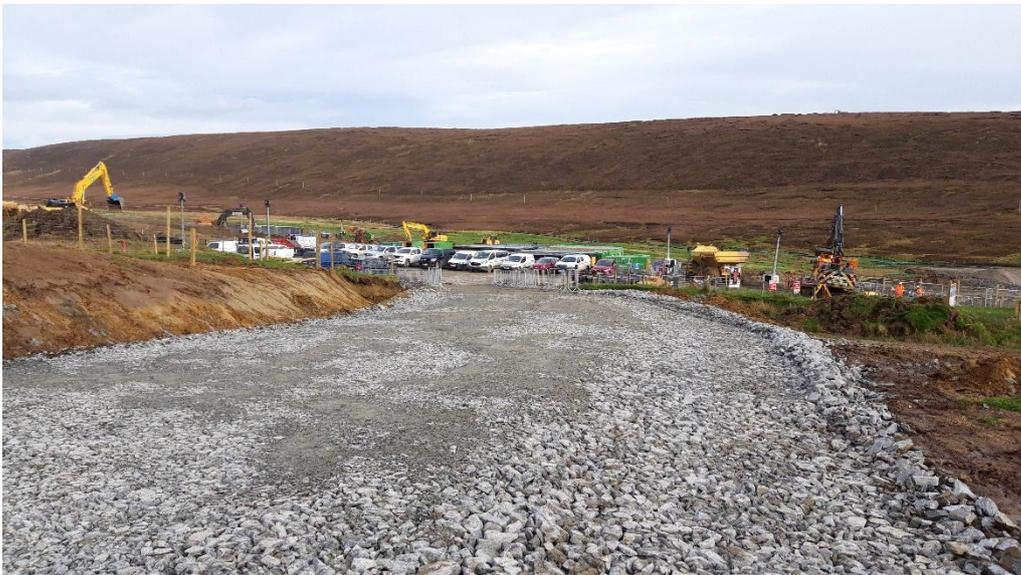
During the audit it was noted that an additional filter drain had been constructed alongside the end of the Kergord Access Track (i.e. where the track connects with the adjacent BAM compound), north of Upper Kergord Farm (refer to Appendix 1, photo 10). It was reported that this was to avoid surface water run-off flowing onto the BAM compound. The Planning Enforcement Officer questioned whether this was in the planning consent and it was confirmed by SSE that this was a deviation from the approved design. The Planning Enforcement Officer stated that any deviations from consented plans must be communicated to the Council Planning Department and approved prior to construction.

Photo 10. End of Kergord Access track with filter drain on right hand-side of image, reportedly constructed to manage run-off that would otherwise flow towards BAM Construction compound in the distance.

| Issue | Auditor Comments | Required Action | Action Owner | Status |
|--|--|---|---|---|
| <p>Pre-planning Works (including site set-up and general management, access tracks, community liaison)</p> | <p>A filter drain was constructed as part of the northern end Kergord Access Track to assist with surface water drainage in the area and avoid run-off towards the adjacent BAM construction compound. This was not part of the approved planning consent.</p> | <p>SSE to ensure relevant information is retrospectively provided to the Council's planning department and that going forward appropriate liaison with the Council planning department is undertaken.</p> | <p>VEWF</p> | <p>Amber</p> |
