Viking Energy Wind Farm LLP

February 2021

1620009158

**VIKING ENERGY WIND
FARM
PLANNING
MONITORING OFFICER
AUDIT REPORT 003: 2ND
DECEMBER 2020 TO 26TH
JANUARY 2021**

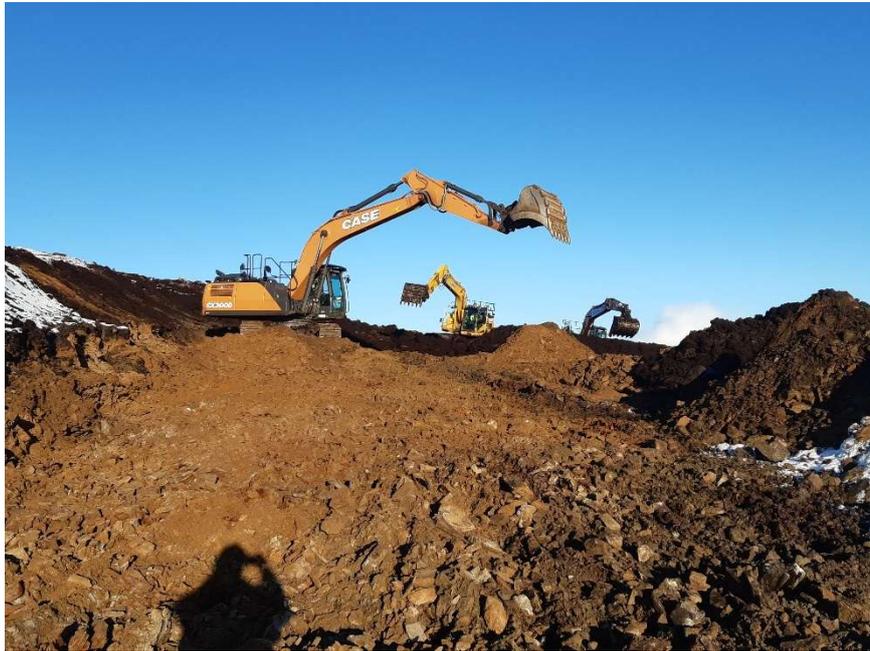
Three excavators were operating at the northern extent of the track at the time of the audit, which included trench excavation for the placement of a culvert. Construction of the road was progressing and it was noted that peat and mineral soils had been deposited to the side of the track (Refer to Appendix 1, Photo 1).

Photo 1. Excavators at Spur 5, peat and mineral soils cast to the side of the track

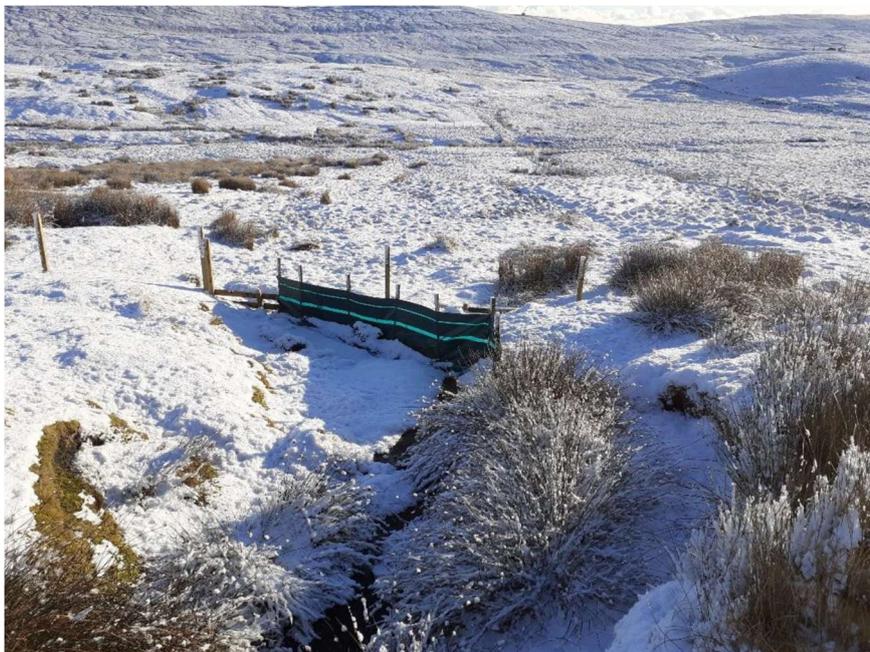
An Environmental Incident was reported on 21st January 2021, which was identified by the Principal Contractor's ECoW. Water containing silt was observed to be entering the Burn of Droswell. Three sources were identified:

- Water entering the burn from beneath the culvert at Ch.850 of the KAT.
- Water originating from the trackside ditch of the KAT through filter stones and silt fencing. Due to the steep topography, silt fencing was not effective in slowing down the water at this location to allow the sediment to settle effectively.
- Discoloured water entering the burn through a peat pipe (a natural conduit) 100 m east of the KAT at Ch.1300.

The cause of the incident was considered to be related to a temporary increase in traffic movements (dump trucks) on the KAT while peat was being deposited into the peat storage area. This resulted in disturbance to material previously placed to construct the track, with heavy

Photo 2. New silt fencing east of KAT Ch.1300 to divert dirty water from peat pipe. (Photograph originally appended to RJM Environmental Incident Report Form ENV 005, dated 26th January 2021).

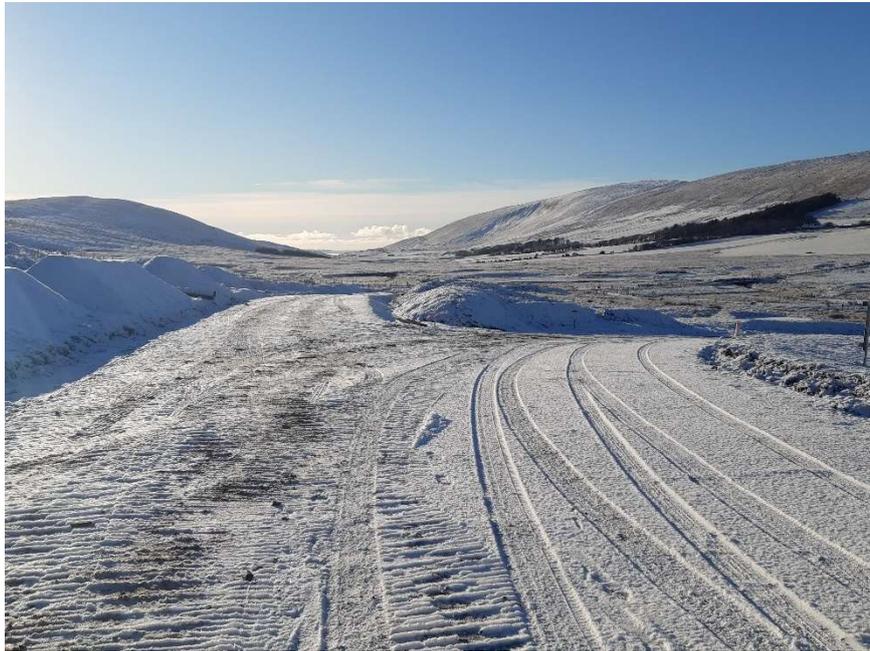
At the western limit of the new road construction, drainage mitigation measures comprising a settlement pond and silt fences were observed via live video link. Mineral soil remained exposed along the final 50 m stretch of the road, prior to placement of stone which was still to be completed. The ACoW confirmed that a full-time archaeological watching brief was undertaken in this area. Records were logged on the GIS Trigger Map which was viewed by the PMO via video call on the day of the audit. The western extent of the road at the time of the audit is shown on Photo 3 of Appendix 1.

Photo 3. Western extent of Sandwater Road.

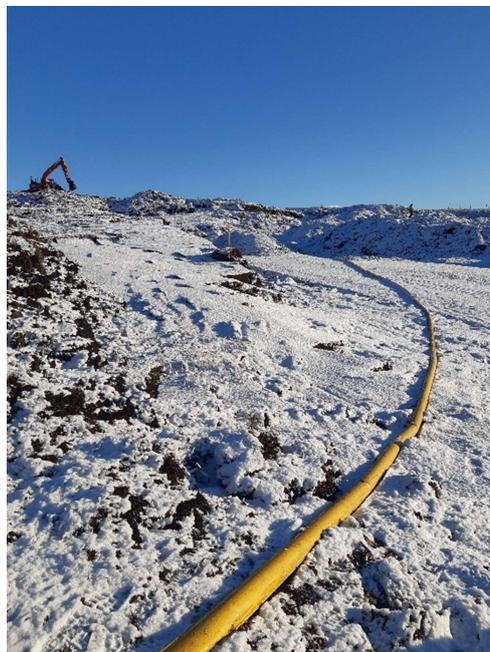
A yellow hose was observed which was in use to temporarily divert dirty (silty) water from the area of the Upper Burn of Swirtars diversion route during excavation of the cutting at Ch.1450 towards a settlement pond (refer to Appendix 1, Photos 4 and 5). The settlement pond was frozen and covered with snow at the time of the inspection.

Photo 4. Hose used to divert silty water from the Upper Burn of Swirtars to settlement pond

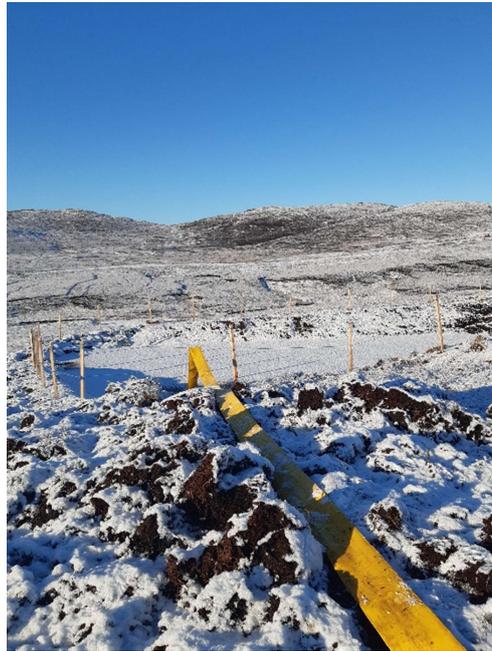
Photo 5. Hose used to divert silty water from the Upper Burn of Swirtars. Settlement pond delineated by posts and frozen at the time of the audit.

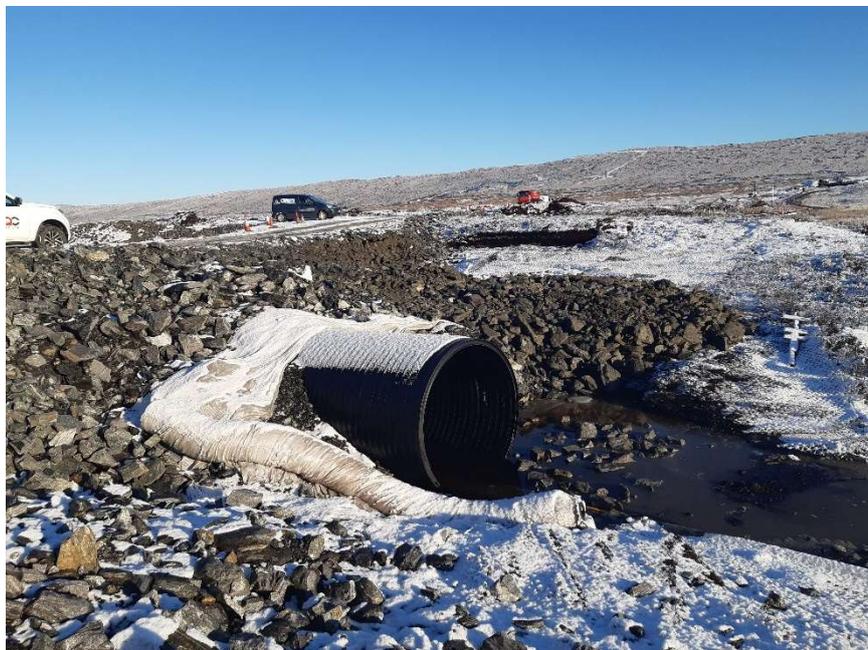
Photo 6. Sandwater Road, Culvert 2

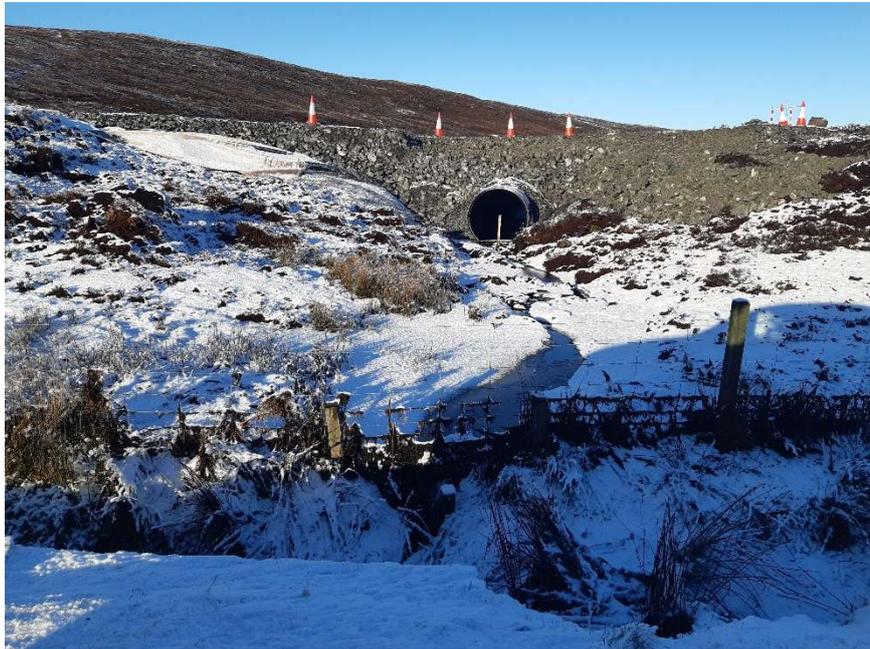
Photo 7. Sandwater Road, Culvert 3

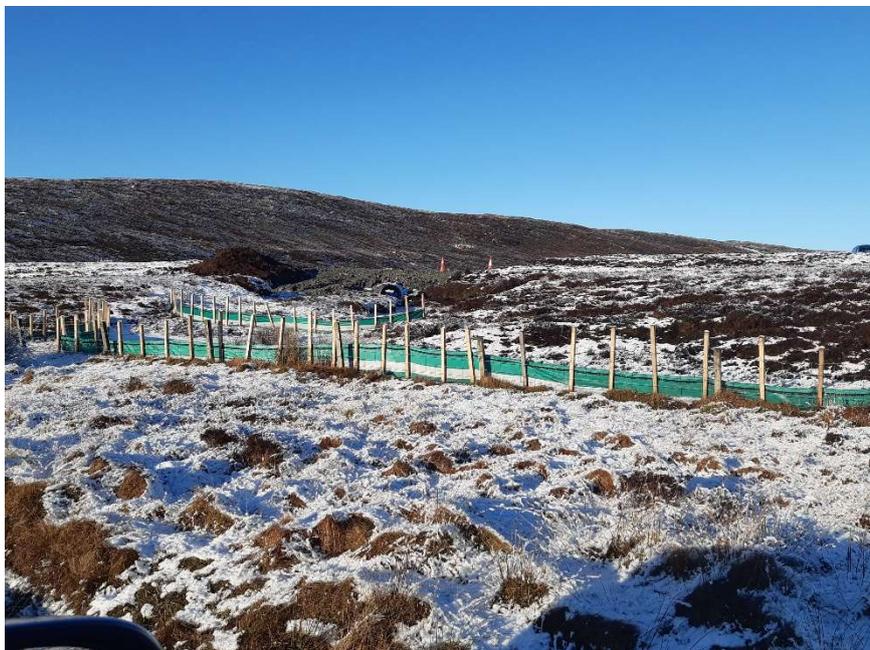
Photo 8. Sandwater Road, Culvert 4

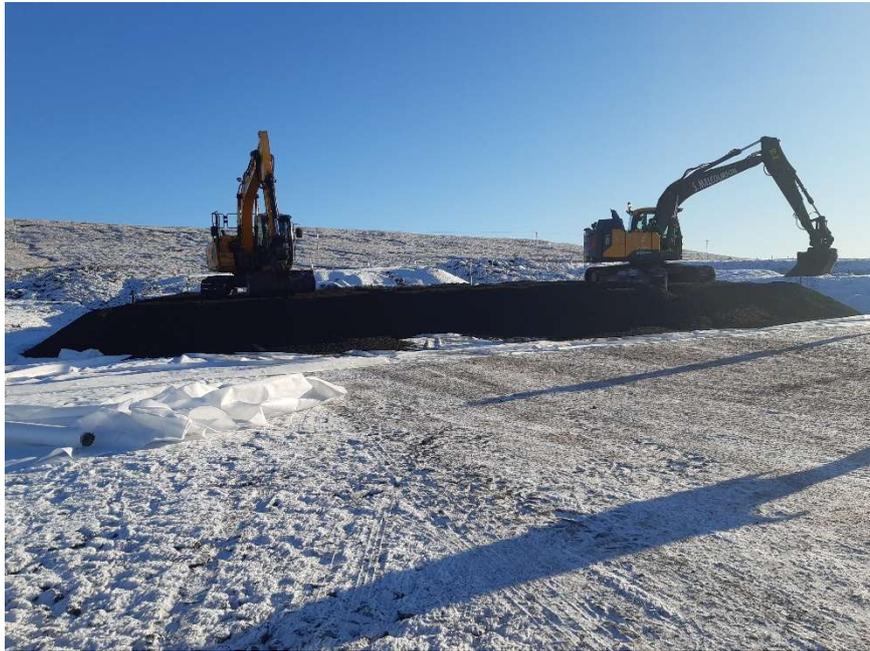
During the audit construction of the eastern end of the road was ongoing via the placement of LECA (lightweight clay aggregate) fill between Ch.0 and the Pettawater Burn (refer to Appendix 1, Photo 9).

Photo 9. Eastern end of Sandwater Road, excavators placing LECA clay aggregate on new road surface

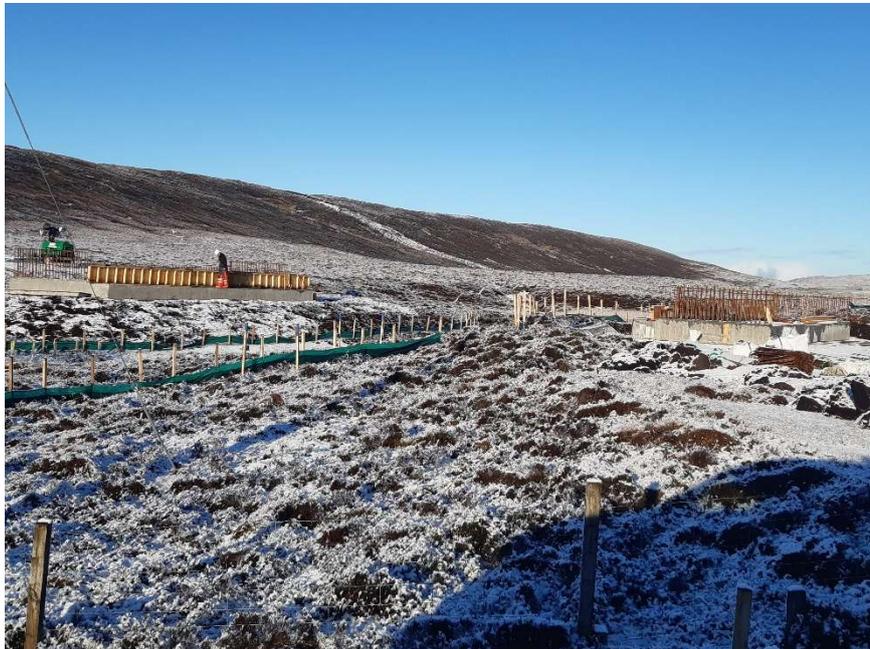
The construction of the bridge over the Pettawater Burn is subject to a CAR License¹⁰. A method statement for the works was prepared by RJ McLeod and submitted to SEPA by SSE on 25th August 2020. SEPA confirmed via email that the method statement had been approved on 26th August 2020. The PMO noted that steel was being positioned onto the eastern concrete bridge abutment during the audit. Concrete had also been poured to form the western abutment and site personnel were in the process of removing wooden shuttering from the cured concrete. Silt fencing was in place along the bank on both sides of the burn. Photograph 10 shows this area at the time of the audit.

Photo 10. Bridge abutments on the banks of the Burn of Pettawater. Silt fencing has been erected on both banks.

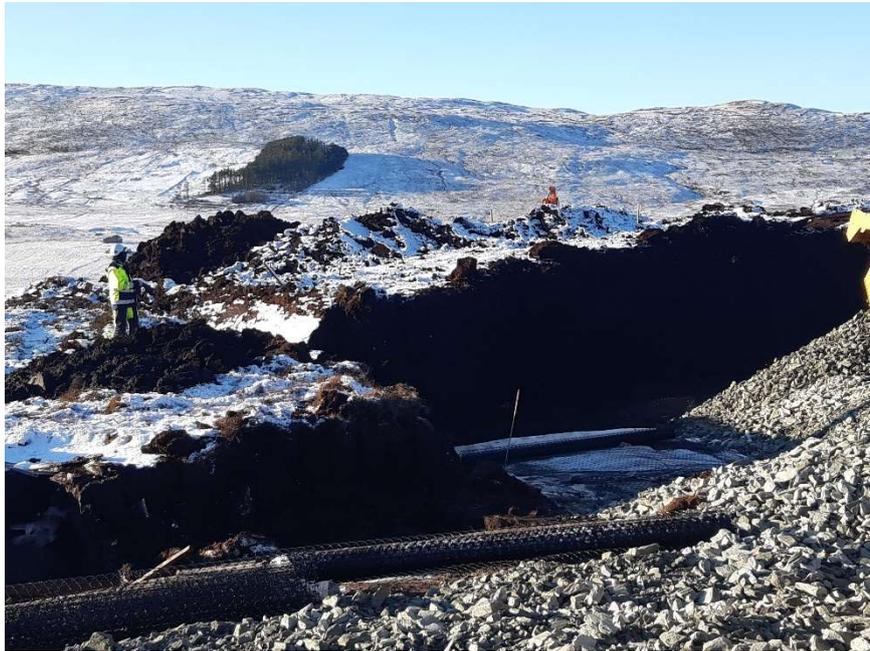
At the time of the audit, stone was being transported via dump trucks for the construction of the transition area of the road (i.e. between Ch.1400 and Ch.1500). The GCoW was observed to be monitoring the works in this area. Photograph 11 of Appendix 1 shows this work area at the time of the audit.

Photo 11. Transition area on Sandwater Road between Ch.1400 and Ch.1500.

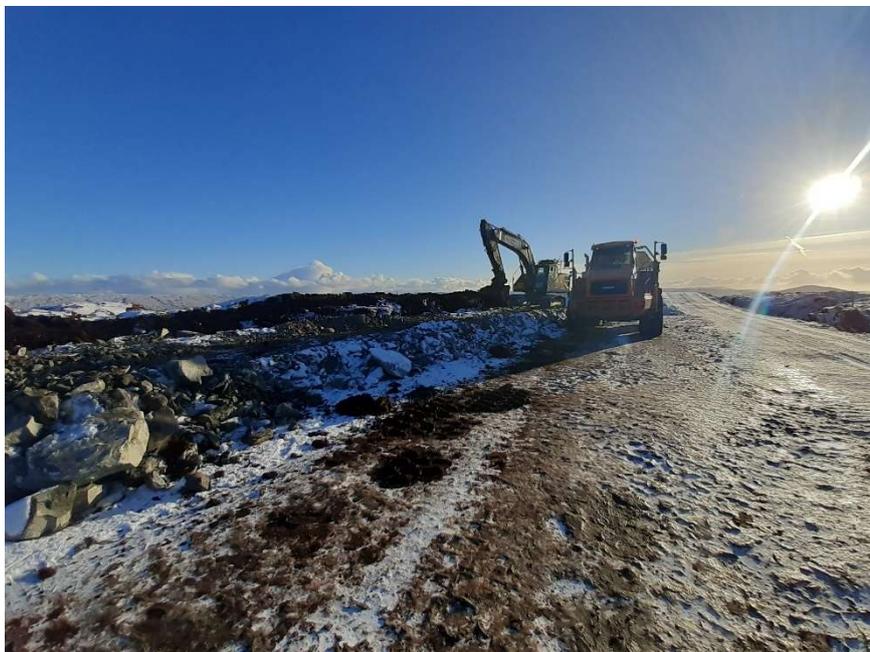
Photo 12. Excavator forming the hardstanding for crane pad at K86 on Mid Kame Ridge

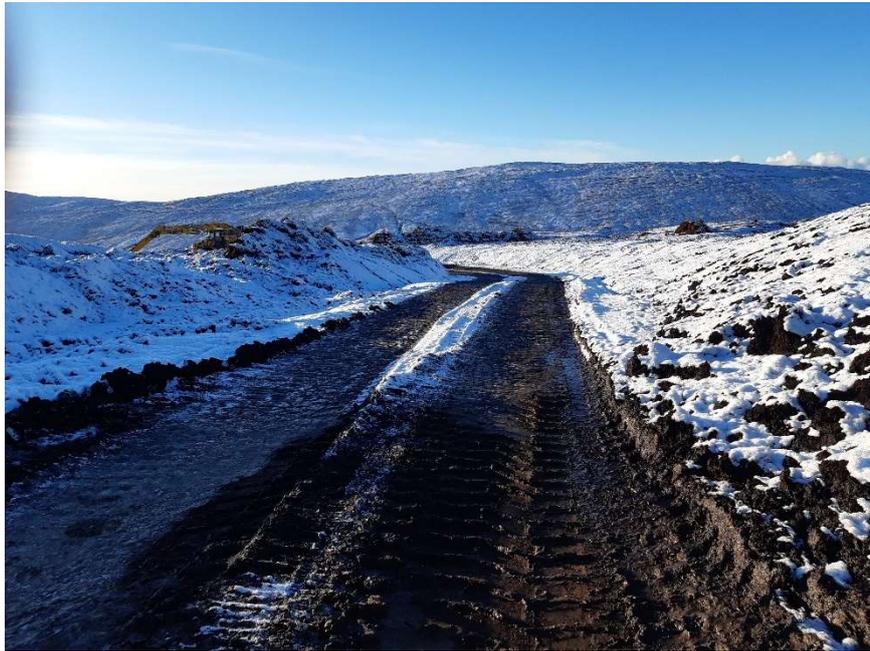
Photo 13. Access track to peat restoration area P0809 on the Mid Kame Ridge

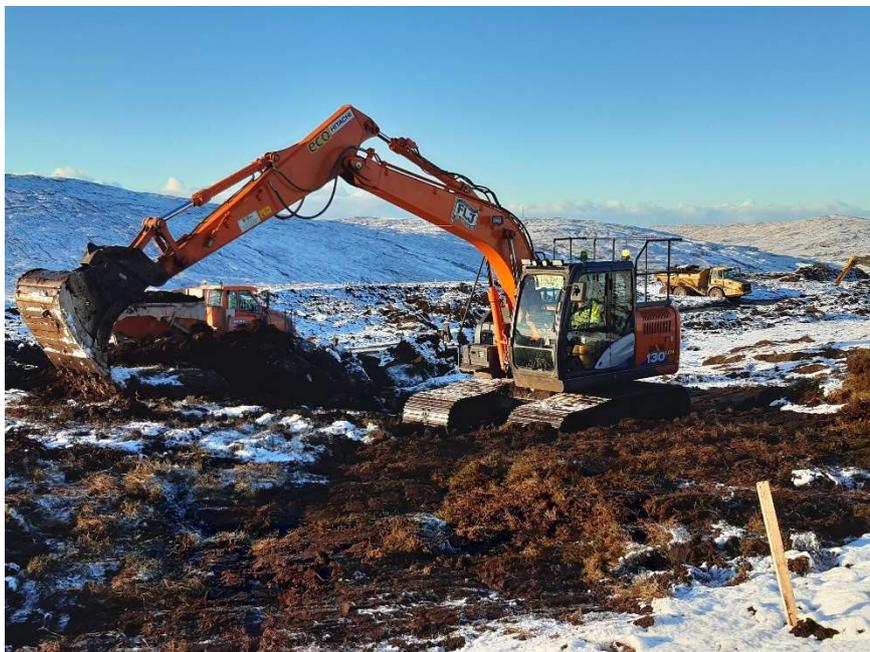
Photo 14. Excavators and dump trucks operating in peat restoration area P0809.

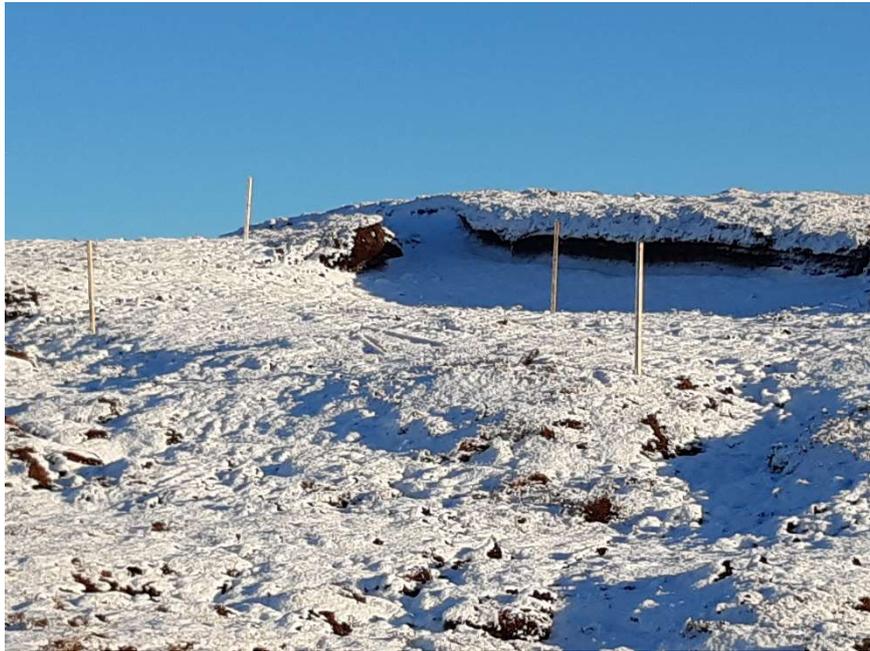
- During formation of the peat restoration area P0809, it was noted by the ECoW that the revised boundaries (as per the revised mapping in the report) had not been adhered to, as an earlier version of the boundary was being referenced. Work was stopped and the revised boundaries were marked out. The ECoW team submitted a SOR given that this incident could have been avoided if the relevant plans had been used. This has not been flagged as an action given that the error was addressed promptly, however the issues encountered must be considered during formation of future peat restoration areas to ensure mistakes are not repeated.

Photo 15. Revised extent of peat restoration area P0809 demarcated by wooden posts.

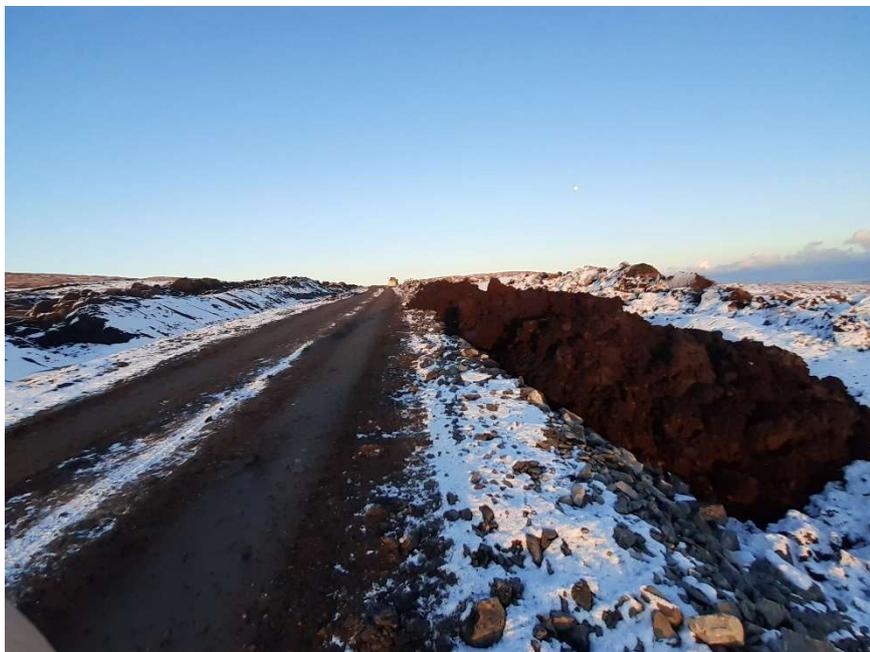
Freshly excavated peat was observed at the side of Spur 22 at the time of the audit. A member of the Principal Contractor team advised that this was part of ongoing reinstatement works. On the following day (27th January 2021) a photograph of the same area was provided to the PMO showing that the peat had been reinstated. More snow had fallen overnight which limited visual assessment of the area but this appeared to show that the peat had been appropriately reinstated as required. Photographs 16 and 17 show the area prior to and after reinstatement.

Photo 16. Freshly excavated peat at Spur 22 (Nesting) observed during audit.

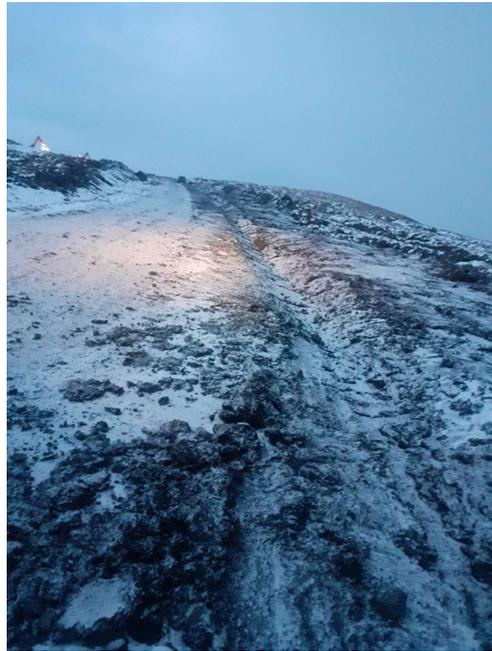
Photo 17. Spur 22 (Nesting) on 27th January 2021 following reinstatement of peat which had been excavated on the day of the audit.

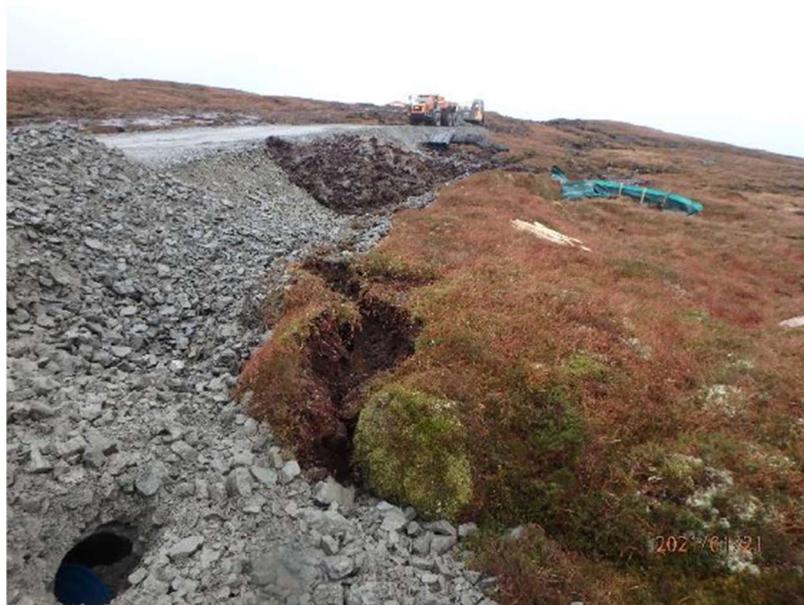
Subsequent discussions with the GCoW revealed that a culvert had been damaged as a result of a bearing failure (i.e. movement of the underlying soil resulting in a foundation failure) during construction of the track. This culvert was not observed as part of the audit. It was reported that the culvert remained functional, that water continued to run clean through the culvert following damage and that this would be monitored regularly. Repairs will be undertaken when traffic movement in the area decrease.

Further details are provided in Section 3.8.1 of this report. Photograph 18 in Appendix 1 shows the area of the damaged culvert.

The GCoW advised that a bearing failure had occurred beneath the floated track section of Array G, Spur 20 (Ch.400 to Ch.450) at Nesting. It was reported that "heave/shears extended laterally 25 m from the track". The failure resulted in damage to a culvert, the track and associated drainage (refer to Appendix 1 Photograph 20). The road was reformed with crushed rock and the downslope verges were reinstated with excavated soil. The Principal Contractor agreed to monitor this location to ensure no further excess movement occurs and the culvert and water crossing will be monitored for the presence of dirty/silty water. The Principal Contractor team discussed techniques that could be used to correct the damage, going forward the foreman and agent will walk ahead of the road construction and agree the techniques to be applied to suit the terrain. It was proposed to monitor water flowing through the damaged culvert and repair the structure when plant movement is reduced in this area. No adverse environmental effects (e.g. impacts to surface water) were reported, however the area will continue to be monitored.

Photo 18. Area of damaged culvert (reported in NCR on 22nd January 2021) following bearing failure on Spur 22.

Issue	Auditor Comments	Required Action	Action Owner	Status
Pre-planning works (access tracks)	A bearing failure occurred on Spur 20 which also resulted in damage to the track, a culvert and drainage.	Damaged culvert to be repaired. Proposed measures to avoid reoccurrence of this issue at other locations to be implemented (i.e. agree construction techniques to be used in accordance with the terrain). Liaison with the GCoW should also be undertaken.	Principal Contractor	Amber
Natural and Built Environment (reinstatement) Materials storage and handling (soil storage)	The placement of peat and mineral soils on top of vegetation has been reported in the last two ECoW reports (Weeks 21-24 and Weeks 25-27). This activity can result in the underlying turves becoming unsuitable for reuse. SORs have been raised by the ECoW with respect to this issue. This issue will be assessed by the PMO during future audits.	Consider the need for further training of site operatives with respect to this issue.	VEWF with assistance from ECoW team	Amber

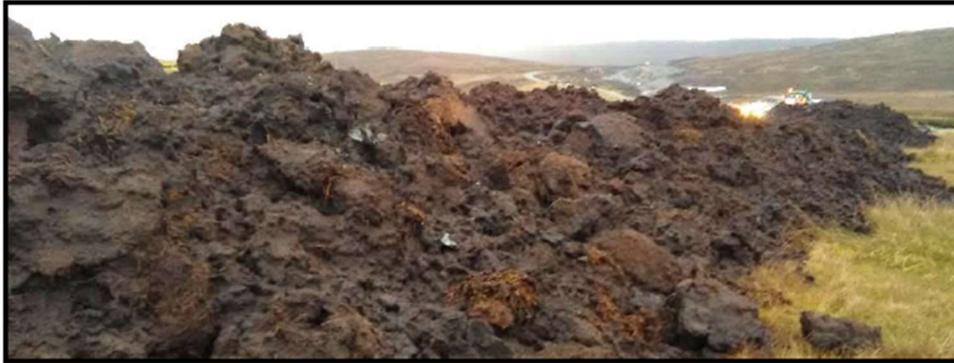
- It was also suggested by the ECoW that reinstatement of turves at Sandwater Road could be improved to ensure bare mineral soil and peat is covered with reinstated turves. Examples observed by the ECoW are shown on Photographs 19 and 20 in Appendix 1. Subsequent discussions with the SSE Environmental Advisor confirmed that areas of reinstatement requiring further work were highlighted by the ECoW and addressed by the Principal Contractor team at the time.

Photo 19. Peat placed on top of vegetation at Sandwater Road, rendering turves unsuitable for reuse. (Original photo included within MBEC Environmental Summary Report)

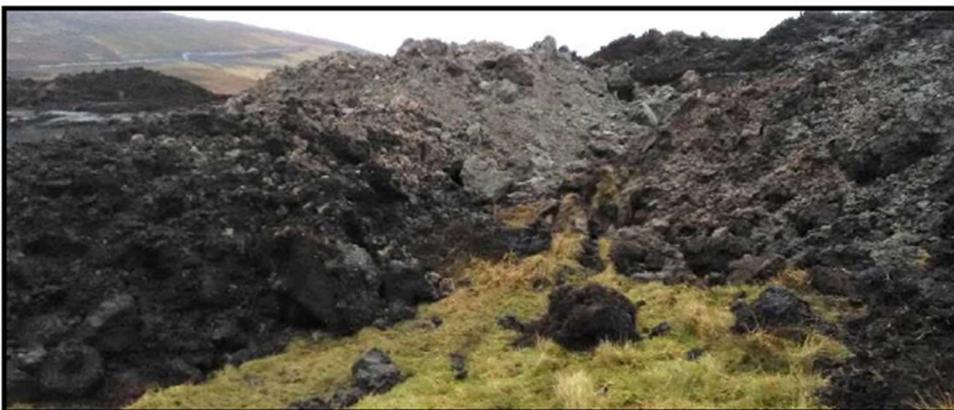
Photo 20. Mineral soils and mixed peaty material temporarily stored over vegetation, with turves potentially unsuitable for reuse. (Original photo included within MBEC Environmental Summary Report)
