Intended for  
**Viking Energy Wind Farm LLP**

Date  
**March 2021**

Project Number  
**1620009158**

# **VIKING ENERGY WIND FARM PLANNING MONITORING OFFICER AUDIT REPORT 004: 27<sup>TH</sup> JANUARY TO 25<sup>TH</sup> FEBRUARY 2021**

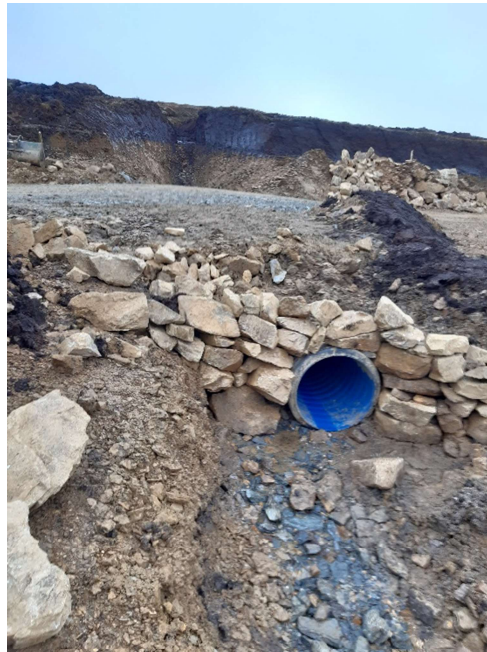
The construction of the track was observed to have progressed and new clean water cut-off trenches were observed along the track. These comprise trenches excavated on the upgradient side of the road, directing clean surface water under the track through a culvert and discharging the clean water into the downgradient catchment area. An example is shown on Photograph 1 of Appendix 1.

**Photo 1.** Clean water culvert installed under the track at Spur 5 (Kergord).

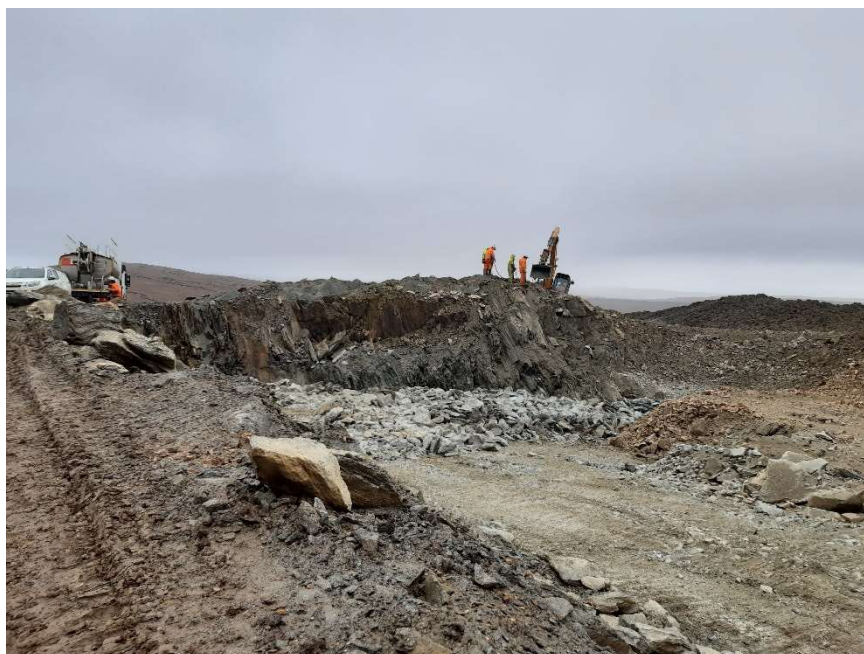
The excavations to form borrow pit KBP02 had commenced since the previous audit and progress is shown on Photographs 2 and 3 of Appendix 1. Peat and mineral soil had been stripped from the area, with peat being removed to a storage area. Drilling had progressed to allow a blast to be undertaken which will create the access road into the borrow pit. The blast was scheduled for the afternoon of the audit. Stone generated from the blast will be processed and used to form access tracks and turbine crane pads.

**Photo 2.** Progress at borrow pit KBP02.

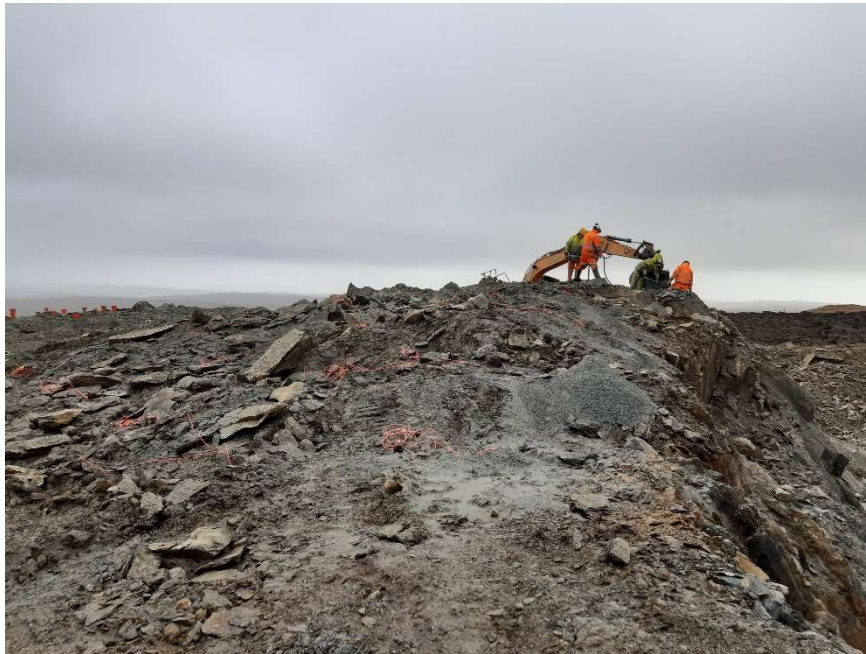
**Photo 3.** Progress at Borrow Pit KBP02. Foreground of image shows drilled areas prior to blasting.

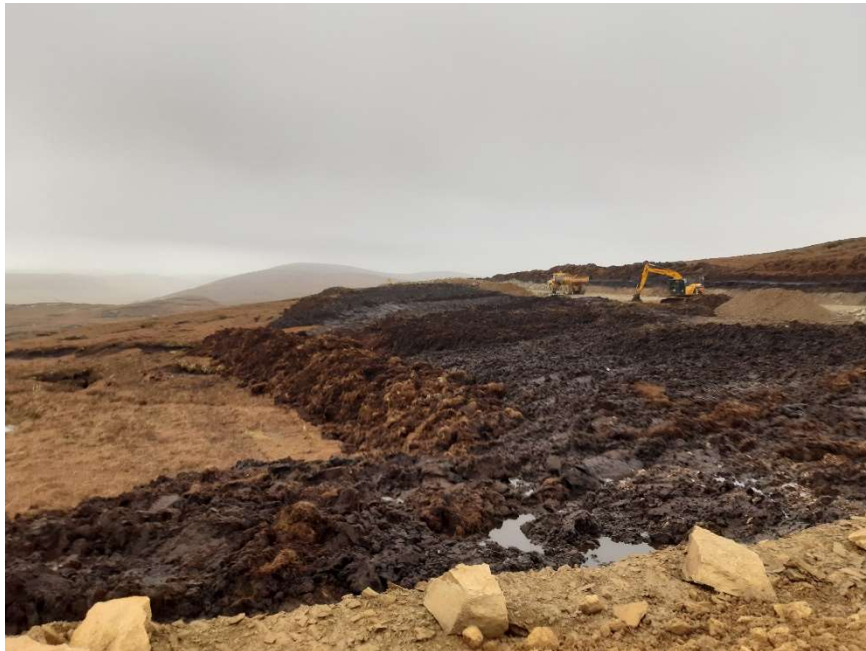
Three proposed peatland restoration areas (P04, P05 and P06) are located to the south of the current work area (beyond Junction 10) as identified in the Peat Management Plan (PMP). These restoration areas are not yet in use. A peat storage area has been created in the vicinity, in proximity to the location of K53, as shown on Photograph 4 of Appendix 1. Surveys of the aforementioned areas have been undertaken by the ECoW to delineate those that are suitable for restoration which were under review by VEWf at the time of the audit. Further details are provided in Section 3.6.2.

**Photo 4.** Peat storage area located at K53.

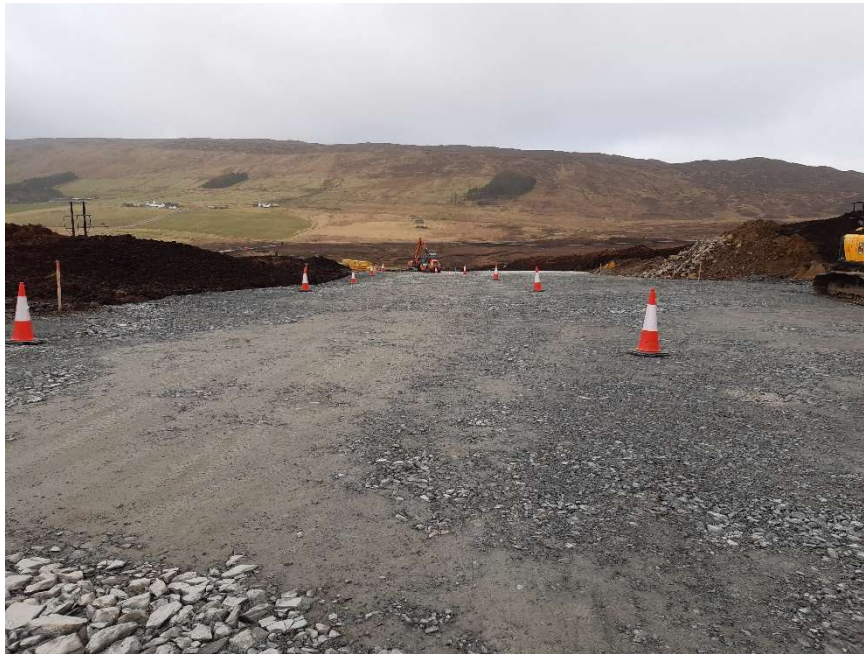
The 'transition area' that was observed during the last audit (i.e. the area where the road transitions from being floated on peat to founded on the underlying soils) had been completed, meaning that the western and eastern sections are now connected. The track was in the process of being widened to accommodate construction traffic and reinstatement of excavated soils was ongoing (refer to Photographs 5 and 6 in Appendix 1).

**Photo 5.** Ch.1400 of Sandwater Road showing the area where the track has been widened since the previous audit.

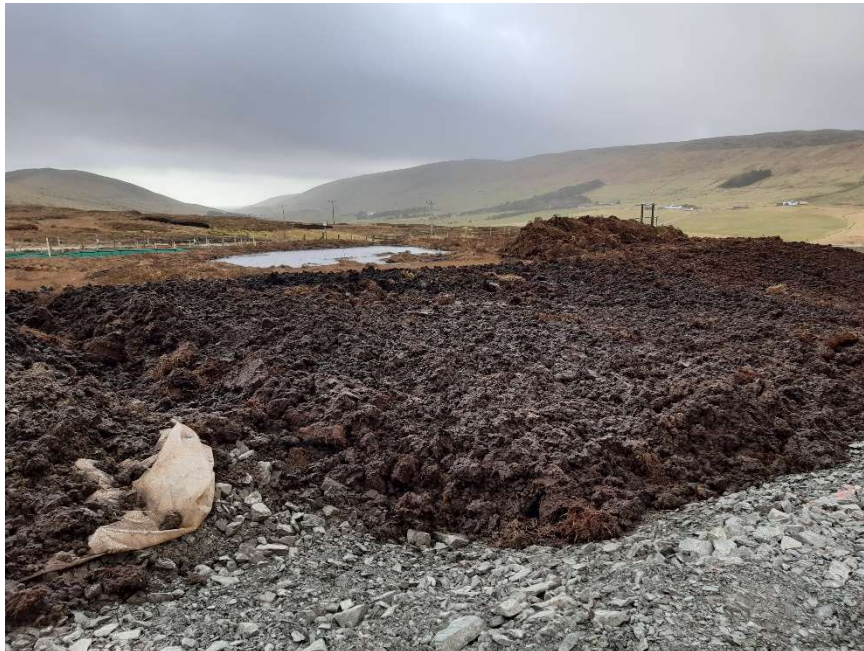
**Photo 6.** Ongoing soil reinstatement at CH.1400 of Sandwater Road.

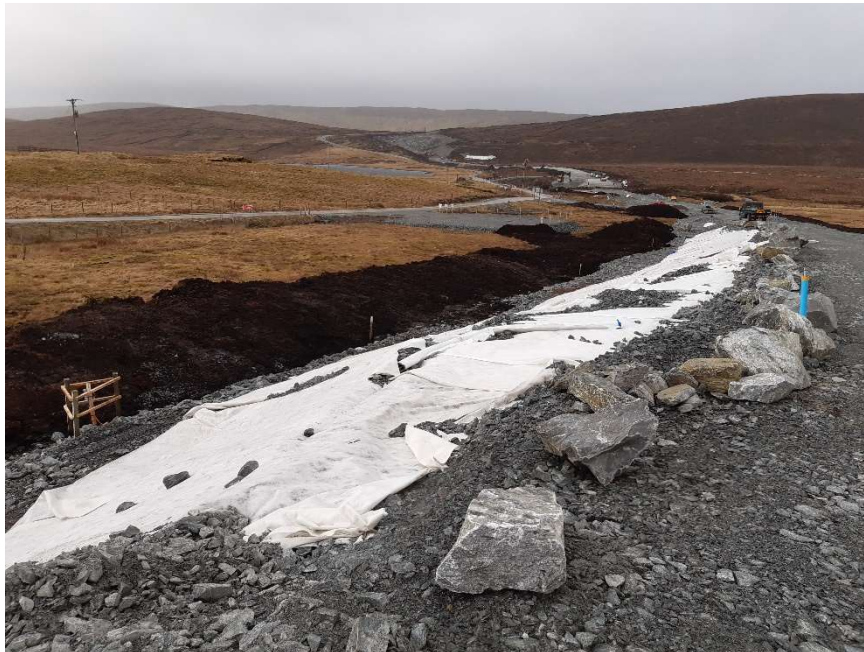
**Photo 7.**

At the eastern end of Sandwater Road the final road levels have been achieved at the junction with the A970. Reinstatement of soils along the edge of the road was observed to be ongoing. The public car park connected to the existing Sandwater Road was observed to have been formed. Photograph 7 in Appendix 1 shows the progress that has been made in this area.

Ch.50 of Sandwater Road. Public car park connected to the original Sandwater Road is shown in the background. Soil reinstatement is ongoing.

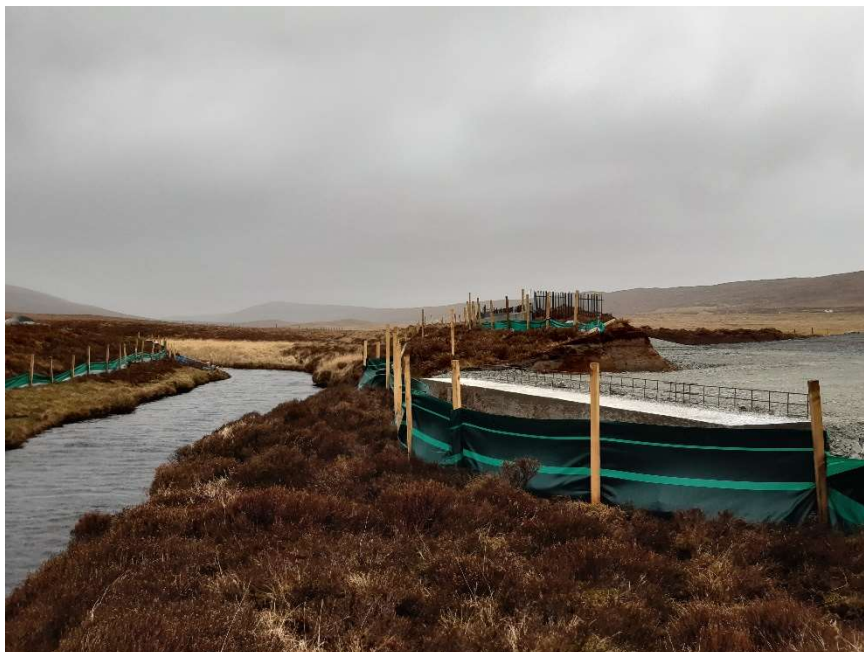
**Photo 8.**

Construction of the bridge<sup>6</sup> over the Burn of Pettawater was ongoing during the remote audit visit. The temporary bridge steelwork was due to be lifted into position during the week commencing 1<sup>st</sup> March 2021 and the associated hardstanding crane pad area had been formed. This temporary crossing will be used by construction traffic until the permanent bridge is constructed. The permanent bridge will be used by construction traffic (e.g. for transportation of turbines and other infrastructure) through the construction phase. Once all construction is completed, the new Sandwater Road (and permanent bridge) would be adopted by SIC for public use, replacing the existing stretch of Sandwater Road adjacent to Sandwater Loch. Silt fencing remains in place, extending beyond the active work areas, on both banks of the burn. Photograph 8 in Appendix 1 shows the eastern abutment of the temporary bridge in the foreground.

Eastern abutment of temporary bridge over the Burn of Pettawater. Permanent bridge abutment is visible in the background.

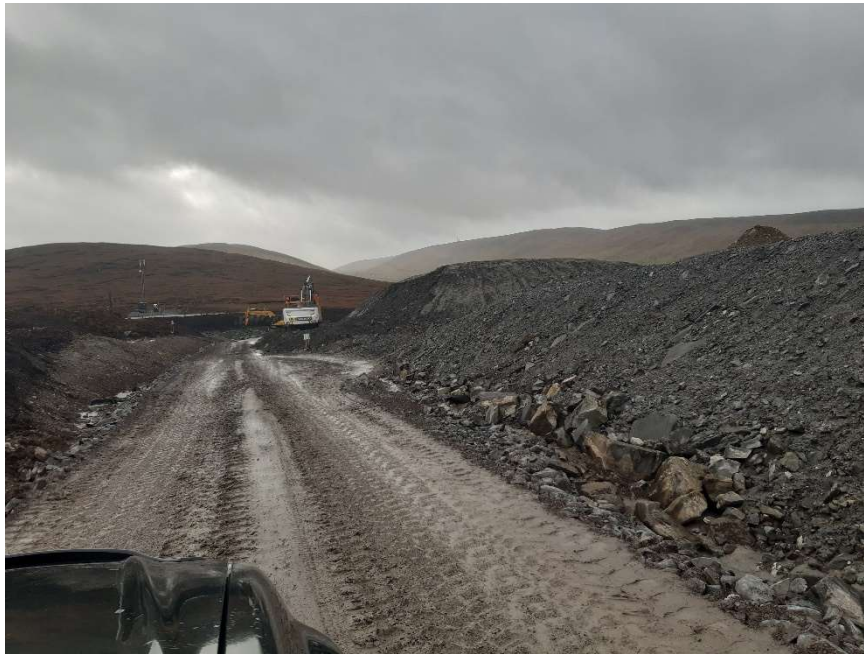
The SSE Environmental Advisor indicated that material within the mineral soil store (i.e. excess mineral soil generated during excavation work throughout the project) located at the southern end of the Mid Kame Ridge (CH.20-CH.50) was being used for the formation of hardstanding at a number of turbine locations. Soil volumes and movements are tracked on the Excavation Register as referenced in Section 5.3.1 of the CEMP. A photograph of the storage area is shown on Photograph 9 of Appendix 1.

**Photo 9.** Mineral soil stockpile at the southern end of Mid Kame Ridge. Material is being used to form access tracks.

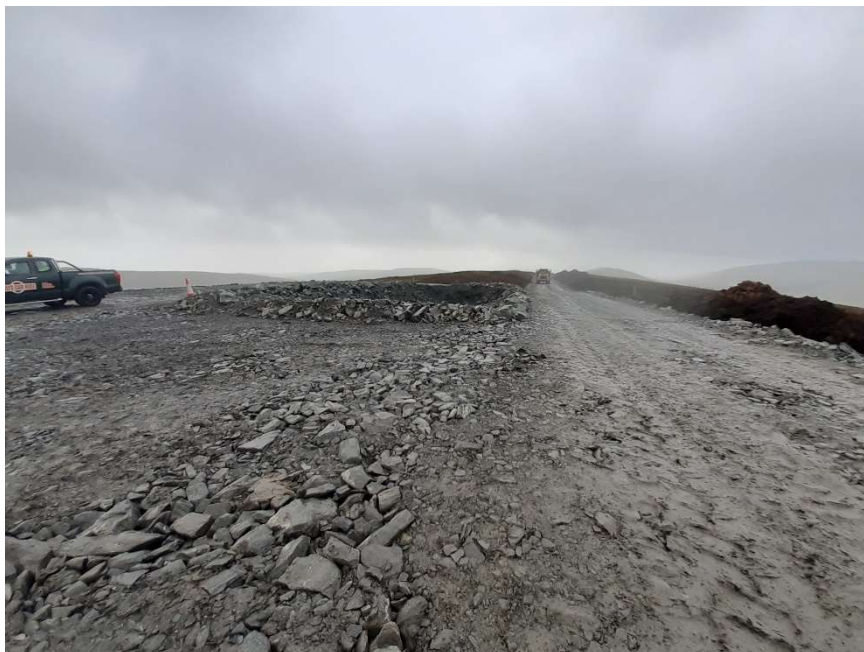
The PMO viewed the hardstanding for K87. The stone to form the crane pad had been placed following excavation of the underlying turves, peat and mineral soils. The SSE Environmental Advisor provided photographs showing the progress that had been made at the hardstanding for K86, which was observed during the previous audit (refer to Photographs 10 and 11 in Appendix 1).

**Photo 10.** Crane hardstanding that has been formed at K86.

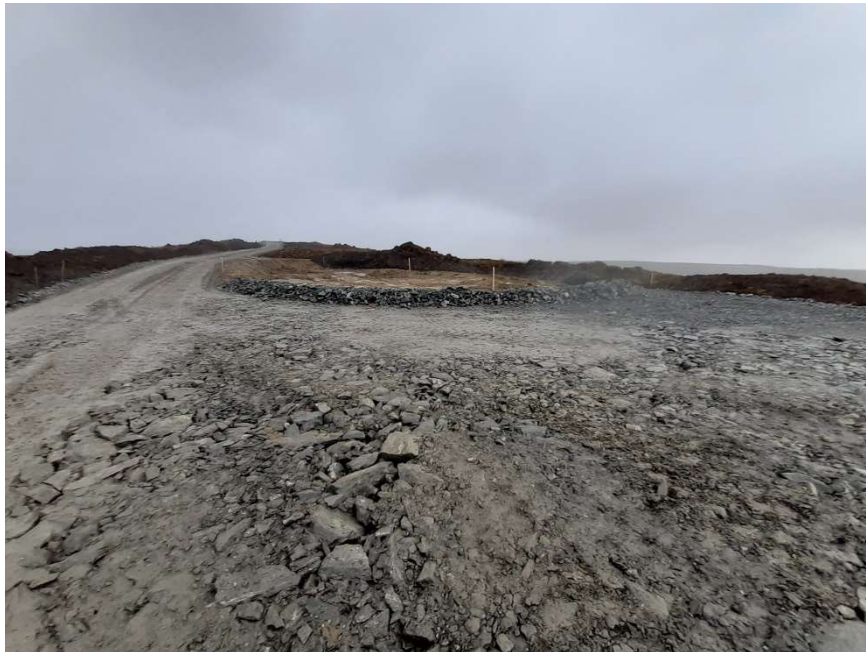
**Photo 11.** Excavation of turbine base at K86 shown beyond crane hardstanding

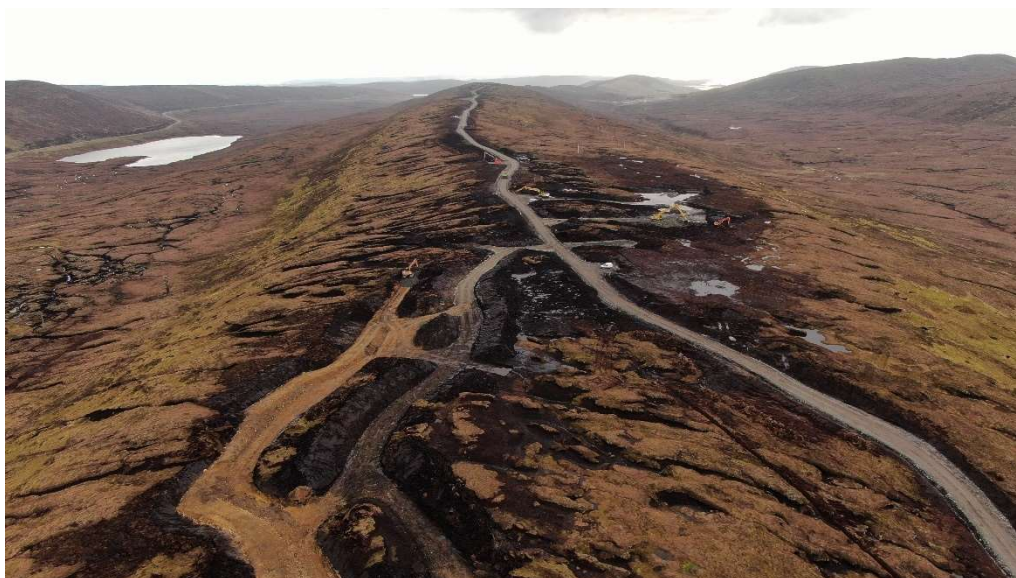
Since the previous audit, restoration of peat within P08 had progressed significantly and was nearing completion. Mineral soil excavated in the vicinity has been used in the formation of access tracks into P09. Three excavators were operating within P09 during the audit with peat being brought into the restoration area with dump trucks. The formation of the temporary tracks with mineral soil is in accordance with the Habitat Management Plan and the tracks are designed to act as stabilising berms upon completion of the restoration area. Tracks will not be connected to the main access tracks and will be overlain with peat so as to be integrated with the restoration structure. An aerial image shows the progress that had been made within P08 and P09 on the day following the audit (26<sup>th</sup> February 2021) on Photograph 12 of Appendix 1.

**Photo 12.** Aerial image of P08 (right hand side) and P09 (left hand side). View facing south along Mid Kame Ridge.

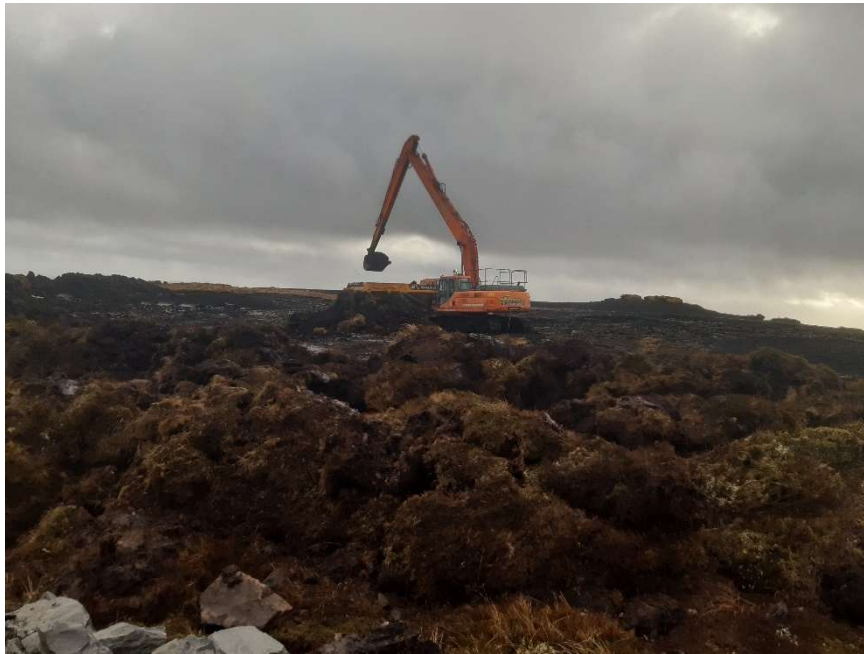
Since the previous audit, track construction has progressed towards N114 and N115 (Spur 22 and 23), and towards N116 and N117. The borrow pit NBP05 search area was in the process of being stripped of surface vegetation and peat in preparation for exploratory drilling and quarrying (refer to Photograph 13 in Appendix 1).

**Photo 13.** Peat stripping at borrow pit NBP05.

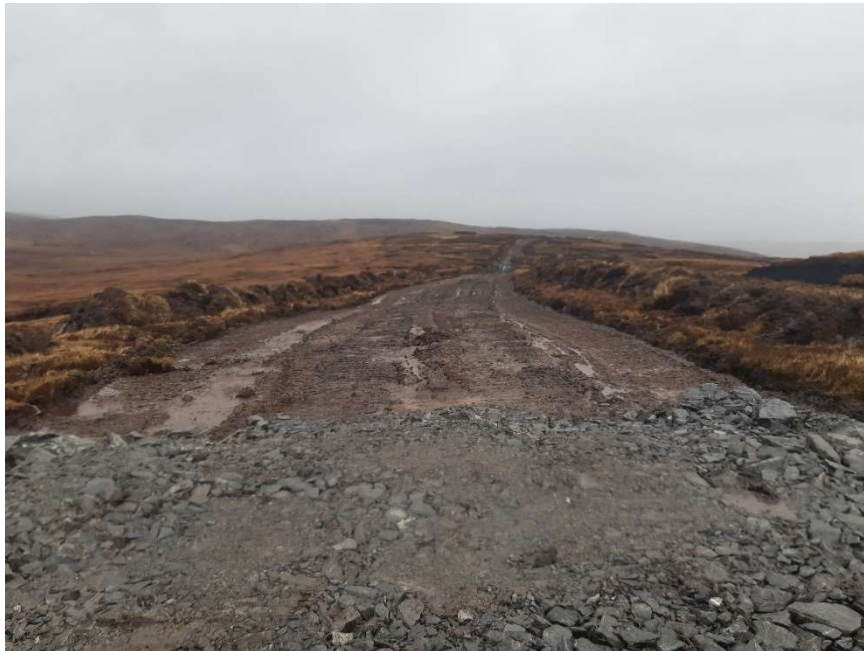
The PMO viewed progress of the tracks leading to N116 (Spur 21) and N117 (Spur 24) from Junction 23. Photograph 14 in Appendix 1 shows the progress that has been made on Spur 24. Progress towards N114 and N115 at Spur 22 and Spur 23 was also observed (refer to Photograph 15 in Appendix 1).

**Photo 14.** Progress on Spur 24 (looking towards N117).

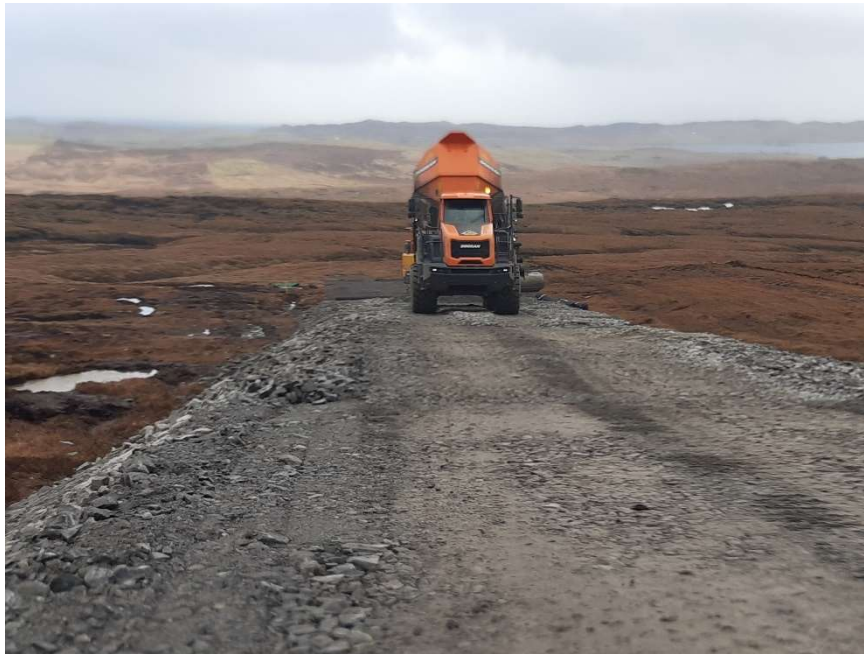
**Photo 15.** Progress at Spur 22.

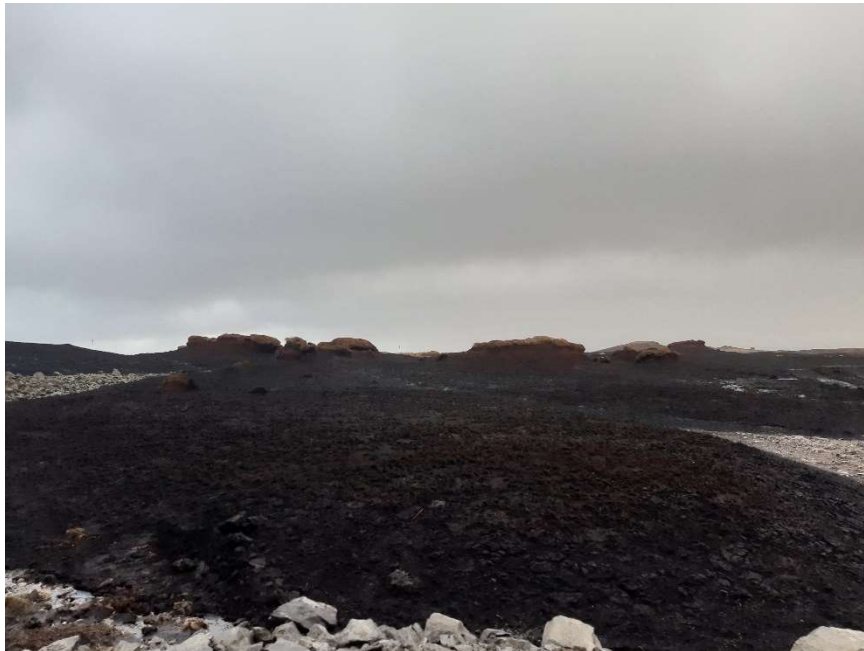
Peat restoration area P27 is located in the vicinity of NBP05. A survey of the area was carried out by the ECoW which confirmed that a larger area than anticipated would be suitable for restoration due to the presence of eroded peat (i.e. peat hags). This is shown on Photograph 16 in Appendix 1. It was reported that this area has been demarcated using canes and that discussions relating to the use of this area for peat restoration were ongoing between the Developer, the Principal Contractor, and the ECoW.

**Photo 16.** Future peat restoration area close to NBP05. Eroded peat hags shown at top of the image.
