Intended for
Viking Energy Wind Farm LLP

Date
April 2021

Project Number
1620009158

VIKING ENERGY WIND FARM PLANNING MONITORING OFFICER AUDIT REPORT 005: 26TH FEBRUARY TO 24TH MARCH 2021

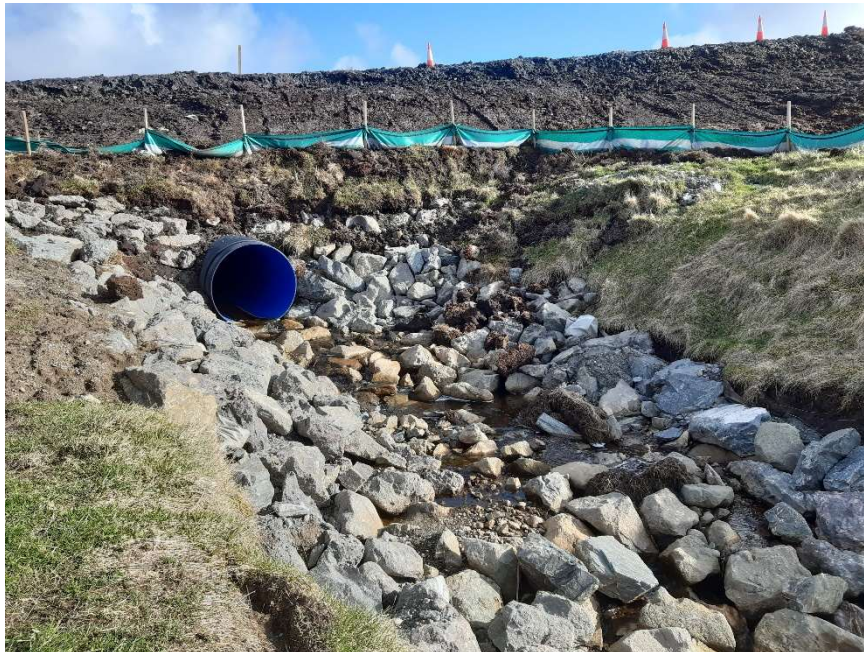
The Droswell Burn culvert under the Kergord Access Track (KAT) was observed during the audit and is shown on Photograph 1 in Appendix 1. It has been noted by the site team that there are occasional occurrences of silt discharge from beneath the culvert structure following periods of heavy rain. No significant impacts to the Droswell Burn have been recorded and the area is monitored regularly. In addition, discussions are ongoing between the Developer and the Principal Contractor to ascertain the need for additional mitigation measures to further limit environmental risks to the watercourse.

Photo 1. Droswell Burn culvert beneath Kergord Access Track

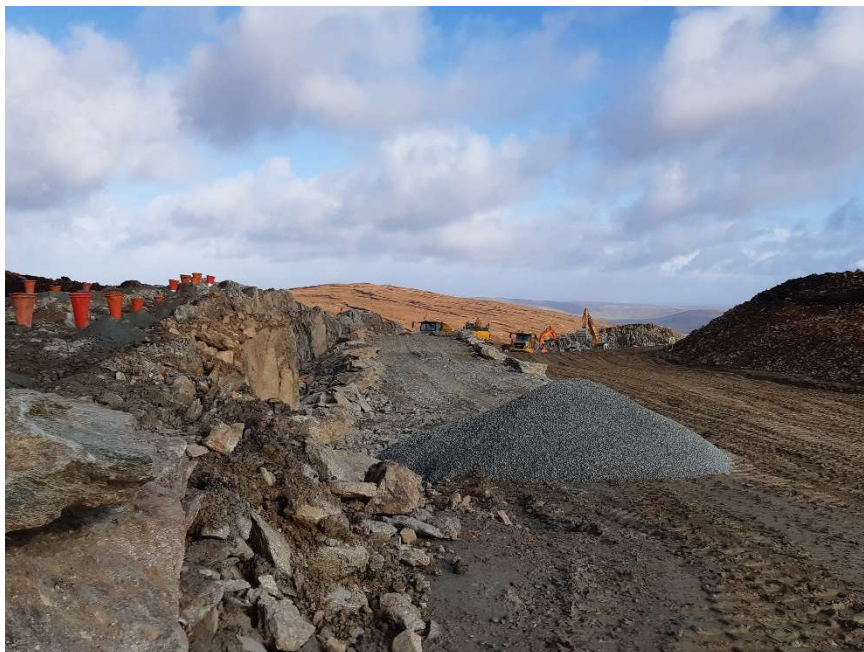
Construction work was continuing at borrow pit KBP02 and preparations (i.e. drilling) had been undertaken for a blast to widen the access point into the borrow pit (refer to Photograph 2 in Appendix 1).

Photo 2. Access to borrow pit KBP02. Area prepared for blasting is shown on the left hand side of the image.

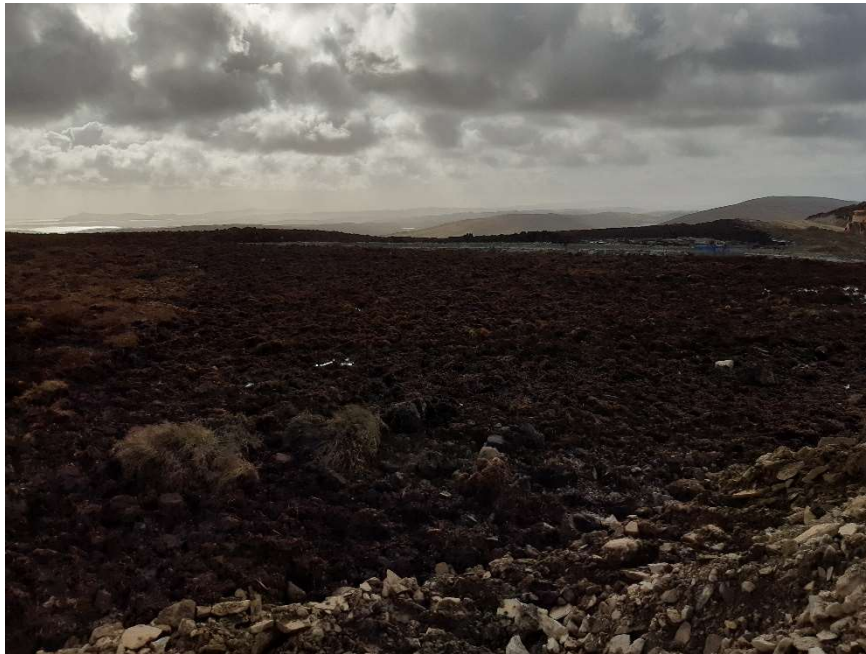
Peat restoration has commenced at PN01 in the vicinity of K53. Through further ecological and geotechnical assessment of the area in the vicinity of K53, and due to ongoing construction works, this area was identified as being suitable for restoration following assessment by the development team and is additional to the areas initially identified for potential restoration in the PMP and Habitat Management Plan (HMP). These documents detail the areas considered suitable for restoration based on the findings of a desktop study, and do not discount the possibility that other areas may be defined as suitable by the Clerks of Works team. Tracks were created from stone excavated from KBP02 to access the restoration area. Now that peat placement is nearing completion, tracks are to be disconnected from the main access tracks and will be covered over with peat (minimum 1 m thickness). Turves were observed being placed over the peat by a long-reach excavator. It was also noted that prior to construction works, that the volume of turves in the area was low. Reseeding of the restored peat will be required, which is in accordance with the HMP. The extent of peat restoration within PN01 is shown on Photographs 3 and 4 of Appendix 1.

Photo 3. Peat restoration within PN01

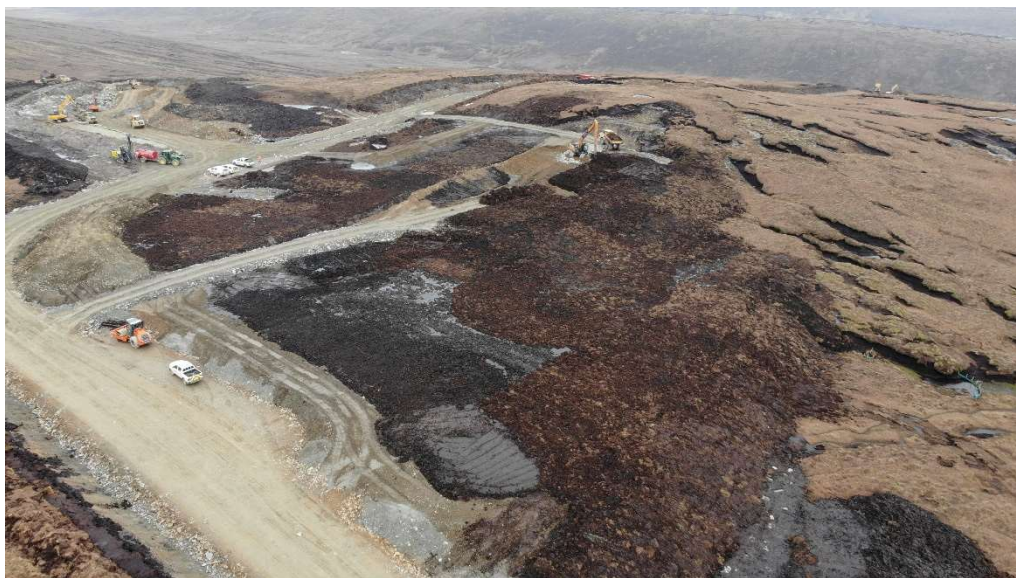
Photo 4. Aerial image showing the extent of peat restoration area PN01

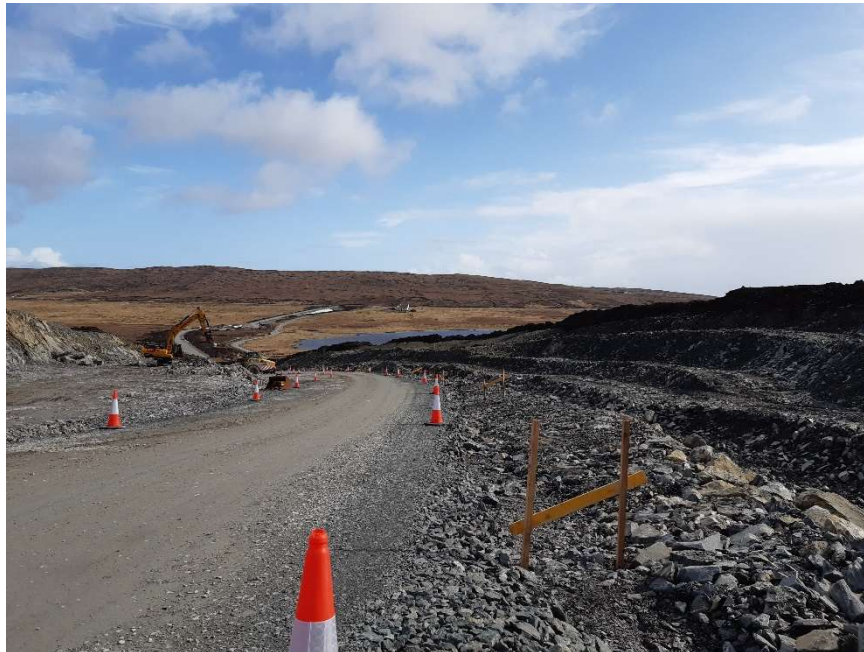
During the audit construction was occurring at approximately CH.800 to CH.900 to widen the road in this area. It was noted that the verges on the southern side of the road have been reprofiled as shown on Photograph 5 in Appendix 1.

Photo 5. Reprofiling of verge on Sandwater Road.

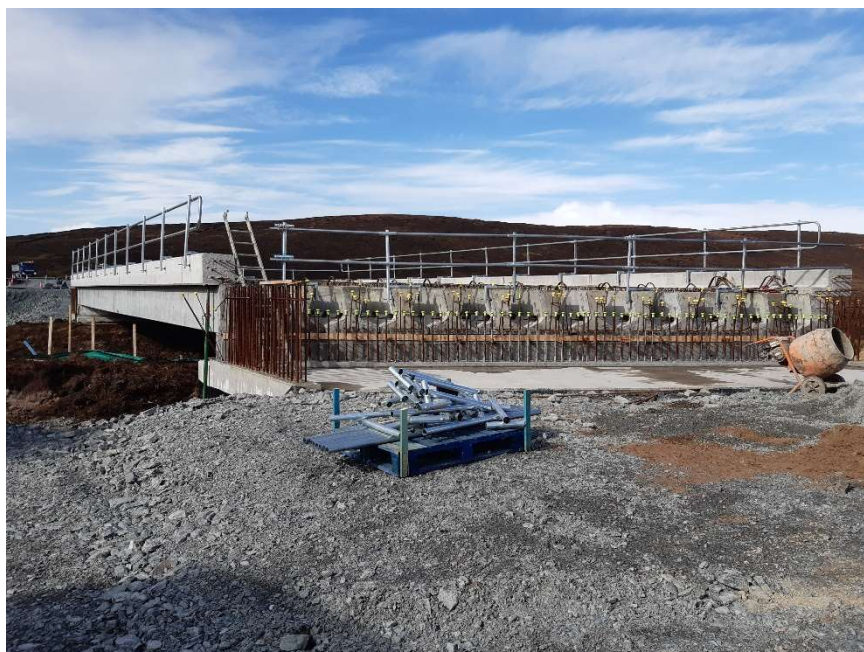
The temporary bridge⁶ over the Burn of Pettawater towards the eastern end of the new Sandwater Road was in place and in use by construction traffic. Construction of the permanent bridge is ongoing which was observed by the PMO during the audit as shown on Photograph 6. Both bridges are shown on Photographs 6 and 7 of Appendix 1.

Photo 6. Construction of the permanent bridge over the Burn of Pettawater

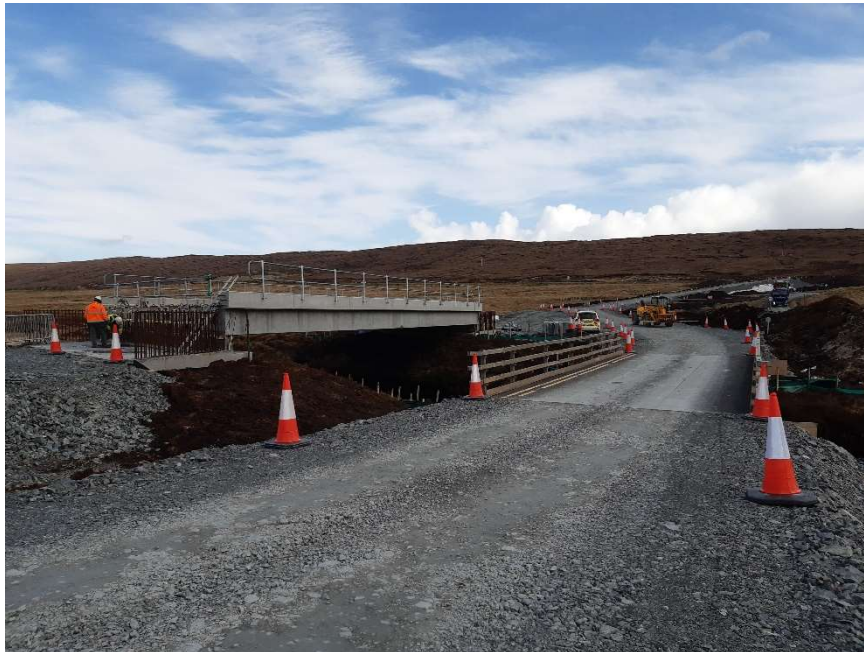
Photo 7. Temporary bridge over the Burn of Pettawater shown on the right. Permanent bridge, under construction, located immediately to the left.

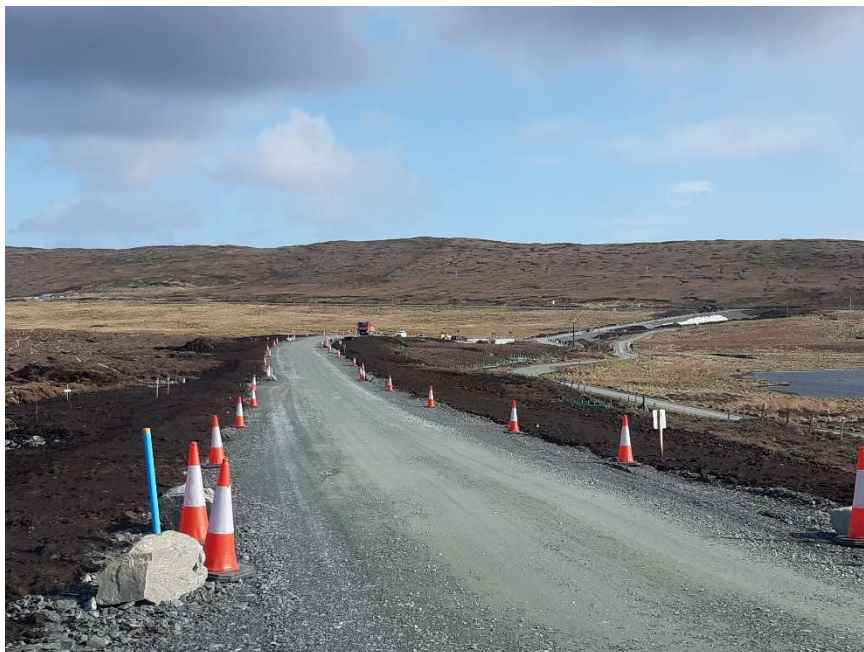
The eastern part of Sandwater Road was undergoing reprofiling on the southern verges as shown on Photograph 8 of Appendix 1. Reprofiling work to the northern verge will follow.

Photo 8. Sandwater Road, facing east, showing ongoing reprofiling works.

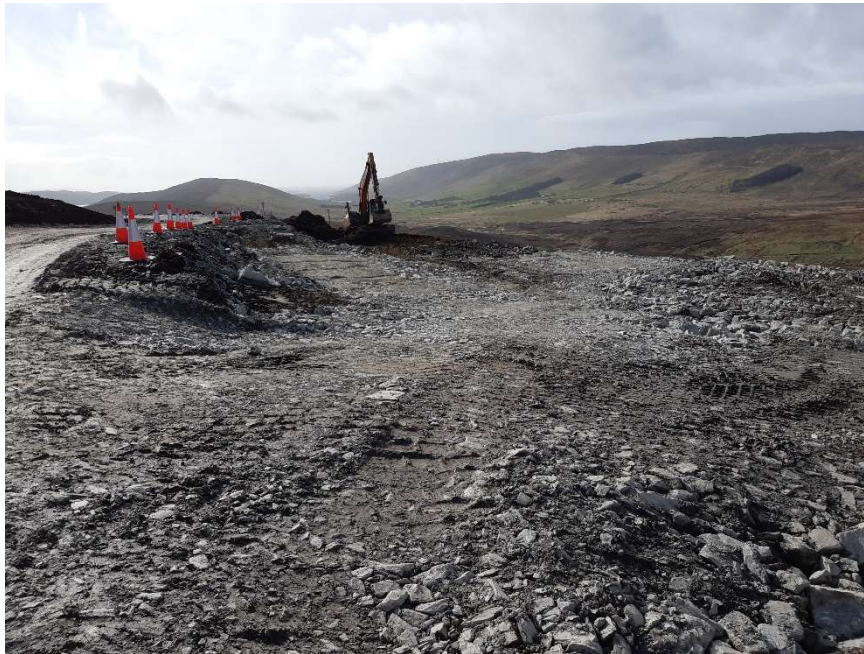
The PMO observed the works that have been undertaken at the hardstanding for K88, the southernmost turbine on the MKR. The area is shown on Photograph 9 of Appendix 1.

Photo 9. K88 Hardstanding crane pad.

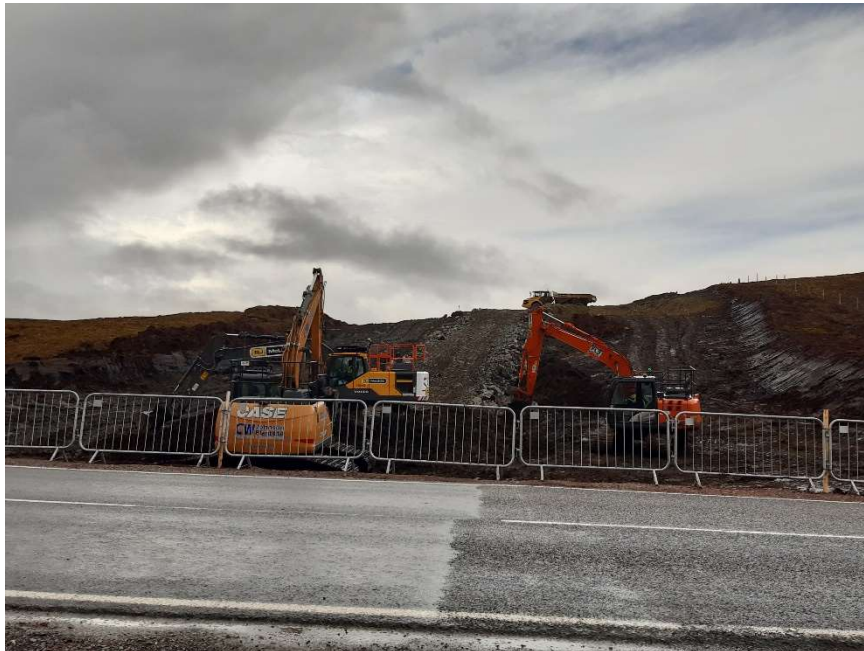
At the northern end of the MKR, a pilot track has been formed to allow the creation of the final stretch of the access track and junction with the A970. Excavators have stripped soil from this area and the SSE Environmental Advisor explained that a blast would be undertaken in order to achieve the required width for the track. Photograph 10 in Appendix 1 shows the ongoing construction works taking place during the audit at the junction with the A970.

Photo 10. Track construction at the northern end of Mid Kame Ridge at the junction with the A970.

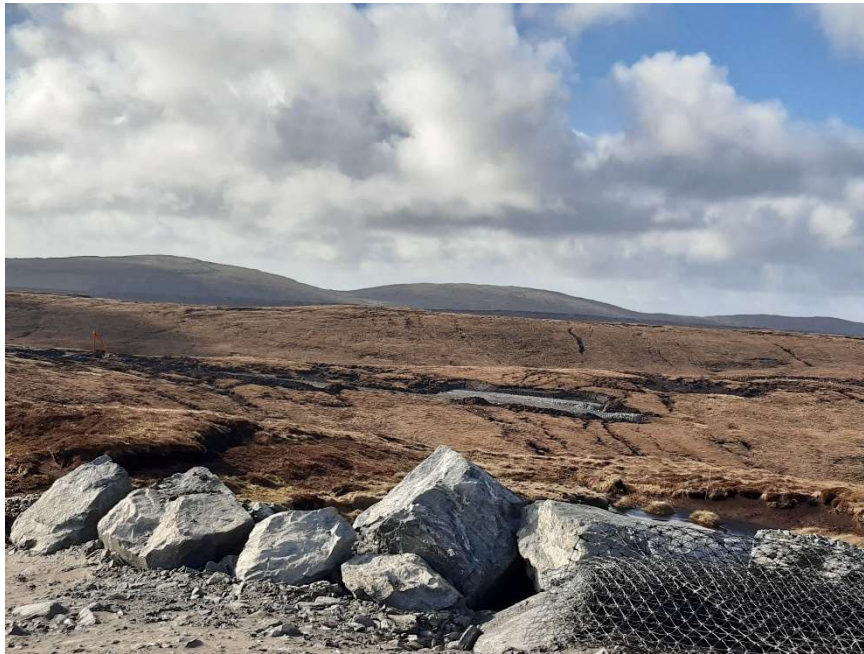
The hardstanding for turbine N116 was in the process of being formed during the audit as shown on Photograph 11 in Appendix 1.

Photo 11. Hardstanding for turbine N116 shown in distance.

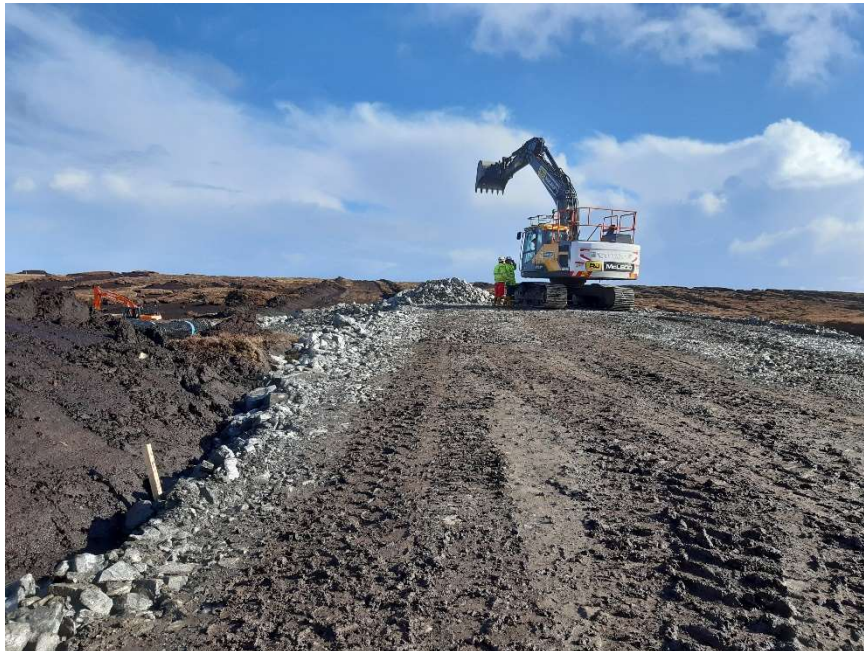
formation of this track has commenced with the stripping of soils and placement of stone as shown on Photograph 12 in Appendix 1.

Photo 12. Progress of track construction at Spur 28.

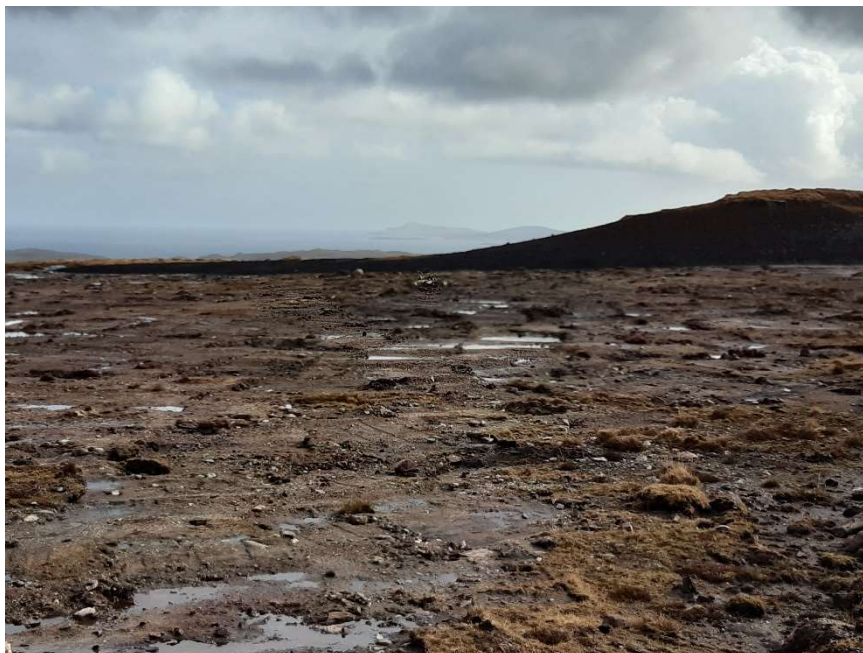
Progress has been made in forming the access track into peat restoration area P27. Discussions regarding the most appropriate method of progressing the restoration works are ongoing between the Developer and the Principal Contractor. The PMO observed areas of bare peat flats within P27 and this is shown on Photographs 13 and 14 of Appendix 1. It was reported that areas of habitat in good condition have been demarcated by the ECoW and that these areas would be avoided during restoration to avoid deterioration of these features. This is shown on Photograph 15 in Appendix 1.

Photo 13. View of bare peat flats located within peat restoration area P27.

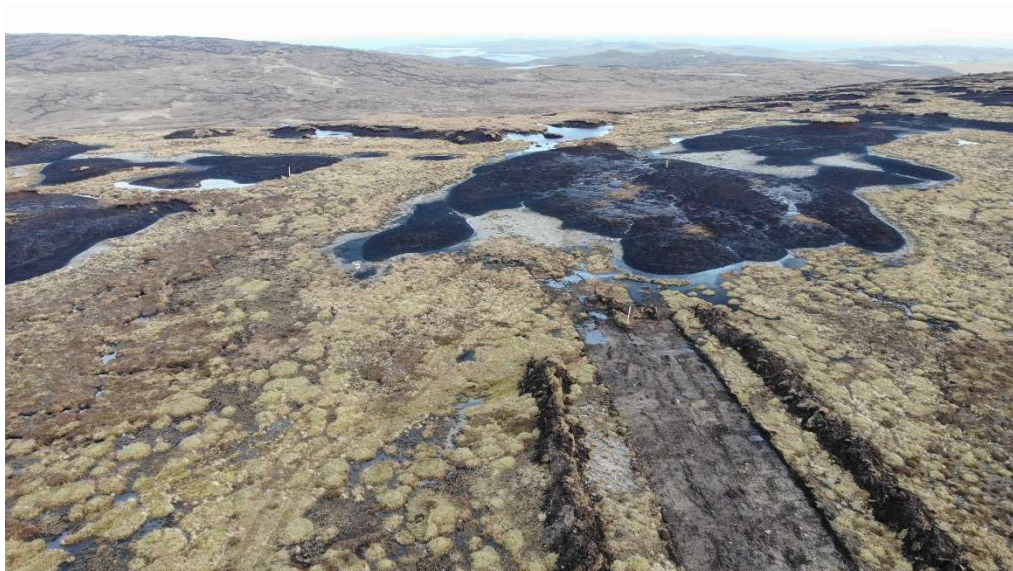
Photo 14. Aerial image showing access track to peat restoration area P27 and the extent of bare peat flats in the vicinity.

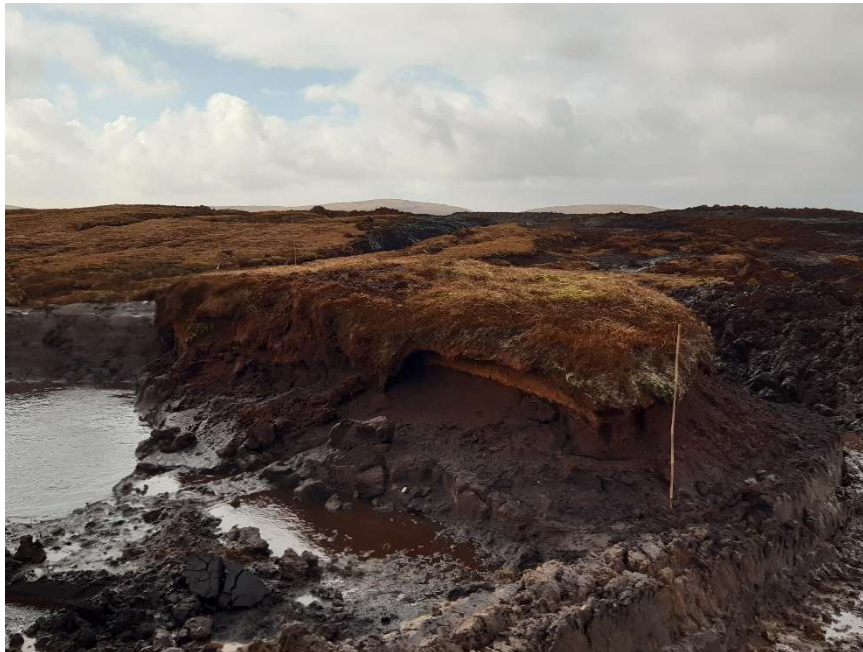
Photo 15. Example of canes that have been used to demarcate areas of peat to be avoided during restoration at P27.

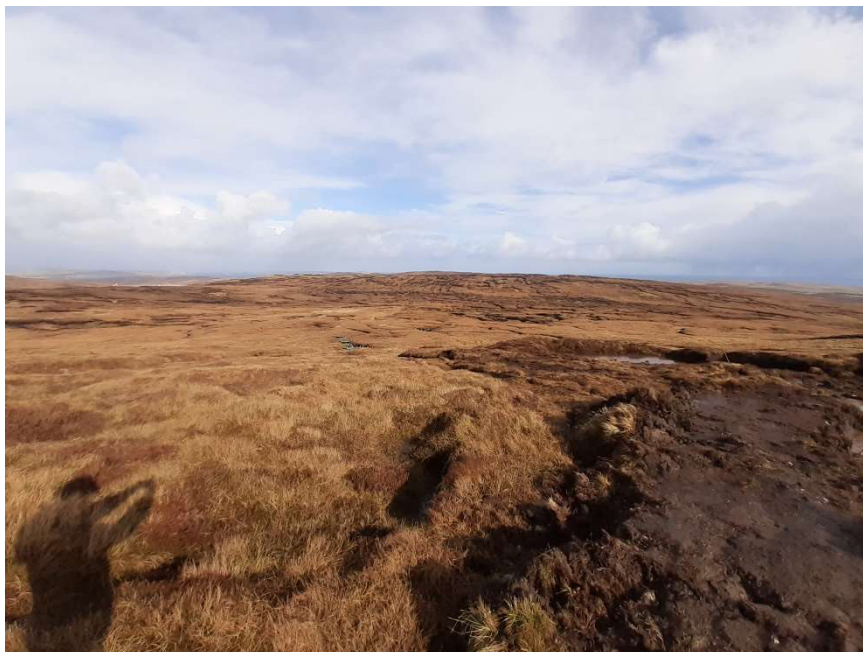
Borrow Pit NBP05 was observed and it was noted that tracks have been formed leading into the borrow pit. Preparatory work had been undertaken in advance of the first blast which was scheduled for the day following the audit. Drainage mitigation measures were observed downgradient of the borrow pit; these included the formation of a soil bund along the edge of the borrow pit, a settlement pond and a series of silt fences beyond the pond within the catchment area. This is shown on Photograph 16 of Appendix 1.

Photo 16. View from the edge of borrow pit NBP05 showing drainage mitigation measures including settlement pond and silt fences present in the distance.
