Intended for  
**Viking Energy Wind Farm LLP**

Date  
**May 2021**

Project Number  
**1620009158**

**VIKING ENERGY WIND  
FARM  
PLANNING  
MONITORING OFFICER  
AUDIT REPORT 006:  
25<sup>TH</sup> MARCH TO 27<sup>TH</sup>  
APRIL 2021**

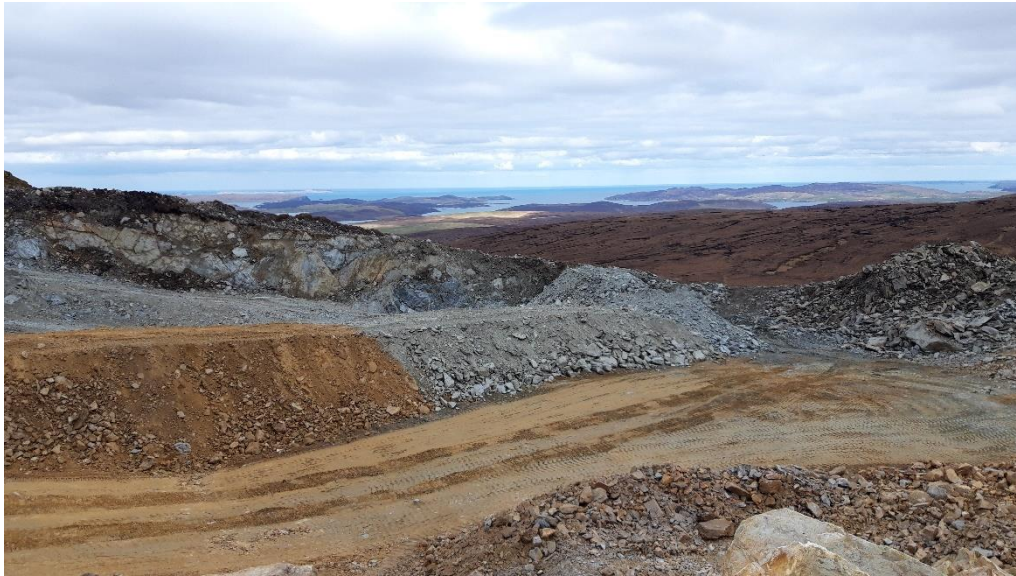
Rock extraction from borrow pit KBP02 is ongoing and this area was viewed during the audit (refer to Photo 1 in Appendix 1). The extracted rock continues to be used for the formation of tracks and crane pad hardstandings.

**Photo 1.** View of borrow pit KBP02

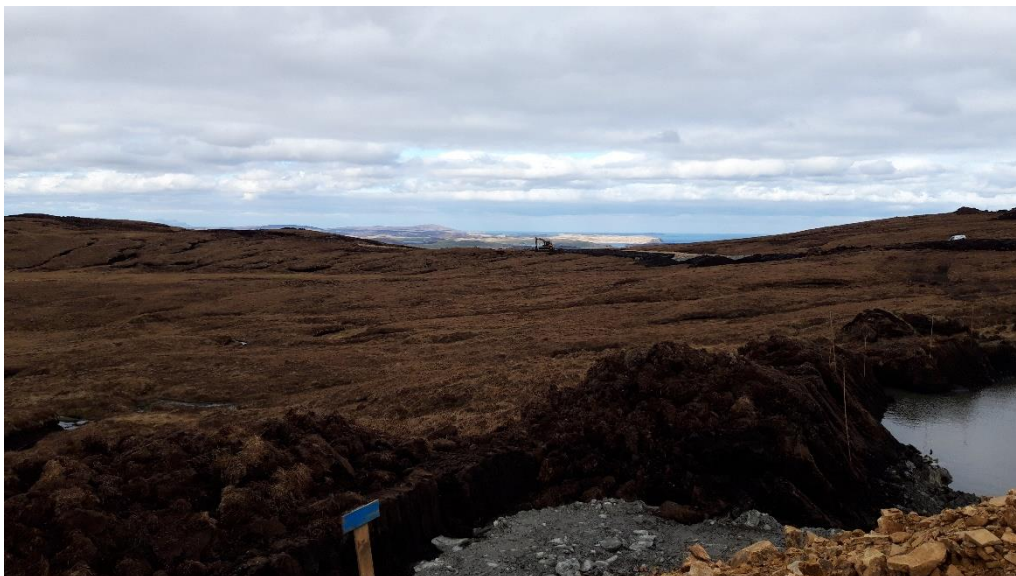
Two excavators were observed to be working in peat restoration area P05 (refer to Photo 2 in Appendix 1) and peat restoration within PN01 is also ongoing.

**Photo 2.** View of activity in peat restoration area P05 from crane pad hardstanding of K54.

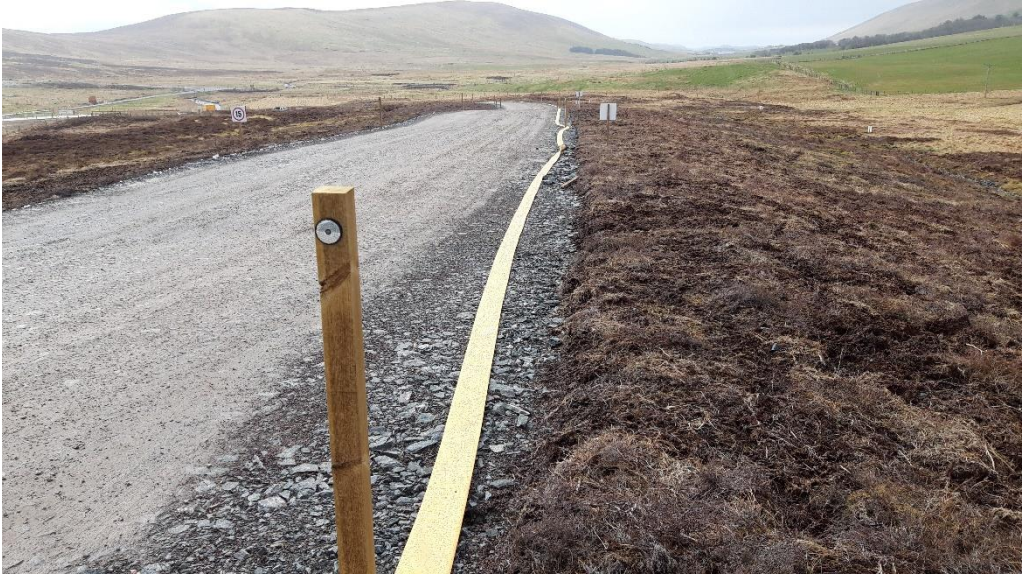
Mitigation measures compliant with Section 7.1 of the CEMP have been implemented along the Kergord Access Track (KAT) in response to public concerns regarding the generation of dust in this location due to vehicle movements. Perforated pipes connected to a pump and clean water supply have been positioned along a 250 m stretch of the edge of the road verge which are used to 'damp down' the access track surface during dry periods (refer to Photo 3 in Appendix 1). Reminders of the site speed limit of 15 mph were provided to vehicle operatives. The Principal Contractor also confirmed that additional water bowsers for dust suppression use have been sourced and that regular visual monitoring is undertaken.

**Photo 3.** Perforated pipes along KAT for dust mitigation. Pump located in distance.

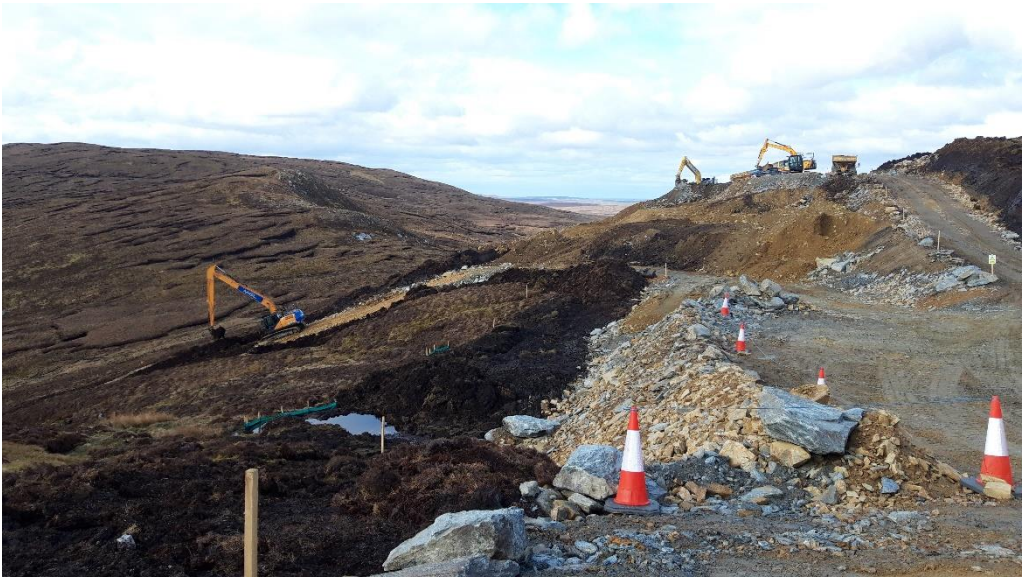
A peat slippage occurred at CH2450 of Spur 4 (coinciding with the location of borrow pit KBP05) on 18<sup>th</sup> April 2021 following the excavations to form the access track. It was reported that turves excavated during the construction of the track had been temporarily stockpiled to the side of the track to be used for reinstatement. A section of the turves subsequently slipped down the hillside.

The PMO observed recovery of the slipped peat during the audit. An excavator was working in the area and a series of bunds have been created within the slipped area to stabilise the slope. This is shown on Photo 4 of Appendix 1.

The CEMP sets out the requirement for the Principal Contractor to maintain a Peat Risk Register (PRR). The area where the peat slip occurred was previously identified on the PRR for the relevant array (Array E). Mitigation measures set out in the PRR relating to the risk of movement of steep slopes as identified between CH2300 and CH2500 were to minimise the volume of peat stored. This was carried out by the Principal Contractor since only turves were stored at the side of track, with the underlying peat soils removed to the peat restoration area, to minimise the volume of material stored in the vicinity of the track.

**Photo 4.** View of peat slip area at CH2450 of Spur 4 at Kergord. Recovery of peat and slope stabilisation in progress.

Discussions between SSE and the Principal Contractor are currently ongoing to ascertain whether there are additional mitigation measures that could be implemented in future for areas where similar topography and related risks are identified.

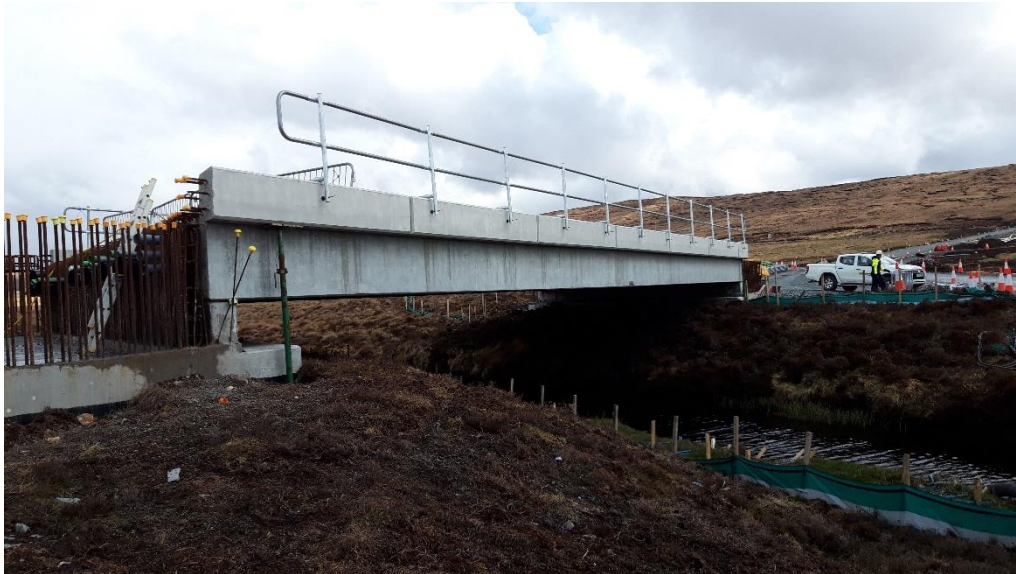
Construction of the permanent bridge over the Burn of Pettawater is ongoing which was observed by the PMO during the audit as shown on Photo 5 of Appendix 1.

**Photo 5.** Progress with construction of permanent bridge over the Burn of Pettawater

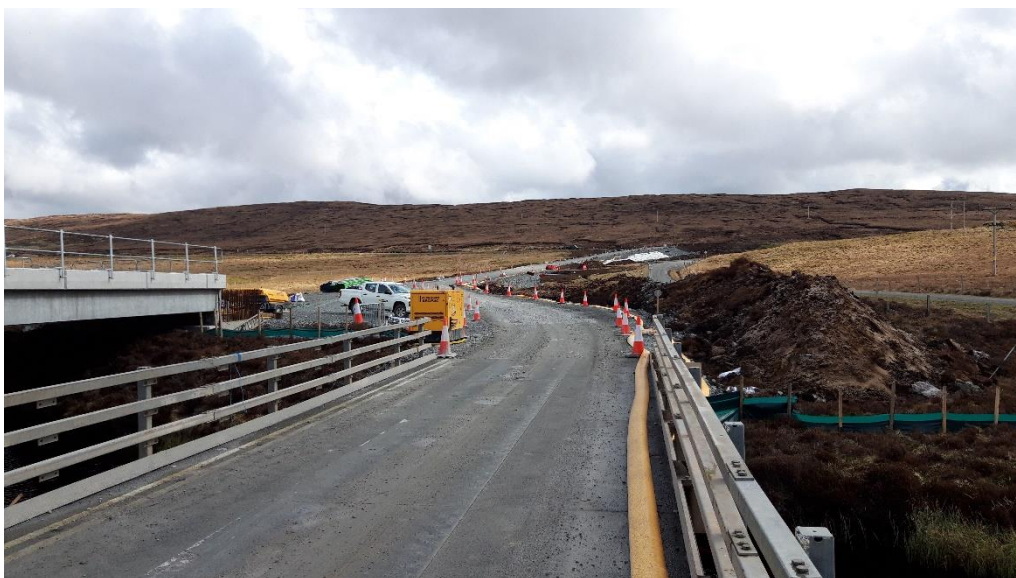
Recently implemented dust mitigation measures were observed on Sandwater Road, comprising perforated pipes connected to a pump and clean water supply (refer to Photo 6 in Appendix 1).

**Photo 6.** Dust mitigation measures ready for use as required along Sandwater Road

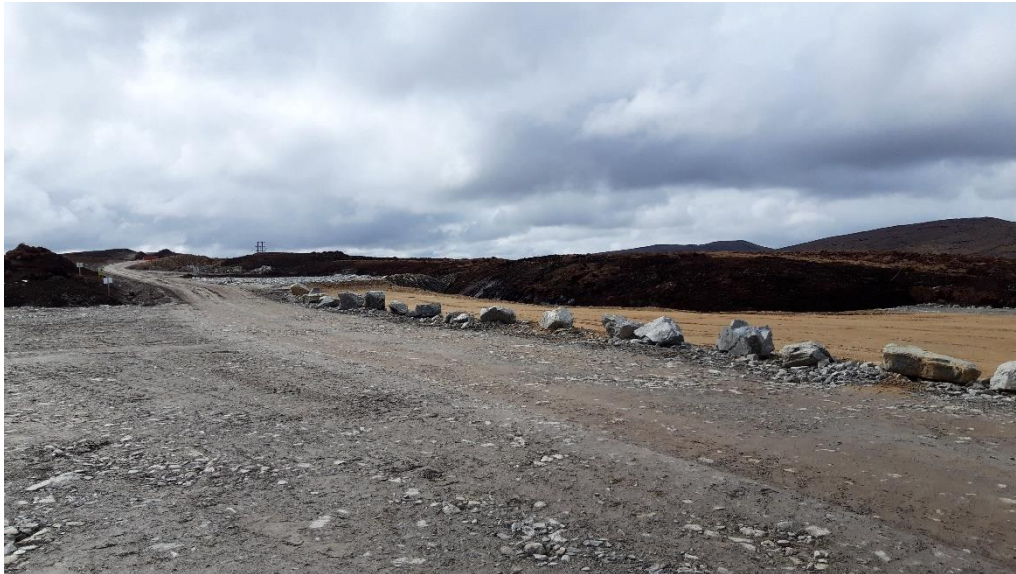
Active work in peat restoration areas P08 and P09 has been completed, with ongoing monitoring undertaken by the ECoW and GCoW. P08 as viewed from the MKR track is shown on Photo 7 in Appendix 1.

**Photo 7.** View of peat restoration area P08 from K79 crane pad hardstanding

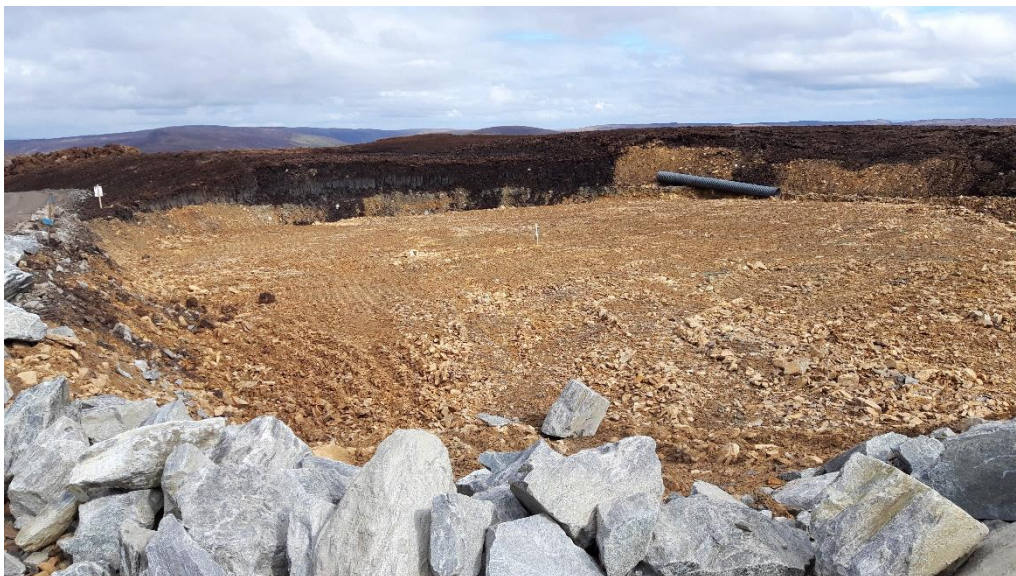
The crane pad hardstanding for K79 has been formed and the turbine base excavated as shown on Photo 8 of Appendix 1. Peat restoration area P09 is located to the rear of the turbine base excavation.

**Photo 8.** Turbine K79 excavation with peat restoration area P09 in the background.

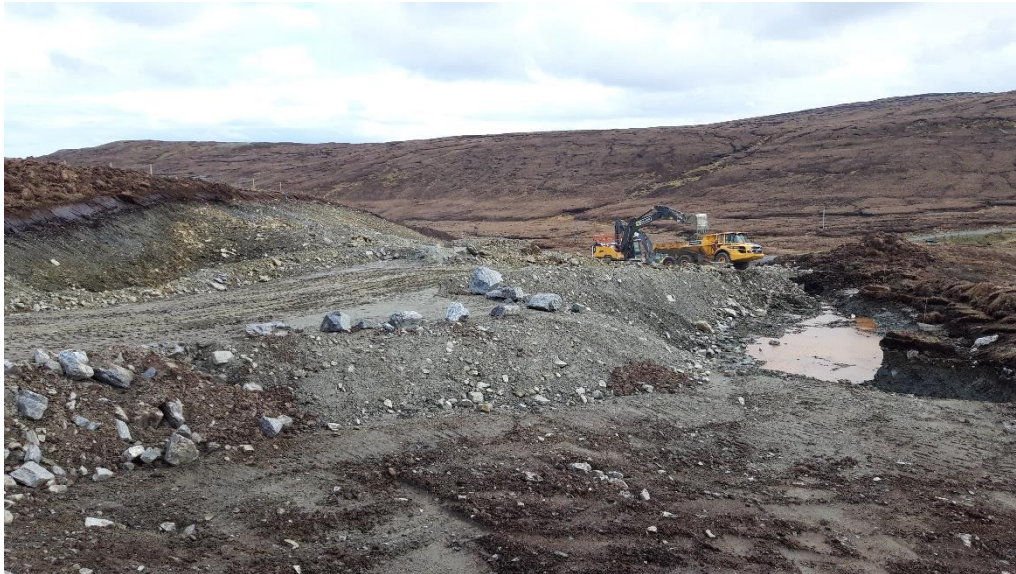
At the northern end of the MKR at Hamarigrind Scord, work is ongoing to form the junction with the A970 and to construct the final stretch of the access track that will connect with the MKR. Rock was in the process of being extracted from this area during the audit which was used for the formation of the crane pad hardstanding for turbine K78. The PMO observed a settlement pond downgradient of active work area at Hamarigrind Scord used to intercept silty water. The water is subsequently pumped back up the hill to the upgradient catchment area. The general work area is shown on Photo 9 of Appendix 1; the settlement pond is located between the machinery and the A970 road beyond (not visible in photo).

**Photo 9.** Excavation of rock at Hamarigrind Scord, being removed for use at the crane pad hardstanding for K78.

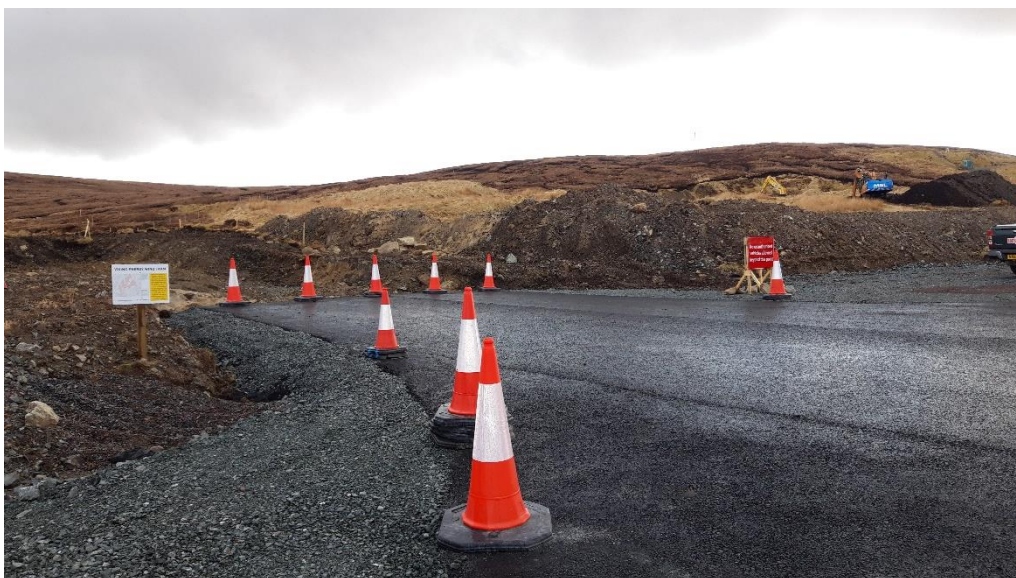
At the time of the audit the work being carried out in the North Compound was limited to the excavation and stockpiling of soil and rock. The immediate junction of the future access track to the North Compound was observed to have been surfaced in asphalt (refer to Photo 10 in Appendix 1).

**Photo 10.** Access point for North Compound at the junction with the A970. Excavators in the background are progressing construction of the North Compound platform.

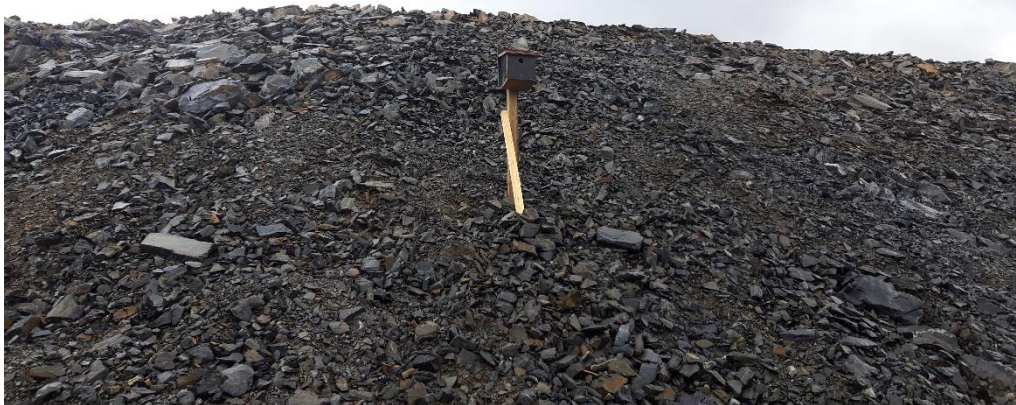
There were few significant changes to the main compound since the previous audit. The PMO noted that the main access route from the A970 to the Main Compound had been surfaced in asphalt. A number of bird nesting boxes were observed to have been installed on the upper level of the main compound (along the exposed rock cutting), and along the northern limit of the compound as shown on Photo 11 of Appendix 1. These boxes provide preferential nesting locations to plant (e.g. dump trucks) since bird nesting within parked vehicles is a common occurrence in Shetland and has the potential to result in vehicle fires.

**Photo 11.** Example of bird nesting boxes that have been installed at the Main Compound.

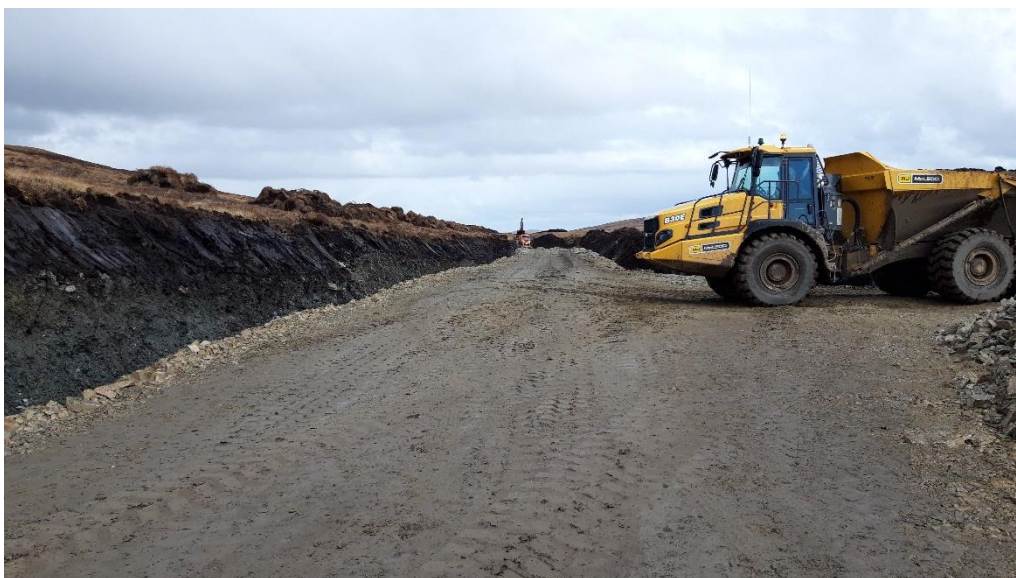
Track construction has progressed as far as turbine N137 on Spur 32 (refer to Photo 12 of Appendix 1). At the time of the audit, peat was being excavated and transported to peat restoration area P27. The PMO viewed culverts that had been constructed to divert drainage beneath the track. Water flowing into and out of the culvert was noted to be clear.

**Photo 12.** Progress of track construction at Spur 32 towards N137.

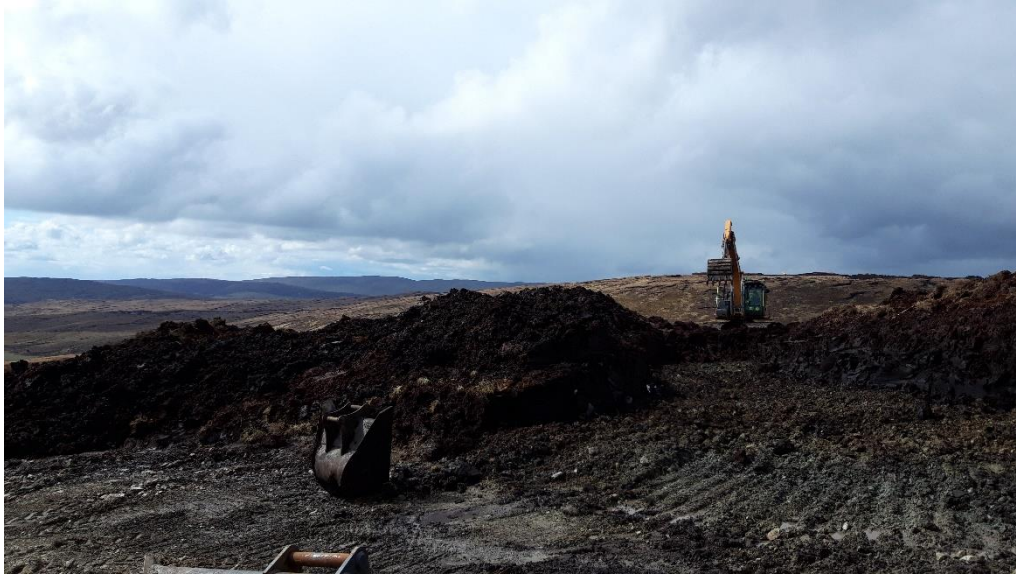
An excavator was observed progressing the removal of peat to allow the subsequent formation of the crane pad hardstanding for turbine location N132 (refer to Photo 13 of Appendix 1).

**Photo 13.** Excavation of peat at the location of N132 on Spur 32.

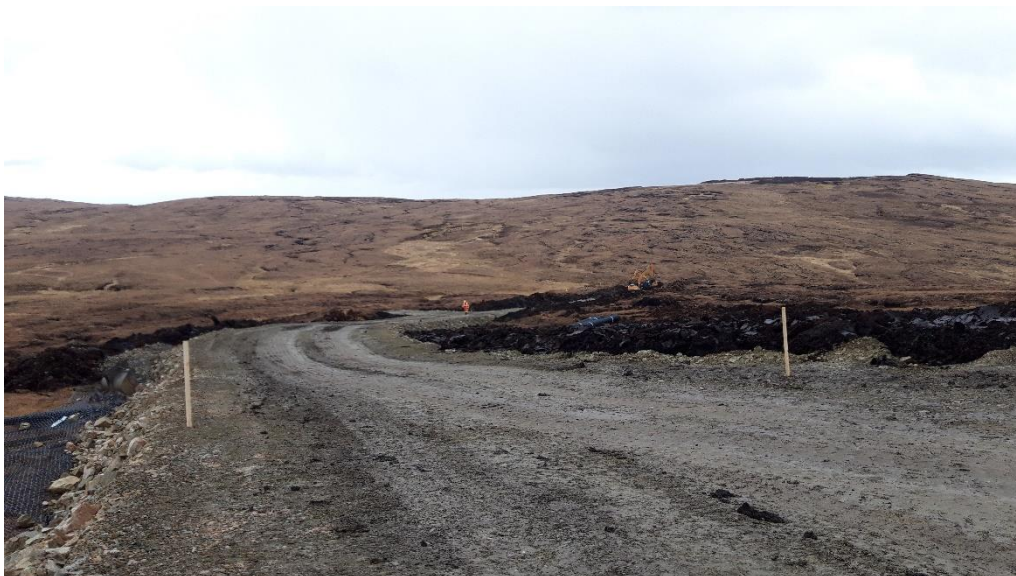
Progress at Spur 27 towards turbine location N122 was observed from Junction 28 as shown on Photo 14 of Appendix 1. Pre-construction surveys have been carried out along the route of Spur 26 to the south (towards turbine location N121) with the route cleared by the ECoW shown to be demarcated.

**Photo 14.** View of progress along Spur 27, viewed from Junction 28.

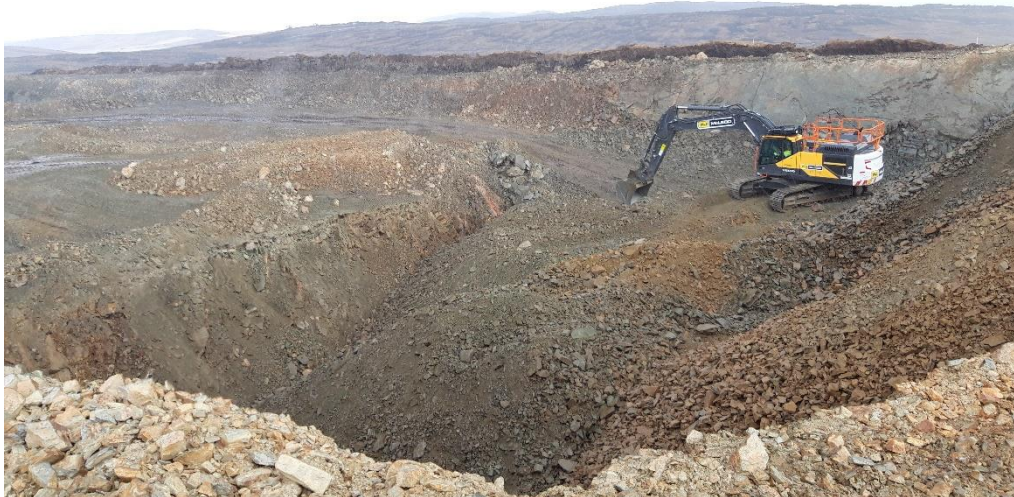
The borrow pit NBP05 was observed; rock extraction continues in this area and preparations were underway for the next blast (refer to Photo 15 and 16 in Appendix 1). Extracted rock is used for the construction of tracks and crane pad hardstandings.

**Photo 15.** Excavator progressing extraction of rock within borrow pit NBP05.

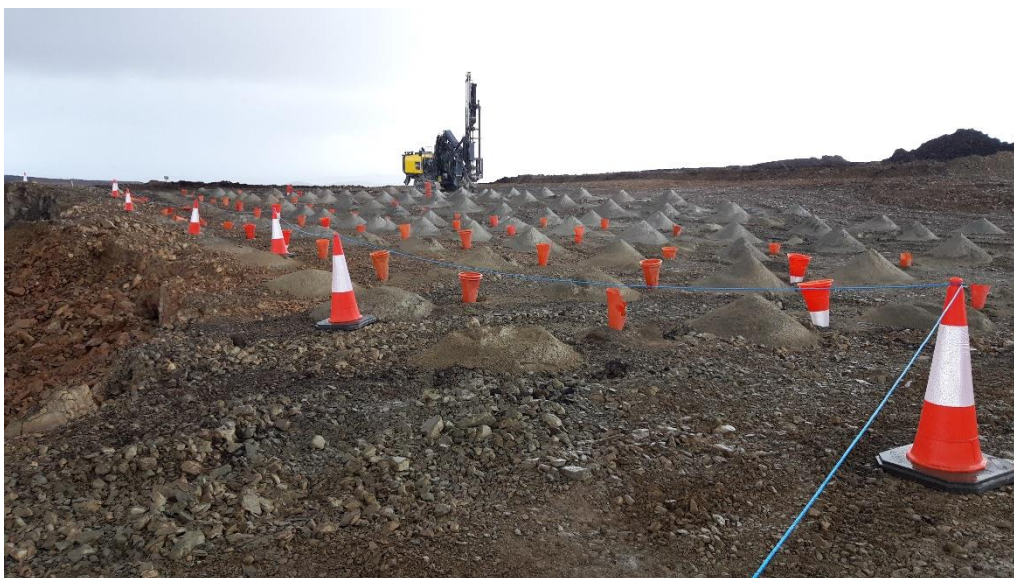
**Photo 16.** Drilling rig working in borrow pit NBP05, preparing for the next blast.

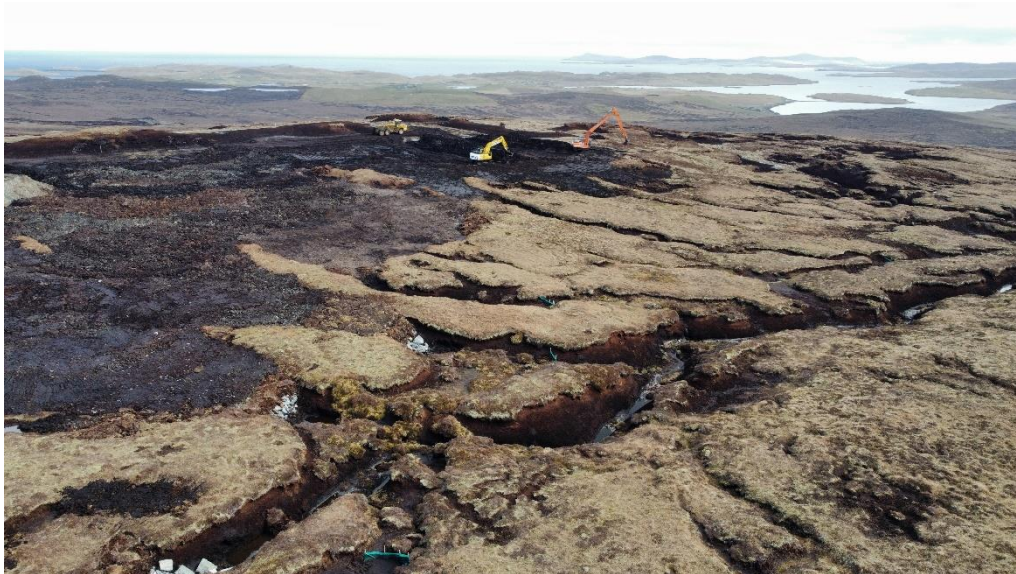
The aerial extent of NBP05 and P27 is shown on Photos 17 and 18 of Appendix 1.

**Photo 17.** Aerial view of peat restoration area P27.

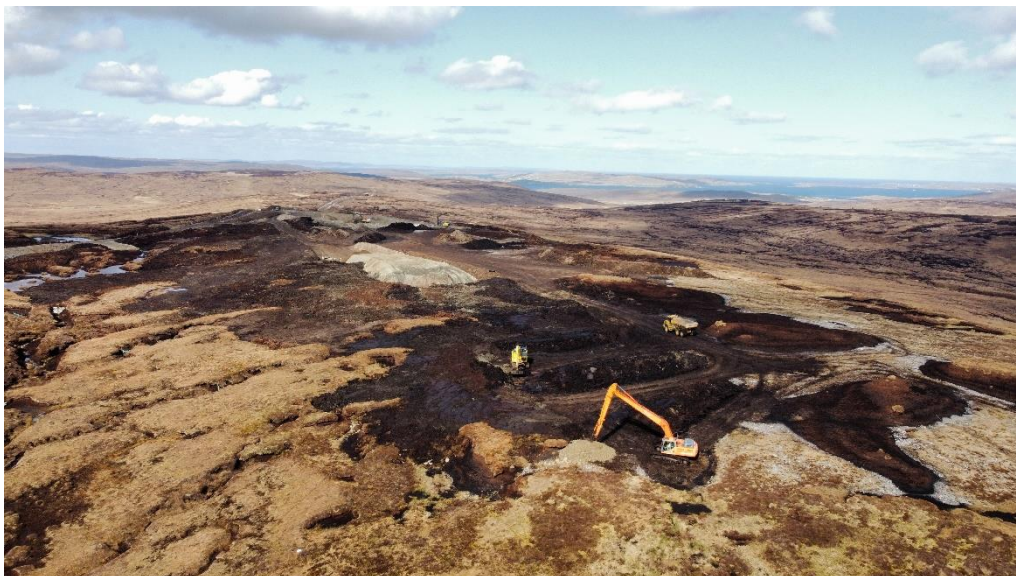
**Photo 18.** Aerial view of peat restoration area P27 in the foreground, and borrow pit NBP05 in the background.
