Intended for  
Viking Energy Wind Farm LLP

Date  
June 2021

VIKING ENERGY WIND  
FARM  
PLANNING  
MONITORING OFFICER  
AUDIT REPORT 007:  
28<sup>TH</sup> APRIL TO 26<sup>TH</sup> MAY  
2021

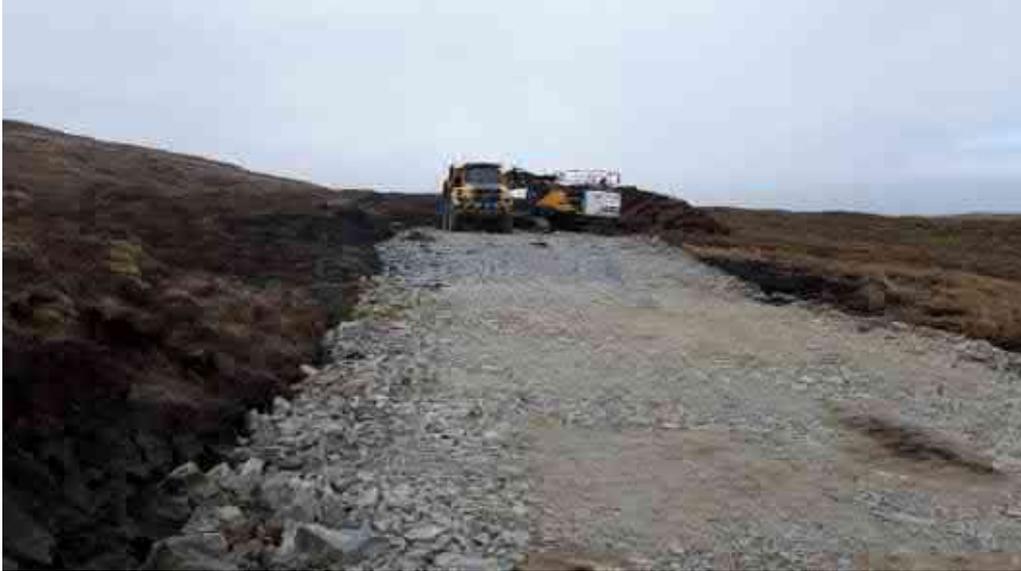
Construction of Spur 4 had progressed beyond the location of turbine K60 at the time of the audit. An excavator was removing peat which was transported to the peat restoration area in proximity to turbine K58. Extracted rock was also in the process of being transported to this work area to continue with track construction. A culvert was noted to have been installed to divert a watercourse beneath the access track in proximity to this location. The general work area is shown on Photograph 1 of Appendix 1.

Photo 1. Removal of peat and placement of stone on access track on Spur 4.

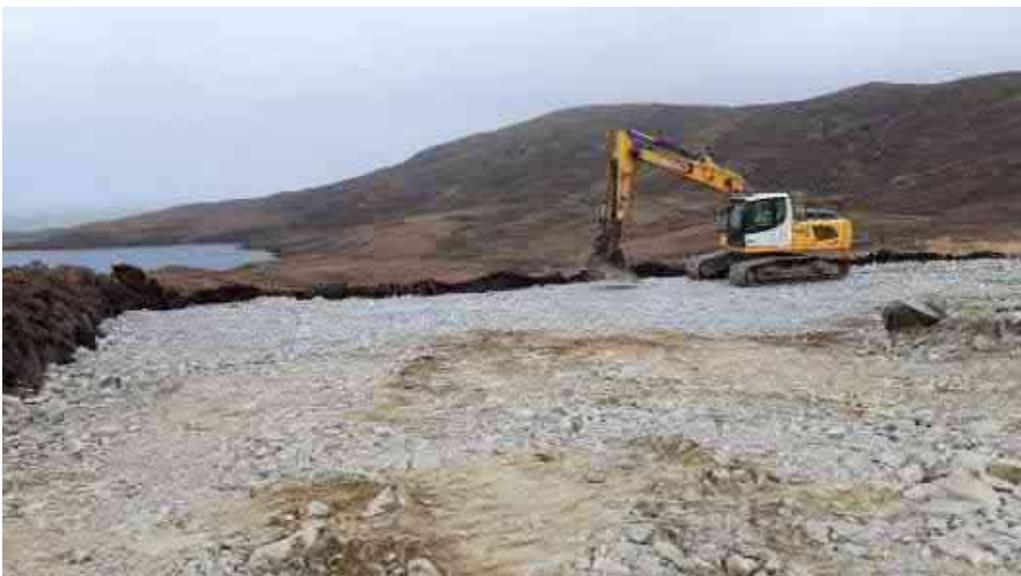
The hardstanding crane pad for turbine K60 was being progressed during the audit as shown on Photograph 2 of Appendix 1.

Photo 2. Formation of hardstanding crane pad at turbine K60.

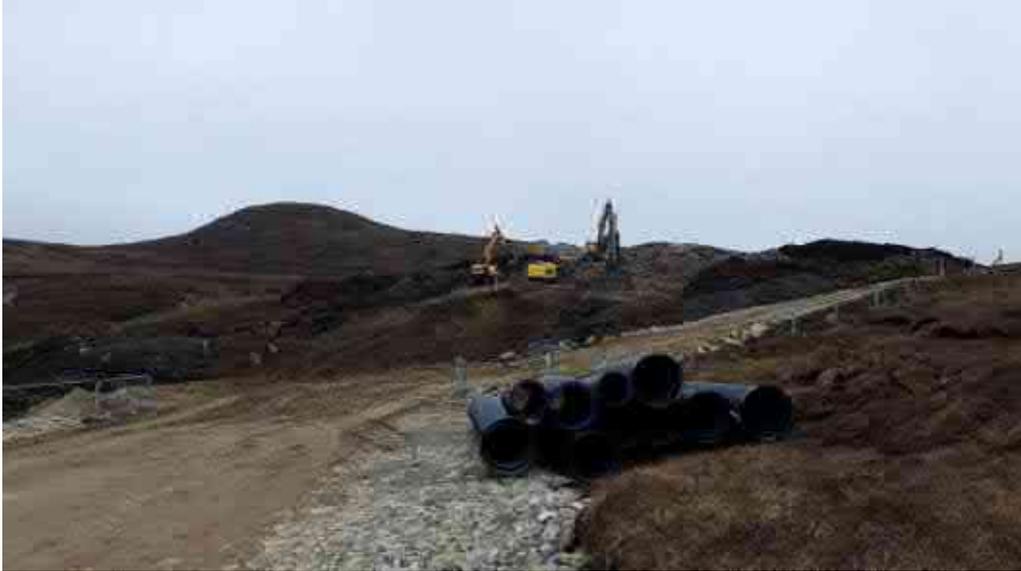
A pilot track had been constructed in order to progress towards the location of turbine K60. A localised area requires drilling and blasting to create the final track route which was observed to be underway at the time of the audit as shown on Photograph 3 of Appendix 1.

Photo 3. Area to be drilled and blasted to allow creation of final access track on Spur 4. Temporary pilot track has been constructed (on right hand side of image).

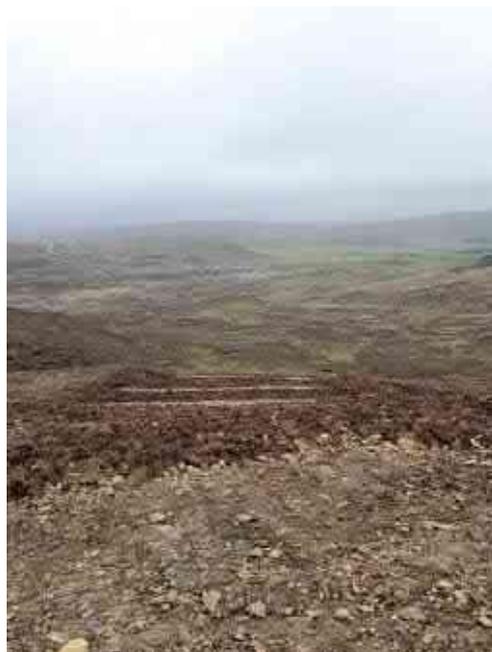
The PMO viewed CH2450 of Spur 4 where the peat slippage occurred prior to the April audit. The area was observed to have been remediated via the formation of stone bunds to stabilise the slope as shown on Photograph 4 of Appendix 1. This area continues to be monitored as noted on the Peat Risk Register (PRR) for Array E.

Photo 4. Remediated peat slip area at CH2450 of Spur 4 at Kergord.

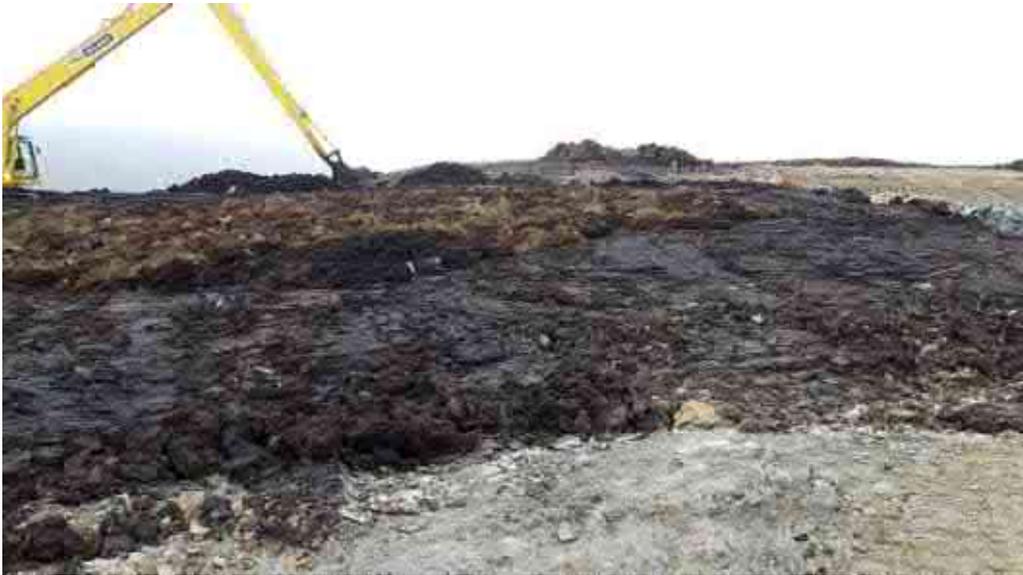
Two peat restoration areas adjacent to Spur 10 (in proximity to turbine K58) were observed by the PMO during the audit; P4C was in progress (refer to photograph 5 in Appendix 1), and P5D which was had been completed (refer to Photograph 6 in Appendix 1).

Photo 5. Ongoing works at peat restoration area P4C.

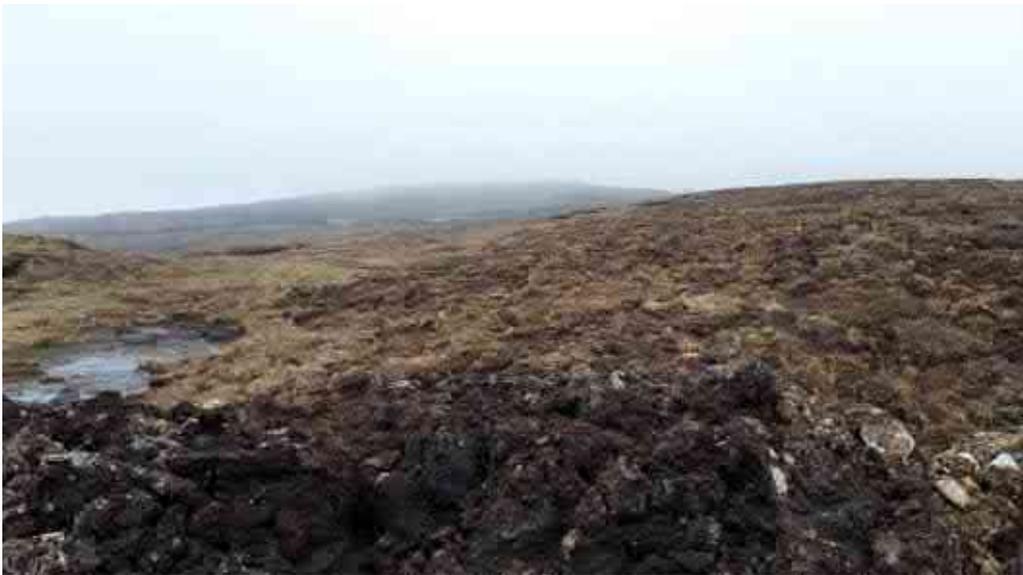
Photo 6. Completed restoration works at peat restoration area P5D.

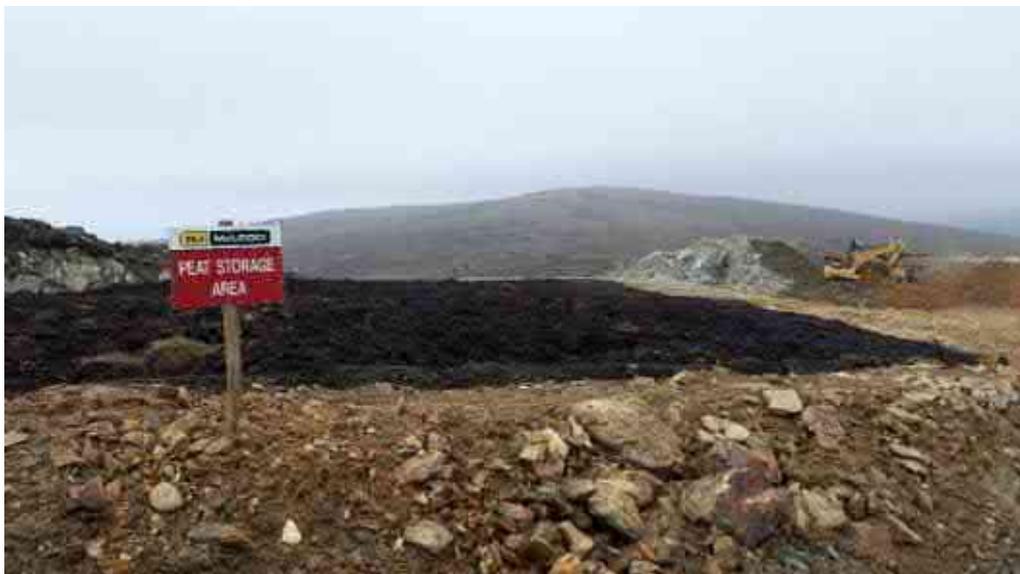
Rock extraction is continuing within borrow pit KBP02. Preparations for blasting were underway at the time of the audit and the extracted stone is used for the construction of crane pad hardstandings and access tracks. A temporary peat storage area was observed for excavated peat that will be used in the future reinstatement of the borrow pit (refer to Photograph 7 of Appendix 1).

Photo 7. Temporary peat storage area within borrow pit KBP02.

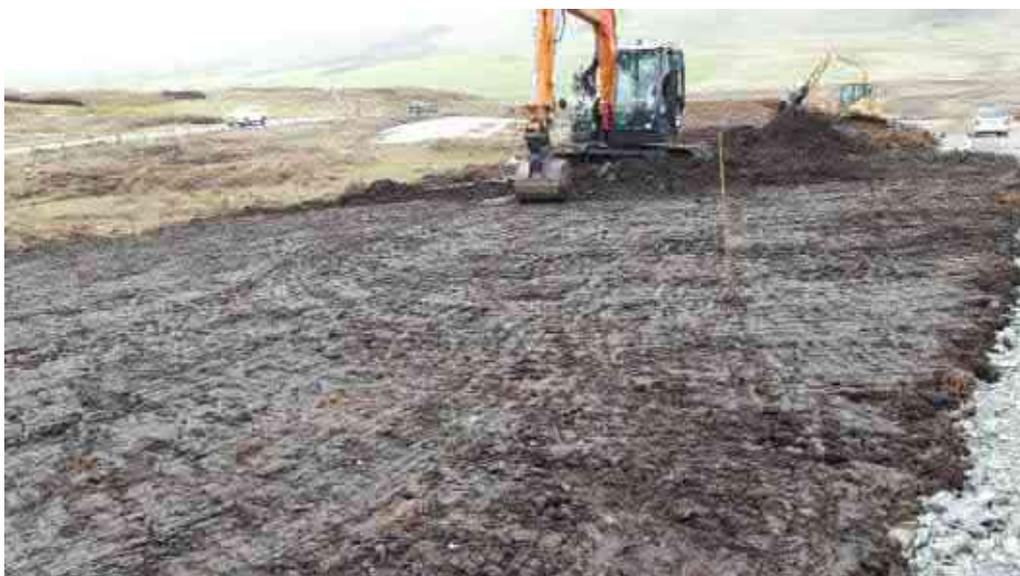
Reinstatement of the southern verge was being undertaken by two excavators in the western half of the new Sandwater track. Reseeding will be undertaken at a later date. The PMO understands that an appropriate seed mix (of local provenance) has been agreed with consultees (as per the terms of Condition 4(2)) and is in the process of being procured. The works in this area are shown on Photograph 8 of Appendix 1.

Photo 8. Ongoing reinstatement on the southern verge of Sandwater Road.

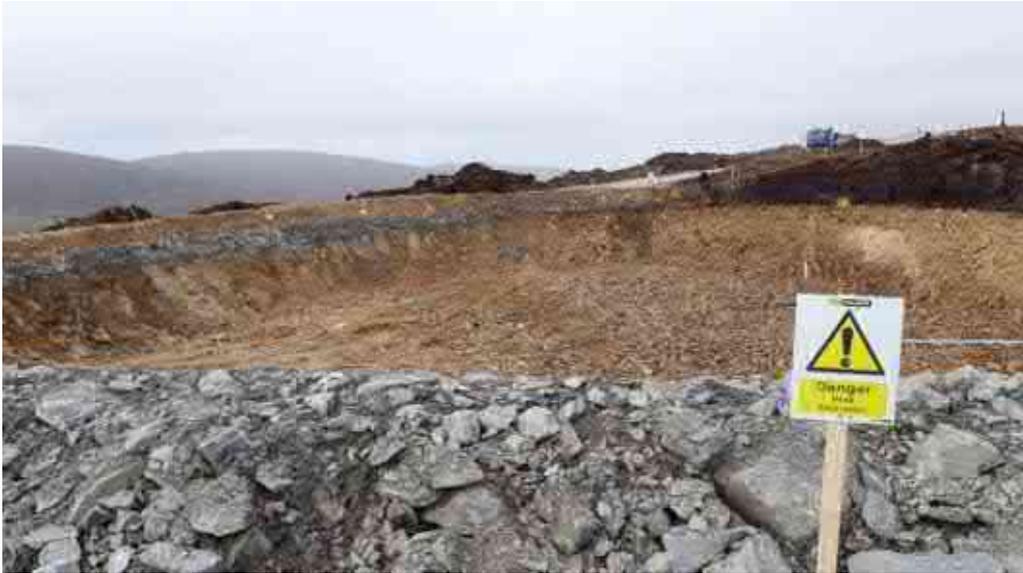
The PMO observed the excavations that have been carried out for the turbine bases at K87 and K88. Turbine base K87 is shown on Photograph 9 of Appendix 1. RJM's Design Management Engineer advised that the excavations will be completed prior to undertaking plate bearing tests to assess the bearing capacity of the formation level.

Photo 9. Turbine base excavation at K87.

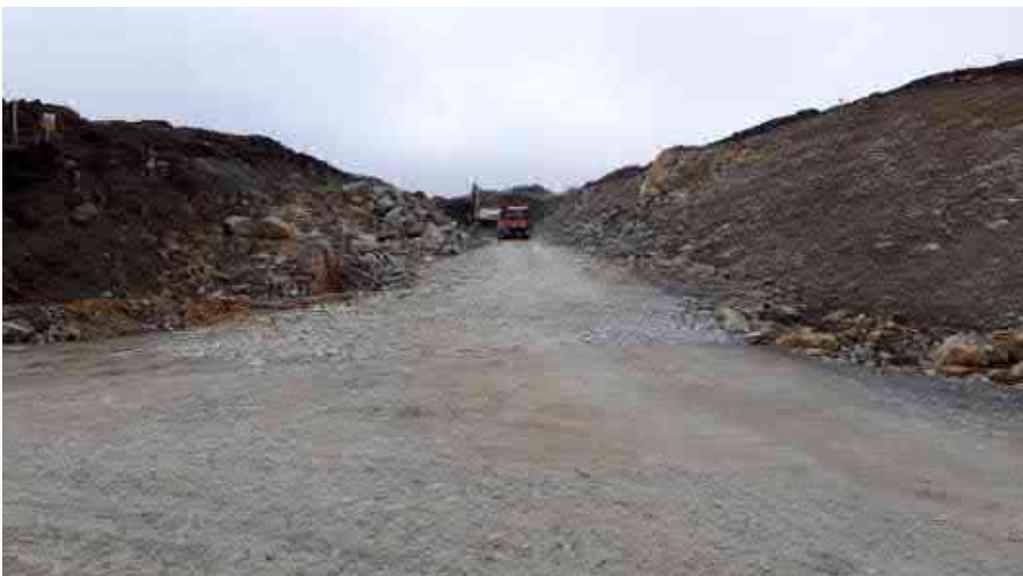
At the northern end of the MKR at Hamarigrind Scord works are ongoing to extract rock to connect with the rest of the MKR. The junction with the A970 has been formed and was in use by trucks removing rock extracted from the cutting and transporting this to the North Compound. The works being progressed in this area are shown on Photograph 10 of Appendix 1.

Photo 10. Rock extraction at Hamarigrind Scord, at the northern end of the Mid Kame Ridge.

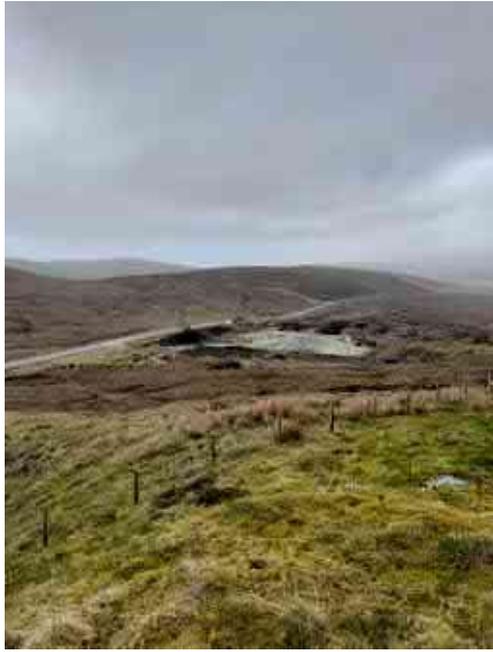
Since the April audit, formation of the Main Compound platform has progressed. An excavator was observed placing a geotextile across the formation level, while stone extracted from Hamarigrind Scord was being used to create the development platform. A general view of the North Compound area is shown on Photograph 11 of Appendix 1.

Photo 11. View of the North Compound (facing north).

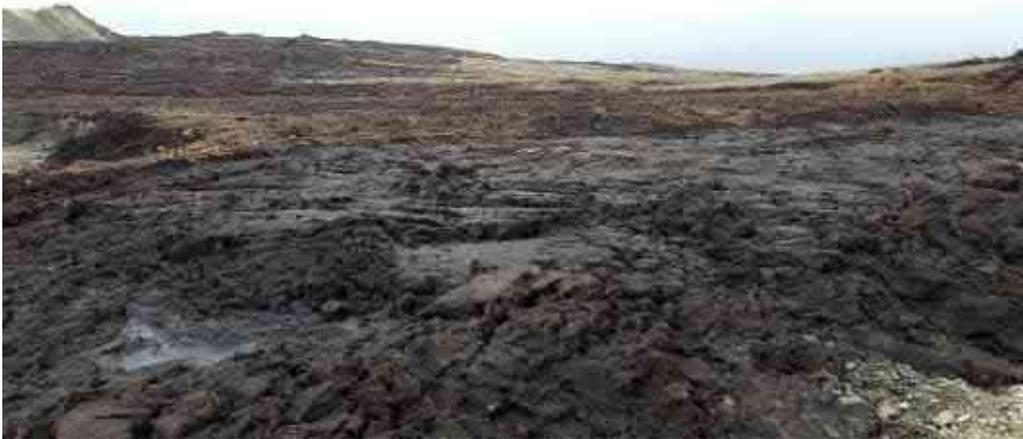
Ongoing peat restoration work at P25 and P27 was observed as shown in Photograph 12 of Appendix 1.

Photo 12. View of progress within peat restoration area P27.

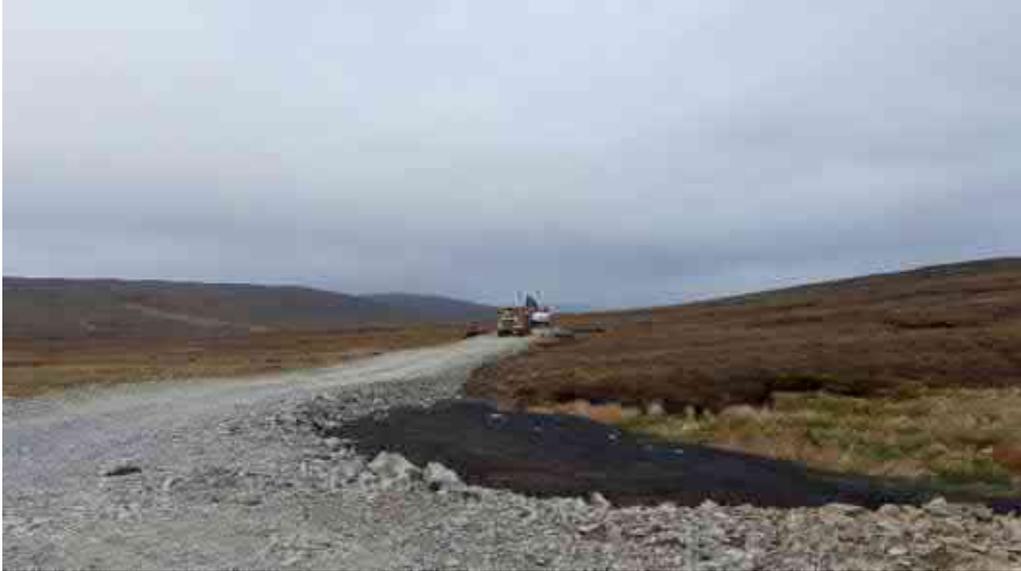
The PMO viewed progress of the access track on Spur 39, north of junction 41 as shown on Photograph 13 of Appendix 1. Works to the south of this junction have been put on hold due to the presence of nesting birds, with resources deployed on to progressing work in others parts of the site.

Photo 13. View of track construction at Spur 39.

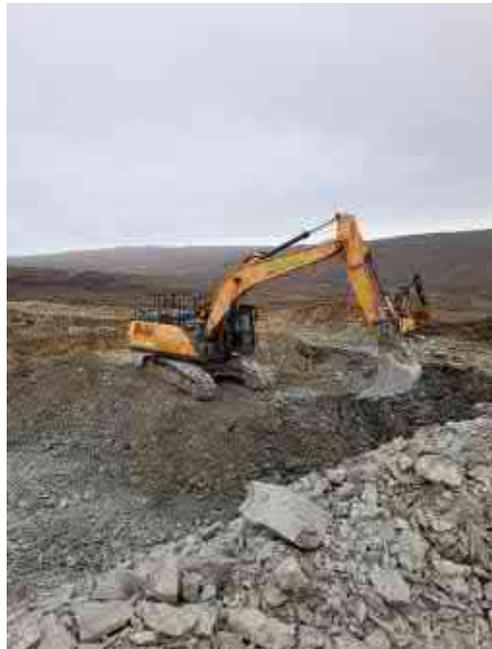
Drilling and blasting has been carried out in the vicinity of turbine N129 to allow the access track to the turbine and hardstanding to be created. The general work area is shown on Photograph 14 of Appendix 1.

Photo 14. Extraction of rock to create access to turbine N129 and associated hardstanding.

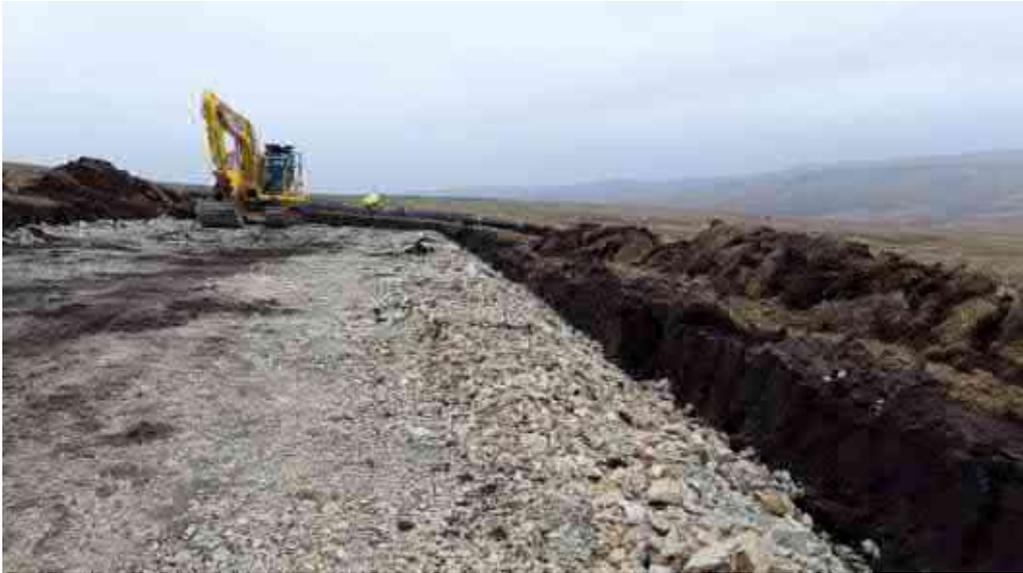
The PMO viewed progress of the access track construction along Spur 27. A pilot track has been created along a section of this spur as a result of nesting bird constraints in the vicinity. Following identification of an active nest by the ECoW, a buffer zone was delineated by canes and the pilot track constructed beyond this area. Track construction works observed by the PMO included the excavation and stockpiling of turves, and placement of geotextile along the track route.

Photo 15. Construction of access track on Spur 27.

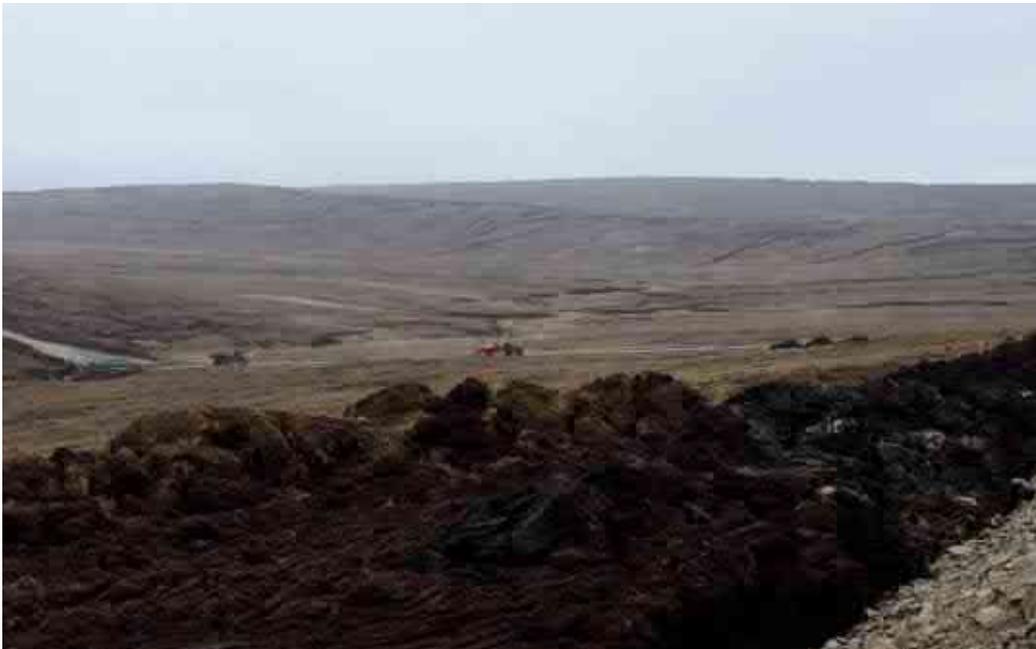
A tractor with water bowser was observed on Spur 27 (refer to Photograph 16 of Appendix 1) dampening the access track in accordance with the dust suppression measures.

Photo 16. View of tractor with water bowser for dust suppression in Nesting area observed from Spur 27.
