SHETLAND ISLAND COUNCIL

Shetland Inter-Island Transport Study

Piers and Harbours - Existing Assets

WORKING PAPER

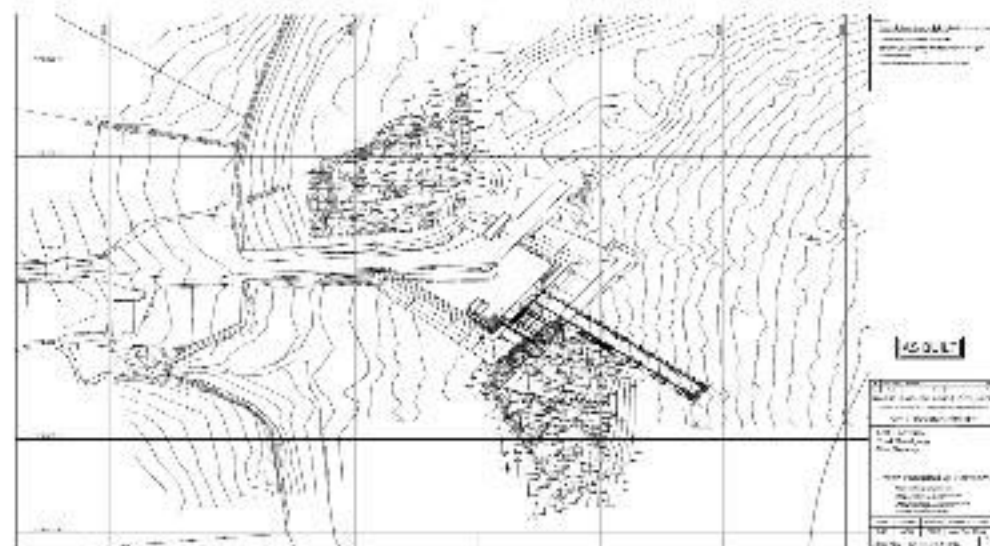
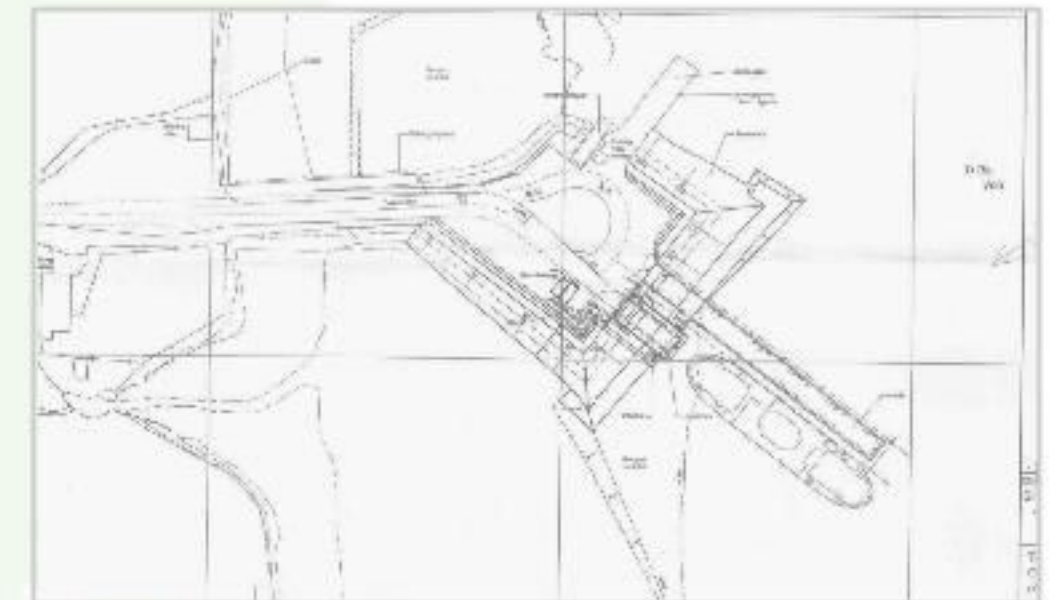
Toft

RoRo vessels berth against a row of fender panels on the inner south western side of a piled jetty that extends 63m from the end of the larger sized linkspan. There is a layby berth on the other side of the jetty.

The terminal was found to be in serviceable condition.

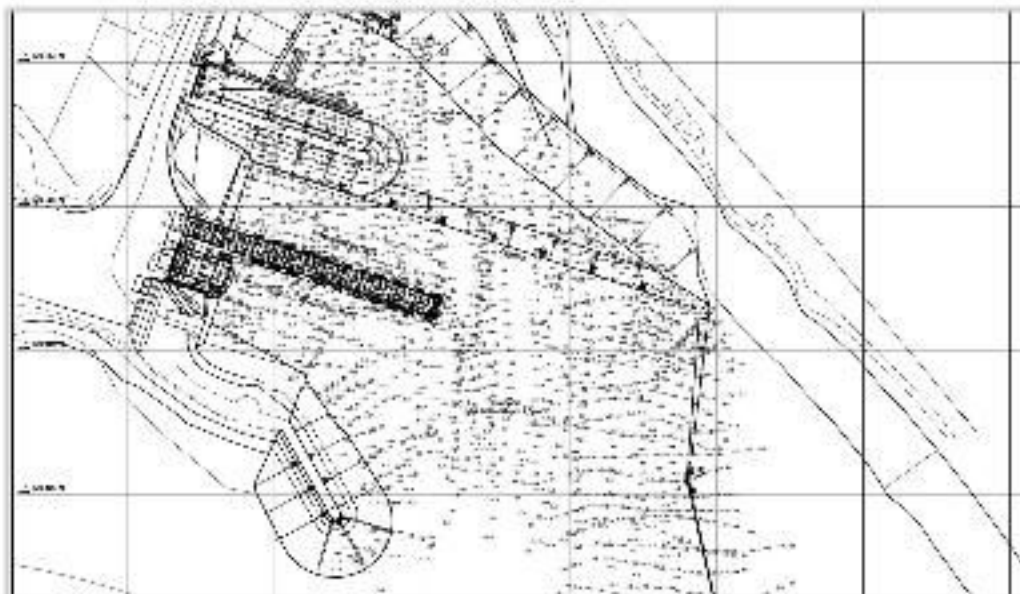
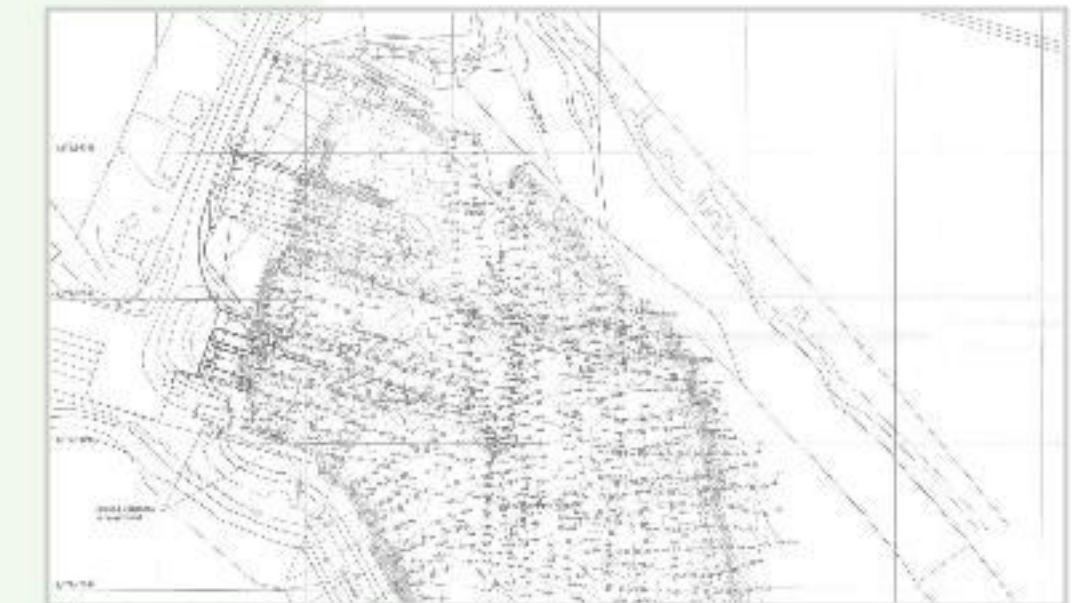
Ulsta

RoRo vessels berth against a row of fender panels on the outer south side of a piled jetty that extends 70m from the end of the larger sized linkspan. There is a layby berth on the other side of the jetty.

The terminal was found to be in serviceable condition.

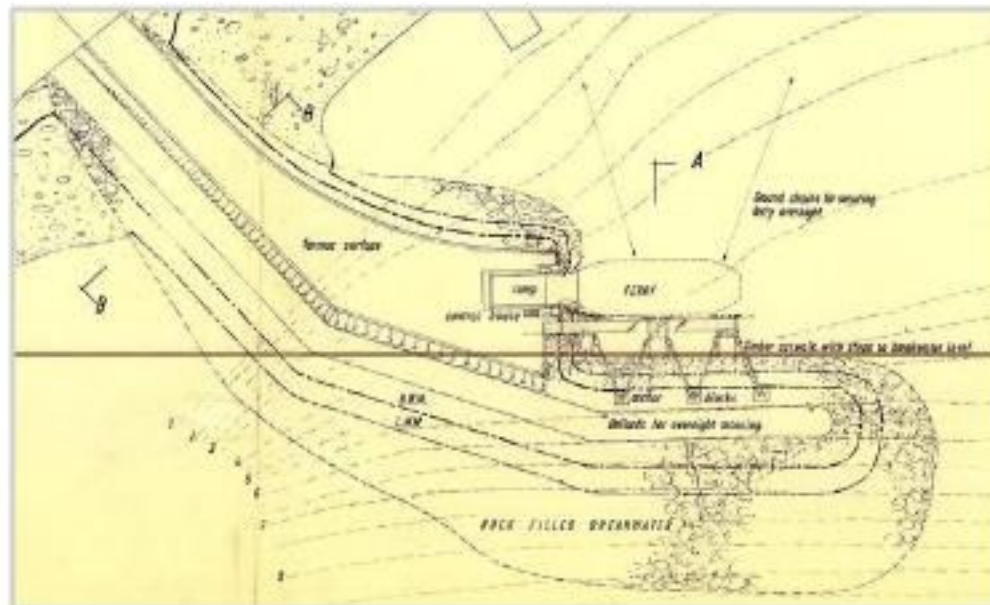
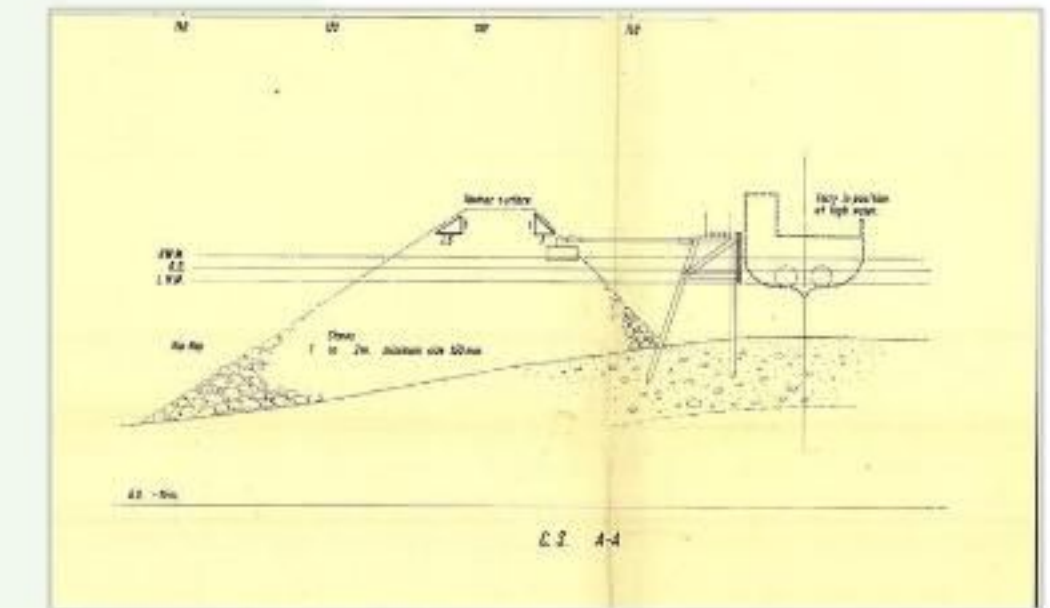
Gutcher

Vessels berth against a row of 3 dolphins on the lee side of the rubble mound breakwater and extend 25m from the end of the linkspan. These timber dolphins are supported against the breakwater by a series of horizontal diagonal timber struts founded on concrete blocks. They are faced with vertical rubber D fenders supported in steel H sections. Plans have been prepared for the construction of an additional dolphin that would help vessel manoeuvring in windy conditions.

The terminal was found to be in serviceable condition.

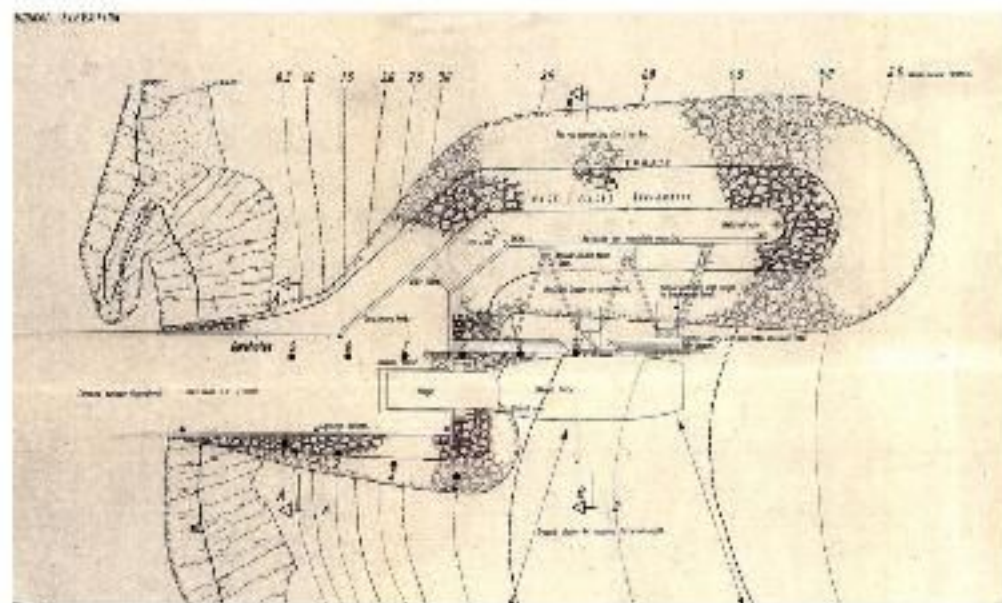
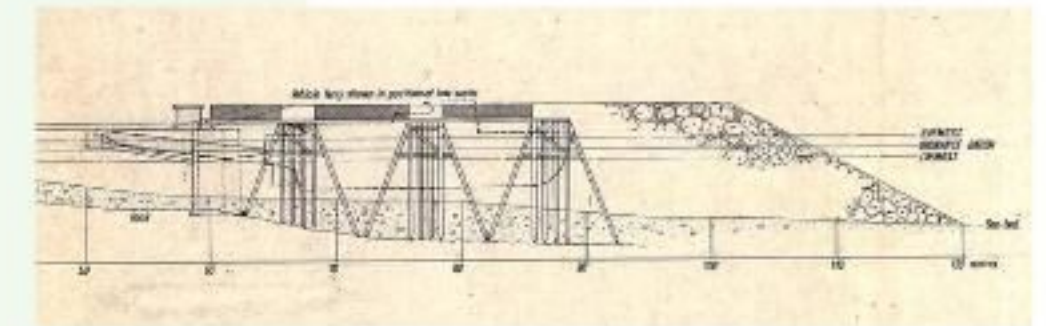
Belmont

Vessels berth against a row of 3 dolphins on the lee side of the rubble mound breakwater and extend 25m from the end of the linkspan. These timber dolphins are supported against the breakwater by a series of horizontal diagonal timber struts founded on concrete blocks and are faced with vertical rubber D fenders supported in steel H sections.

The terminal was found to be in serviceable condition.

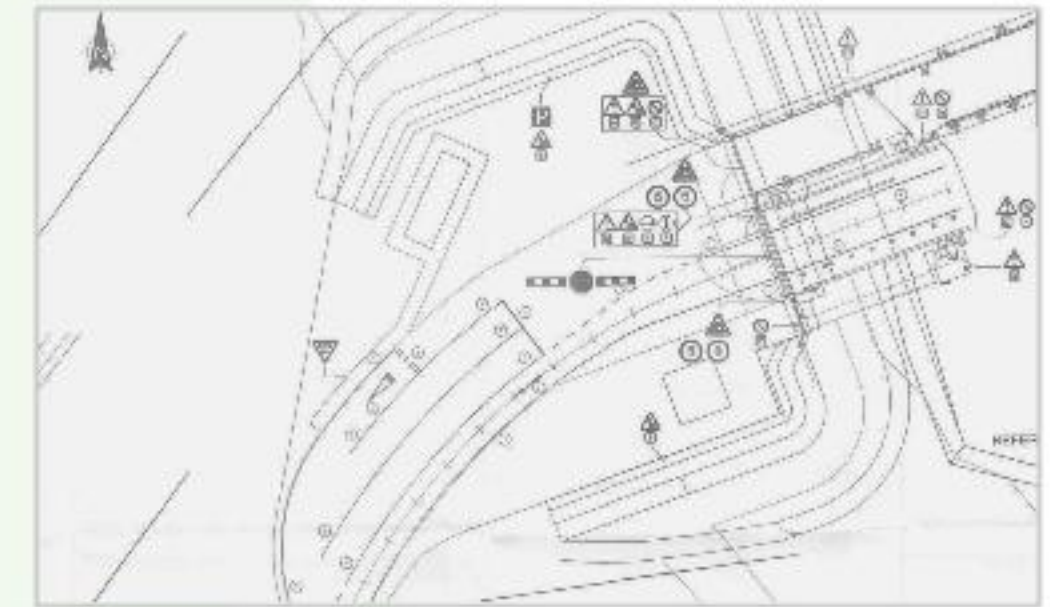
Hamars Ness

RoRo vessels berth against a row of fender panels on the southern side of a piled jetty that extends 50m from the end of the larger sized linkspan. There is a layby berth on the other side of the jetty.

The terminal was found to be in serviceable condition.

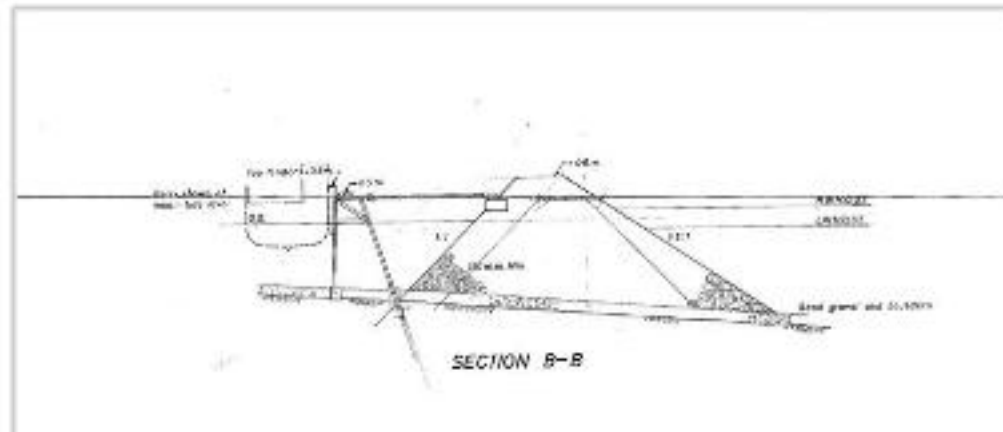
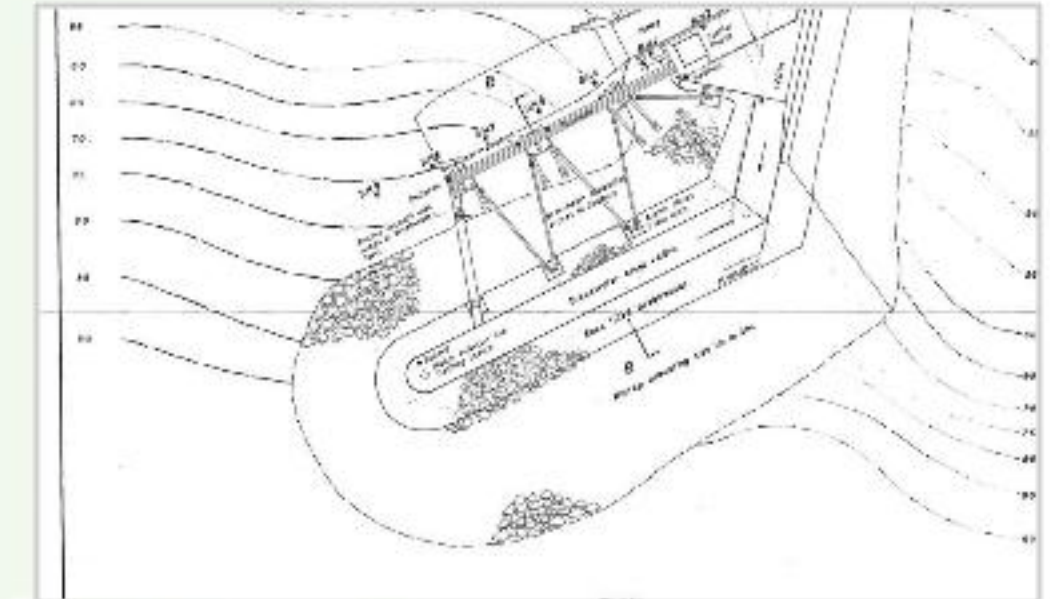
Laxo

Vessels berth against a row of 5 dolphins on the lee side of the rubble mound breakwater and extend 38m from the end of the linkspan. These timber dolphins are supported against the breakwater by a series of horizontal diagonal timber struts founded on concrete blocks and are faced with vertical rubber D fenders supported in steel H sections.

The terminal was found to be in serviceable condition.

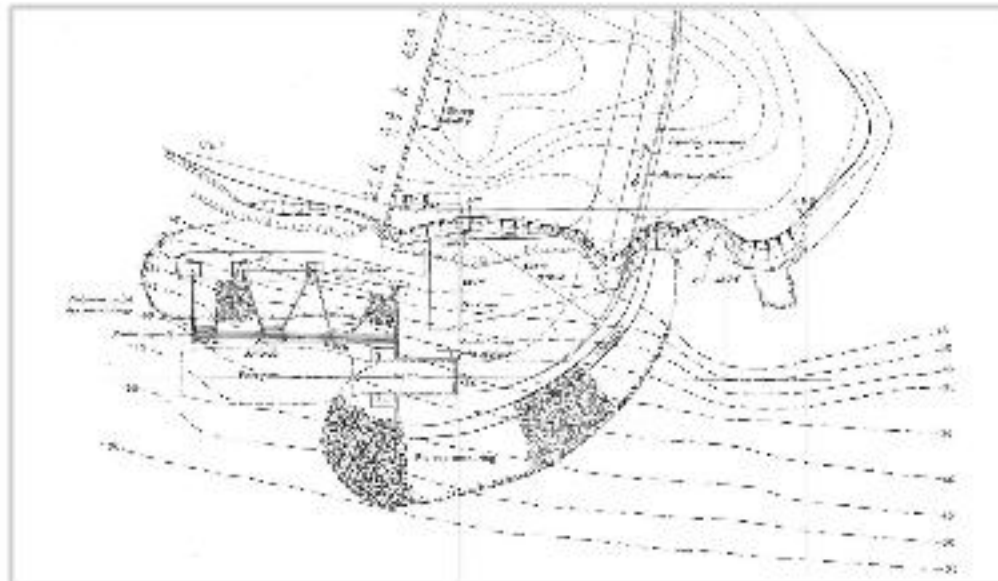
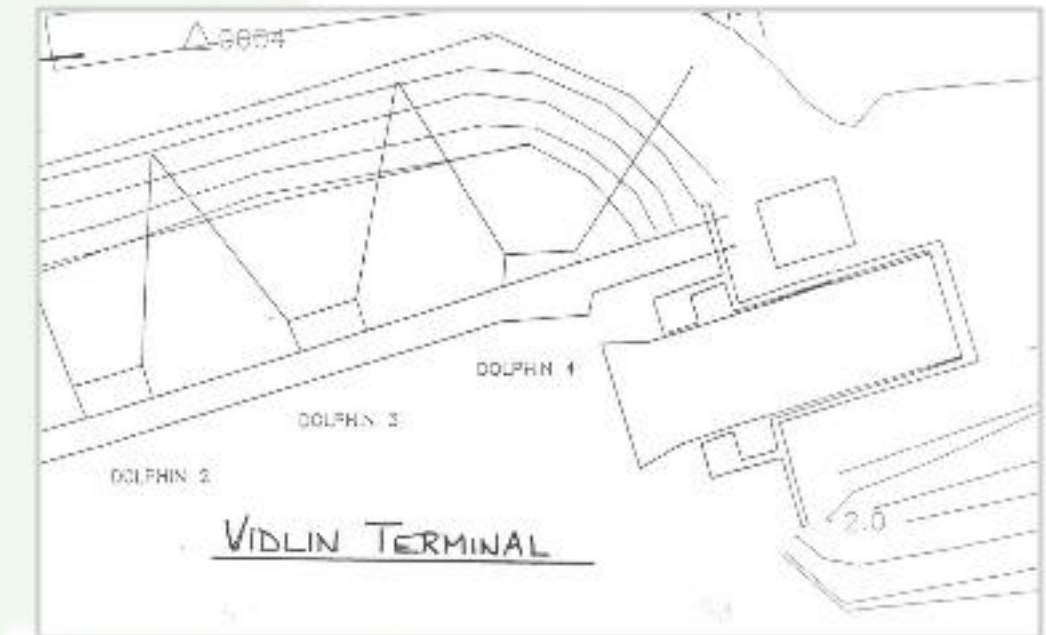
Vidlin

Vessels berth against a row of 4 dolphins alongside a rubble mound and extend 33m from the end of the linkspan. These timber dolphins are supported against the breakwater by a series of horizontal diagonal timber struts founded on concrete blocks and are faced with vertical rubber D fenders supported in steel H sections.

The terminal was found to be in serviceable condition.

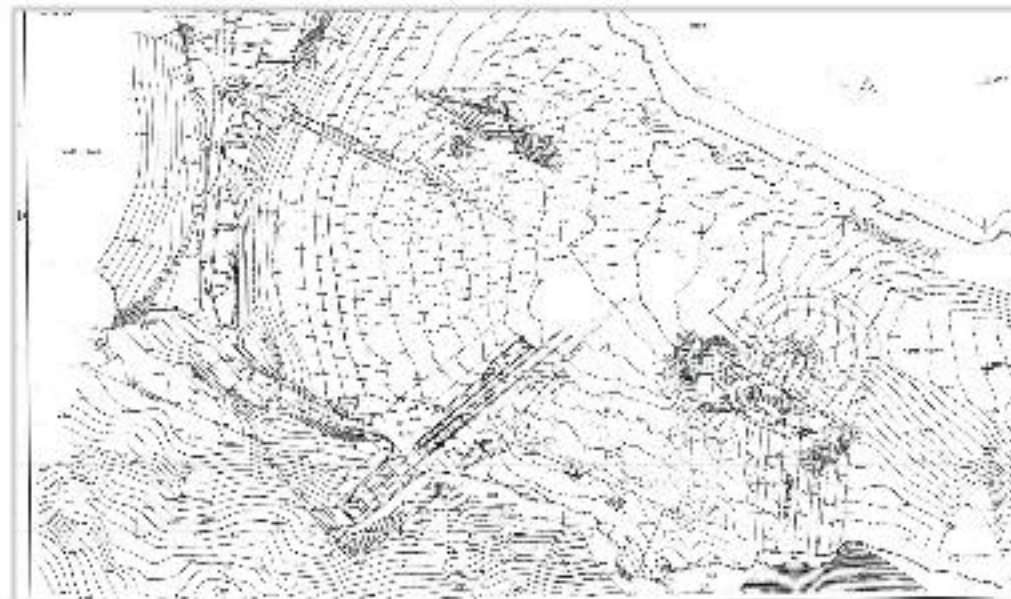
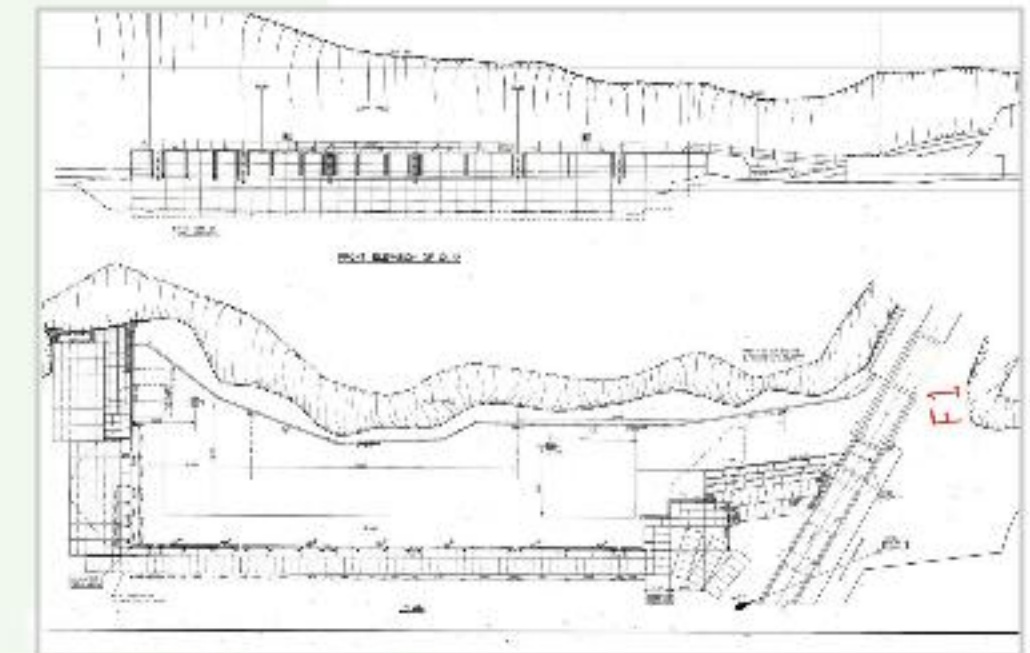
Fair Isle

Vessels berth against a 60m long concrete quay in the lee of the rubble mound breakwater. However, this is an exposed location and the ferry vessel is removed from the water on a slipway cradle when rough weather is expected. This means that existing ferry vessels can overnight here safely.

It is understood that the terminal is in serviceable condition.
