Intended for  
**Viking Energy Wind Farm LLP**

Date  
**June 2022**

Project Number  
**1620009158**

# **VIKING ENERGY WIND FARM PLANNING MONITORING OFFICER AUDIT REPORT 020: 21<sup>ST</sup> MAY 2022 TO 17<sup>TH</sup> JUNE 2022**

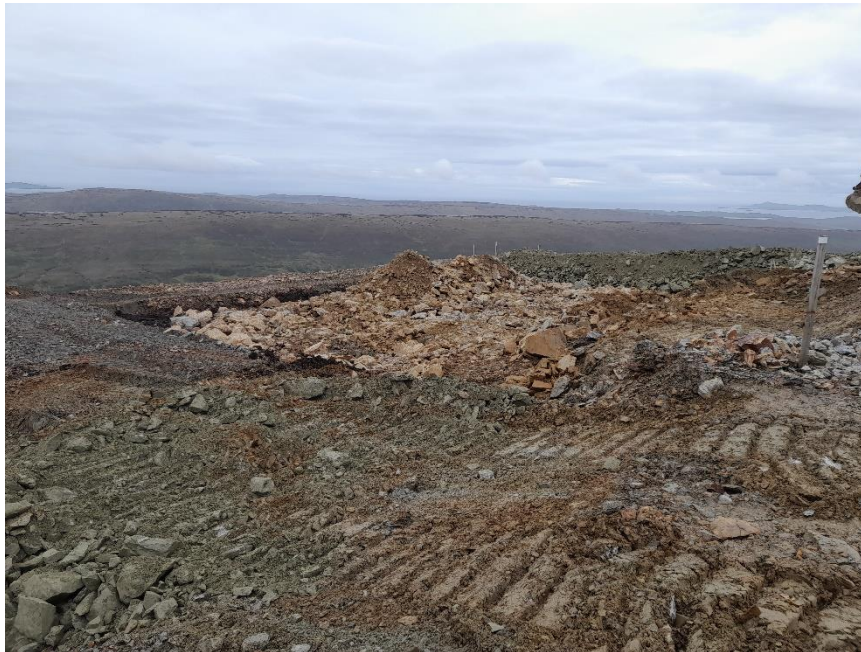
The construction of tracks and bases has continued across the arrays with steelwork and concrete pouring, and the backfilling of bases ongoing. Installed drainage measures are of good quality and preventative mitigation will continue to be installed as turbine base and hardstanding excavation continue. The construction of blade fingers at K44 was observed by the PMO. The design engineer noted that a toe bund had been constructed between the two blade fingers (Photo 1), and peat will be infilled between the fingers once the turbines have been erected.

**Photo 1.** Toe bund between blade fingers at K44

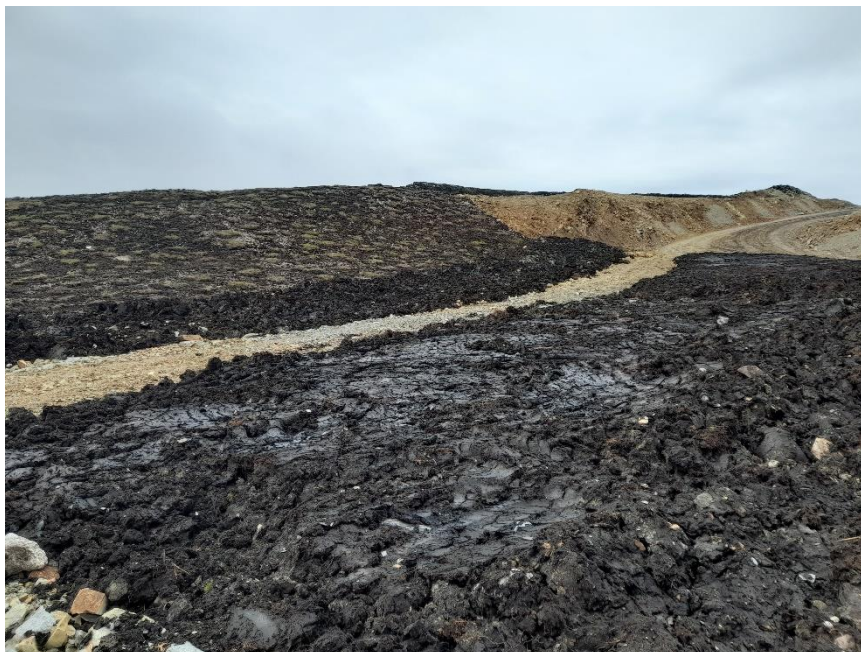
The PMO observed the storage of peat within the KBP02 borrow pit. The peat was being stored in cells (Photo 2) which will be re-landscaped following the decommissioning of the borrow pit. It is noted that a geotechnical engineer completes monthly audits of the stability of the borrow pits.

The GCoW indicated that there may be further works required regarding the peat storage in KBP02, however there is no requirement to move the peat during the current period works.

**Photo 2.** Peat being stored in KBP02

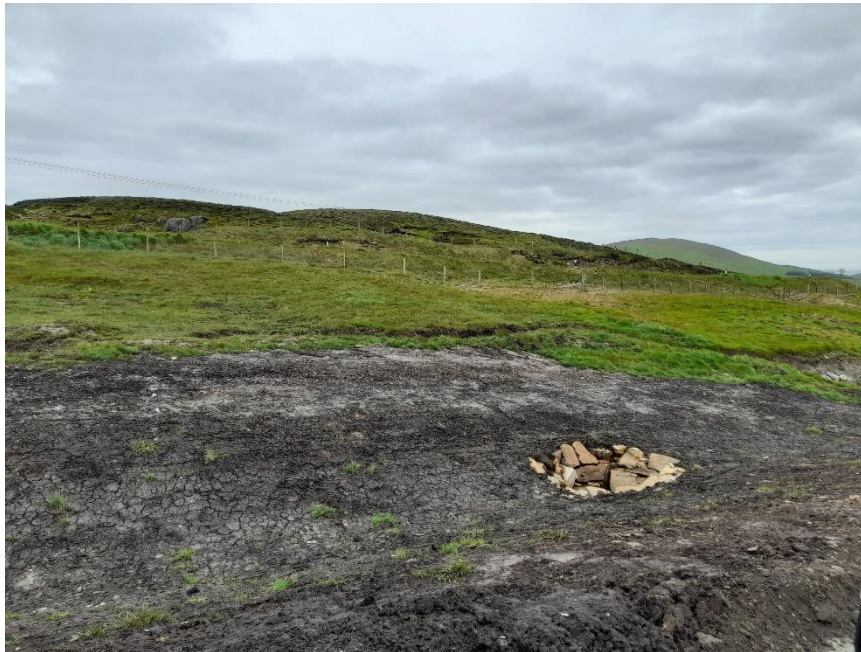
A drainage culvert has been improved and leads into the burn at the western side of the track (Photo 3).

**Photo 3.** Drainage culvert on Sandwater road

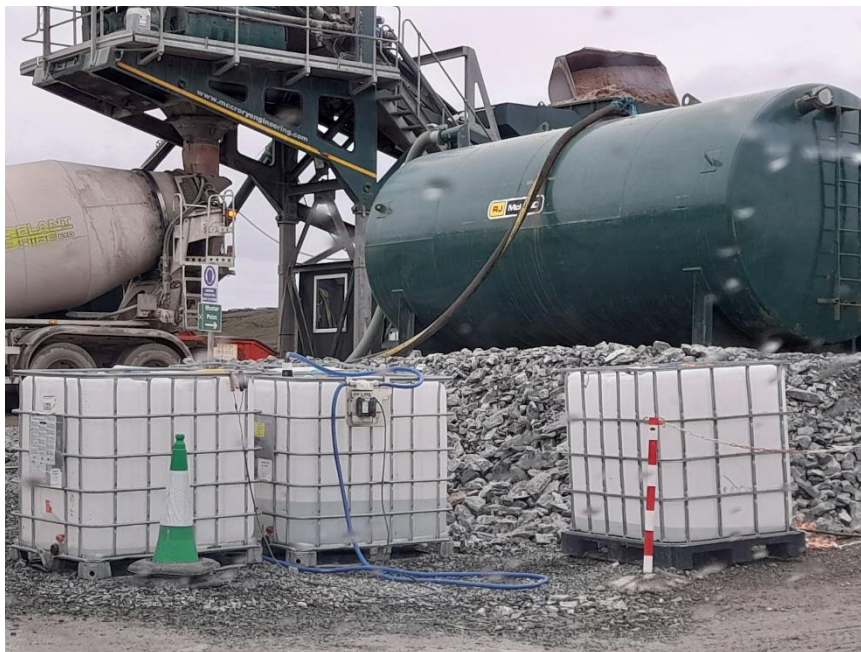
During PMO 20, three IBCs were observed to be on the compacted stone surface (Photo 4), however all were in use with the concrete pouring works that were ongoing. The remainder of the IBCs were on hardstanding. It was discussed with the H&S Advisor during the walkover that the management of the IBCs were under review and that risk assessments were being updated. It was however agreed that if IBCs are not being stored on hardstanding then they should be in a temporary bund.

Materials Storage and Handling (e.g. oil/fuel storage and peat/mineral soil storage and handling).	PMO observed non-compliance with the waste management plan. Approximately 3 no. IBCs were being stored directly on the ground, rather than on an area of hardstanding.	A temporary bund is required whilst the IBCs are being stored off the hardstanding.	Principal Contractor	Amber
Natural and Built Environment (e.g. ecology, biosecurity, protected sites, archaeology and site restoration).	<p>Ecological constraints identified by the ECoW team are communicated to the Principal contractor and Developer to allow mitigation measures to be implemented and rescheduling of preparatory and construction work as required. These are also marked out by poles on the site and included on ecological sensitive plans issued to the Principal contractor.</p> <p>Watching briefs have been undertaken by the ACoW where potential archaeological constraints</p>	No action required.	N/A	Green

**Photo 4.** IBCs directly on compacted stone surface

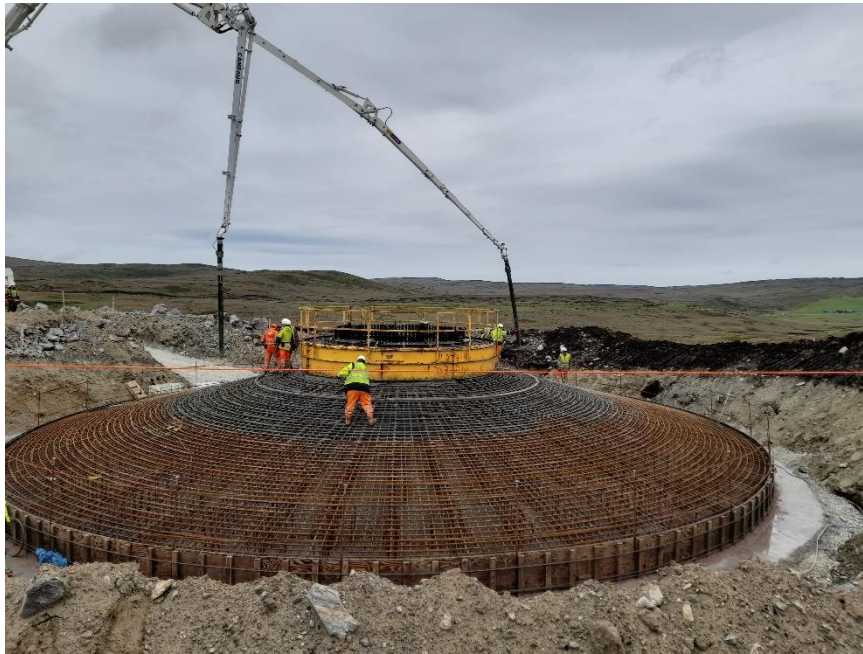
During the PMO visit, base N95 was being poured (Photo 5), and several other bases had been poured and backfilled since PMO 019 (Photos 6 and 7). Water crossing 15 has also been completed since PMO 019 (Photo 8).

**Photo 5.** N95 base being poured

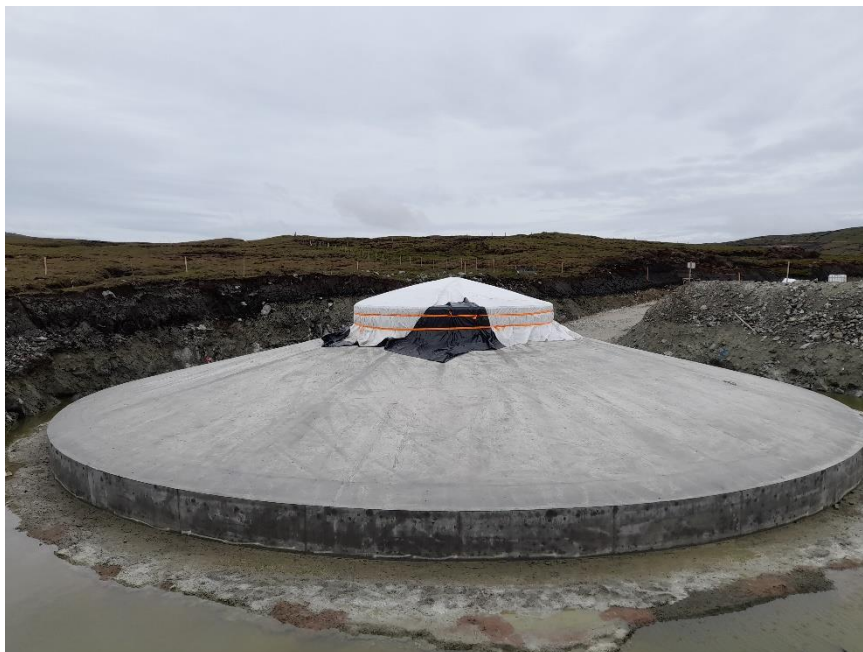
**Photo 6.** N93 base poured

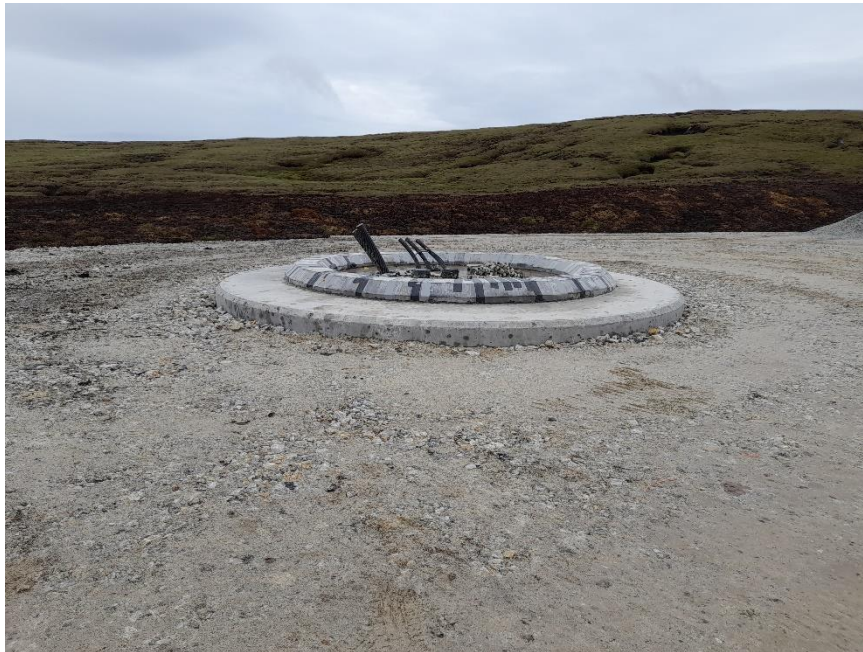
**Photo 7.** N89 base backfilled

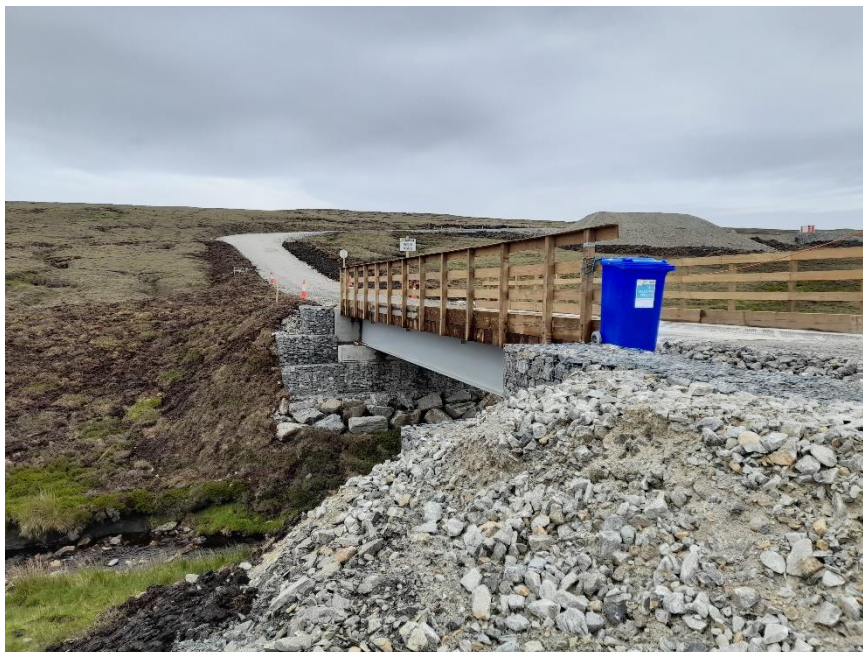
**Photo 8.** Bridge at Water crossing 15

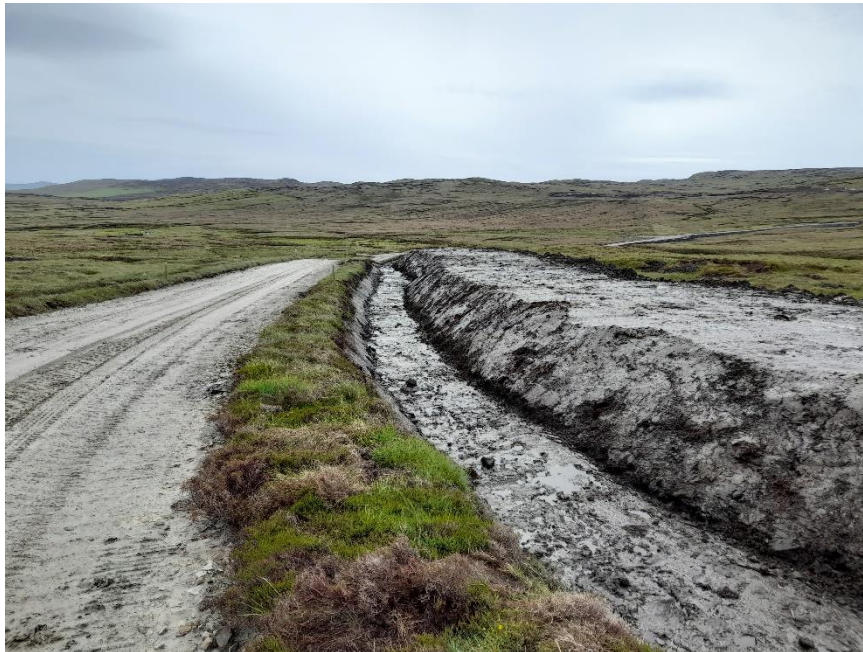
Cable trenching works had been carried out between N140 and N141 (Photo 9).

**Photo 9.** Cable trenching works between N140 and N141

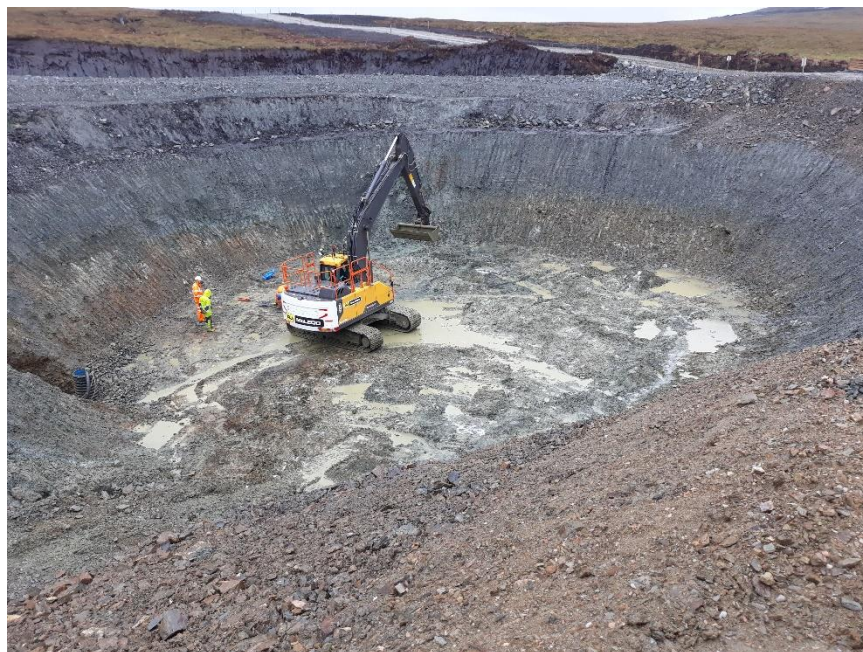
N143 base had been up-filled, ready for blinding and steel fixing, during the PMO audit, but had been noted by several parties to have been a success, despite the deep excavation and groundwater management that was required to found the base on suitable strata (Photo 10 courtesy of RJ Macleod).

**Photo 10.** N143 deep base (photo courtesy of RJ Macleod)

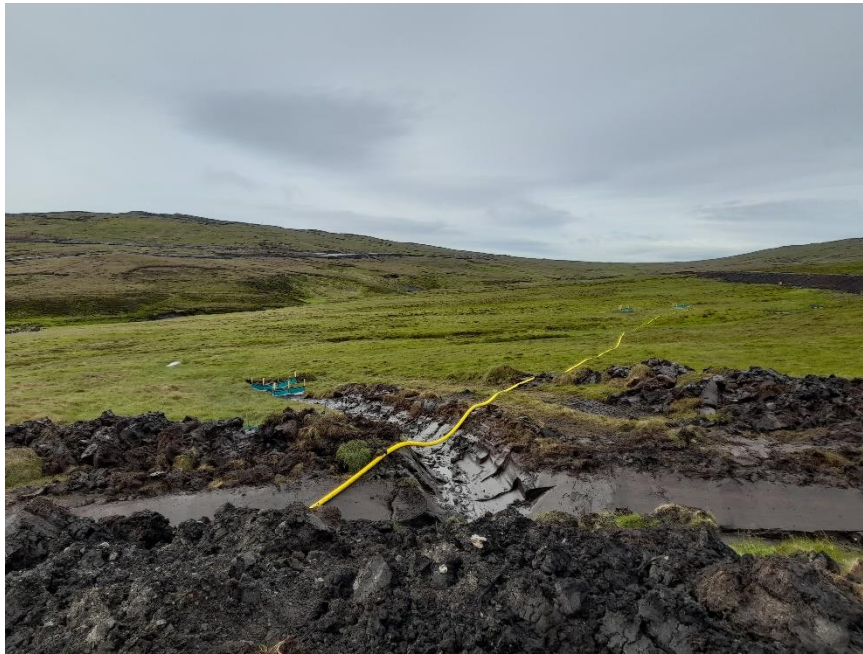
During the construction of base N140, water had been pumped from the base excavation and into the Burn of Grunnafirth, as per the discharge consent for the works. On the 8<sup>th</sup> of June, site personnel noticed high levels of sediment in the Burn, that was traced back to the water being pumped from N140. The pump was stopped, and sediment and water stopped flowing into the Burn. Following an investigation, the sediment concentrations were within the levels specified by the discharge consent, and no breach was recorded. Nonetheless, the site team informed SEPA of the incident, for their records. Additional mitigating measures put in place ensured no further sediment entered the Burn. These additional measures included allowing the water to enter the ground at a point further away from the Burn, to allow vegetation and silt traps to catch the sediment prior to entry into the Burn, the instalment of additional silt traps, and a reduction in the flow rate of the pump.

During the PMO visit, the pumping hose running further from the Burn was noted (Photo 11), and the Burn was free of sediment (Photo 12).

**Photo 11.** Longer hose route for water being pumped from base

Pollution Prevention and Response (e.g. use of spill kits, silt control, cement/concrete, water resources).	An incident where elevated concentrations of sediment were realised into a Burn due to pumping of a base excavation occurred on 8th June. The discharge consent was not breached. Site personnel reacted quickly and mitigation has been put in place to ensure this incident is not repeated.	No action required.	N/A	Green
Noise, Dust, and Air Quality	Complaints regarding dust had been received by SIC during the audit period. The weather had been particularly dry during this time.	Continued monitoring of dust conditions and implementation of control measures as needed; and ongoing liaison as required with other construction operators.	N/A	Green

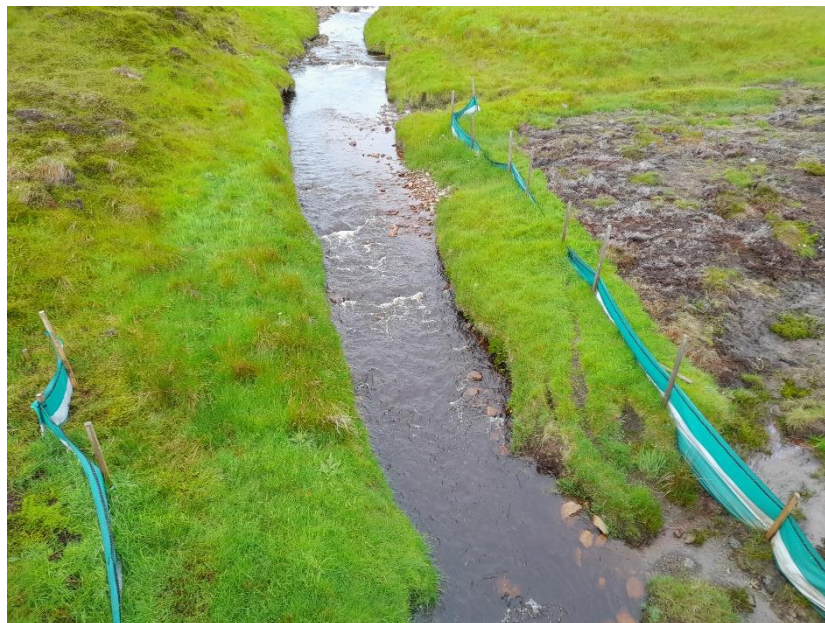
**Photo 12.** Burn of Grunnafirth free of sediment

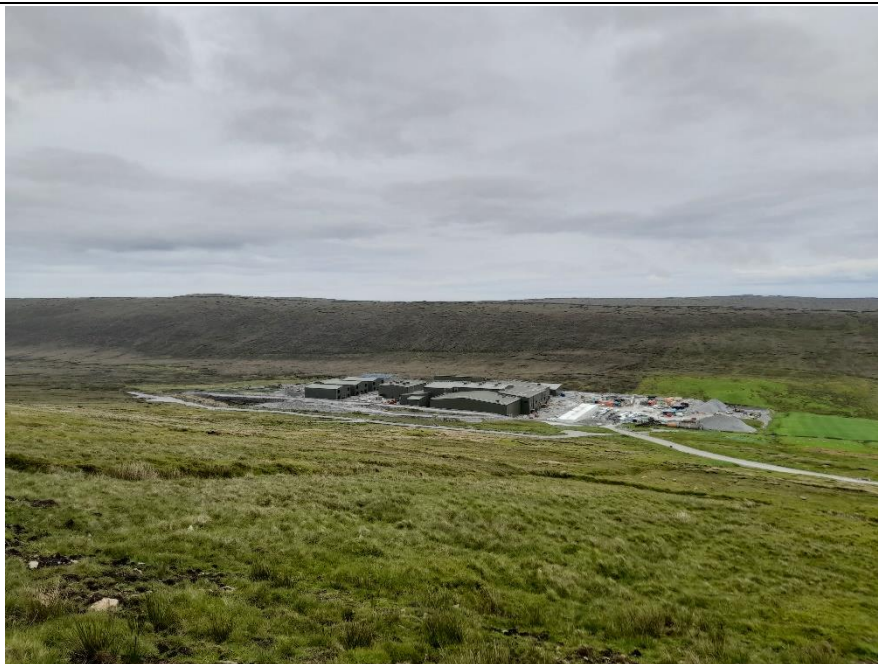
Views from Kergord access tracks showed that additional cladding had been installed since PMO 18 (Photo 13).

**Photo 13.** View of substation.
