Intended for
Viking Energy Wind Farm LLP

Date
July 2022

Project Number
1620009158

**VIKING ENERGY WIND
FARM
PLANNING
MONITORING OFFICER
AUDIT REPORT 021:
18TH JUNE 2022 TO 20TH
JULY 2022**

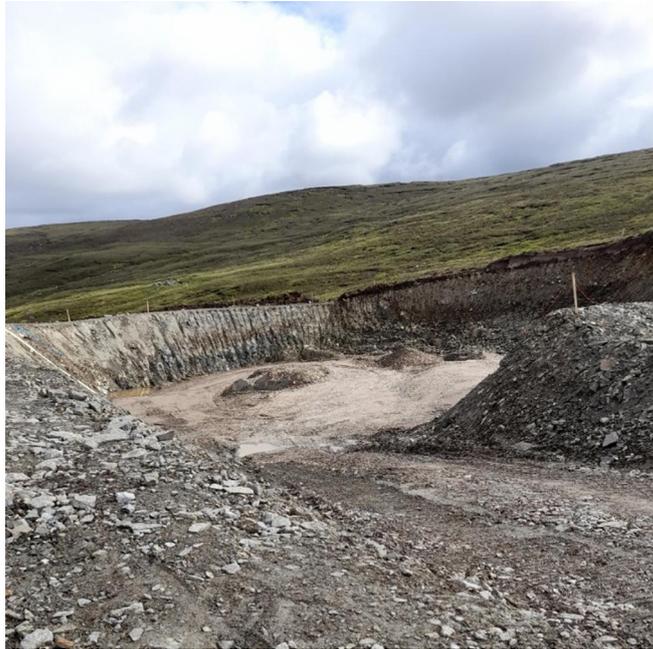
The construction of tracks and bases has continued across the arrays with steelwork and concrete pouring, and the backfilling of bases ongoing. Installed drainage measures are of good quality and preventative mitigation will continue to be installed as turbine base and hardstanding excavation continue. The base excavation at K68 was observed by the PMO. Limited work was ongoing on site due to summer holiday stand-down. The PMO observed equipment for dewatering the excavation, including a pump unit (sat on spill mat) and hoses discharging to vegetation via silt fencing (see photos 1, 2 and 3).

Photo 1. Base excavation at k68

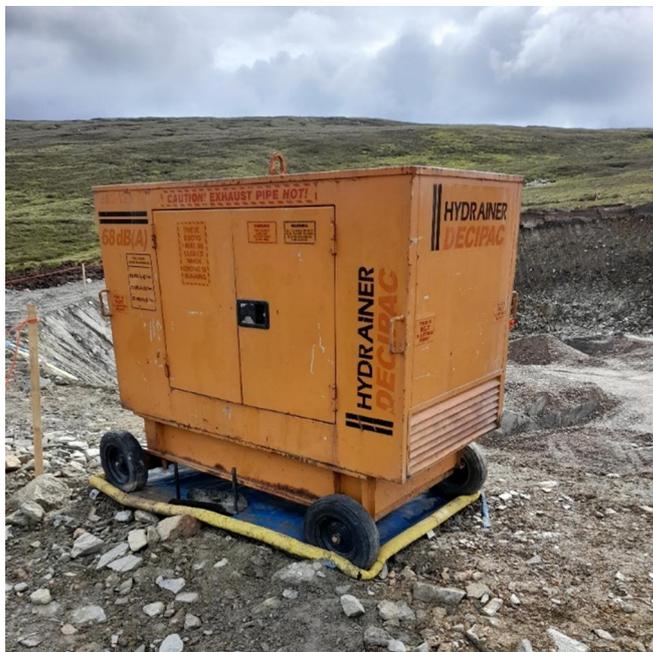
Photo 2. Pump on spill mat

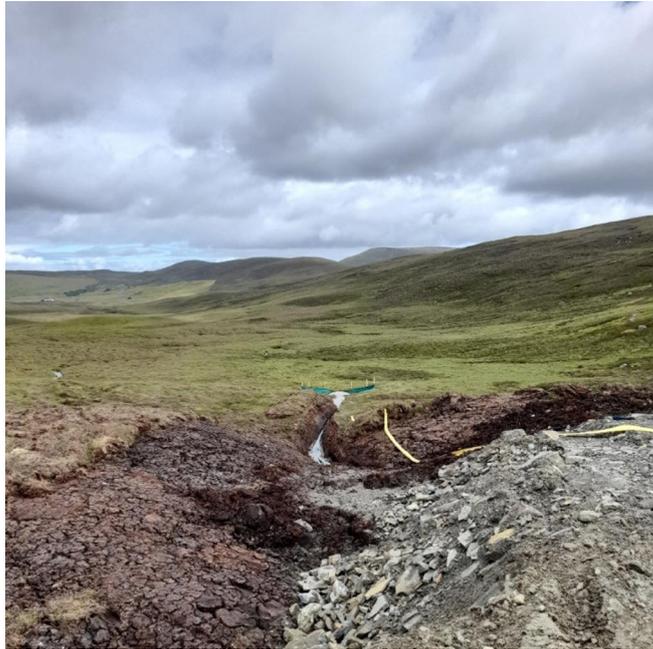
Photo 3. Drainage from k68 excavation

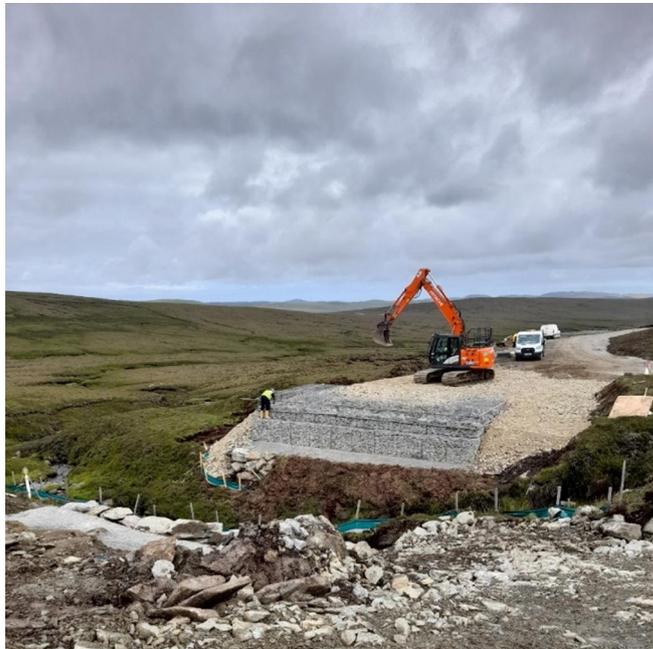
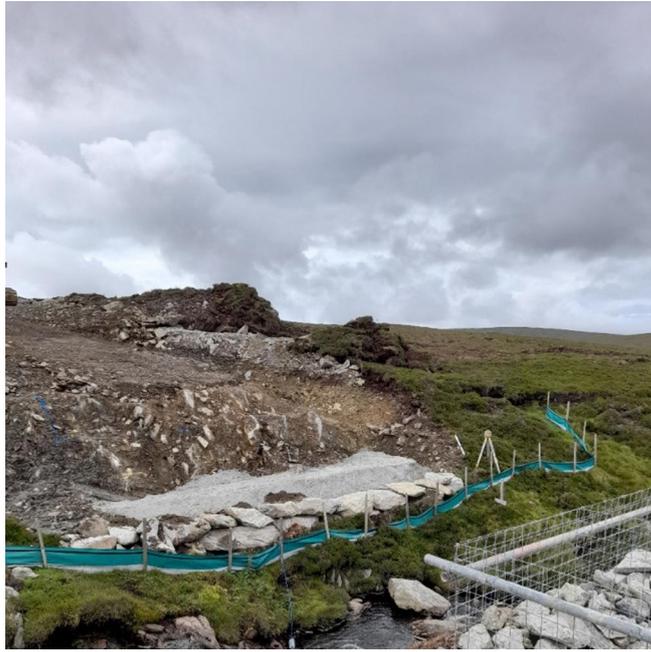
The PMO observed the construction crew in the process of building watercourse crossing WC03 (photo 4 and 5), which drains the Truggles Water (between K64 and 66). There was evidence of ground reinstatement around the foot of the bridge foundations and rock filled gabions, which was noted to be good practice, with reinstatement progress in parallel with the work, rather than being left until the end. Spill kits were checked and found to be in good order.

Photo 4. WC03 construction

Photo 5. WC03 construction

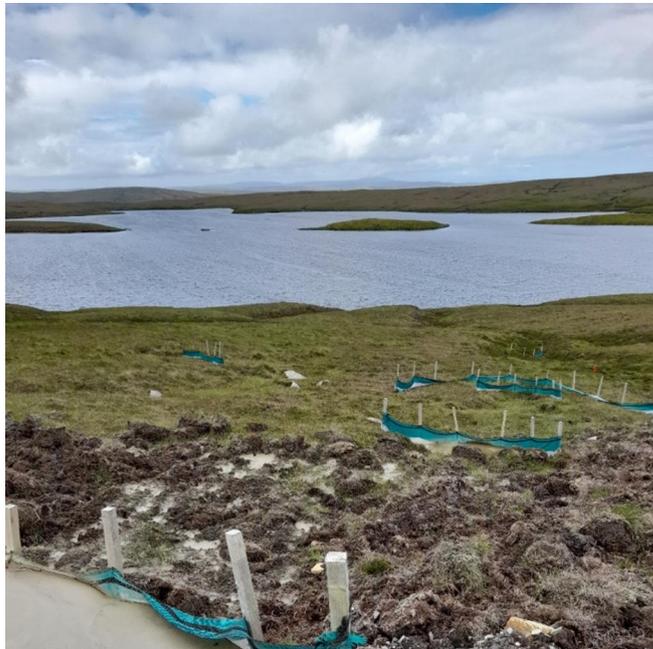
The PMO observed the drainage management measures installed adjacent to the track to treat runoff from borrow pit KBP03 (photo 6 and 7). The installed measures appeared to be effective in providing settlement of solids prior to discharge, although it was dry at the time of the audit. Some of the silt fencing downstream of the track was noted to be loaded with sediment and will require ongoing maintenance. The SSE Environmental Site Manager confirmed that the need to clean out these silt fences has been set as an action in the Environmental Mitigation Log/Risk Register for the project.

Photo 6. Silt mitigation

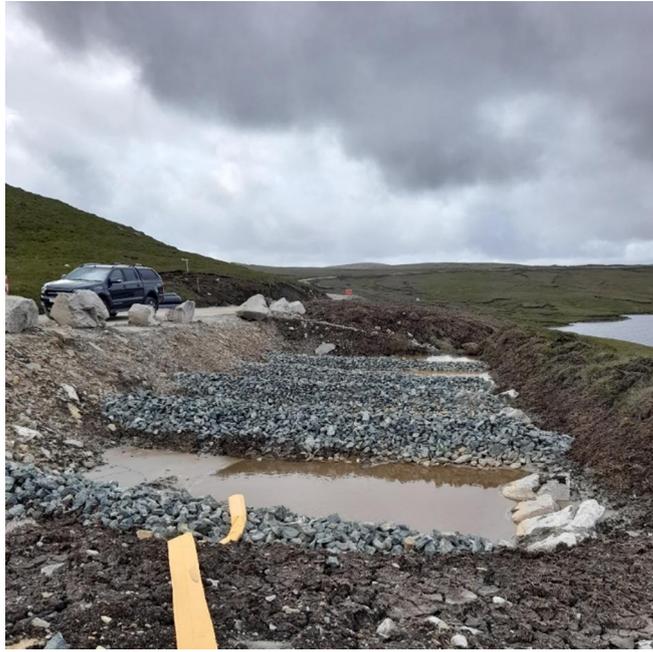
Photo 7. KBP03 Drainage Management

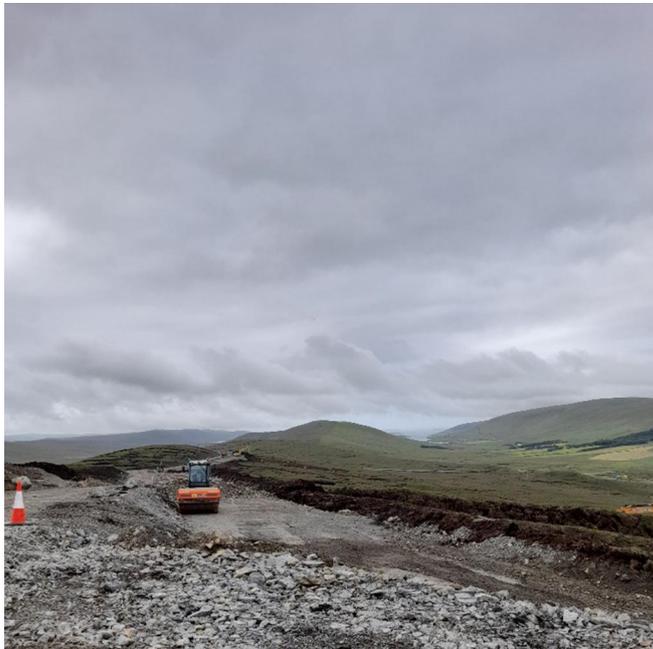
The PMO visited the MKR and can confirm the reinstatement of the peat movement (photo 8,9 and 10). The peat movement resulted in localised disturbance of peatland. No other environmental consequence was noted. The PMO understands that SEPA attended site following the event and raised no issues regarding environmental damage or risk.

Photo 8. MKR Cable Track/Trench Preparation

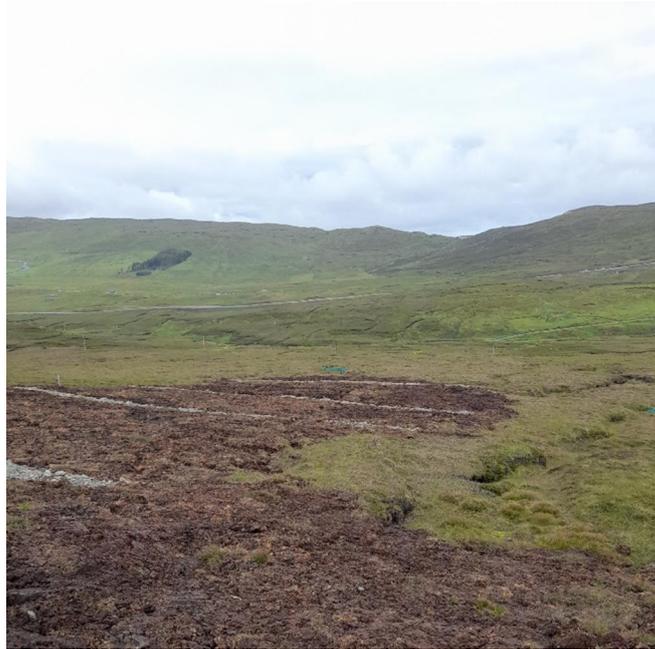
A peat movement event was recorded on the 4th July 2022 adjacent to spur 18 on the MKR (located at approximately chainage 500). A section of the cable trench approximately 15 m long and 8 m wide slipped down the west side of MKR, over a distance of approximately 72 m. The incident was reported in the local media some days after the event had been noted, remediated and reported internally. The PMO understands that following an investigation it was found that

an alternative construction method would have been more effective in this location. Remedial action was taken quickly, with the peat reinstated using a series of rock bunds. The cable trench is now founded, rather than floating.

The GCoW confirmed the peat movement on MKR and that the main cause has been identified as the type of construction method used at this specific location, as opposed to a more effective alternative. The GCoW has highlighted the potential ongoing risks on the west side of the MKR associated with the cross country cable route. These risks are noted in the risk register and will be continually monitored on site during construction.

Photo 9. Peat Landslide on west side of MKR following reinstatement

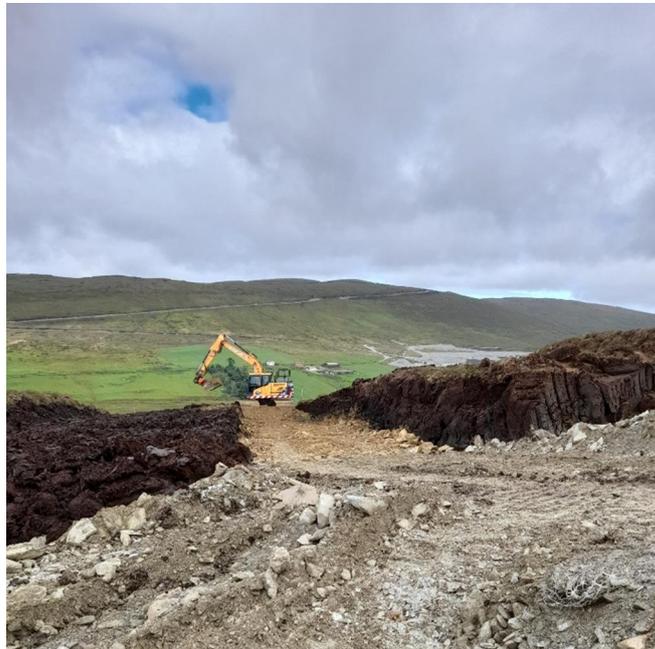
Works on the west side of MKR are ongoing on the cross country cable route. All parties have identified the potential geotechnical concerns associated with the construction of the cross country routes. The Contractor and their Geotechnical Consultant are following the construction methodology and Peat Risk Registers have been prepared and assessed for the cable routes ahead of the works. This Risk Register includes the Contractor's mitigation in connection with the Method Statements and Risk Assessments. The principal mitigation is understood to be avoiding the stockpiling of peat or excavation arisings at the edge of the cable route.

Photo 10. Start of temporary track construction for cross country cable to connect to substation from MKR

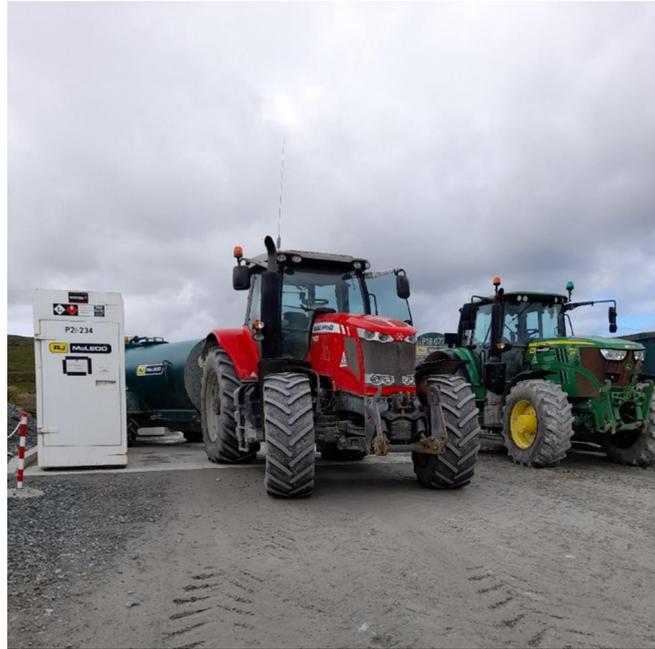
The fuel storage at the compound was noted to be in good order, with spill kit provided (photo 11). Waste segregation was in place with appropriate signage noted (photo 12).

Photo 11. Refuelling mobile fuel bowsers at North Compound

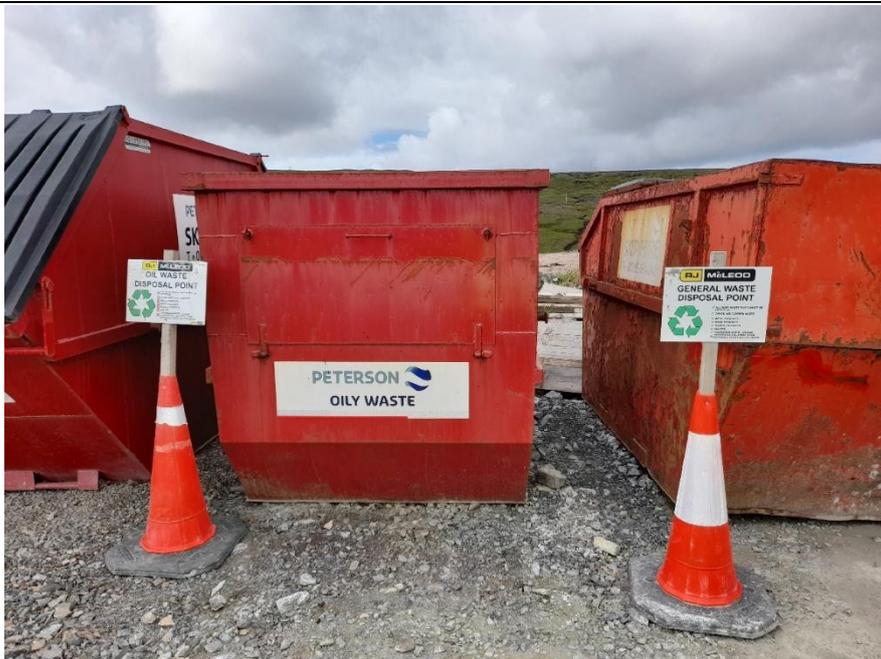
Photo 12. Waste segregation at north compound

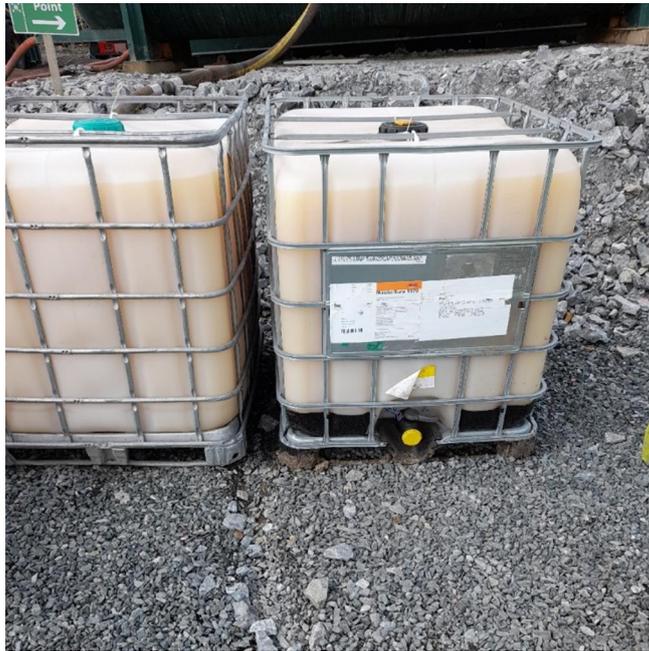
During PMO 21, four IBCs were observed to be on the compacted stone surface (photo 13). Two were in use with the concrete batching works that were ongoing, while two were reportedly expected to be used later in the week. The remainder of the IBCs were on hardstanding. It was discussed with the RJM ECOW at the time and later with the SSE Environmental Site Manager. Both agreed that temporary impermeable bunding should be provided e.g. in the form of visqueen sheeting and stone.

Materials Storage and Handling (e.g. oil/fuel storage and peat/mineral soil storage and handling).	Approximately 4 no. IBCs with concrete plasticizer were being stored directly on the ground, rather than on an area of hardstanding.	A temporary bund is required whilst the IBCs are being stored off the hardstanding. The SSE Environmental Site Manager has confirmed that the contractor will provide a temporary "bund" made up of a visqueen sheet bunded with sandbags.	Principal Contractor	Amber
Natural and Built Environment (e.g. ecology, biosecurity, protected sites,	Ecological constraints identified by the ECoW team are communicated to the Principal contractor and Developer to allow mitigation measures to be implemented and rescheduling of preparatory and construction work as required.	No action required.	N/A	Green

Photo 13 IBCs stored outside bunded area

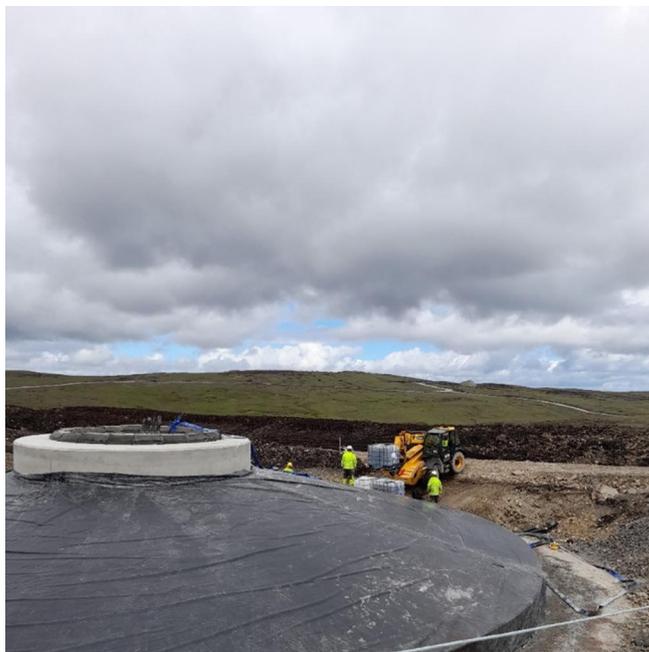
The PMO visit included observations at turbine base N119, where a crew was setting up a closed loop water cooling system, pumping water through the recently poured foundation base. The system was set up with IBCs of water, recirculating the water through the comms and electrical cable ducting installed in the base (photo 14).

Photo 14 N119 – curing using recirculated water

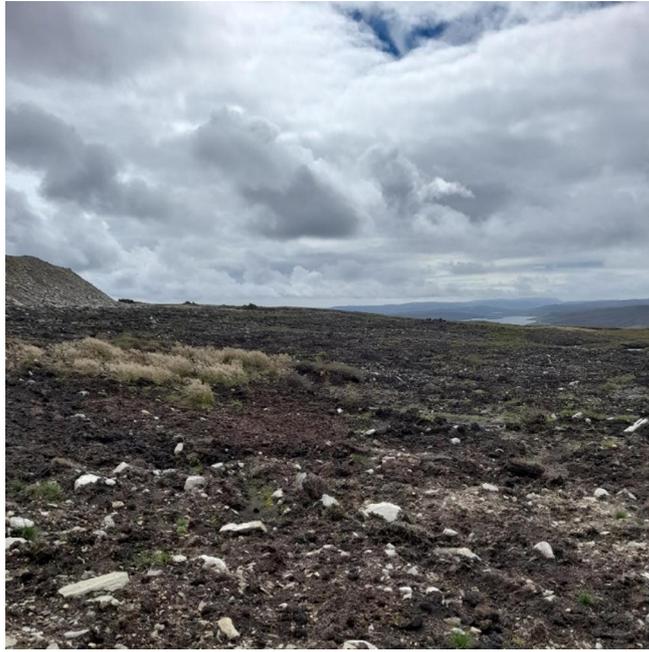
Observations were made at the peat restoration area adjacent to NBP05 (photo 15). Stone and mineral content was noted on the surface. The PMO understands that final steps in the restoration work are still to be undertaken and further guidance is being sought from the Habitat Management Plan officer and local peatland restoration contractor in order to restore the eroded peatland such that conditions are created, which in time will be conducive to the formation of blanket bog. The PMO understands that this restoration will not be completed until works at NBP05 are complete and restoration will be carried out in conjunction with the borrow pit reinstatement to ensure a sympathetic and blended finish across the areas.

Photo 15 Peatland Habitat Restoration Area adjacent to NBP05

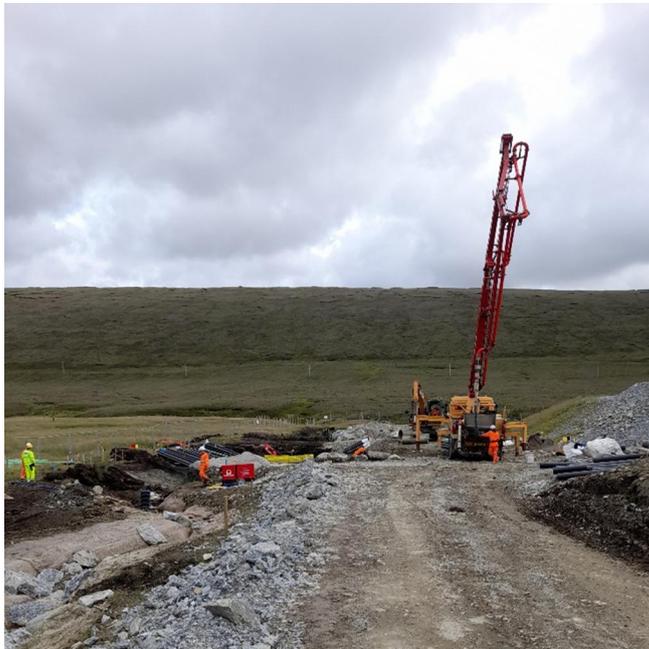
The PMO made observations of works currently being undertaken under license to install cable ducts under the northern perimeter drain, which ultimately discharges water into the Burn of Weisdale. The perimeter drain has been temporarily diverted and crews were noted to be overpumping water during the site visit (photo 16) into an adjacent field, with appropriate silt fencing in place.

Photo 16 Cable ducting works under the substation perimeter drain
