Date
September 2022

Project Number
1620009158

VIKING ENERGY WIND FARM PLANNING MONITORING OFFICER AUDIT REPORT 023: 22ND AUGUST TO 18TH SEPTEMBER 2022

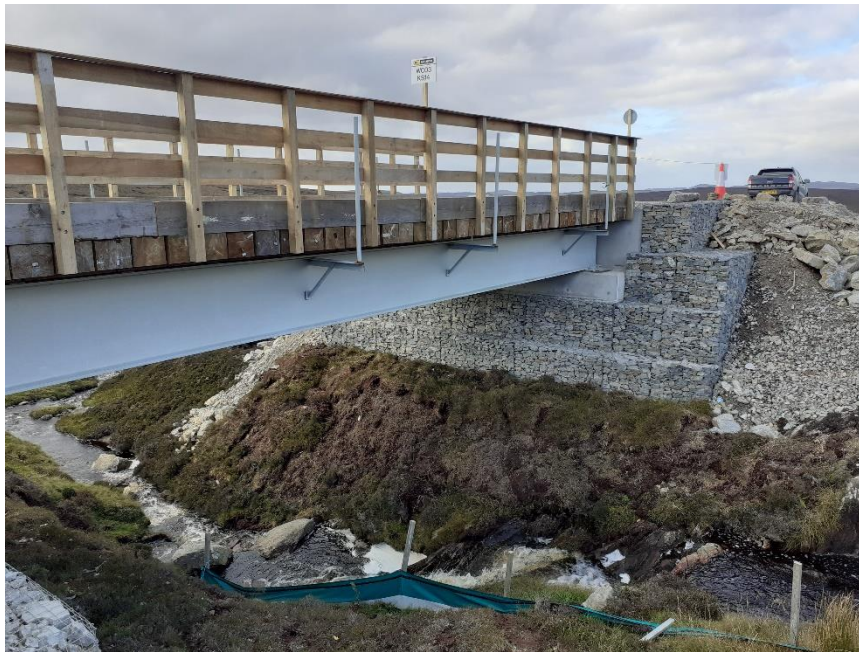
All construction of turbine bases has been completed in this area, following the completion of K61, K67 and K68 since the last PMO visit. Further works are being carried out on the access tracks to ensure that the lorries carrying the turbine components can access all base locations. The final water crossing (WC03) has been completed (Photo 1).

Photo 1. Water crossing WC03 complete

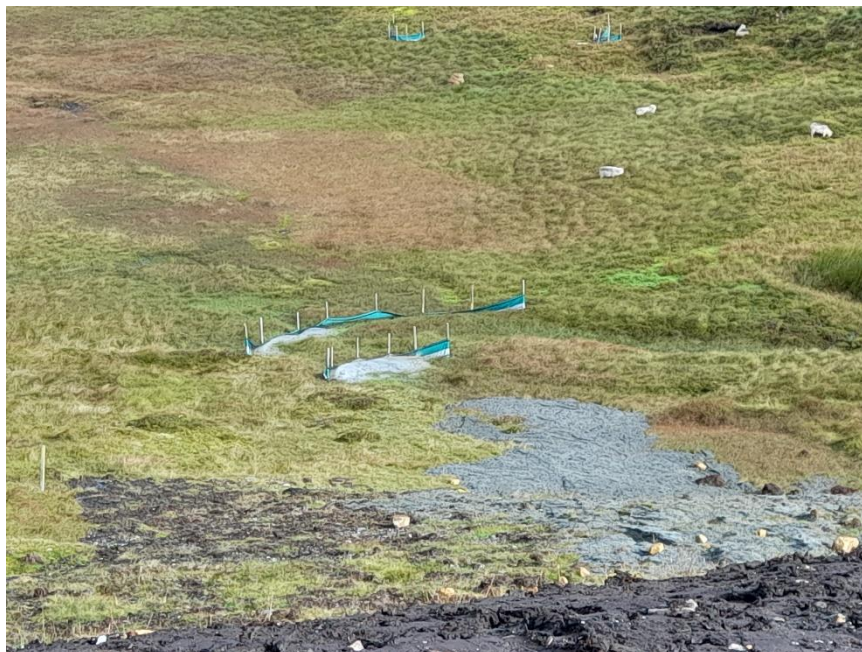
It was noted by the ECoW during discussions prior to the PMO visit that silt from washout from the cable trenches was observed to the south-west of K43 during a period of heavy rainfall; however, it is noted that the silt did not enter a watercourse. During the PMO visit, the area of concern was observed. Sediment is visible on the downward slope to the south-west of K43 (Photo 2). Work is required to remove this silt from the area. The PMO understands that this item is recorded on the environmental mitigation log/risk register to ensure that the issue is resolved. The cable trenches have since been backfilled and therefore this is unlikely to re-occur in this area.

Photo 2. Sediment to the south-west of K43

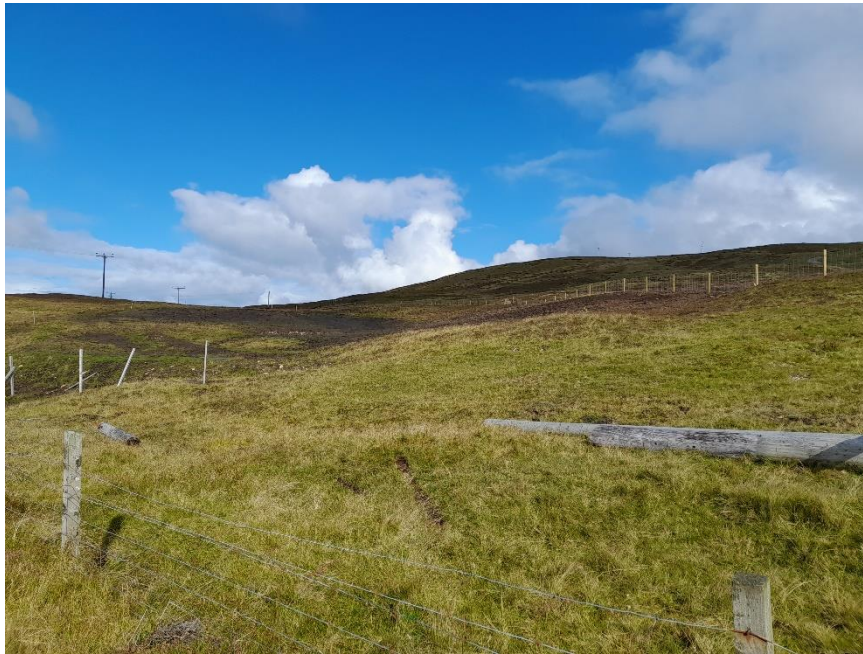
Re-instatement of the western compound (never used) has been undertaken. The peat has been restored in this area and fencing has been erected on a 'like for like' basis (Photo 3).

Photo 3. Re-instatement of the western compound.

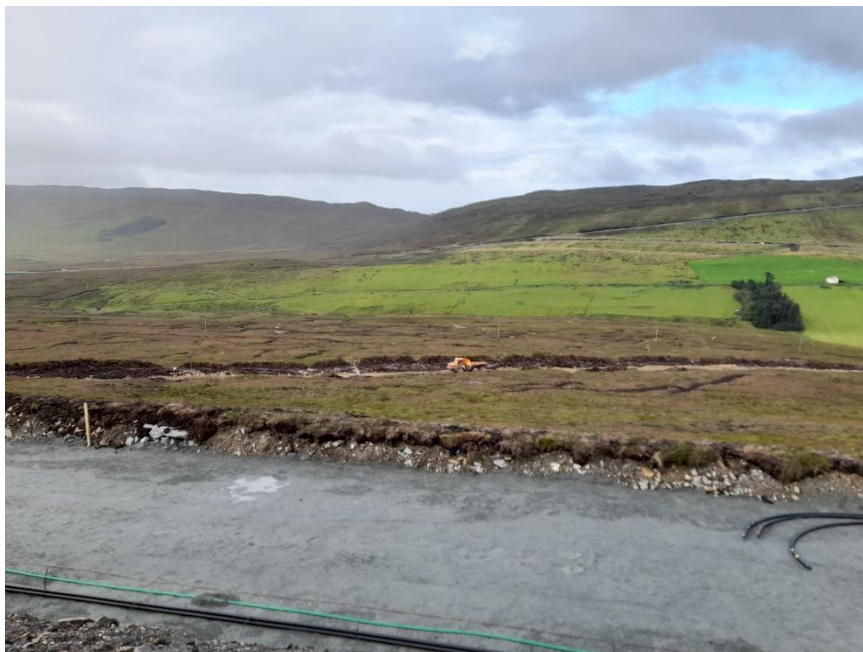
Works for the cross country cable route (from K88 to the east of the substation) is ongoing. The method for the construction of the cable trench has changed from 'V trenching' to laying a founded access track and wider cable trenches, as has been observed on the rest of the site. The current works are prioritising the creation of an access track to the Burn of Weisdale, where a water crossing will be installed (Photo 4 and Photo 5). Peat is being stripped for the laying of the floating road and is currently being stockpiled downgradient of the excavation.

Photo 4. Cross country route from K88 to the substation

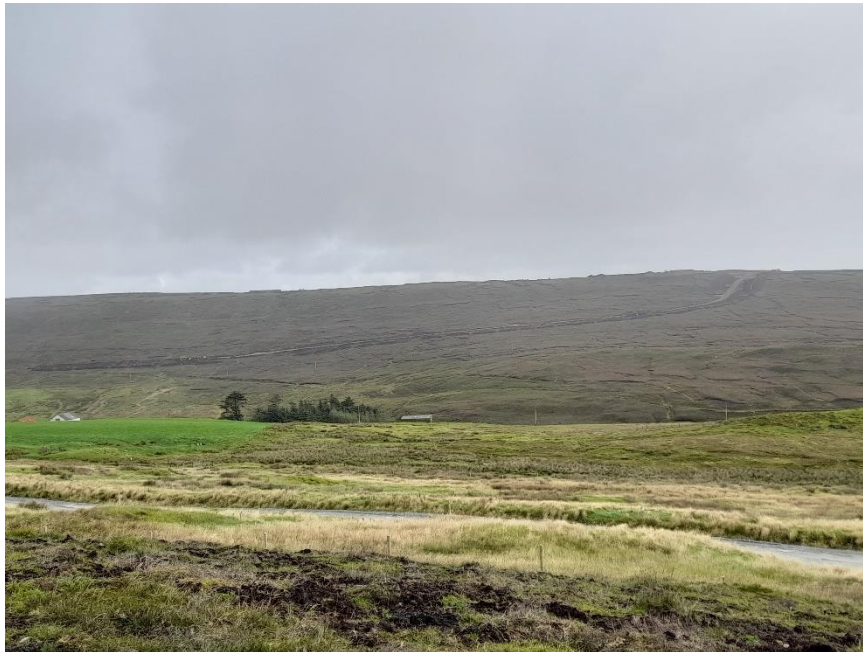
Photo 5. Cross country route from K88 to the substation (view from Kergord Access Track)

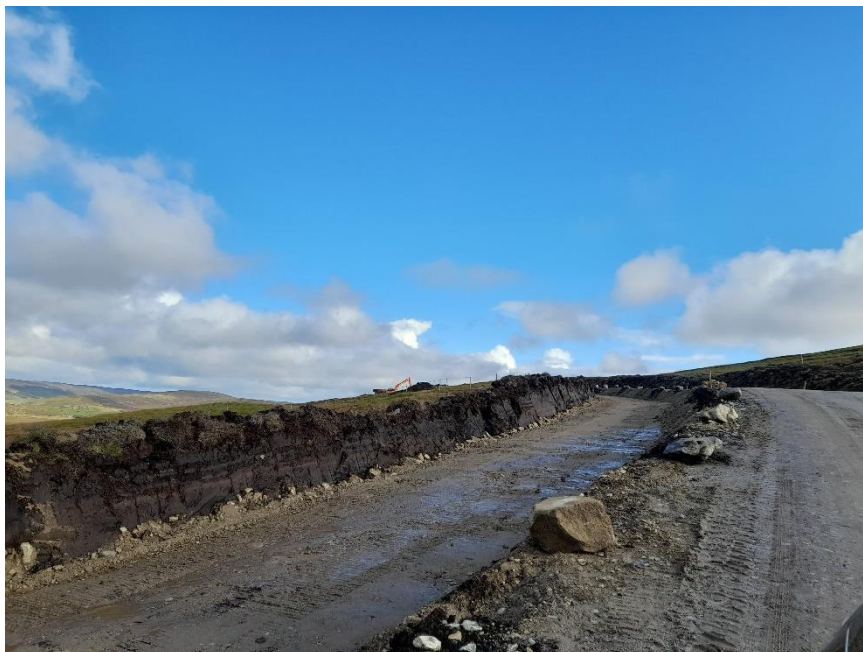
All concrete turbine bases have been completed. Cable tracks were being excavated (Photo 6).

Photo 6. Cable tracks in north nesting

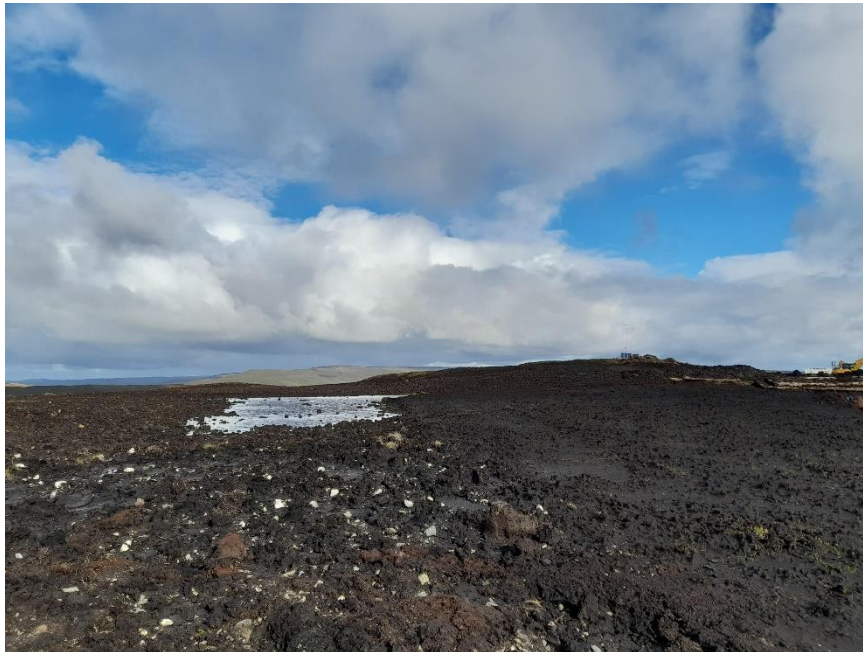
Phase 1 of peat restoration has been completed in P15 (Photo 7) and P15 (photo 8). P17 has had some seeding around the edges. Seeding works need to be completed before October in order to be most efficient. It is expected that P17 will be seeded, however it may not be possible to seed P15 before October. If this is the case, seeding will recommence in the spring.

Photo 7. P15 peat restoration area

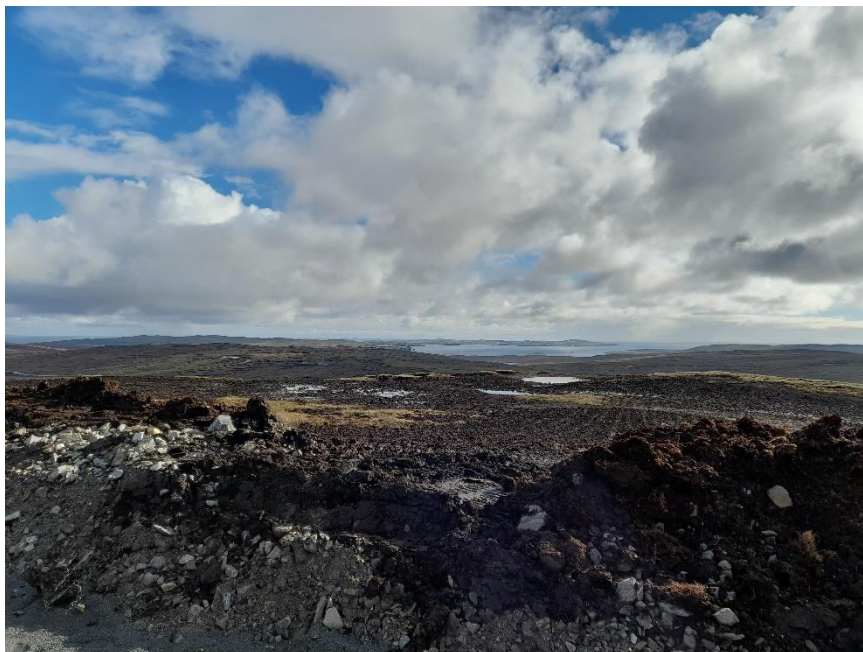
Photo 8. P17 peat restoration area

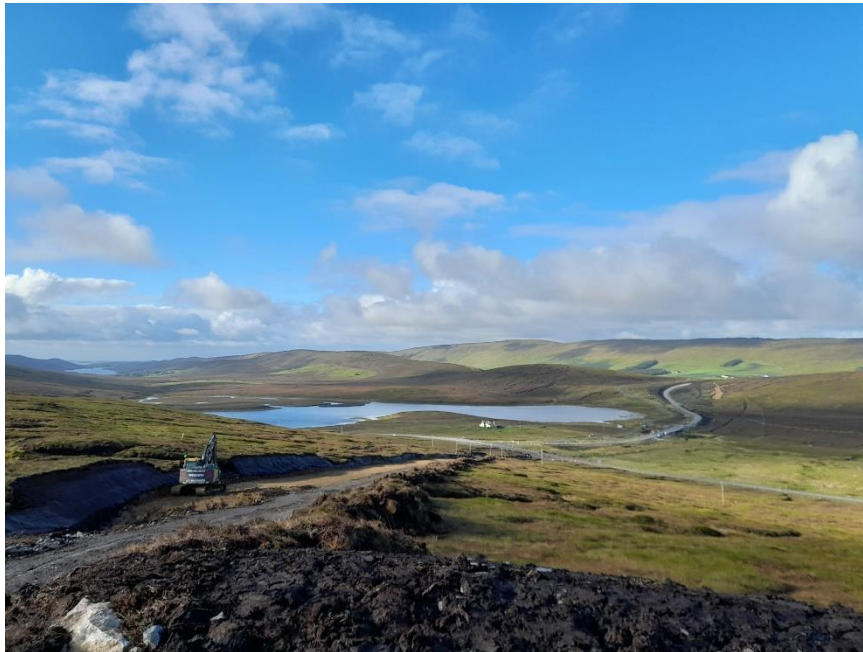
The cross country cable route from Nesting to the A970 has commenced. The track and cable trench have been excavated and whin dust is being laid at the base of the cable trench (Photo 9). The cable route will cross the A970 to continue its route to Sandwater Road. A temporary road is being constructed to the east of to A970 in preparation for road closures for this work (Photo 10).

Photo 9. Cross country route from Nesting to A970

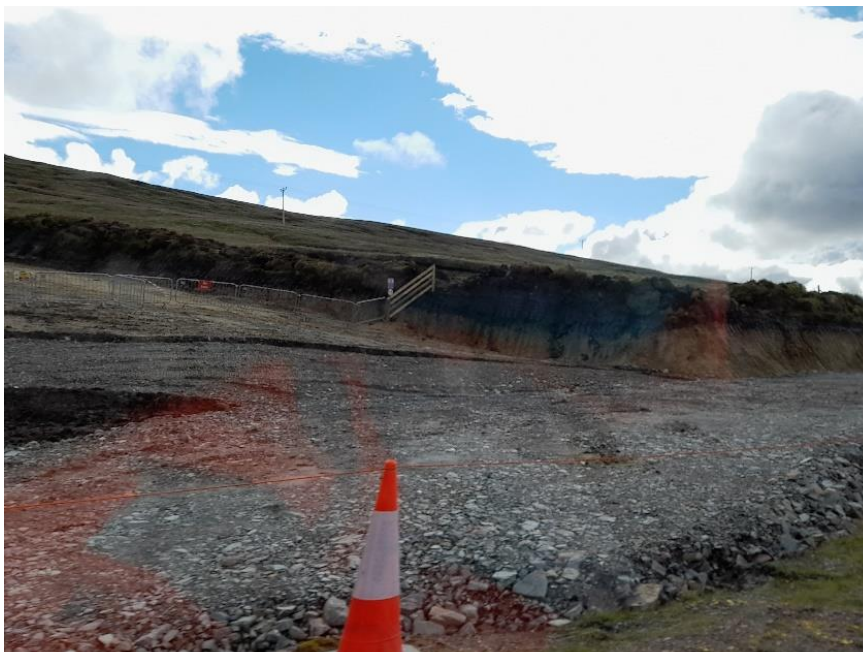
Photo 10. Temporary road on A970.

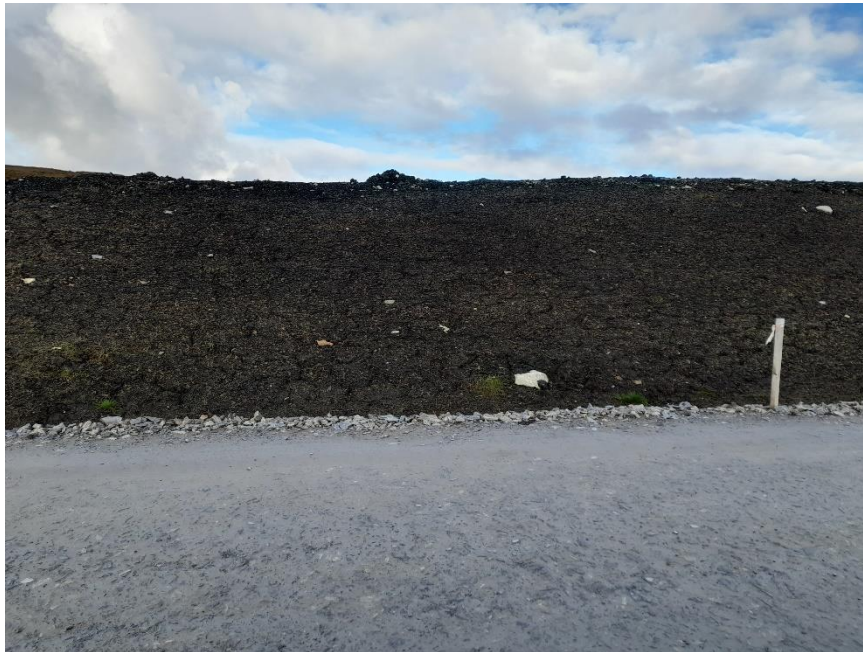
Hydroseeding of the peat along the embankments has been undertaken (Photo 11).

Photo 11. Hydroseeding in Nesting

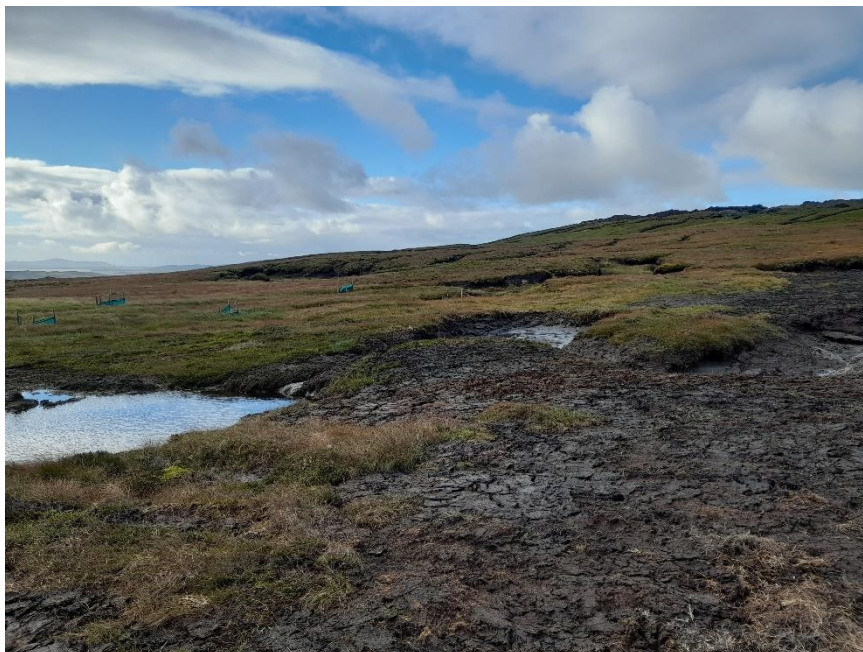
It was noted by the ECoW during discussions prior to the PMO visit that silty water had entered the Burn of Flamister from a location near N118 during a period of heavy rainfall from a borrow pit at a high flow rate, however, the volume of sediment had not exceeded the action levels. Mitigation was put in place as soon as the event occurred. The pump now operates at a slower rate and passes through more vegetation before reaching a series of pools and silt fences before being discharged to the Burn (Photo 12).

Photo 12. Pools and silt fences near Burn of Flamister

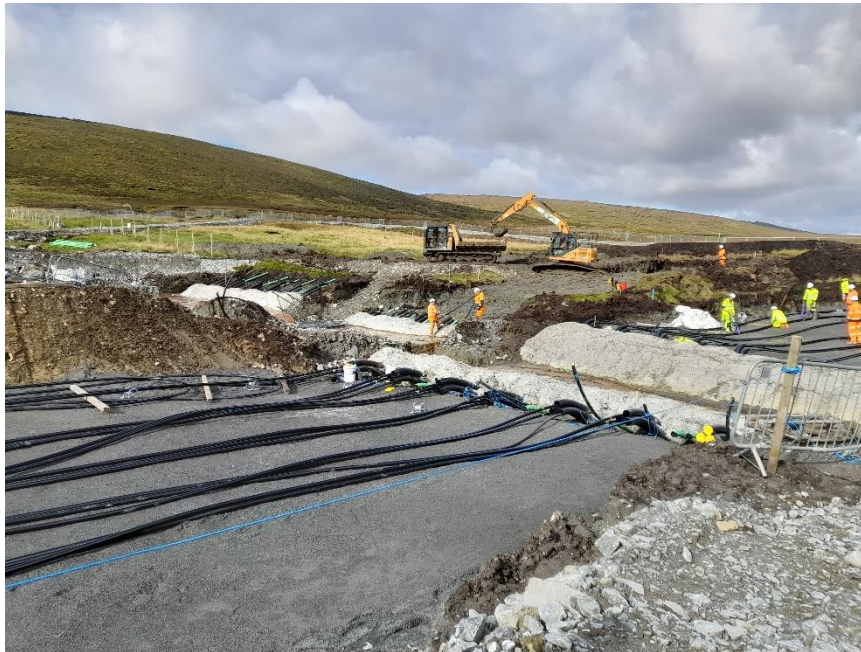
Construction of substation cable under the diverted Northern Watercourse is ongoing (Photo 13). Once completed, the Northern Watercourse will be restored to its original location, on top of the substation cable. Excavation of the cable trenches from the substation to the Burn of Kergord is underway.

Photo 13. Construction of substation cable under previous location of Northern Watercourse

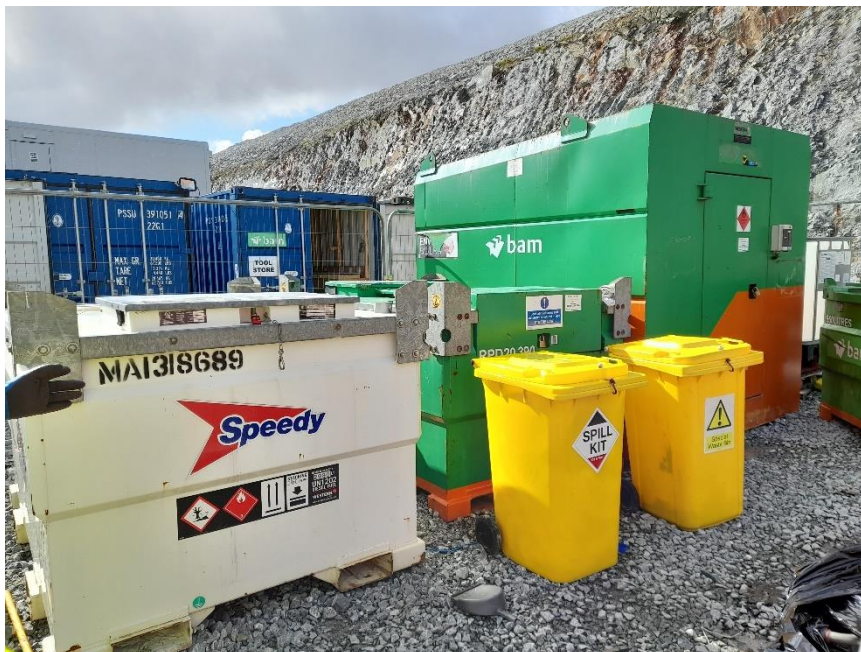
The fuel storage at the substation was noted to be in good order, with spill kit and fire extinguisher provided (Photo 14). The waste skips are clearly labelled for segregated waste management.

Photo 14. Fuel storage in substation

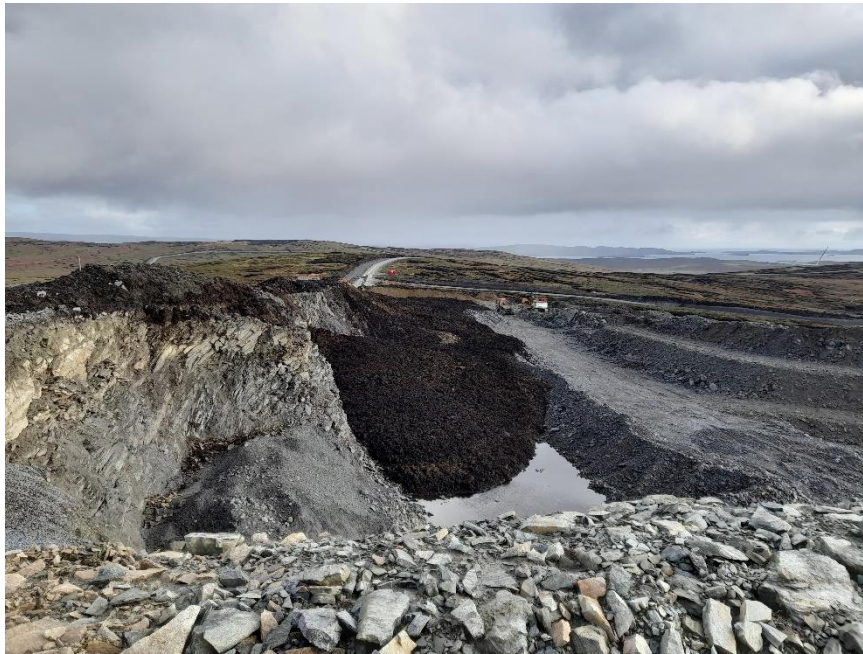
The GCoW required clarification as to whether peat storage in NBP01, NBP05 and KBP02 is permanent or temporary (Photo 15). The Design Engineer confirmed that the peat storage is temporary and the majority of the peat will be re-use when reinstating the cross country route and the borrow pits.

Photo 15. Temporary peat storage in NBP05
