Viking Energy Wind Farm LLP

October 2022

1620009158

# VIKING ENERGY WIND FARM PLANNING MONITORING OFFICER AUDIT REPORT 024: 19<sup>TH</sup> SEPTEMBER TO 23<sup>RD</sup> OCTOBER 2022

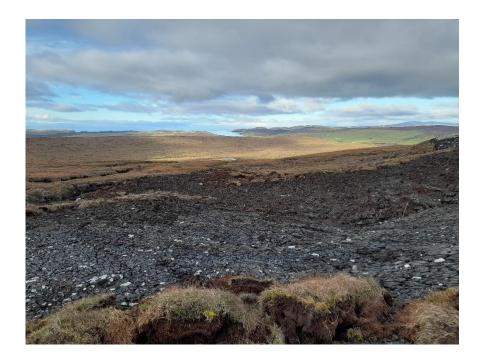
It was noted by the GCoW, prior to the site visit, that there had been a peat movement adjacent to the base at K70. This was observed during the site visit (Photo 1). The peat was part of reinstatement works but had moved down the hill by around 30 m following a period of heavy rain. The peat moved into an adjacent area of restoration which had yet to be reprofiled. The Design Engineer noted that this peat area was due for restoration, and during that process structural bunds will be installed to retain the peat, and the peat shall be profiled to tie in with the surrounding landscape. There are no significant environmental impacts as a result of the movement.

**Photo 1.** Peat movement at K70

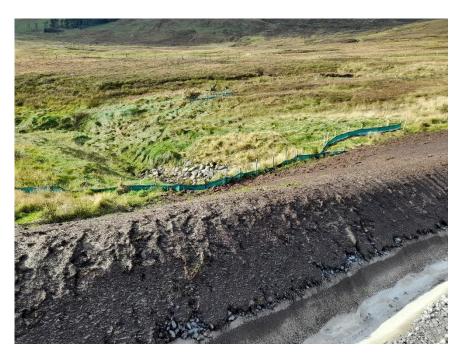
The Kergord Access Track crosses the Droswell Burn to the north of the B9075 There have been historical incidents of silty water entering the Burn, and although below the levels of sediment discharge permitted at the site, works have been undertaken to prevent further incidences. The road has been capped, and an impermeable membrane has been put in place alongside the road to prevent water flowing directly from the road foundations to the Burn (Photo 2). In addition, concrete lined surface water drains have been put in place either side of the roadway, and these drain to the vegetation at the side of the Burn (Photo 3). Monitoring will continue in this area to track whether further mitigation is required.

**Photo 2.** Surface water drainage at the Droswell Burn

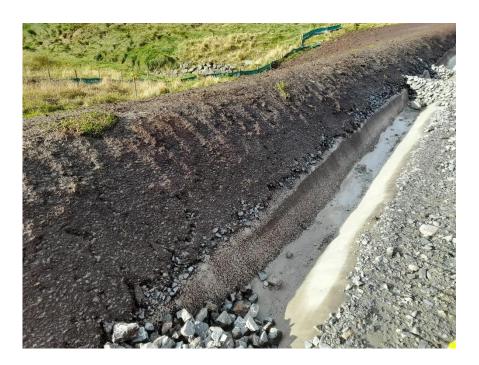
**Photo 3.** Surface water drainage at the Droswell Burn

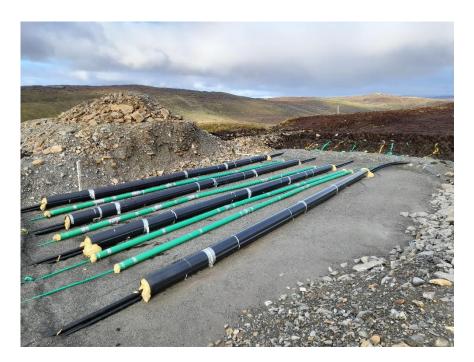
Backfilling of cable trenches has been undertaken and the outstanding backfill areas are on hold following final testing of the cables used in the cable trenches (Photo 4).

**Photo 4.** Cable trenches awaiting backfilling on Mid Kame Ridge

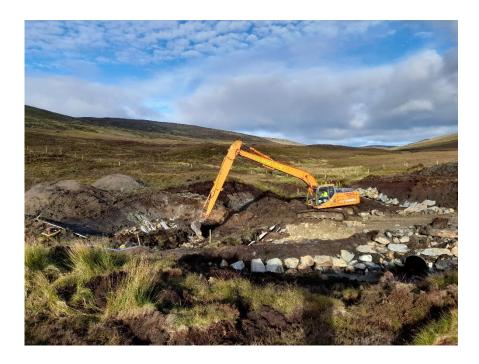
In line with the approved cross country cabling route works, the Burn of Weisdale has been diverted to allow for the laying of ducts beneath the Burn (Photo 5). This crossing will connect the cables Mid Kame Ridge, Nesting and North Nesting turbines to the substation. The diversion has temporarily changed the course of the Burn to the east and directed flow through a stone lined gully and a covered culvert (Photo 6). The material from the base of the Burn was excavated and segregated and will be replaced at the base of the Burn to ensure like-for-like reinstatement.

**Photo 5.** Burn of Weisdale Diversion

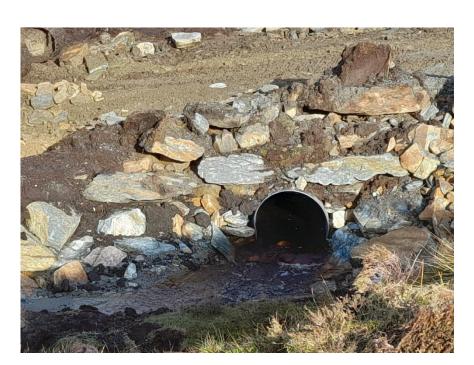
**Photo 6.** Stone lined gully and covered culvert in the Burn of Weisdale diversion

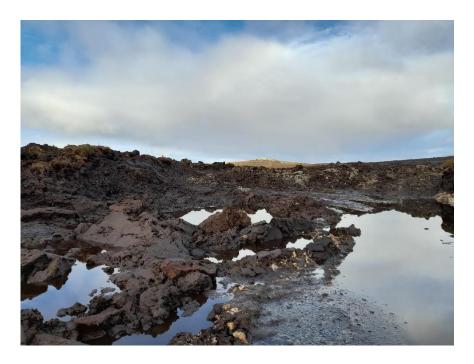
Peat storage at the north of Mid Kame Ridge has been paused (Photo 7) and peat is being temporarily stored in a location to the south of Mid Kame Ridge (Photo 8) since the route is more direct to the work area. Bunds have been put in place in the temporary storage to the south of the ridge to ensure the storage of material on the slope is managed.

**Photo 7.** Peat storage area at the north of Mid Kame Ridge

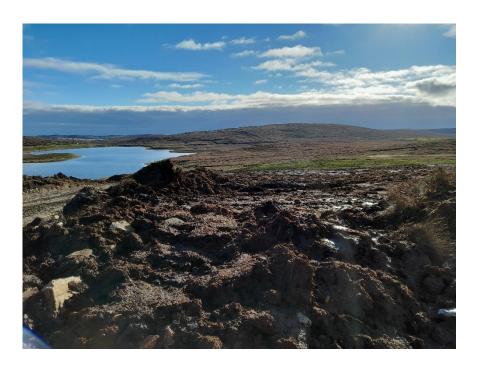
**Photo 8.** New Peat Storage area at the south of Mid Kame Ridge

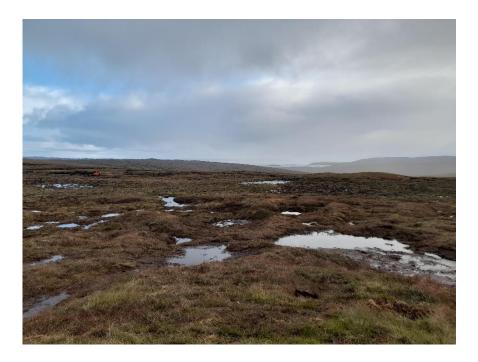
Phase 2 of peat restoration is ongoing in P21 (Photo 9). Specialist subcontractors are being used to tie in the area with the existing peat landscape. Ponds and drainage routes are being created (Photo 10).

**Photo 9.** Peat restoration area P21

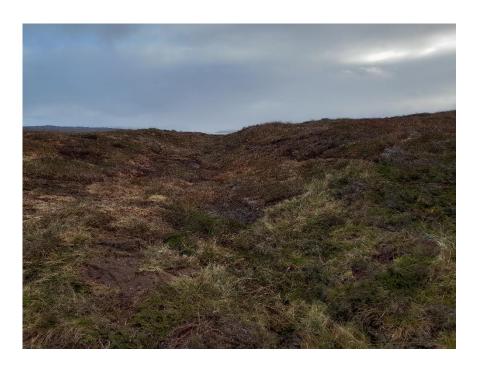
**Photo 10.** Peat restoration area P21

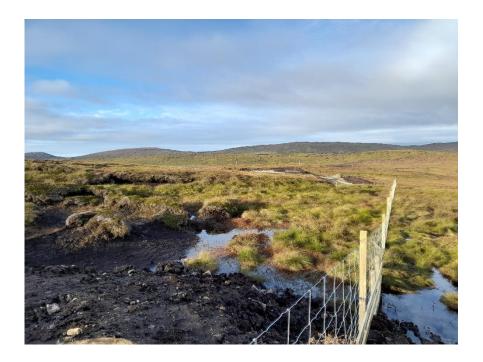
Fencing is being installed at the boundaries of the peat restoration areas. Fencing is completed in areas P7, P11 and P33 (Photo 11). Fencing is in the process of being erected in P14.

**Photo 11.** Fencing installed at P11 peat restoration area

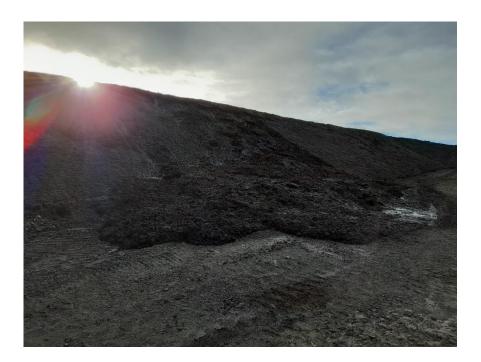
The GCoW mentioned prior to the site visit that there had been a minor peat movement on a cutting on track Spur 52, on the way to turbine base N94 (Photo 12). The Design Engineer confirmed that the area would be reprofiled, and additional drainage would be put in place following the movement. There are no significant environmental impacts as a result of the movement.

**Photo 12.** Peat movement in cutting in Spur 52

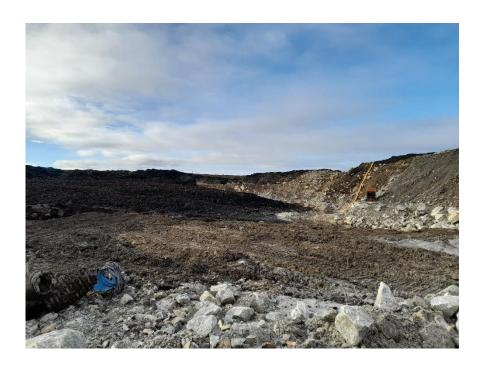
More peat has been stored in NBP01 since the last PMO visit (Photo 13). The Design Engineer confirmed that this is temporary storage and will be re-used to backfill cable trenches.

**Photo 13.** Peat storage in NBP01

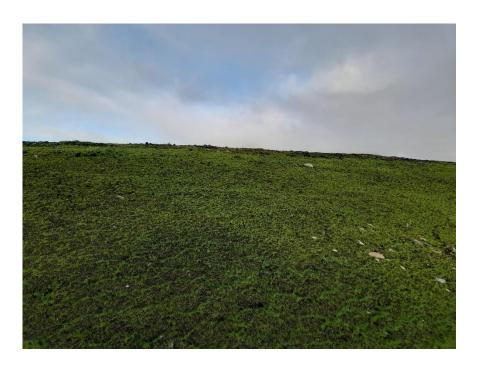
Hydroseeding of the peat along the embankments has been undertaken and early growth is present along the cuttings adjacent to the access tracks (Photo 14).

**Photo 14.** Hydroseeding in Nesting

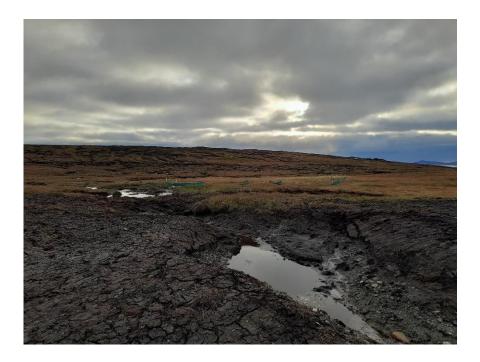
It was noted by the ECoW during the previous PMO visit that silty water had entered the catchment which enters the Burn of Flamister; however the volume of sediment had not exceeded the permitted levels. It was noted that the silty water reached the most upstream part of the Burn, however the flow of the sediment through the vegetation and silt fences ensured that the silty water was not sustained further downstream. Mitigation was put in place and viewed during the previous PMO audit. During this PMO audit, the mitigation remains in place and the Design Engineer confirmed that no further silty water incidents had been noted. Ongoing monitoring of the area is being undertaken (Photo 15).

**Photo 15.** Silt fencing at Burn of Flamister

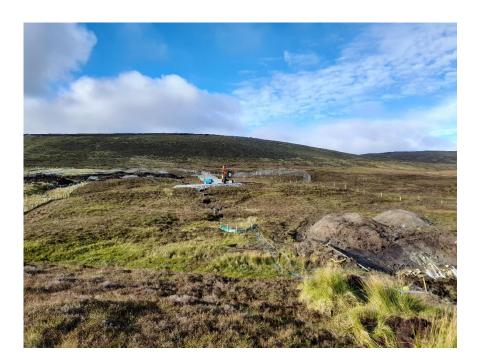
Construction of substation cable under the diverted Northern Watercourse is ongoing (Photo 16). The Northern Watercourse is a manmade feature, designed to divert upgradient groundwater away from the Convertor Station platform. Once the cable laying is completed, the Northern Watercourse will be restored to its original location, on top of the substation cable. Excavation of the cable trenches and the laying of cables from the substation to the Burn of Weisdale is complete and awaiting testing (Photo 17). Further excavation to a cable jointing pit is required, and this is where the cables from the substation will meet the cables from the turbine cables from Nesting, North Nesting and Mid Kame Ridge.

**Photo 16.** Laying of cable from Burn of Weisdale to substation

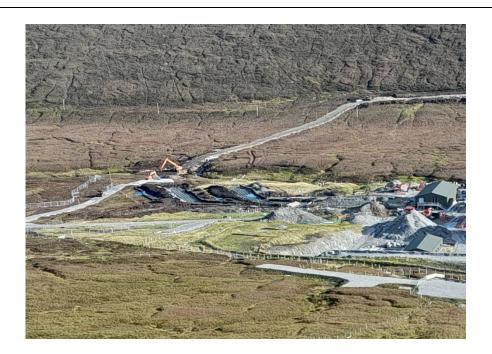
**Photo 17.** Laying of cable from Burn of Weisdale to substation

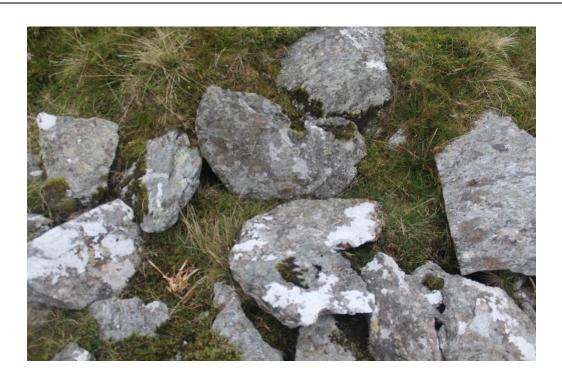
The Millstone Quarry was identified in the Western Array (Photo 18), within the windfarm boundary but approximately 100 m from any working areas. The quarry has now been fenced off and the ACoW has added the Millstone Quarry to the Heritage Environment Record (HER). During the walkover to identify the quarry, a Cairn was also noted. The Cairn will also be added to the HER.

**Photo 18.** Millstone Quarry in Western Array
