Intended for
Viking Energy Wind Farm LLP

Date
January 2023

VIKING ENERGY WIND FARM PLANNING MONITORING OFFICER AUDIT REPORT 027: 26TH DECEMBER 2022 TO 17TH JANUARY 2023

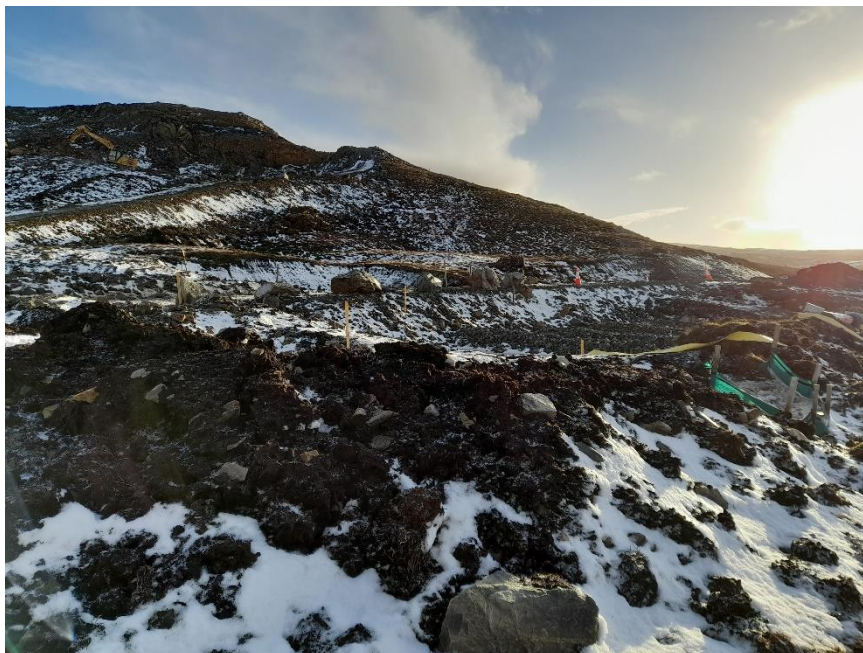
In response to periods of heavy rainfall and prevention of silty water events, a water pump with reactor is being used between K61 and K62 on settlement ponds by Maa Water (Photo 1). The reactor is a flocculation system that helps settle out the sediment within the drainage water. This was first observed during the November PMO audit, and further information is available in the PMO025 report.

Photo 1. View of settlement ponds and water pump with reactor near Maa Water

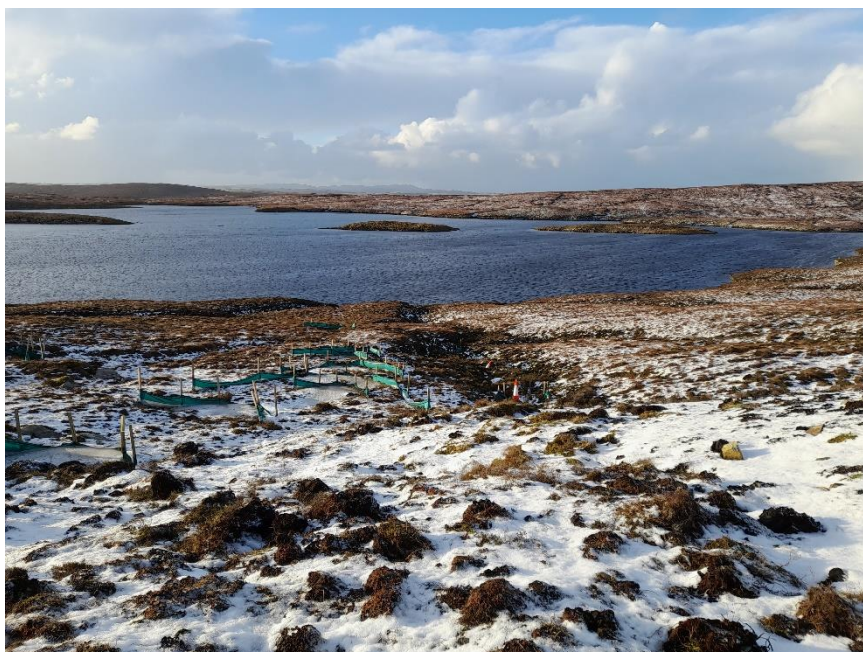
Photo 2. View of drainage system near Maa Water: Settlement pond, culvert and silt traps

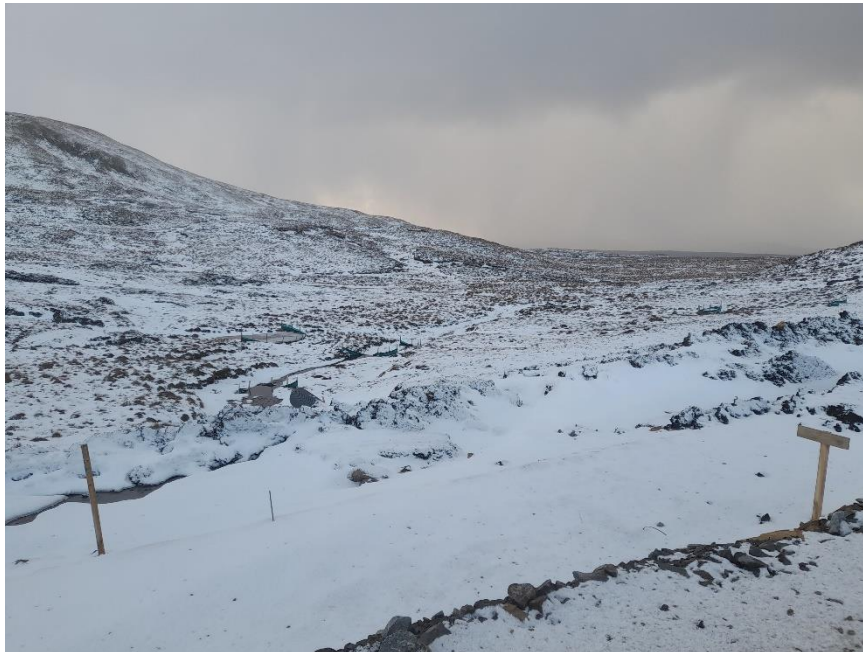
Peat bunds had undergone further maintenance along the access track between Junction 13 and K50. During periods of heavy rainfall, runoff from the road was flowing into the catchment area. The peat bunds have been put in place to divert the runoff into the vegetation in order to filter the sediment prior to surface water entering the Burn of Lunklet (Photo 3).

Photo 3. Peat bunds in place between Junction 13 and K50 to control drainage from the access tracks

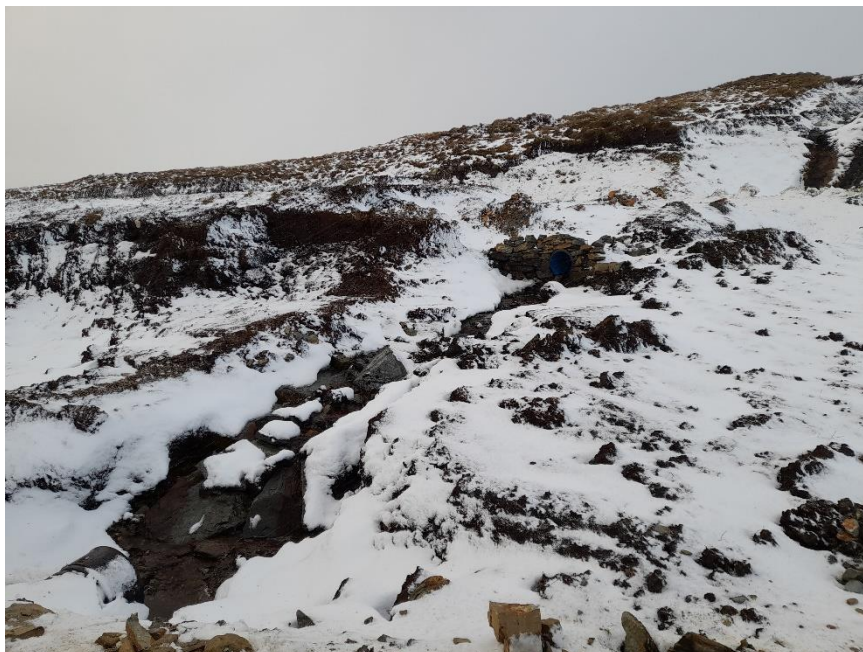
The cross-country cable track from Kergord to the substation has commenced. Clean water culverts are being installed as the track is progressed (Photos 4 and 5).

Photo 4. Clean water culverts being installed as the cross-country cable track is progressed from Kergord to the substation

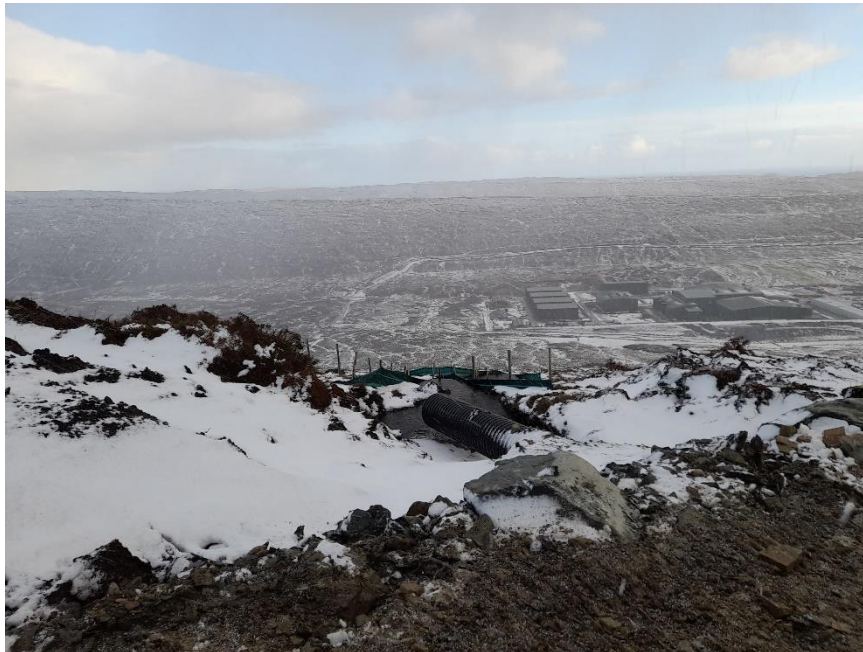
Photo 5. Clean water culverts being installed as the cross-country cable track is progressed from Kergord to the substation

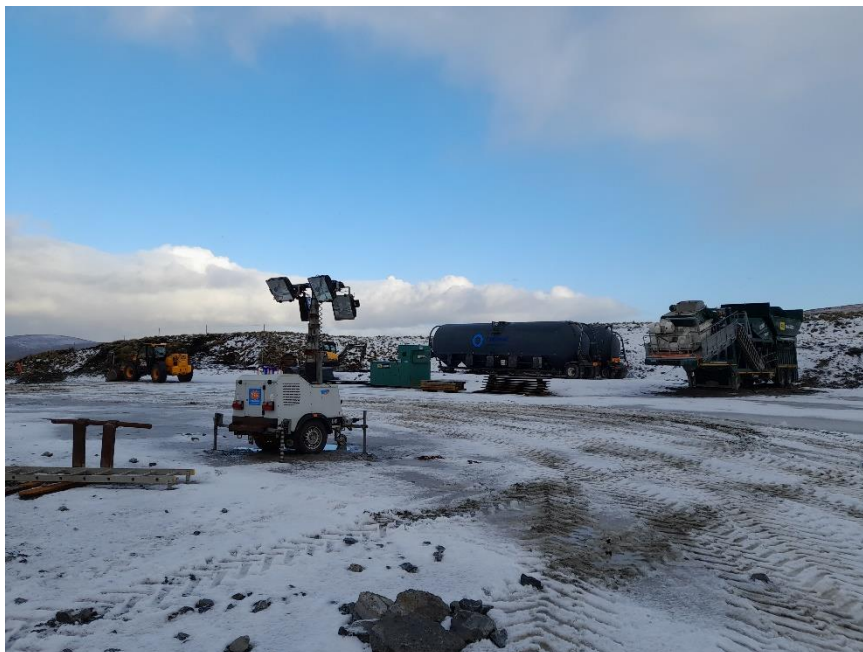
The batching plants were observed to have been decommissioned; however, tanks, IBCs and other plant were awaiting removal from the compound (Photos 6 and 7). It was noted by the Design Engineer that the tanks were empty. IBCs with contents still in them were stored in the concrete bunds. Concrete hardstanding had been broken out to the east of the compound and the hardstanding remained in the west of the compound.

Photo 6. Removal of tanks from the batching plant in the northern compound

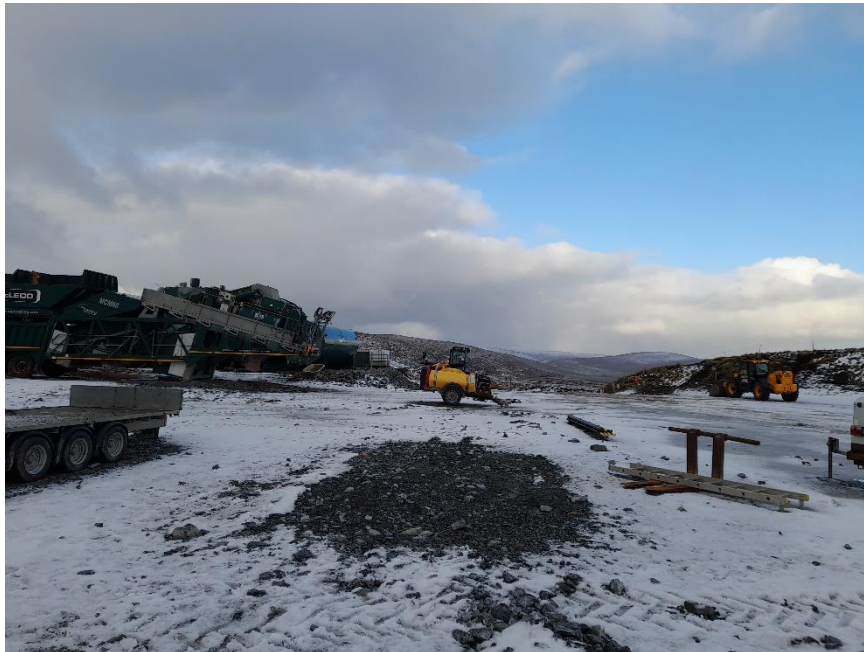
Photo 7. Removal of tanks from the batching plant in the northern compound

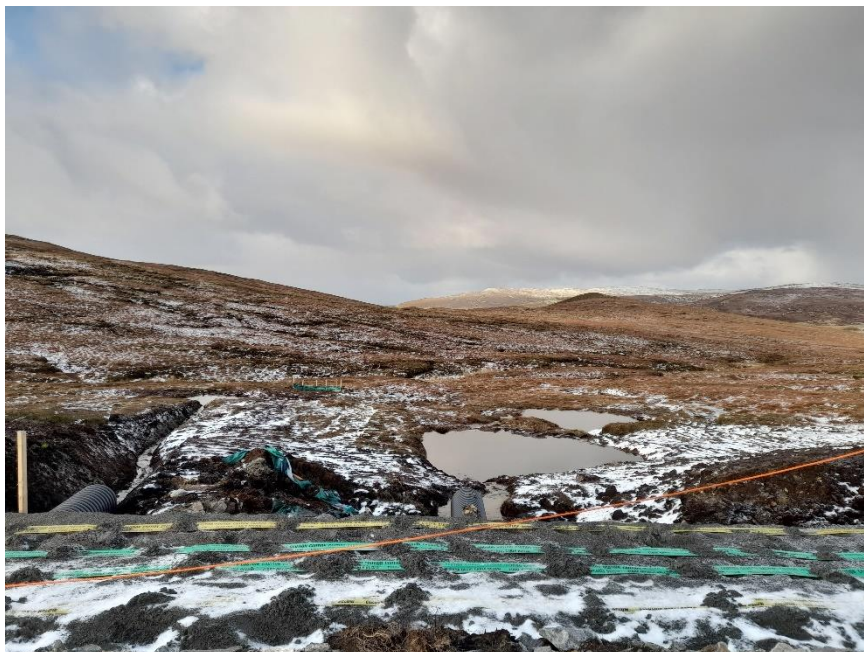
The silt fences have been cleared of the silt caught to date to ensure they are operating in the most efficient way. In addition, a series of ponds have been installed as a more long-term solution to drainage management from the access tracks (Photos 8 and 9).

Photo 8. Silt fences have been maintained and settlement ponds installed for longer term drainage solutions between N92 and N95.

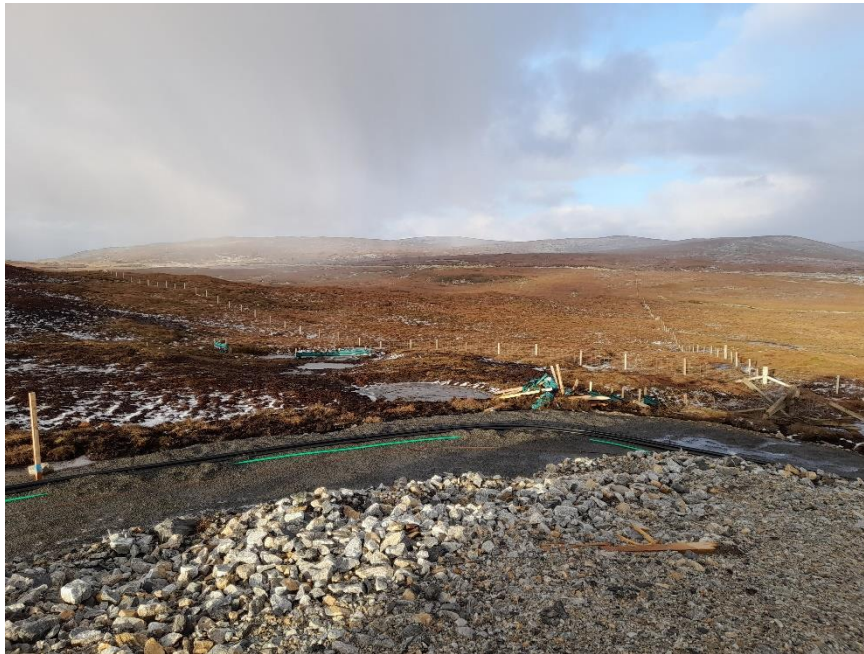
Photo 9. Silt fences have been maintained and settlement ponds installed for longer term drainage solutions between N92 and N95.

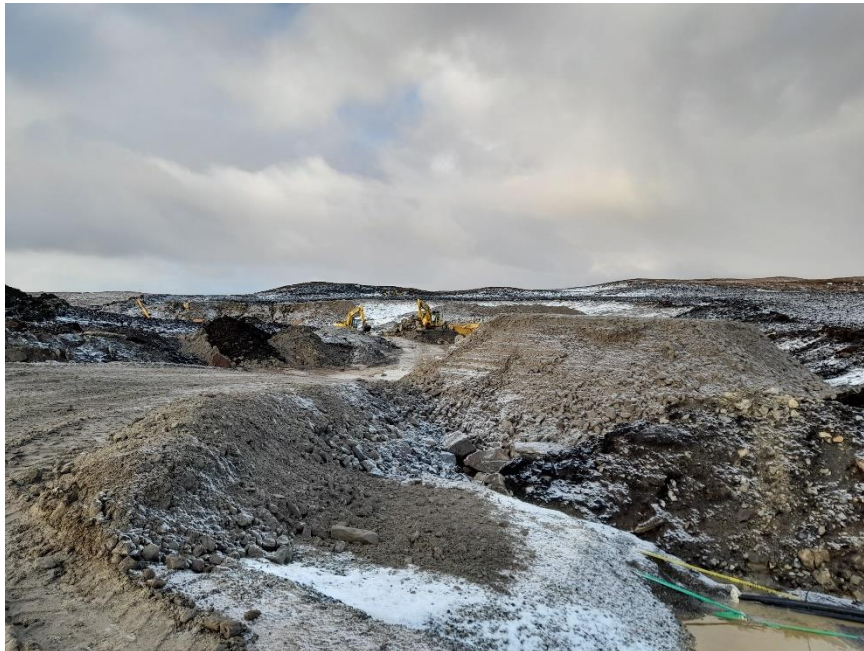
Water had built up in NBP01 over the Christmas break and the water in the base of the borrow pit was being pumped out of the base during the audit (Photo 10). There is further rock extraction to be undertaken in this borrow pit.

Photo 10. Pumping water from NBP01

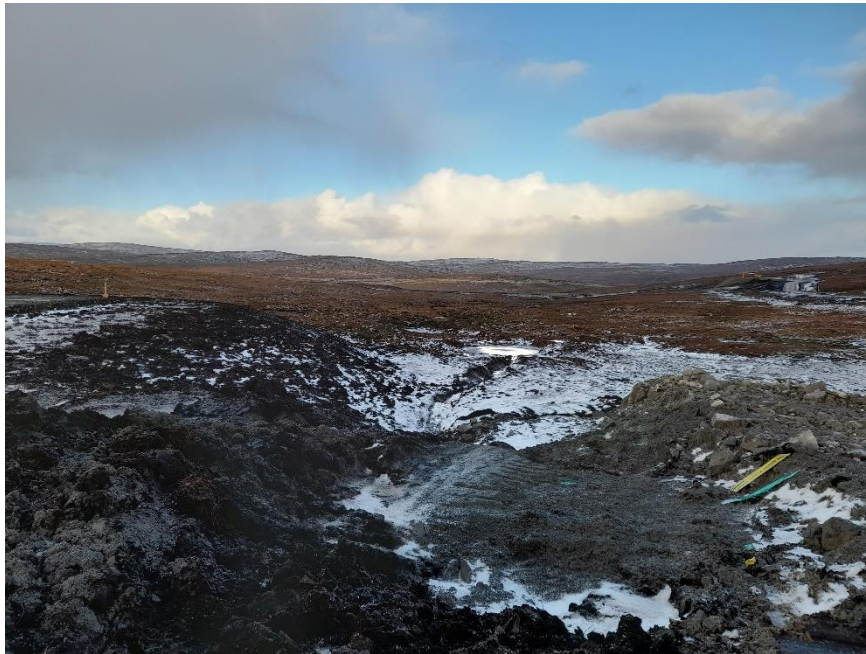
The peat movement at N97 has been relandscaped (Photo 11).

Photo 11. Peat movement at N97 being relandscaped

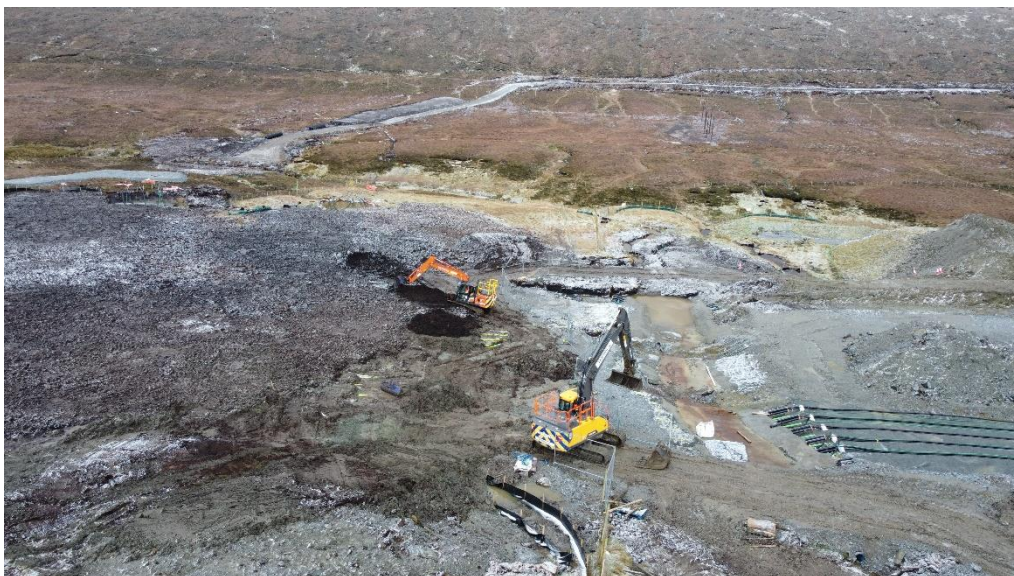
Construction of substation cable arrays under the diverted Northern Watercourse has been completed and the cable trenches have been backfilled (Photo 12). The area is currently being landscaped (Photo 13) and will then be handed over from the Design Engineer to the Principal contractors of the substation area.

Photo 12. Cable trenches around northern watercourse have been backfilled
(Photo courtesy of SSE)

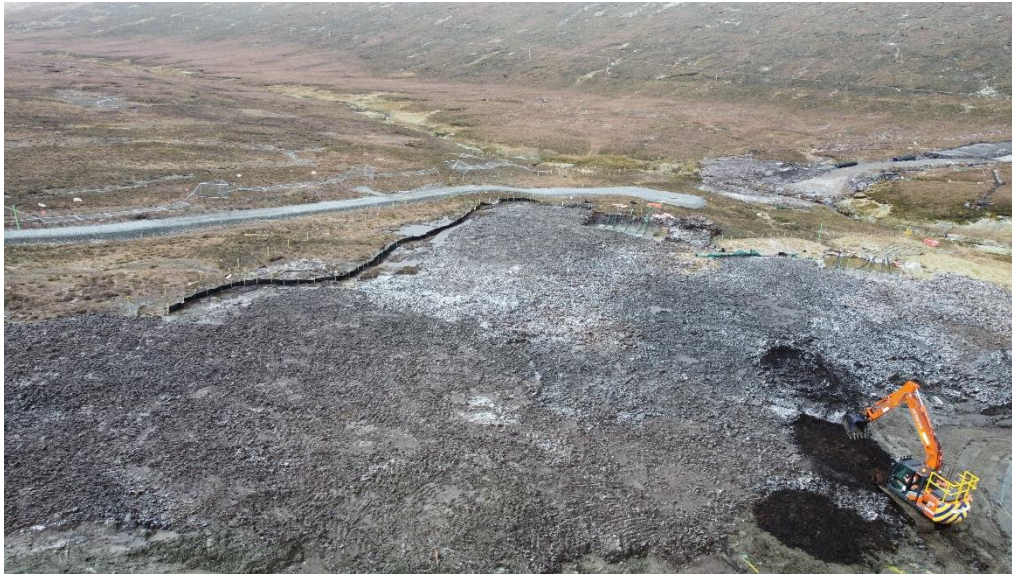
Photo 13. Area around backfilled cables at northern watercourse being relandscaped (Photo courtesy of SSE).

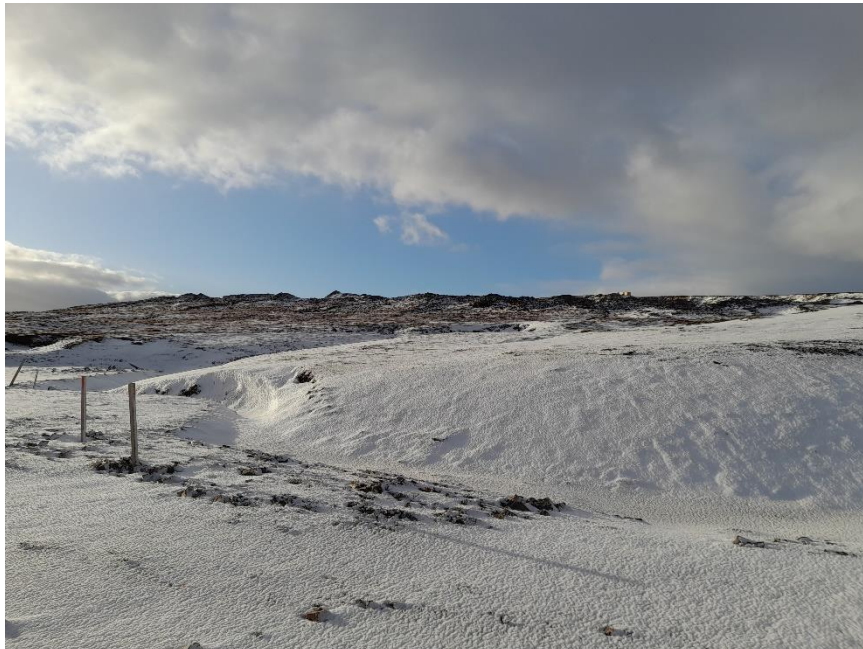
The ECoW raised a movement of peat that had occurred at NBP05. It was noted that there were no geotechnical issues about the current position of the peat, and it was agreed by all parties that the risk of further movement is low. The peat movement has spread into an area of blanket bog (Photo 14); however, it is noted that this movement is within the area originally agreed the borrow pit would extend into. This will continue to be monitored as further rock extraction is undertaken and will be raised when the plans for borrow pit restoration have been reviewed.

Photo 14. Peat movement at NBP05

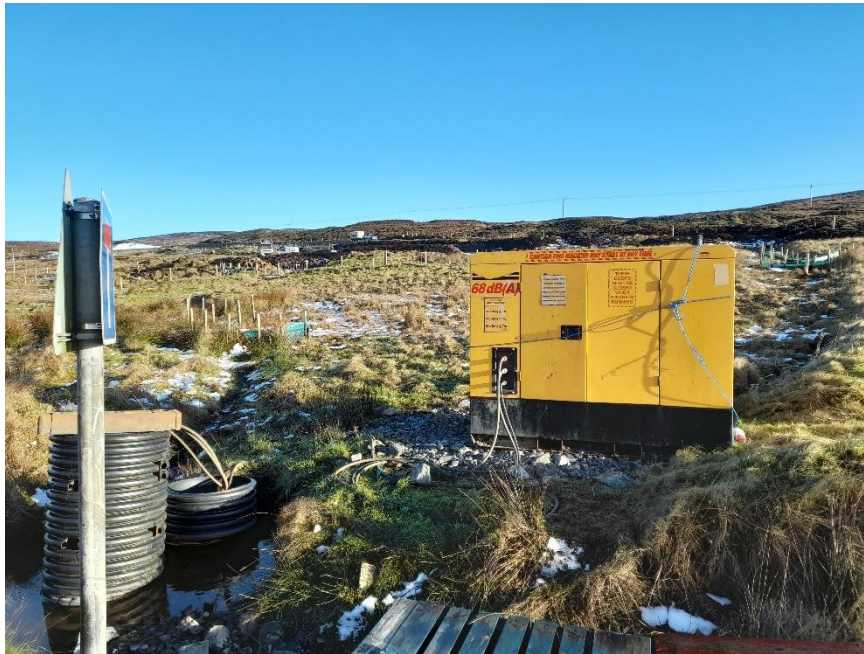
During PMO027 audit, the area of concern was observed. The silty water gathered in the roadside drainage swale is pumped into high ground to allow drainage through vegetation before entering the drainage swale that leads to the Burn of Weisdale (Photos 15 and 16). The Design Engineer noted that it is good practise not to leave pumps running unattended for long periods of time and so the pumps were not used during the Christmas break. Provision was in place to check sensitive areas during the break, including this location. Due to the pump not being constantly switched on, the drainage water from the road had built up in the roadside swale.

Photo 15. Drainage at the Weasdale Burn

Following the complaint, a member of site staff and a local SEPA representative had visited the site to monitor the suspended sediment concentrations entering the Burn of Weisdale. All values were found to be below the permitted level. It was decided that the pump would be switched on as an additional precaution.

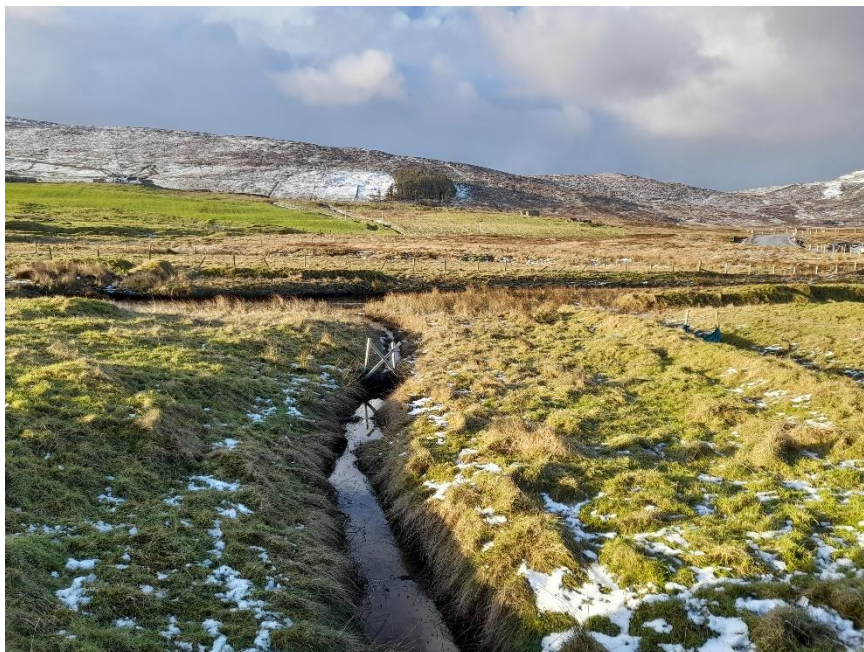
Photo 16. Drainage at the Weasdale Burn
