Intended for  
**Viking Energy Wind Farm LLP**

Date  
**February 2023**

Project Number  
**1620009158**

# **VIKING ENERGY WIND FARM PLANNING MONITORING OFFICER AUDIT REPORT 028: 18<sup>TH</sup> JANUARY TO 19<sup>TH</sup> FEBRUARY 2023**

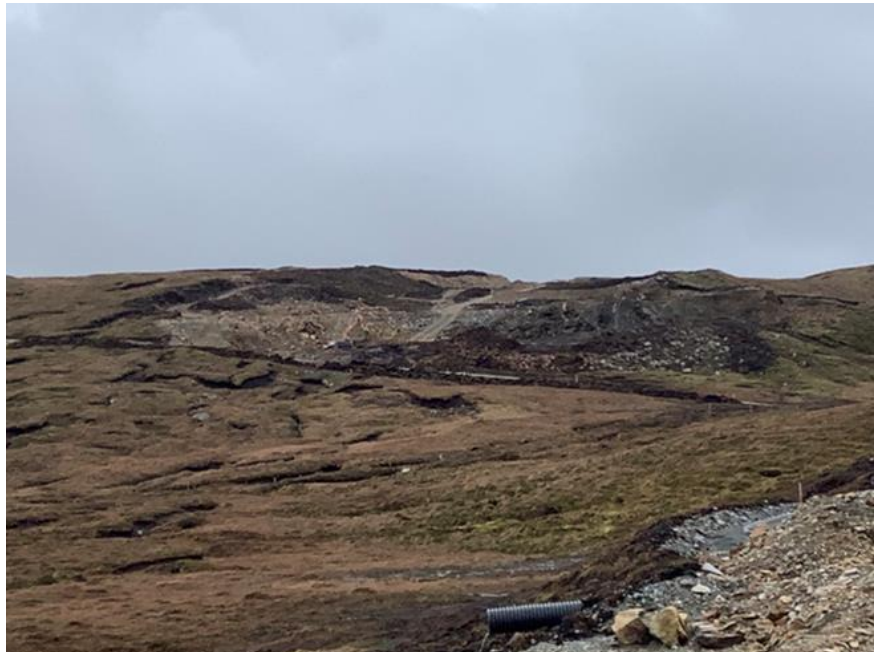
During the visit, rock was being taken out of KBP02 following final blasting (Photo 1). This is part of the reprofiling process of the borrow pit face in preparation for reinstatement. The reinstatement of this section of KBP02 has been expedited in keeping with mitigation commitments made to SEPA.

**Photo 1.** View of KBP02

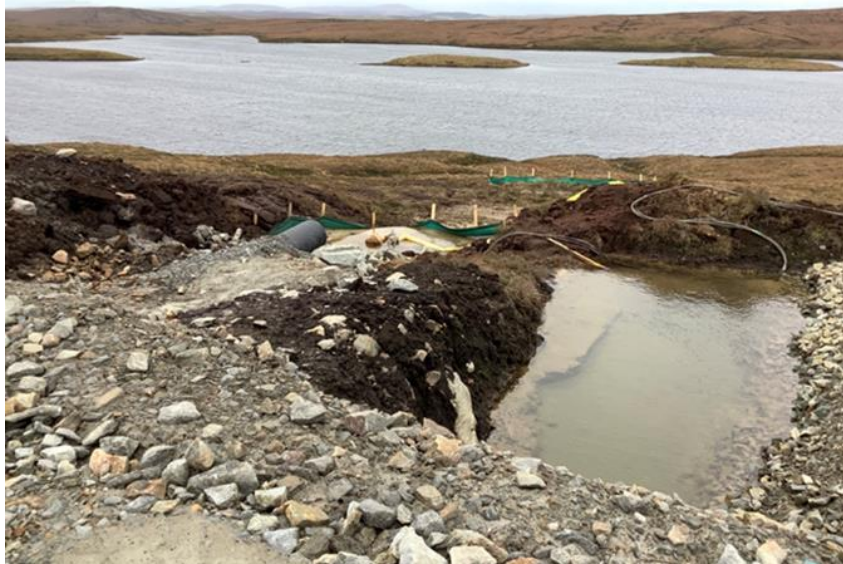
Following notes in the PMO027 report, the drainage mitigation around Maa Water has been closely monitored. The outlet of peat pipes downslope of the track and hardstanding have been infilled and additional mitigation installed should they spring again. It is being closely monitored to assess the impact of infilling. The water pump with reactor (further information provided in PMO025 report) was still in place and will be turned on when heavy rainfall is anticipated. The settlement ponds will require re-siting as they are currently located on the route of the planned cable trenches. The new ponds and mitigation measures will be implemented on the upslope side of the track to allow the cable trenches to be formed. On the day of visit, the settlement pond was in situ and water pump turned off (Photo 2).

**Photo 2.** Mitigation by Maa Water with settlement pond, water pump and silt fences

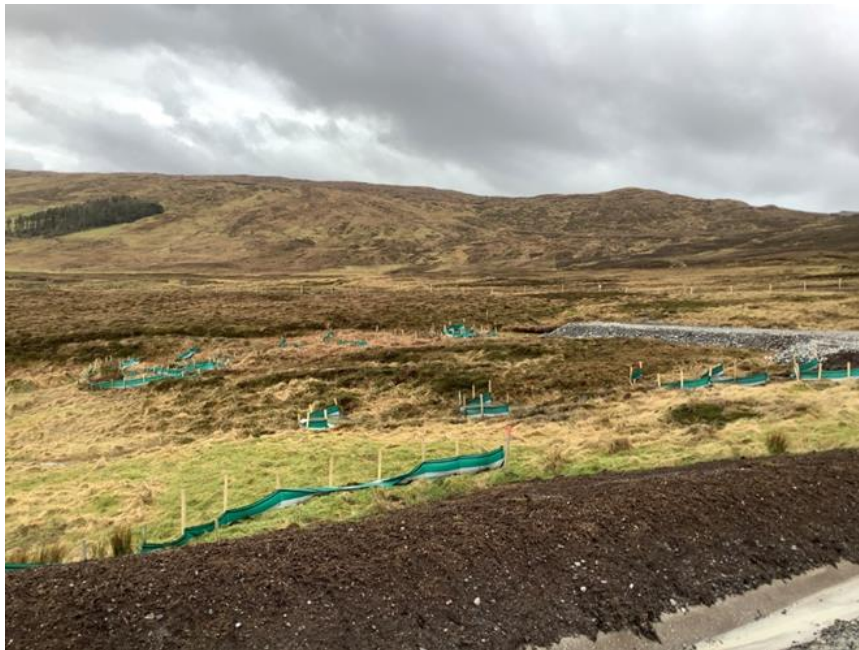
Following observations raised by the SSER ECoW, the frequency of silt fence maintenance by Droswell Burn has increased. Silt fences nearest to the road have also been replaced with a larger arc fence to increase coverage (Photo 3).

**Photo 3.** View of silt fences by Droswell Burn

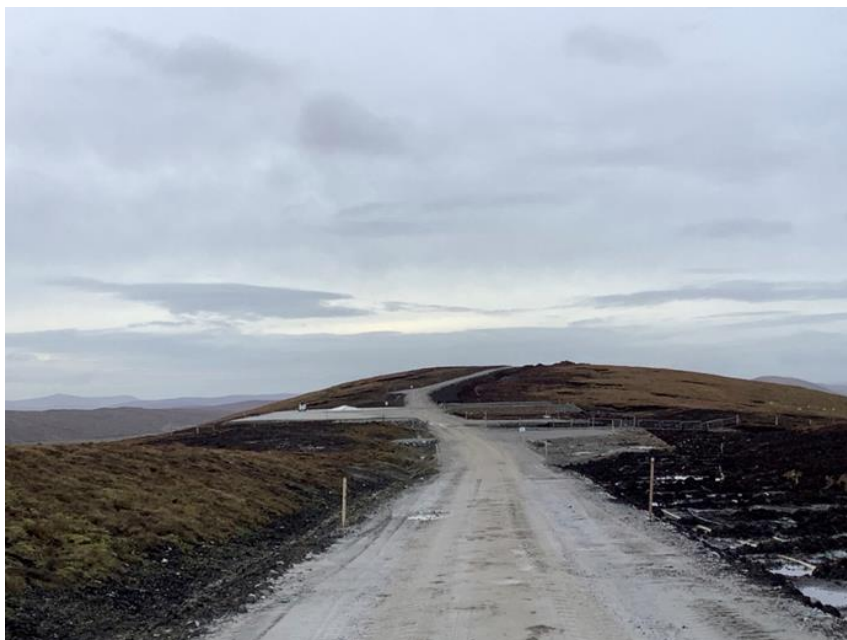
All turbine hardstanding on MKR have been layered and capped with the majority of the roads also completed (Photo 4). PLT has been completed on Arrays C and D.

**Photo 4.** View towards turbine 042 (previously K82) showing capped road and turbine hardstand

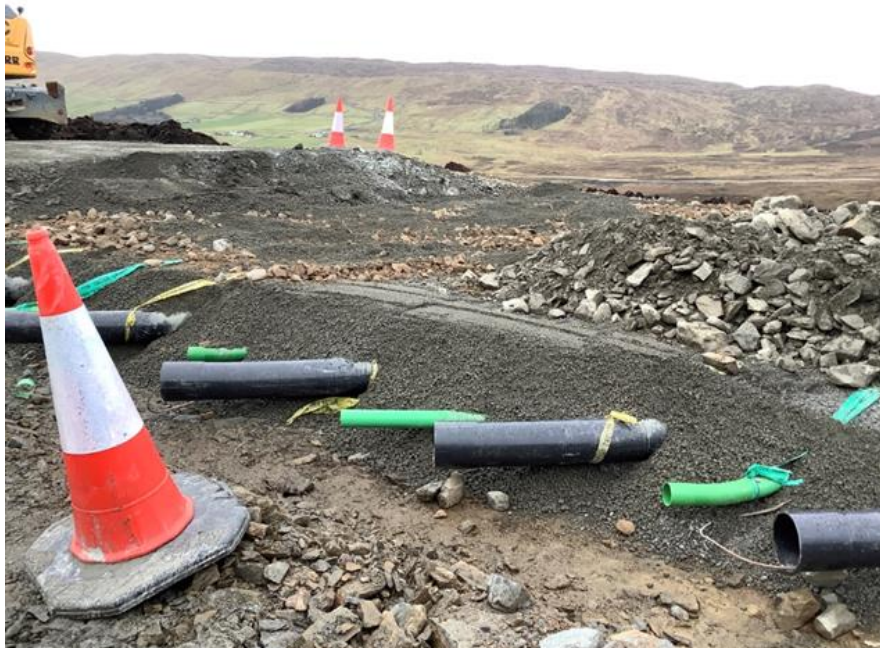
On the day of the visit, the track was being excavated to install the cable trench linking the cross country cabling from the eastern arrays to the cross country route to the substation (Photo 5).

**Photo 5.** Track excavation near turbine 036 (previously K88)

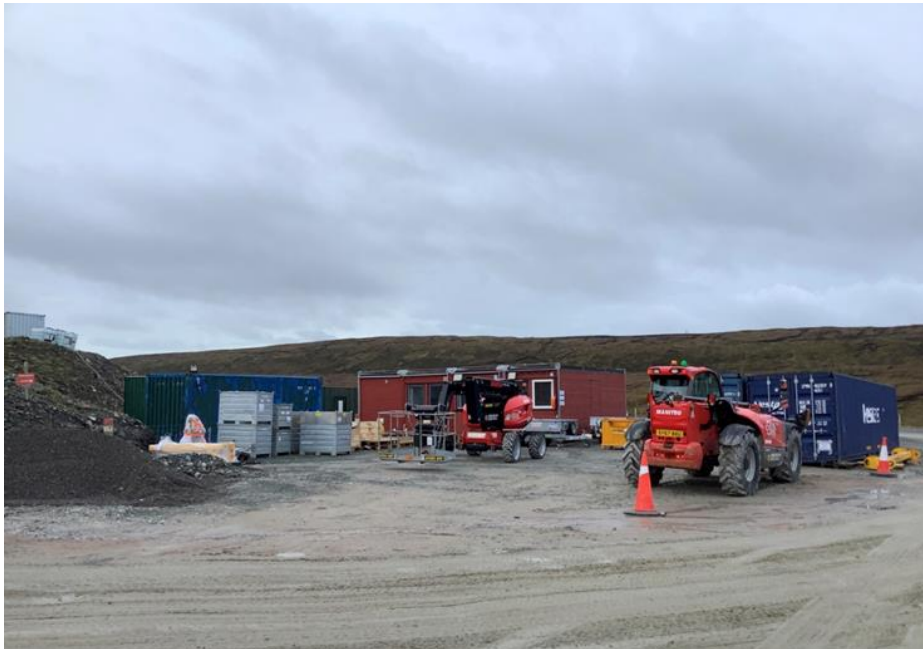
Top parts of the North Compound were being cleared out on the day of visit. The concrete batching plants were no longer in place at the North Compound. Vestas were setting up a satellite compound in the lower parts of the North Compound (Photo 6).

**Photo 6.** View of Vestas North Compound

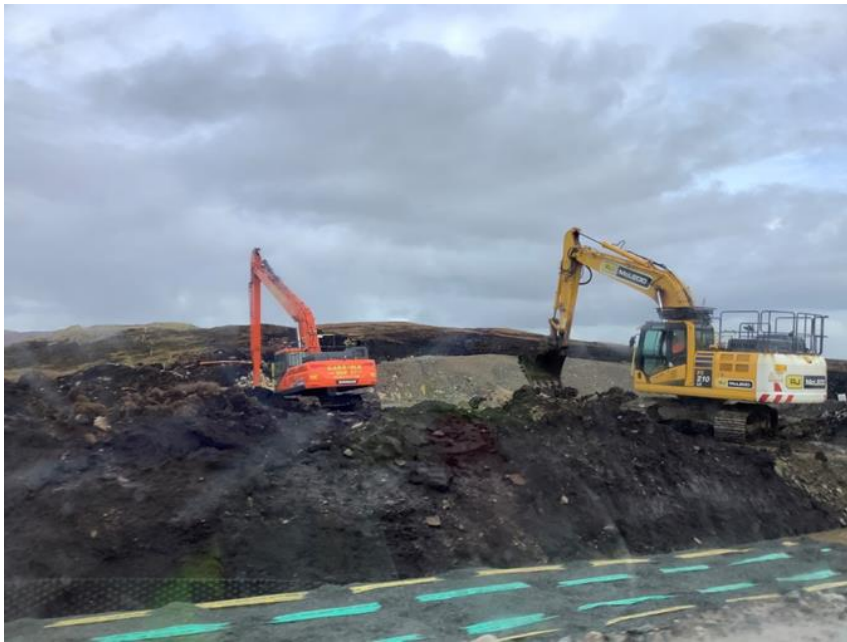
Final earthworks associated with turbine hardstands have been completed in Array J, with PLT completed in Array M. On the day of visit, cable trenches around turbine 048 (previously N90) were being prepared for backfilling (Photo 7) with Array F being prepared for cabling. Turbine components delivery was in progress in the area (example Photo 8) with elements being delivered to turbine 047 (previously N89) during the visit.

**Photo 7.** Preparation for backfilling of cable trenches near turbine 048 (previously N90)

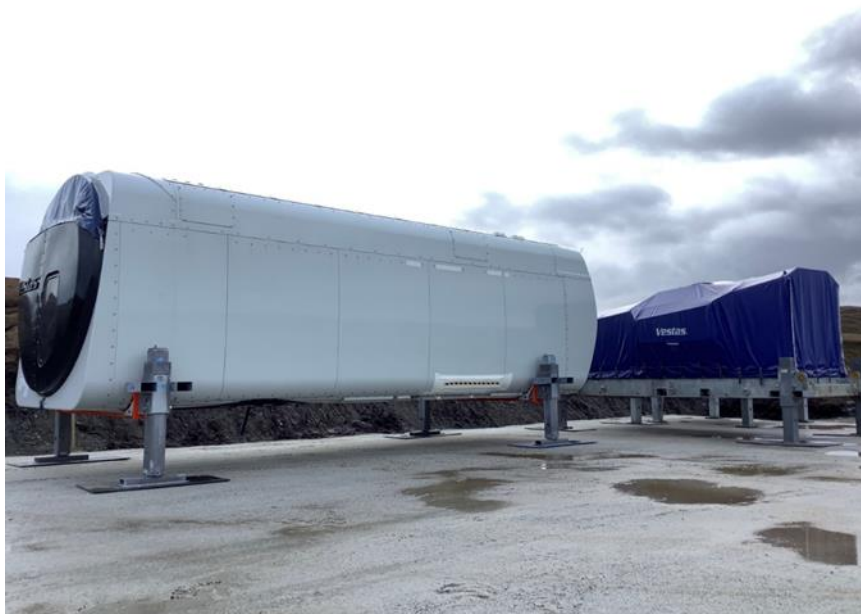
**Photo 8.** Delivered turbine components at turbine 054 (previously N96)

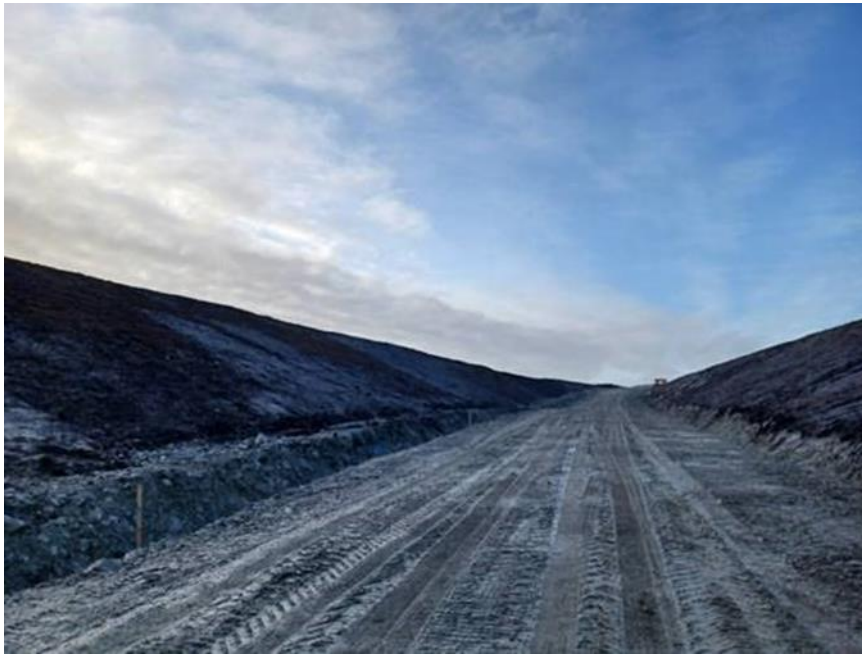
Following reports of peat slumps at spur 52 (PMO025 and PMO026), the embankment has been reprofiled to improve stability and re-dressed with peat (Photo 9). Cable trenches near turbine 052 (previously N94) have also been excavated with turbine hardstand completed and capped.

**Photo 9.** View of Spur 52 (Photo courtesy of RJM)

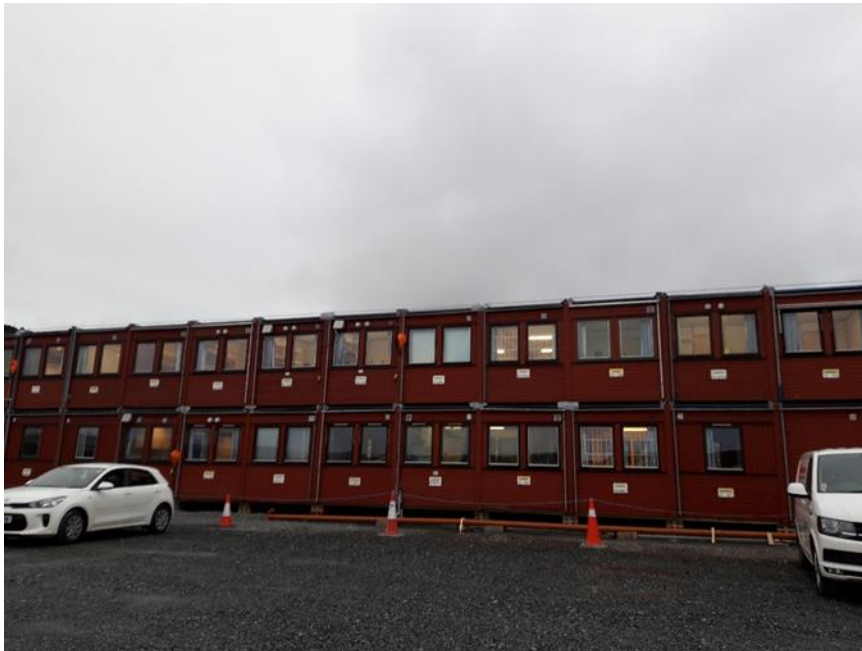
Vestas have set up site offices and welfare facilities across the car park, opposite the original offices and welfare facilities (Photo 10).

**Photo 10.** Vestas offices and welfare facilities at main compound

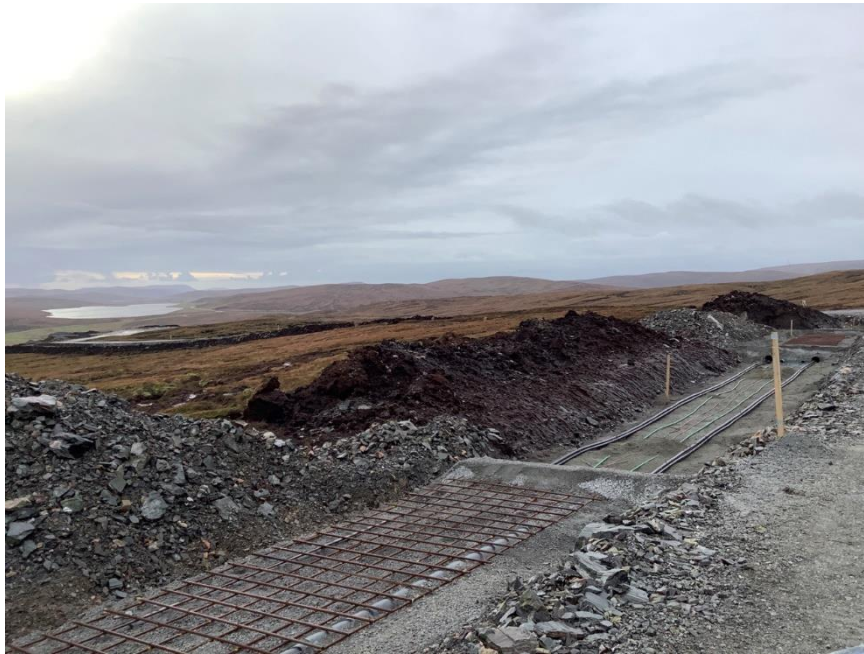
On the day of visit, cable trenches around turbine 073 (previously N114) were being prepared for backfilling. As per design, reinforcement measures were being installed to protect cables where the cable trenches may be impacted by crane positions (Photo 11).

**Photo 11.** Concrete Protection detail for cables that pass through assist crane hardstands at turbine 073 (previously N114)

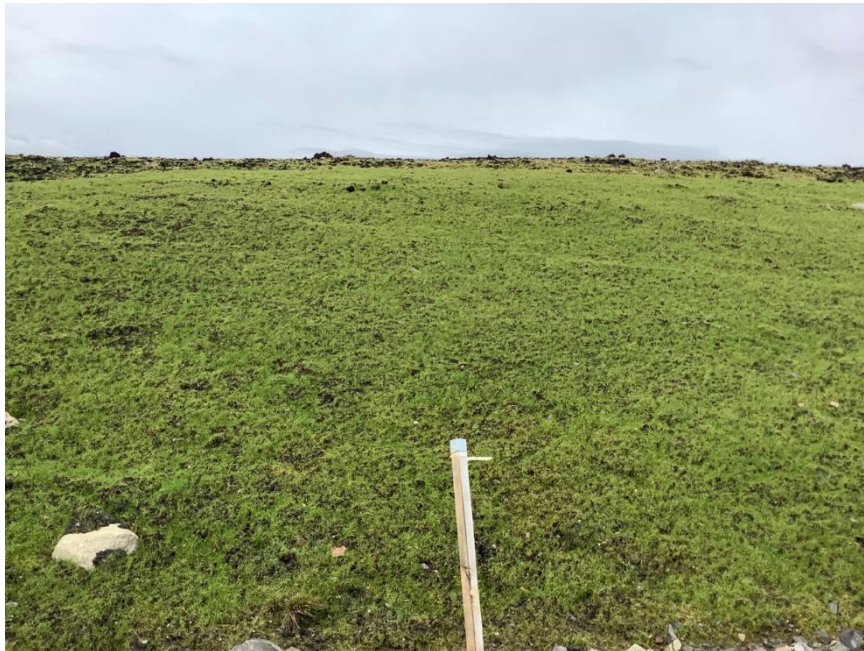
Hydroseeding of the peat along cuttings adjacent to the access tracks were holding well with growth observed (Photo 12).

**Photo 12.** Growth from hydroseeding between turbine 069 and 071 (previously N111 and N113)

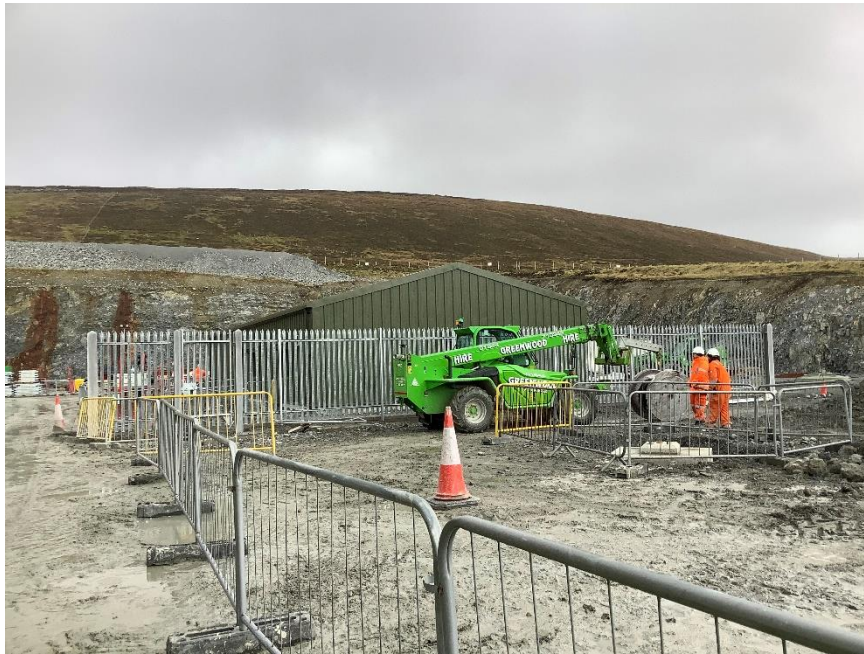
A new fence has been constructed marking the operational area of the substation (Photo 13).

**Photo 13.** New fence at substation

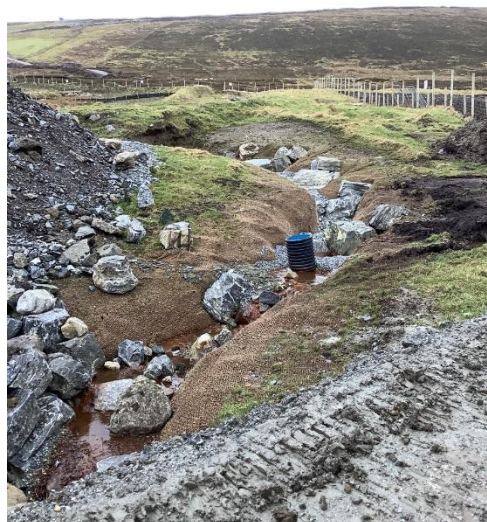
Work relating to the restoration of the northern watercourse is progressing well (Photo 14) with some additional reprofiling ongoing on the southern side. The ongoing reprofiling requires interaction with the HVDC site as they have responsibility for completing the design and reinstatement of the diverted northern watercourse. Backfilling of the incoming cable arrays from the wind farm has been completed and is in good condition (Photo 15). Reseeding of this area is

**Photo 14.** View upstream to the restoration of the Northern Watercourse

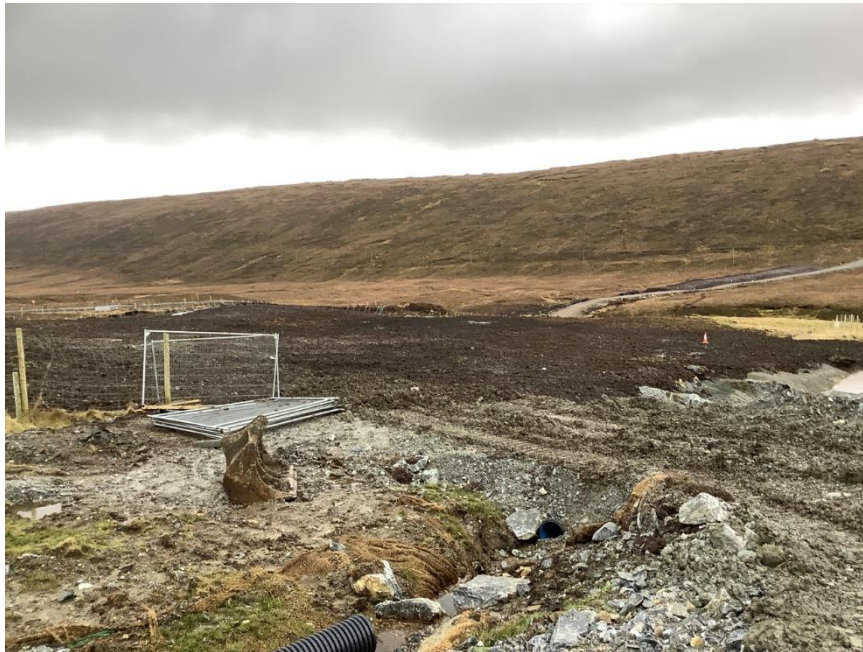
**Photo 15.** View of completed backfilled area of incoming arrays from the wind farm

currently being resourced. A natural field gully was intercepted during the cable array works and diverted into the northern watercourse. The adoption of this diversion is under discussion with the HVDC site

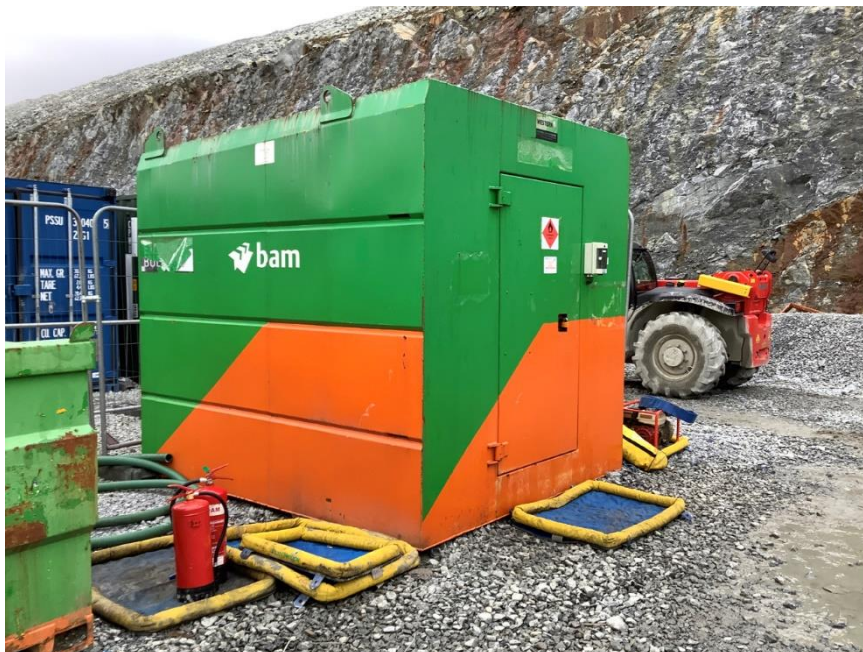
The fuel storage at the substation was noted to be in good order, with spill kit and fire extinguisher provided (Photo 16). The waste skips were clearly labelled for segregated waste management.

**Photo 16.** Spill mat and fire extinguisher at substation

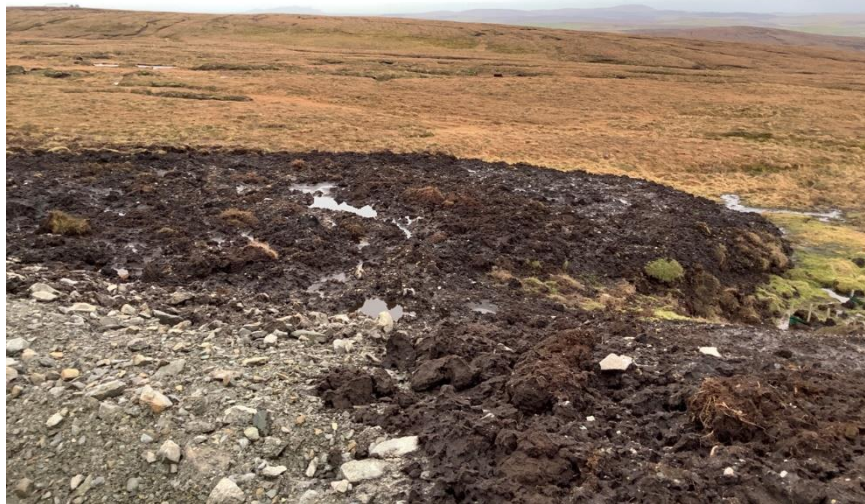
Turbine 005 (previously K73) was observed due to a comment from the GCoW regarding a peat slump covering an area of blanket bog. Further information is provided in Section 3.8.1.

As noted in Section 3.1.2, the GCoW mentioned a movement of peat occurred at turbine 005 following reinstatement works (Photo 17). It was agreed by all parties that the risk of further movement is low and stability of undisturbed ground has not been compromised. This will continue to be monitored and will be reinstated in keeping with the surrounding environment and topography once turbine delivery has been completed.

**Photo 17.** Peat slump at turbine 005 (previously K73)

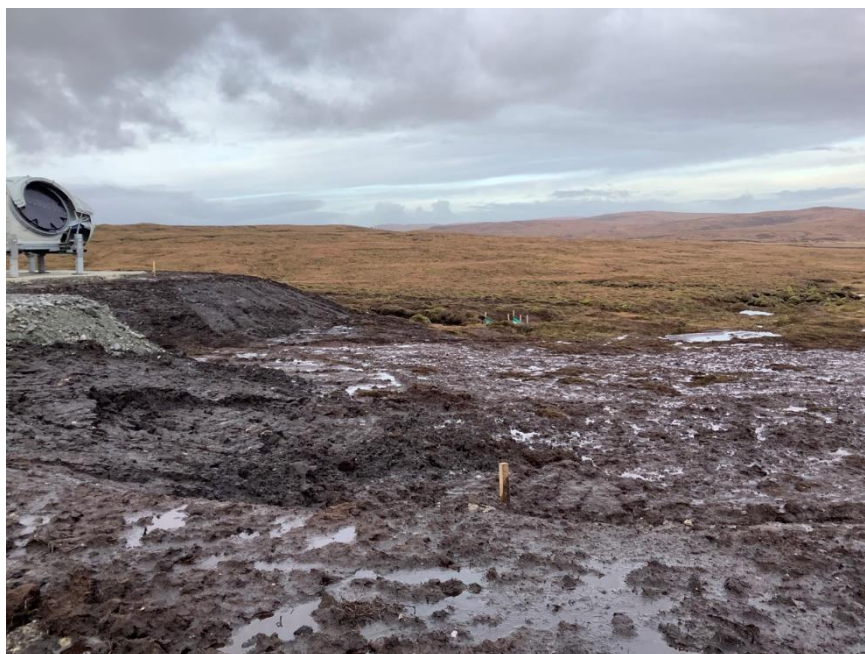
As noted in Section 3.4.2, the GCoW raised movements of peat at turbine 055 and P17 with concern regarding stability, surface run off and erosion. Additional silt fences and turf bund has been installed at turbine 055 (Photo 18) to minimise surface run off. Regarding P17, both Principal Contractor and SSE Site Environmental Manager note that observations are part of the settling process and will be addressed in phase 2 of peat restoration.

The ECoW raised a movement of peat at turbine 055 and P17, noting movement spreading into areas of blanket bog and potential erosion. The concerns are shared by GCoW with response included in Section 3.7.2. As noted above, observations in P17 are part of the settling process.

**Photo 18.** View of turf bund and silt fences for peat movement by turbine 055 (previously N97)
