Intended for  
**Viking Energy Wind Farm LLP**

Date  
**March 2023**

Project Number  
**1620009158**

# **VIKING ENERGY WIND FARM PLANNING MONITORING OFFICER AUDIT REPORT 029: 20<sup>TH</sup> FEBRUARY TO 21<sup>ST</sup> MARCH 2023**

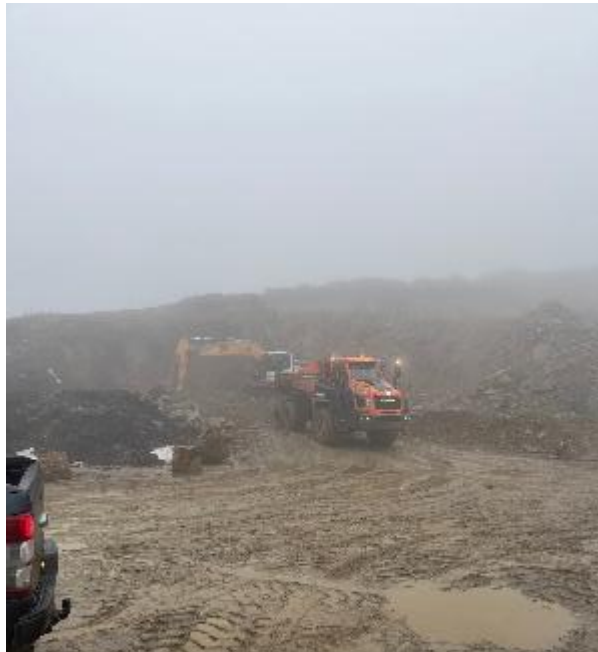
During the visit, rock was being taken out of KBP02 (photo 1). This is part of the reprofiling process of the borrow pit face as discussed with SEPA to expedite capping of the offending area in Kergord. The full reinstatement of this section is scheduled for April 2023 in keeping with mitigation commitments made to SEPA. Recently installed surface water management measures by KBP03, including settlement ponds and circulation pumped through a reactor were inspected. The surface water management was recently relocated from the downslope to upslope side of the access track to the other to accommodate cable installation (photo 2 and 3).

**Photo 1.** View of KBP02

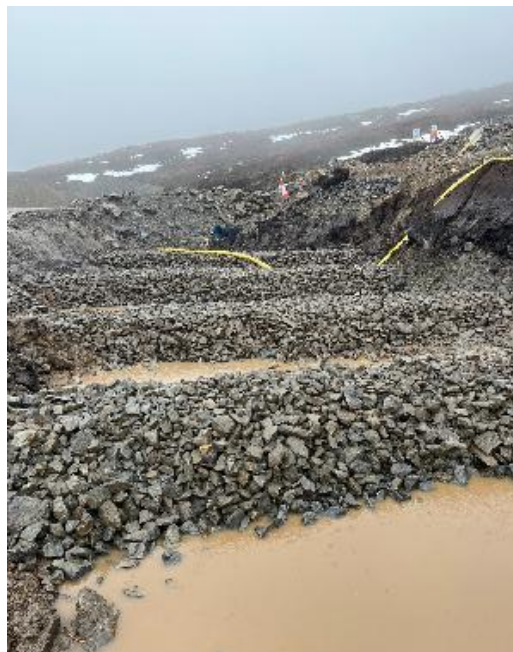
**Photo 2.** Mitigation by Maa Water with settlement pond, water pump (and silt fences out of shot), by KBP03

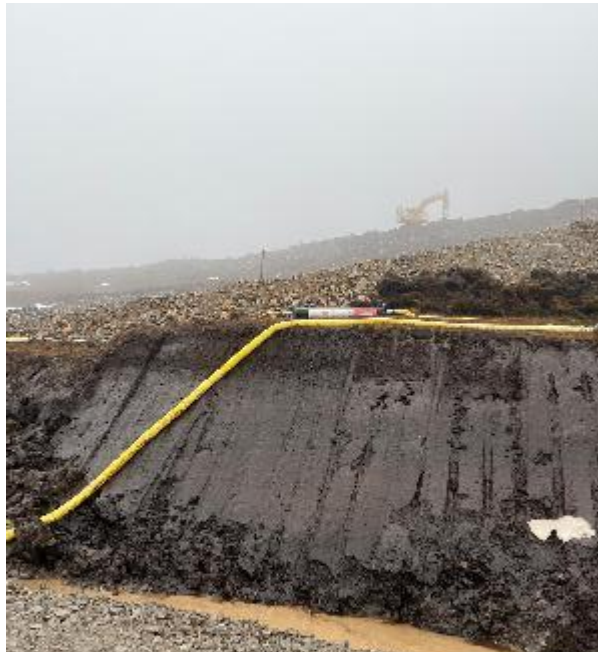
**Photo 3.** View of pump/reactor upgradient of Maa Water, by KBP03

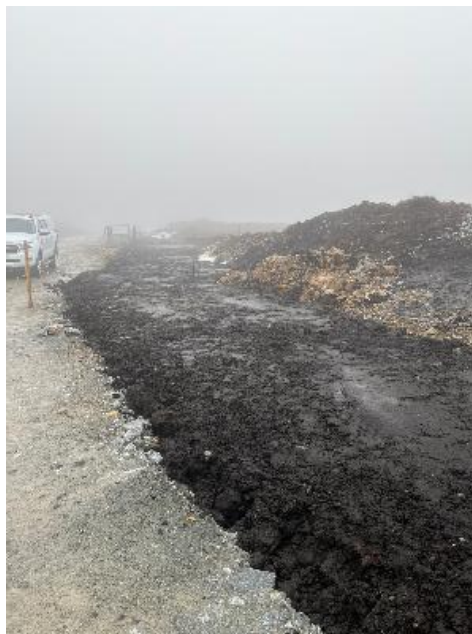
Photo 4 shows a recently reinstated section of cable track. The PMO observed concrete deliveries to the site from an off-site batching facility. The concrete was being used to form impermeable 'plugs' in sections of the cable track on steep gradients in order to avoid the cable tracks becoming a preferential subsurface drainage pathways. Work was also underway to provide concrete reinforcement to sections of the cable route where additional protection for cables is required (e.g. where the cable array passes underneath hardstanding areas, blade fingers or access routes (photo 5 and 6).

**Photo 4.** Cable track reinstatement near KBP02

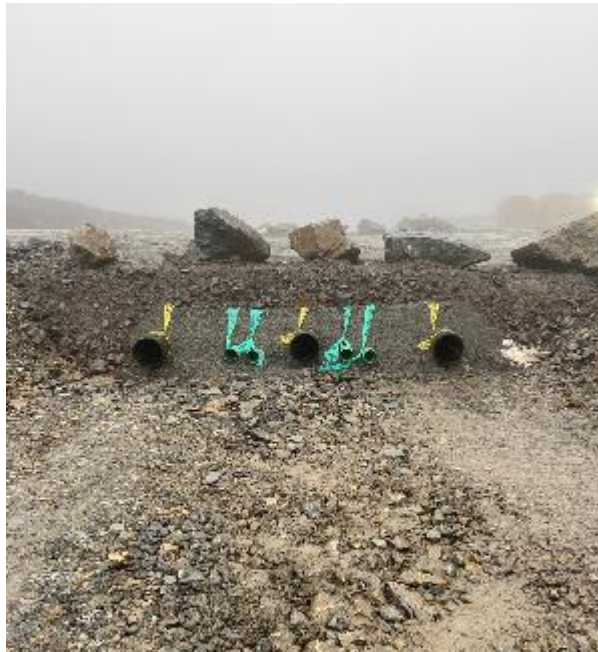
**Photo 5.** Cable ducts and reinforcement at entrance to Vestas compound (KBP06)

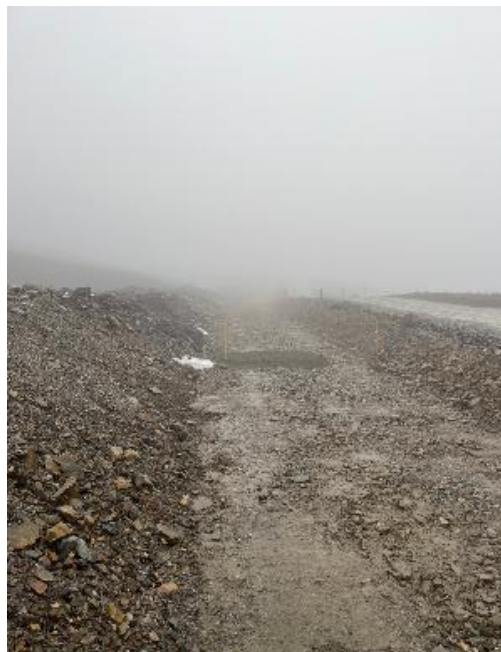
**Photo 6.** Cable track concrete plug (partially poured)

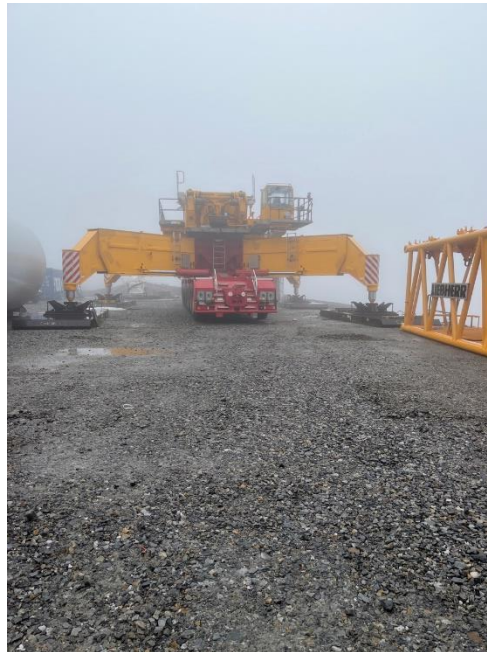
Cranes for turbine erection were noted on site at K46 and K43 (photo 7 and 8). Turbine component laydown was inspected at K46 (photo 9).

**Photo 7.** Mobile crane (lattice boom) – K46

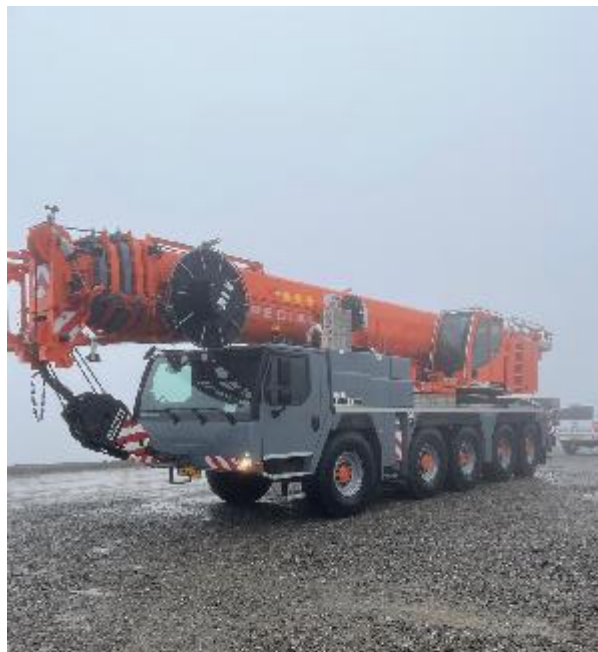
**Photo 8.** K43 – telescopic boom mobile crane

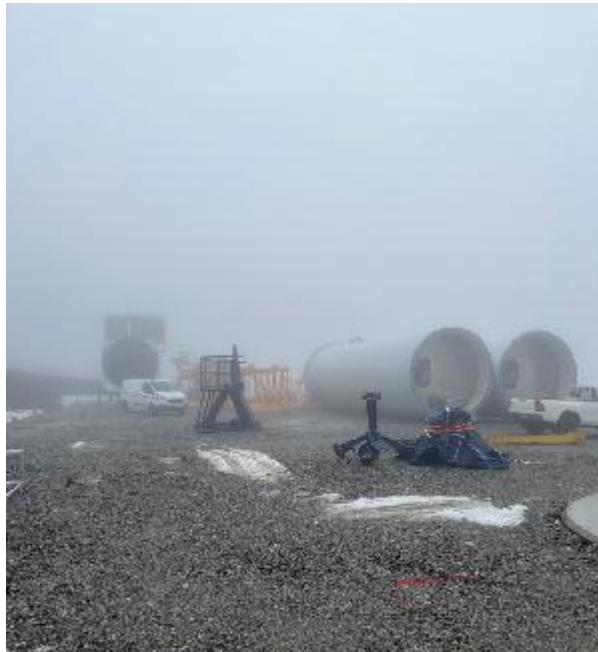
**Photo 9.** K46 laydown

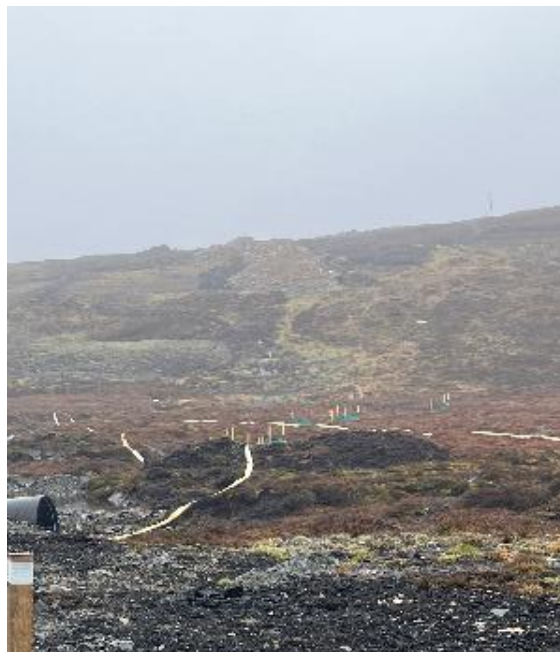
cable route are still in good condition prior to recommencement. The cable route has been marked out in the area adjacent to the Sandwater Track. Preparatory work in progress was noted to include the installation of silt fencing, delivery of pumps for the surface water management and pollution prevention plan and stockpiling of stone for the cable track (photo 10).

**Photo 10.** Silt fencing and stone stockpiles adjacent to Sandwater track ready for cross-country cable route

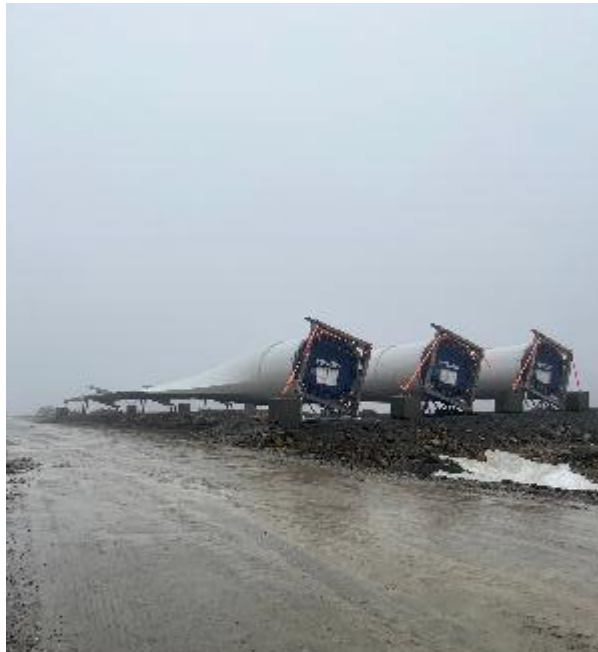
The first tower section was noted to have been installed in several locations, with all turbine components delivered to some locations and turbine component deliveries ongoing (see photo from N100, photo 11, 12).

**Photo 11.** N100 blade laydown on blade fingers

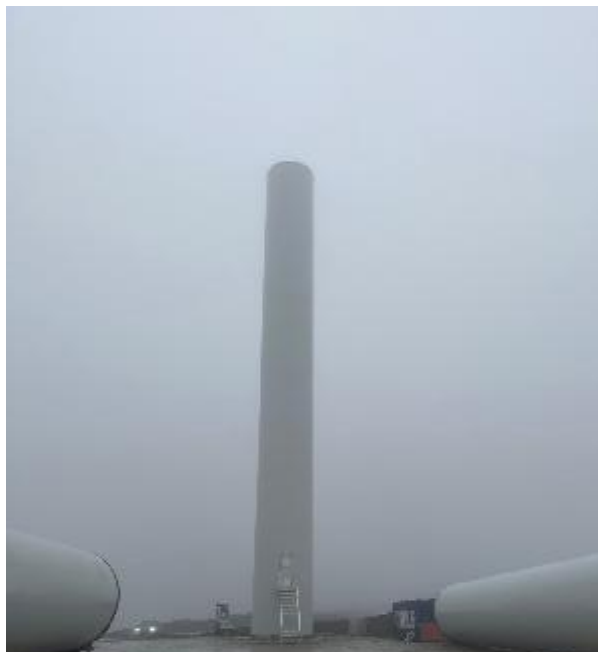
**Photo 12.** Tower N100 lower section erected

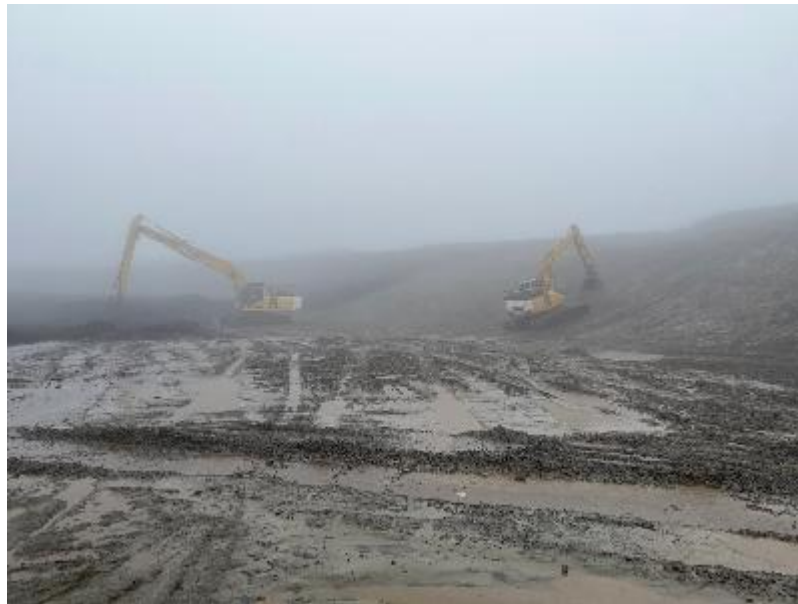
Rock extraction and reprofiling work was noted to be progressing at NBP05 during the audit (photo 13).

**Photo 13.** Reprofilng work at NBP05

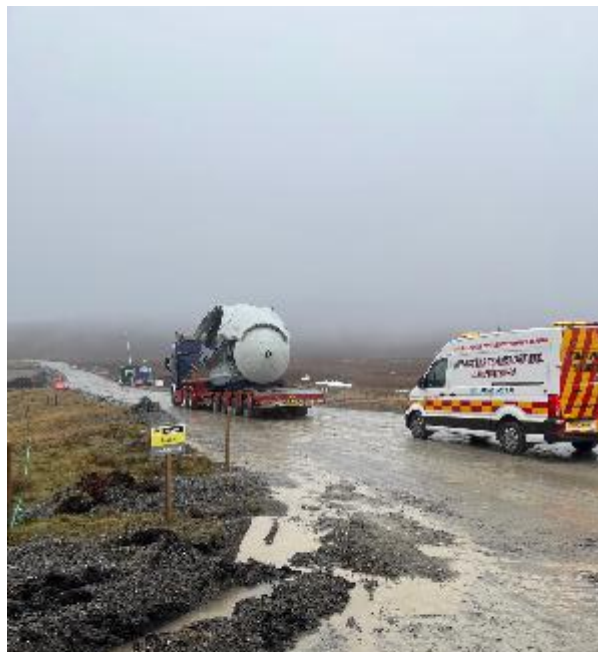
**Photo 14.** AIL on Sandwater Track

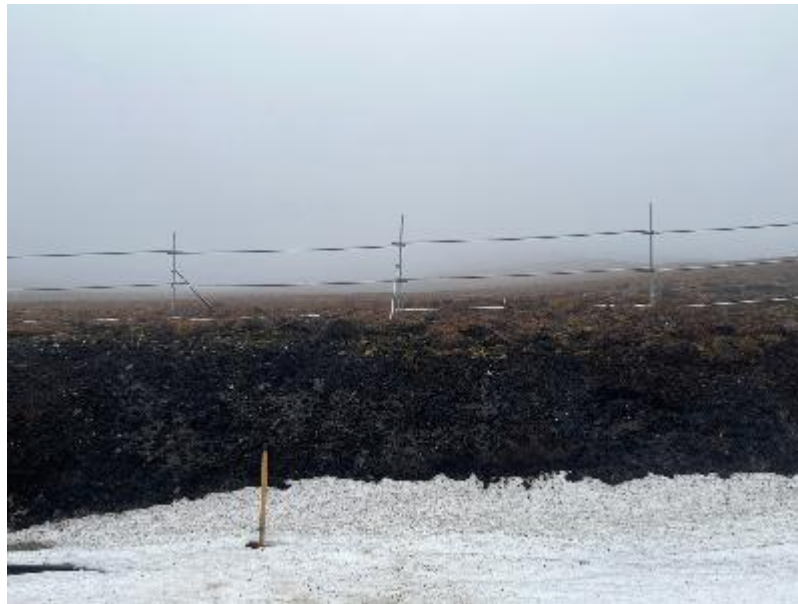
Scaffolding was noted near turbine N100 to be covered with netting to provide a visual screening barrier to avoid disturbance to potential bird nesting locations (photo 15), in keeping with what was installed last season.

**Photo 15.** N100 bird mitigation (netting still to be installed on scaffold)
