Date
April 2023

Project Number
1620009158

VIKING ENERGY WIND FARM PLANNING MONITORING OFFICER AUDIT REPORT 030: 20TH MARCH TO 16TH APRIL 2023

Audit Number	PMO 030
Location	Kergord Main Construction Compound Nesting North Nesting North Compound
Weather Conditions	Overcast with showers at times (7°C). Moderate breeze
Audit Date	13 th April 2023
Audit Period	20 th March – 16 th April 2023
Audit Owner	Ramboll UK Ltd

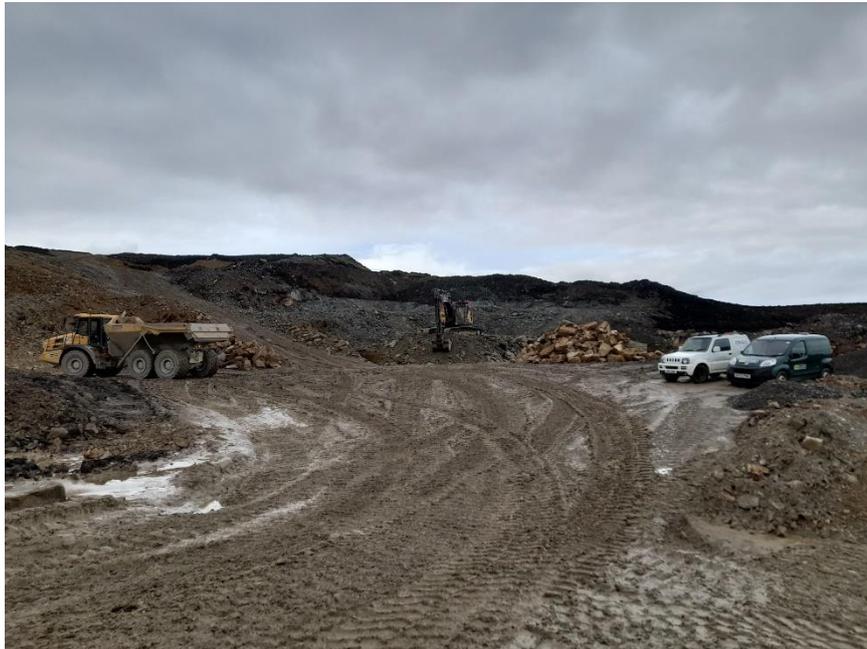
During the visit, rock was being taken out of borrow pit KBP02 (photo 1). This is part of the reprofiling process of exposed section of oxidising rock in the northern section of the borrow pit as discussed with SEPA, to expedite capping of the borrow pit. The full reinstatement of the northern section is scheduled for April 2023 in keeping with mitigation commitments made to SEPA. Design works for further settlement ponds are being undertaken in line with longer term treatment plans agreed with SEPA. These involve treatment of the water to raise the pH and counter the hydrochemical reactions which are occurring in the lower reaches of the affected water courses.

Photo 1. View of KBP02

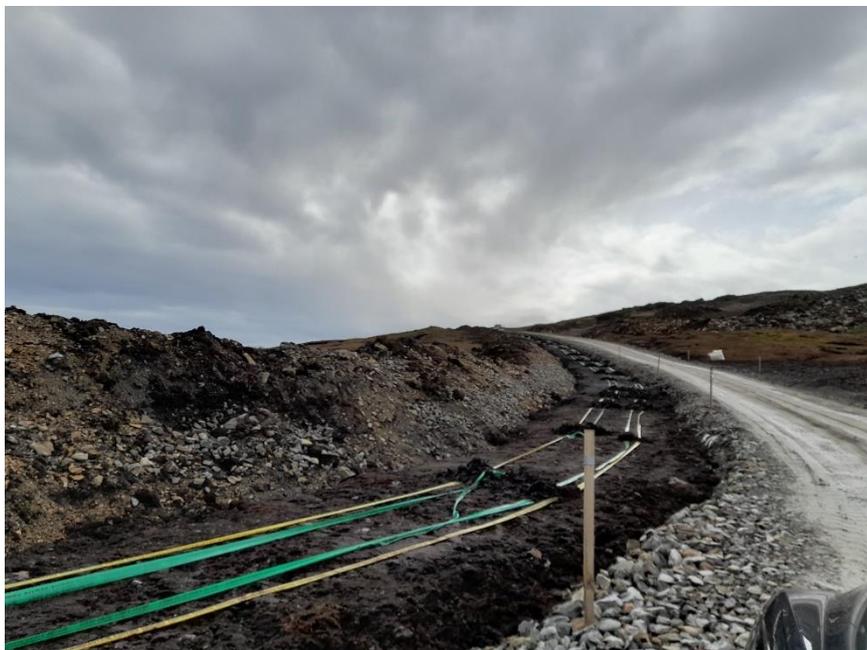
Cable laying is ongoing across Kergord. Where this has been completed, cable tracks were being backfilled with peat (photo 2). Part of the works in the cable trenches included the relaying of the cable bedding material base given that some had been noted to erode during the time that the cable trenches had been open (photo 3).

Photo 2. Backfill of cable tracks from KBP02 to K51

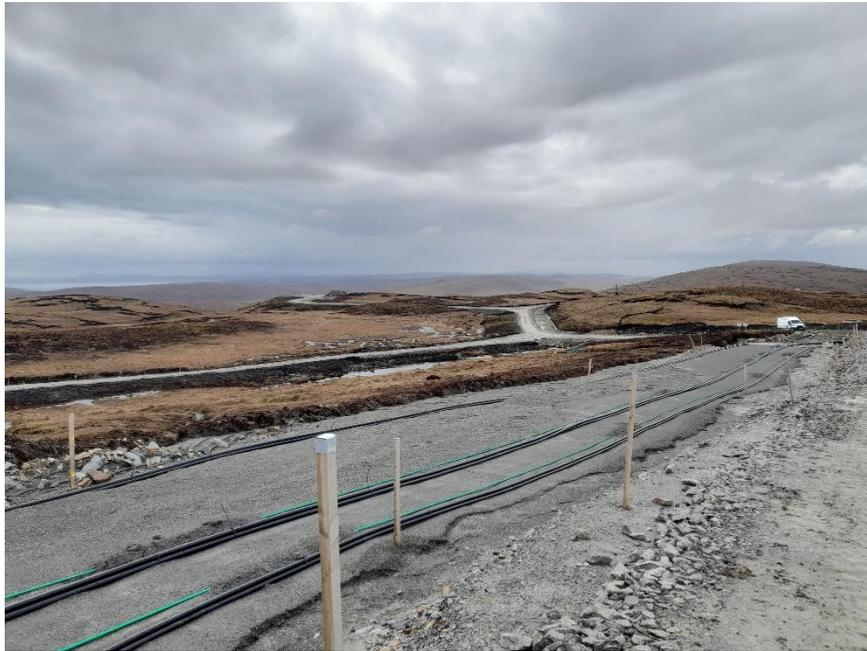
Material had been backfilled along a number of the cable trenches. Some of the trenches had evidence of erosion of the cable bedding material following the wet weather over the winter period, and this was re-laid prior to laying of the cables.

Photo 3. Erosion of cable bedding material

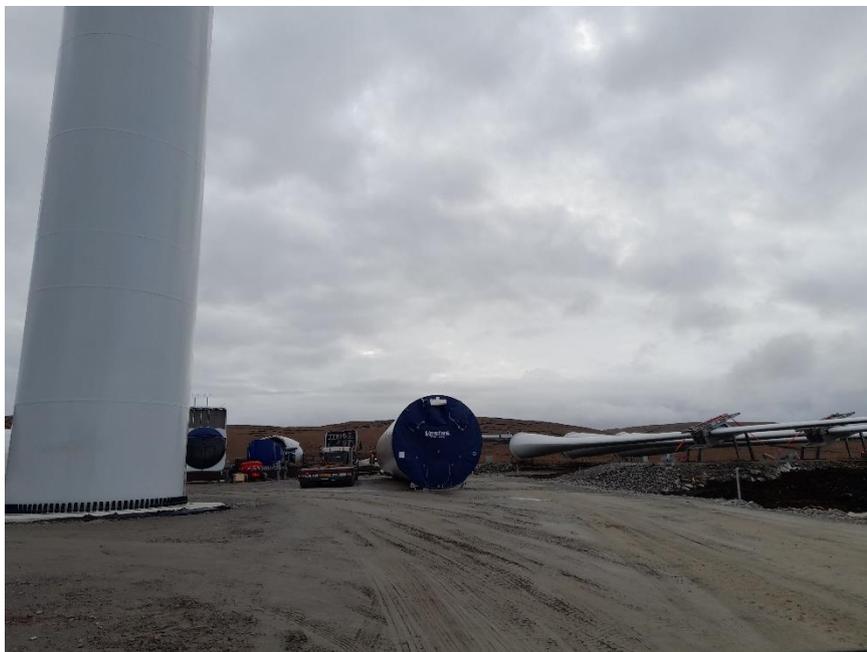
Turbine components had been laid at several base areas (photos 4 and 5) and the first two tower section were also observed to have been erected at many locations, including K50 which was being lifted during the audit (photo 6). K77 turbine tower and nacelle erection had been completed and was awaiting the blades to be lifted into place (photos 7 and 8 show the lattice boom crane in position). It was observed during the audit that no spill kits were present within the working area; however, it is noted that no works were being undertaken at the time due to the wind conditions. Conversations with site personnel building the crane explained that spill kits were in the form of mobile bins that were kept centrally and brought to the crane when it was operational. It is recommended that SSE complete audits of the spill kits and refuelling procedures when these works are being undertaken.

Photo 4. Laydown of turbine components at K63

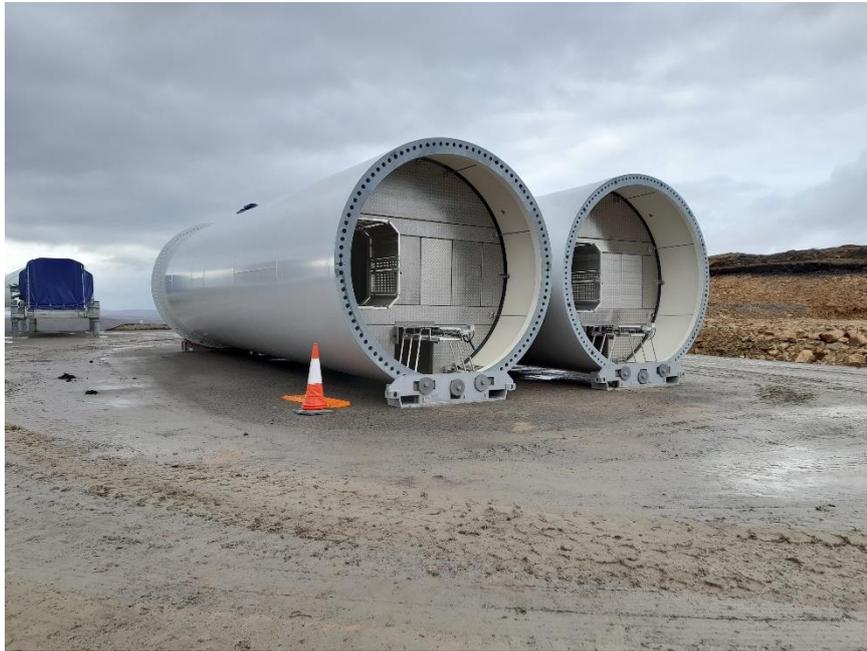
Photo 5. Laydown of turbine components at K52

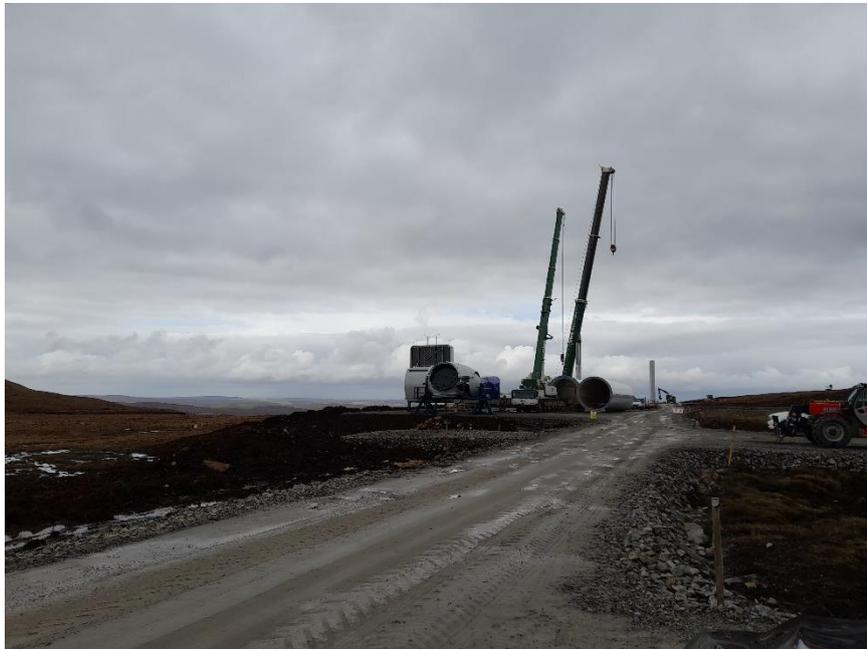
Photo 6. Turbine erection at K50

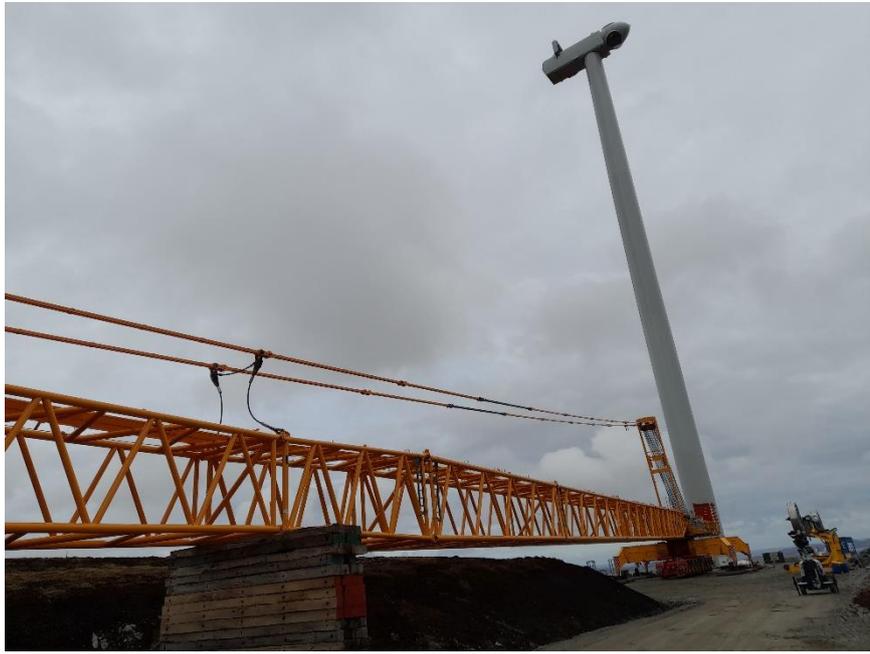
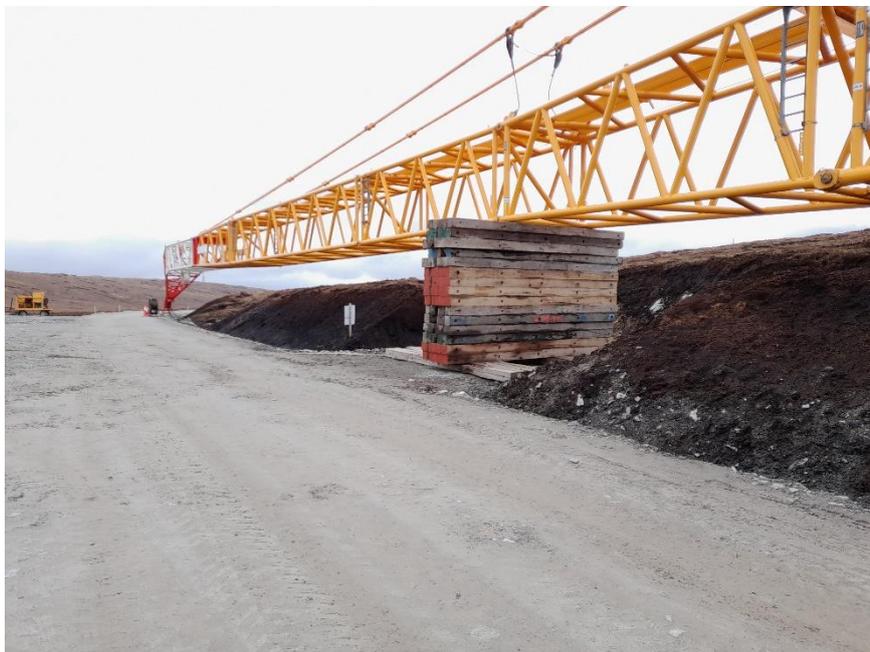
Photo 7. K77 lifting preparation

Photo 8. K77 lifting preparation

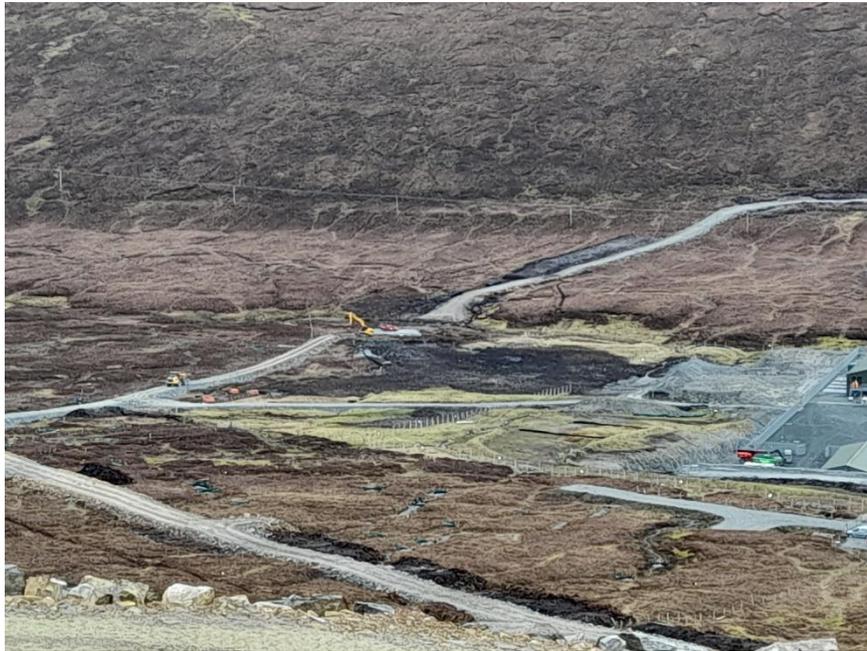
The access track for the cross-country route was being finalised, with construction having reached an area adjacent to the three cable jointing bays to the north of the substation. The track was being extended further towards the Burn at the time of the audit (photo 9). No turf strip of excavations relating to the cable trench had been carried out at the point of the audit.

Photo 9. Construction of cross-country cable access track

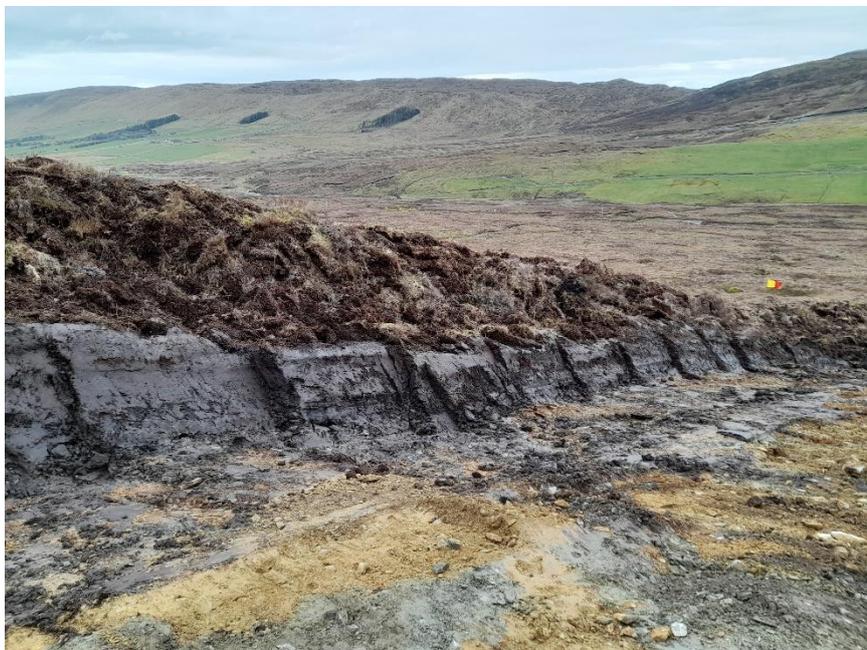
The cross-country cable trench was being excavated. The turf stripping had been completed for the majority of the route, and the excavation of the peat was being undertaken at the point of the audit (photos 10 and 11).

Photo 10. Turf stripping at cross-country cable route

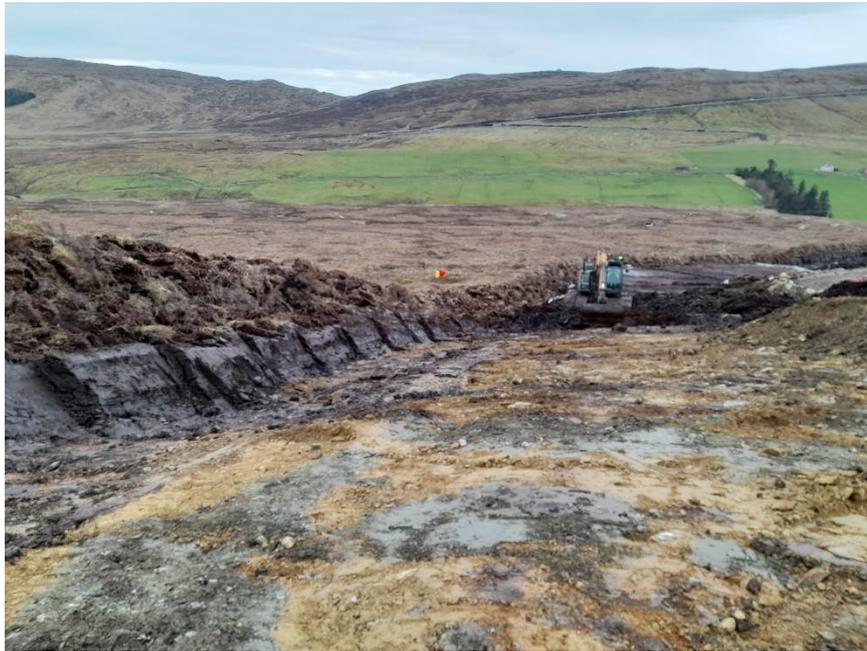
Photo 11. Cable trench excavation at cross-country cable route

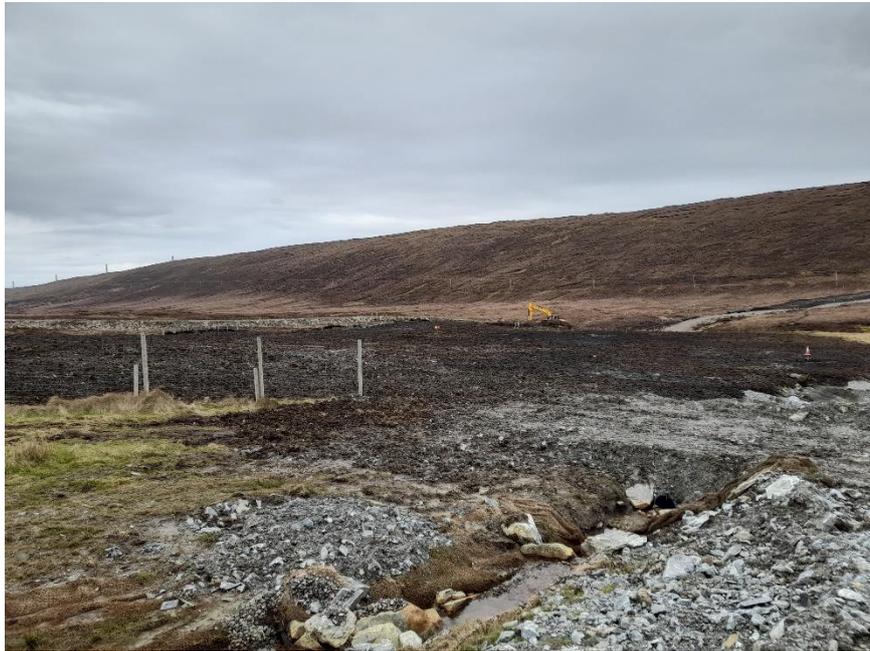
A floating access track was being constructed from Pettawater bridge to the A970 in preparation for the excavation of the cross-country cable route (photo 13). Drainage between Mid Kames Ridge and Pettawater had already been upgraded in preparation for the works, including new culverts, an extension to the drainage ponds, surface water pumps and preferential rock drainage pathways.

Photo 13. Pettawater Bridge to A970 access track

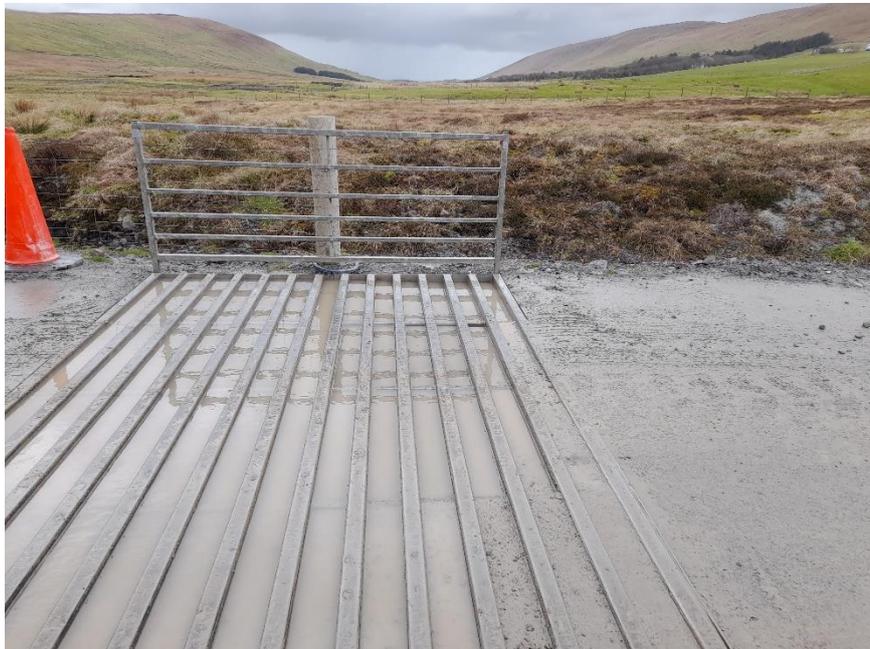
The ECoW had mentioned a silty water event at the Weisdale Burn following a period of heavy rain in the week prior to the audit. It seems that drainage is flowing from the access track into low points (including a cattle grid) that had filled up and impacted the drainage route (photo 14). SSE engineers are currently reviewing the design of the road and the drainage in order to prevent silty water incidences in periods of high rainfall. Following the audit, it was confirmed that the Design Engineers have pumped out the water from the cattle grid.

Photo 14. Drainage defects near the Weisdale Burn

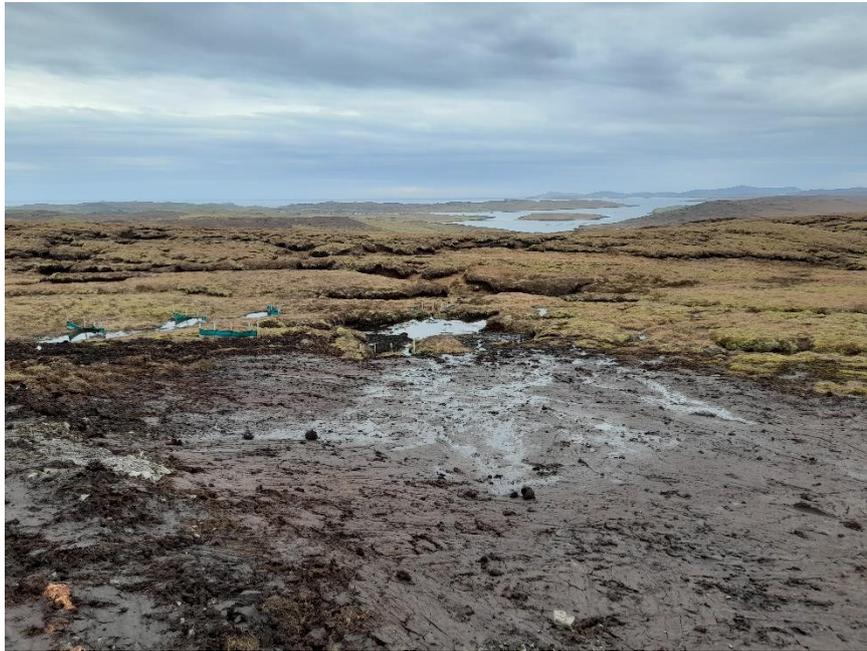
The ECoW had noted a silty water event in the area of N112 following the reprofiling of the area surrounding the blade fingers. During the time of the audit, a localised peat slump was observed between the blade fingers, and the silt fences at the base of the reprofiled areas had failed due to the movement (photo 15). At the time of the audit, a machine was working on the reprofiling and stabilising works. This area should continue to be monitored by the Clerks of Work and SSE and will be monitored again during the next PMO audit.

Photo 15. N112 reinstatement

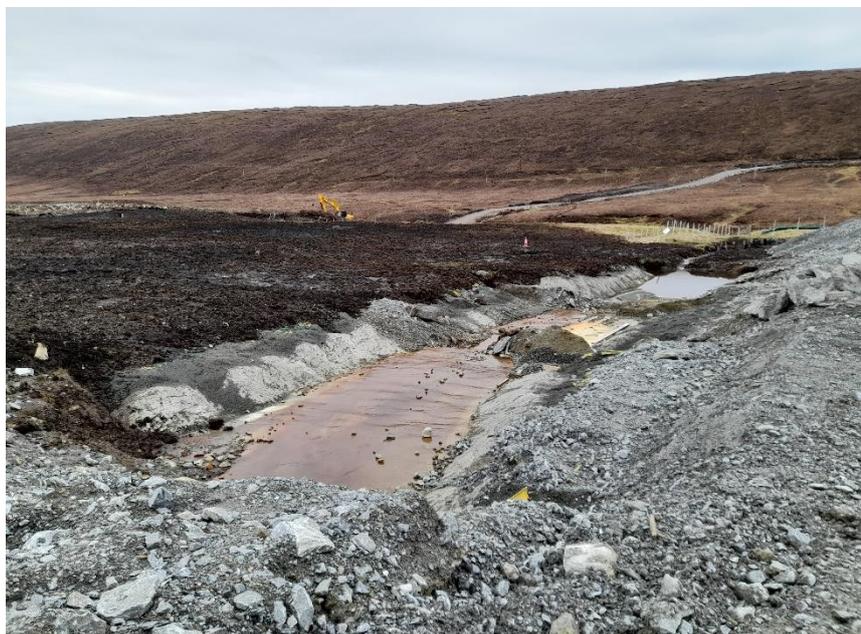
The area to the north of the substation has been reprofiled following the diverting of the watercourse and laying of the cable ducts (photo 16). The reinstatement of the Northern Watercourse is the responsibility of the HVDC project. Following the construction of the cable ducts by the Principal Contractor, the construction liabilities have been handed back to the HVDC project. The excavation and formation of three jointing bays will be done following the laying of the cables from K88 to the substation, and it has been agreed to delay seeding of this area until those works are completed.

Photo 16. Reprofiling to the north of the substation
