Date
May 2023

Project Number
1620009158

VIKING ENERGY WIND FARM PLANNING MONITORING OFFICER AUDIT REPORT 031: 17TH APRIL TO 21ST MAY 2023

Audit Number	PMO 031
Location	Kergord Main Construction Compound Nesting North Nesting North Compound
Weather Conditions	Overcast, dry (7°C). Moderate breeze
Audit Date	17 th May 2023
Audit Period	17 th April – 21 st May 2023
Audit Owner	Ramboll UK Ltd

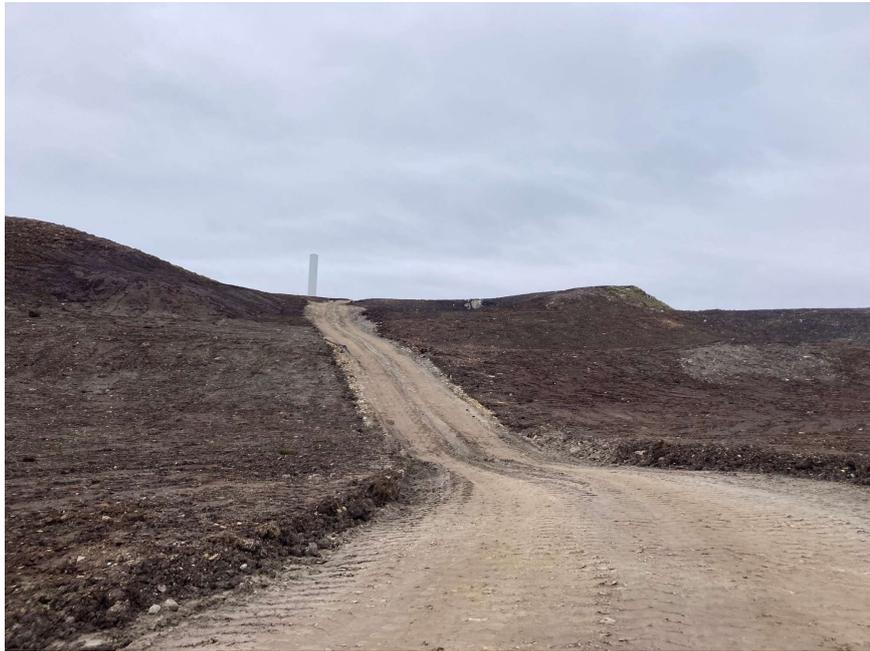
During the visit, KPBP02 was observed (photo 1). Planned capping works have been completed in the northwest section as per the mitigation plan agreed with SEPA. The plans for the reinstatement of the rest of the borrow pit are under review. An access track runs in the middle of the capped area. This track will be reinstated last, as it allows access to T024, and will also allow the reinstatement of the main body of the pit. The reprofiling appeared to be matching the local natural topography, this was observed from T027. During profiling of the reinstated pits, operators blend profiling contours into the profile of the surrounding natural areas. The peat will be seeded following completion of the peat capping. SSE have requested that the thickness of the capping layer of peat in the northwest section of the pit be increased so as to maximise the anaerobic capabilities of the capping layer.

Photo 1. View of KBP02

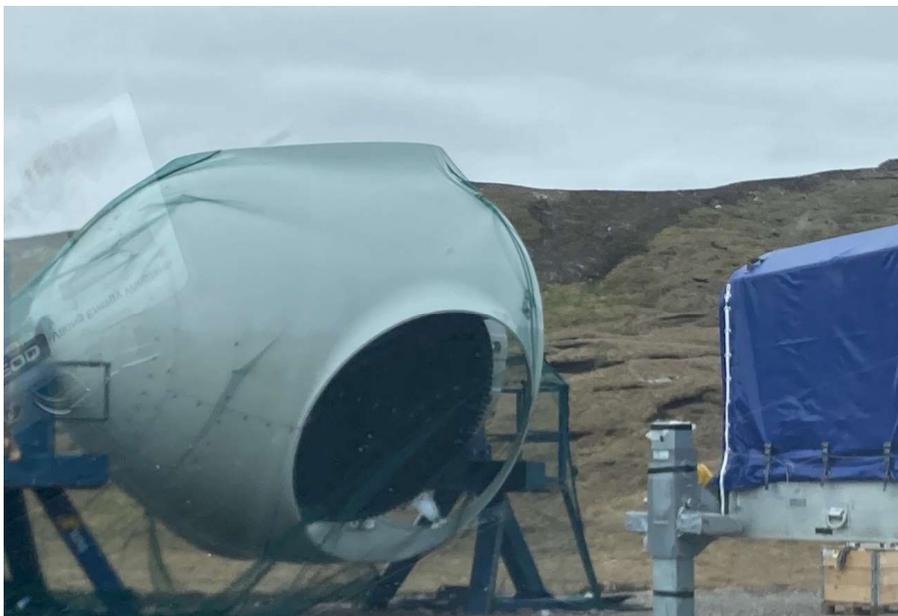
Turbine components were present at a number of base areas. At T025, netting acting as a deterrent to nesting birds was observed to be covering a hub section. In addition, the holes of a support frame were blocked with plastic wrapping (photo 2). A number of cranes were observed from a distance across the Kergord area. Trucks were observed to create some dust however this appeared limited on the day of the audit visit. RJ McLeod have indicated that more site personnel have been trained to drive the tractor and water bowser used of dust suppression, which will help with dust management over the drier periods. Sprinklers were observed to be working along the new Sandwater Road section during the audit.

Photo 2. Netting placed over hub section and plastic wrapping covering holes of support frame as bird deterrents at T025

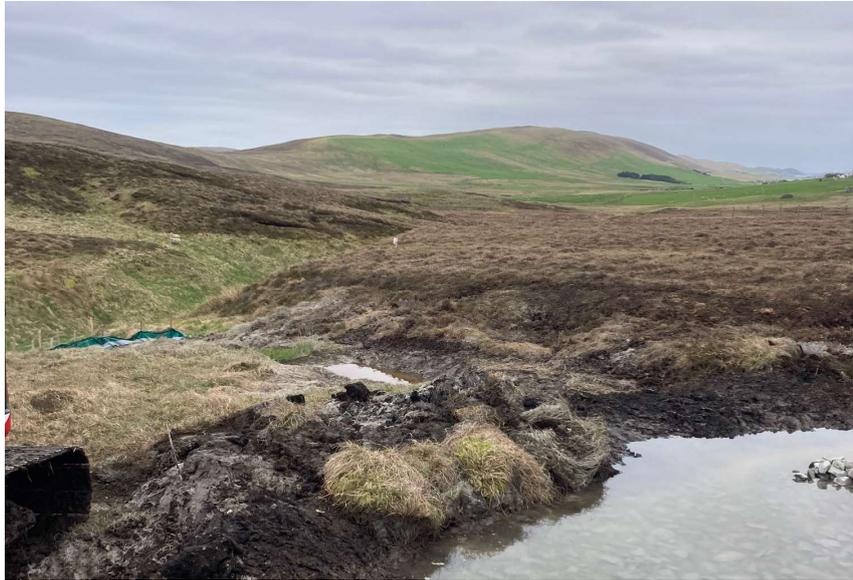
The site visit included the location of a silty water incident which occurred on the 16th May near the Droswall Burn. During improvement works, the digger accidentally went through the bund of the settlement pond and released the residual contents of the settlement pond. These were minimal as the majority of its contents had been pumped out, but the thicker sediment remained in its base and was released, some of which reached the burn. Actions were taken immediately, and a silt fence was put in place (photo 3). The volume of silty water observed to have been released into the burn was not significant, but was clearly visible in the burn. Turbidity of the affected burn water was tested and was confirmed to be below the permitted levels. At the time of the visit, a machine was completing the reinstatement of the area. The pond was complete, with stones placed on the outer edge (photo 4).

Photo 3. Site of silty water incident at the Droswell Burn

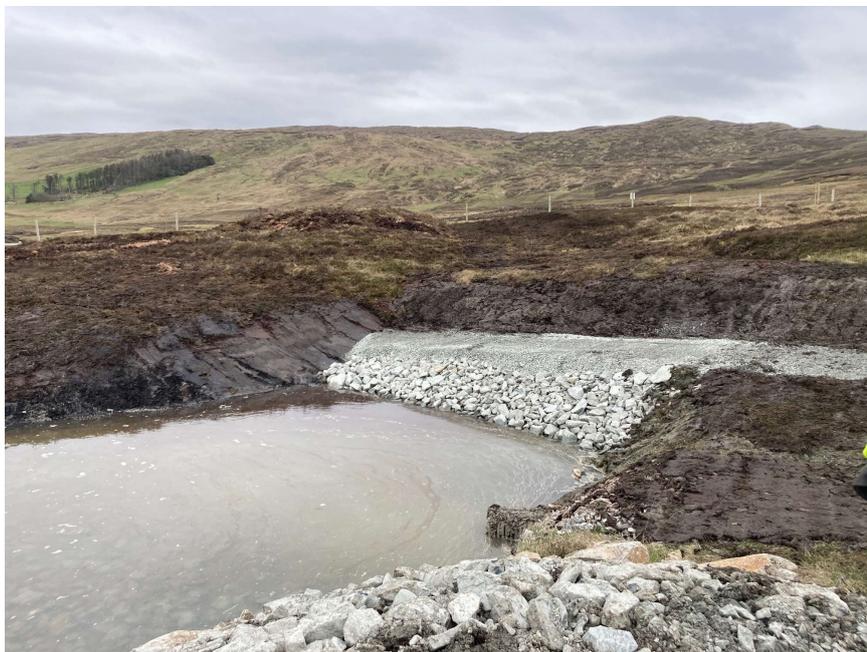
Photo 4. Completed pond at the Droswell Burn

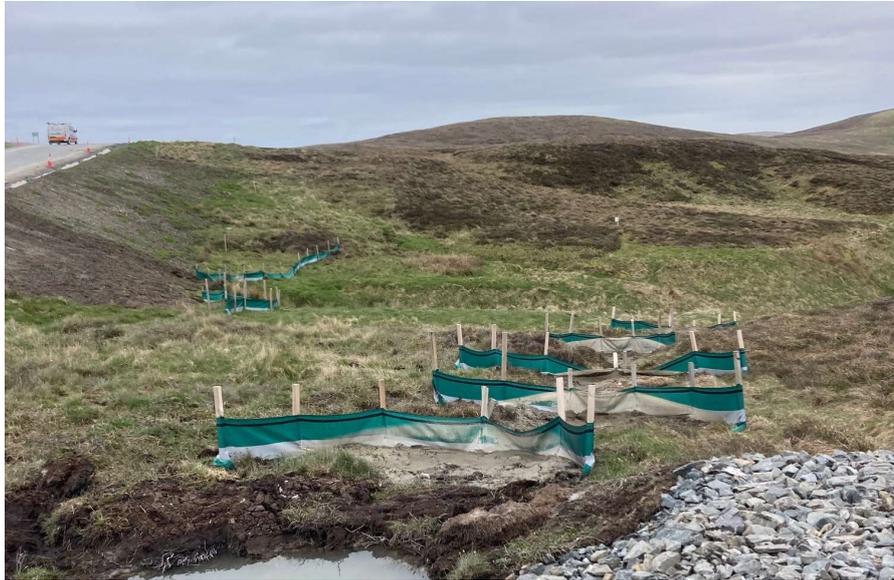
Some of the silt fences at the Drowall Burn were observed to be full, however in good working order (photo 5). The silt fences are part of the improvement works at the Drowall Burn. At present, these fences are temporary but are being monitored to assess the effectiveness of the system. A decision will be made later on whether these fences will be required longer term.

Photo 5. Silt fences at the Droswell Burn

It was explained by RJM ECoW that following the installation of the permanent drainage, not all the temporary drainage (i.e silt fences) are required. They remain in-situ given that silt fence removal is not currently a high priority. The temporary drainage is programmed to be removed in the upcoming months, following completion of the cabling works. In the area of the Drowall Burn, the silt fences remain in operation and RJM should continue monitoring and maintenance when required.

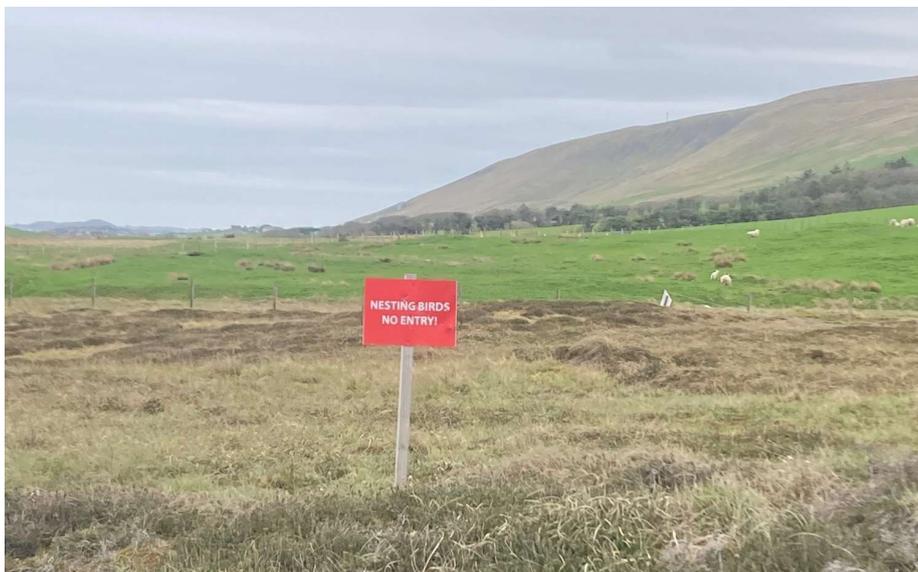
West of the Weisdale Burn, an established nest of birds is present, with the nesting pair reported to be sitting on eggs. Signs have been put up to clearly indicate the area (photo 6). RJM ECoW confirmed that every morning messages are sent to all construction teams to give information on sensitive areas with potential bird nesting/bird activity.

Photo 6. Warning signs where nesting birds are present near Weisdale Burn

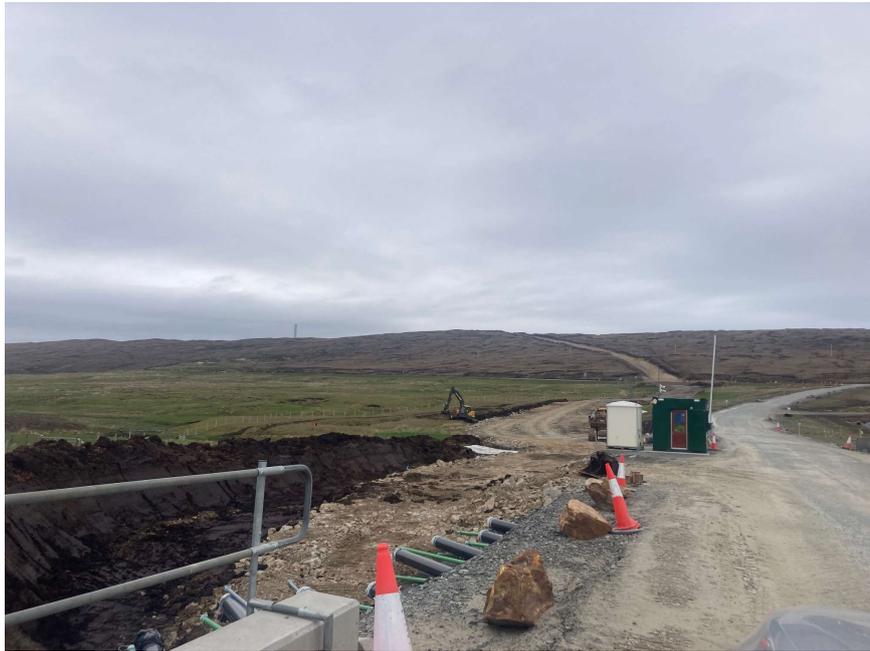
Cable trench preparation works on Sandwater Road were being progressed during the audit (photo 7). Drainage between Mid Kames Ridge and Pettawater had already been upgraded in preparation for the works, including new culverts, an extension to the drainage ponds, surface water pumps and preferential rock drainage pathways.

Photo 7. Cable trench on Sandwater Road looking East

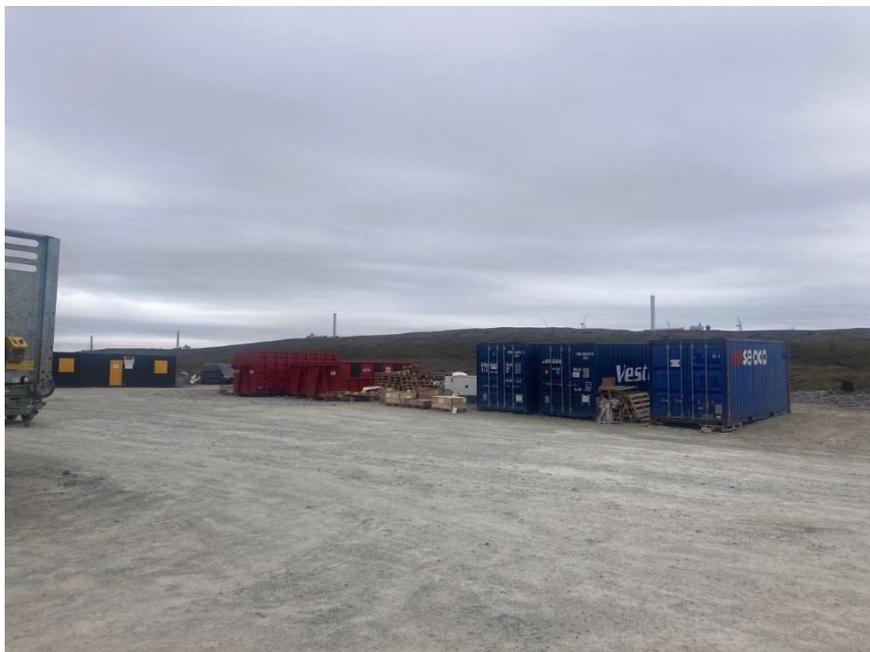
The north compound was briefly visited during this PMO audit. The compound appeared generally tidy and in good order, with the presence of welfare facilities, containers, skips, equipment, and Ad Blue IBCs (photo 8). No Vestas staff were noted to be present at the compound during the visit.

Photo 8. Vestas North compound

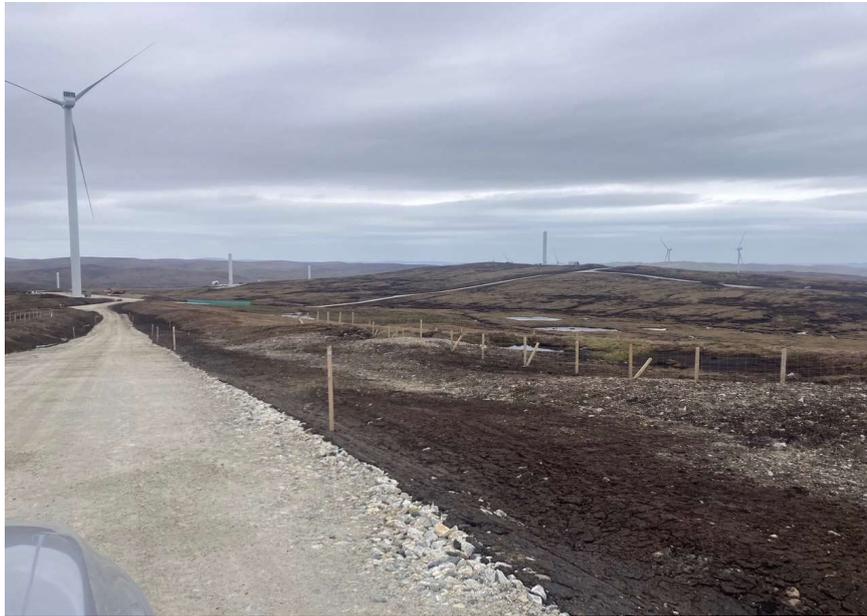
In this area, seven turbines were fully erected at the time of the audit, with most of the ancillary work now completed (photo 9). Reinstatement and drainage maintenance works are ongoing, with a number of diggers across the site observed to be undertaking peat reinstatement during the audit. A number of cabling trenches were observed to be open and still requiring backfilling (photo 10). Capping of the roads has been complete, though it is acknowledged that a final topping up layer may be completed prior to handover to the SSE operational team.

Photo 9. General view of North Nesting, looking towards T058

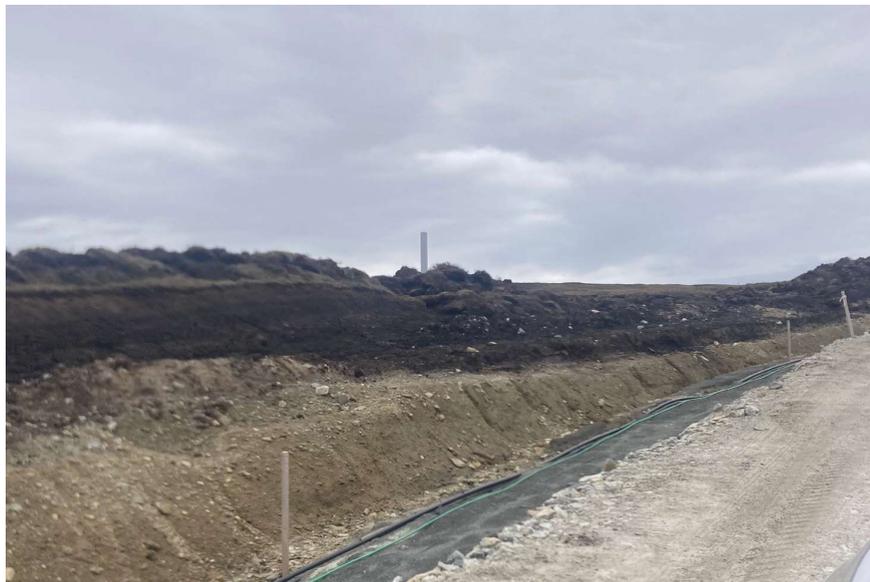
Photo 10. Cable trench requiring backfilling north of T047

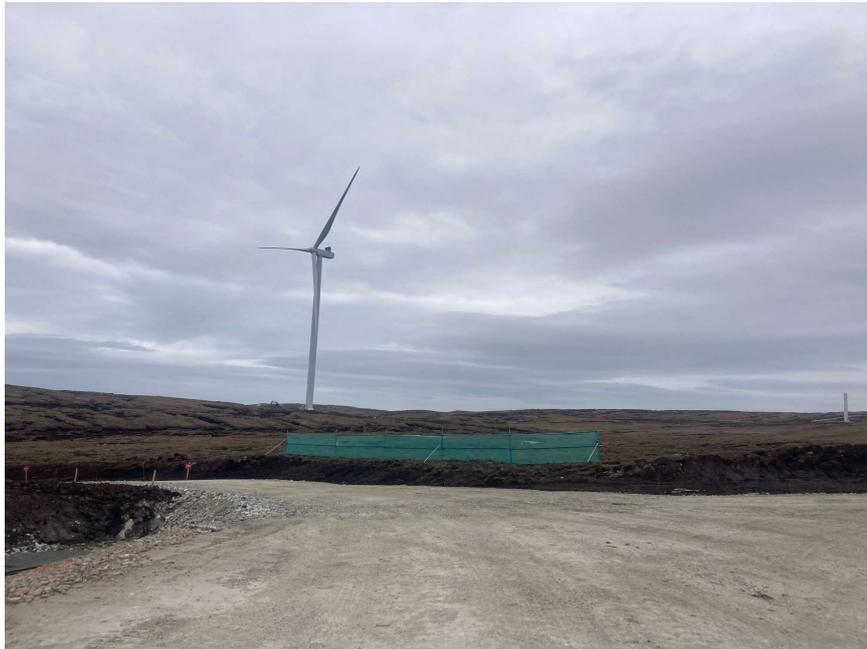
Birds are currently nesting on the edge of the lochan located south of T058. A screen is present along the track south of T058, to avoid visual disturbance from the on-going works that are taken place here (photo 11). At T058 and T063 located closest to the ponds, all works associated with turbine erection were undertaken ahead of the bird nesting to minimise disturbance, as the lochan is known to be a prime nesting ground. The screen has been efficient in minimising disturbance to birds, which were observed on the lochan during the visit. The screen will stay in place until all works are completed in North Nesting.

Photo 11. Screen at T058 to limit visual disturbance to nesting birds

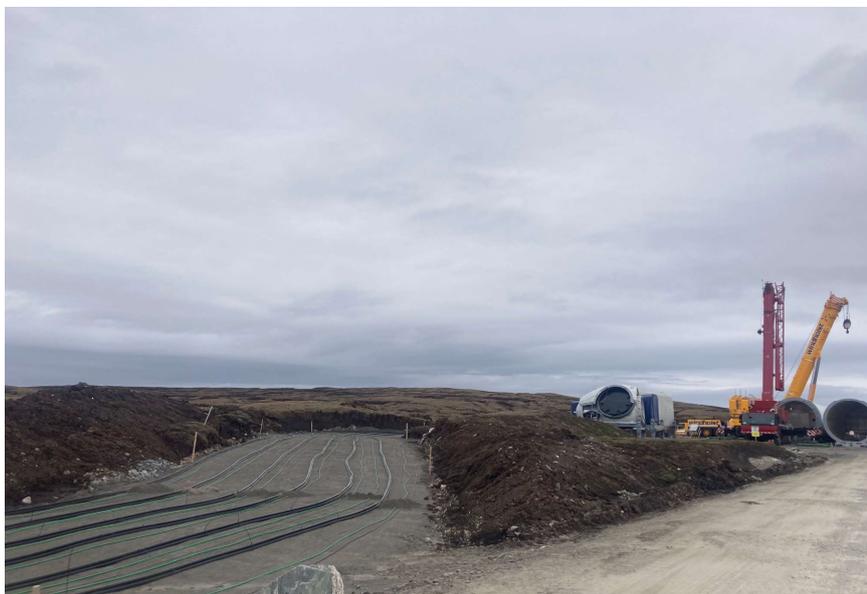
In this area, turbines are being erected, with a number having partially completed towers. At T69, two cranes and turbine components were observed to be present, though no work was on-going during the audit visit. The cable trench to T069 was open with cables laid out (photo 12).

Photo 12. Cabling trench and cranes at T069

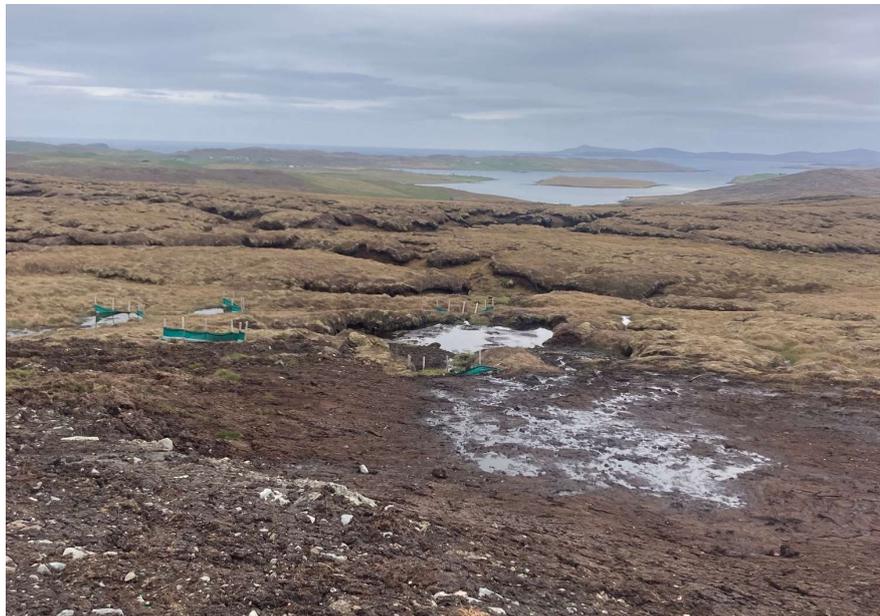
The ECoW had noted a silty water event in the area of T070 following the reprofiling of the area surrounding the blade fingers in April. At the time of the April audit, a machine was working on the reprofiling and stabilising works. Since then, the area has been fully reinstated with drains put in. During the May audit, the area was observed to be in good condition (photo 13). The silt fences that were observed during the last audit were still in place and appeared full, however RJM ECoW indicated that all ground disturbing works are completed in this area and therefore it is very unlikely that silty water would occur, therefore the silt fences in this area are redundant. They will be carefully removed as part of the snagging phase. It was indicated that no further incident of dirty water has been reported.

Photo 13. T070 reinstatement

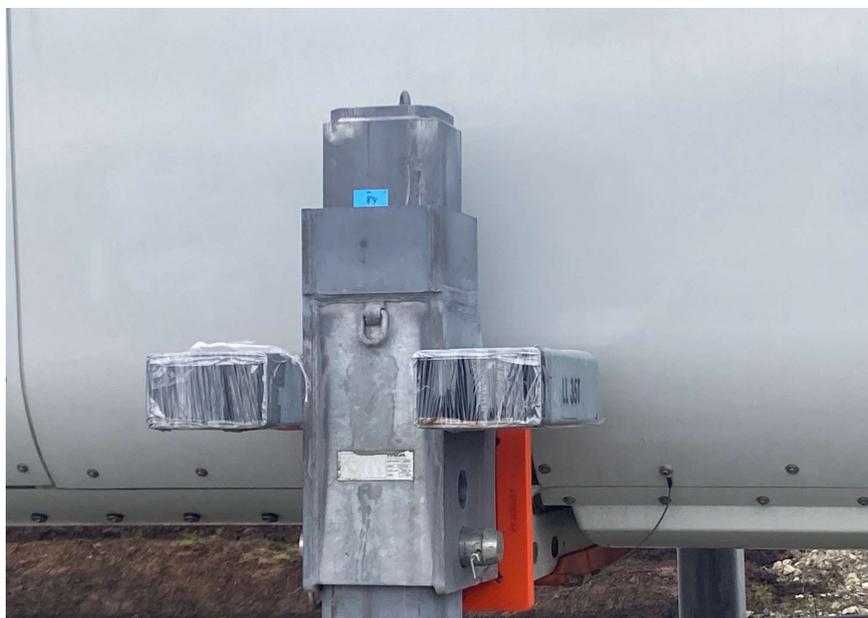
Metal frames supporting turbine equipment present at T075 were noted to have protection against bird nesting, in the form of plastic wrapping of holes (Photo 14). This was noted to be present at most of the locations observed during the audit, within Nesting and other areas visited.

Photo 14. Plastic wrapping covering supporting frame hole at T075 as bird deterrents

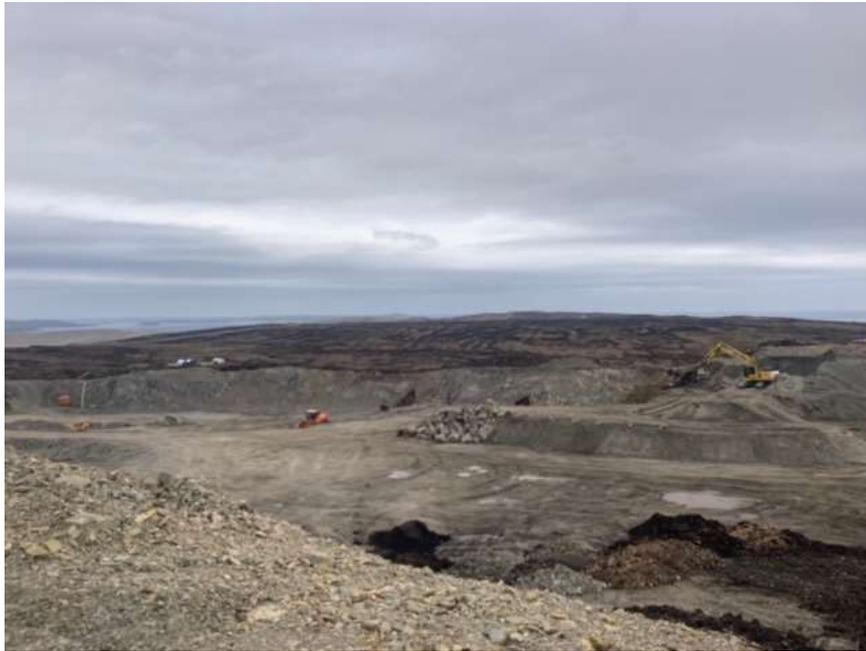
Rock excavation was ongoing at NBP05 at the time of the audit, with diggers observed to be extracting rock (photo 15). Peat capping works were observed to have started (photo 16). Borrow pit restoration plans for NBP05 have been issued to SSE and review by their ECoW is ongoing. Reinstatement works will continue once reinstatement plans have been approved.

Photo 15. Rock excavation at NPB05

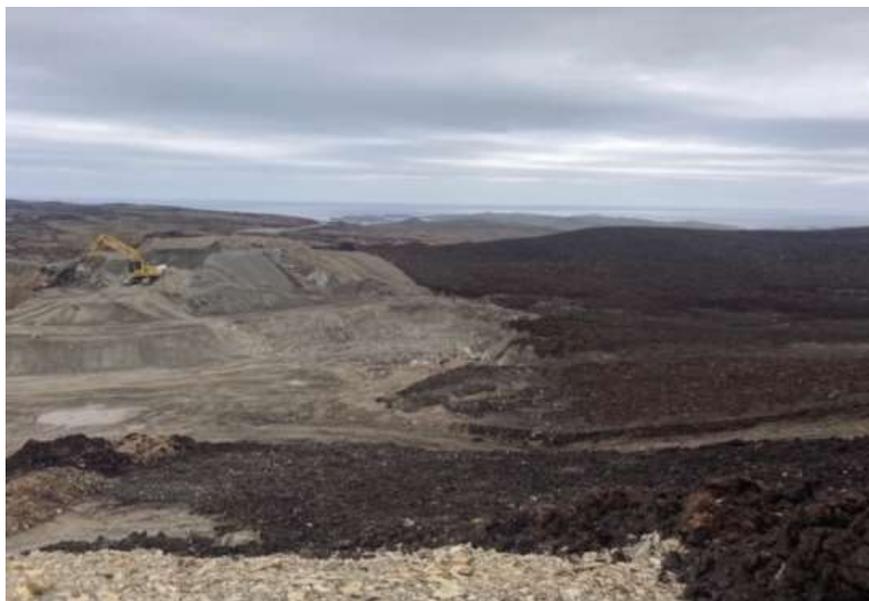
Photo 16. Reinstatement works at NBP05
