Intended for
Viking Energy Wind Farm LLP

Date
June 2023

Project Number
1620009158

VIKING ENERGY WIND FARM PLANNING MONITORING OFFICER AUDIT REPORT 032: 22ND APRIL TO 18TH JUNE 2023

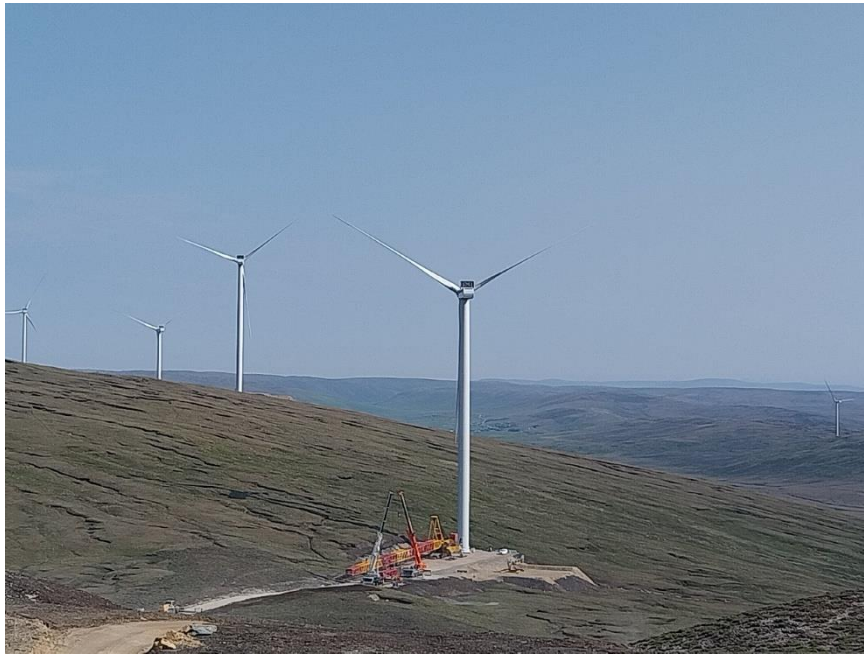
In this area, 35 turbine pre-installations (first two tower sections erected) have been completed and of these 26 have been fully constructed by the end of this auditing period. At T026, the crane was being de-rigged following turbine erection (Photo 1). Installation of the nacelle for T014 was observed from T016. During the visit, turbine components were being offloaded at T022 in preparation for turbine erection.

Photo 1. Crane being de-rigged following turbine erection at T026

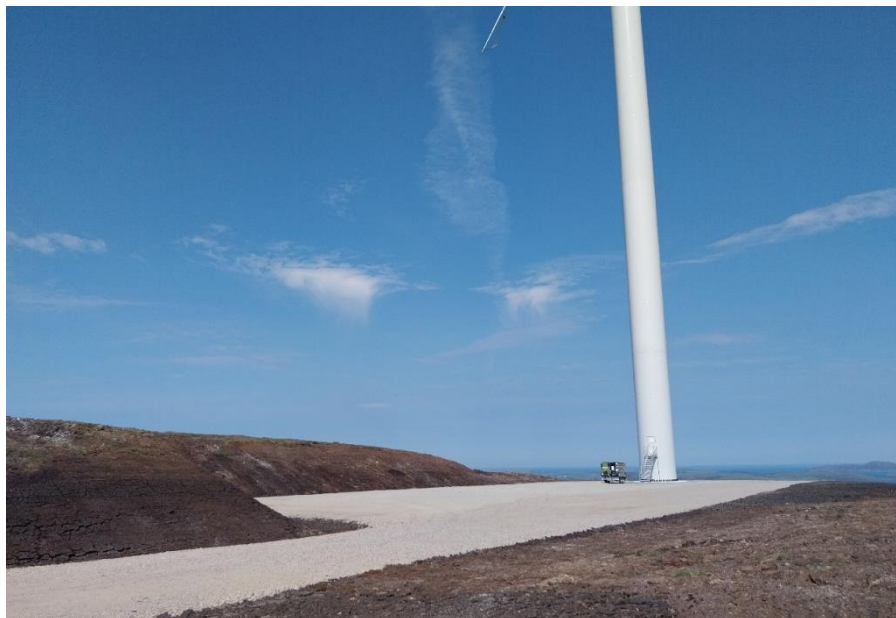
Final reinstatement and capping of road and turbine hardstand following turbine erection has begun with T001 completed (Photo 2). Blade fingers have been removed and boom assembly areas kept. A LiDAR plinth has been installed near T001 (Photo 3).

Photo 2. Capped road and hardstanding at T001

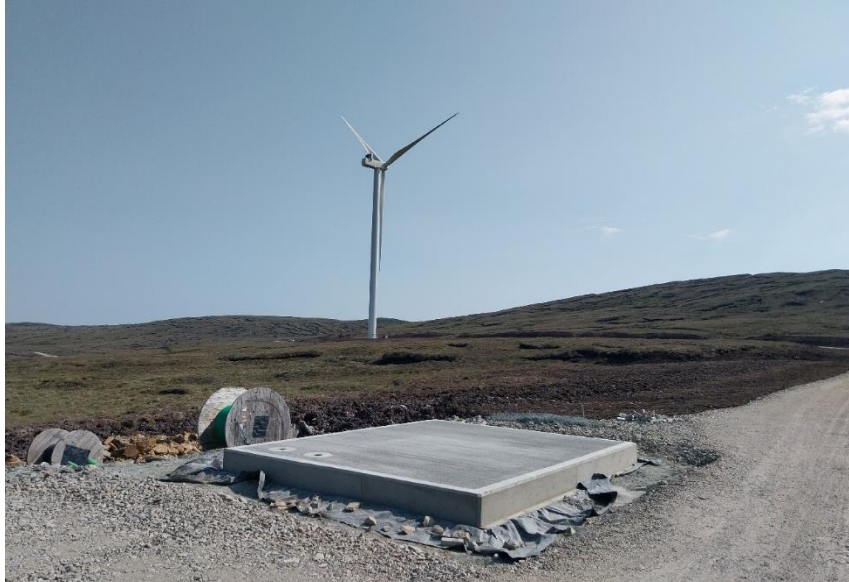
Photo 3. LiDAR Plinth installed by T001

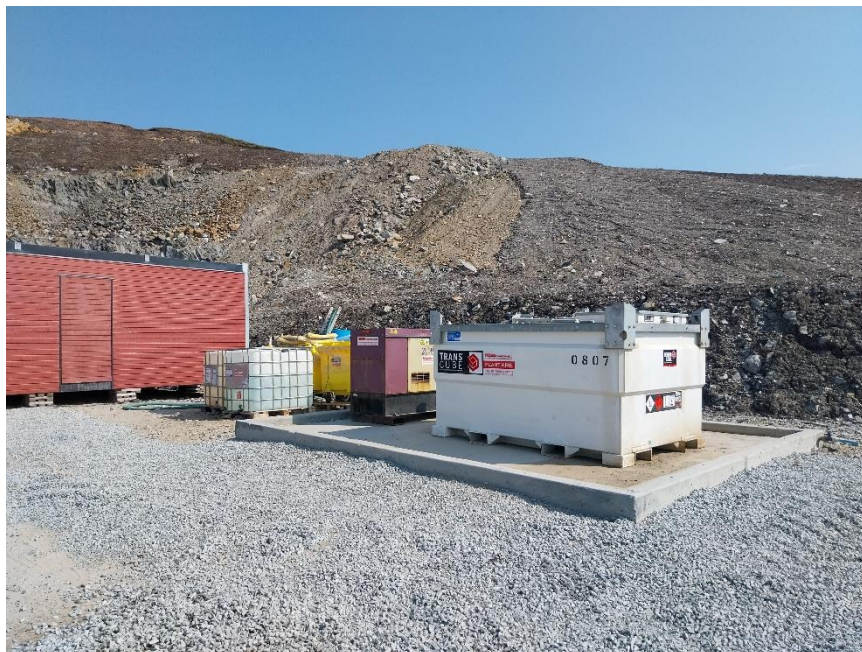
KBP05 is being used by Vestas as satellite compound. The compound appeared tidy and in good order. Labels were observed on waste skips indicating the waste streams to be deposited in each skip, with IBCs and fuel tanks banded (Photo 4). Loading and unloading of waste skip were observed during the visit.

Photo 4. Bunded IBCs and fuel tanks at KBP05 Vestas Satellite Compound

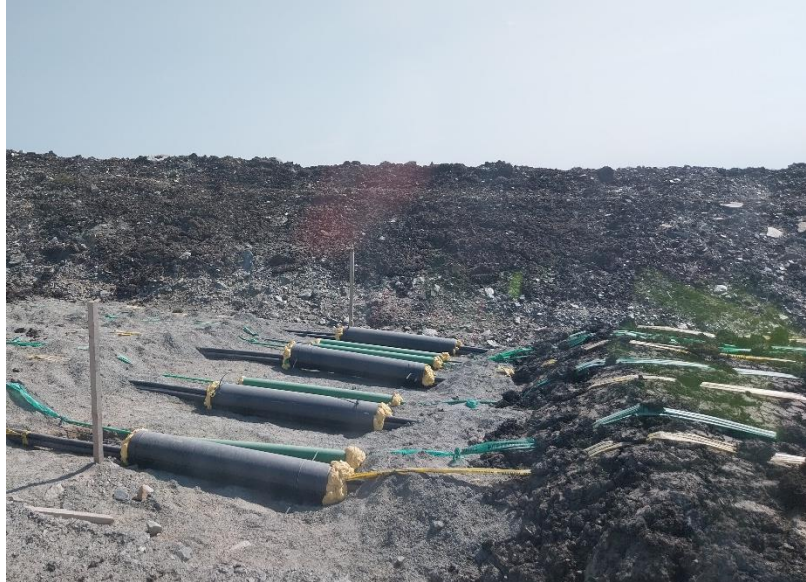
Cable laying is ongoing across Kergord. During the visit, laying of material in preparation for backfilling of cable trenches and preparation for concrete plug were observed by T024 (Photo 5).

Photo 5. Preparation for concrete plug installation in cable trench by T024

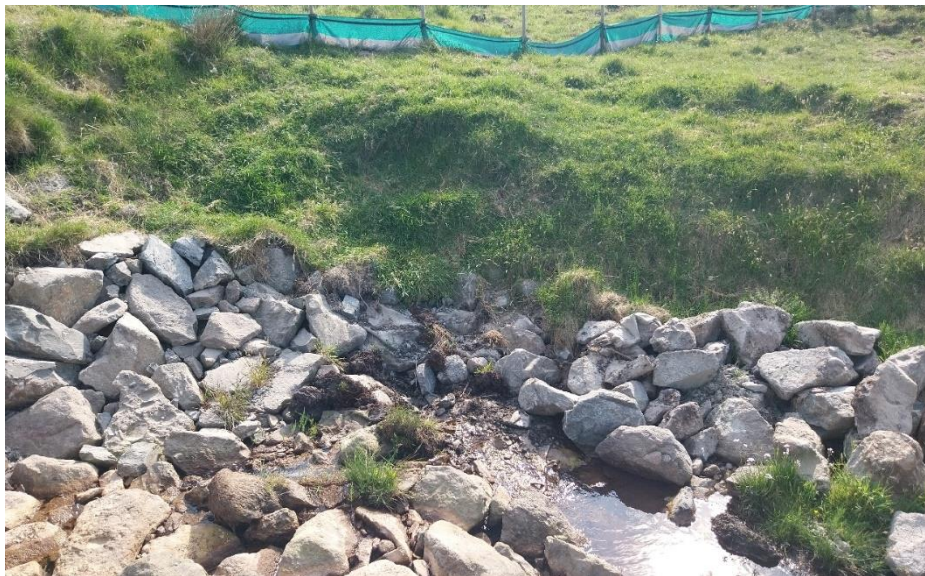
The Principal Contractor removed some rocks on top of the concrete canvas to allow assessment of an occasional source of fine sediment release (Photo 6). The weather is currently too dry to reach a conclusion and the assessment is ongoing.

Photo 6. Exposed concrete canvas for assessment by Droswall Burn

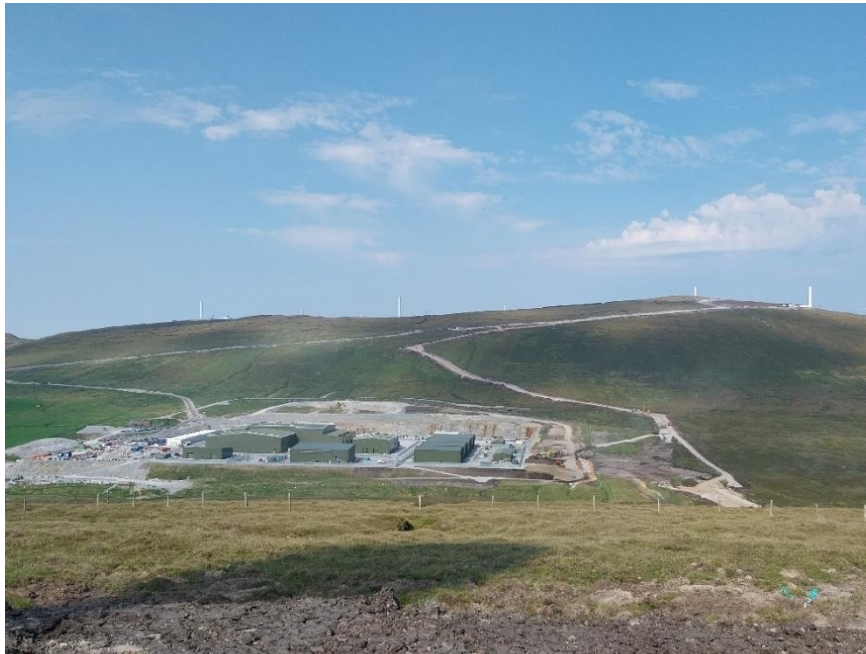
Cross country cable trench excavation from Kergord to the Substation has been completed with cable laying activities and backfilling of cable trenches observed during the day of visit (Photo 7).

Photo 7. View of cross country cable route from Kergord to Substation

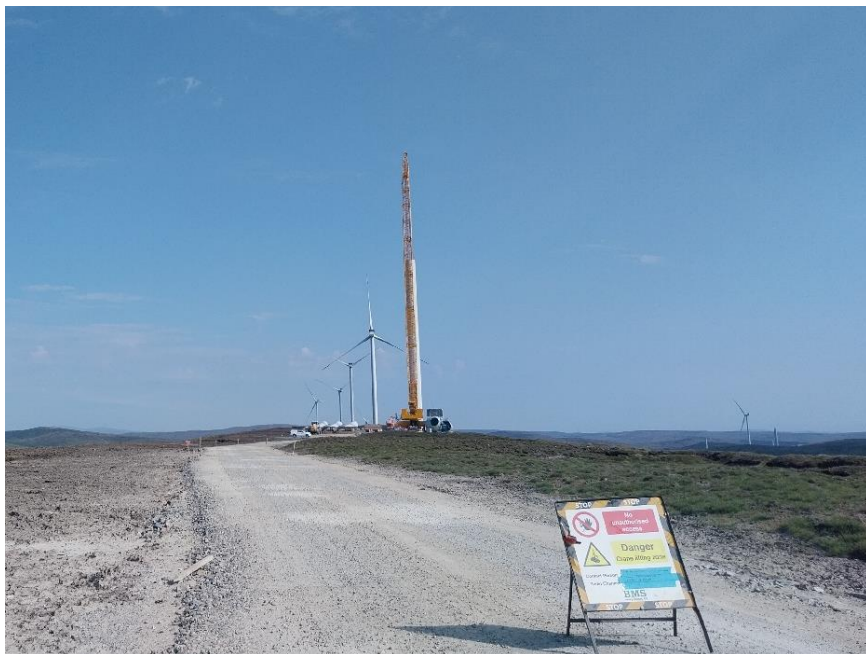
In this area, 11 turbine pre-installations have been completed and of these seven have been fully constructed with all turbine components delivered by the end of this auditing period. Checks for completion of pre-installation phase at T037 were observed during the visit. Lifting of the top tower at T041 was observed from outside the safety lifting zone (Photo 8).

Photo 8. View of T041 turbine erection from outside the safety lifting zone

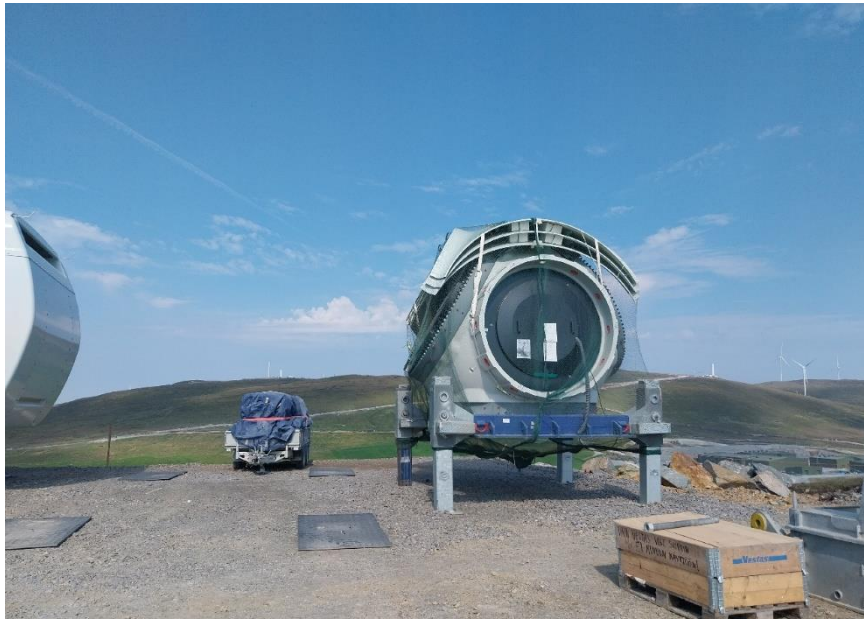
At T036, netting acting as a deterrent to nesting birds was observed to be covering the support frame with holes being blocked with plastic wrapping (Photo 9). This was noted to be present at most of the locations observed during the audit, within MKR and other areas visited.

Photo 9. Netting on turbine component at T036

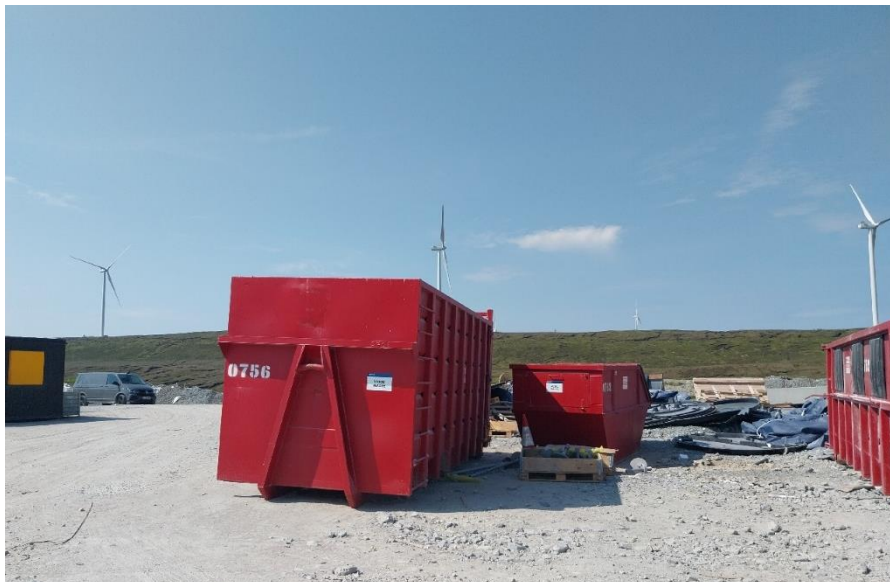
The north compound was briefly visited during this PMO audit. The compound appeared tidy and in good order, with the presence of welfare facilities, containers, skips, equipment, and Ad Blue

IBCs. Skips were clearly labelled (Photo 10), IBCs and fuel tanks banded. A cable drum was being transported from the North Compound storage area during the visit.

Photo 10. Labelled waste skips at North Compound

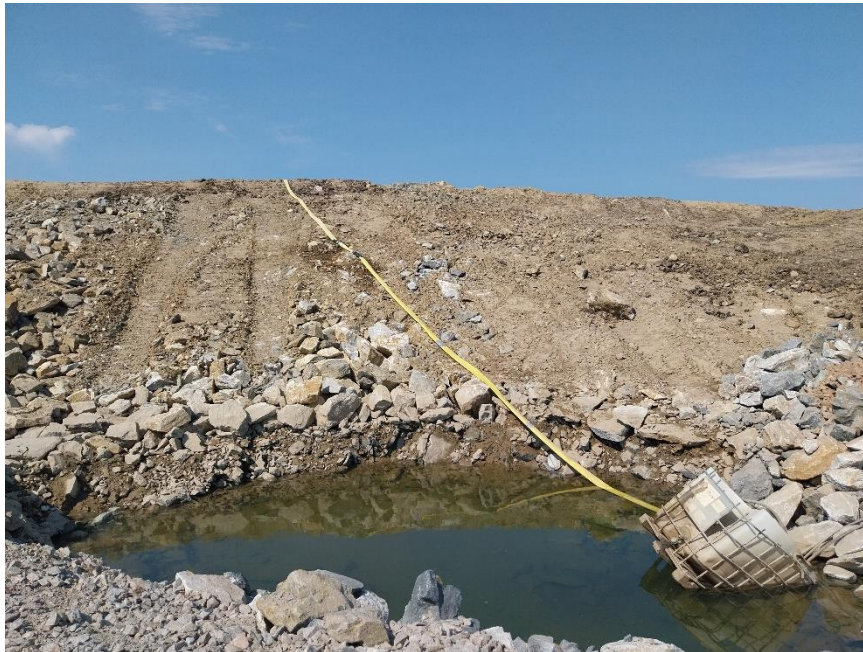
Peat was observed to be taken from NBP01 temporary storage for backfilling of cable trenches. A settlement pond was noted in NBP01 and is utilised to supply water to bowsers involved in dust management suppression activities (Photo 11).

Photo 11. Settlement pond utilised to supply water to bowzers for dust suppression management at NBP01

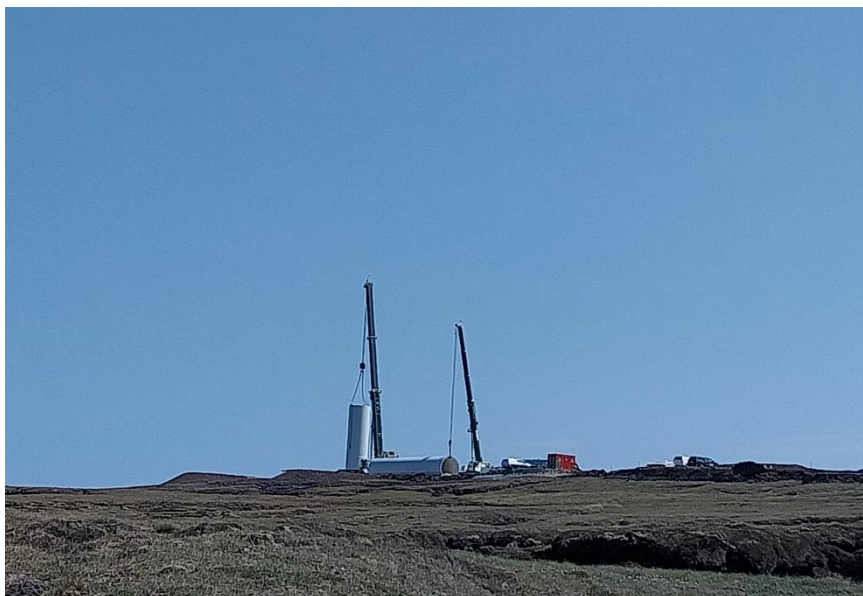
All 36 turbines at Nesting area have completed pre-installation by the end of this audit period. During the visit, the erection of first two section of towers at T095(Photo 12) and installation of

Photo 12. First two sections of tower being lifted at T095

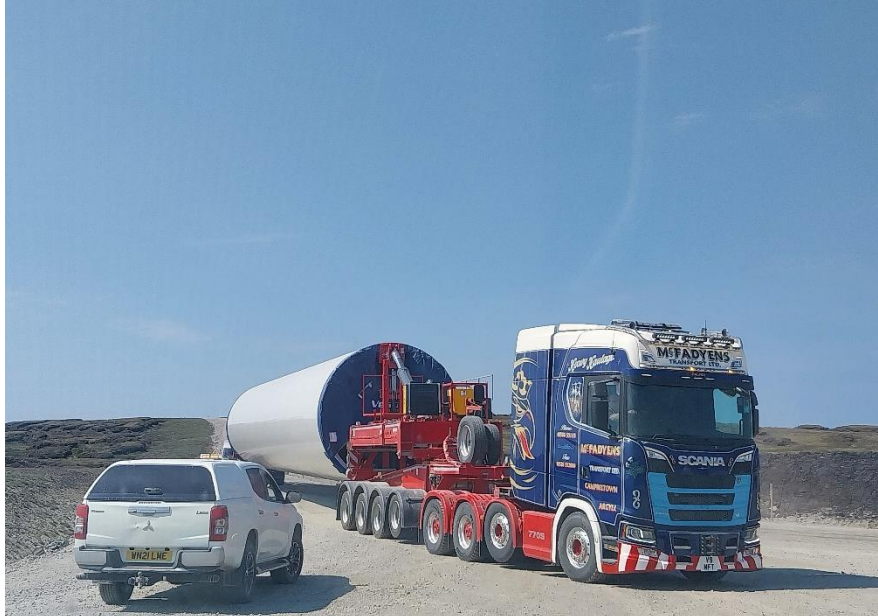
cooler top at T088 were observed. During the visit, turbine components were being delivered to T082 (Photo 13).

Photo 13. Turbine delivery to T082

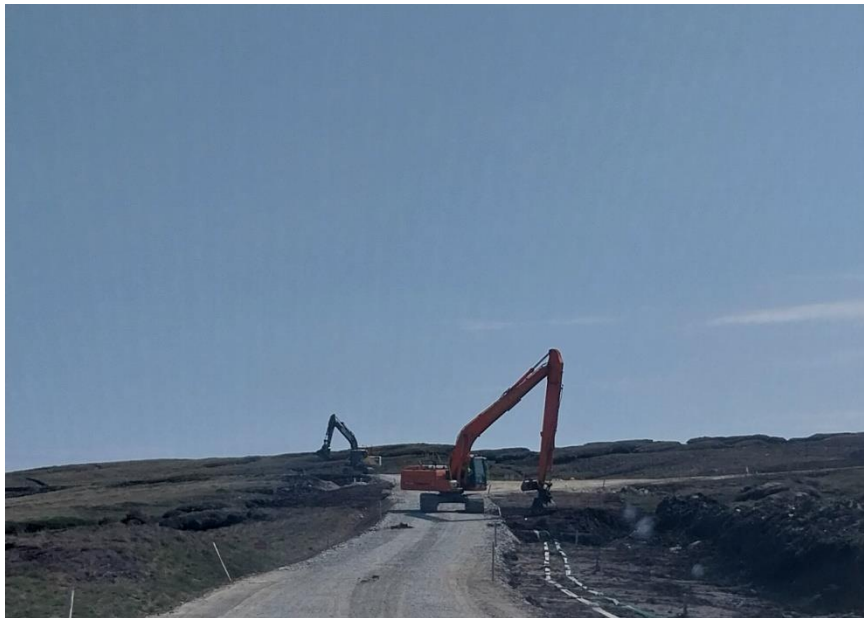
Cable trench backfilling is ongoing across Nesting. During the visit, backfilling of cable trenches was observed by T095 (Photo 14).

Photo 14. Backfilling of cable trenches by T095

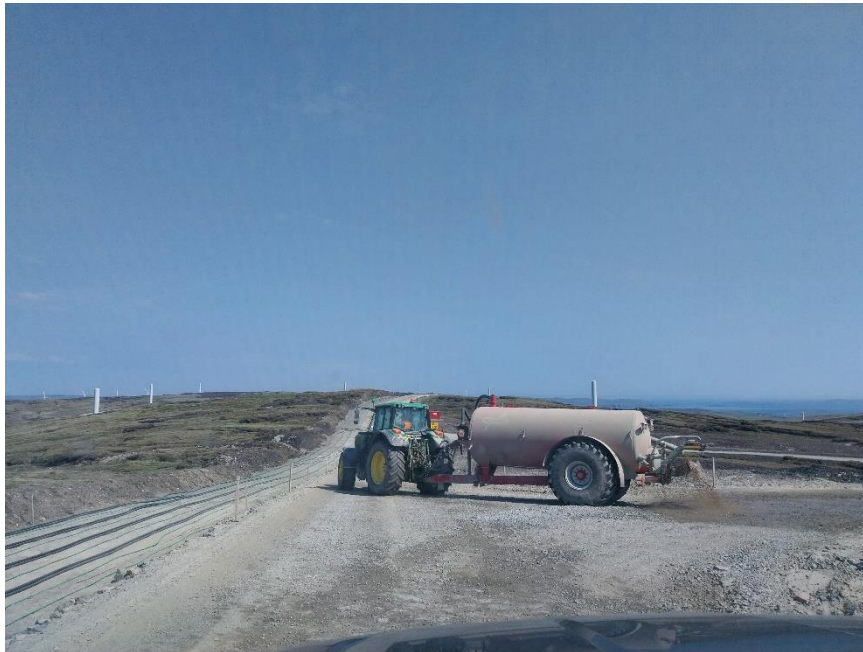
Rock removal from previously blasted rock was observed at NBP05 during the audit. A bowser was observed leaving NBP05 after filling up from a settlement pond within NBP05 and was engaging in dust suppression management activities (Photo 15).

Photo 15. Bowser deployed on dust suppression activity by NBP05

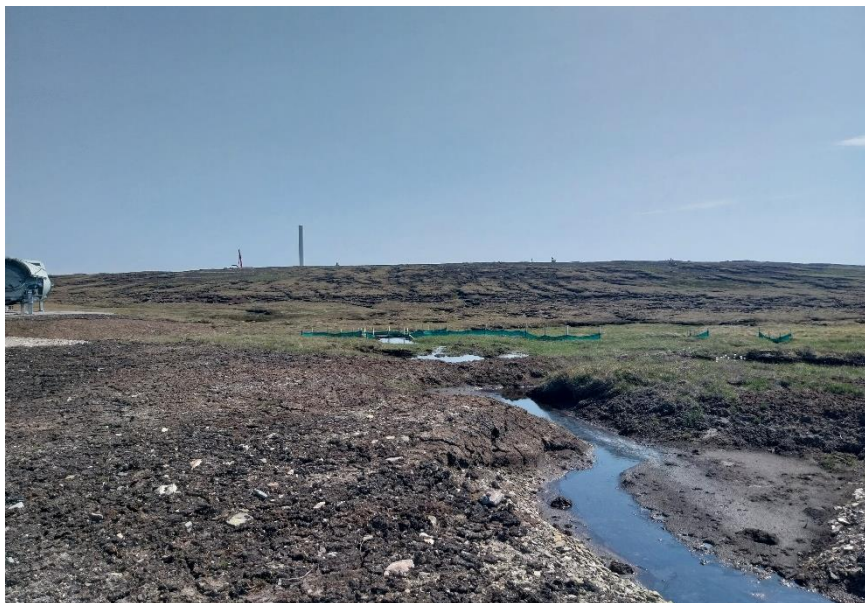
The site is undergoing transition between temporary drainage into permanent operational drainage. Upgrade, landscaping and reinstatement works on drainage have begun, with T076 being one of the examples (Photo 16). The temporary drainage (including silt fence) is programmed to be removed in the upcoming months, following completion of the cabling works.

Photo 16. View of upgraded drainage, silt fences and landscaping by T076

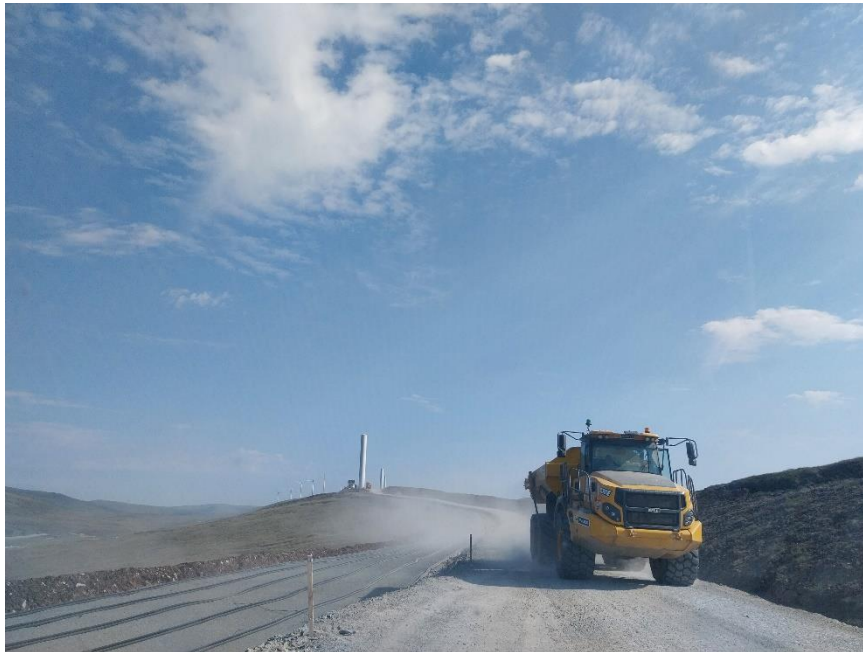
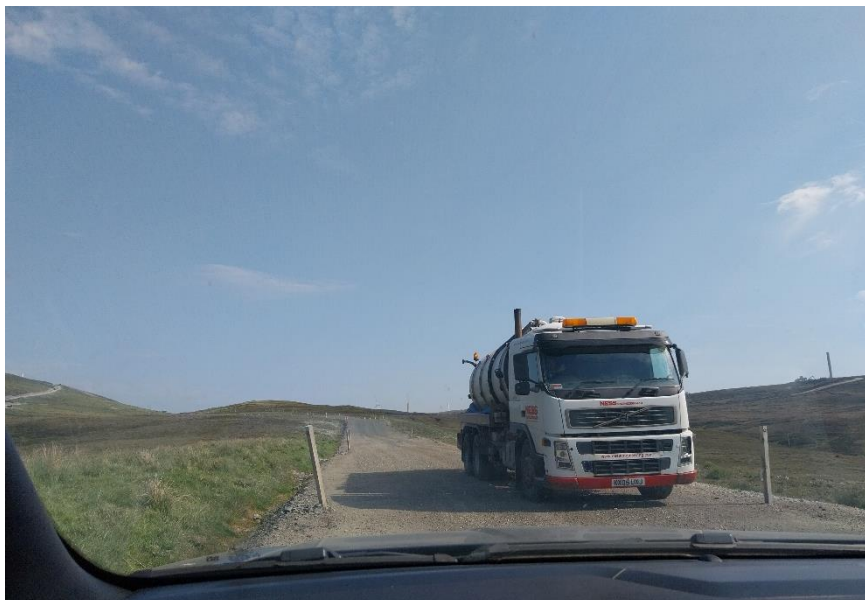
The dust suppression management was audited during the PMO visit in the presence of SIC Planning Officer. Trucks were observed to create some dust and dust is significantly minimised following deployment of bowser (Photos 17 and 18). RJM confirmed that there are 7 bowsers on site across all areas. However, filling up of bowsers from natural sources (e.g. Burn of Weisdale as observed during visit) is limited by abstraction license as agreed with SEPA. Given the dry period and low water level, water flow of natural sources is also monitored on top of agreed abstraction limits. Man-made water sources on site are used whenever possible but is also struggling with low water level due to dry period.

Photo 17. Articulated Dumper Truck (ADT) on road before dust suppression management activity

Photo 18. Gulley sucker vehicle on road after dust suppression management activity, with visibly less dust
