Intended for
Viking Energy Wind Farm LLP

Date
July 2023

Project Number
1620009158

VIKING ENERGY WIND FARM PLANNING MONITORING OFFICER AUDIT REPORT 033: 19TH JUNE TO 20TH JULY 2023

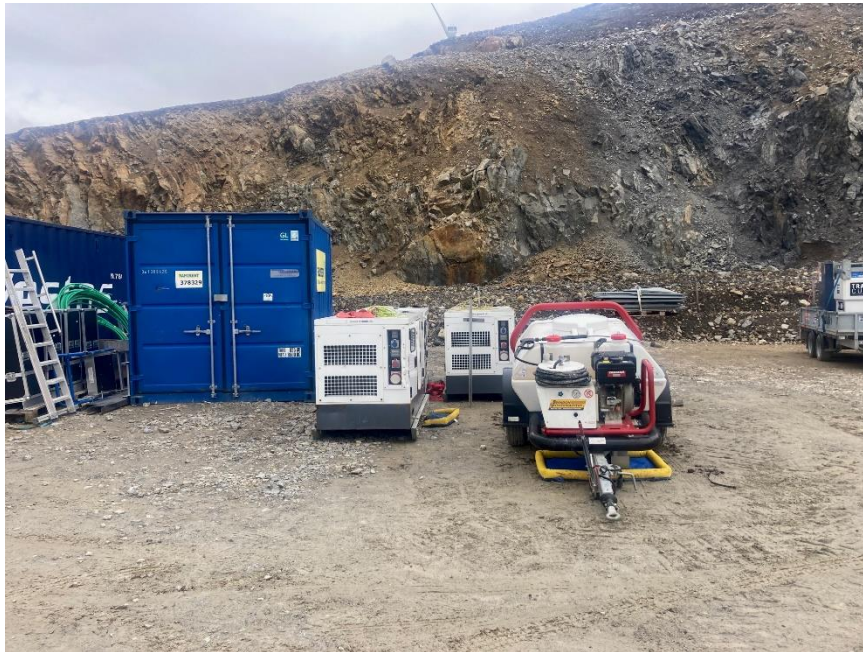
KBP05 is being used by Vestas as satellite compound and was observed during the visit. The compound appeared tidy and in good order (photo 1). Fuel cells and a petrol bowser were observed within a newly formed bunded area covered by plastic sheeting with stones placed on top (photo 2). The plastic sheeting was observed to be damaged on the walls of the bund at two locations (one location shown in photo 3). The damage noted on the sheeting appeared to be where it had been torn to allow it to fit into the vertical corners. This does not compromise the integrity of the underlying material, however the plastic sheeting should be replaced where damaged and care should be taken during operations to prevent any damage. Observation of this area should form part of the next PMO audit. It was also noted that the plastic sheeting on top of the bund was weighted down by rocks placed onto the sheeting (photo 2, 3). Although this is not considered to represent a risk, the use of more robust weighting measures would improve the area and should be considered.

Photo 1. Vestas Satellite compound at KBP05

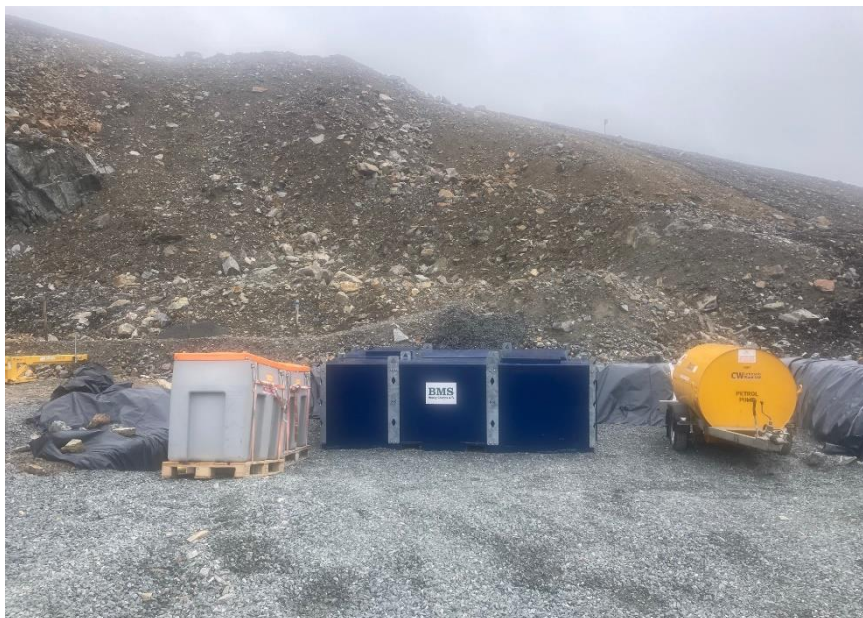
Photo 2. Banded area within Vestas Satellite compound at KBP05

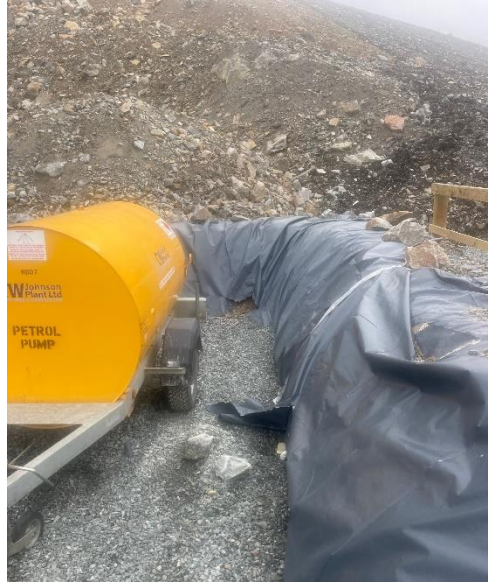
Photo 3. Damaged wall of bundled area plastic sheeting within Vestas Satellite compound at KBP05

Issue	Auditor Comments	Required Action	Action Owner	Status
<p>Pollution Prevention and Response (e.g. use of spill kits, silt control, cement/concrete, water resources).</p>	<p>During the audit the PMO observed spill kits to be well stocked and readily available in areas where liquids are stored.</p> <p>SSE have carried out their own audits on spill kits and refuelling processes when Vestas contractors have been conducting the lifts. This is to be continued, to ensure that refuelling operations across all areas are compliant with the CEMP and approved RAMS on fuel handling.</p>	<p>Toolbox talk to remind contractors of refuelling procedures and refuelling procedures monitoring required.</p>	<p>Principal Contractor and all sub contractors</p>	<p>Amber</p>
<p>Pollution Prevention and Waste (e.g. use of spill kits and littering)</p>	<p>During the audit the PMO observed the plastic sheeting present on the walls of the fuel storage banded area at the Vestas Satellite compound to be damaged. This however did not result in any spill or environmental incidents.</p>	<p>Replacement of damage plastic sheeting required.</p> <p>Good maintenance and care of plastic sheeting during operations required.</p>	<p>Vestas</p>	<p>Amber</p>

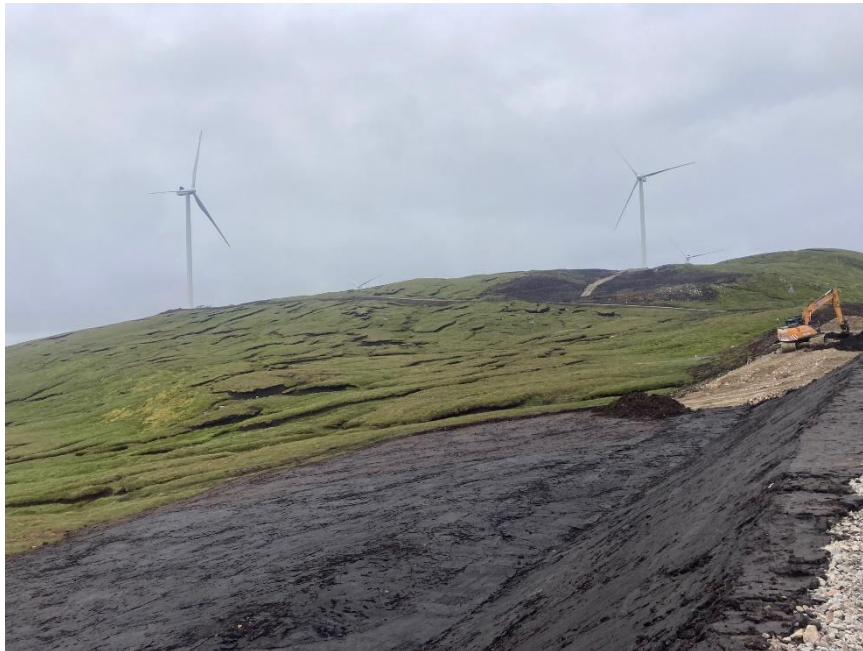
The reinstatement works at T026 were observed during the visit, with peat capping on-going (photo 4). A system of ponds has been created downgradient from T026 hardstanding (photo 5) to help increase the pH of the water runoff. The pH of the water continues to be monitored.

Photo 4. Peat capping at T026

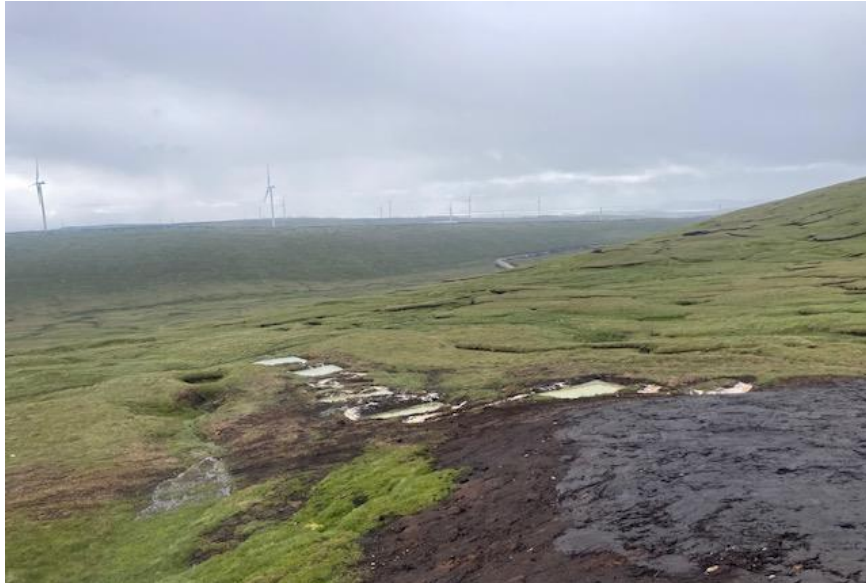
Photo 5. Pond system at T026

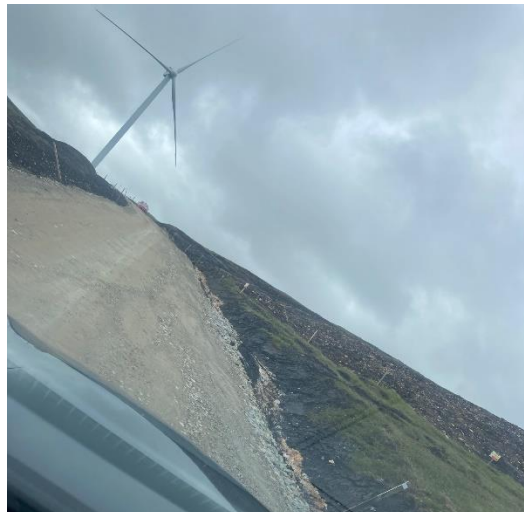
excess reinstatement peat is available. Drainage channels on spur 5 between KBP02 and junction 13 were observed to be working well (photo 6).

Photo 6. Drains on spur 5 between KBP02 and junction 13

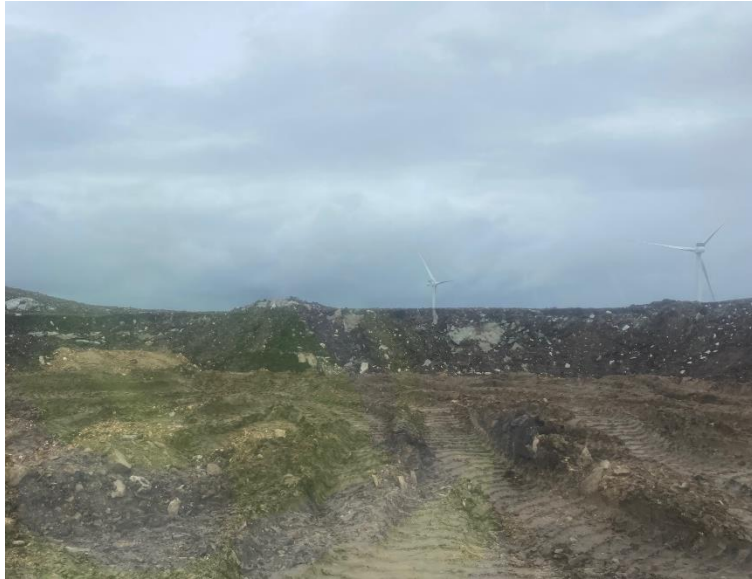
Peat from the temporary storage in the main body of the borrow pit was being taken for backfilling of cable trenches and reinstatement works elsewhere on site (photo 7). The reinstatement plans for the main body of KBP02 are still under consideration.

Photo 7. Temporary peat storage at the back of KBP02

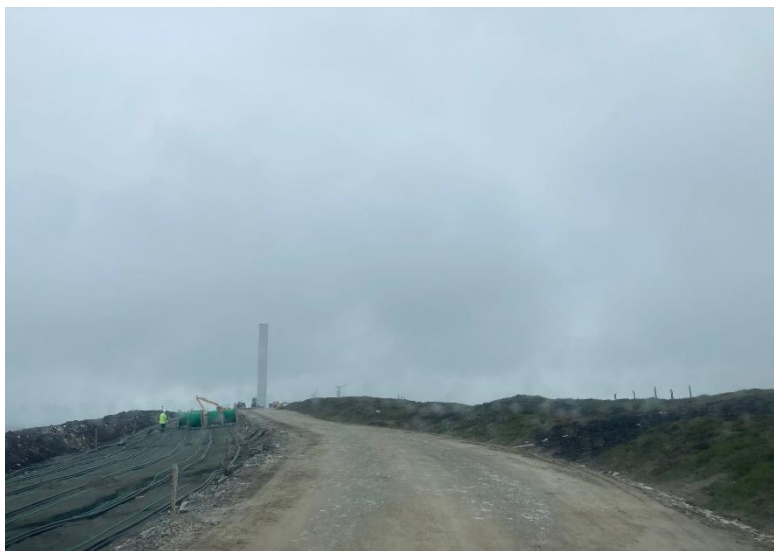
On the MKR, cable laying activities and backfilling were observed to take place south of T036 during the visits (photo 8).

Photo 8. Cable laying and trench backfilling operations south of T036

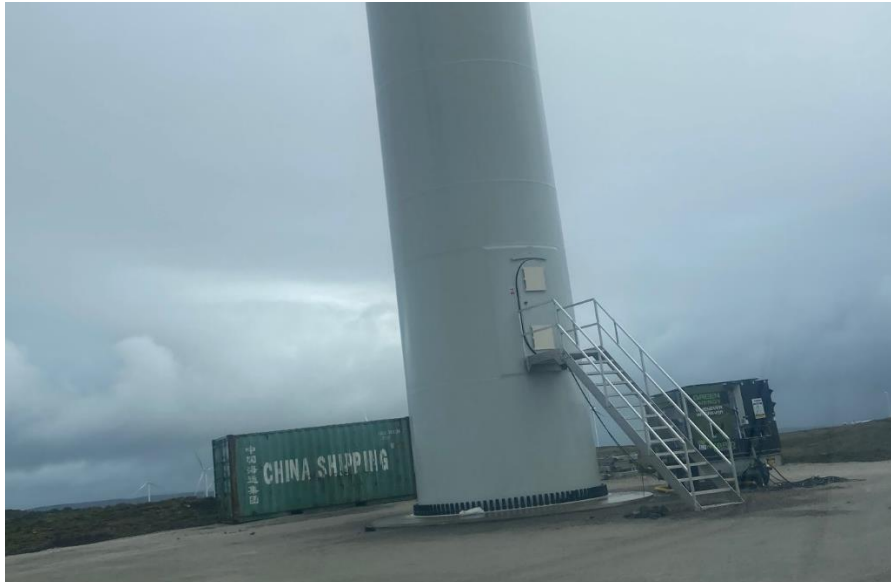
Pre-energisation checks were observed to be taking place at T041, with the presence of a generator at the base of the turbine (Photo 9). This was also observed at T040 and at a number of other turbines. Although the generators are double skinned, plant nappies are required to be used. It was noted that plant nappies were missing at a few locations. This was discussed with SSE who indicated that Vestas were having supply issues in receiving the last of the required plant nappies, but the delivery of these were expected imminently. A check of plant nappy usage during pre-energisation operations should form part of the next PMO audit visit.

Photo 9. On-going pre-energisation checks at T041

<p>Pollution Prevention and Waste (e.g. use of spill kits and littering)</p>	<p>During the audit the PMO observed plant nappy to not be used by Vestas' contractor under generator for the pre-energising checks. This however did not result in any spill or environmental incidents.</p> <p>Open metal drip trays were observed to be used at the Vestas Satellite compound. This however did not result in any spill or environmental incidents.</p>	<p>Toolbox talk to remind contractors of refuelling procedures and refuelling procedures monitoring required.</p> <p>No open drip tray to be used. Plant nappies to be placed under all static plant.</p>	<p>Vestas</p>	<p>Amber</p>

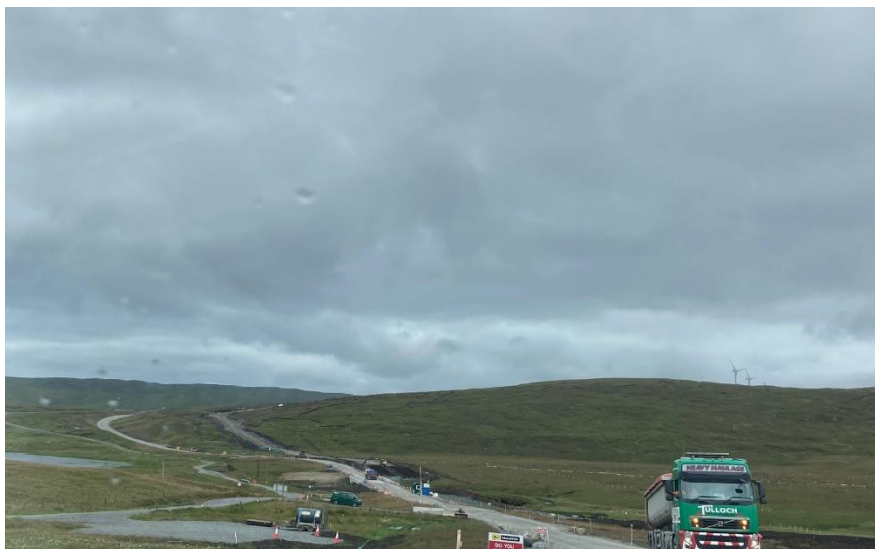
Backfilling operations were observed along the Sandwater track during the visit (photo 10), with backfilling of the cable trench in the upper areas and backfilling of the trench and track in the lower part by the Burn of Pettawater.

Photo 10. On-going backfilling works along the Sandwater track

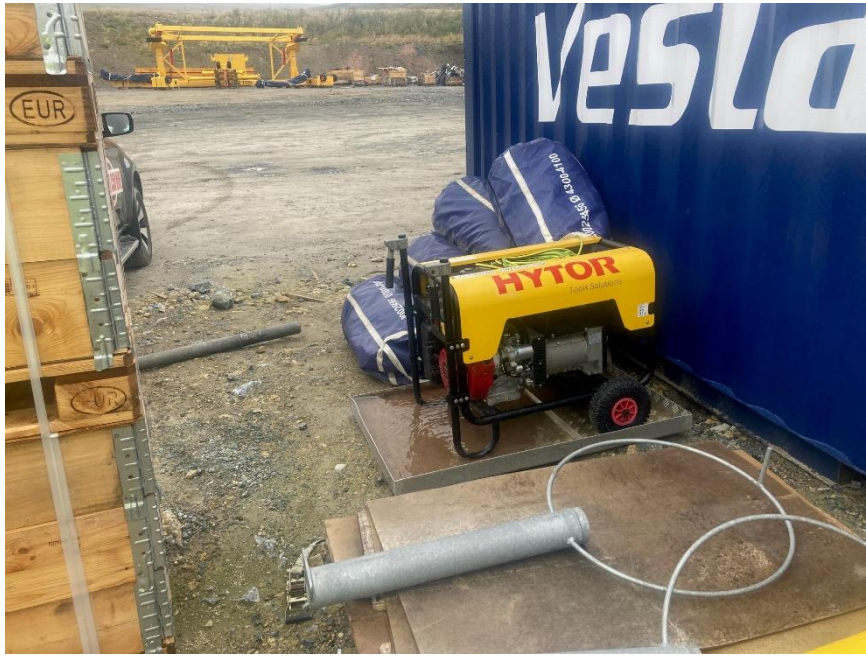
Plant nappies were observed to be present under static equipment stored at the compound. Two generators were observed to be placed over opened metal drip trays (photo 11), these should be replaced with plant nappies as per the CEMP requirements.

Photo 11. Open drip tray at Vestas North compound

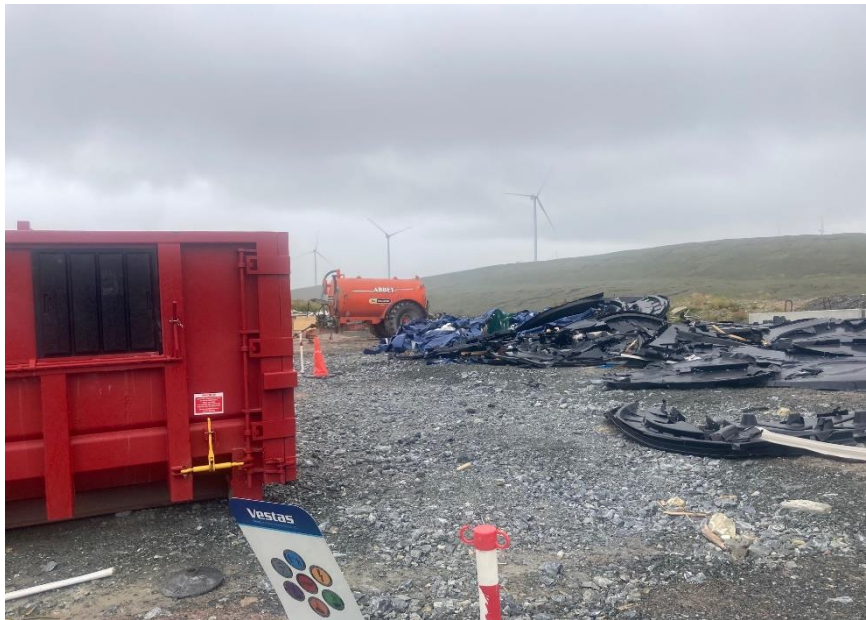
Covers for the end of nacelles were observed to be piled behind the skip area (photo 12). The plastic waste was loose and although heavy, was observed to be prone to being caught by strong wind. The plastic waste should be appropriately stored in skips. Additional plastic skips will be required. This is to be assessed during the next PMO site audit.

Photo 12. Loose plastic waste at Vestas North Compound

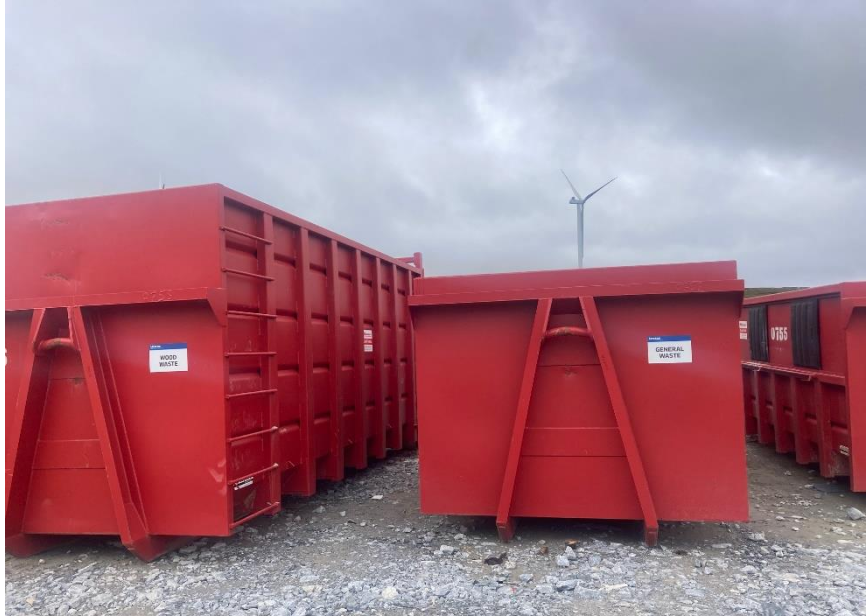
Photo 13. Labelled skips at Vestas North Compound

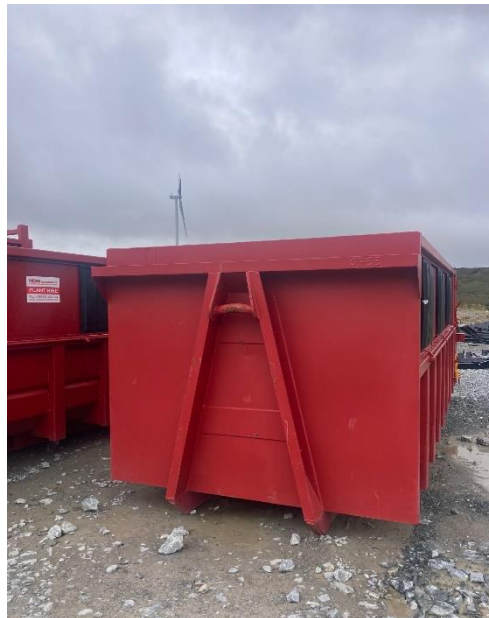
All skips (except 1) were clearly labelled (Photos 13), which appeared to be for plastic (Photo 14). During an SSE internal audit prior to the PMO July audit visit, it was noted that one skip was not labelled and was notified through the raising of a Safety Observation Card. SSE is to follow up on action taken. IBCs and fuel tanks were banded. No activity was taking place at the compound during the visit.

Photo 14. Plastic skip unlabelled at Vestas North Compound

Issue	Auditor Comments	Required Action	Action Owner	Status
Noise, Dust, and Air Quality	No complaints regarding dust had been received by SIC during the audit period.	Continued monitoring of dust conditions and implementation of control measures as needed; and ongoing liaison as required with other construction operators.	N/A	Green
Resources, Waste and Transport.	The project manages wastes through a Site Waste Management Plan, the plan identifies the contractors transferring the waste and the disposal sites. Documents are retained in line with regulatory requirements.	No action required.	N/A	Green
Resources, Waste and Transport.	<p>Loose plastic waste observed at the Vestas North compound requires to be placed in skips.</p> <p>Plastic skip observed at the Vestas North compound to not be labelled.</p>	<p>Loose plastic waste identified to be placed in skips.</p> <p>Labelling of all skips present on site required.</p>	Vestas	Amber

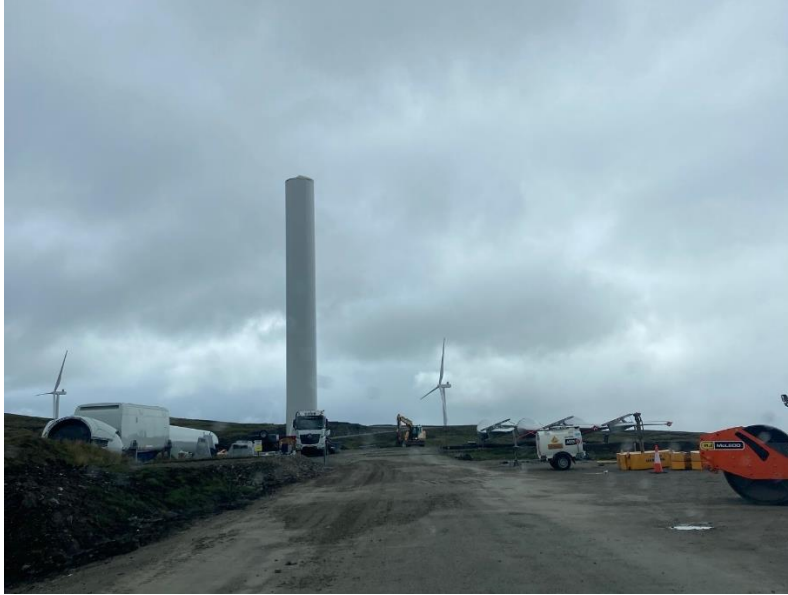
Photo 15. View of partial construction at T069, with turbine components at the base

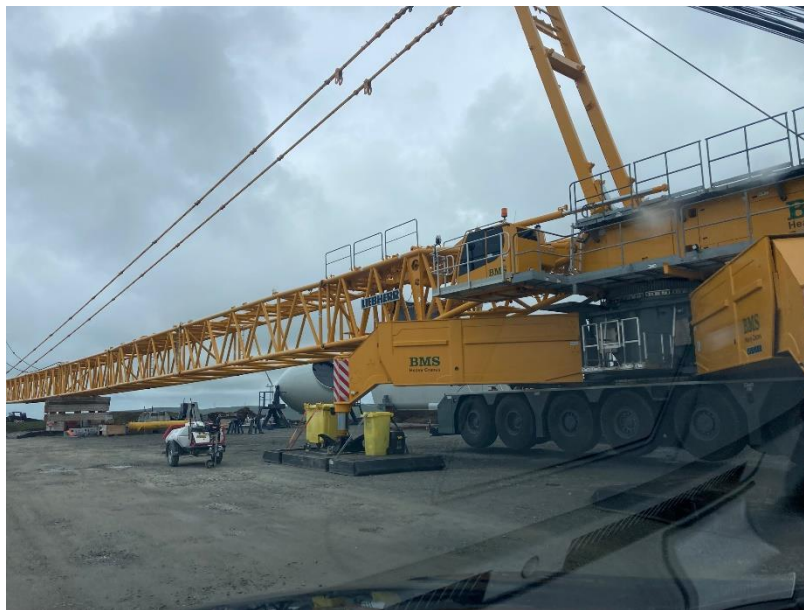
During the visit, T069 pre-installation had been completed and was awaiting final construction, with the remaining turbine components stored on the hardstanding (Photo 15). At T075, a crane was observed to be present, with components at the base waiting to be lifted. Spill kits were noted to be present by the crane (photo 16).

Photo 16. Crane at T075 with spill kits in place and turbine components at the base waiting to be lifted

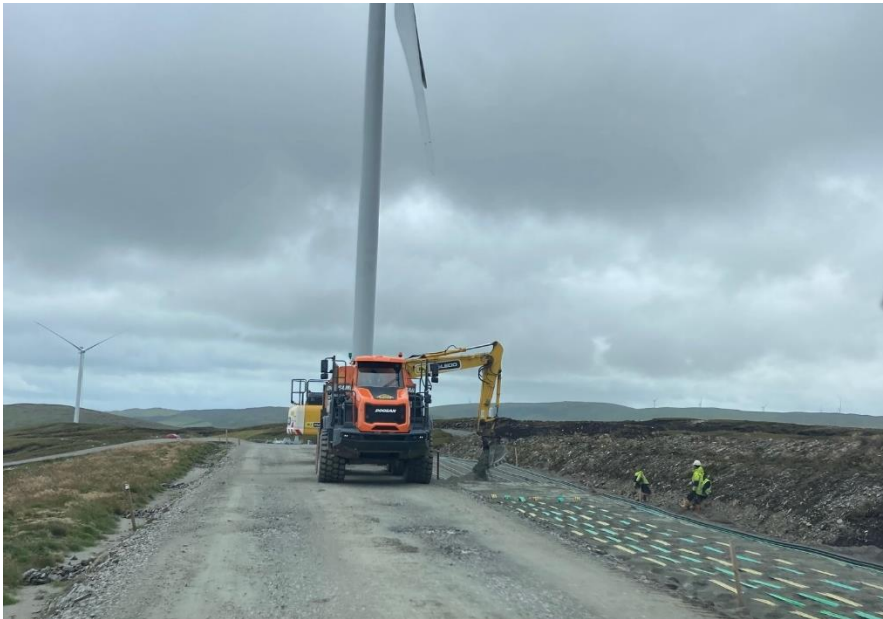
Cable trench backfilling is ongoing across Nesting. During the visit, backfilling of cable trenches was observed by T071 with win-dust being brought in for placement on top of the cables (photo 17).

Photo 17. Cable trench backfilling by T071

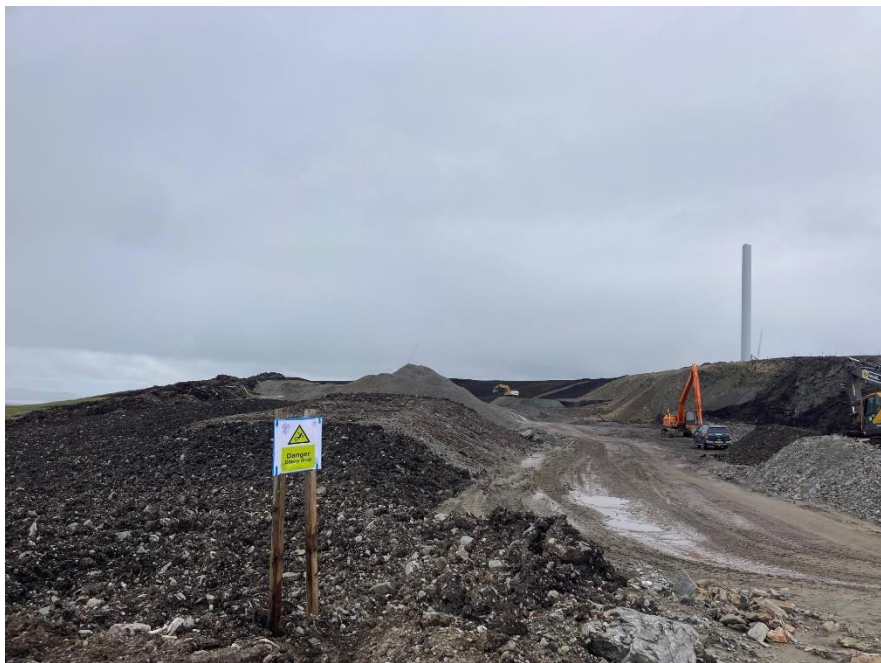
Photo 18. Material process at NBP05

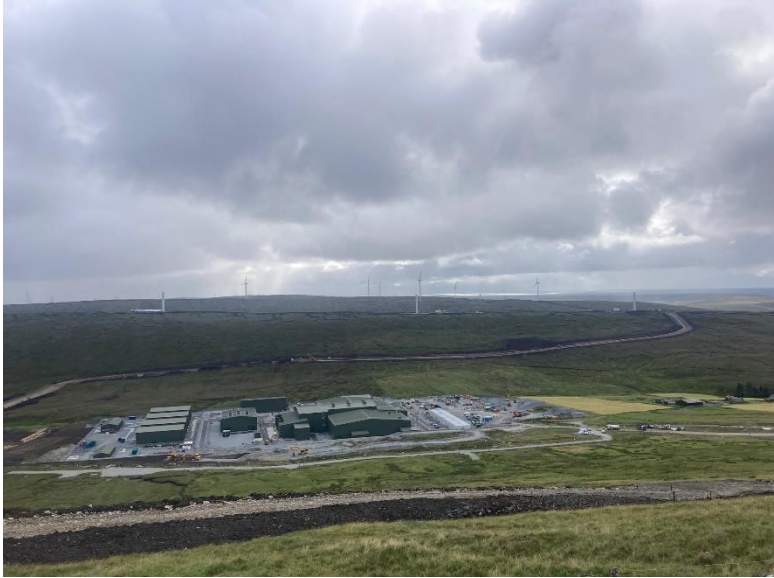
The substation was not visited during this PMO audit. It was observed from a distance from Upper Kergord Road (Photo 19). It was noted that the majority of the works have now been completed at the substation. On-going reinstatement works could be observed directly west and south of the substation during the visit.

Photo 19. Substation observed from Spur 5 on approach to Upper Kergord
