Date  
**August 2023**

Project Number  
**1620009158**

# **VIKING ENERGY WIND FARM PLANNING MONITORING OFFICER AUDIT REPORT 034: 24<sup>TH</sup> JULY TO 20<sup>TH</sup> AUGUST 2023**

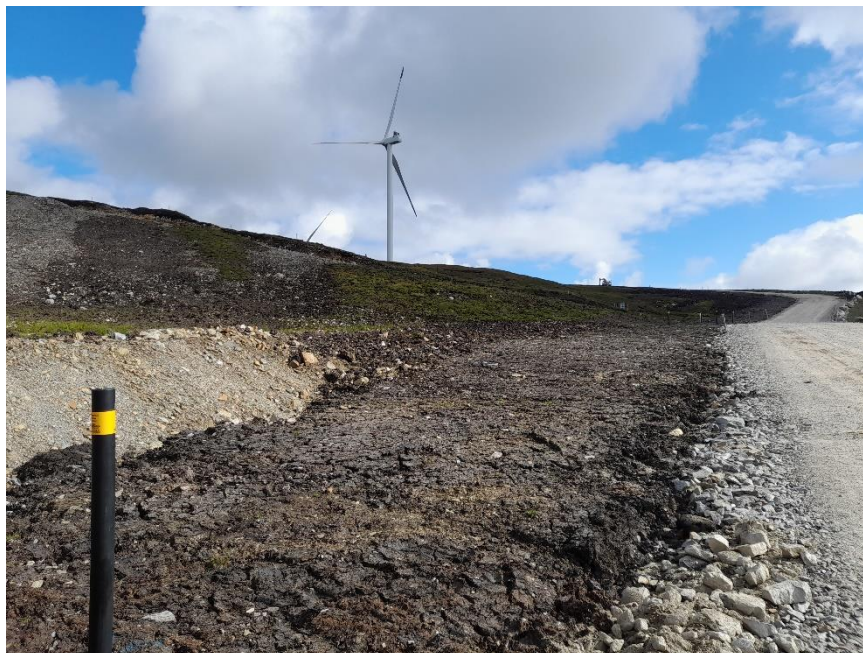
All cable laying activities across Kergord have been completed, including the cross-country route to the substation. The cable trenches are in the process of being backfilled across the area (Photo 1), using peat stored in temporary stockpiles in KBP02 and other areas.

**Photo 1.** Backfilling cables in Kergord Area

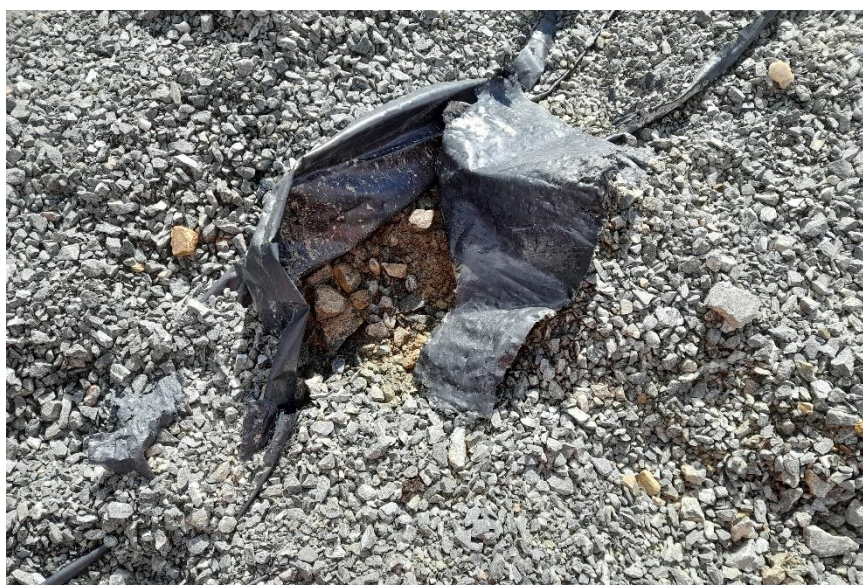
KBP05 is being used by Vestas as satellite compound and was observed during the visit. The compound appeared tidy and in good order. The refuelling area was inspected during the July PMO audit and the plastic sheeting was found to be in poor condition. The sheeting remains in poor condition (photo 2 and 3) with a hole leading directly to the unsurfaced ground beneath. Vestas have stated that they will be repairing the plastic sheeting this week. SSE will conduct an audit next week to monitor the progress. This should be monitored during the next PMO audit.

**Photo 2.** Sheetting in poor condition within refuelling bund in Vestas Compound

Issue	Auditor Comments	Required Action	Action Owner	Status
Pollution Prevention and Waste (e.g. use of spill kits and littering)	During the audit the PMO observed the plastic sheeting present on the walls of the fuel storage bunded area at the Vestas Satellite compound to be damaged. A direct breach in the floor of the refuelling area was observed. This however did not result in any spill or environmental incidents.	Replacement of damage plastic sheeting required.  Good maintenance and care of plastic sheeting during operations required.  SSE to conduct audit of the compound to ensure this is carried out before the next PMO audit.	Vestas	Amber
Noise, Dust, and Air Quality	No complaints regarding dust had been received by SIC during the audit period.	Continued monitoring of dust conditions and implementation of control measures as needed; and ongoing liaison as required with other construction operators.	N/A	Green

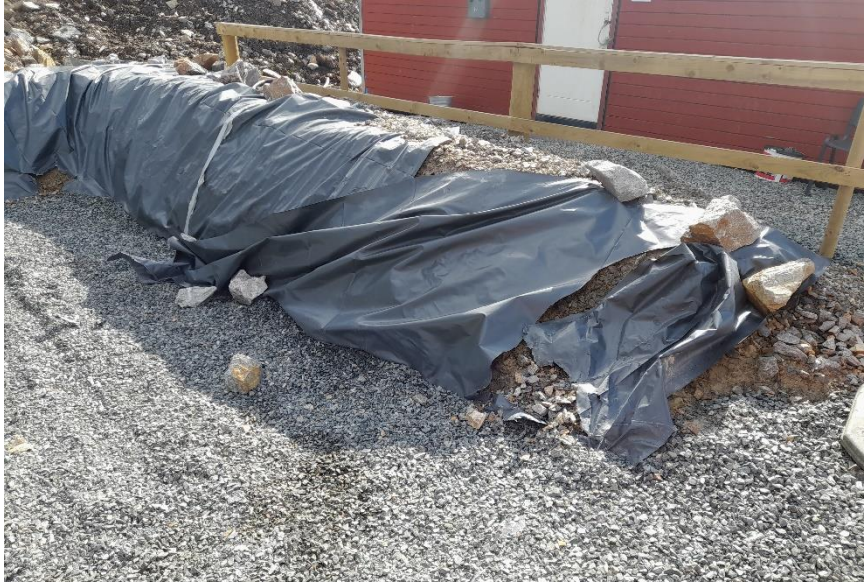
**Photo 3.** Sheeting in poor condition within refuelling bund in Vestas Compound

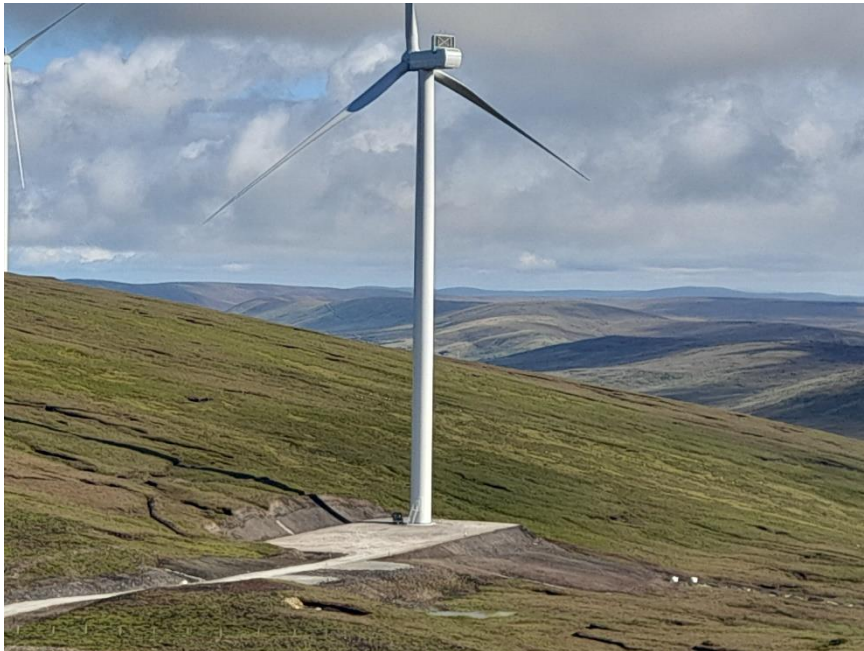
**Photo 4.** Removal of blade finger and reprofiling at T026

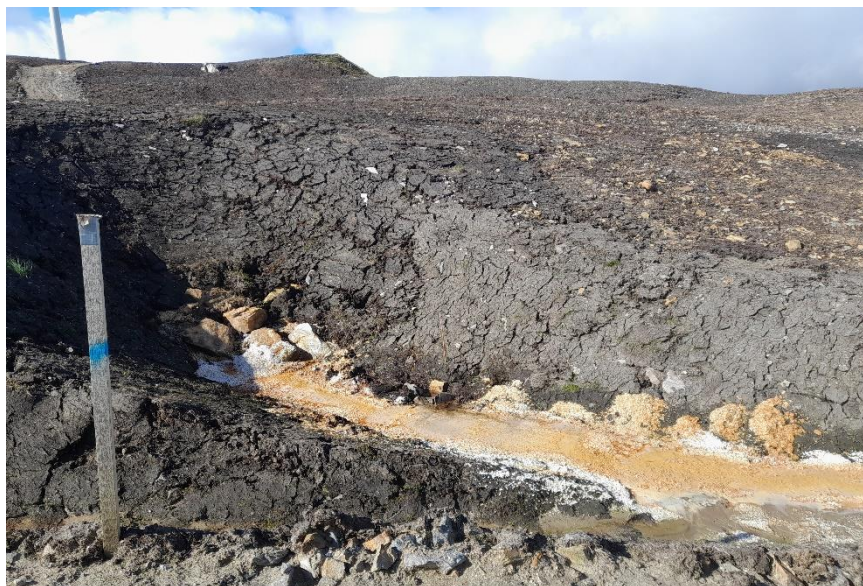
The ongoing treatment of the water from KBP02, as part of the works agreed with SEPA including settlements ponds (photos 5 and 6), seem to be having the intended impact on the pH of the water. The pH has increased and metal concentrations reduced in the Burn of Lunklet and Weisdale. The water will continue to be monitored and variations related to seasonal changes will be recorded.

**Photo 5.** Lining of drainage gullies from KBP02

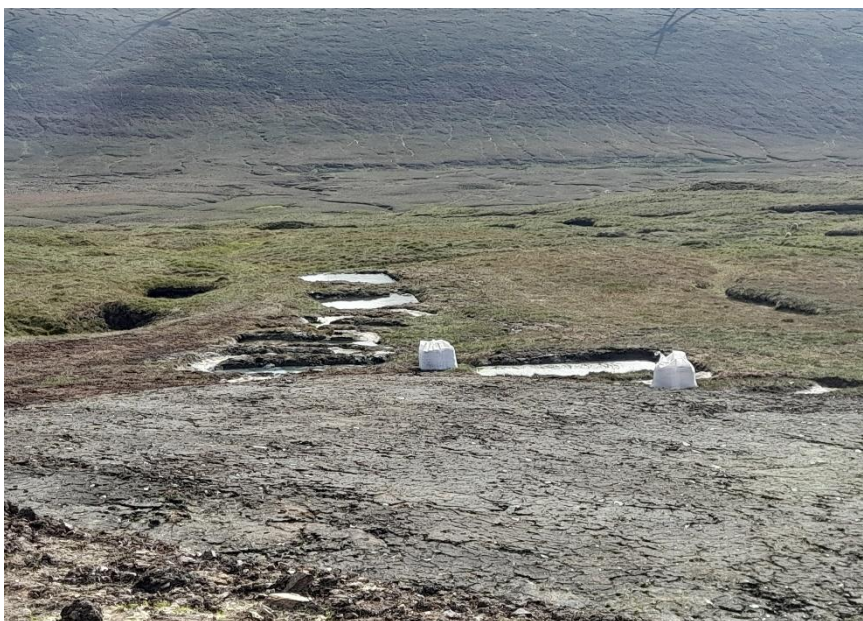
**Photo 6.** Settlement Ponds

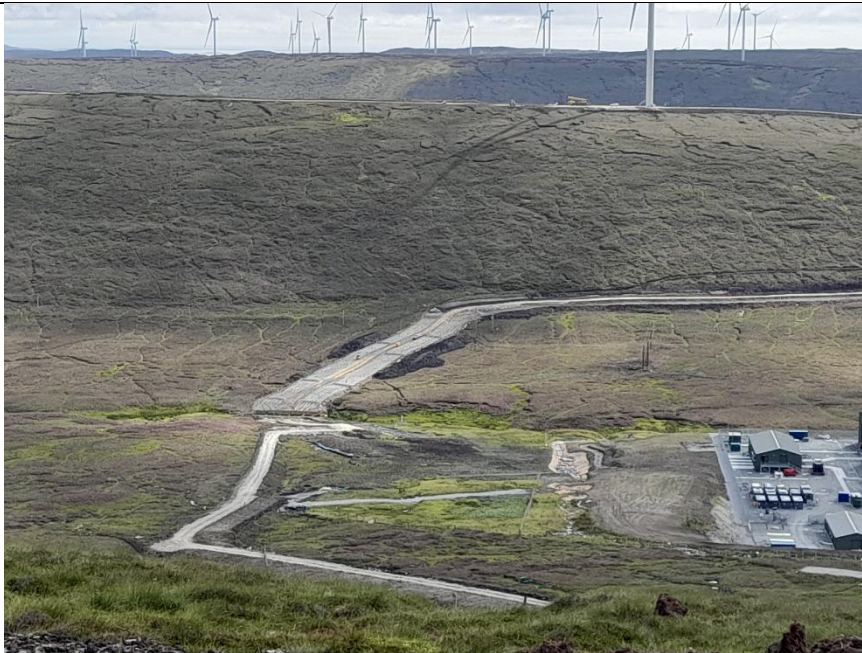
**Photo 7.**

Cable trench backfilling was being undertaken along the cross-country route from MKR to the substation (photos 7 and 8). The peat originally stripped from the excavations has been stockpiled and will be reused for the backfilling of the trench. A temporary peat store was also being used as a source of peat to enable backfilling of the cable trenches. The upslope trench is nearing completion of backfill and the downslope trench is being backfilled using the remaining peat. A small slump of the peat stockpile was noted during communications with the GCoW and was observed during the PMO, however, the GCoW confirmed that there were no stability issues, have not caused any issues since the observation and the peat was due to be used imminently. Backfilling of the cable trenches was also being undertaken along the cross-country route from MKR to Sandwater Road (photo 9). The temporary fine material "whin-dust" stockpiled near the Sandwater Road cutting is being used as bedding material in the cable trenches.

Cable trench backfilling on the cross-country route from Mid Kames Ridge to the substation

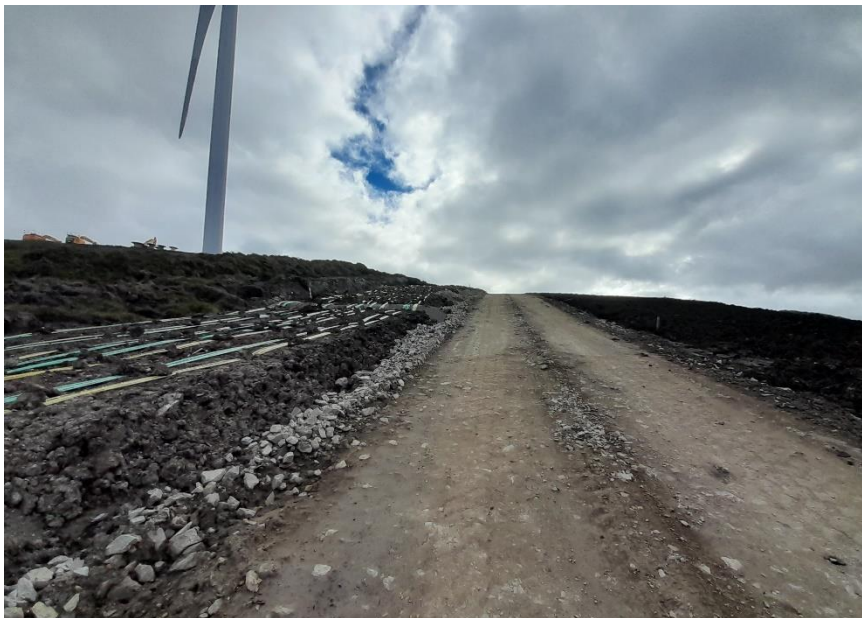
**Photo 8.**

Cable trench backfilling on the cross-country route from Mid Kames Ridge to the substation

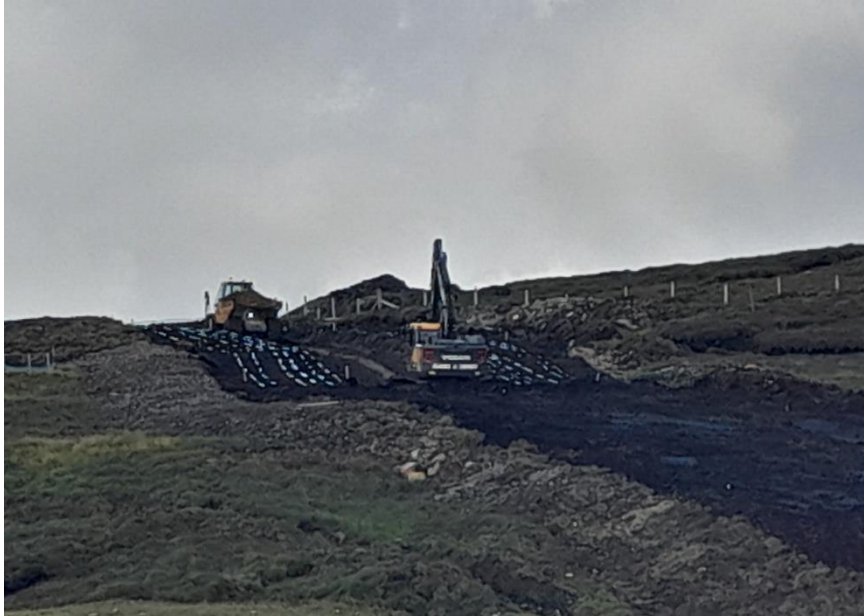
A silty water event occurred during a period of heavy rainfall on the 11<sup>th</sup> of August, the week prior to the PMO audit. No exceedances of the permit thresholds were recorded and hence is not a reportable event under the terms of the Construction Site License. It was noted that the primary mitigation measures consisting of settlement ponds and water pumps were in use to cope with the silty water run off, however, the saturation of the moorland dispersal area and the silty water flowing into the Burn of Pettawater was unforeseen. Once noted, the pump was turned off and the silty discharge ceased within an hour. The sediment was believed to have originated from a combination of the cable trenches (which hadn't been backfilled at that point) and run off from Sandwater track. The trenches are now in the process of being backfilled and the stockpile of fine material is in the process of being removed from this location. RJ McLeod have reviewed the mitigation measures to prevent a recurrence but there is an appreciation that the lack of space and naturally saturated conditions in this area mean that measures can be stretched to capacity. The removal of the sediment source will limit the risk of future silty water incidents at this location.

**Photo 9.** Cable trench backfilling on the cross-country route from mid Kames Ridge to Sandwater Road

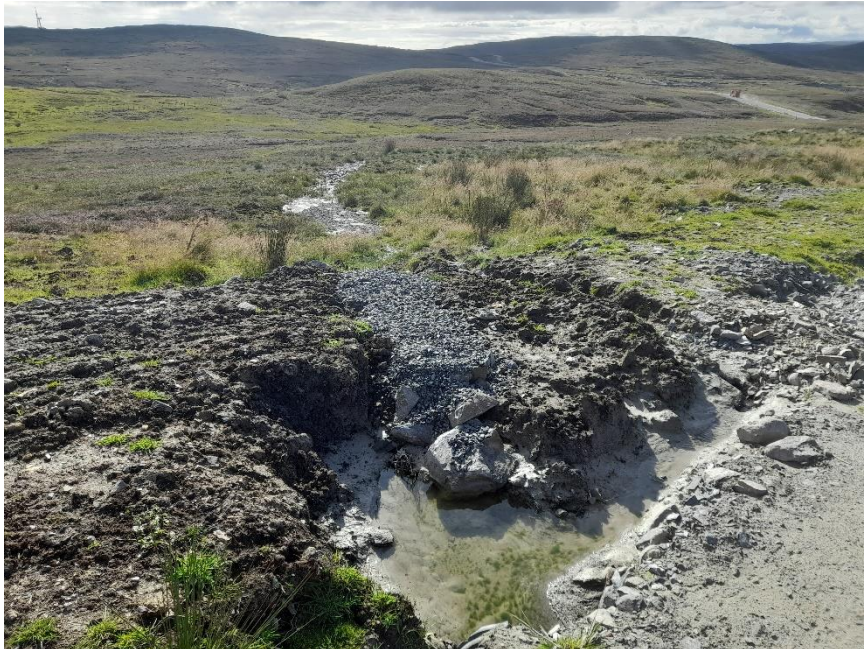
The observation in the Droswell Burn is believed to have originated from the run-off at the junction between the KAT and Spur 5, which migrated through the eastern tracksides drainage systems and into the Burn of Droswell north of the culvert area (photo 10). It is noted that this is in a different source of sediment and water to those mentioned in previous PMO reports. SSE have taken an action to review the drainage set up in this area and determine the cause.

**Photo 10.** Land drains draining towards the Droswell Burn

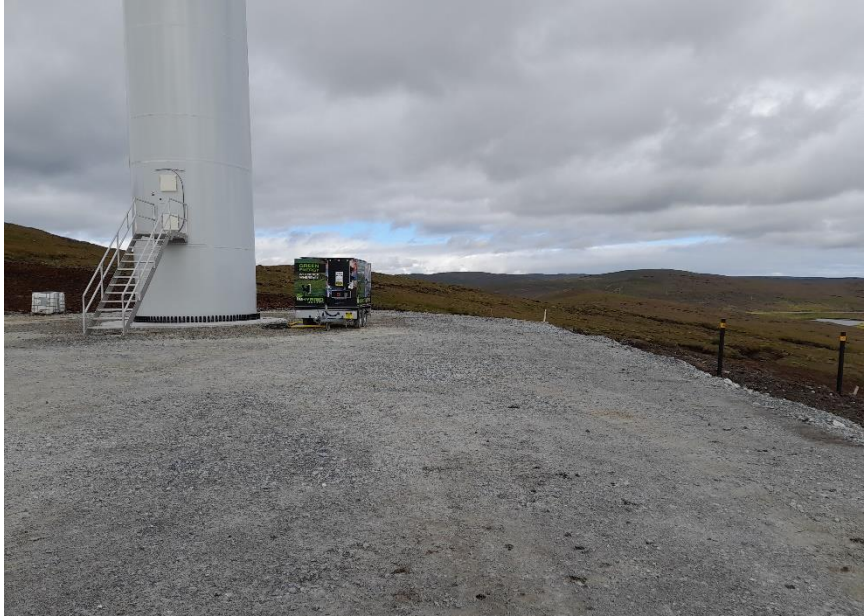
During the prior audit, it was noted that plant nappies were not in place under all of the pre-energisation generators. Plant nappies were observed under all pre-energisation generators during this audit (photo 11).

**Photo 11.** Plant nappies on energising generators

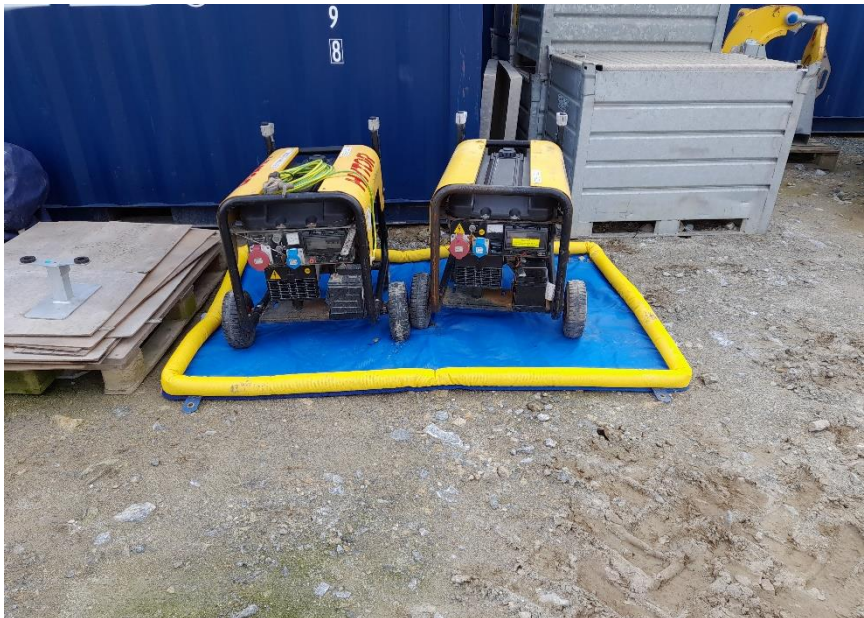
Plant nappies were observed to be present under static equipment stored at the compound (photo 12), rather than the drip tray observed during the previous PMO audit. Plastic waste was observed to be lying directly on the ground rather than in skips during the July audit, and it was confirmed that these had been removed from site (photo 13). Skips are present within the compound, and all were observed to be labelled (photo 14).

**Photo 12.** Plant nappies being used in North Compound

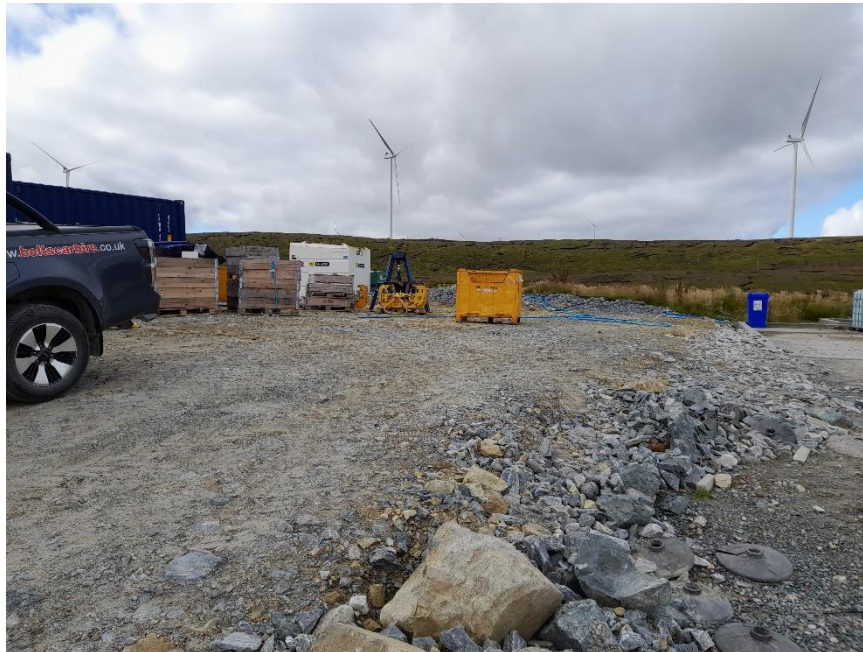
**Photo 13.** Plastic waste removed

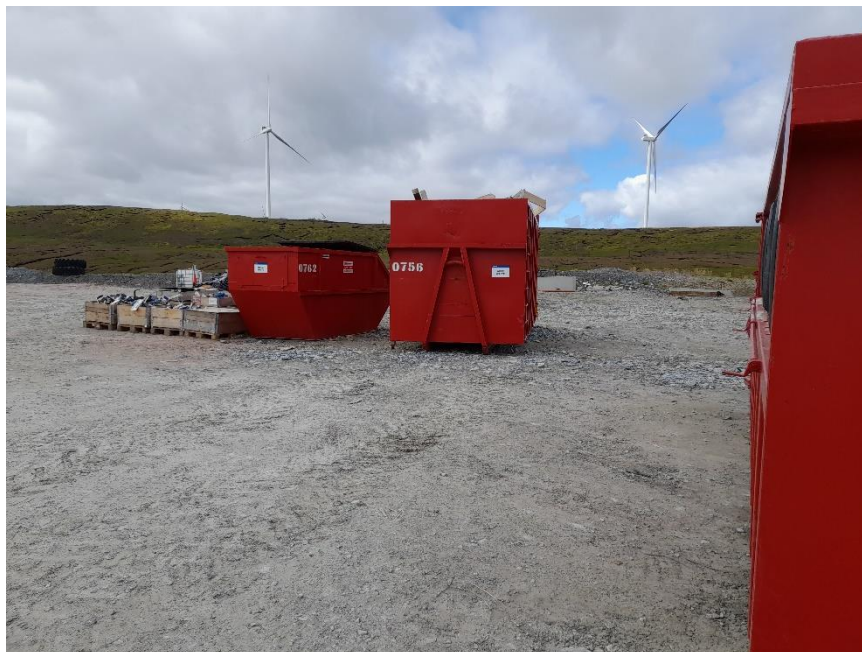
**Photo 14.** Skips labelled

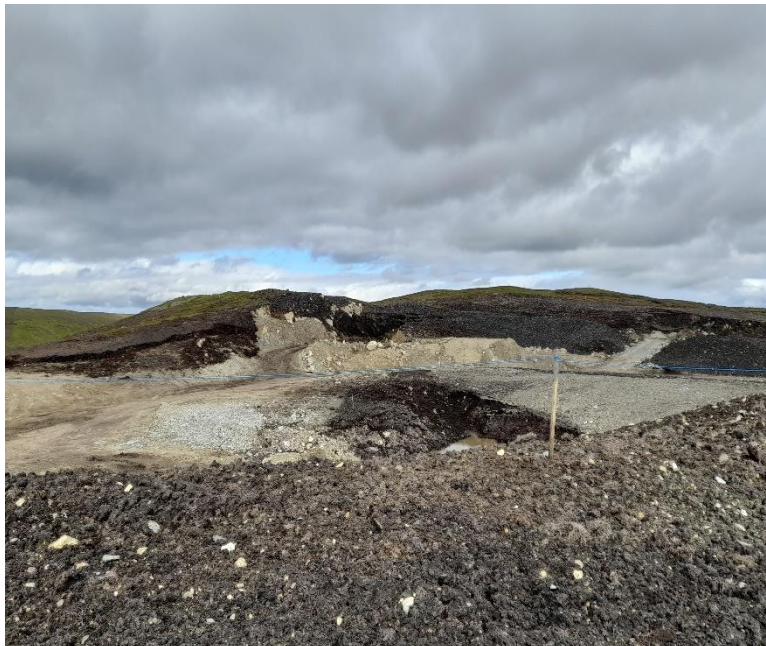
Peat was being excavated from the temporary peat store in NBP01 for the backfilling of cable trenches (photo 15). Some borrow pit restoration plans have been received but are awaiting geotechnical review.

**Photo 15.** Using peat from temporary peat storage in NBP01

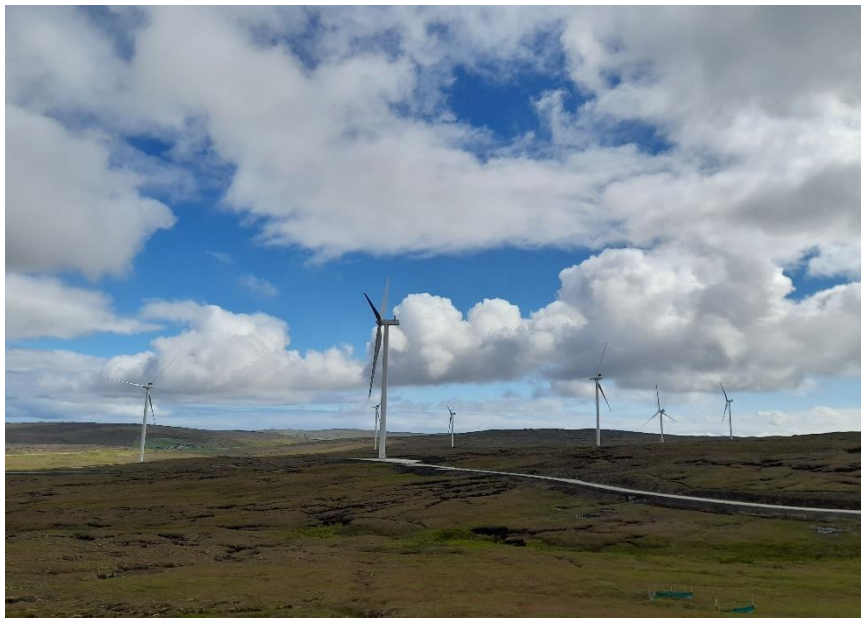
Discussions were being undertaken around assessing whether temporary drainage solutions require removal or whether permanent drainage is required, as stated in Section 3.2.2 and as part of normal construction practice. This includes the silt fences at Junction 57 in North Nesting (photo 16).

**Photo 16.** Silt fences at Junction 57 in North Nesting

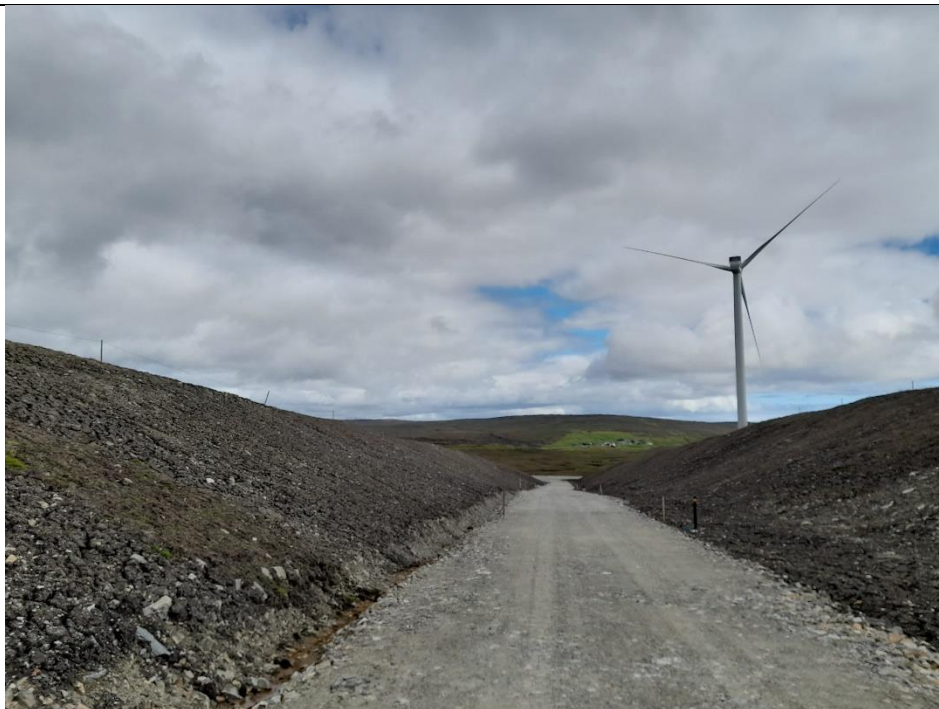
The reprofiling and hydroseeding of the peat at Spur 52 was observed (photo 17). Previous discussions with the GCoW suggested that the profile being created may be too steep (following previous peat runouts). The Principal Contractor has provided evidence to SSE that the slope is within specification. This area will be monitored by SSE and the GCoW to ensure that the angle of the slope is suitable for the peat.

**Photo 17.** Reprofilng and hydroseeding of embankment at Spur 52 in North Nesting

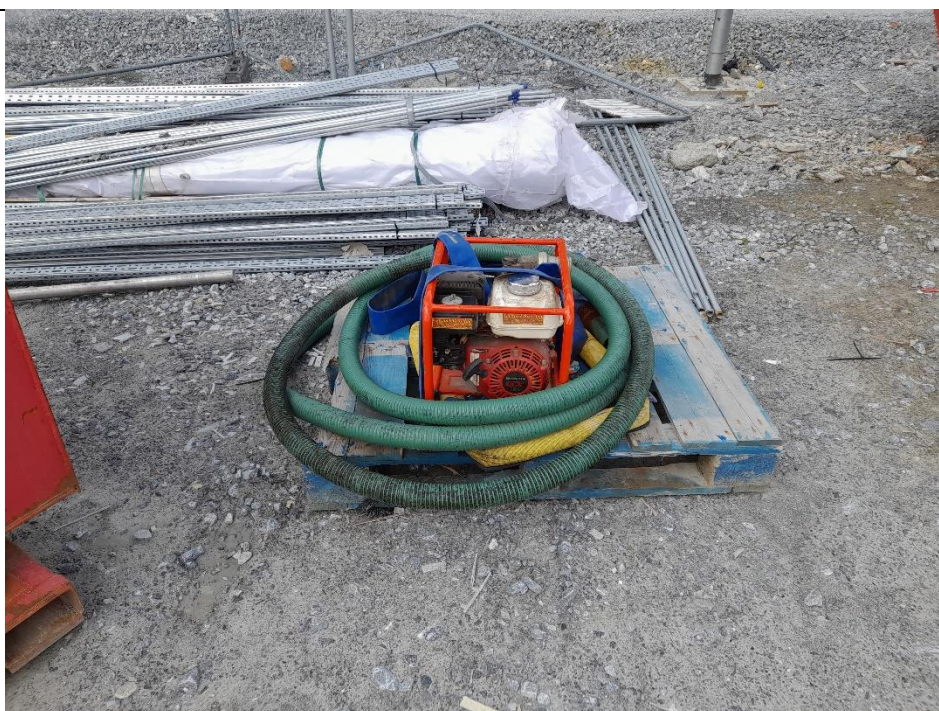
The civil works at the substation have been completed and the remaining work includes the commissioning of the electrical equipment within the purpose-built housing. The laydown area was observed, and plant nappies were being used during storage of equipment (photo 18). The majority of items have been removed from the area; however, some fuel storage remains. SSE are going to enquire whether this is necessary for any upcoming work or whether this could be removed.

**Photo 18.** Plant nappies being used in substation laydown area

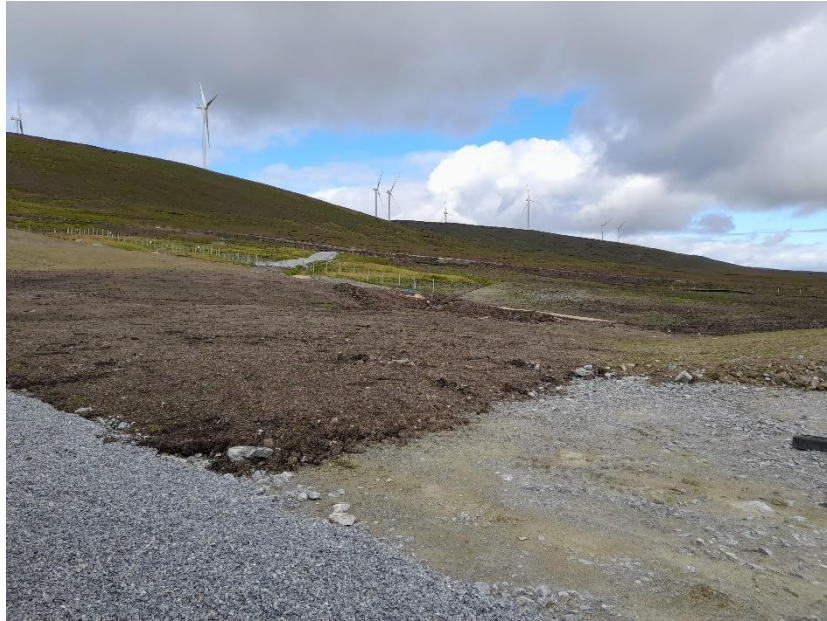
The land to the north of the substation has been reprofiled and growth from the remaining turves and inherent seed bank has been observed (photo 19). Seeding will be completed once the cable jointing works are signed off. Palisade fencing has been erected, enclosing the substation area.

**Photo 19.** Land to the north of the substation has been reprofiled
