Intended for  
**Viking Energy Wind Farm LLP**

Project Number  
**1620009158**

# **VIKING ENERGY WIND FARM PLANNING MONITORING OFFICER AUDIT REPORT 035: 21<sup>ST</sup> AUGUST TO 15<sup>TH</sup> SEPTEMBER 2023**

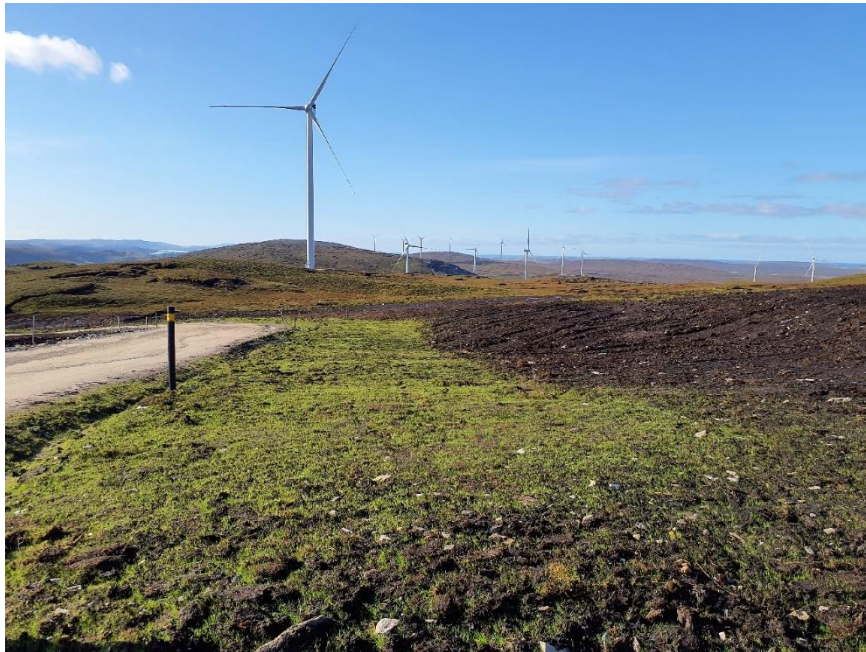
The majority of the cable trenches have been backfilled other than areas where jointing is required. Additional hydroseeding has been completed, concentrated mainly on backfilled cable trench routes, with further localised seeding scheduled for the end of September 2023 and a wider programme throughout the spring and summer of 2024 (Photo 1).

**Photo 1.** Hydroseeding on backfilled cable trenches near T021

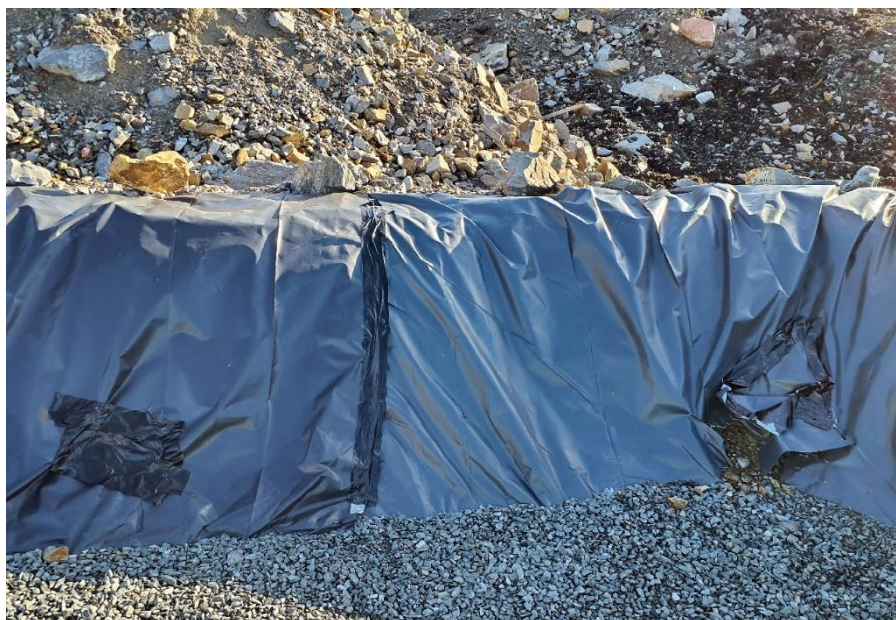
KBP05 is being used by Vestas as a satellite compound and was observed during the visit. Following the July and August PMO audits, the plastic sheeting at the refuelling area was inspected. Attempts to patch the hole previously observed were noted (Photo 2). However, gaps could still be observed where the plastic sheeting is in poor condition or where the sheeting overlaps, exposing the unsurfaced ground beneath. The Principal Contractor has been asked to replace or reline the area taking more care not to create tears. A diesel bowser was also observed sitting outwith the area (Photo 3). The Principal Contractor later confirmed the bowser was outside the area while the repairs were being carried out. This should be monitored during the next PMO audit.

**Photo 2.** Taped sheeting with remaining tear within refuelling bund in Vestas Compound

Issue	Auditor Comments	Required Action	Action Owner	Status
	permitted levels. Further mitigation has been put in place in the areas of concern.			
Pollution Prevention and Response (e.g. use of spill kits, silt control, cement/concrete, water resources).	The SSE Renewables Environmental Manager notified the PMO in March 2023 that there have been some exceedances of Environmental Quality Standards of some trace metals in water quality sampling in the Burn of Lunklet.	Investigation into the source of the trace metals is ongoing. Short-term mitigation measures have been implemented as per the SEPA accepted mitigation plan with long-term mitigation strategy progressing.	VEWF	Amber
Pollution Prevention and Waste (e.g. use of spill kits and littering)	<p>During the August audit, the PMO observed the plastic sheeting present on the walls of the fuel storage bunded area at the Vestas Satellite compound to be damaged. A direct breach in the floor of the refuelling area was observed.</p> <p>During the September audit, the PMO observed that effort has been made to patch the damage. However, direct breach to the floor of the refuelling area can still be observed.</p> <p>This however did not result in any spill or environmental incidents.</p>	<p>Replacement of damage plastic sheeting required.</p> <p>Good maintenance and care of plastic sheeting during operations required.</p> <p>SSE to conduct audit of the compound to ensure this is carried out before the next PMO audit.</p>	Vestas	Amber

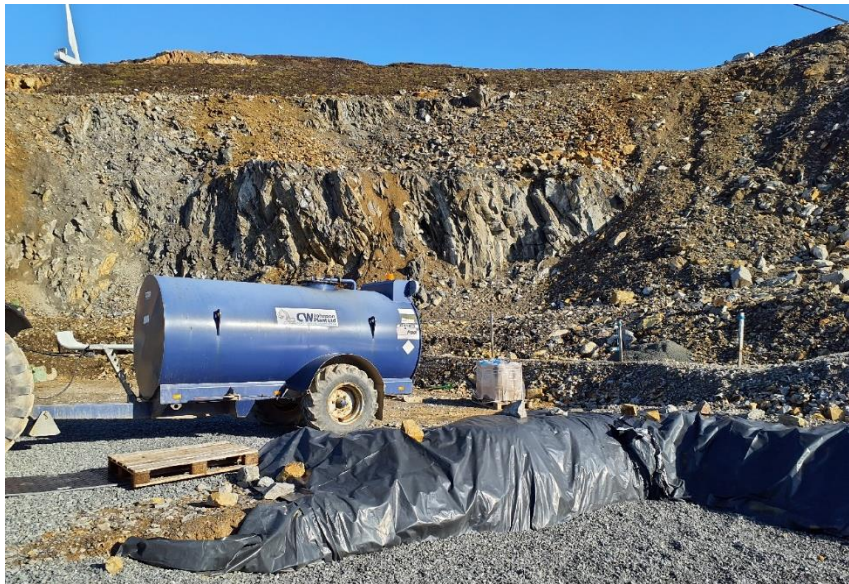
Materials Storage and Handling (e.g. oil/fuel storage and peat/mineral soil storage and handling).	During the audit the PMO observed a diesel bowser sitting outwith the fuel storage bunded area at the Vestas Satellite. This however did not result in any spill or environmental incident. It is noted that the bowser had been repositioned to facilitate repair works.	<p>Moving the diesel bowser back into the fuel storage bunded area following repair.</p> <p>SSE to conduct audit of the compound to ensure this is carried out before the next PMO audit.</p>	Vestas	Green

**Photo 3.** Bowser sitting outwith refuelling bund in Vestas Compound

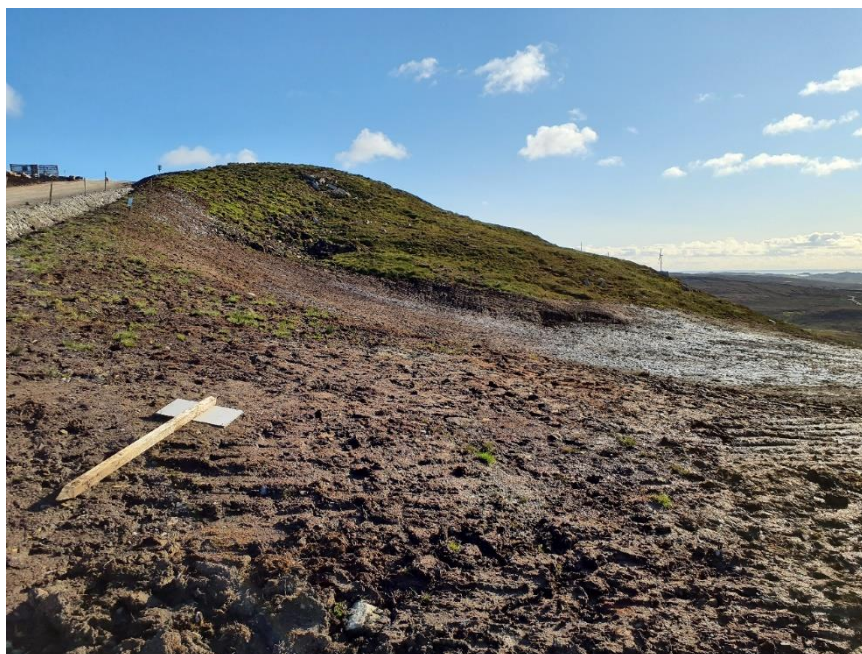
The majority of the peat from the temporary peat storage by KBP05 has been taken for backfilling, with the temporary peat storage area now reprofiled (Photo 4). The area was observed to be in good condition and subject to further reseeding.

**Photo 4.** Reprofiled temporary peat storage by KBP05

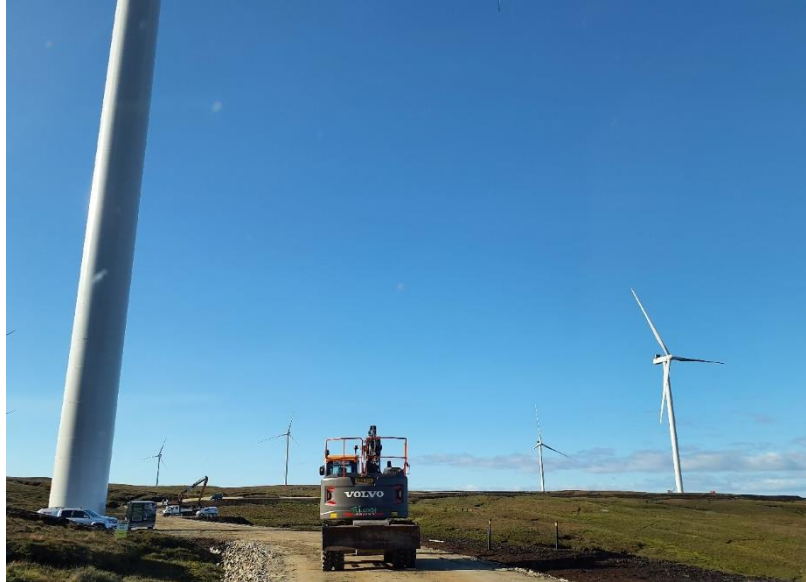
During the PMO visit, it was observed that stone was being taken from KBP03 to upgrade tracks, for example by T015 (Photo 5). Borrow pit reinstatement plans have yet to be received for KBP03 and KBP05.

**Photo 5.** View of track upgrade by T015

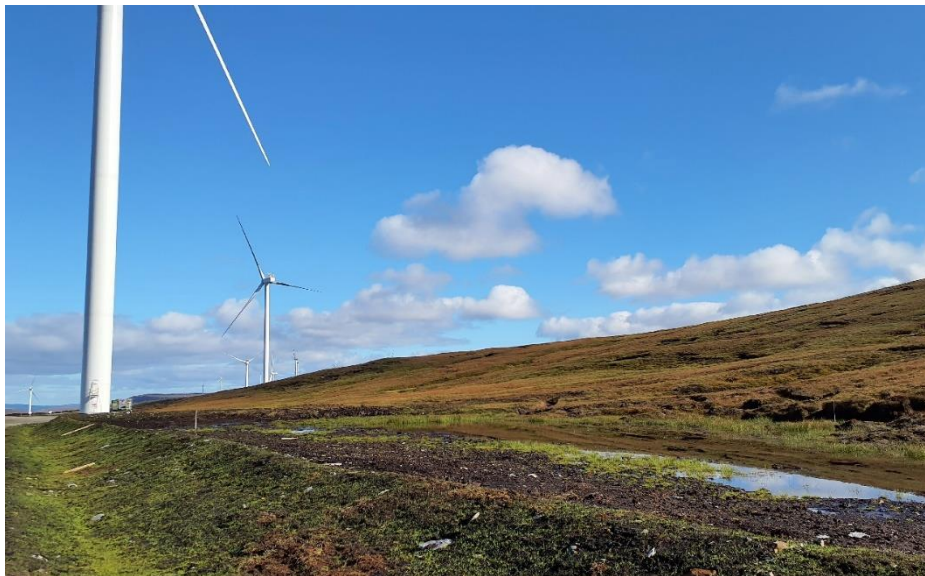
All landscaping and reinstatement of the turbine hardstanding areas across Kergord has been completed. Landscaping work adjacent to T004 includes a new pond, which has been landscaped into the roadside with the intent to provide local habitat enhancement (Photo 6). Permanent drainage between T001 and T002 was observed to be in good condition (Photos 7 and 8). Photo 9 shows an area of reinstatement containing a cut off ditch installed as part of the construction phase drainage management. The need for this ditch as part of operational surface water management requirements is the subject of ongoing review. Peat restoration areas across Kergord were also observed to be in good condition.

**Photo 6.** Reinstated track and turbine hardstand with road-side pond by T004

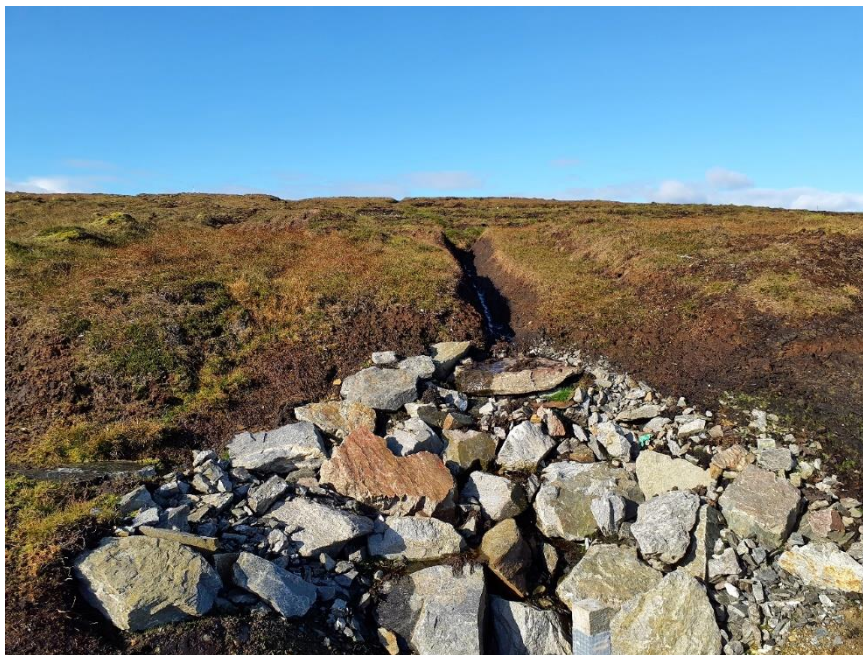
**Photo 7.** Upgraded drainage by T001, view upstream of track with swale

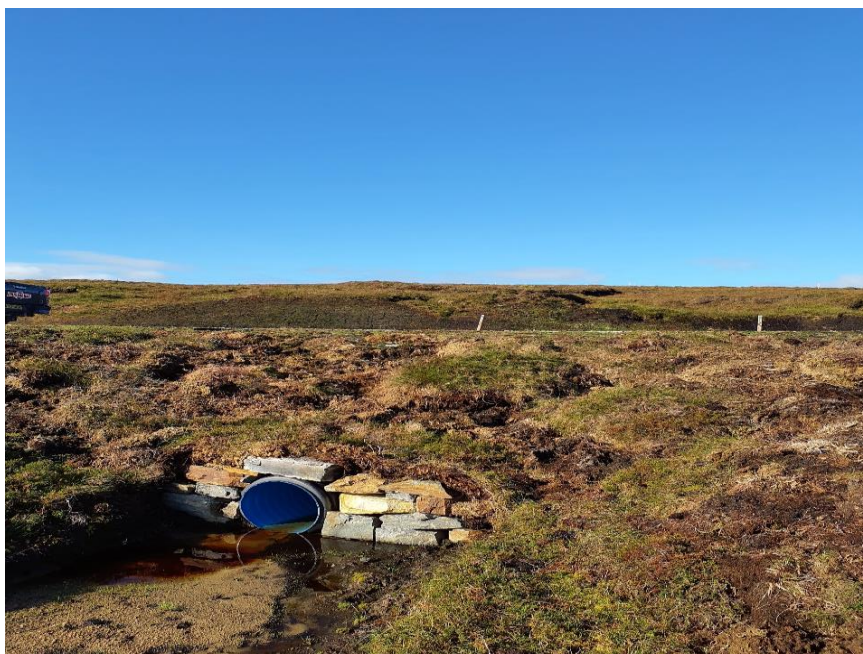
**Photo 8.** Upgraded drainage between T001 and T002, view from downstream of track

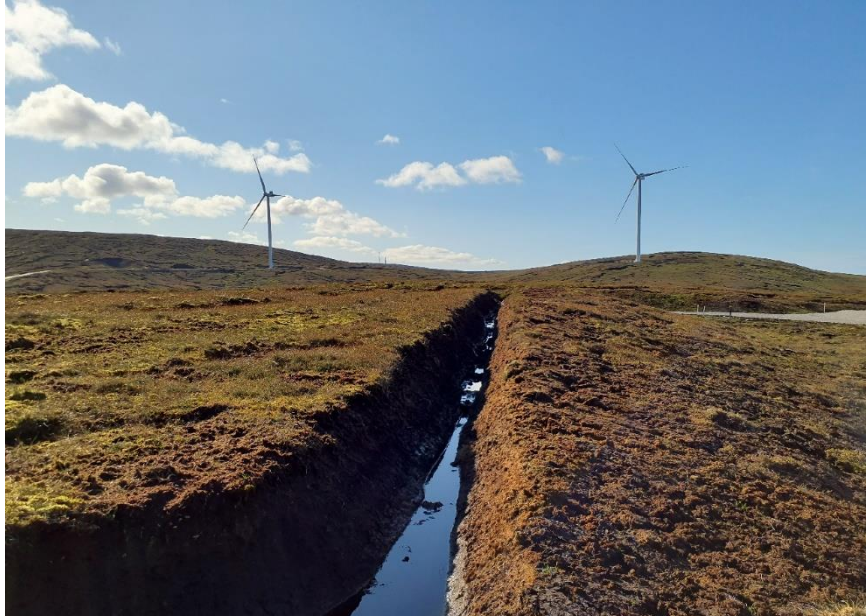
**Photo 9.** View of installed drain near T004

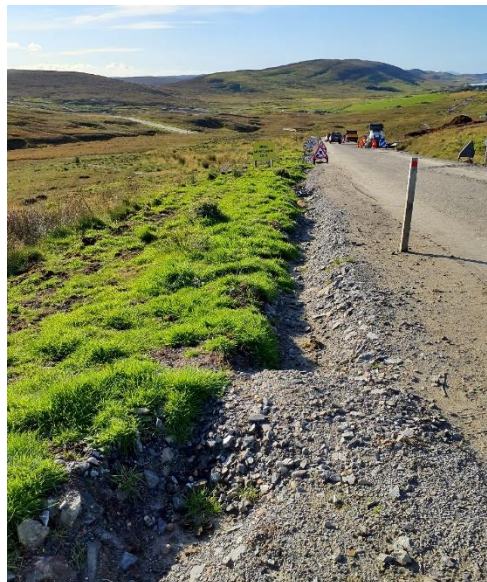
Following the previous PMO034 report and a review of the drainage set up at the junction between the KAT and Spur 5 by the Principal Contractor and SSE, additional check dams have been added (Photo 10). Check dams can reduce the speed of run-off and allow sediment to settle and be trapped. SSE will continue to monitor the drainage capability in this area and remains in discussion with the Principal Contractor regarding drainage on the east of the KAT and south of the junction to Spur 5. This and all other drainage works will be monitored by the PMO throughout the remaining audits.

**Photo 10.** Check dams in trackside drainage at the junction between KAT and Spur 5

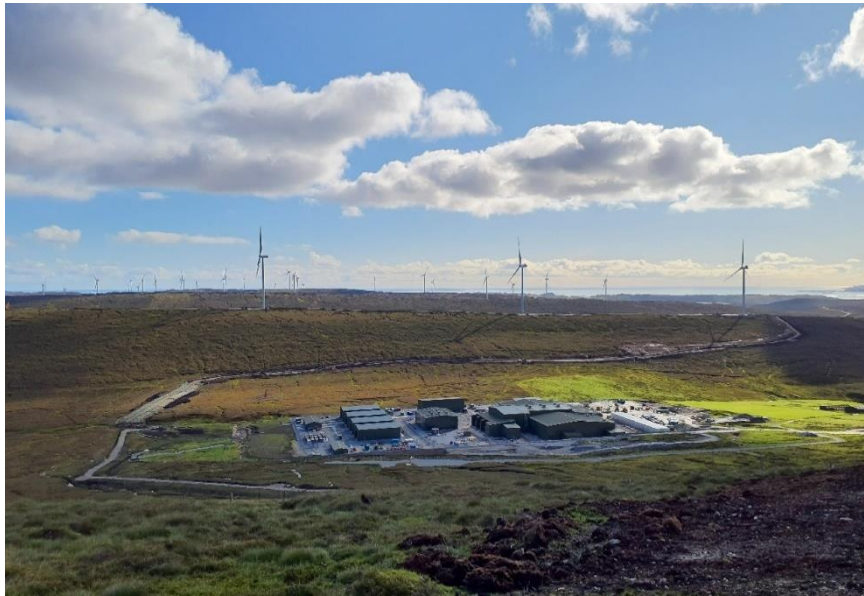
During the visit, the PMO observed ongoing work to backfill the cross-country cable route from MKR to the substation (Photo 11).

**Photo 11.** View towards substation and cross-country route from MKR to substation

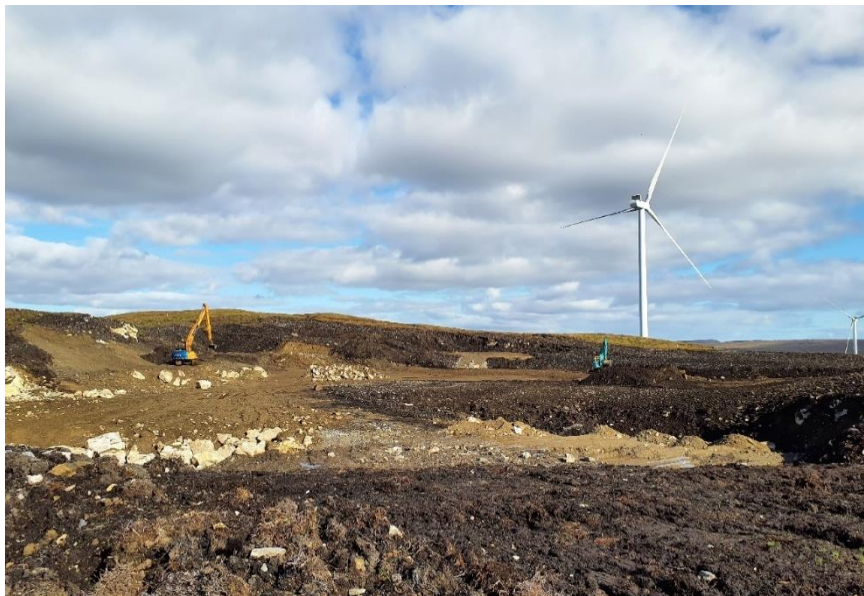
During the visit, reprofiling of NBP01 was observed (Photo 12). It is understood that the geotechnical review of borrow pit restoration plans is progressing between SSE and the Contractor.

**Photo 12.** Reprofiling of NBP01

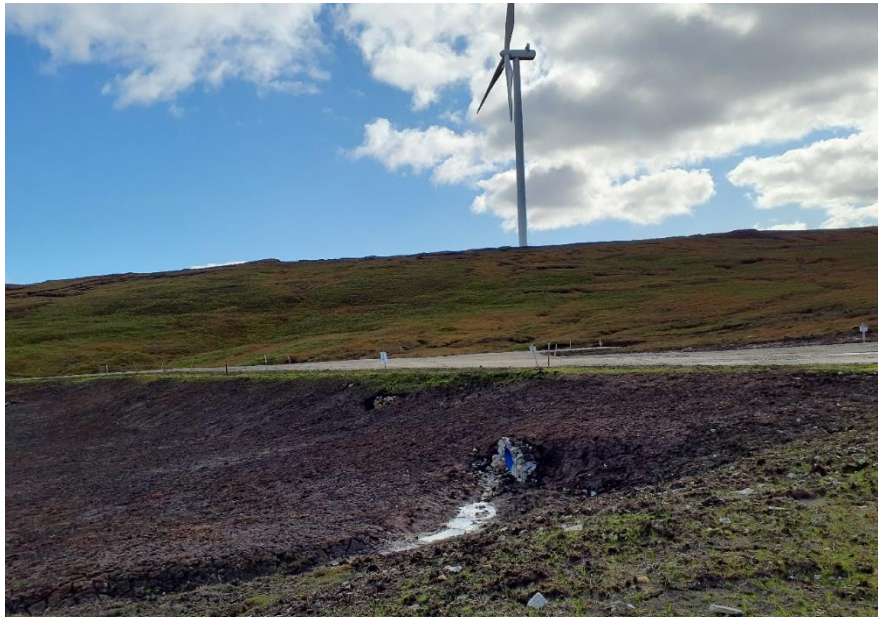
Reinstatement and drainage upgrade work has been completed at Spur 45. The area was noted to be in good condition during the audit visit, and this item has since been removed from the Risk Register (Photo 13).

**Photo 13.** Reinstatement and drainage upgrade at Spur 45 near T055

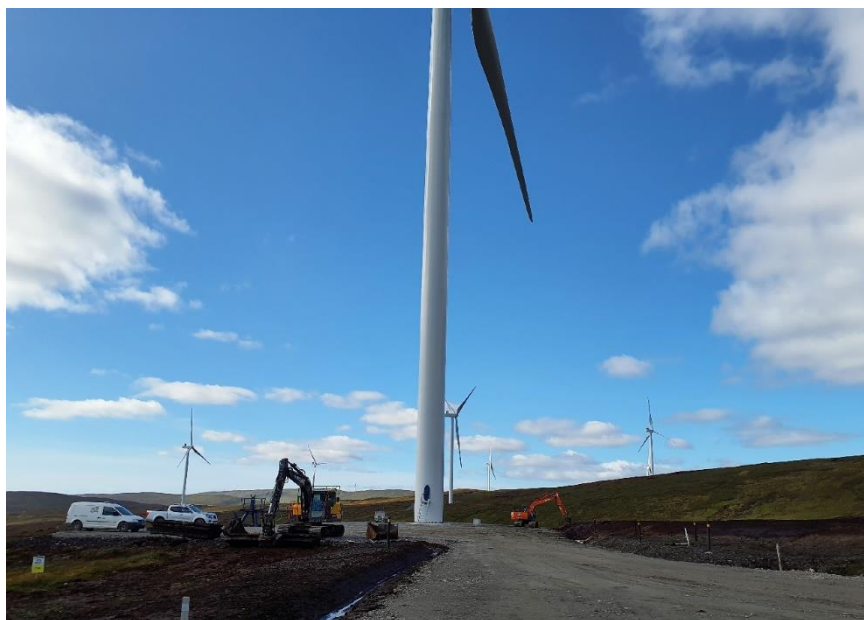
Turbine hardstanding areas across the Nesting array were being reinstated and landscaped to operational requirements, as observed at T100 (Photo 14).

**Photo 14.** Active turbine hardstand reinstatement by T100

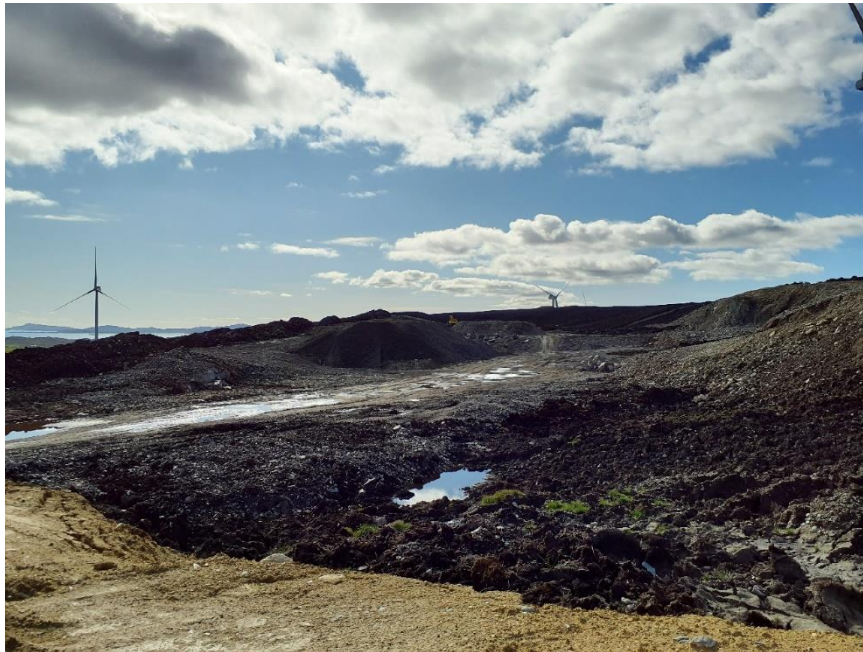
As part of the reinstatement work, stone from the decommissioned blade fingers was being used to infill NBP05 (Photo 15).

**Photo 15.** View of NBP05

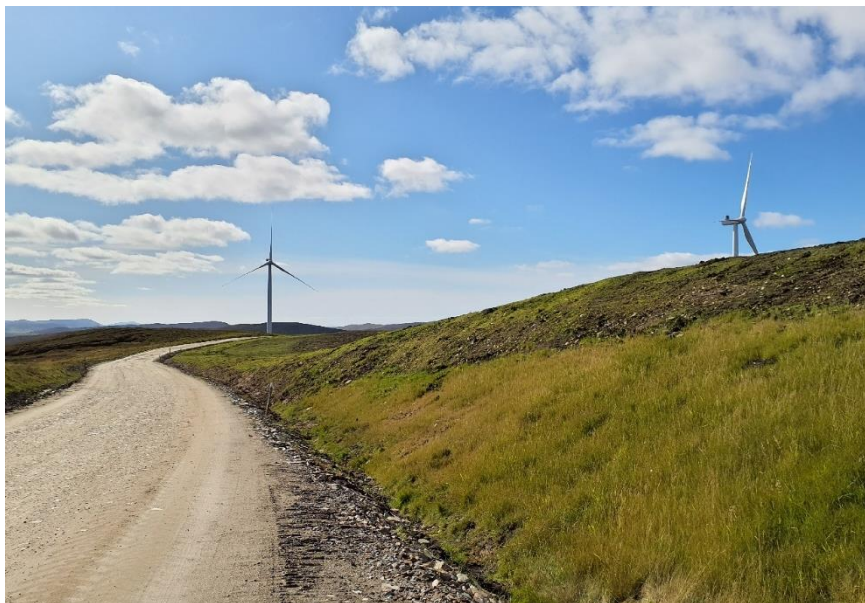
The majority of the cable trenches, other than areas where jointing is required, have been backfilled. Backfilling of cable trenches was observed at T080 during the visit. Additional hydroseeding has started, concentrated mainly on backfilled cable trench routes, with further localised seeding scheduled for end of September 2023 and a wider programme throughout the spring and summer of 2024. Successful growth produced by hydroseeding from 2022 was observed by T071, alongside additional hydroseeding from August 2023 (Photo 16).

**Photo 16.** View of hydroseeding from 2022 (foreground) and from August 2023 (background) by T071

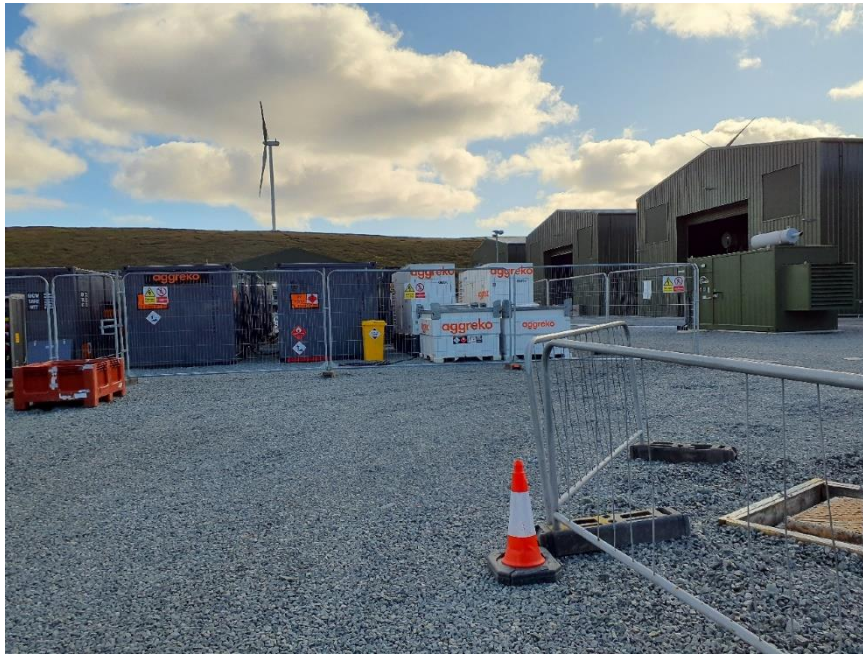
Following the previous PMO034 report, SSE confirmed that the refuelling area had been demobilised with further PMO monitoring still required. Four temporary generator packages have been installed for upcoming work which also requires monitoring. RAMS detailing spillage control measures and refuelling activities have been received and reviewed by SSE. The electrical equipment was being set up on the day of visit and hence a full audit was not possible. It was however noted from afar that there were spill kit and fire extinguisher in place (Photo 17).

**Photo 17.** Aggreko Commissioning Generator Package Set-Up
