Intended for  
**Viking Energy Wind Farm LLP**

Date  
**October 2023**

Project Number  
**1620009158**

# **VIKING ENERGY WIND FARM PLANNING MONITORING OFFICER AUDIT REPORT 036: 18<sup>TH</sup> SEPTEMBER 13<sup>TH</sup> OCTOBER 2023**

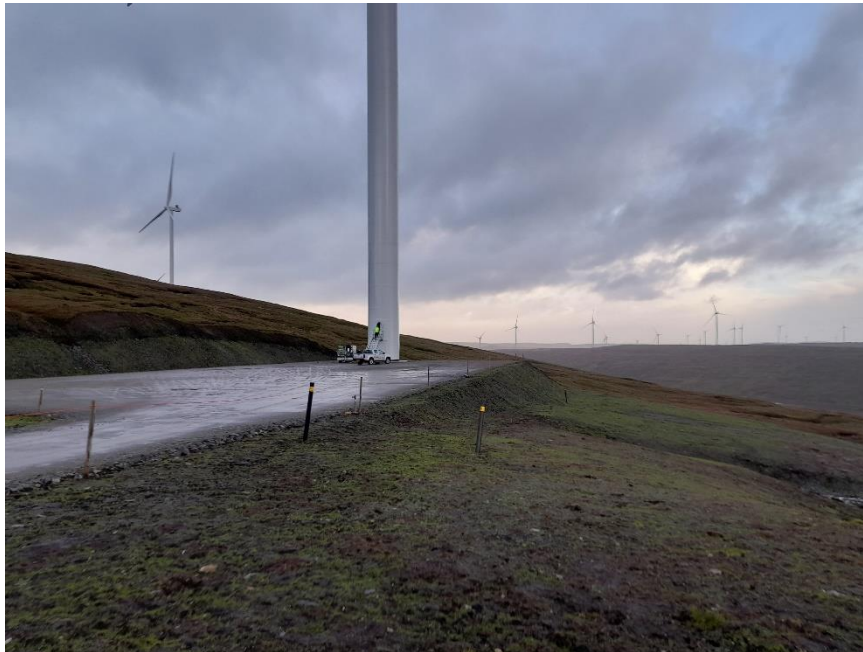
The majority of the cable trenches have been backfilled and all cable jointing and cable testing are now complete. Much of the site has been reinstated and hydroseeded. Hydroseeding works concentrated on the backfilled cable tracks and the works has been completed for this season and appears to be progressing well (photo 1). Further hydroseeding works, targeting the area beyond the cable tracks, will be undertaken in spring / summer of 2024.

**Photo 1.** Hydroseeding on backfilled cable trenches and general areas at T026

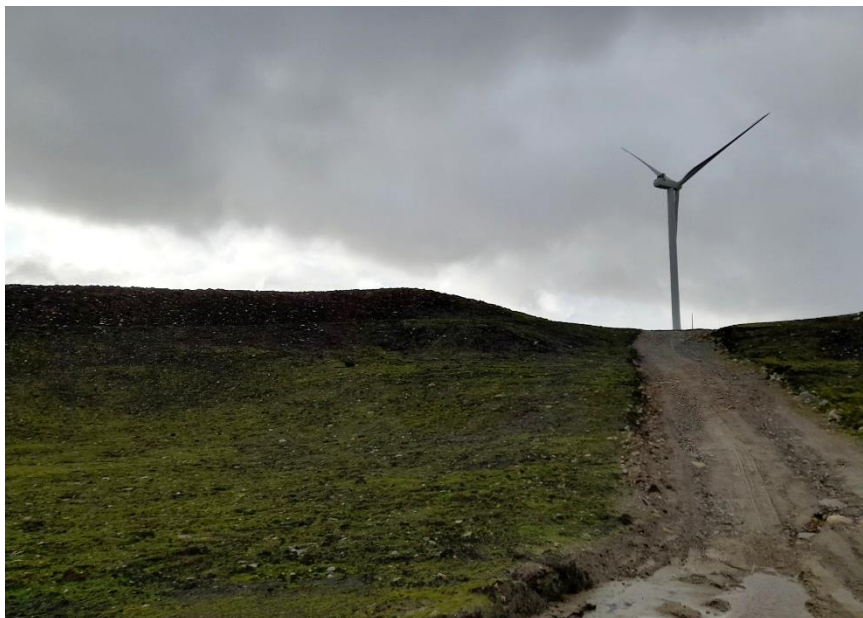
As noted in the previous report, KBP02 has been fully reinstated and hydroseed on the lower sections. The area was inspected and the vegetation is showing signs of growth (photo 2). The drainage from the borrow pit is being continually monitored and SSE and the Principal Contractor are aware that further upgrades to the drainage system into the Burn of Lunklet may be required. This will be continually assessed over the winter period and chemical testing and reporting will continue to be shared with SEPA.

**Photo 2.** Reprofilling and hydroseeding in KBP02

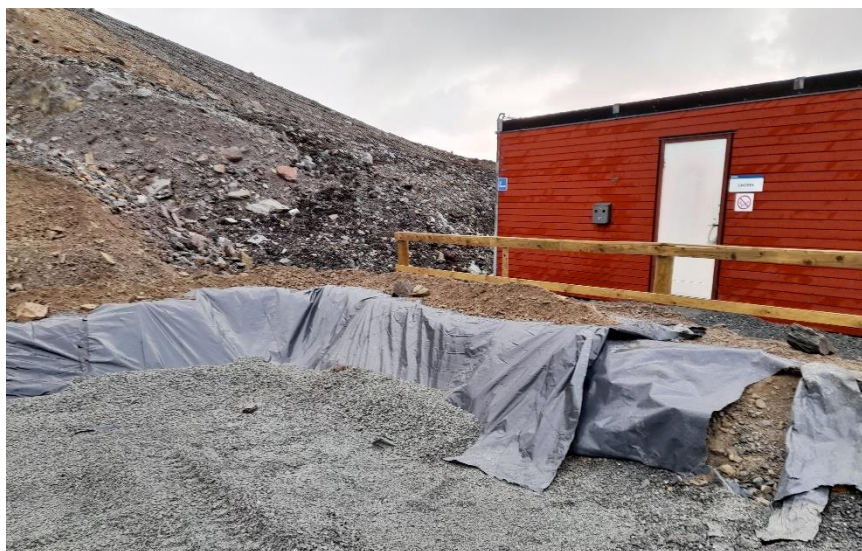
KBP05 is being used by Vestas as a satellite compound and was observed during the visit. Following the July, August and September 2023 PMO audits, the plastic sheeting at the refuelling area was inspected. Works were underway to re-sheet the area and reinstate the gravel base of the bund (photos 3 and 4). This should be re-visited during the next PMO audit, to assess the completed remediation works.

**Photo 3.** Breaches in refuelling bund in KBP05 being repaired

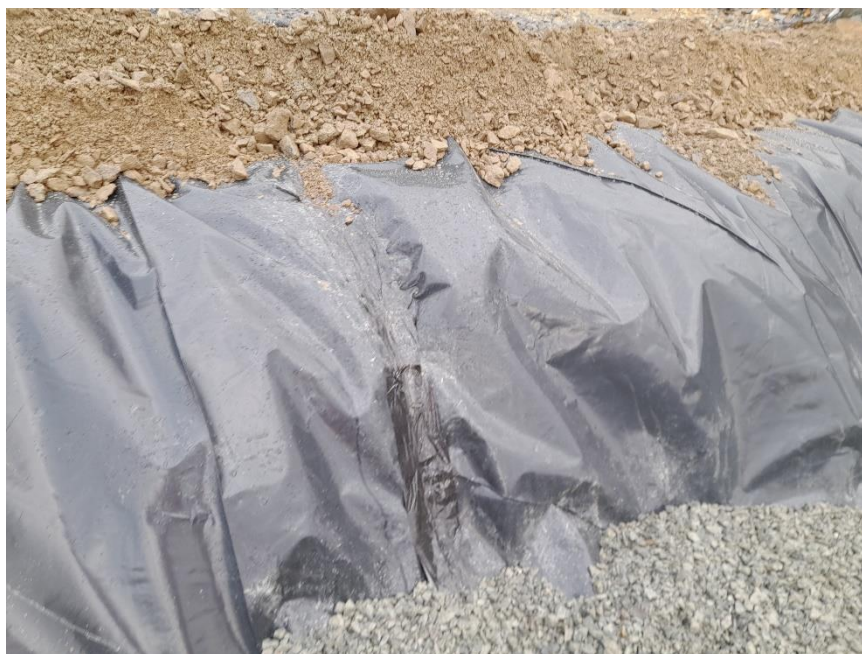
**Photo 4.** Repair of lining in refuelling bund in KBP05

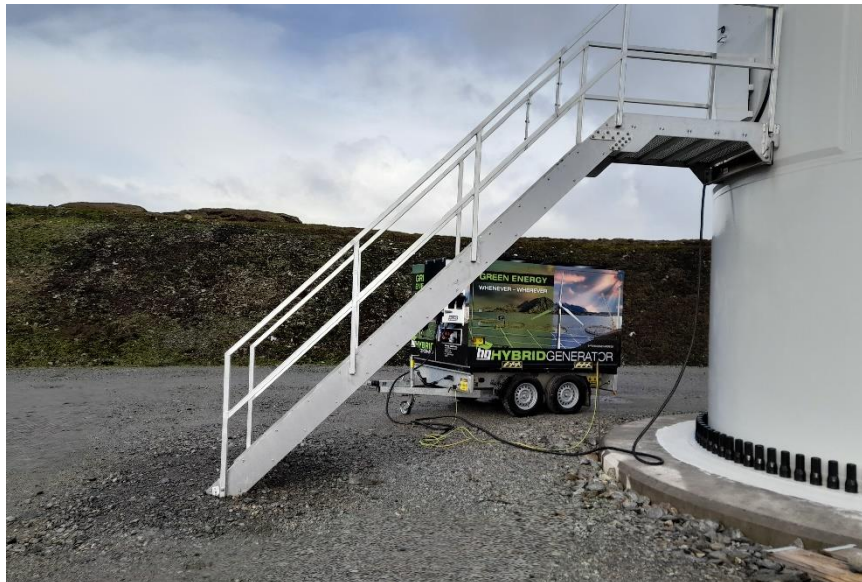
Plant nappies were observed on the majority of generators at the turbine bases across Kergord. One generator at T035 did not have a plant nappy (photo 5). SSE have informed Vestas.

**Photo 5.** No plant nappy at T035

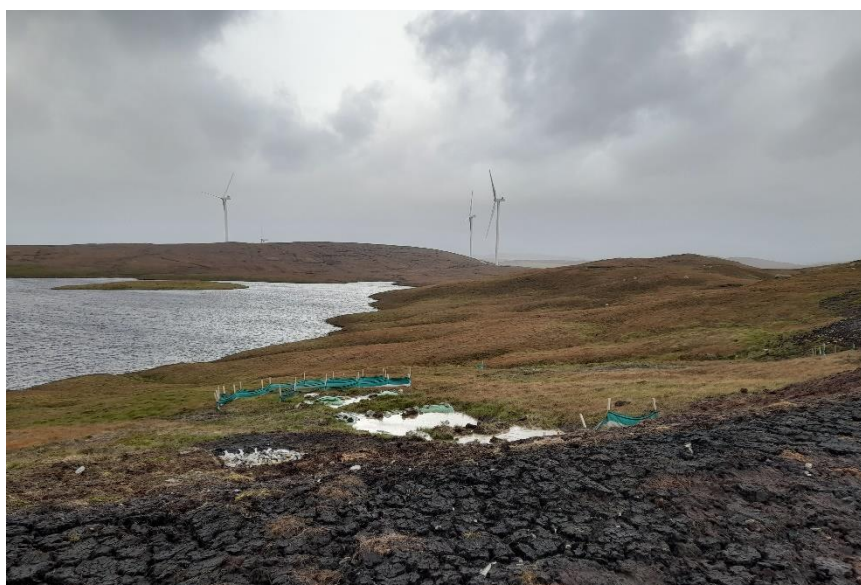
Rock is continuing to be processed from KBP03; however, no further blasting is required at this borrow pit. The water draining from the borrow pit and the surrounding area is being channelled along the track and into settlement ponds due to previous issues with silty water entering Maa Loch through a peat pipe (photo 6). The diversion and settlement ponds seem to be successfully draining, and no silty water events have been recorded to date.

**Photo 6.** Settlement ponds for diverted water from KBP03 at Maa Loch

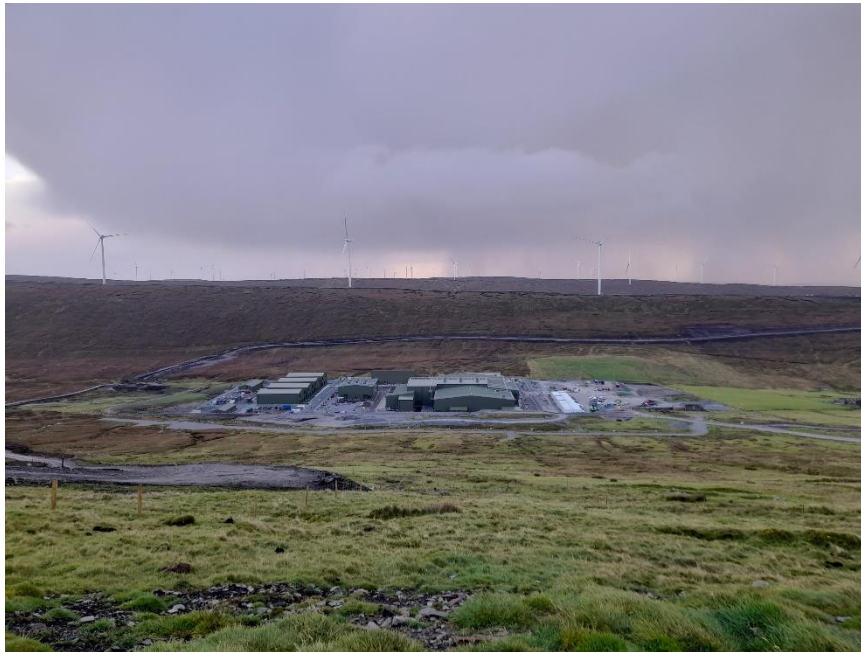
During the visit, the PMO observed ongoing work to backfill the cross-country cable trench from MKR to the substation (photo 7). It is noted that the access track will remain until the cable testing is complete. A silty water event occurred on the 10<sup>th</sup> of October which originated from the cross-country access route and led to silty water in the Burn of Weisdale. The run-off from the track had burst through the bund on the downgradient side due to a short period heavy rain, causing the silty water to bypass the existing mitigation measures. The incident occurred at a work area, where works were halted, and the plant was remobilised to resolve the issue. The bund was reinstated, and silt fences were installed (photo 8). The suspended sediment concentration of the burn fell (below the site limits) following the installation of the mitigation. The incident was reported to SEPA, who visited the site to measure the concentration of suspended sediment. The suspended sediment was reported to be within the permitted level at that time.

**Photo 7.** Cross country route from Mid Kames Ridge to substation

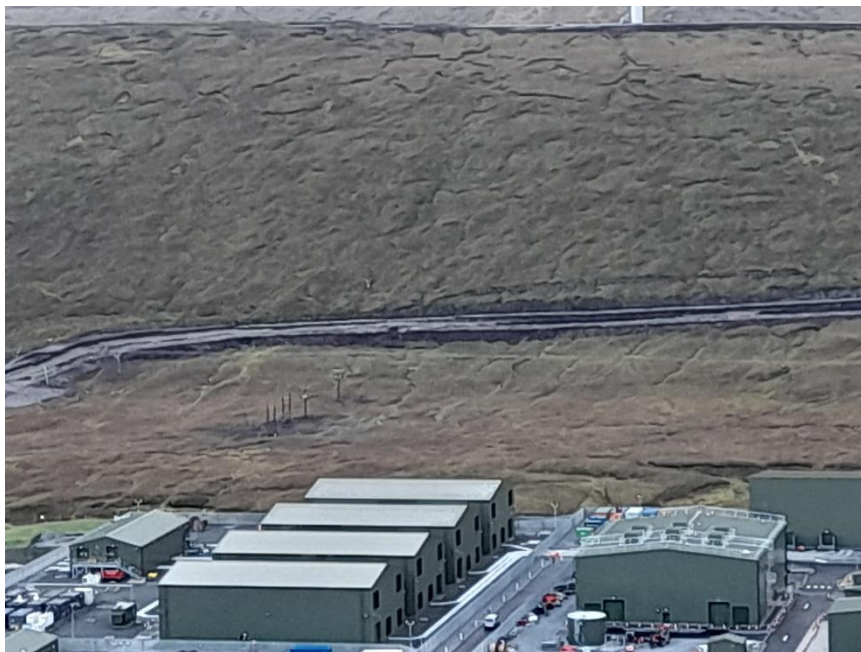
**Photo 8.** Repair of bund on the Mid Kames Ridge to substation cross country track and installation of silt fences following a silty water event in the Burn of Weisdale

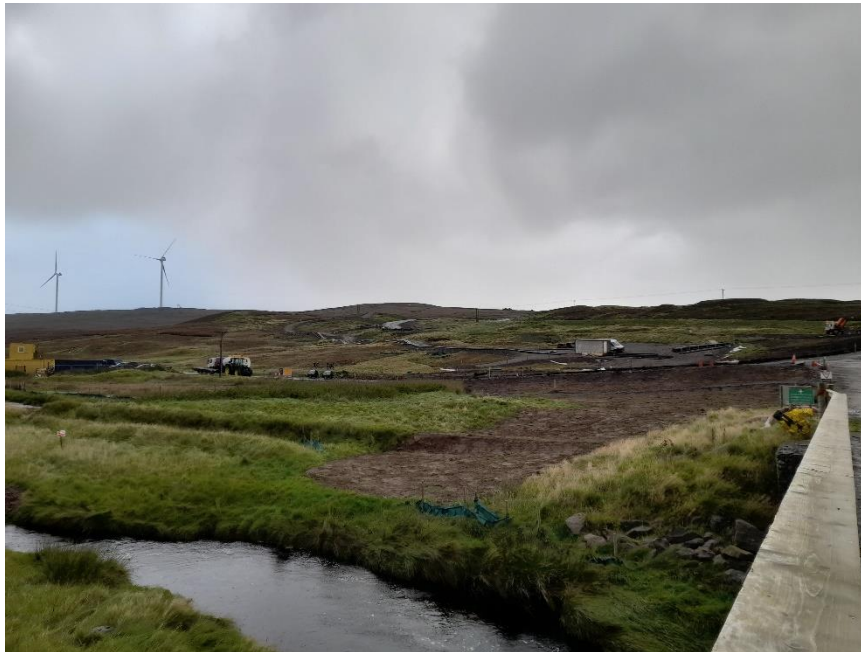
Morgan Sindall are in the process of laying a cable from the substation to the A970 on behalf of SSE Networks (photo 9). The works are outside the scope of the PMO audit; however, it is noted that Morgan Sindall are liaising with RJ Macleod to ensure they are employing correct drainage mitigation measures and the works are not impacting the reprofiling of the Sandwater Road.

**Photo 9.** Cable laying by BAM on behalf of SSE Transmission near Sandwater Road

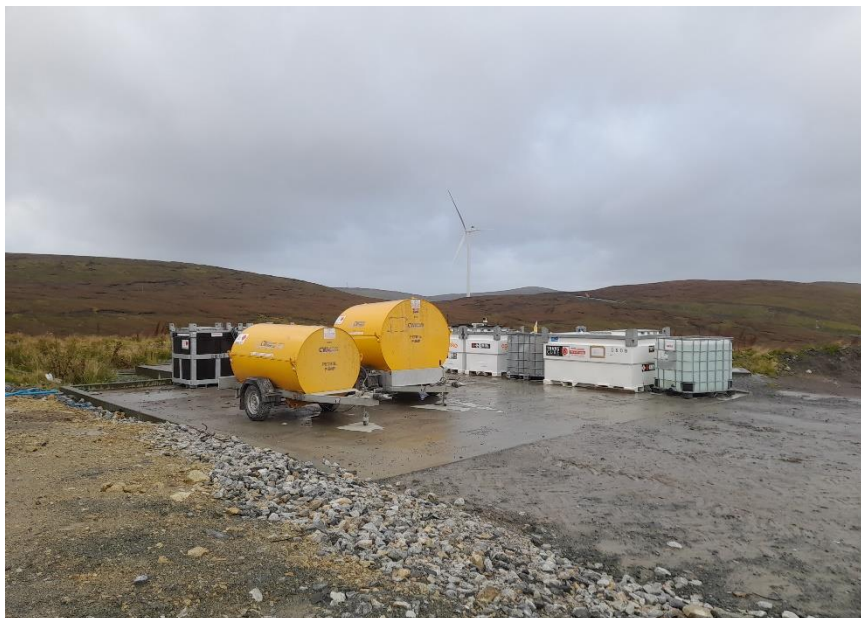
Minimal waste was being stored on this site now that the turbine erection works have been completed. Fuel bowsers were being stored on hardstanding (photo 10) and plant nappies were present under generators (photos 11 and 12).

**Photo 10.** Bowsers on hardstanding in the northern compound

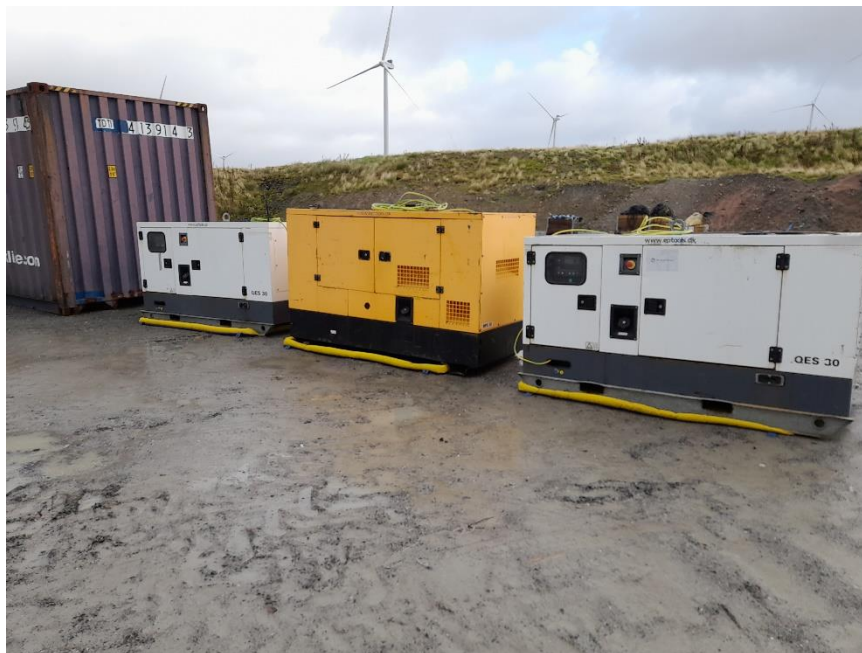
**Photo 11.** Plant nappies beneath generators in northern compound

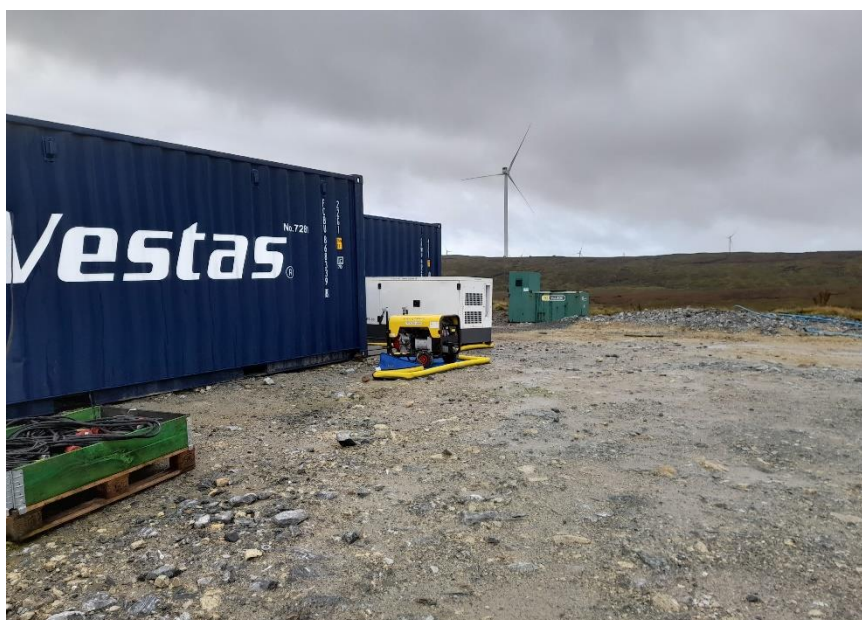
**Photo 12.** Plant nappies beneath generators in northern compound

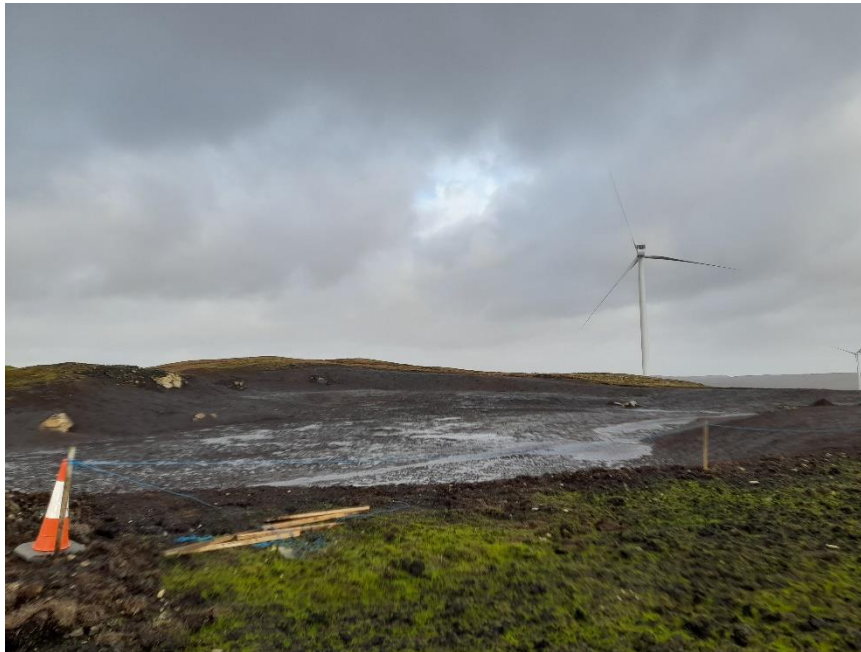
NBP01 was being backfilled and reprofiled and is near completion (photo 13). Hydroseeding will be undertaken in spring 2024. The area will be monitored for drainage over the winter months and further drainage will be installed if required.

**Photo 13.** Backfilling and reprofiling of NBP01

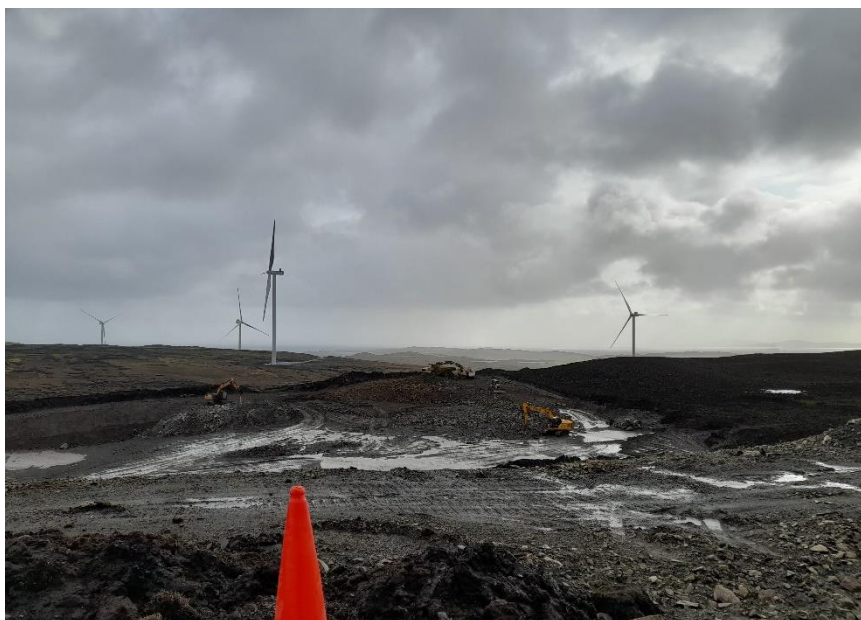
NBP05 was being reprofiled (photo 14). This included the remediation of a historical peat movement (previously reported) on the boundary of the borrow pit. At the time of the audit the peat was being pulled back up the slope as to reinstate the original profile (photo 15). The habitat management plan for the borrow pit is currently under review.

**Photo 14.** Reprofilling of NBP05

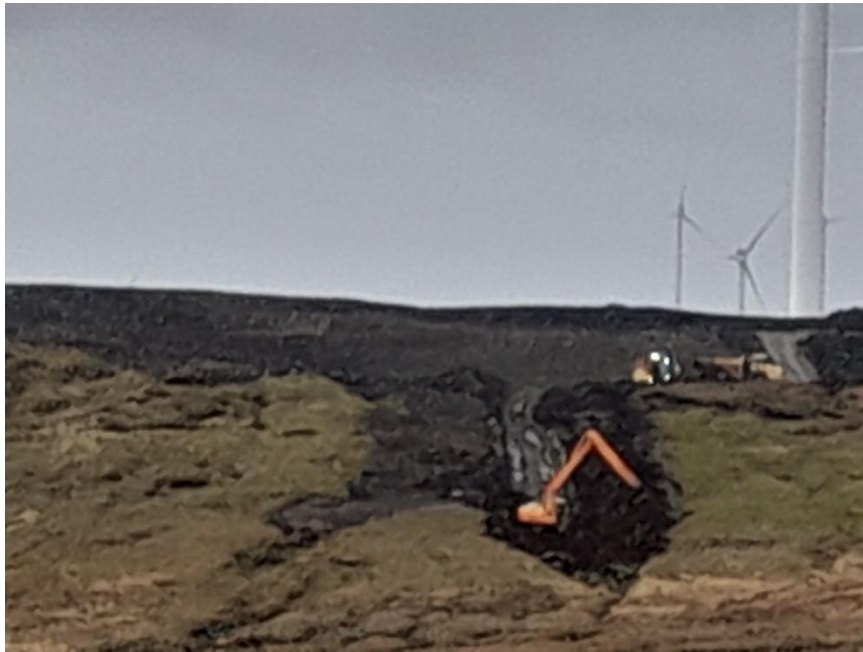
**Photo 15.** Removal of peat from historical peat slide at NBP05

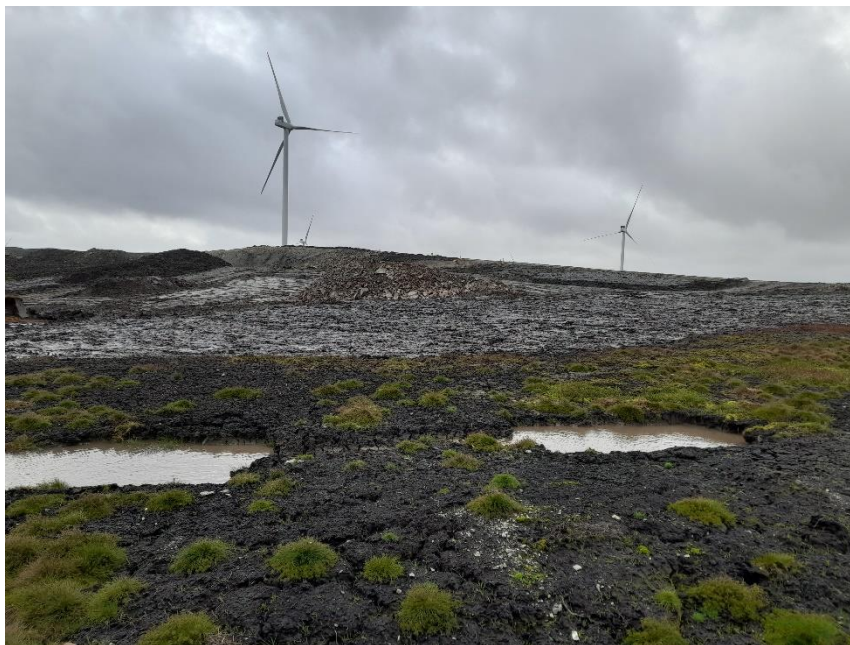
A silty water event was noted at the Burn of Flamister. The cause of the silty water is believed to be from the reprofiling of the surface in the north of the search area of NBP05. The event was of short duration, caused by a short period of heavy rainfall, and settlement ponds were constructed along the access track between the borrow pit and the turbine base on the day of the incident (photo 16). The settlement ponds will slow the movement of water so that the sediment drops out prior to entry into the tributaries that lead to the Burn of Flamister. The drainage in this area will continue to be monitored and should be revisited during the next PMO audit.

**Photo 16.** Settlement ponds installed at NBP05

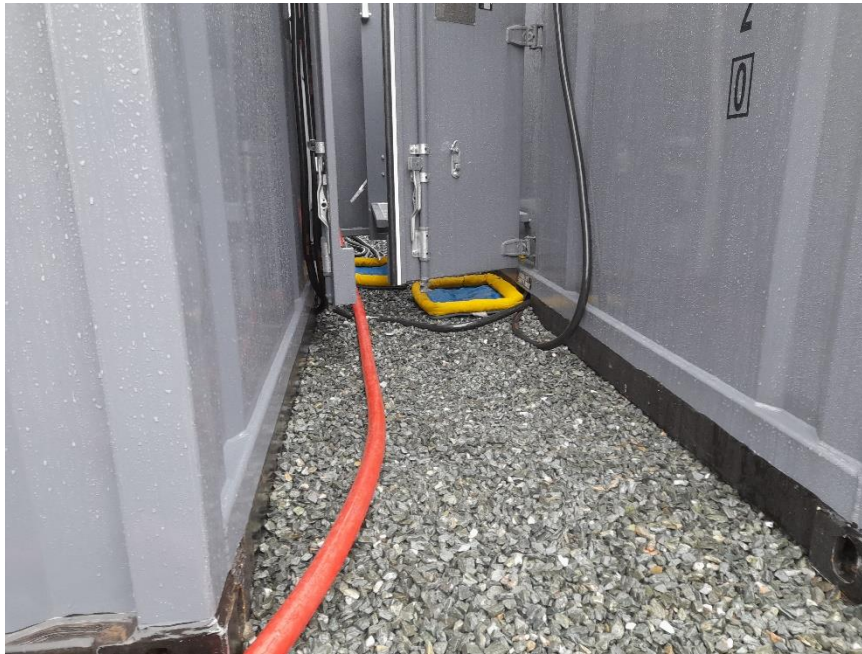
The original laydown and refuelling area in the substation is being decommissioned, leading to minimal waste and equipment being stored in this area. In order to commission the substation transformers, a series of four high voltage generators have been installed adjacent to the transformer halls to provide the power for the commissioning process. Refuelling of the four generators was being undertaken at the time of the audit. The refuelling was being done in line with the RAMS. Drip trays, spill kits and fire extinguishers were all in place at the time of the refuelling (photo 17).

**Photo 17.** Drip trays / plant nappies in place during the refuelling of generators in the substation
