Intended for
Viking Energy Wind Farm LLP

Date
November 2023

VIKING ENERGY WIND FARM PLANNING MONITORING OFFICER AUDIT REPORT 037: 14TH OCTOBER TO 22ND NOVEMBER 2023

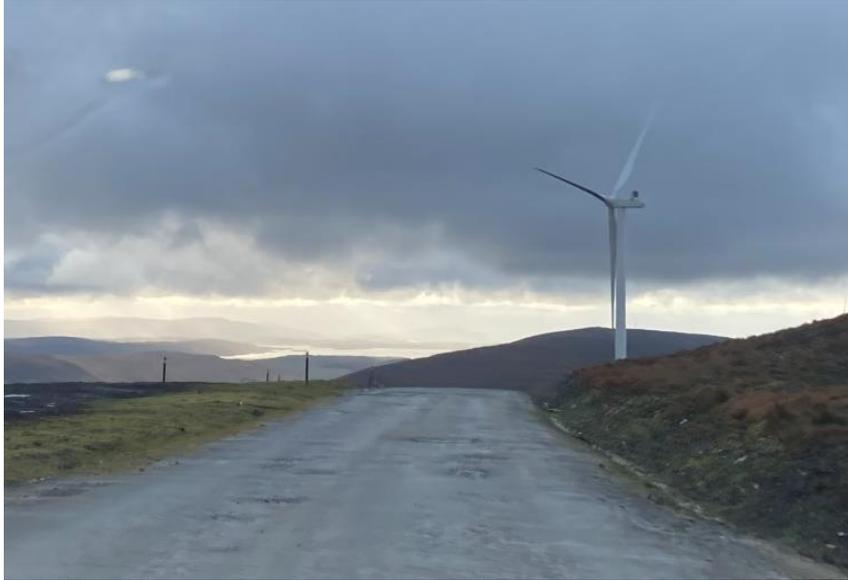
The majority of the cable trenches have been backfilled and all cable jointing and cable testing are now complete. Much of this area has been reinstated and hydroseeded. Hydroseeding works concentrated on the backfilled cable tracks and have been completed for this season. The hydroseeding appears to be successful, with good growth observed on completed areas across Kergord (photo 1). The remaining of the hydroseeding works will be undertaken in spring / summer of 2024.

Photo 1. Hydroseeding on backfilled cable trenches north of T021

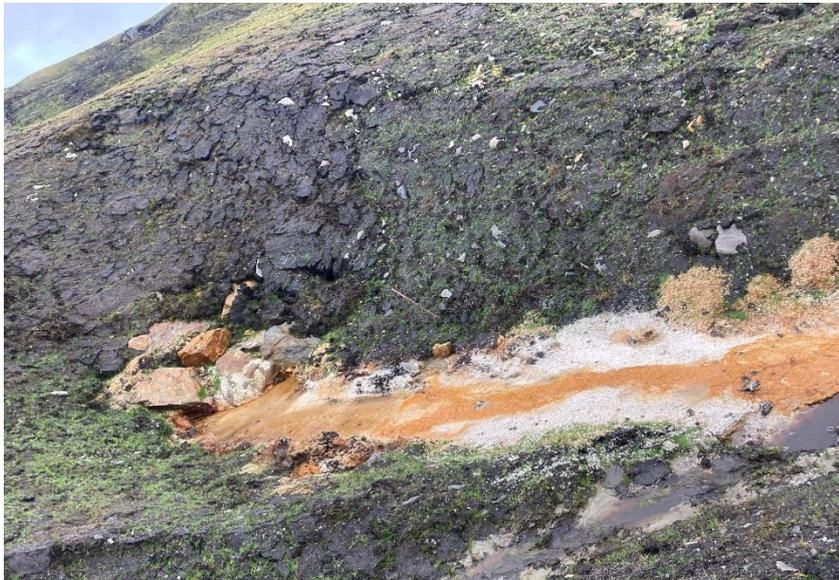
The drainage and water treatment system at KBP02 were observed during the audit visit (photo 2). The drainage from the borrow pit is being continually monitored and the treatment system continually checked and maintained to ensure best performance. SSE and The Principal Contractor are aware that further upgrades to the drainage system into the Burn of Lunklet may be required. This will be continually assessed over the winter period and chemical testing and reporting will continue to be shared with SEPA.

Photo 2. Drain along the track off KBP02

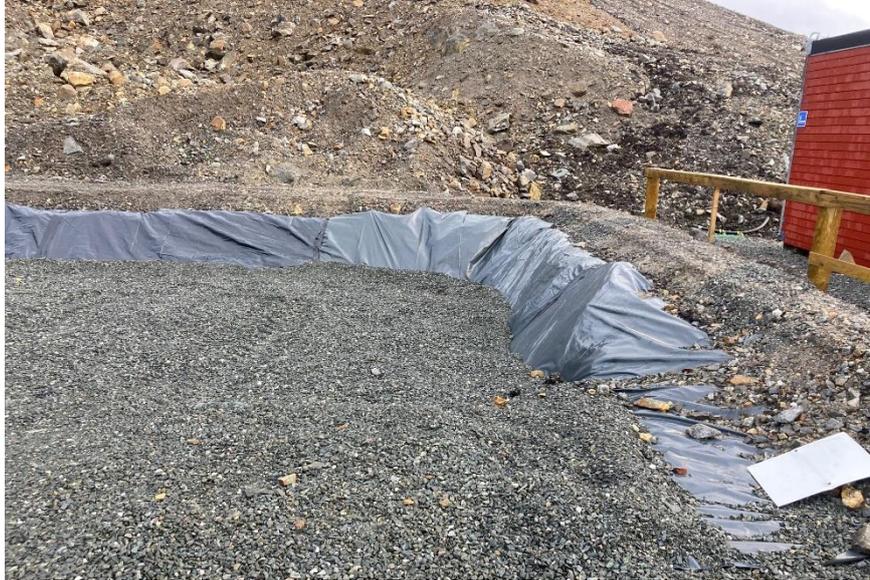
KBP05 is being used by Vestas as a satellite compound and comprises a refuelling bund. During the previous audit visit, works were underway to re-sheet the area and reinstate the gravel base of the bund. This area was inspected during the November audit visit. It was observed that satisfactory works have been undertaken, with the plastic sheeting having been successfully replaced and showing no evidence of wear or tear (Photo 3 and 4). It was indicated that limited activity is now taking place at this compound, except for welfare facility and the refuelling bund. Reprofiling of the back of the pit was observed during the audit visit (photo 5). The compound was observed to be tidy and well maintained.

Photo 3. Repaired refuelling bund in KBP05

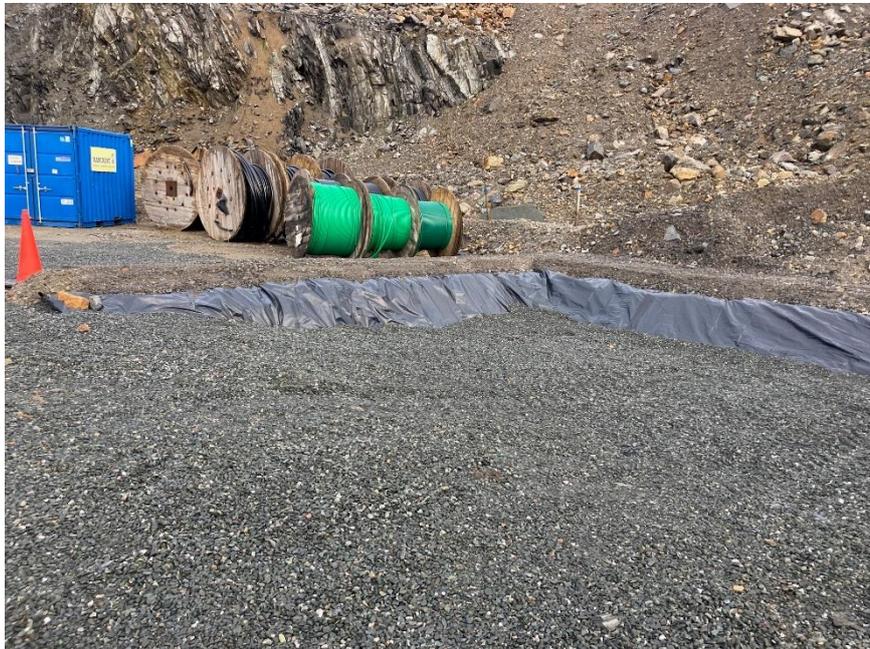
Photo 4. Repaired refuelling bund in KBP05

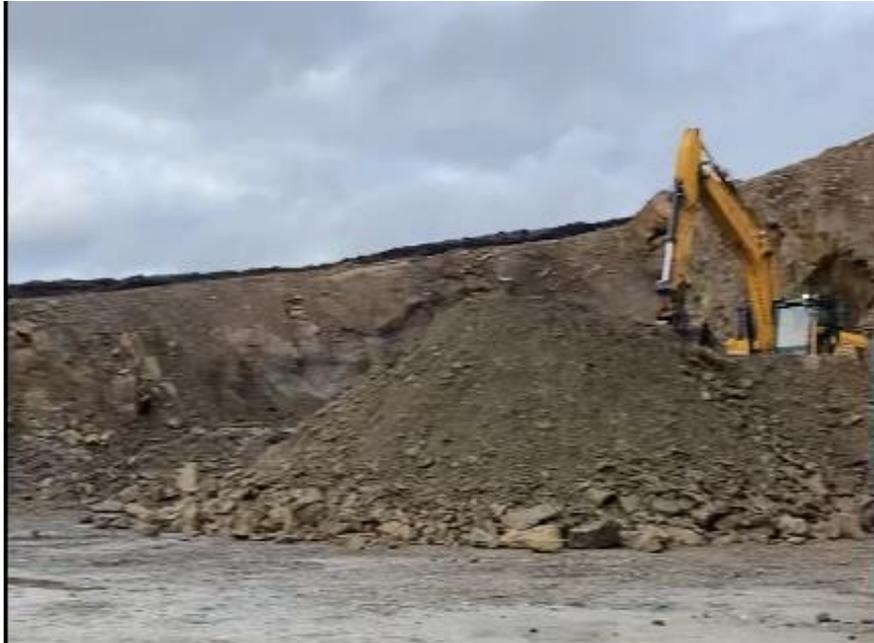
Photo 5. Reprofiling at the back of KBP05

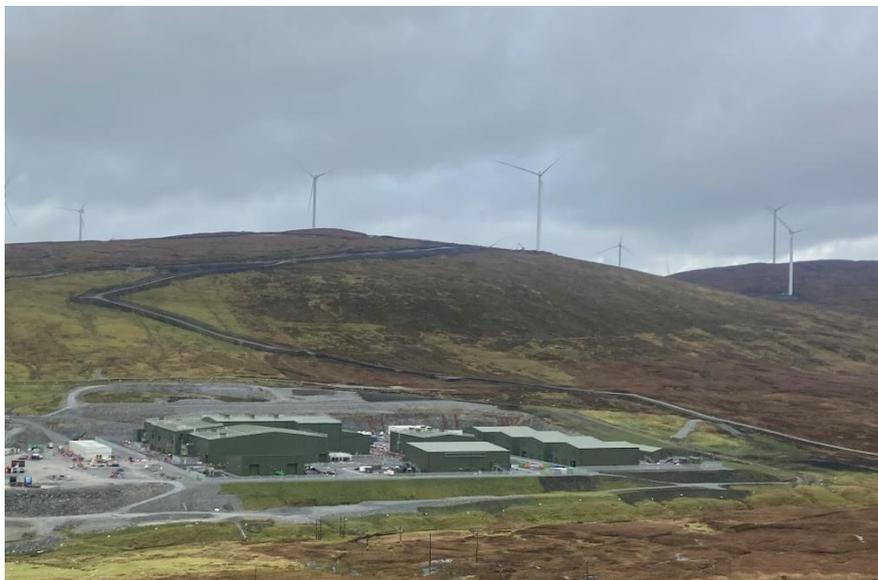
During the visit, backfilled trenches along the track from Upper Kergord to the substation were observed from a distance at Mid Kame Ridge, with on-going backfilling works being undertaken towards the upper section of the track (photo 6).

Photo 6. Backfilled cable trench along the cross-country route from Upper Kergord to the substation

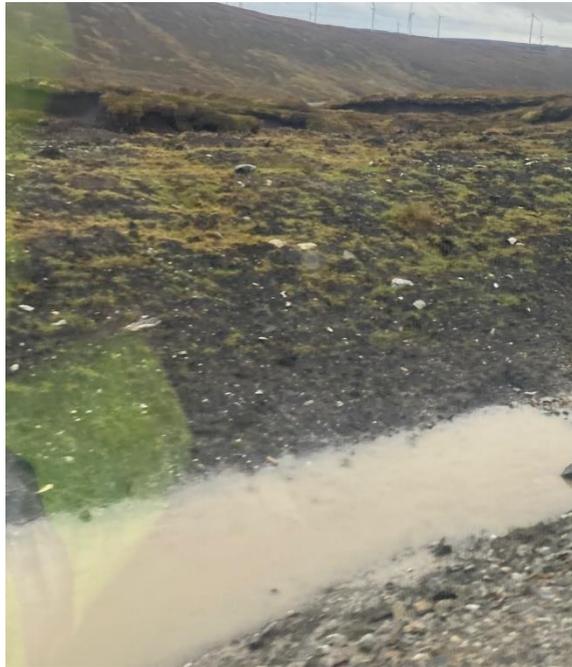
During the audit, silty water was observed in the drains at the bottom of the MKR track at T046 (photo 7), before the drain water flows into settlement ponds. The track was observed to be muddy (photo 8), which was explained to be as a consequence of the increased traffic due to the temporary closure of the Sandwater track to allow permanent drainage installation works to proceed. The silty water was therefore concluded to be surface runoff from the muddy track. SSE indicated that they would report these issues for the Principal Contractor to deal with following the audit visit. SSE also indicated that the report of such issues forms part of the snagging process which includes drain improvement, where required. It should be noted that while there was evidence of dirty water in the drains from the track and hardstanding areas, the drains and downstream silt fences were functioning as intended to control water and allow it to settle. There was no evidence of off-site silty water migration from the drains.

Photo 7. Silty water in drains along MKR track, off T046

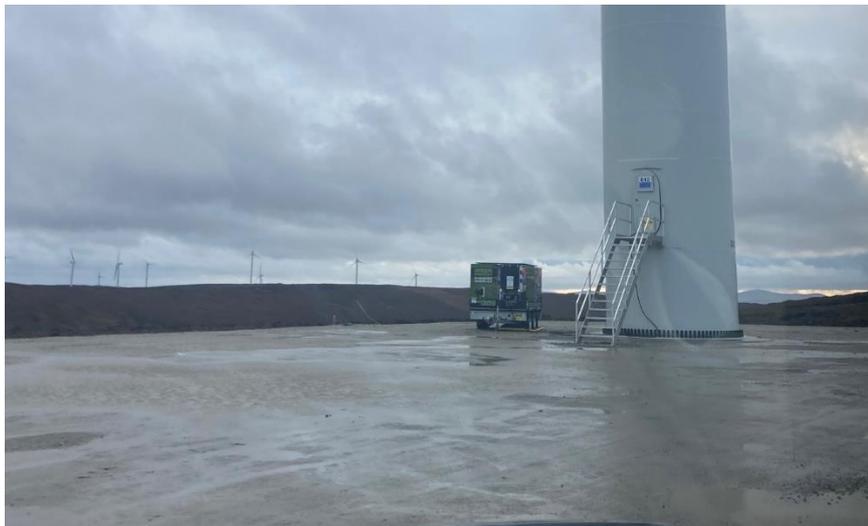
Photo 8. Mud on the MKR track, off T042

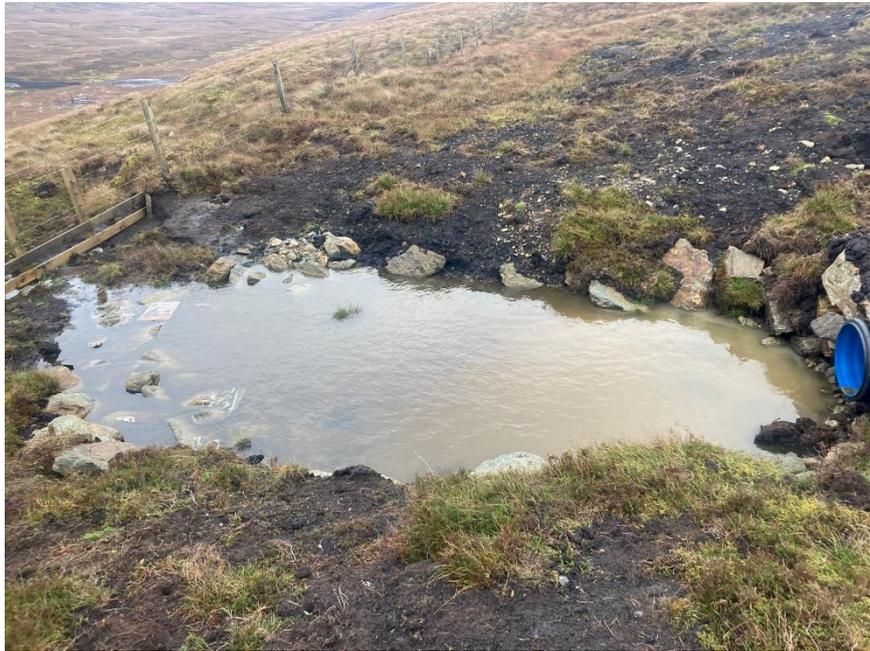
Litter was noted on settlement ponds along and to the west of the MKR track (photo 9). It was indicated that a litter purge was planned across the entire site over the next few weeks following the audit visit. It was discussed that tool box talks about littering should be regularly given to all contractors to prevent litter being left across the site, particularly once the litter purge will be completed to avoid re-littering of the site. The next audit visit should put particular focus on noting whether litter is present across the entire site, and confirmation that contractors have been reminded of their duty to not create any litter.

Photo 9. Litter observed in settlement pond west of the MKR track between T038 and T037

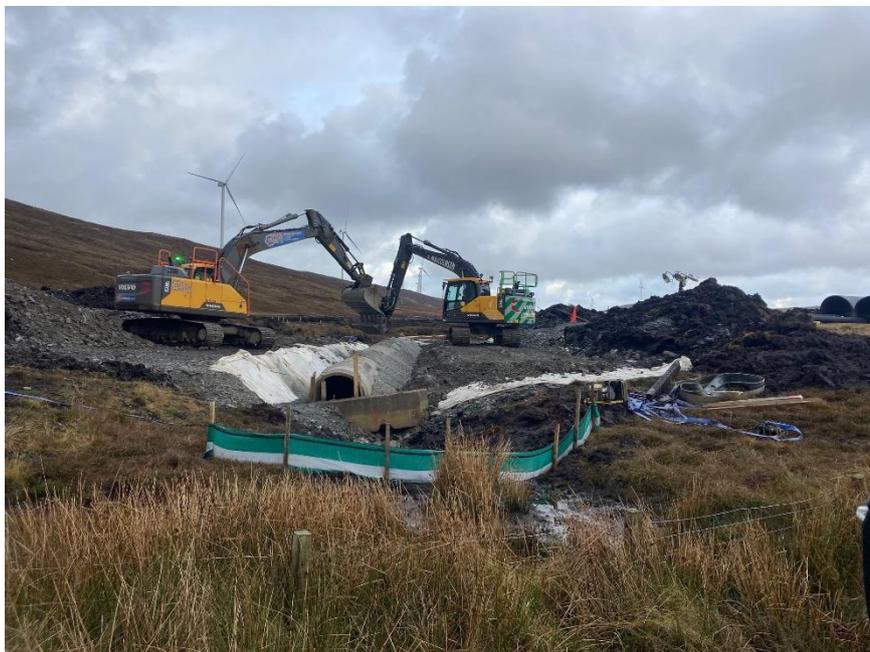
At Sandwater track, planned culvert replacement works were on-going during the audit visit (third culvert), with a stone backfill being placed over the last of the three replaced culverts (Photo 10). Pumps were observed to be in place to manage the water from around the works and prevent any impact to the Sandwater Loch. Completed backfilling of the second culvert was also observed (Photo 11), with headwalls and landscaping still to be undertaken. The Geotechnical advisor for the works was present at the time of the visit and gave a rundown of the works undertaken to date, with no major concerns reported. It was indicated that the works were nearing completion. The next audit visit should include an inspection of the completed works.

Photo 10. On-going planned culvert replacement works at Sandwater track

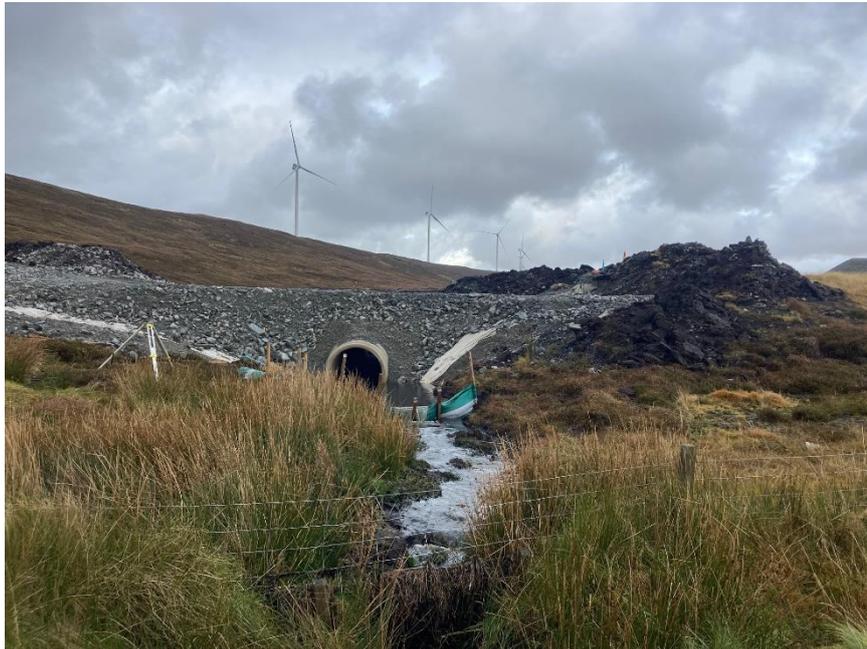
Photo 11. Completed backfilling of the second culvert replacement at Sandwater track

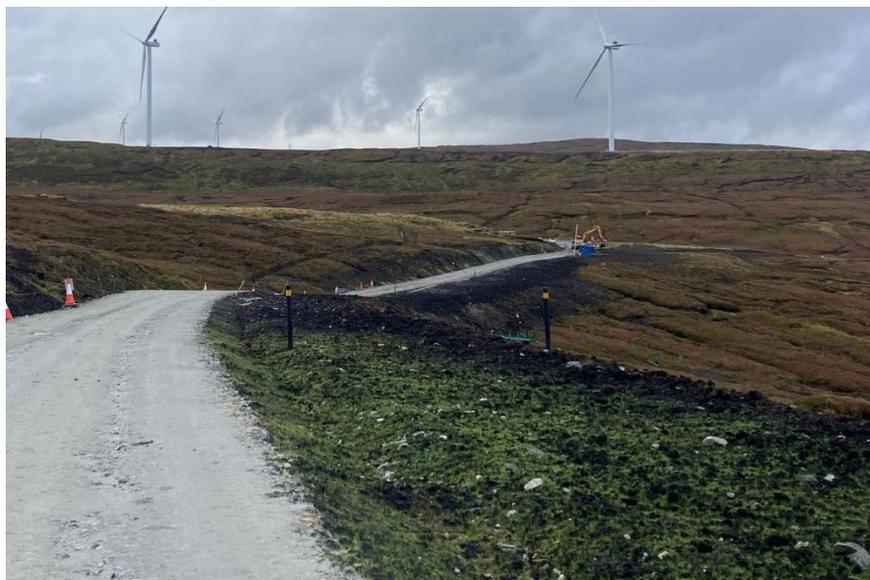
All cable trenches have been backfilled, with the completion of the backfill of the cross-country routes on-going during the visit. Areas of hydroseeding on the reinstated cable trenches were observed to present a good vegetation cover (photo 12).

Photo 12. Hydroseeding on reinstated cable trench at North Nesting

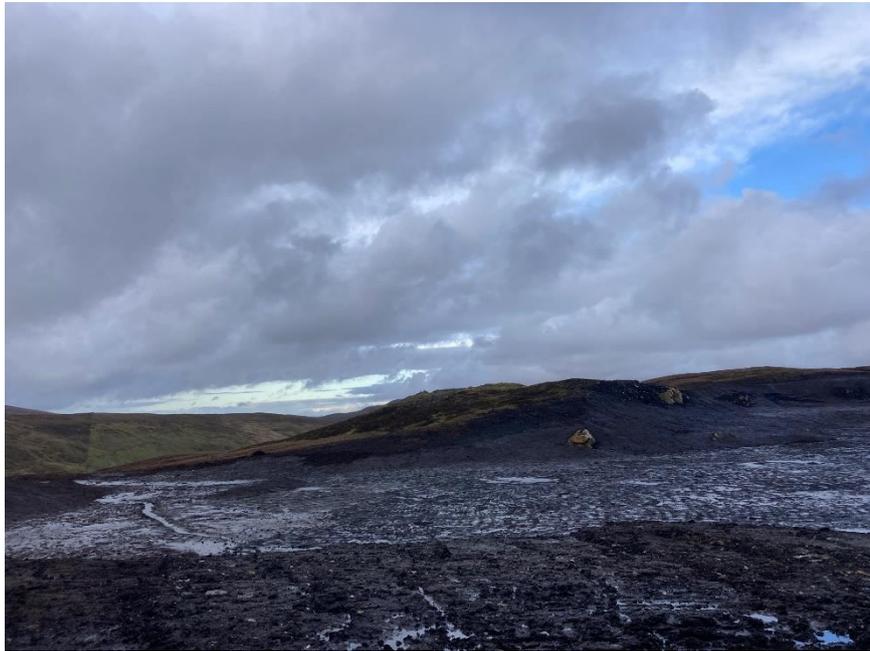
During the audit, on-going backfilling and reprofiling works at NBP01 were observed (photo 13). The central area of the pit was observed to be waterlogged with a naturally formed drainage channel in the centre of the pit running in a south to north direction (photo 14). This area is under constant monitoring and improvement works such as drains may be required. Final profiling works are ongoing and in discussion with SSER. This will include the monitoring of the designed passive drainage system. Hydroseeding is scheduled to take place in spring 2024.

Photo 13. Completed backfilling and reprofiling at NBP01

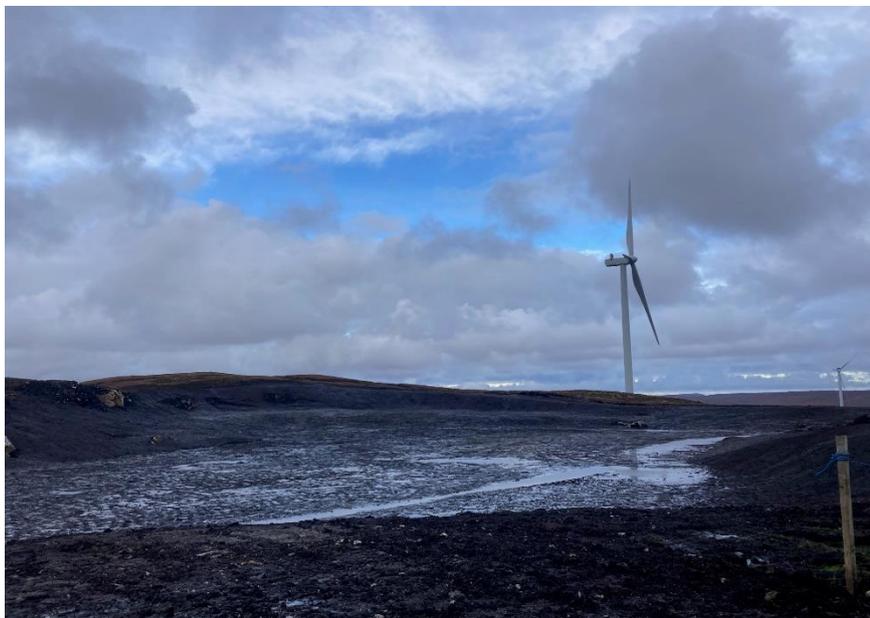
Photo 14. Completed backfilling and reprofiling at NBP01

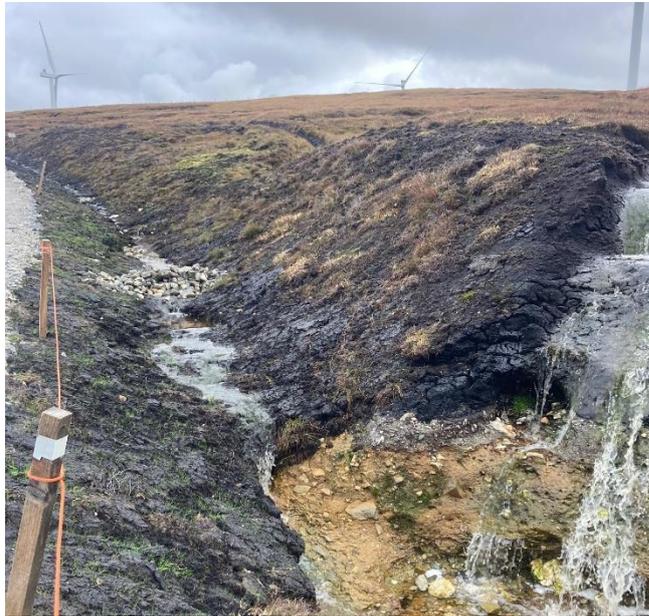
Drains were observed along the track 100m from the access gate to North Nesting, with clear water observed to be discharging from the drain (photo 15).

Photo 15. Drains along the track at North Nesting, 100m from the access gate

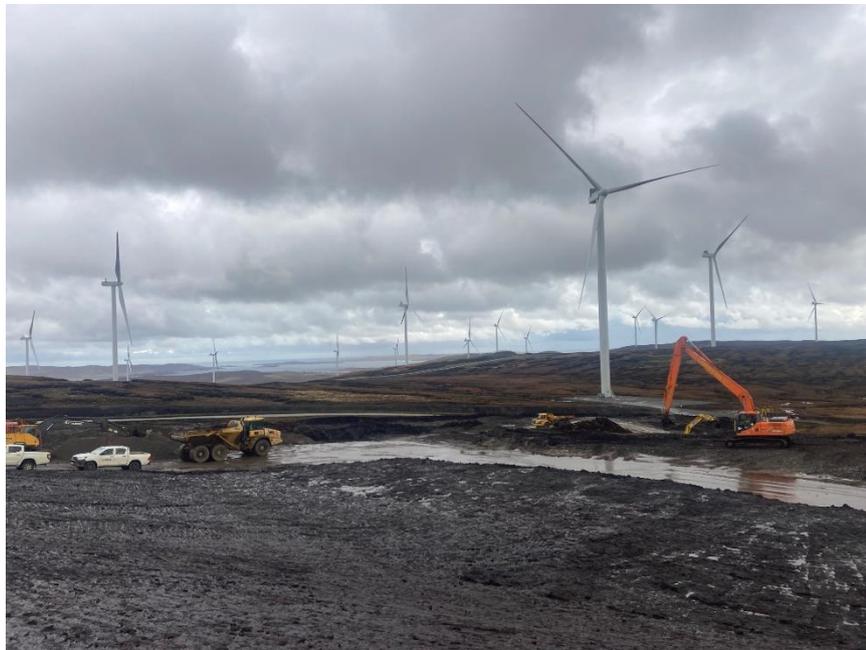
During the audit visit, reprofiling works at NBP05 were observed. At the time of the audit the peat was being placed on the edge of the slope to reinstate the original profile (photo 16), and stones were being placed on the track that runs through the pit (photo 17). An alternative reinstatement plan for NBP05 is being progressed through consultation to create an enhanced biodiversity area.

Photo 16. On going works at NBP05

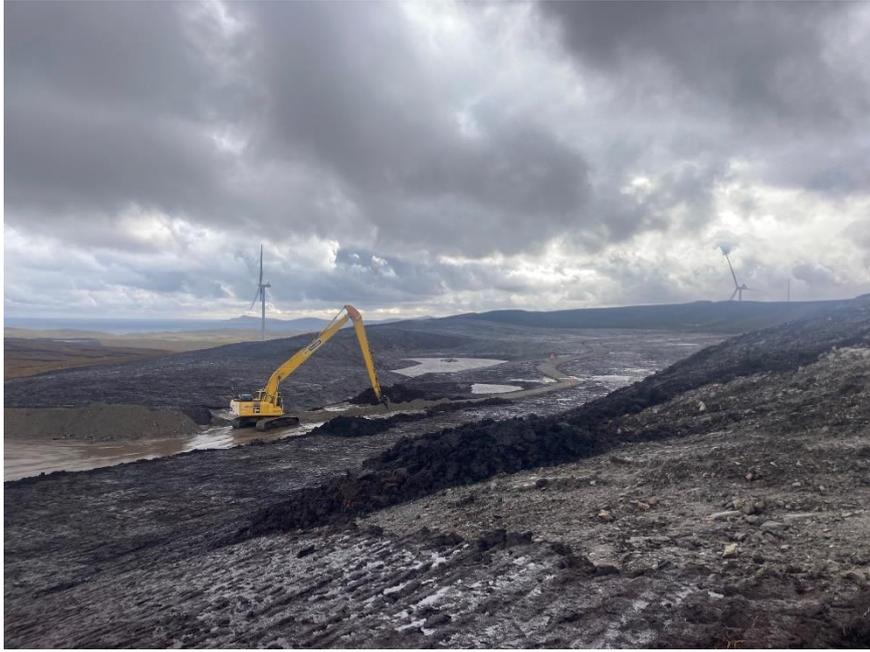
Photo 17. On going works at NBP05
