Date
December 2023

Project Number
1620009158

VIKING ENERGY WIND FARM PLANNING MONITORING OFFICER AUDIT REPORT 038: 23RD NOVEMBER TO 19TH DECEMBER 2023

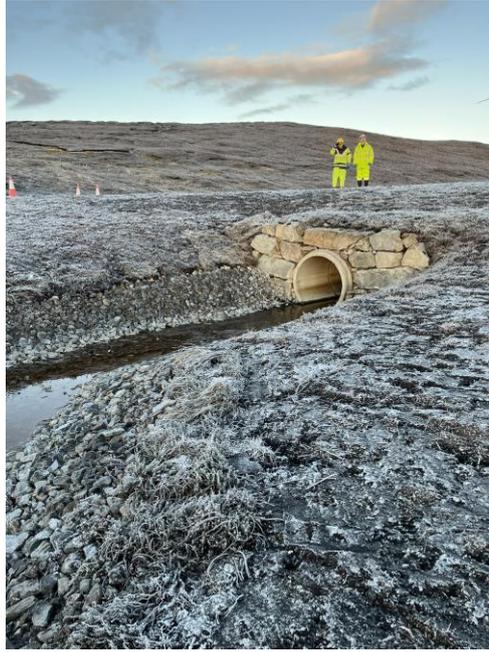
Observations were made at the Sandwater track. Culvert replacement works, which were ongoing during the November audit visit, were noted to be complete (photo 1 and 2).

Photo 1. Sandwater Track Culvert

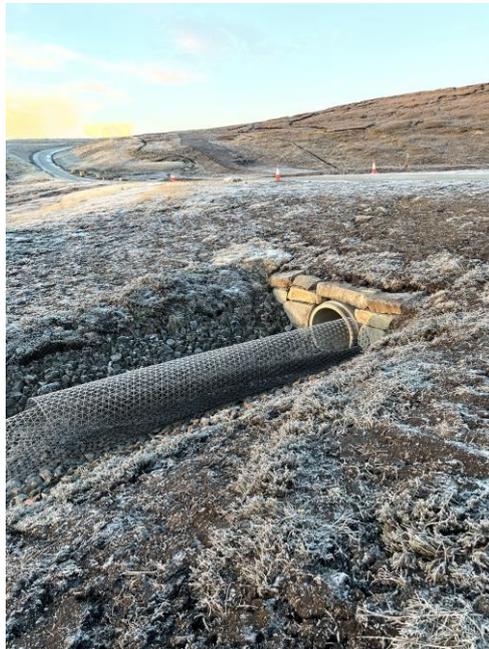
Work sites were noted to have been left tidy with the exception of some geotextile (photo 2), which the SSE Environmental Advisor undertook to report (to request uplift) on return to the main compound.

Photo 2. Geotextile reported for uplift at Sandwater Track

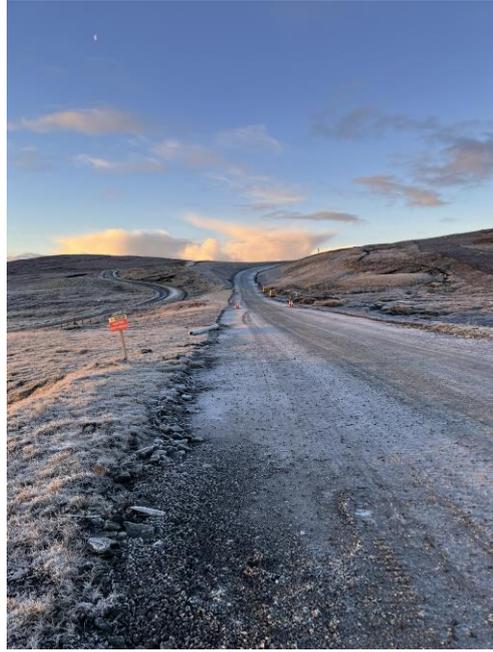
Photo 3.

As previously reported, the adjacent cross country cable works have been completed and ground reinstated (photo 3). Watercourses were running clear at the time of the audit.

Sandwater Track – Looking west towards Kergord – reinstated cross country cable track on right of image

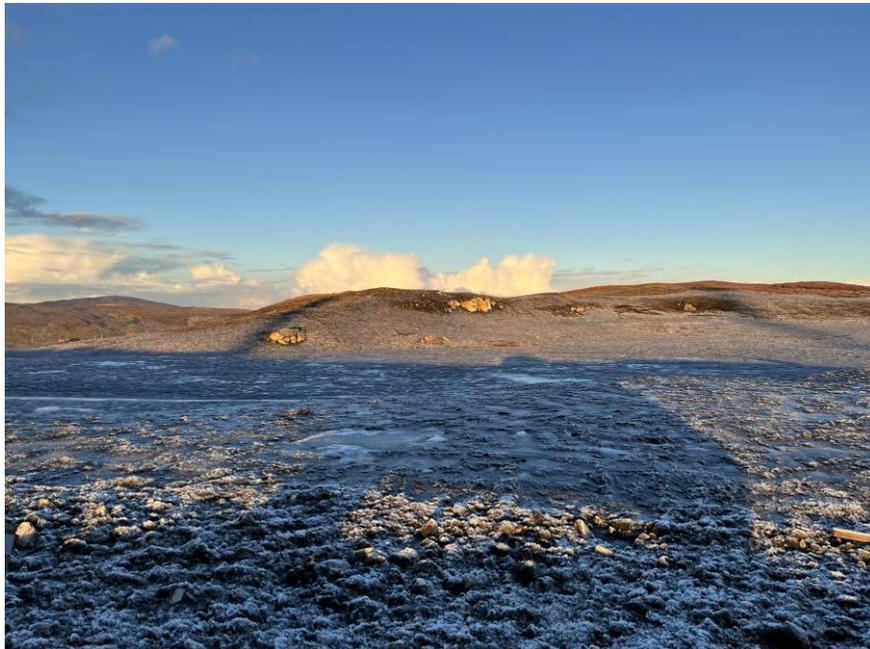
Photo 4.

North Nesting NBP01 reinstatement

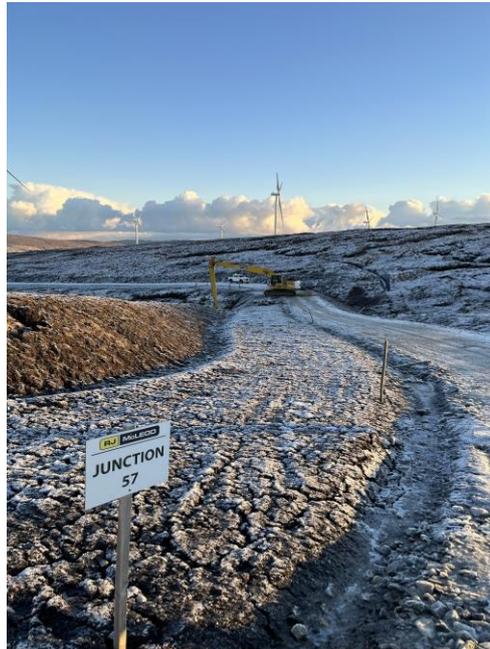
Activities in this area during the audit included the construction of a headwall on a watercourse crossing near Spur 43/ junction 57 (photo 5 and 6).

Photo 5. Headwall works near Spur 43/junction 57 North Nesting

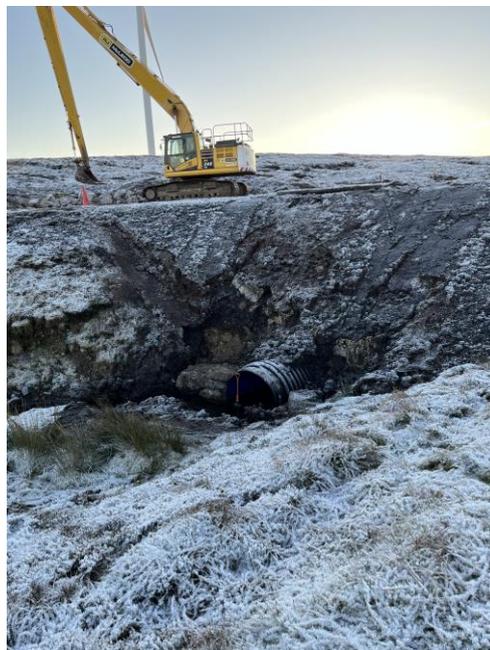
Photo 6. Headwall works near Spur 43/junction 57 North Nesting

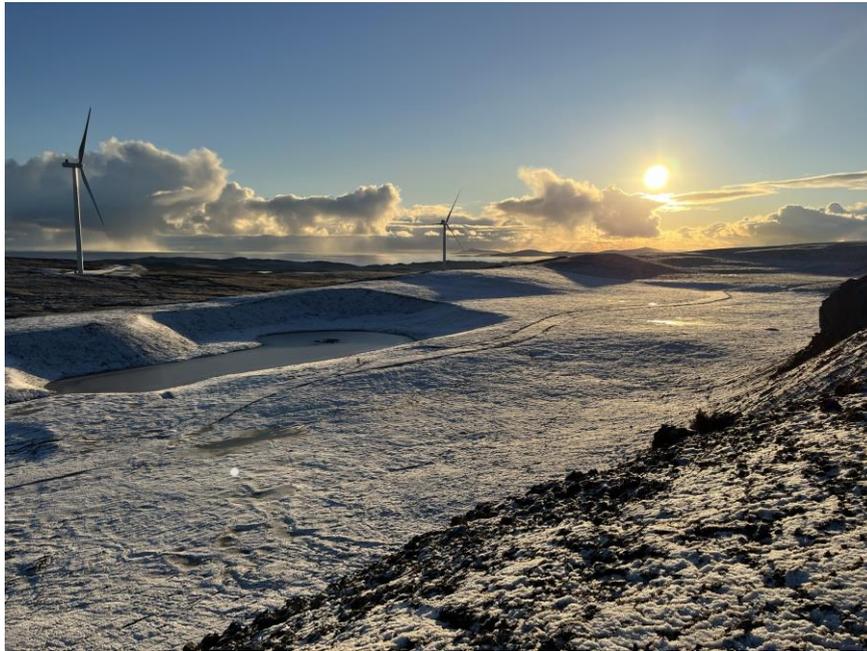
During the audit visit, the restoration work at NBP05 was observed (photo 7).

The PMO understands that discussions are progressing between SSE and RJM to agree an alternative reinstatement plan, including woodland planting within the restored NBP05. RJM are in the process of finalising detailed proposals with a view to implementing in 2024 prior to final handover.

Recent work had been completed to seek to provide a revised surface water management strategy downstream of NBP05. Drainage mitigation and the diversion of surface water flows was carried out to prevent against silty water run out from the north east extremity of the reinstated borrow pit as had been noted during a period of heavy rain. The PMO understands that the SSE ECoW will continue to monitor this in the new year to confirm performance and acceptance.

Photo 7. NBP05 reinstatement profile - Nesting

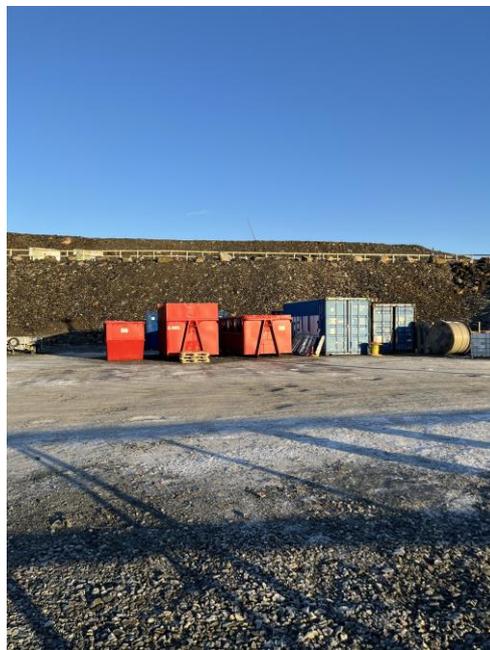
The car parking, original site offices and welfare facilities are functioning well. The lower level only was observed during the site audit and appeared tidy. It was noted that preparations are underway for the removal of a significant proportion of the temporary office and welfare provision in early 2024.

Photo 8. Main Compound
