Intended for
Viking Energy Wind Farm LLP

Date
January 2024

Project Number
1620009158

VIKING ENERGY WIND FARM PLANNING MONITORING OFFICER AUDIT REPORT 039: 18TH DECEMBER 2023 TO 19TH JANUARY 2024

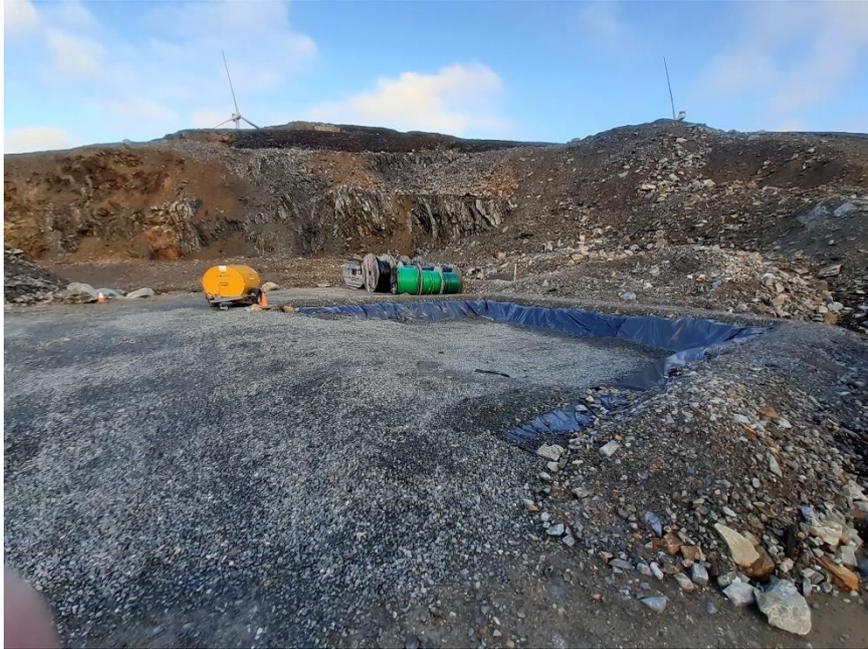
KBP05 is being used by Vestas as a satellite compound and comprises a refuelling bund. This area was inspected during this audit visit. The plastic sheeting lining the bund was inspected and presented no evidence of wear or tear (Photo 1). A fuel bowser was however noted to be present outside of the bund, this was reported to Vestas via RJM and following the audit the bowser was taken into the bunded area.

Photo 1. Fuel storage area at KBP05

Issue	Auditor Comments	Required Action	Action Owner	Status
<p>Pollution Prevention and Waste (e.g. use of spill kits and littering)</p>	<p>During the August 2023 audit, the PMO observed the plastic sheeting present on the walls of the fuel storage bunded area at the Vestas Satellite compound to be damaged. A direct breach in the floor of the refuelling area was observed.</p> <p>During the September 2023 audit, the PMO observed that effort has been made to patch the damage. However, direct breach to the floor of the refuelling area can still be observed.</p> <p>During the October 2023 audit, further works were being conducted to repair the breach. This however did not result in any spill or environmental incidents.</p> <p>During the subsequent audits, the bund was observed to have been successfully repaired and in good condition.</p> <p>A fuel bowser was observed to have been left outside of the bunded area. This was reported and sorted following the audit visit. This did not result in any spill or environmental incidents.</p>	<p>Replacement of damage plastic sheeting when required.</p> <p>Good maintenance and care of plastic sheeting during operations required.</p> <p>SSE to conduct audit of the compound to ensure good condition of bund is maintained and storage of bowsers within bunded area.</p>	<p>Vestas</p>	<p>Amber</p>

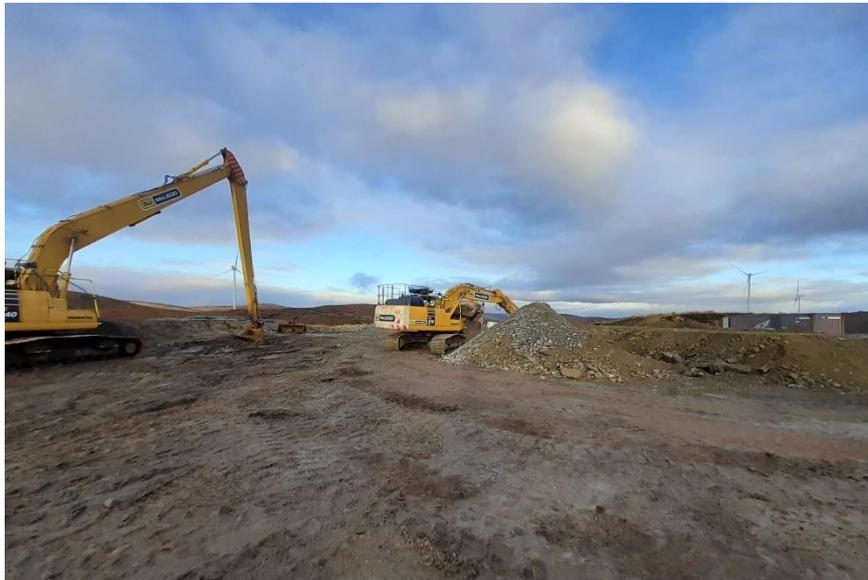
The western section of the compound is being retained by SIC Road Department as a storage area and is being regraded and levelled (photos 2 and 3). An access road will link this area to the existing SIC access point of the A970 south of the windfarm access point.

Photo 2. Reinstatement of North Compound

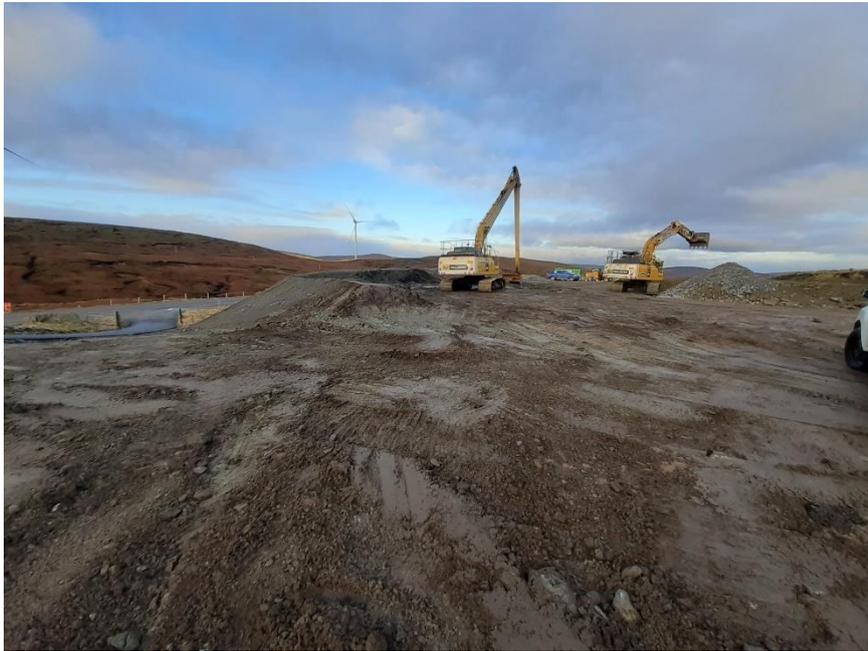
Photo 3. Reinstatement of North Compound

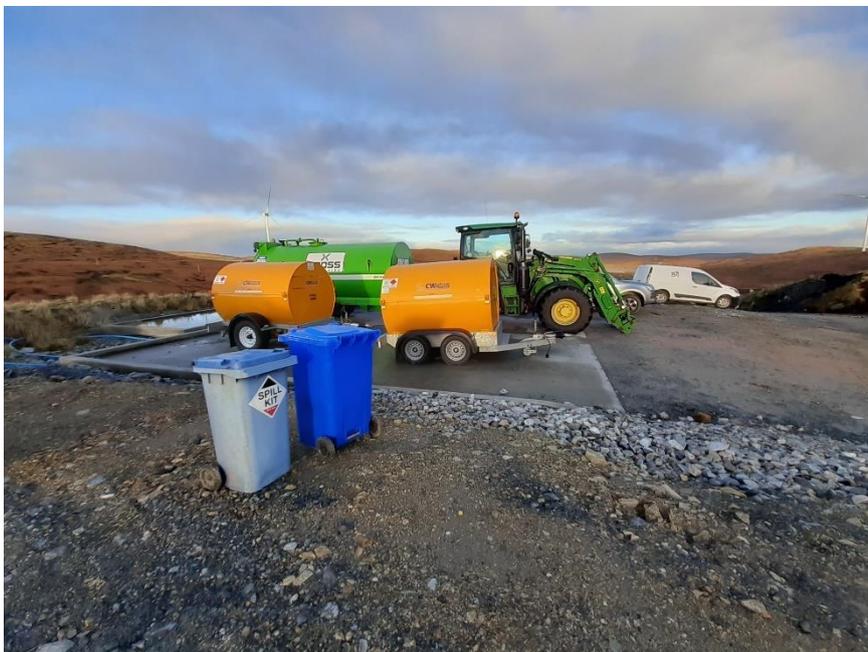
Evidence of good fuel storage practice was noted during the audit (photo 4). The plinth and interceptor present onsite will be retained by SIC in the final design.

Photo 4. Fuel storage good practice at North Compound

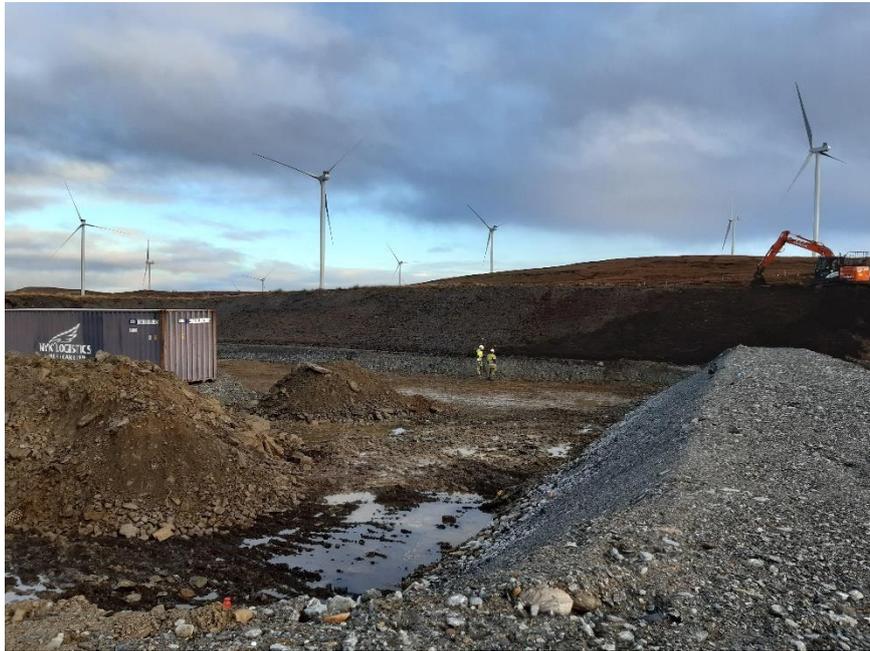
A container was noted to be present onsite (photo 5); this will be removed by Vestas in due course.

Photo 5. Setting out for North Compound new car park

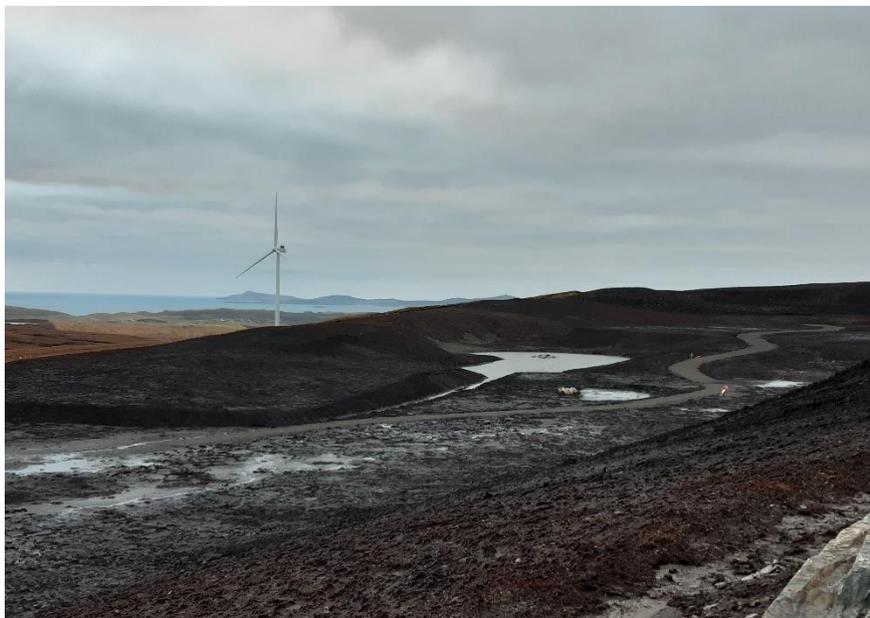
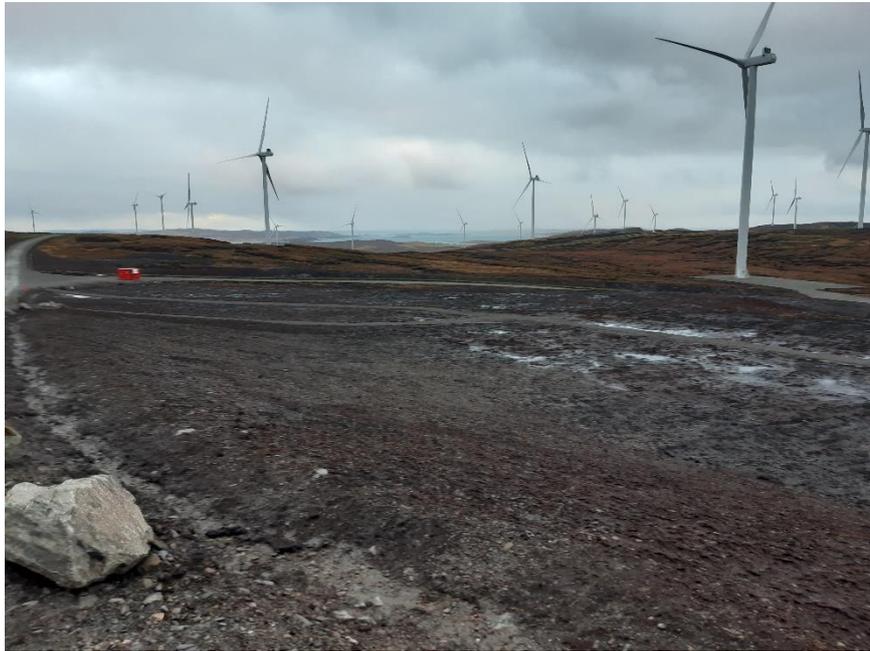
During the audit visit, the restoration work undertaken to date at NBP05 was observed (photos 6 and 7).

The PMO understands that reprofiling has largely been completed, and that SSE ECoW will continue to monitor drainage to confirm performance and acceptance.

RJM design team (SWECO) will be attending site in March 2024 to discuss sign off on the geotechnical aspects for the upfill of all borrow pits, including NBP05.

Discussions are continuing between SSE and RJM to develop an alternative reinstatement plan which includes a native woodland within the restored NBP05.

It is understood that the outstanding works required at geotechnical event 016 (corresponding to a movement of peat located on the eastern side of NBP05) have been agreed with RJM and will be actioned over the coming weeks. The works will require signing off by all parties, it is anticipated that this will take place in March 2024.

Photo 6. NBP05 restoration works completed to date

Photo 7. NBP05 restoration works completed to date

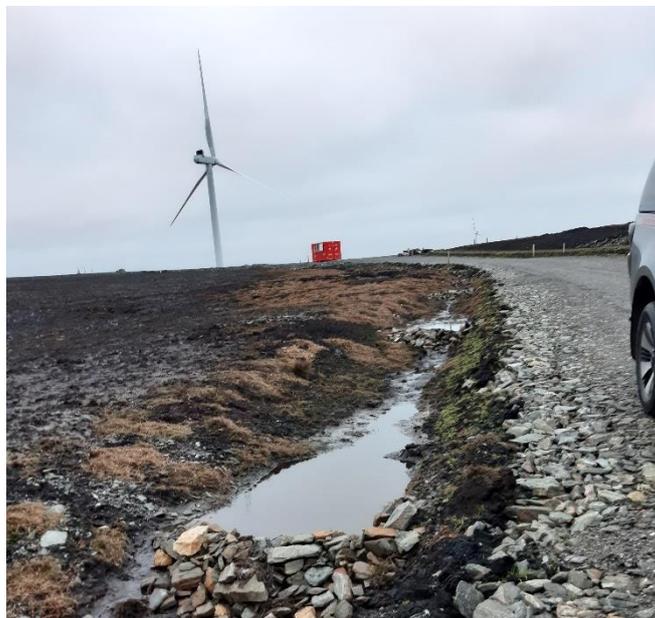
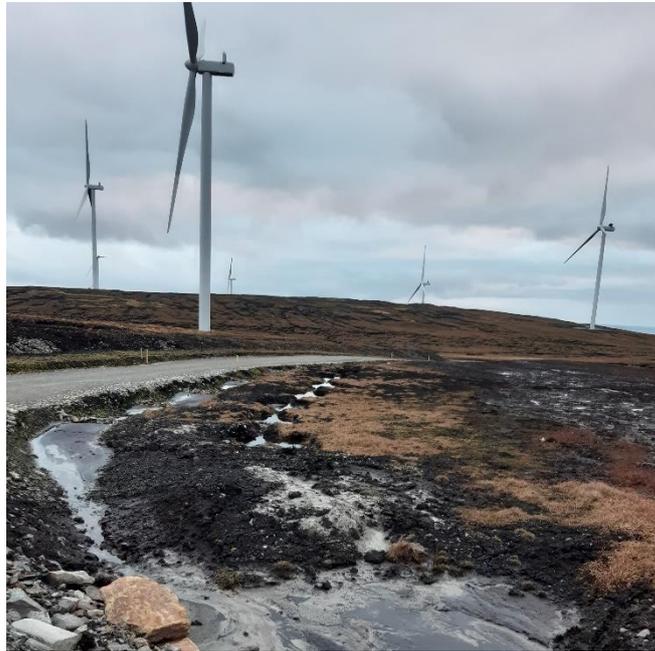
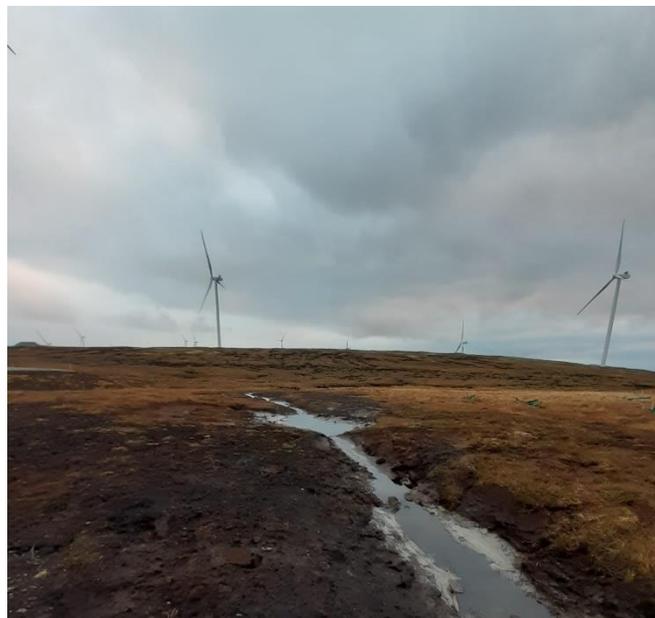
The drainage works undertaken at N118 were observed as part of this audit (photos 8 to 10). It was observed that the settlement ponds are being effective at retaining sediments. The two upstream ponds were observed to be full however and requiring emptying. Downstream ponds were observed to be clear of sediments, indicating that the upstream ponds were still functioning well as retention measures despite being full. The outlet to the Burn of Flamister appeared cleared also, with no obvious evidence of siltation. An internal SOR was raised following the audit and the upstream ponds were cleared between the 12th and 19th January 2024. This area should form part of the next audit visit.

The ECoW commented that the settlement ponds put in place in the area around N118 are working well, preventing dirty water going into the Burn of Flamister. It was noted that the ponds were filling up with soils, and that regular checks and good maintenance regime are required to ensure that the ponds keep doing their job.

Photo 8. Drainage at N118

Photo 9. Drainage at N118

Photo 10. Drainage at N118

<p>Pollution Prevention and Response (e.g. use of spill kits, silt control, cement/concrete, water resources).</p>	<p>The PMO observed that upstream silt ponds at N118 were full, which was reported as a SOR. This however did not result in a dirty water incident, with downstream ponds and the outlet to the Burn of Flamister noted to be clear during the audit visit.</p>	<p>Ensure regular inspection of drainage system and emptying of ponds as required.</p> <p>SSE to undertake further audit of this area.</p>	<p>Principal contractors</p>	<p>Green</p>
<p>Pollution Prevention and Response (e.g. use of spill kits, silt control, cement/concrete, water resources).</p>	<p>The SSE Renewables Environmental Manager notified the PMO in March 2023 that there have been some exceedances of Environmental Quality Standards of some trace metals in water quality sampling in the Burn of Lunklet.</p>	<p>Investigation into the source of the trace metals is ongoing. Short-term mitigation measures have been implemented as per the SEPA accepted mitigation plan with long-term mitigation strategy progressing.</p>	<p>VEWF</p>	<p>Amber</p>

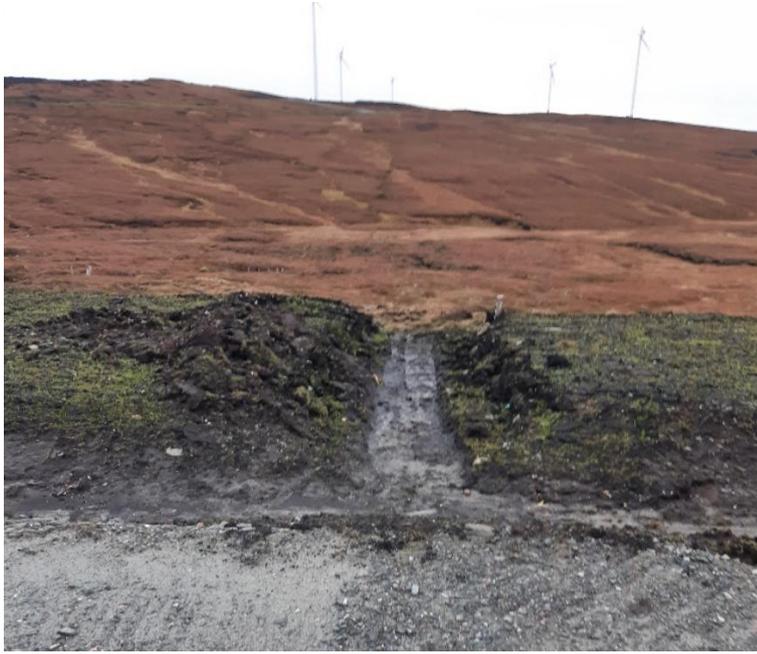
Trackside Drainage was observed at various location across Nesting, and a series of outlets were noted (photo 11 to 13). RJM confirmed that these features are the early stages of forming additional outlets from the permanent trackside drainage. These works should form part of the next audit visit.

Photo 11. Trackside outlet in progress south of T088

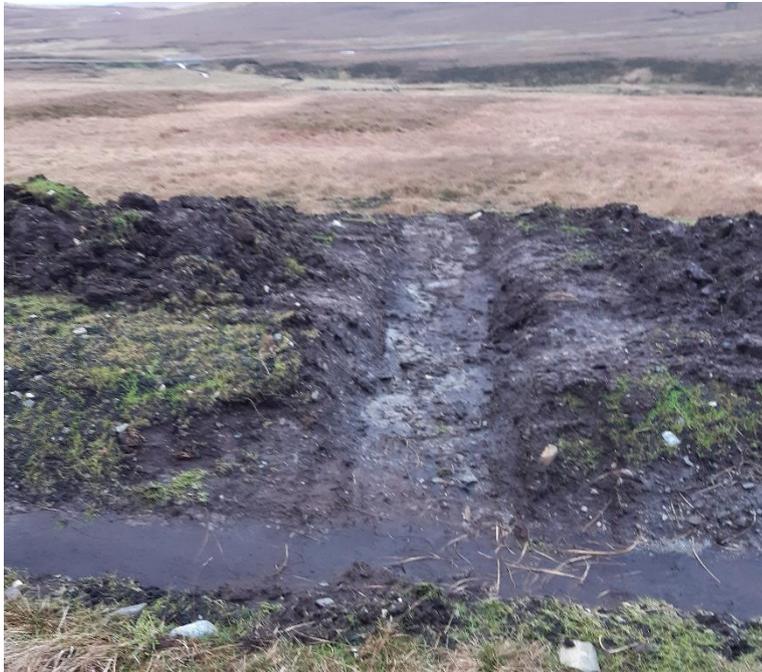
Photo 12. Trackside outlet in progress south of T089

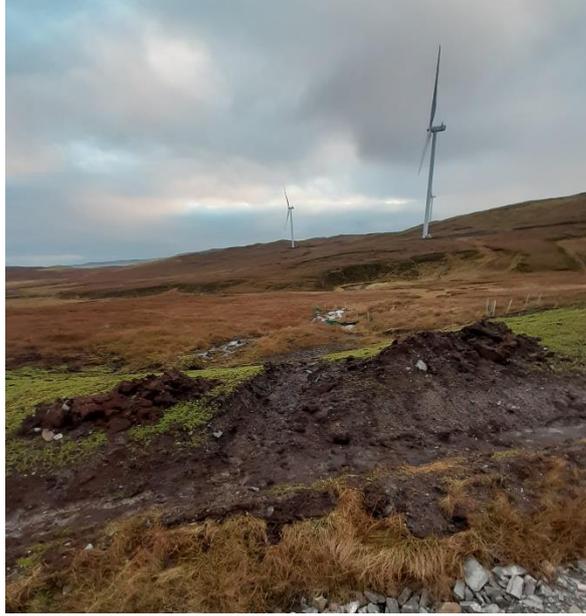
Photo 13. Trackside outlet in progress between T080 and T087

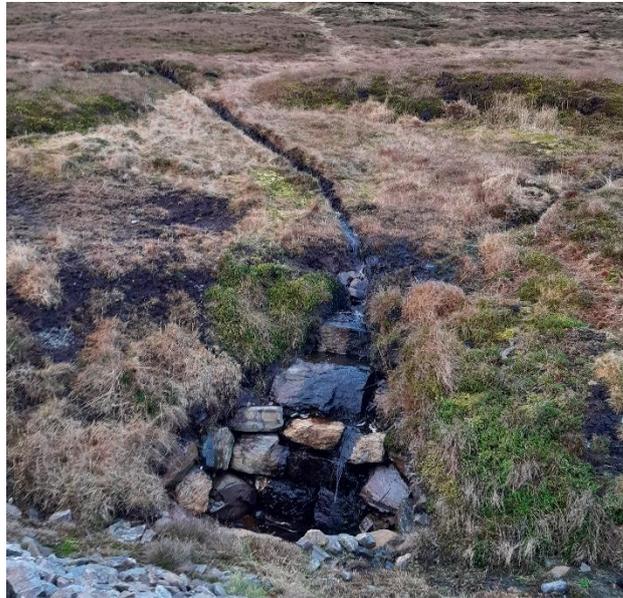
Good practice in the on-going reinstatement and permanent drainage work was observed across the site, including at Spur 32 south west of T099 (photo 14).

Photo 14. Permanent drainage good practice at T099
