Intended for
Viking Energy Wind Farm LLP

Date
February 2024

Project Number
1620009158

VIKING ENERGY WIND FARM PLANNING MONITORING OFFICER AUDIT REPORT 040: 20TH JANUARY TO 17TH FEBRUARY 2024

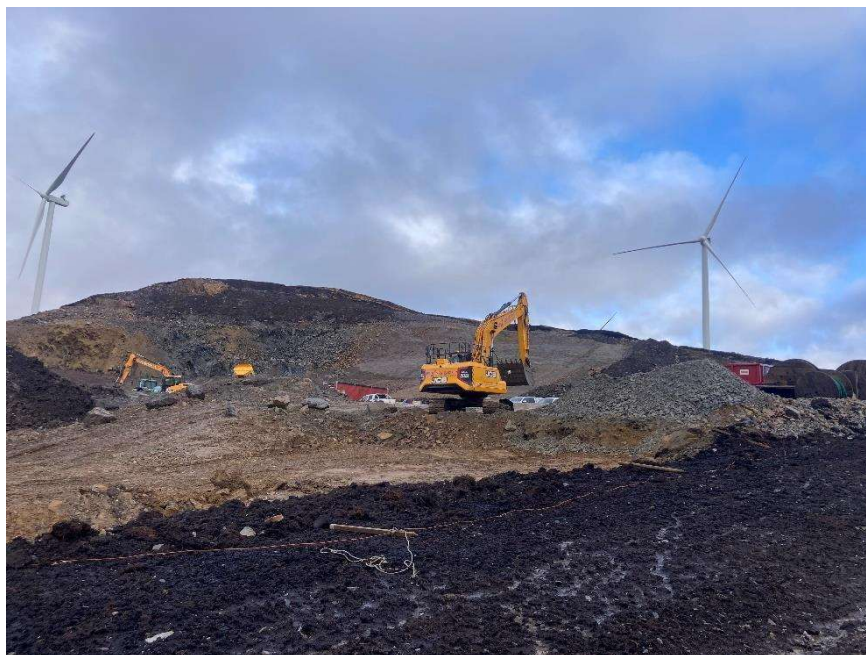
Demobilisation of KBP05 was observed during the audit visit, as well as on-going reshaping and reinstating works (photo 1). Excess stone at KBP05 was being transported to KBP03 for the on-going reprofiling and reinstatement works. KBP03 was observed from a distance, with machines undertaking reshaping work (photo 2). These areas should form part of the next audit visit.

Photo 1. Demobilisation and reinstatement works at KBP05

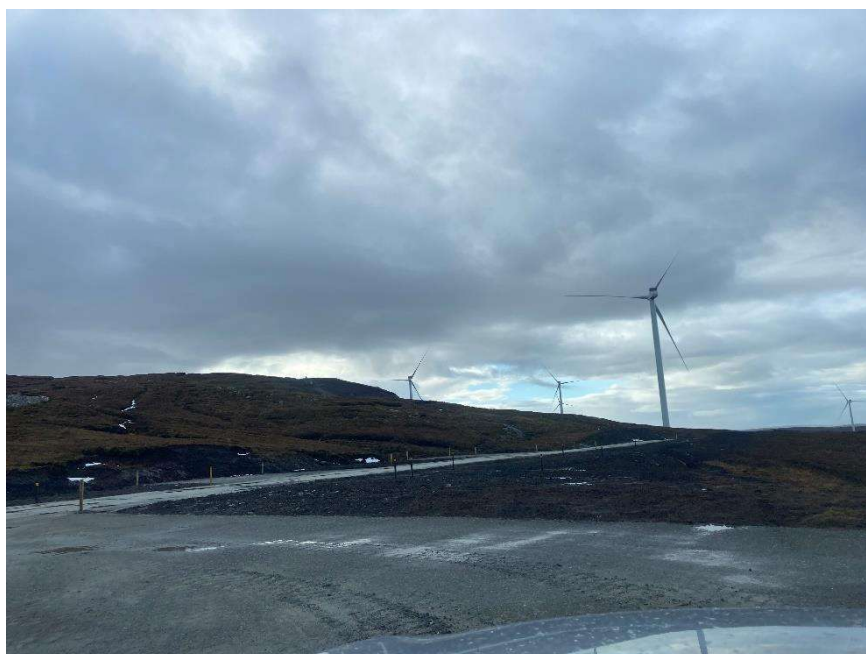
Photo 2. View of KBP03 observed from T017

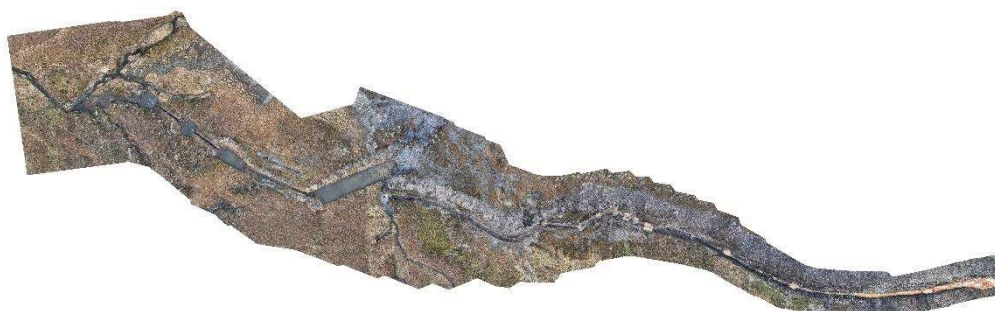
The water treatment system downstream from KBP02 was observed during the audit visit, with an enlarged and improved pond system (photo 3). The treatment system at T026 was also observed (photo 4). Permanent treatment solutions are currently being considered for the water in this area.

Photo 3. Aerial view of the water treatment system downstream from KBP02

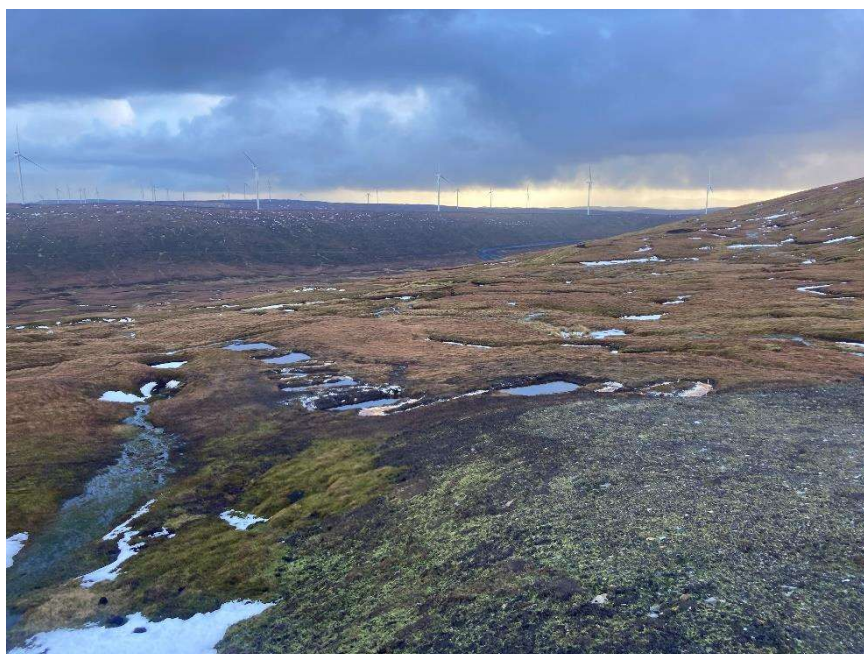
Photo 4. Water treatment system at T026

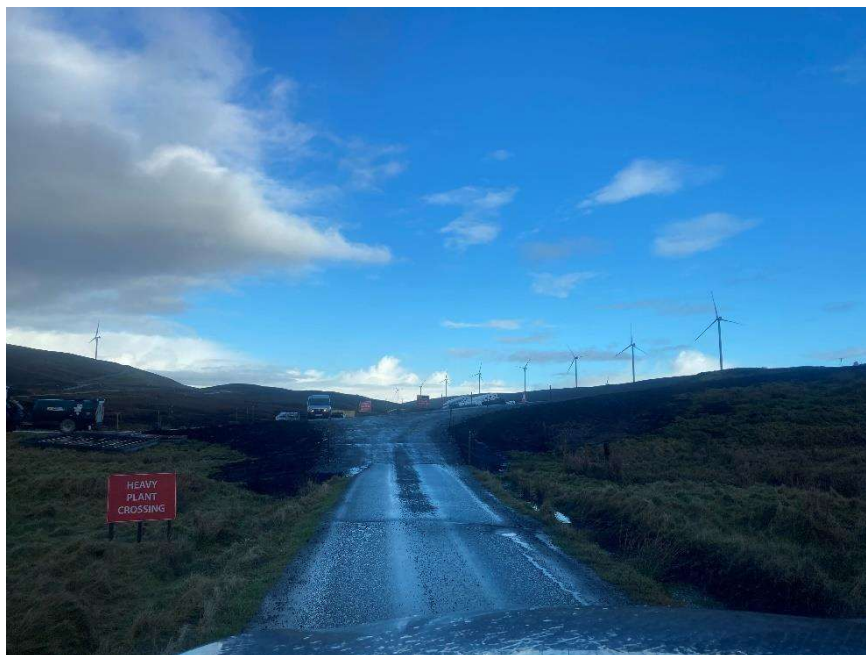
On-going works were observed at the Sandwater road junction, with reprofiling and reforming of the road to facilitate access to the substation (photo 5). This area should form part of the next audit visit.

Photo 5. On-going upgrading works at Sandwater Road to substation junction

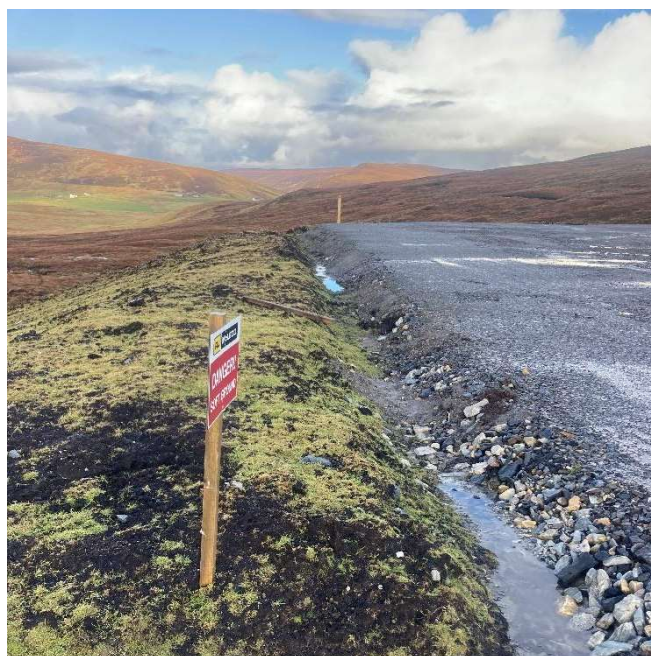
Along the MKR, the drains at the bottom of the MKR track at T046 were observed to be running clear before the drain water flows into settlement ponds (photo 6).

Photo 6. Drains off T046

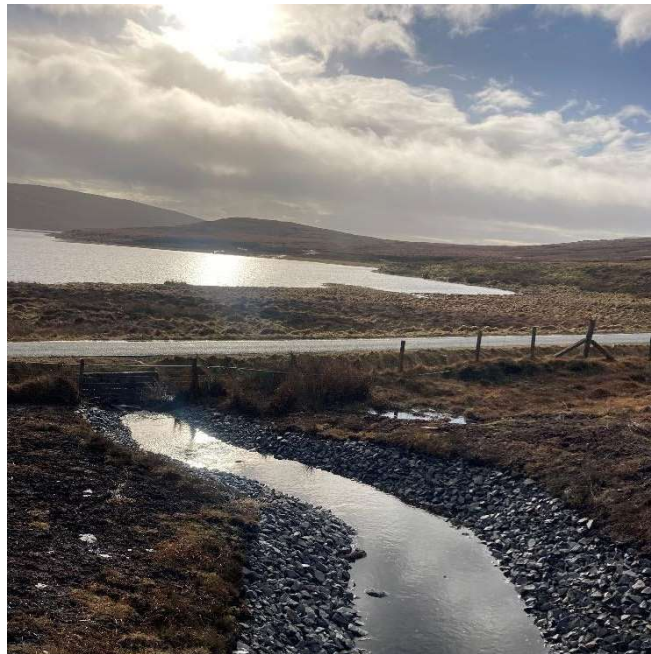
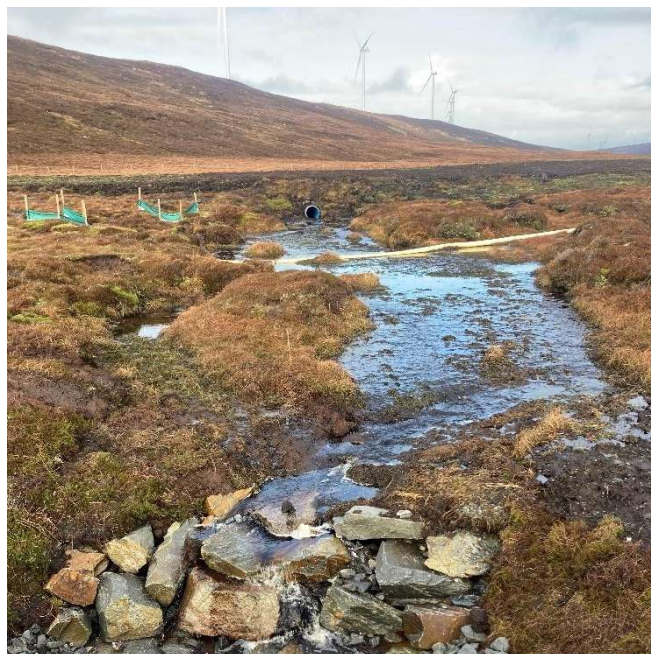
Along Sandwater track, the completed culvert works were observed to be completed to a high standard, with water observed to be running clear (photo 7 and 8). Water ponding was noted in one area along the track (photo 9). SSE raised the issue with RJM as a SOR following the audit visit.

Photo 7. Culvert 1 drain at Sandwater track

Photo 8. Culvert 1 drain at Sandwater track

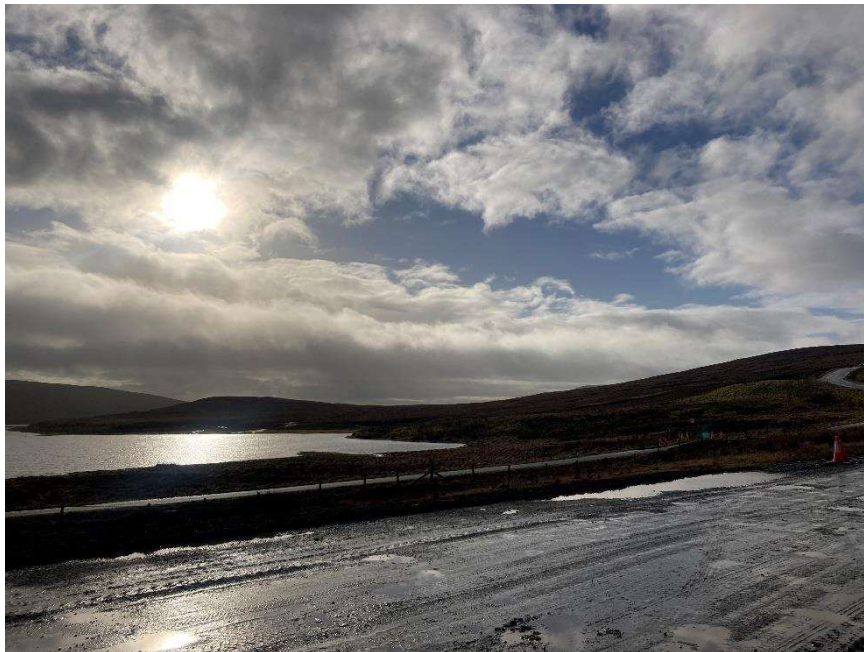
Photo 9. Water ponding on Sandwater track

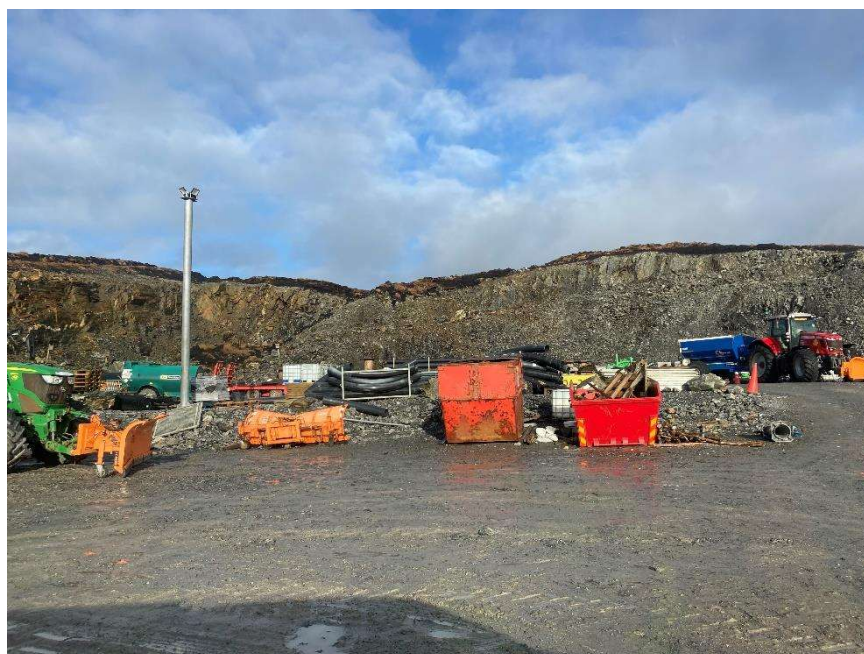
The main compound was audited during this visit. The compound was overall in good order however would benefit from a general tidy up (photo 10). Signage was absent for a number of skips (photo 11). Plant nappies were present under static plants and generators (photo 12). The need for improved housekeeping was acknowledged by RJM following the restart of works after the Christmas break and the recent bad weather, and it was indicated that this is being undertaken.

Photo 10. Main compound general view

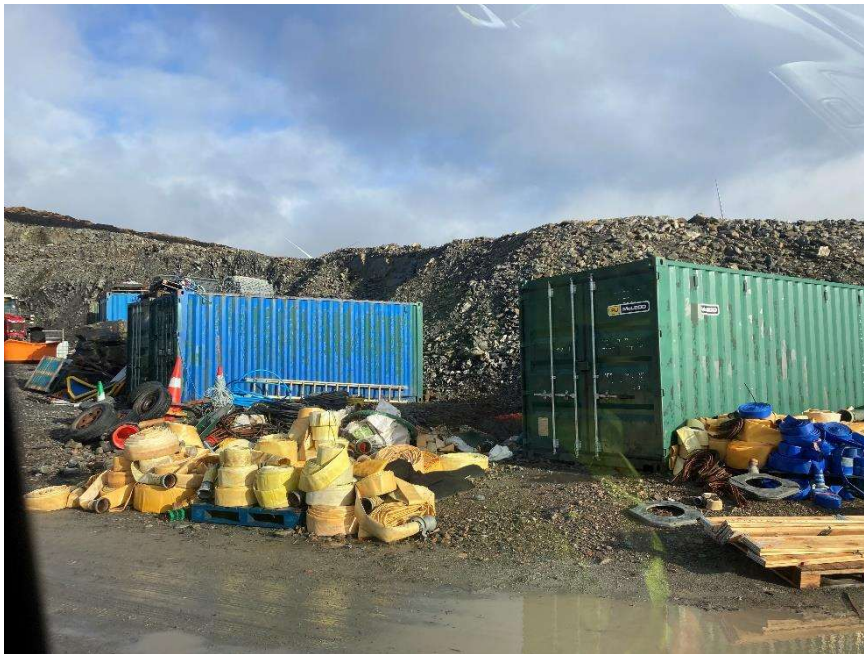
Photo 11. Main compound general view

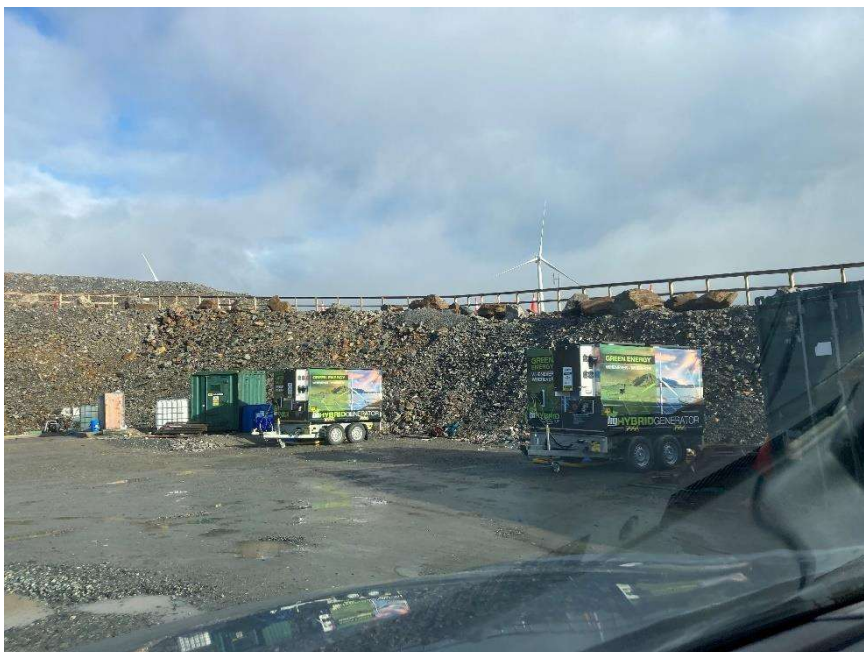
Photo 12. Plant nappies in use under generators at the main compound

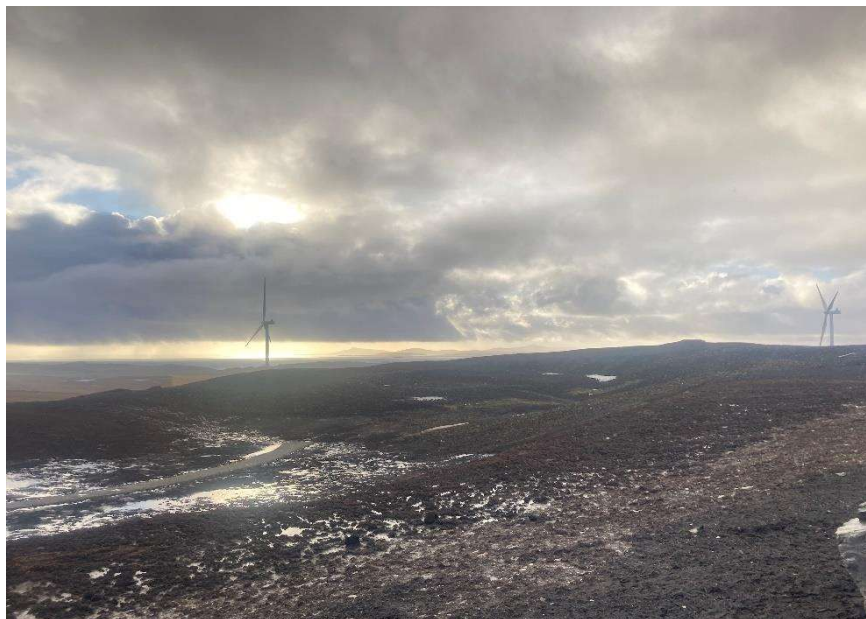
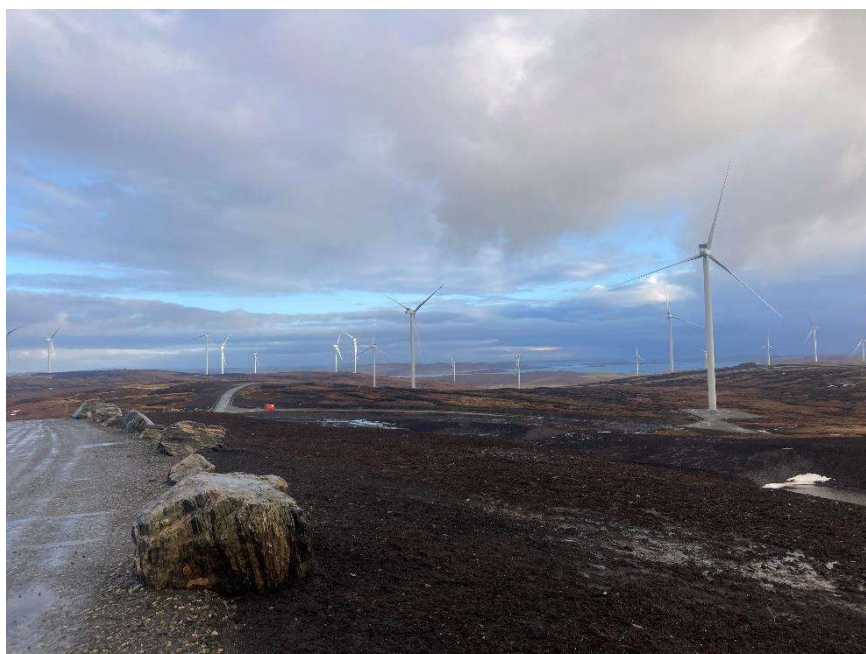
During the audit visit, the restoration work undertaken to date at NBP05 was observed (photos 13 and 14).

Photo 13. NBP05 restoration works completed to date

Photo 14. NBP05 reinstatement works completed to date

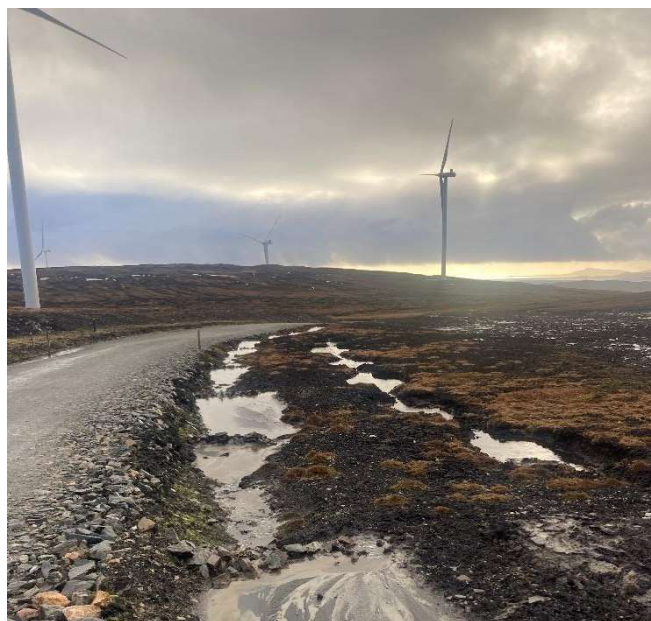
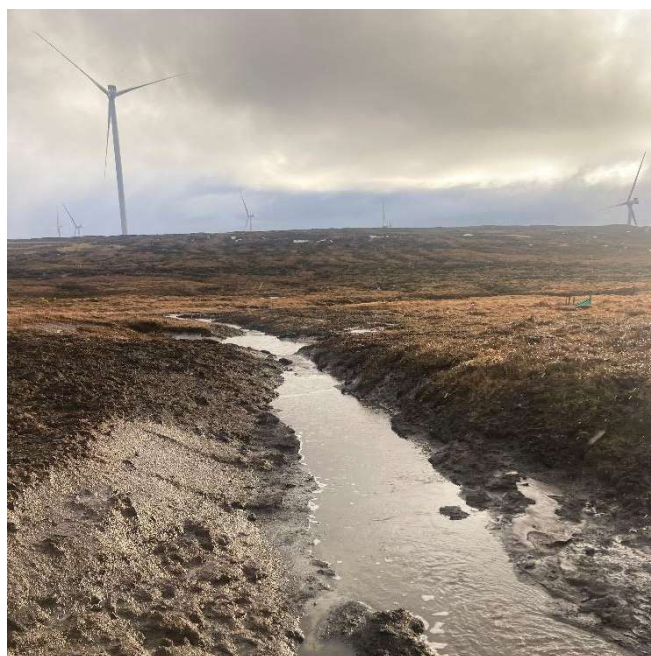
The drainage works undertaken at T076 were observed as part of this audit (photos 15 and 16). It was observed that the settlement ponds are being effective at retaining sediments. Upstream ponds were observed to be full however and requiring emptying. SSE raised an internal SOR following the audit visit for the check dams to be emptied of silt by RJM. Downstream ponds were observed to be clear of sediments and the stream was observed to be clear, indicating that the retention measures were functioning well despite some of the ponds being full. This area should form part of the next audit visit.

Photo 15. Drainage at T076

Photo 16. Drainage at T076

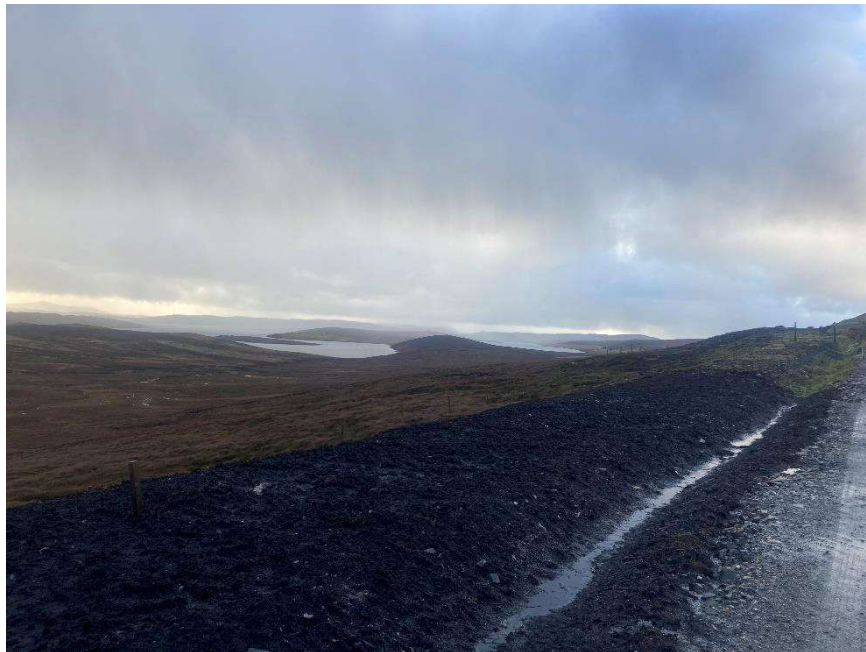
Good practice in the on-going reinstatement and permanent drainage work was observed across the site (photo 17). This included vegetated retention ponds observed at the crossing of the burn of Forse between T079 and T080 (photo 18).

Photo 17. Permanent drainage good practice between T099 and T100

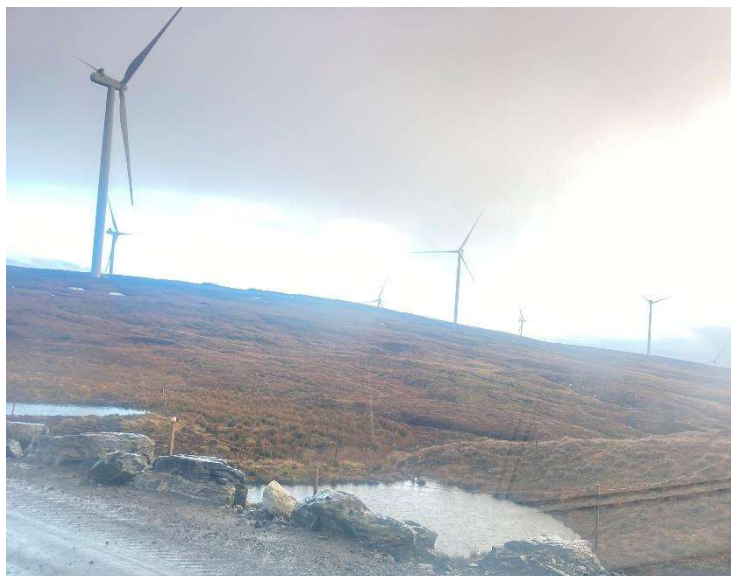
Photo 18. Vegetated retention ponds at the Burn of Forse Crossing

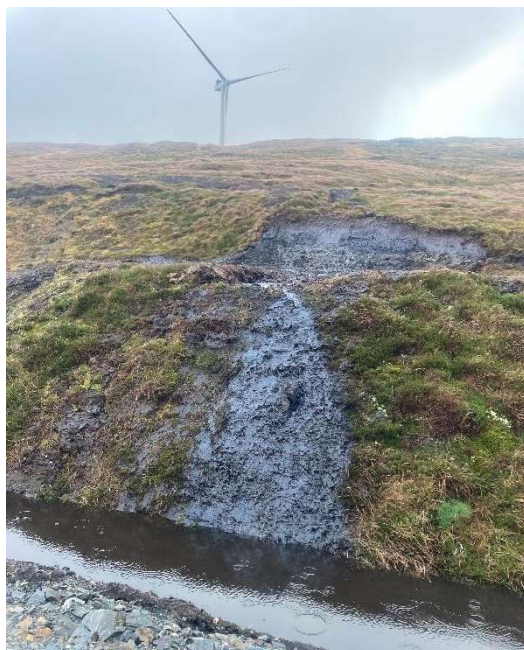
A run off of peat was observed on the reinstated auxiliary hardstanding at T099 (photo 19). SSE raised this issued with RJM as a SOR following the audit visit. It was also noted that drainage off T100 would benefit from improvement work (photo 20).

Pollution Prevention and Response (e.g. use of spill kits, silt control, cement/concrete, water resources).	<p>A drainage peat wash was observed at T099, this was reported as a SOR. This however did not result in significant dirty water reaching the drain.</p> <p>It was also noted that drainage off T100 would benefit from improvement work.</p>	<p>Ensure regular inspection of drainage system and undertake improvement works as required.</p> <p>SSE to undertake further audit of this area.</p>	Principal contractors	Green
Pollution Prevention and Response (e.g. use of spill kits, silt control, cement/concrete, water resources).	The SSE Renewables Environmental Manager notified the PMO in March 2023 that there have	Investigation into the source of the trace	VEWF	Amber

Photo 19. Peat run off at T099

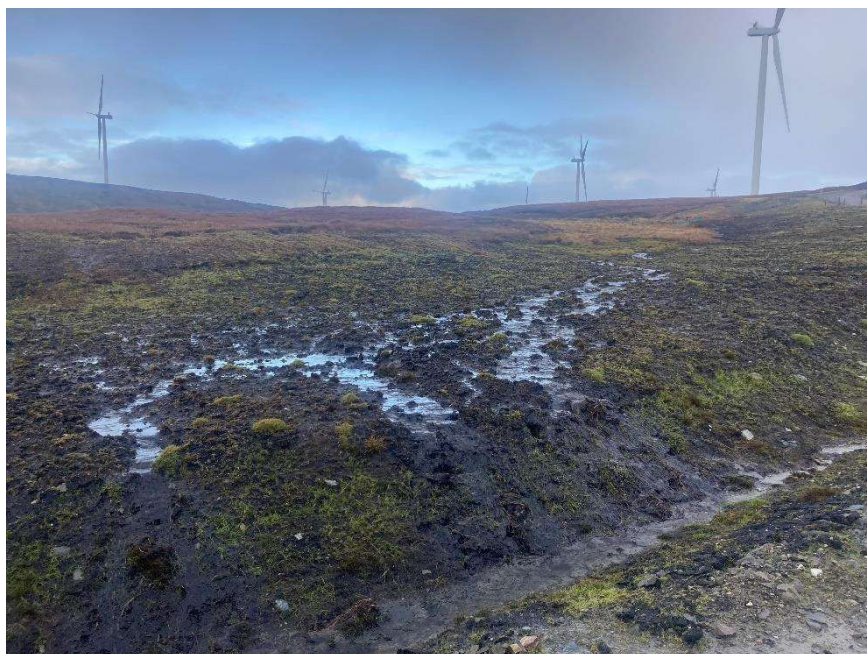
Photo 20. Drainage off T100
