Viking Energy Wind Farm LLP

March 2024

# VIKING ENERGY WIND FARM PLANNING MONITORING OFFICER AUDIT REPORT 041: 19<sup>TH</sup> FEBRUARY TO 15<sup>TH</sup> MARCH 2024

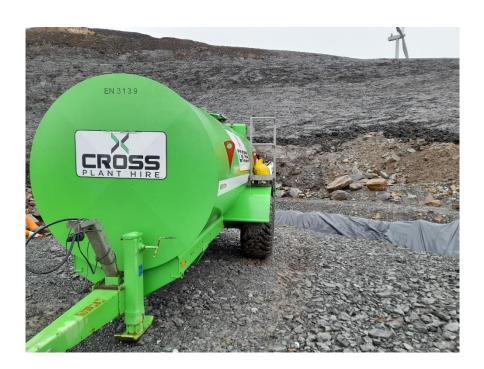
Demobilisation of KBP05 was almost complete, with the exception of the removal of the temporary cabins and temporary bund. The temporary bund was observed to be in good condition (photo 1). The area surrounding the temporary cabins had been reprofiled using peat (photo 2). During the week of the 11<sup>th</sup> of March, site meetings were taking place between SSE, RJ McLeod, the GCoW and ECoW to assess and discuss the reprofiling works undertaken in accordance with the general reinstatement reprofiling (although no specific reinstatement plan was issued for KBP05 or KBP03, SSER and RJ McLeod engineers (Sweco) retrospective assessing the profiling works undertaken to date to ensure reinstatement has been carried out ). KBP03 was undergoing reinstatement works (photo 3).

**Photo 1.** Temporary bund in KBP05.

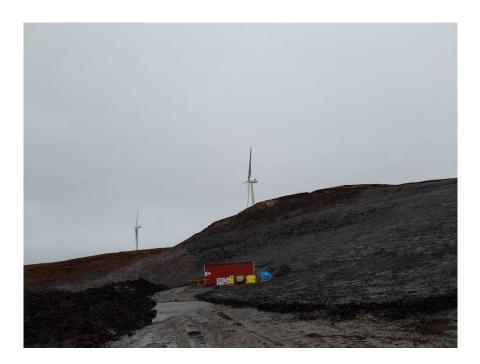
**Photo 2.** Reprofiling of KBP05.

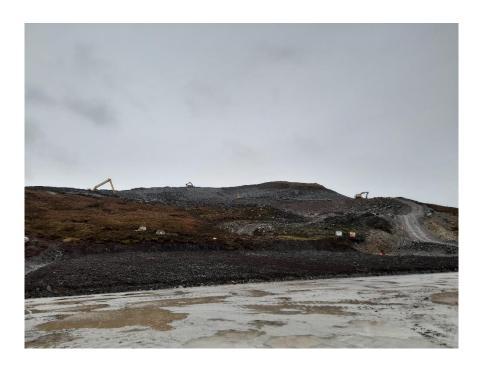
**Photo 3.** KBP03 reinstatement works.

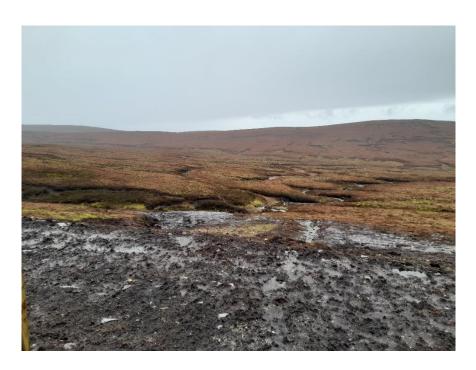
A peat movement was observed at T008 (photo 4). The movement was within peat that had previously been used to backfill an area, likely due the heavy rainfall that has been recorded over the winter months, that led to a localised area of instability. Given the proximity of the slip to the burn, further works will need to be undertaken to ensure the peat doesn't reach the burn and ensure long-term stability of the area near T008. RJ McLeod are aware of the slip and have been discussing remedial options with the GCoW and ECoW.

The GCoW confirmed that they had been involved in ongoing discussions around borrow pit reinstatement and undertook a joint visit with RJ McLeod and Sweco on the week of the  $11^{th}$  of March. The GCoW also mentioned the recent peat movement in T008, as discussed in Section 3.1.2.

**Photo 4.** Peat slip at T008.

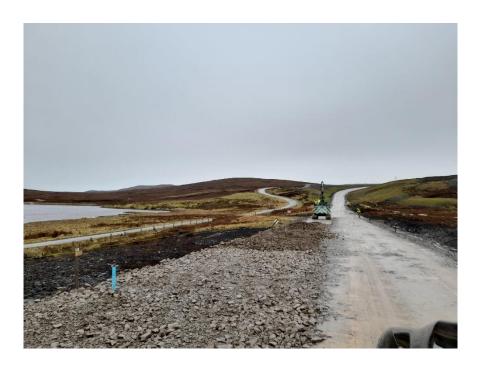
The Sandwater track was in the process of being raised to its final levels prior to surfacing (photo 5). Material from the borrow pits were being used to raise the road (photo 6), and this included an area where ponding was observed during the February PMO audit.

**Photo 5.** Raising the Sandwater track.

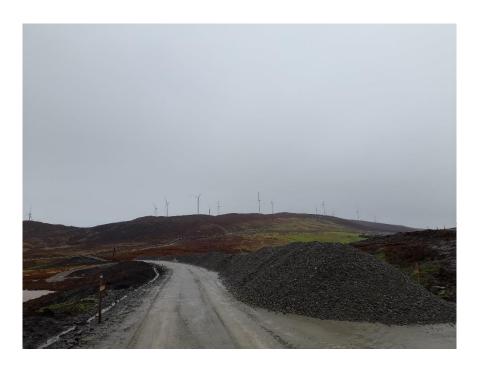
**Photo 6.** Material from borrow pits being used to raise the Sandwater track.

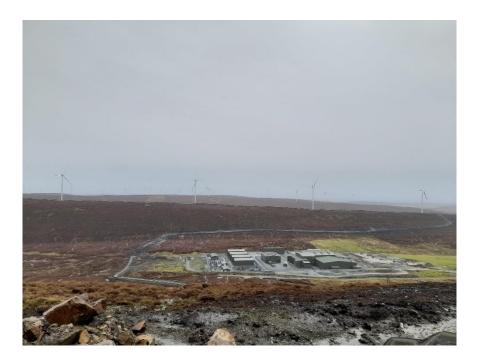
The cross country tracks have been backfilled and works are ongoing to stabilise these areas for seeding that will be undertaken later in the year (photo 7).

**Photo 7.** Cross Country routes in the Kergord Valley

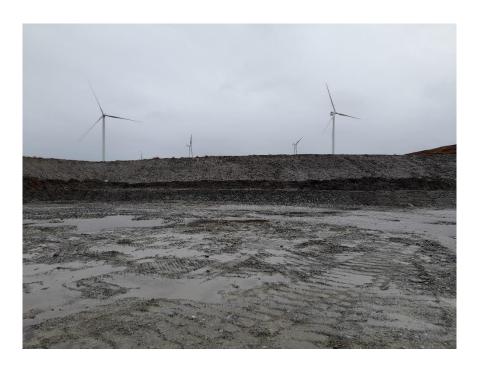
The demobilisation of the northern compound had been completed by the time of the PMO audit and a bund had been built to separate the area of the car park and the area of the council depot / laydown area (photos 8 and 9). Further works (such as drainage and resurfacing) were noted to be on hold until the planning application had been approved.

**Photo 8.** Demobilisation of the Northern Compound

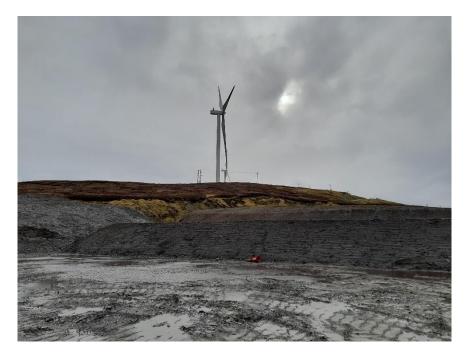
Photo 9. Creation of bund in the Northern Compound to separate potential future car parking area and council lay down area.

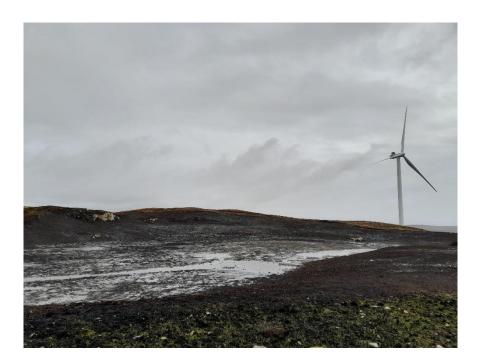
NBP01 has been reinstated and reprofiled (photo 10).

**Photo 10.** NBP01 reprofiling.

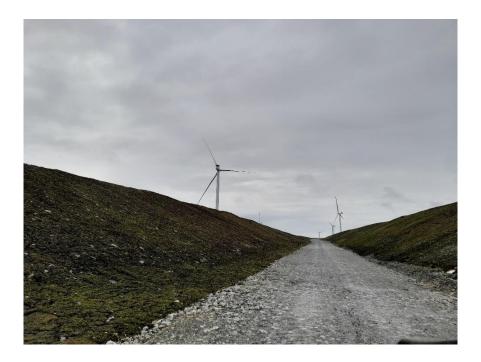
The cutting in Spur 52 was hydroseeded in 2023 following stabilisation of a peat slump on the embankment. No recurrence of the peat slide has occurred, and the vegetation growth is taking hold (photo 11).

Photo 11. Cutting on Spur 52.

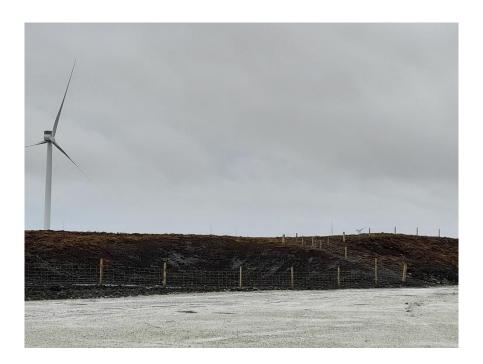
Fencing of the habitat management areas is being undertaken across North Nesting (photo 12).

**Photo 12.** Fencing of Habitat Management areas.

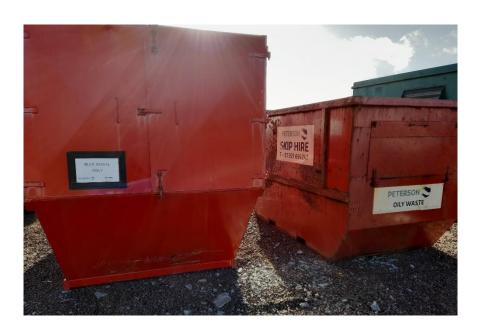
Following the observations noted in the February audit, the main compound was visited again. The main compound was found to have been tidied since the last audit; however, further signage is required on the skips (photo 13).

**Photo 13.** Further signage required on skips in the main compound.

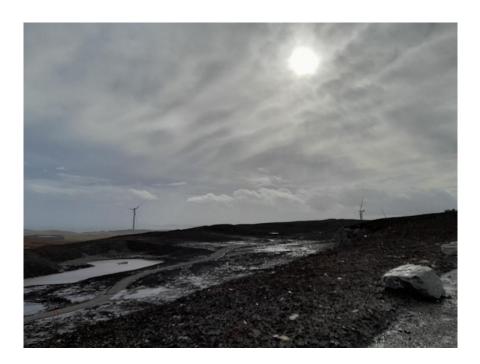
During the audit visit, the reinstatement work at NBP05 was observed (photo 14). Discussions are continuing between SSE and RJM to develop an alternative reinstatement plan which includes a native woodland within the restored NBP05. The SIC have approved an amendment to the CEMP to allow the alternative restoration to be carried out, including the creation of a native woodland. The native woodland habitat will increase the biodiversity of the area and is an improvement on the basic minimum restoration requirement.

**Photo 14.** NBP05 reinstatement works completed to date.

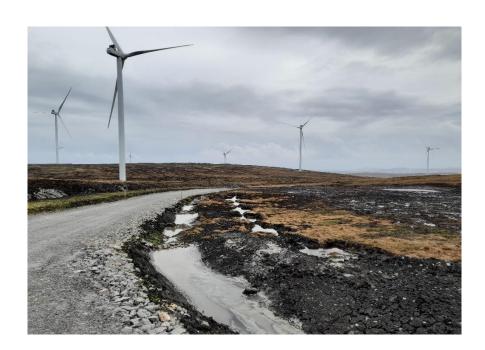
Drainage at T076 was noted during the conversations with the ECoW prior to the audit. The silt within the drainage settling ponds had filled up, making the drainage less efficient. By the time of the audit, the silt had been removed (photo 15). The downstream drainage was observed to be clear running into the burn. Drainage in this area should continue to be monitored by the project team, and should be observed during the next audit.

Borrow pit reinstatement is being closely monitored by the ECoW. Inspection and monitoring of the additional surface water management measures put in place downgradient from NBP05 are on-going. The ECoW commented that the settlement ponds put in place in the area around T076 are working well; however, these had recently silted up, as discussed in Section 3.6.2. The silt had been removed by the time of the PMO audit.

**Photo 15.** Removal of silt from settlement ponds at T076.
