Date
April 2024

Project Number
1620009158

VIKING ENERGY WIND FARM PLANNING MONITORING OFFICER AUDIT REPORT 042: 16TH MARCH TO 19TH APRIL 2024

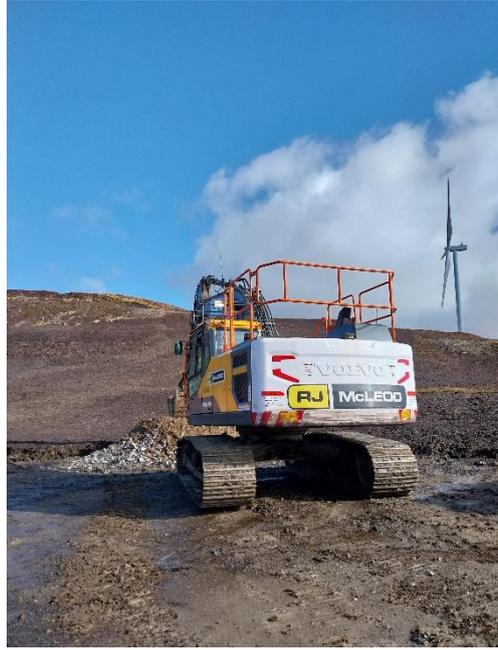
Demobilisation of KBP05 was almost complete, with the removal of the temporary cabins and temporary bund still awaiting. During the PMO visit, stones were observed to be taken from KBP05 to profile access to the Anderson Track (Photo 1).

Photo 1. Stones taken from KBP05 to profile access to the Anderson Track

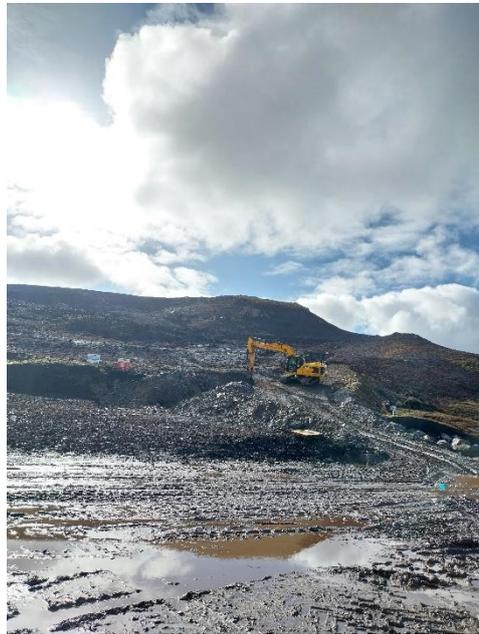
Reprofiling work was observed in KBP03 during the PMO visit (Photo 2) and reinstatement of a peat storage area opposite the upper entry of KBP02 was also observed. SSE continues to engage with specialists to design a permanent alternative treatment system for downstream of KBP02 as previously reported. In the meantime, RJM continues to maintain the temporary system.

Photo 2. Reinstatement in progress at KBP03

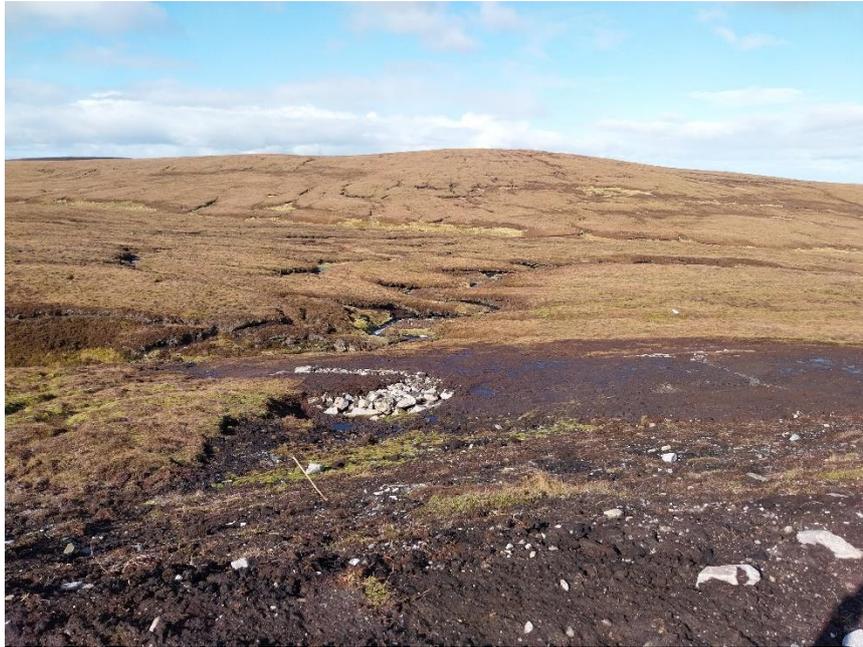
Remedial works for the movement of peat off the approach track to T008 (as reported in March 2024) were noted to have been completed. The affected area was reformed and reprofiled, new channels were created with stone to ensure long-term stability and prevent peat from reaching the burn (Photos 3 and 4). The remedial work is in good condition and both GCoW and ECoW have been involved throughout the process.

Photo 3. Completed remedial work at T008

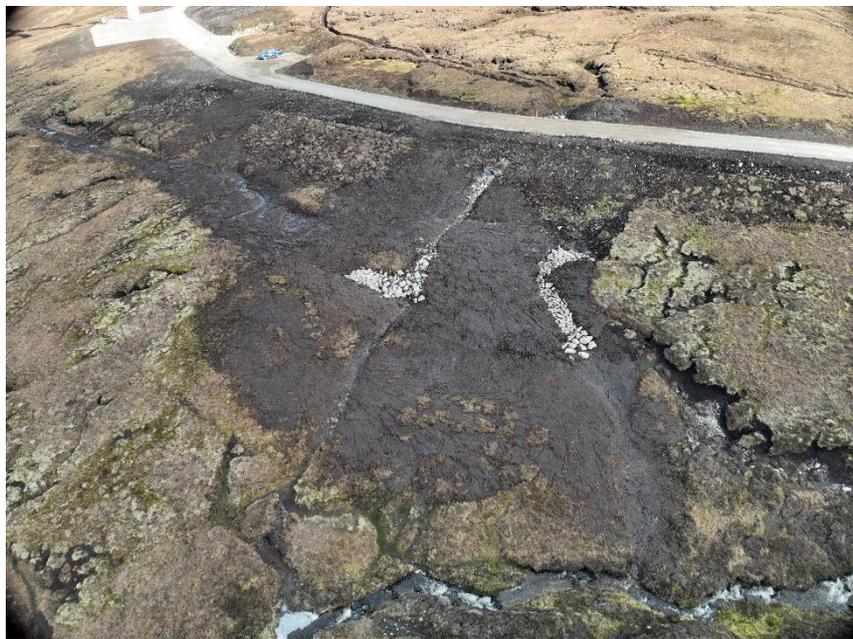
Photo 4. Aerial view of remedial work at T008

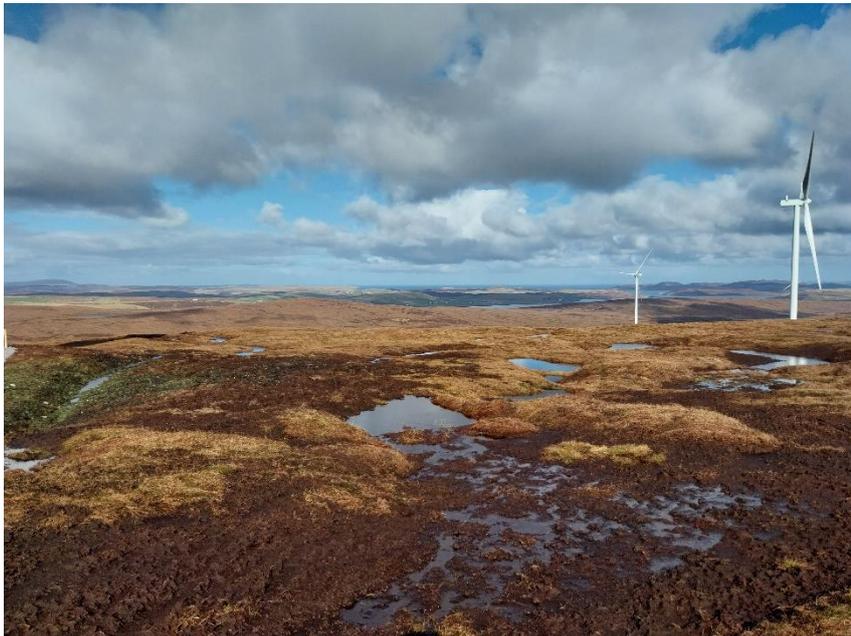
Ground physical work in Peat Restoration Area 2 (P02) has been completed (Photo 5), with locally harvested seed yet to be sown onto areas where vegetation is required. Ground physical work has also been completed in P29.

Photo 5. View of completed ground physical work at P02

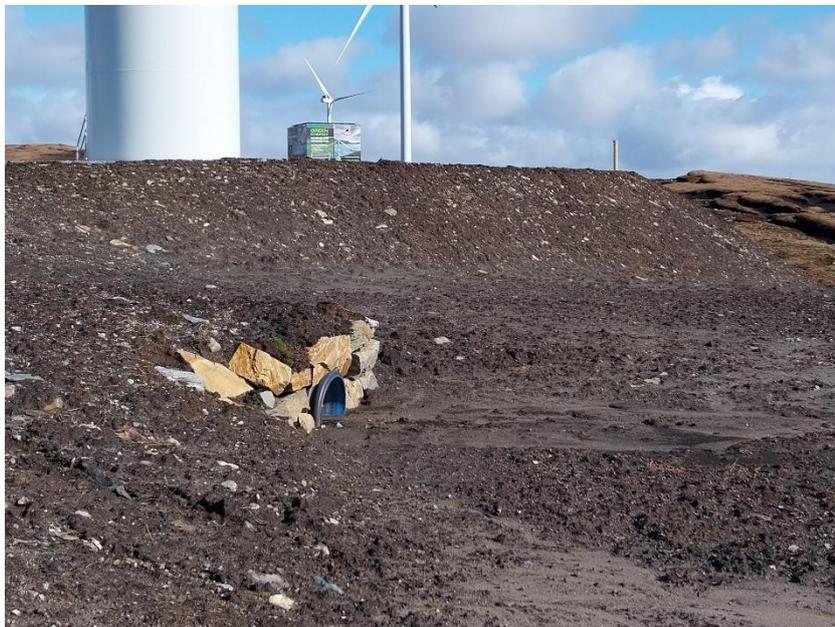
The culvert by T018 was observed to discharge directly onto peat (Photo 6). This has been flagged to SSE and a drainage channel should be installed, to regulate the outflow from the culvert and prevent peat erosion, this should be monitored in the next audit.

Photo 6. View of culvert by T018

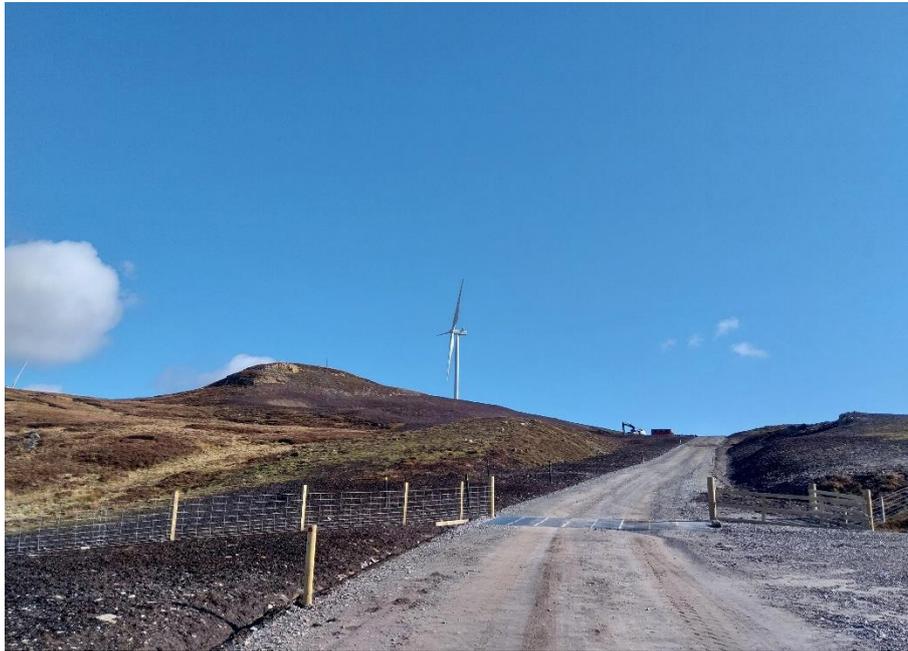
New land boundary fencing to re-establish land ownership is being undertaken across Kergord (Photo 7). Road leveling and resurfacing work is being observed at the access into Kergord and at Junction 5 (Photo 8).

Photo 7. New land boundary fencing installed by KBP05

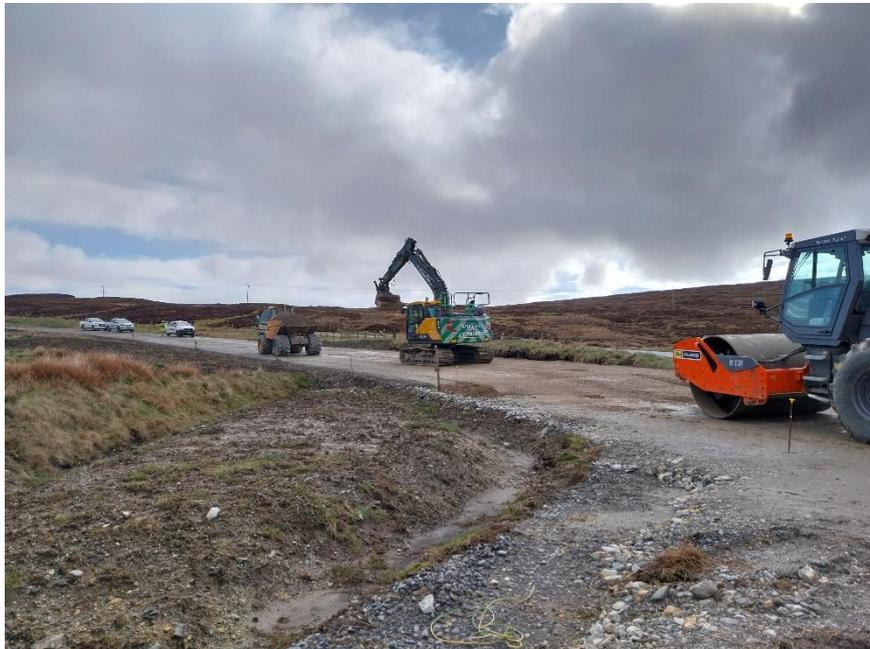
Photo 8. Road levelling and resurfacing work at the access into Kergord

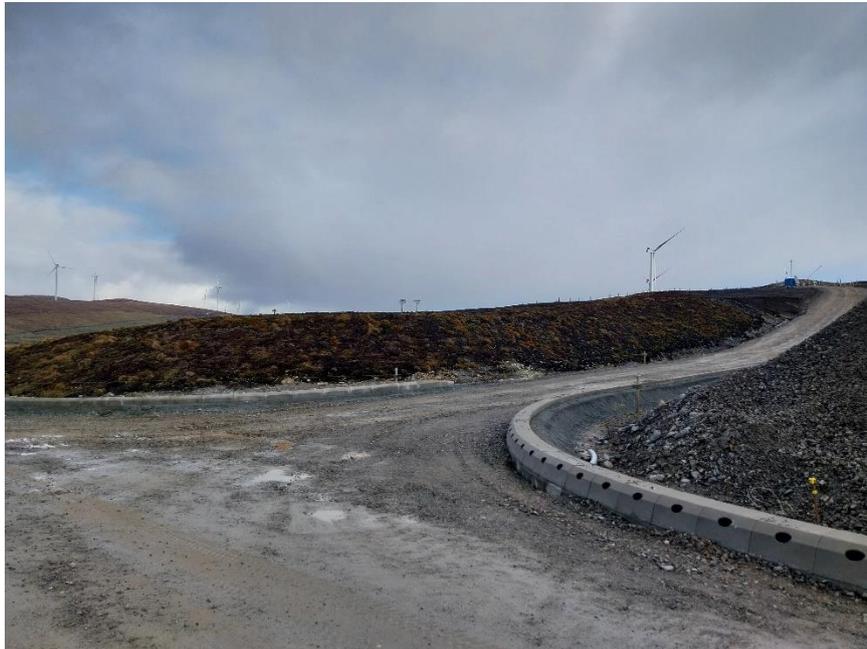
The Sandwater track area was observed during this audit visit. Mid Kame Ridge was not observed during this visit, however, it was noted that the bellmouth junction kerbing onto MKR was being installed (Photo 9).

Photo 9. View of permanent bellmouth junction by MKR

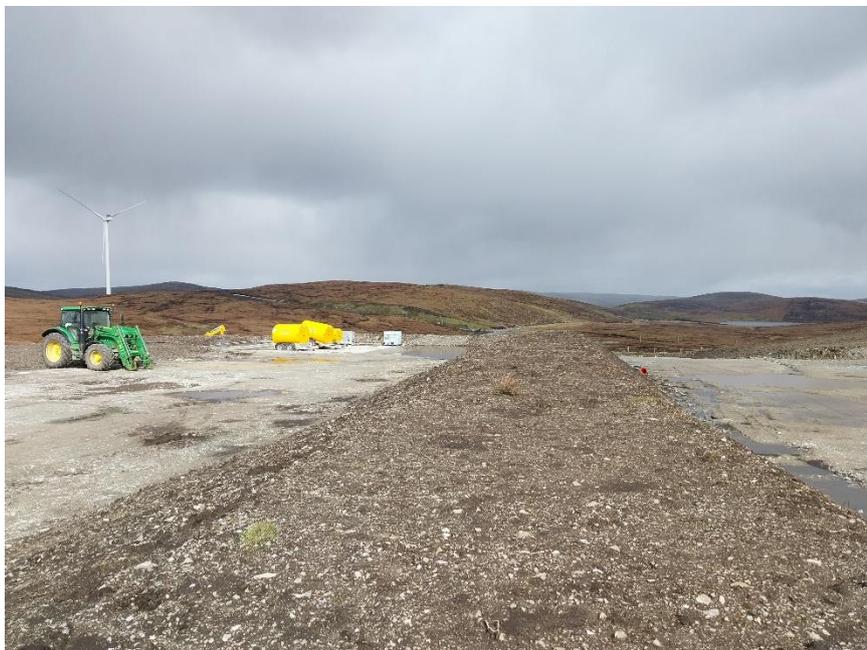
The bund to separate the area of the proposed new recreational carpark and the area reserved for SIC has been completed (Photo 10). Both the new recreational carpark and SIC area are in the design stage and all further works (such as drainage and resurfacing) were noted to be on hold until the planning application is approved.

Photo 10. View of permanent bund that separate two areas at North Compound

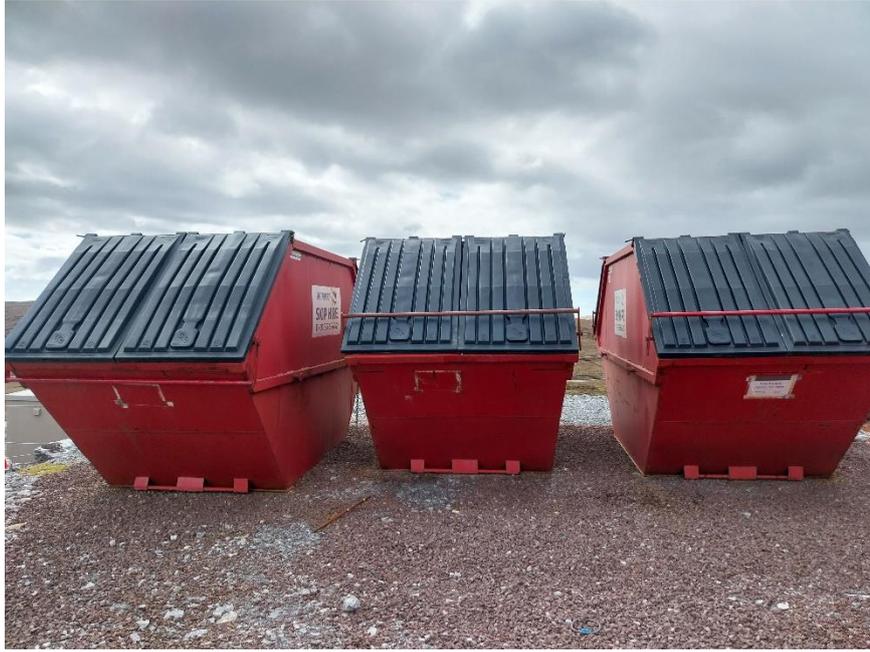
Following the observations noted in the February and March audit, the main compound was visited again. The main compound was found to have been tidied since the February audit; however, signage was noted to still be missing on multiple skips during the audit (Photo 11). Following the visit, SSE reported that signage has been re-installed on skips (Photo 12), this should be observed again during the next audit.

Photo 11. Missing signage on skips by Main Compound

<p>Materials Storage and Handling (e.g. oil/fuel storage and peat/mineral soil storage and handling).</p>	<p>Some missing skip signage were observed at both Main Compound and the Substation. Signage issue has been reported missing at the Main Compound during the last audit visits.</p> <p>Fire extinguisher was observed to be missing at the Substation by the generators when work was being observed.</p>	<p>Following the PMO visit, SSE confirmed that the fire Extinguisher has been replaced at the Substation.</p> <p>Following the PMO visit, SSE confirmed that the signage has been replaced at the skips. SSE to continue maintaining sinage at skips.</p>	<p>SSE/ Aggreko</p>	<p>Green</p>

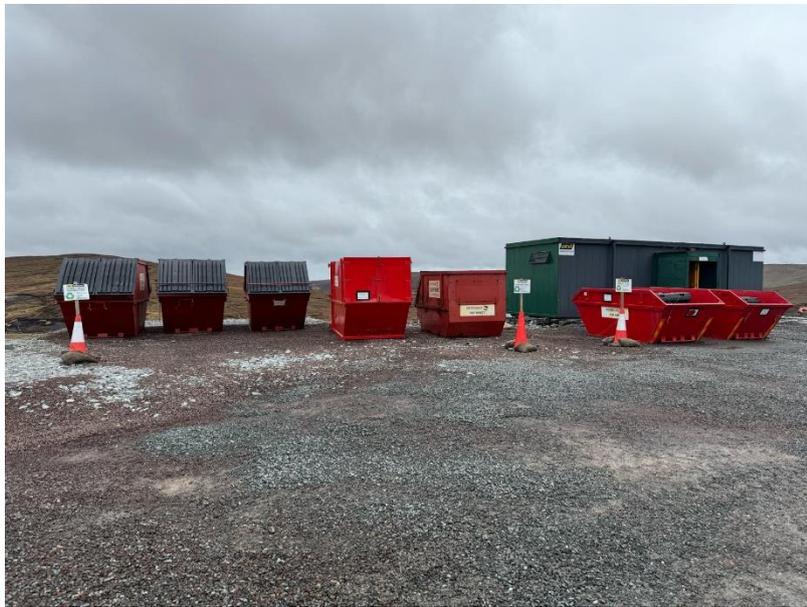
Photo 12. Replaced signage on skips by Main Compound (Photo provided by SSE)

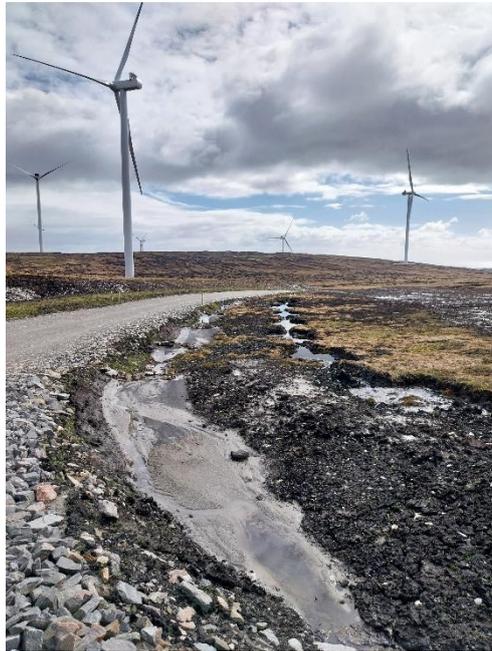
The drainage settling pond at T076 was observed to be silted up during the audit visit (Photo 13), as also noted in the March Report. However, despite the settling pond being full, with the installment of more settling ponds, the downstream drainage was observed to be clear running into the burn, confirming the efficiency of the drainage (Photo 14). It is important to note that the weather was dry and clear during the audit and hence, drainage in this area should continue to be monitored by the project team and continue to be observed during future audits.

The ECoW commented that the settlement ponds put in place in the area around T076 are working well; however, these had recently silted up, as discussed in Section 3.6.2. The drainage downstream was however observed to be running clear during the PMO visit.

Photo 13. Silt in drainage settling pond at T076

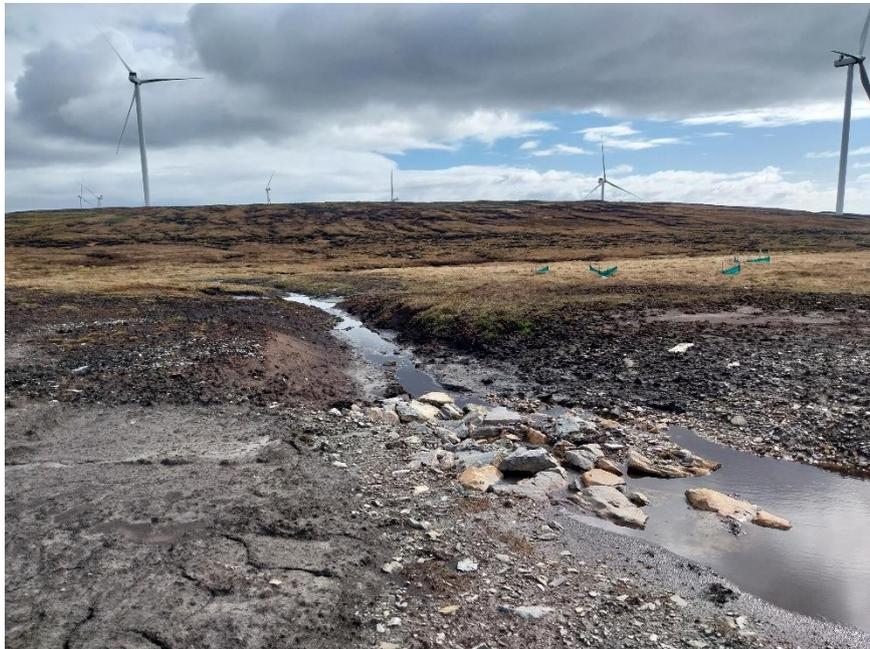
Photo 14. Drainage running clear downstream of T076

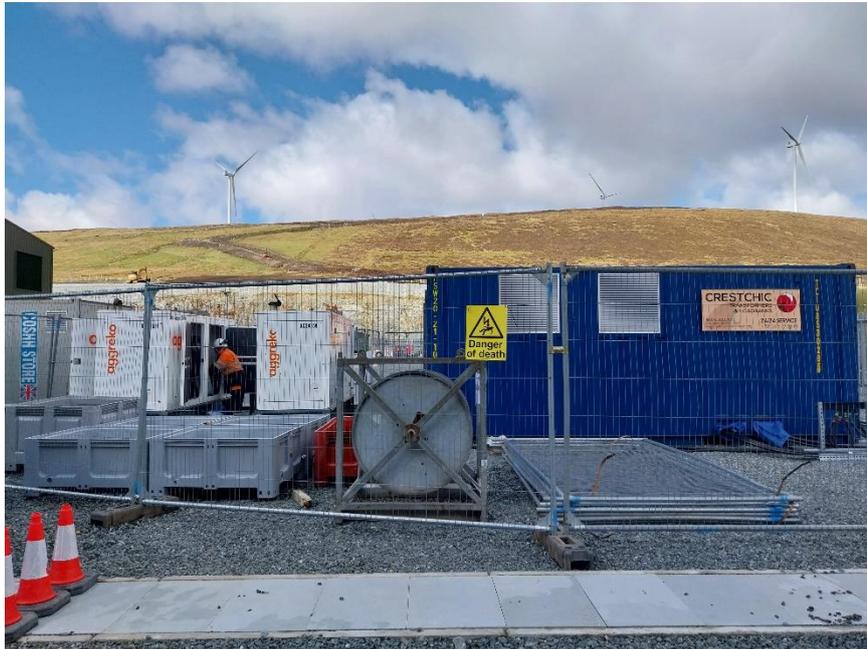
The substation transformers have now been commissioned and the high-voltage generators, temporarily needed for transformer commissioning purposes, are being decommissioned. At the time of the visit, two of the generators were demobilised with two still remaining on site (Photo 15). Absorbent plant nappies and spill kits were observed to be available next to the generators, however, no fire extinguisher appeared to be present in the vicinity. This has been flagged to both SSE and Aggreko.

Photo 15. View of remaining generators at the Substation

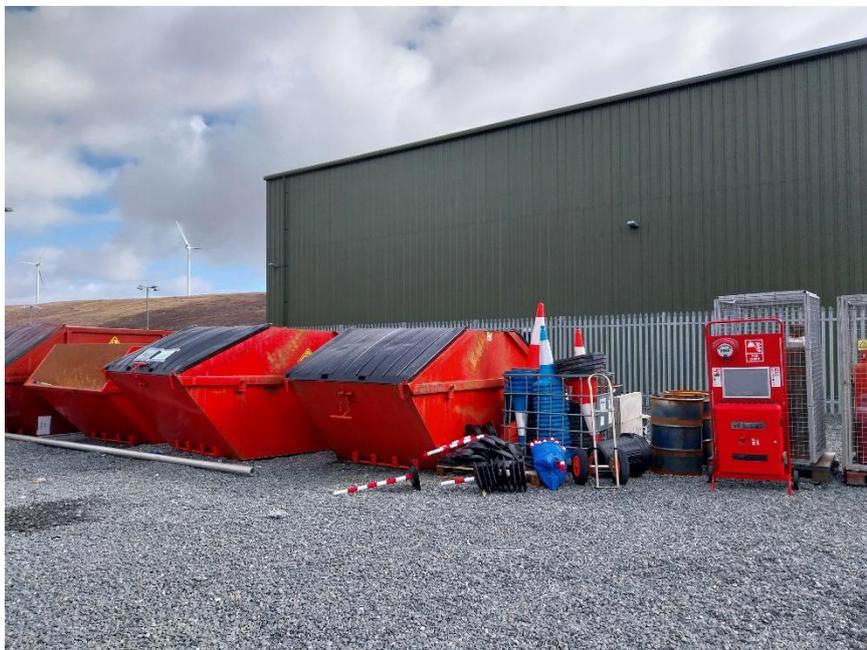
The waste and equipment storage and laydown areas were observed to be generally tidy. However, signage on two of the skips were observed to be missing (Photo 16).

Photo 16. Missing signage on skips at the Substation

Following the PMO visit, SSE has confirmed via communications that the missing skips labels and fire extinguishers have been replaced, this should be confirmed and observed again during the next audit.
