Intended for  
**Viking Energy Wind Farm LLP**

Date  
**May 2024**

Project Number  
**1620009158**

# **VIKING ENERGY WIND FARM PLANNING MONITORING OFFICER AUDIT REPORT 043: 20<sup>TH</sup> APRIL TO 17<sup>TH</sup> MAY 2024**

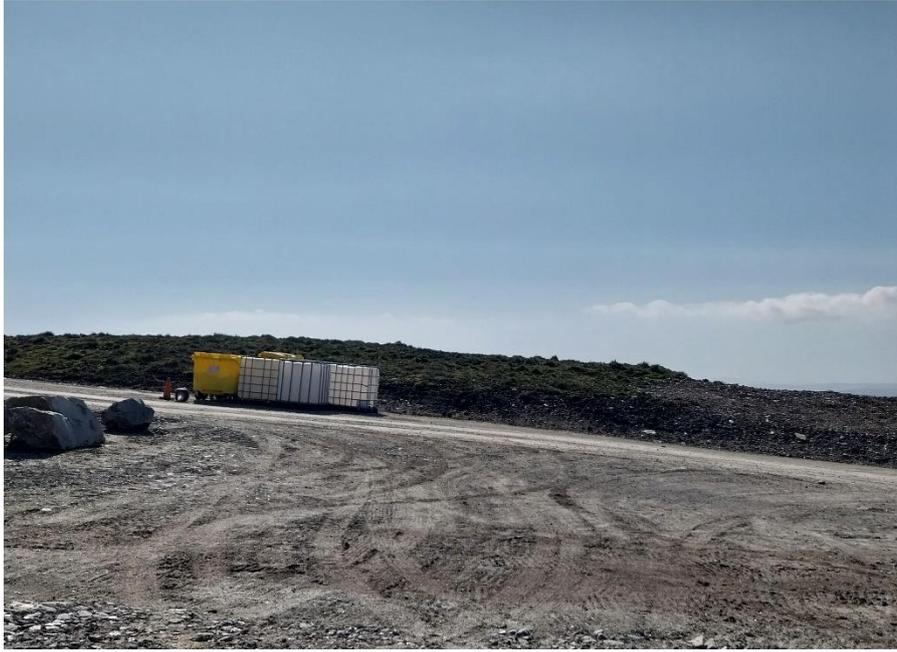
Demobilisation of KBP05 was close to complete, with temporary cabins and temporary bund removed, and final items awaiting removal by the road side on the day of the visit (Photo 1). Access to the Anderson Track has been completed (Photo 2).

**Photo 1.** Final items awaiting removal from KBP05

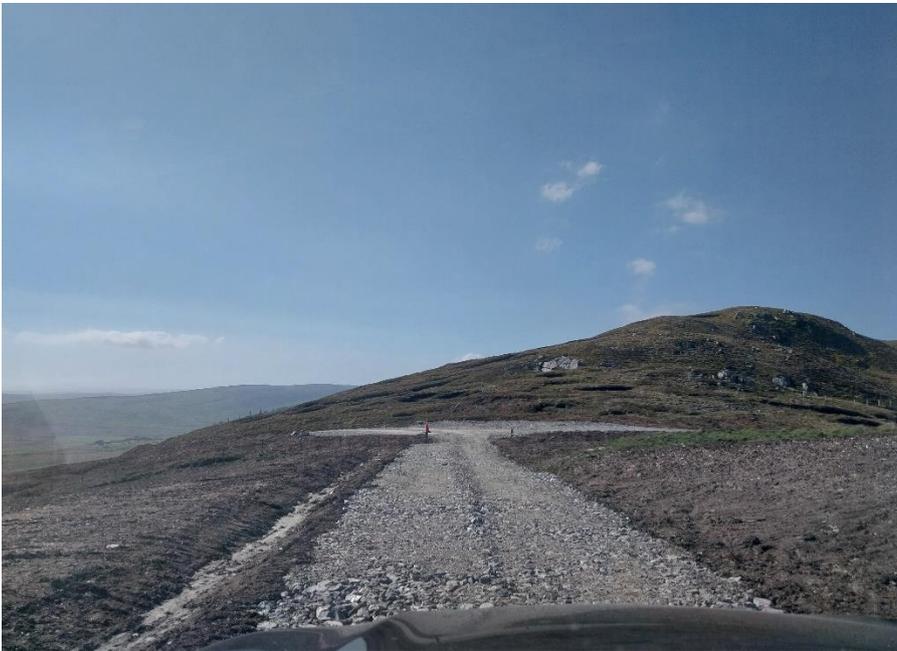
**Photo 2.** Completed access to Anderson Track

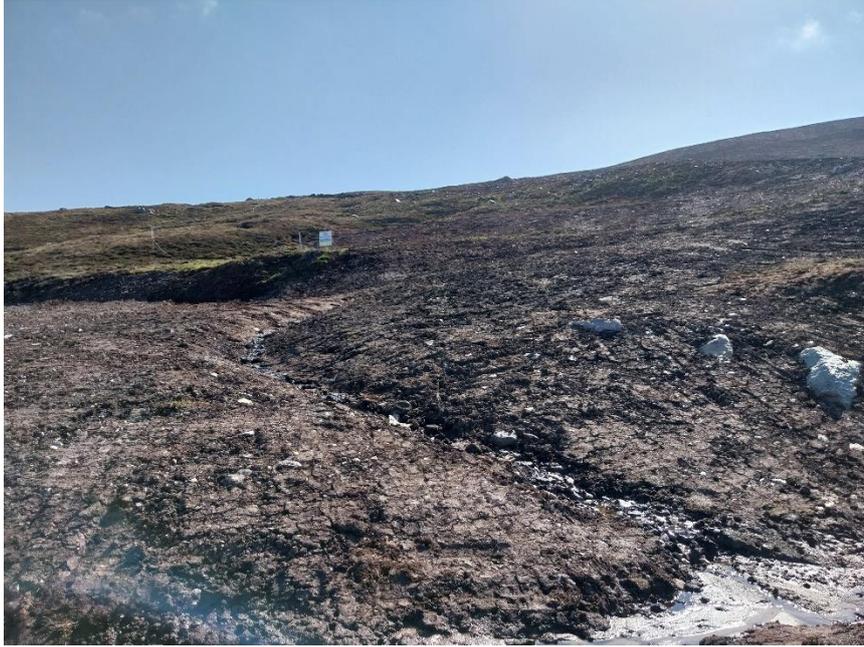
Permanent drainage by KBP03 was observed to be in good condition (Photos 3 and 4). Discussion on a permanent alternative treatment system for downstream of KBP02 is still ongoing between SSE and specialists. In the meantime, RJM continues to maintain the temporary system.

**Photo 3.** Drainage channel from KBP03 going into culvert

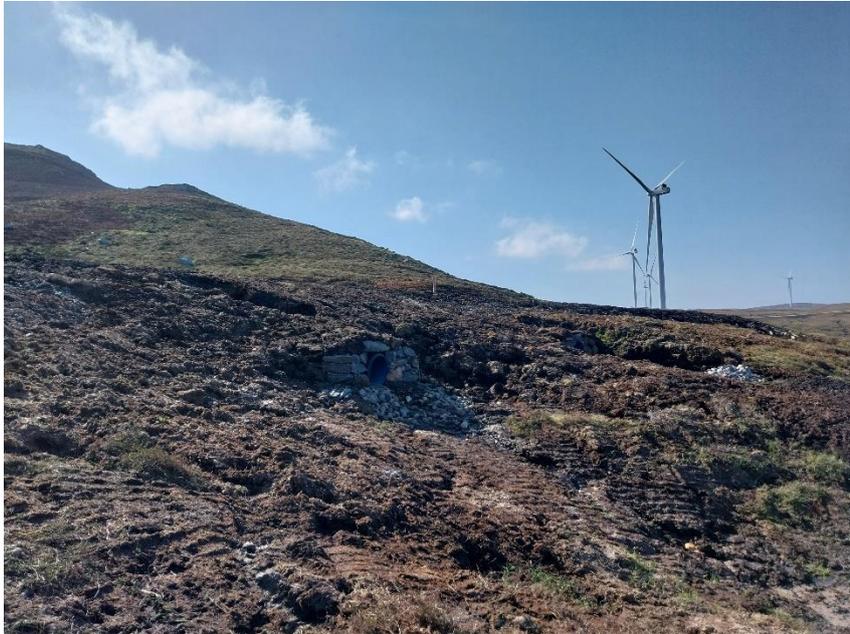
**Photo 4.** View of culvert downstream of KBP03

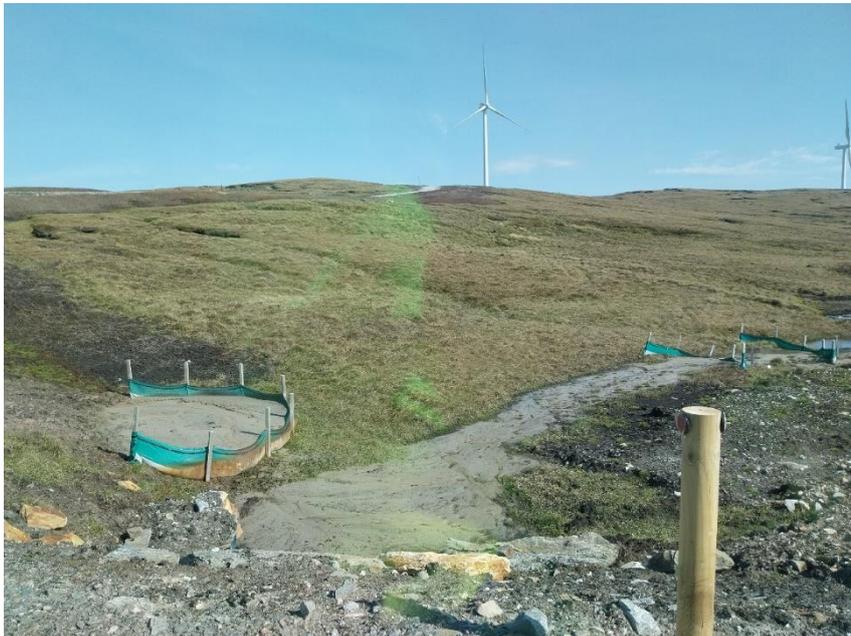
Following the April report, silt fences by Junction 9 remained full during the audit (Photo 5). RJM has been notified and this item continues to be on their mitigation log. The removal of silt fences has begun in Kergord with those at Junction 5 fully removed. The silt fences at Junction 9 should be cleaned out in the coming weeks when the silt fence is due to be removed. This should be monitored in the next audit.

**Photo 5.** Full silt fences at Junction 9

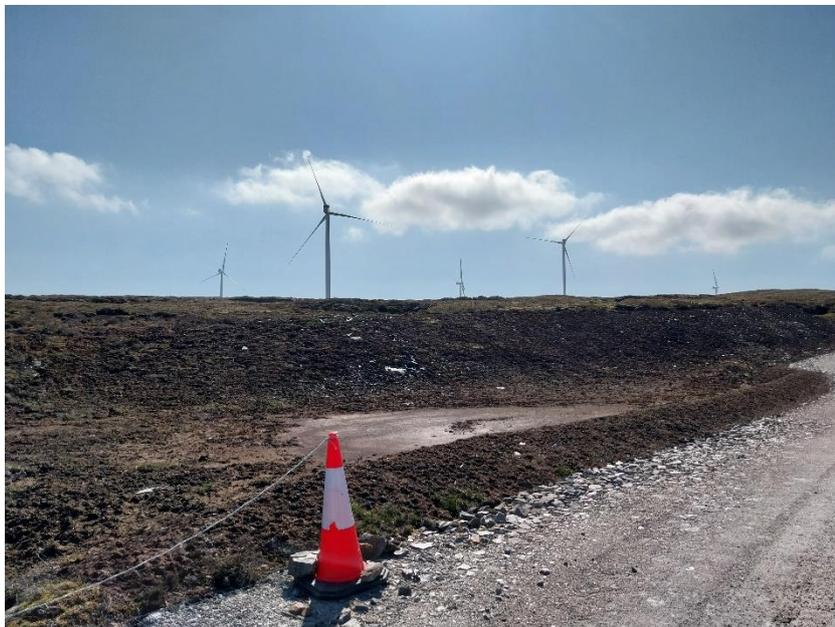
The culvert by T018 discharging directly onto peat as reported in April remains unchanged. This has been flagged to both SSE and RJM and should be monitored in the next audit. A natural pond with silt has been observed by watercourse crossing 3 (WC03) between T007 and T008 (Photo 6). SSE has recommended for that area to be built as a permanent settlement pond.

**Photo 6.** Recommended location for settlement pond by WC03

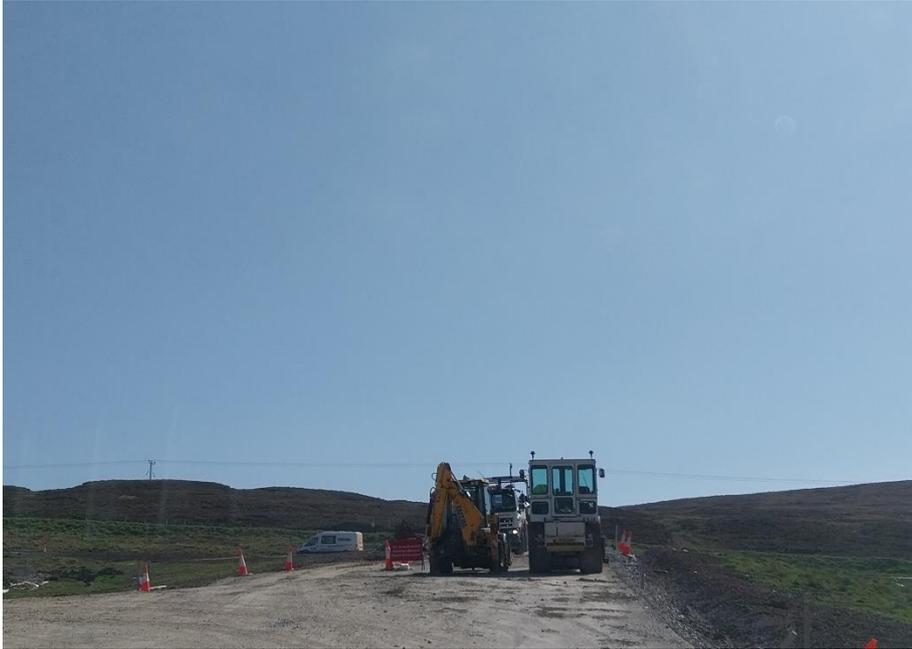
During the visit, the Sandwater track was closed to undergo final preparations ahead of being covered in tarmac in the coming weeks (Photo 7). During the visit, temporary track stripping at the Burn of Weisdale Cross on KAT was observed (Photo 8). Drainage and culverts under Sandwater track were observed from B9075 and noted to be in good condition (Photo 9).

**Photo 7.** Sandwater track being closed to undergo final preparations ahead of tarmacking

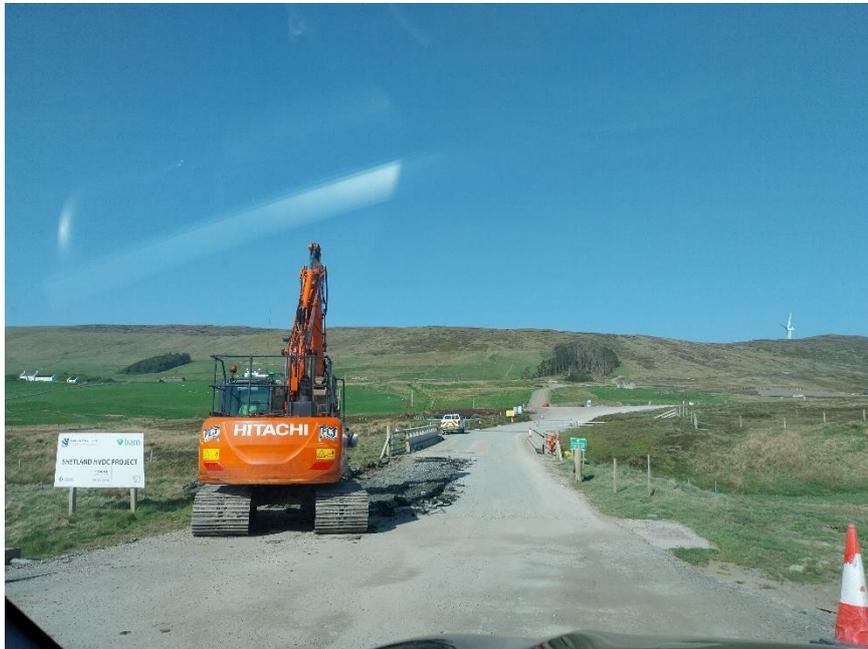
**Photo 8.** Road stripping at the Burn of Weisdale Cross on KAT observed

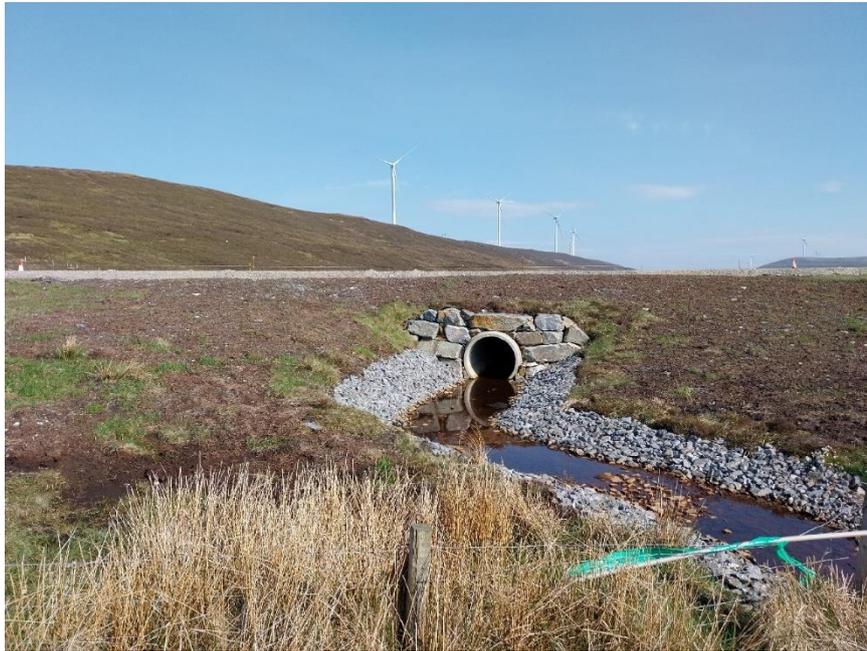
**Photo 9.** View of Sandwater track culvert from B9075, observed to be in good condition

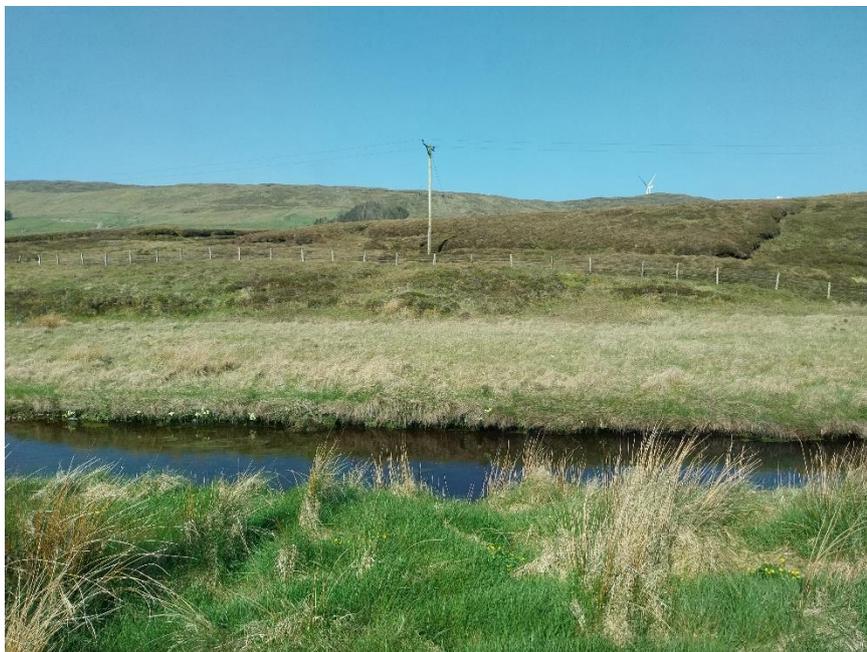
A peat movement event was recorded on the 8<sup>th</sup> May 2024 on a section of cable track being prepared by SSEN (under CDM transferred to them from RJM). The section of cable track where the event occurred runs parallel with the new Sandwater Road on the shallow downslope approach into Kergord Valley. The incident was reported in the local media on the day of the event. The PMO understands that SSEN is currently investigating the event and will remediate the area once it is deemed safe. The ACoW, ECoW, and GCoW have since been informed of the event and will review the remediation plans drafted by SSEN once received. All remedial action will be carried out by SSEN and monitored by SSER.

On the day of the visit, the area of the peat movement event was still on safety stand-down. The PMO observed the event area from B9075 and noted that the peat movement did not reach the public road nor the Burn of Weisdale downslope (Photo 10). Mitigation measures had been implemented to prevent any silty washout from migrating to the burn.

**Photo 10.** View of Burn of Weisdale downslope of peat movement event

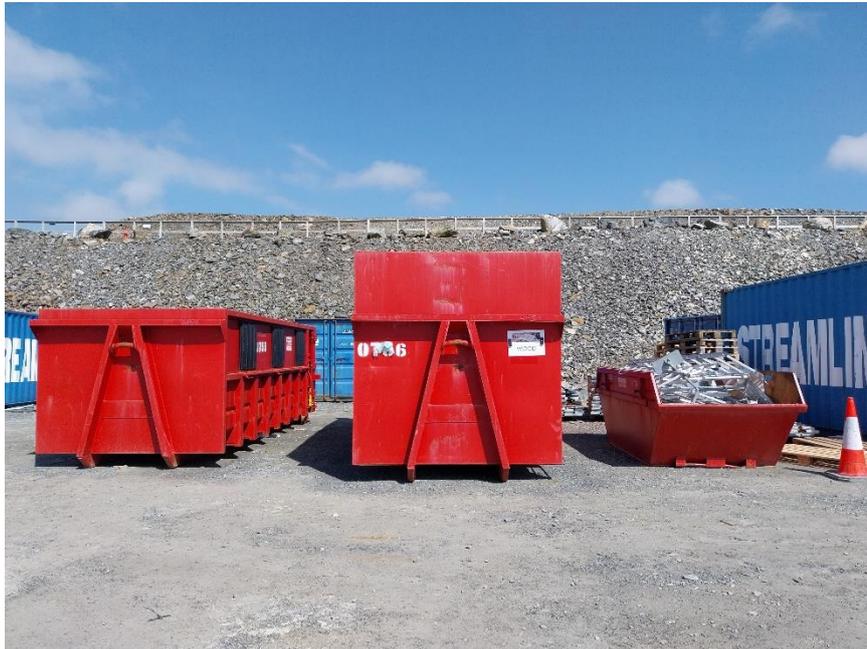
Following the observations noted in the February, March and April audits, the main compound was visited again. It was observed that previously missing signages on waste skips have now been replaced. The clearing out of the upper level has just begun with some items being moved to the lower level. The PMO observed missing signage on new waste skips (Photo 11) and a door missing on one of the storage units (Photo 12). This should be observed during the next audit.

**Photo 11.** Missing signage on new skips by Main Compound

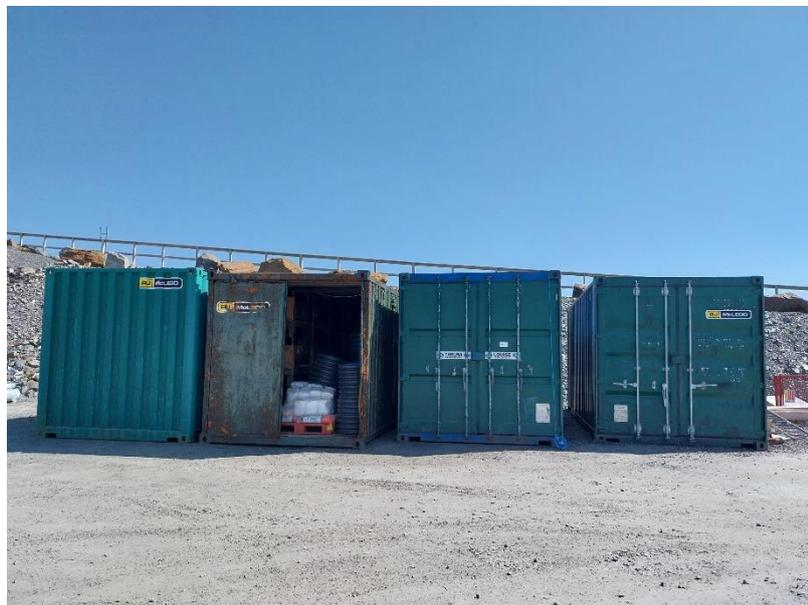
**Photo 12.** Missing door on storage unit by Main Compound

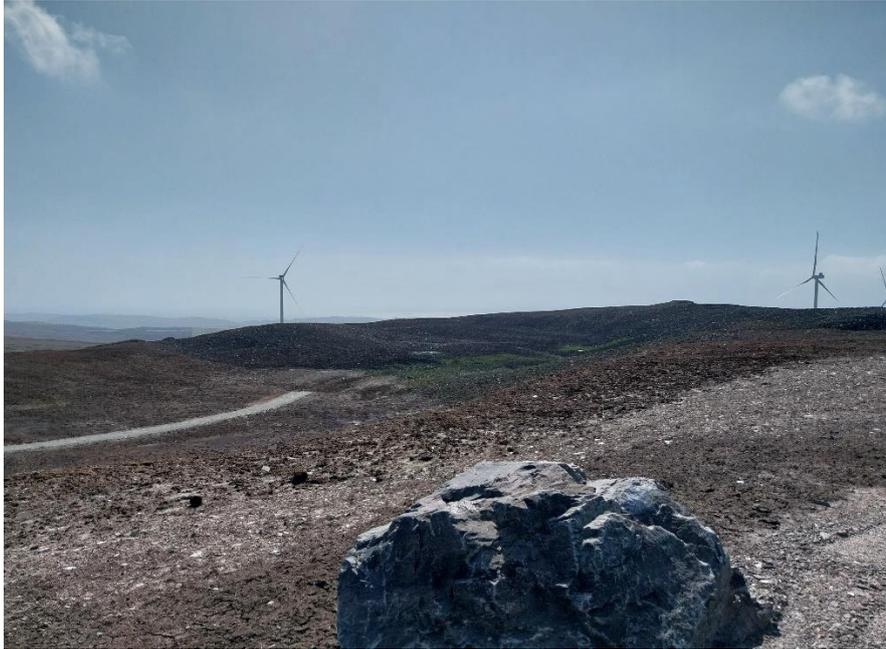
RJM continues to be in the process of designing permanent drainage for NBP05 to accommodate native woodland. During the visit, some natural vegetation growth has been observed on the edge of NBP05 (Photo 13).

**Photo 13.** Natural vegetation growth observed at the edge of NBP05

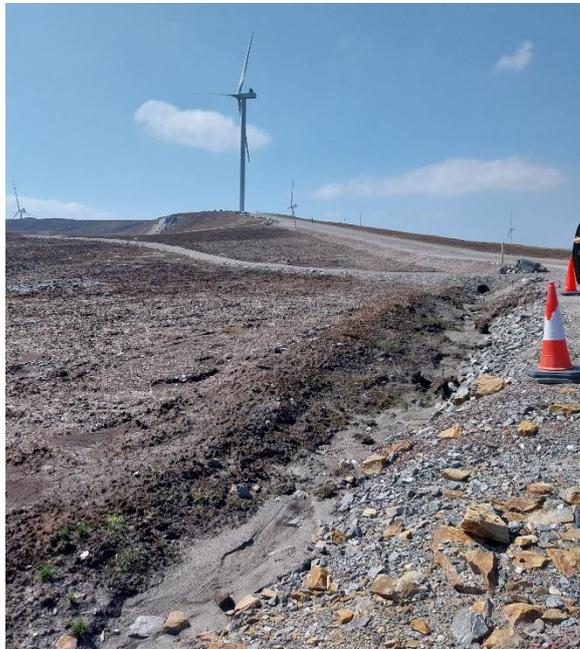
The larger pond at the top of the drainage system at T076 was observed to be silted up during the audit visit (Photo 14), as also noted in the March and April Report. However, despite the larger pond being full, with the installment of more check dams, the downstream drainage was observed to be clear running into the burn. It is important to note that the weather was dry and clear during the audit and hence, recommendations are for the silt at the top pond to be removed to improve efficiency. Drainage in this area should continue to be monitored by the project team and continue to be observed during future audits.

**Photo 14.** Silt observed at the top of T076 drainage

The ECoW commented that the settlement ponds put in place in the area around T076 are working well; however, these had recently silted up and have been recommended to be removed, as discussed in Section 3.6.2.

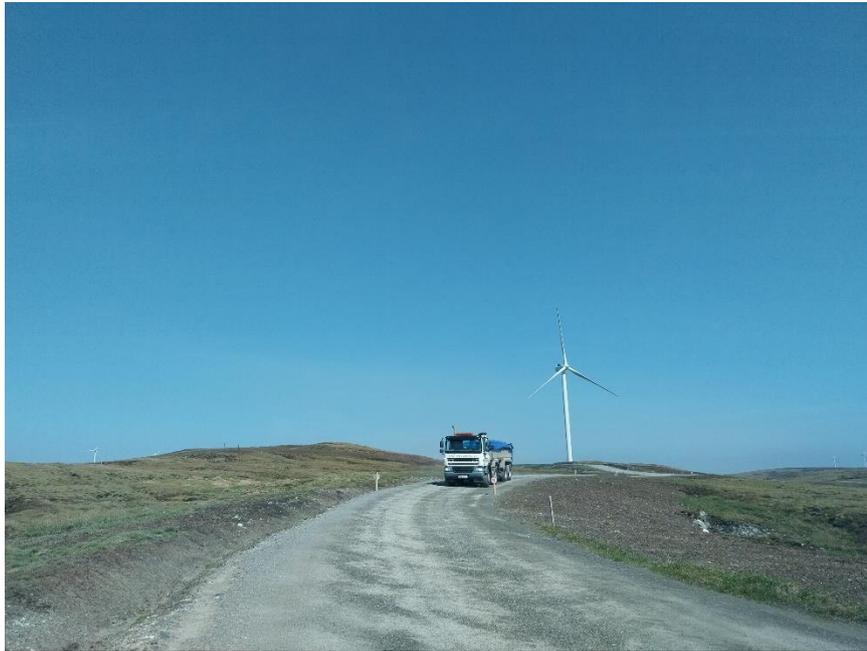
An active water bowser was observed during the PMO visit. Tracks in Nesting were damped down during the visit and have been observed to successfully suppress dust (Photo 15). With the reduced activity on site, RJM confirmed that there are two water bowsers on site with at least one active during working hours. Should the condition and activity level change, there are three tractors available on call as water bowser support.

**Photo 15.** Observation of truck driving on road following dust suppression

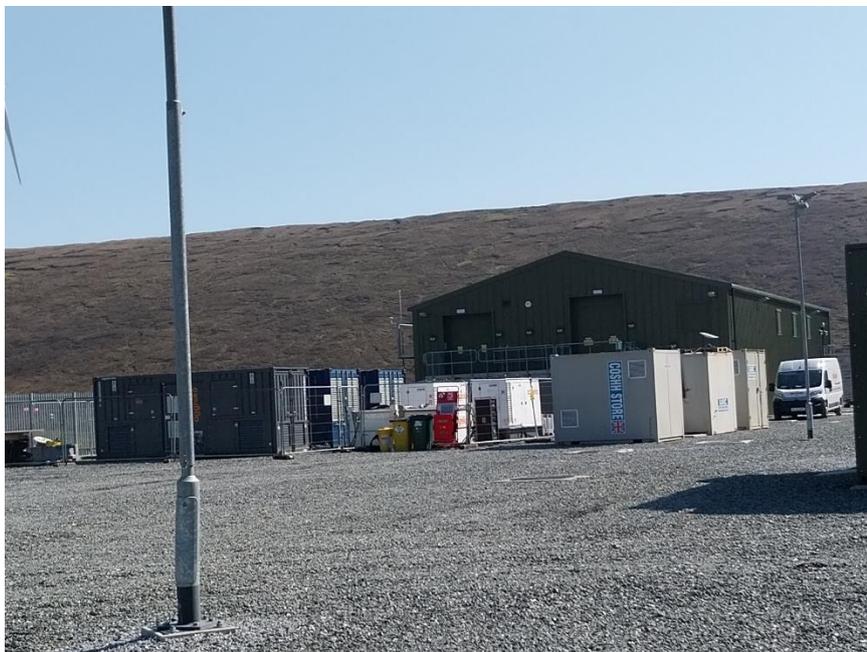
Following the April report, fire extinguishers has been replaced and can be observed by the two remaining generators (Photo 16). The missing waste skip signages have also been replaced.

**Photo 16.** Replaced fire extinguisher at the Substation
