The Knab, Lerwick

Desktop Survey Report

Shetland Island Council

November 2018

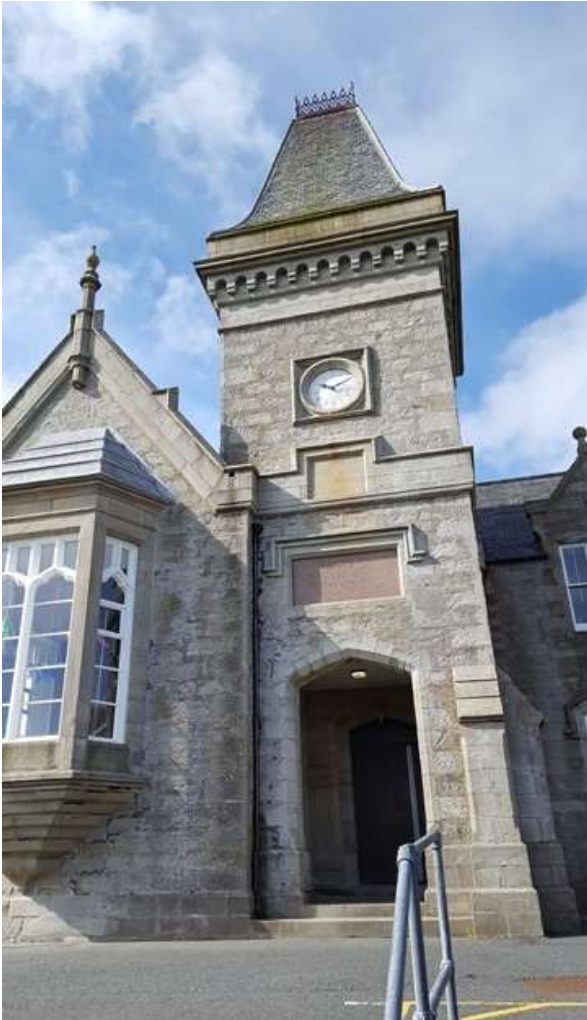
Anderson Institute

- Condition of the structure is good; no signs of significant foundation related movement or cracking.
- Condition of the external stonework appears to be good. Some past re-pointing has been carried out using cement based mortars.

- Some surface erosion and weathering of the stonework on east (front) elevation, especially in and around the entrance porch area and below the projecting bay window

- Signs of old movement to the projecting stonework of the bay window to the main hall and previous crack repairs to the masonry. Past crack repairs elsewhere typically at window heads on rear elevation.

- Internally the structural condition generally is good. Two areas of water penetration which risk rot and decay of roof and floor timbers; at gable wall to south end, and to the north side of the main hall space.

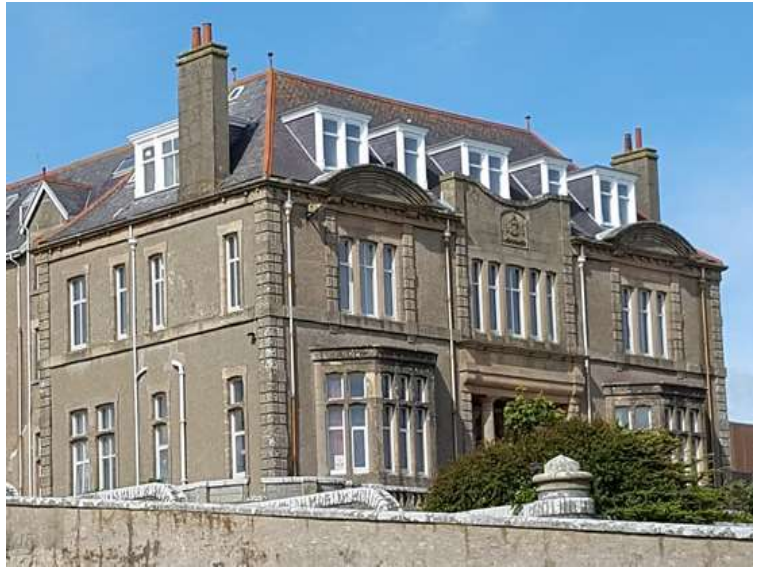
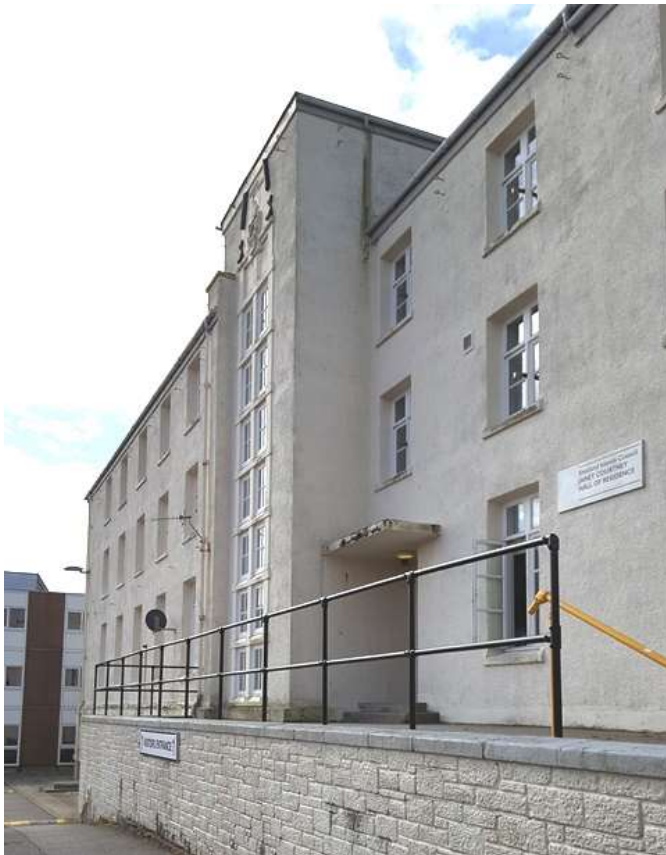
Bruce Hostel

- The internal floors are be suspended timber construction and the roof a cut timber construction.
- Generally, the condition of the structure appears to be good. There are no signs of significant movement or cracking. Condition of external stonework appears to be good.

- Internally two upper floor and rear wings are not in use. Some water damage to floors and ceiling - leaking plumbing rather than water ingress through the roof

- Tired internal fabric appears but fair condition structurally. Some of the internal spaces have been subdivided in the past with plaster boards and timber stud partitions.
