Local Review Ref: 2022/276/PPF - LR46 – Proposed installation of photovoltaic (PV) panels and reharl exterior at Church of Scotland, Papa Stour, Shetland, ZE2 9PW

Visual Non-Intrusive Property Fabric Condition Inspection & Report

Papa Stour Kirk, Papa Stour, Shetland

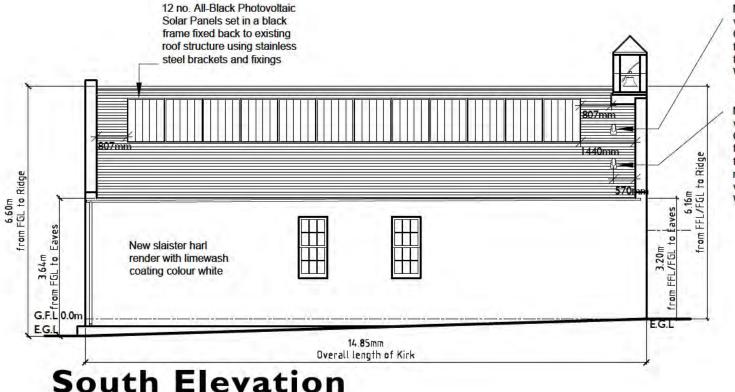
New metal "swan neck" ventilation terminal with Code 5 lead sheet soakers to match existing connected to ventilation ductwork from WC Pump Unit

New metal "swan neck" ventilation terminal with Code 5 lead sheet soakers to match existing connected to ventilation ductwork from mechanical extract ventilation from Access ble WC

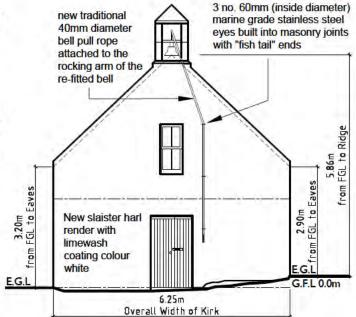
New slaister harl render with limewash

coating colour white

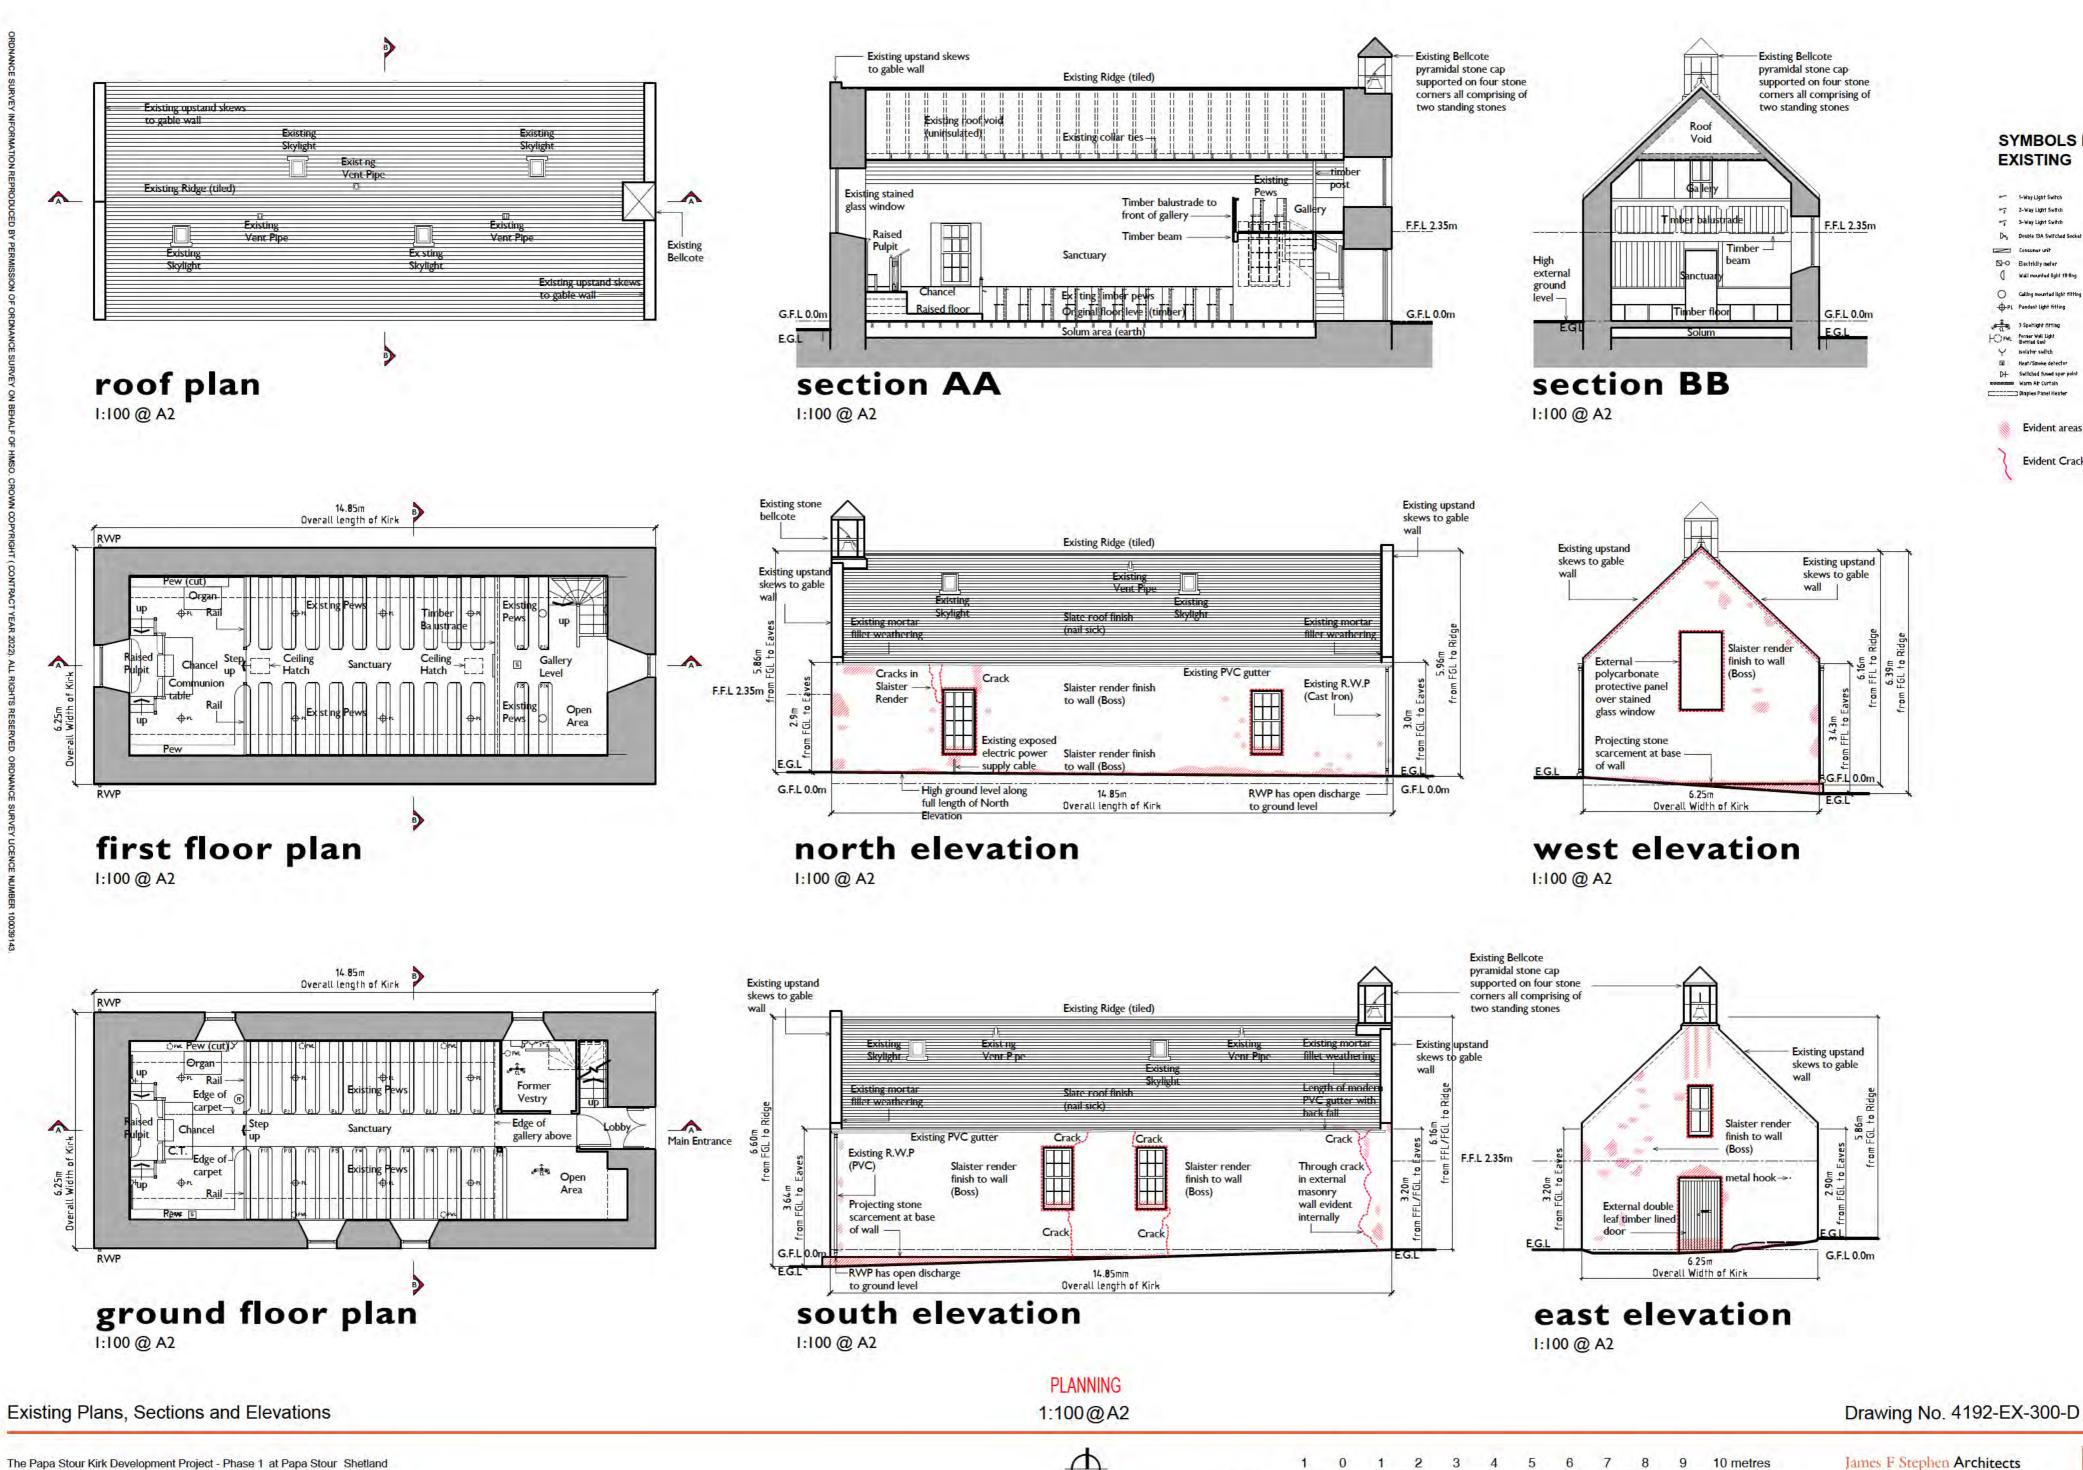
Evident areas of defects

**Evident Cracks**
