Intended for  
**Viking Energy Wind Farm LLP**

# **VIKING ENERGY WIND FARM PLANNING MONITORING OFFICER AUDIT REPORT 050: 13<sup>TH</sup> MARCH TO 11<sup>TH</sup> JUNE 2025**

<b>Audit Number</b>	PMO 050
<b>Location</b>	Kergord Sandwater Road Nesting North Nesting Main Compound
<b>Weather Conditions</b>	Sunny with clouds, 13°C
<b>Audit Date</b>	11 <sup>th</sup> June 2025
<b>Audit Period</b>	13 <sup>th</sup> March – 11 <sup>th</sup> June 2025
<b>Audit Owner</b>	Ramboll UK Ltd

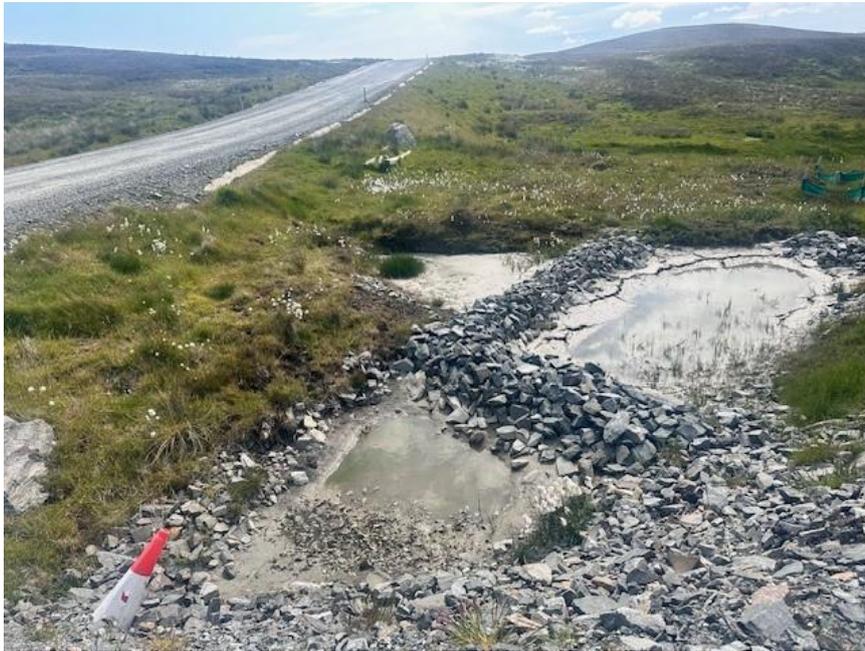
The new design for permanent surface water management to provide attenuation and treatment of surface water draining to the Burn of Droswell from the KAT was observed (photo 1). Slight siltation of the upper retention ponds was noted and SSER indicated that this would be dealt with during the week. Temporary silt fences remain near the Burn, these will be removed as part of the snagging phase. This area should be visited during the next PMO audit.

**Photo 1.** Permanent surface water management at the Burn of Droswell

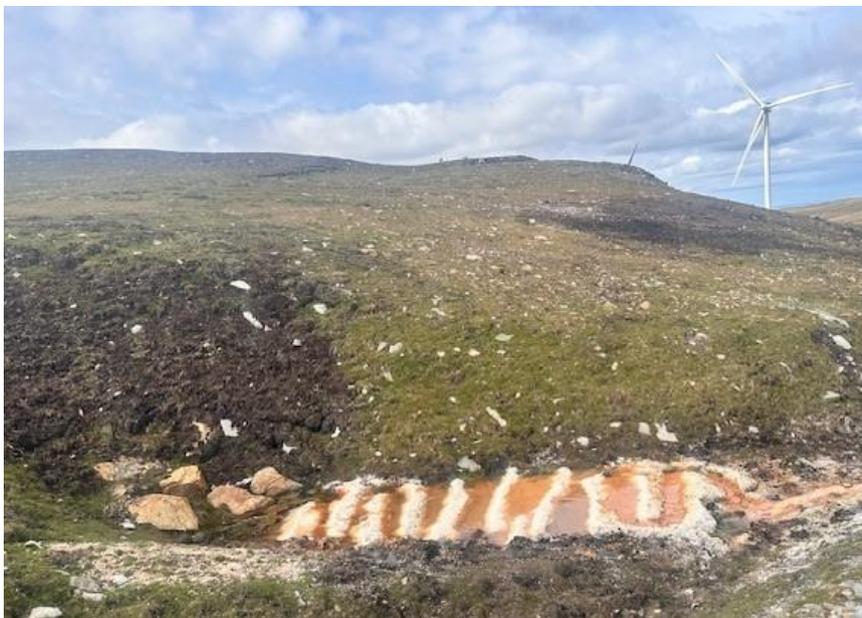
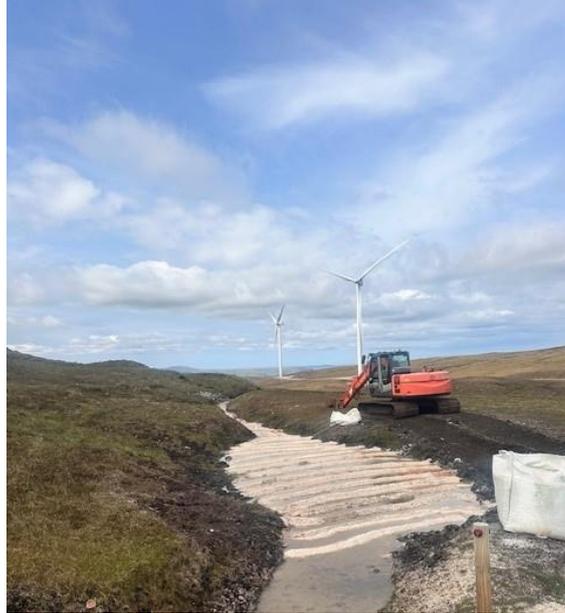
The PMO audit included inspection of the temporary drainage treatment at KBP02 (photos 2 and 3). SSER have taken on the monitoring and maintenance of the treatment system, with continued water monitoring and sampling which has shown an improvement of the water quality. A new design for the treatment system has been agreed with subject matter experts and SEPA, and will be implemented in the coming months to further improve the water quality.

**Photo 2.** Temporary drainage treatment at KBP02

**Photo 3.** Temporary drainage treatment at KBP02

Issue	Auditor Comments	Required Action	Action Owner	Status
kits, silt control, cement/concrete, water resources).	construction cut-off ditches that were used during construction to mitigate pollution risks. This is ongoing.			
Pollution Prevention and Response (e.g. use of spill kits, silt control, cement/concrete, water resources).	Temporary silt fences used during the construction works remain at the Burn of Droswell.	To be removed by the Principal Contractor in the Spring	Principal Contractor	Amber
Pollution Prevention and Response (e.g. use of spill kits, silt control, cement/concrete, water resources).	The SSE Renewables Environmental Manager notified the PMO in March 2023 that there have been some exceedances of Environmental Quality Standards of some trace metals in water quality sampling in the Burn of Lunklet.	Short-term mitigation measures have been implemented as per the SEPA accepted mitigation plan. New design for treatment system to be implemented.	SSER Operational Team	Amber

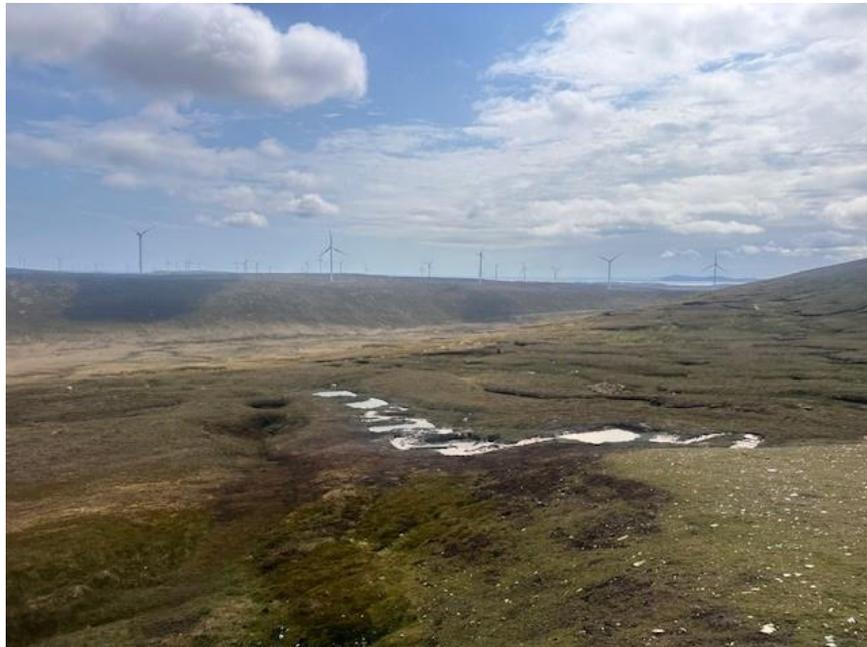
The pond system located down from T026 was also observed and appeared in good condition (photo 4).

**Photo 4.** Pond treatment system at T026

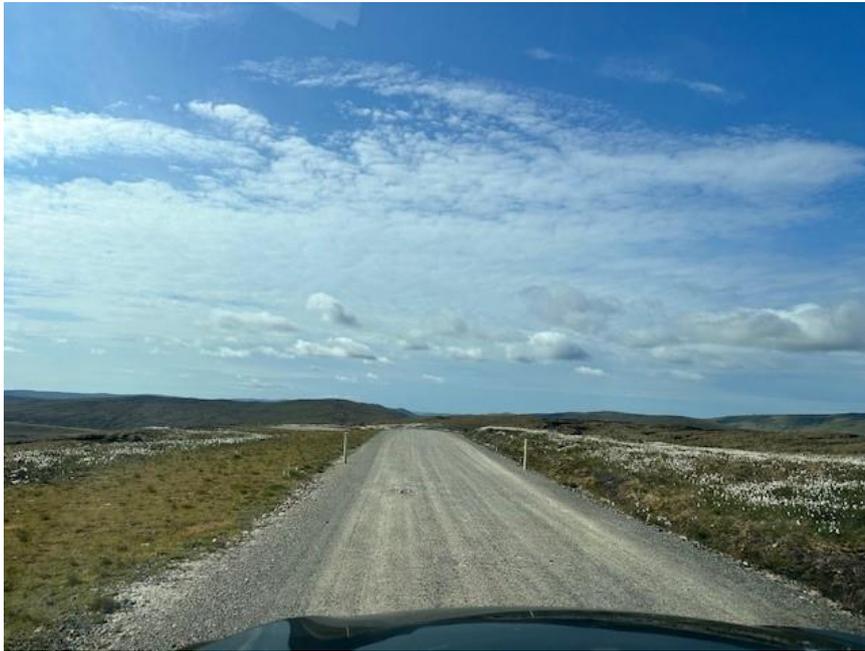
A good state of vegetation was observed at KBP02 and along the main track (photo 5) following the hydroseeding that took place in spring 2024.

**Photo 5.** Vegetated areas hydroseeded in 2024 north of KBP02

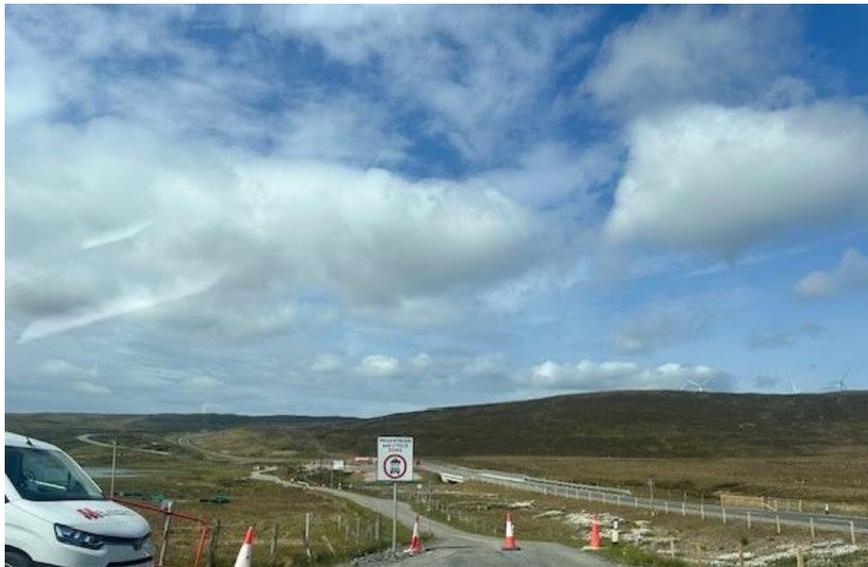
The former B9075 remains closed to public traffic due to the ongoing works (photo 6). Once the road is formally "stopped up" and closed to public traffic, it will become a recreation route for pedestrian and bicycles.

**Photo 6.** Former B9075 to become recreational route

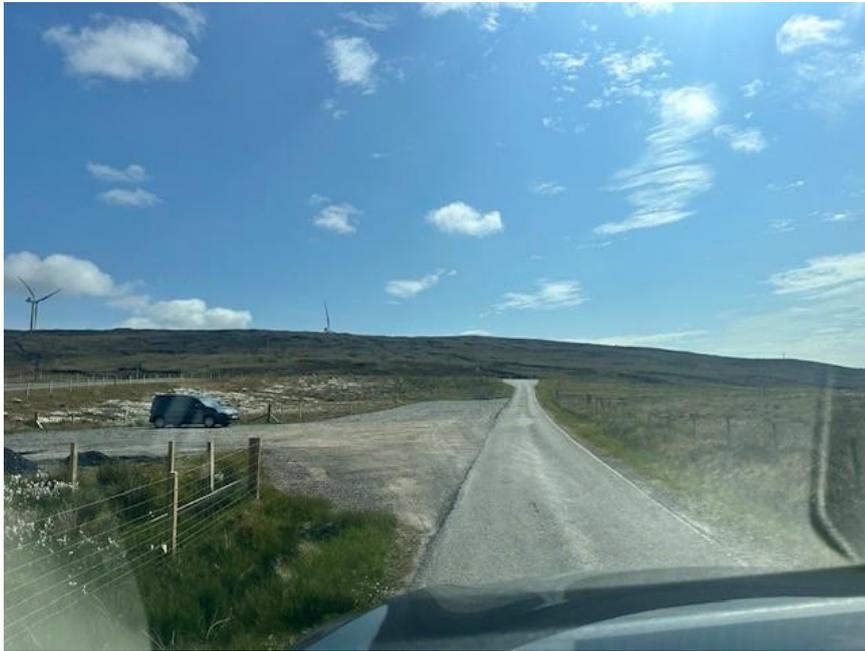
It hasn't yet. The temporary carpark is in situ. Photo 7 shows the temp area on the left, the area to the right is being constructed at present. Upon completion the new permanent carpark will incorporate the old temporary area and will be surfaced.

The temporary car park located between the new Sandwater Road and the former B9075 remains (photo 7). This area is being extended and will form the permanent carpark, which will be surfaced. SSER have indicated that the car park will be used for carshare as well as for visitors taking part in recreational activities in the area.

**Photo 7.** Sandwater Road – car park area and future recreational route to the A970

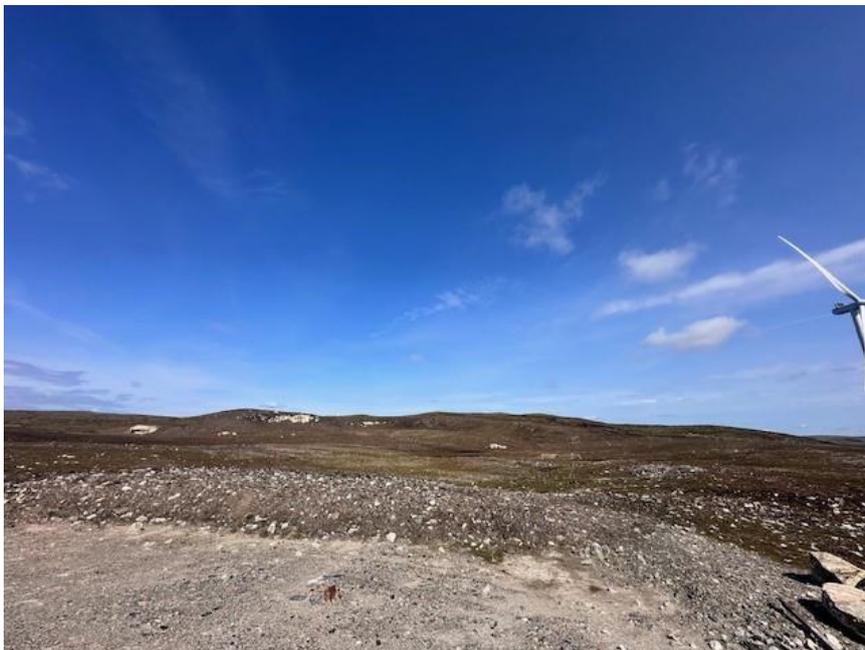
Hydroseeding was observed to be successful across the area (Photo 8).

**Photo 8.** Vegetated areas hydroseeded in 2024 in North Nesting (T049)

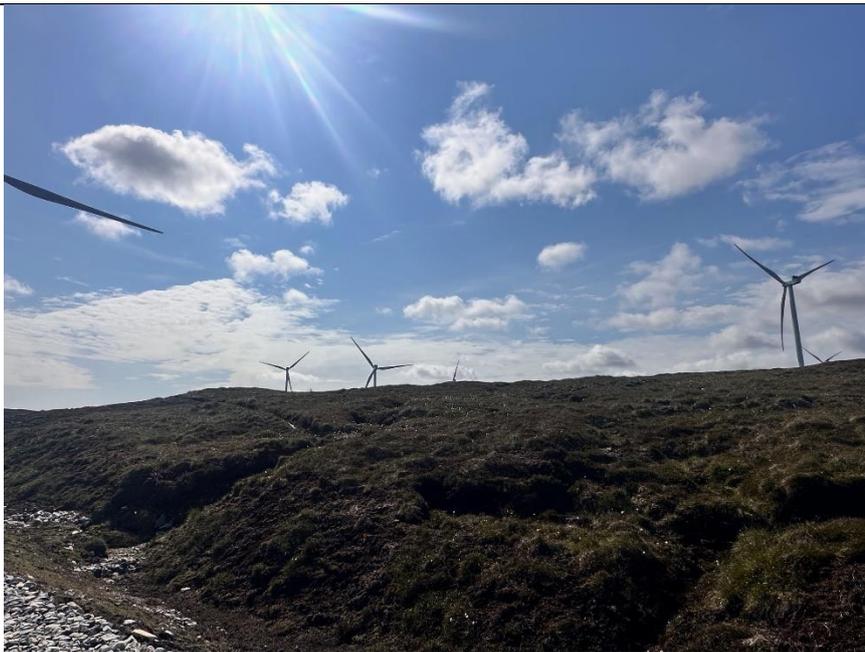
It is understood that reinstatement work to remove/block up or reinstate construction cut-off ditches that were used during construction to mitigate pollution risks was on-going at the time of the audit and scheduled to take place over the coming weeks around North Nesting and the entire site (photo 9). The reinstatement of these features will prevent unnecessary drainage of the restored peatland.

**Photo 9.** Ongoing reinstatement of cut-off ditches (North Nesting)

Natural and Built Environment (e.g. ecology, biosecurity, protected sites, archaeology and site restoration).	Ecological constraints identified by the ECoW team are communicated to the SSER operational team to allow mitigation measures to be implemented. The ECoW construction phase duties are now complete, albeit follow up surveys are proposed for 2025 to assess the success of reinstatement and the need for any remedial work. The construction phase duties of the ACoW are complete.	No action required.	SSER Operational Team	Green
Pollution Prevention and Response (e.g. use of spill)	Additional reinstatement work is required around the site to remove/block up or reinstate	Continued reinstatement of cut off ditches	Principal Contractor	Amber

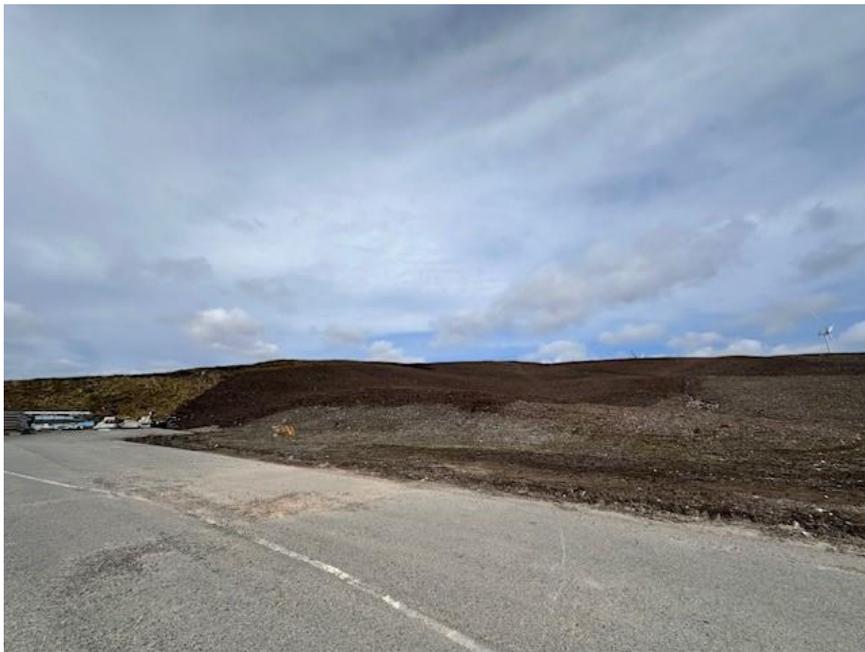
The majority of the area has been reinstated with peat (photos 10), and hydroseeding has taken place. In the centre, a small area remains with a site office (former visitor centre) to the north, an area of carparking, and a skip (photo 11). The compound appeared tidy.

**Photo 10.** Main compound reinstatement

It is understood that the remainder of the compound will be reinstated in the next few months, with hydroseeding to take place in spring / summer 2026.

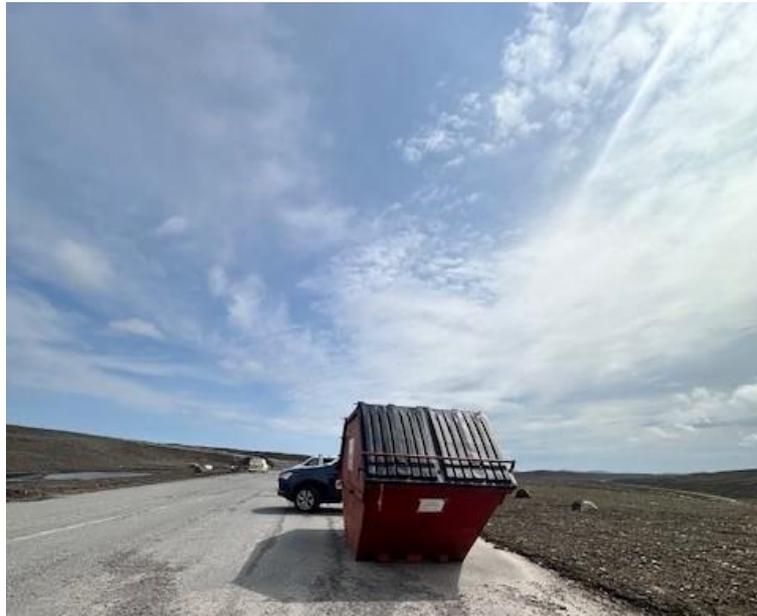
**Photo 11.** Skip at main compound with appropriate labelling

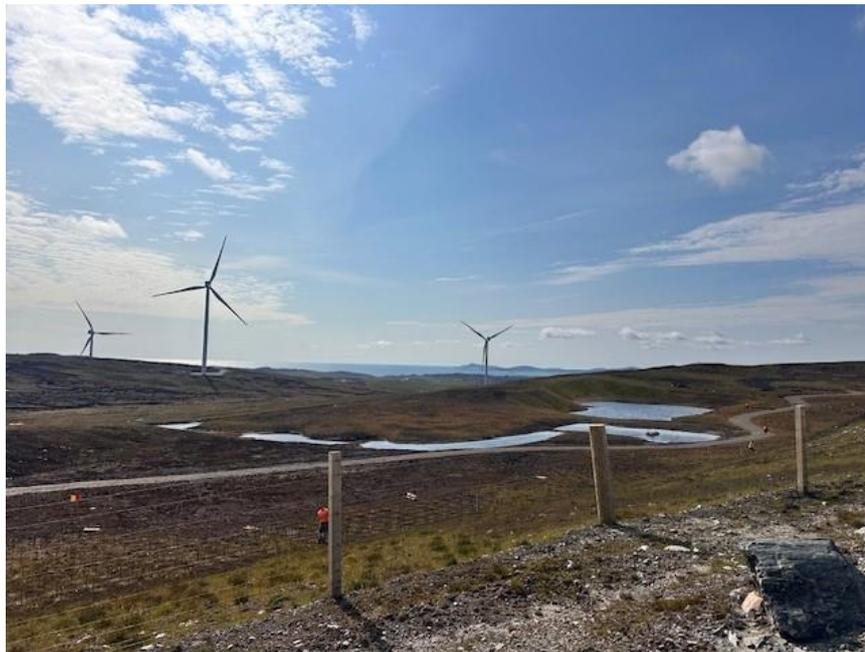
NBP05 was observed during the audit visit. The water features created appeared in good working order with a good state of vegetation on the slopes (photo 12). Works on-going during the audit visit included the placement of guards around the tree saplings that have been planted across the south-western part of the restoration area (photos 13 and 14). Landscaping personnel present on site indicated that the placement of guards will provide protection from wildlife and wind which has been shown to impact the tree growth. A tree health assessment will be undertaken in the coming weeks, and depending on the findings of the assessment additional measures may be implemented to help tree growth and restoration efforts.

**Photo 12.** Water features and vegetated slopes at NBP05

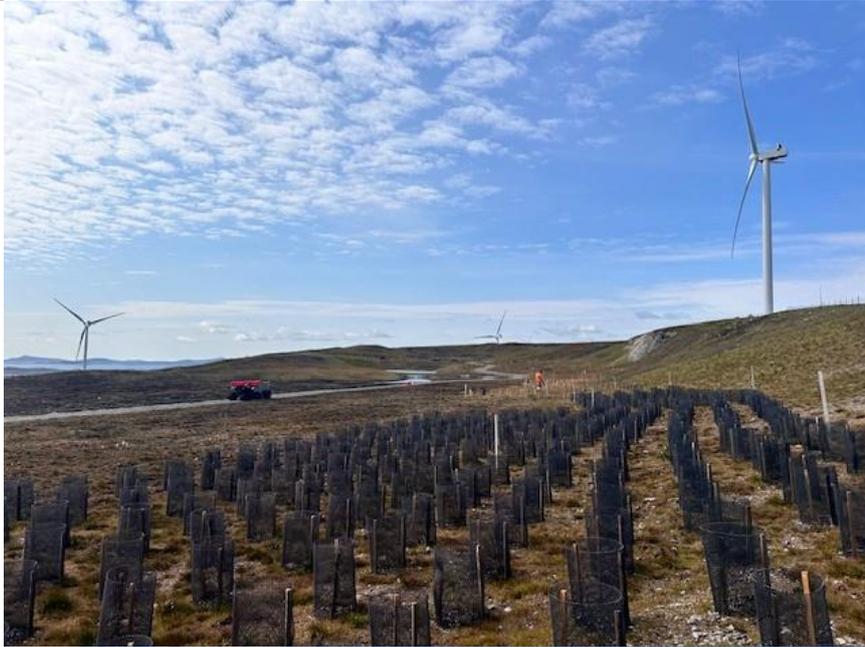
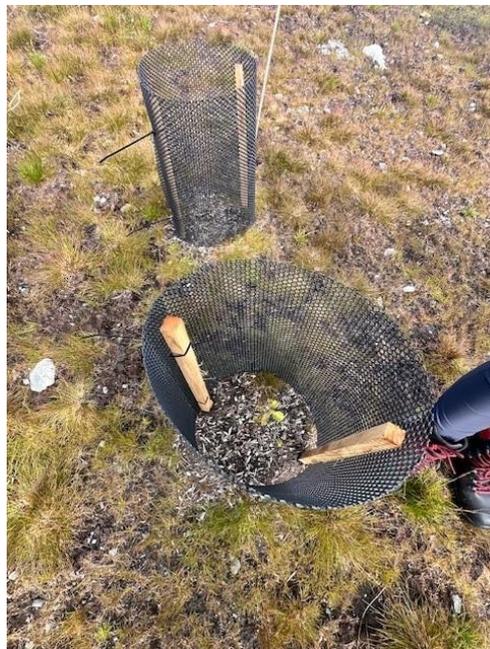
**Photo 13.** Placement of tree guards at NBP05

**Photo 14.** Placement of tree guards at NBP05

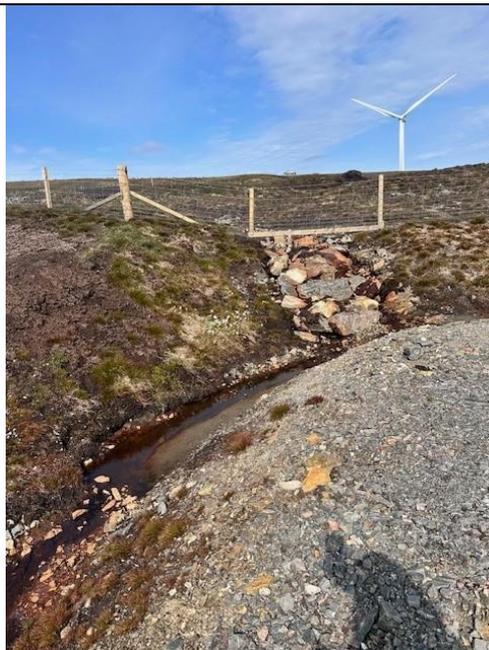
Drainage at T076 was observed (photo 15). The water was noted to run clear close to NBP05 and further downstream across the peat towards the watercourse. Ongoing monitoring of groundwater and surface water levels are continuing in this area. This area should be visited during the next PMO audit.

**Photo 15.** Drainage at T076
