Intended for
Viking Energy Wind Farm LLP

Date
September 2025

Project Number
1620009158

VIKING ENERGY WIND FARM PLANNING MONITORING OFFICER AUDIT REPORT 051: 12TH JUNE TO 3RD SEPTEMBER 2025

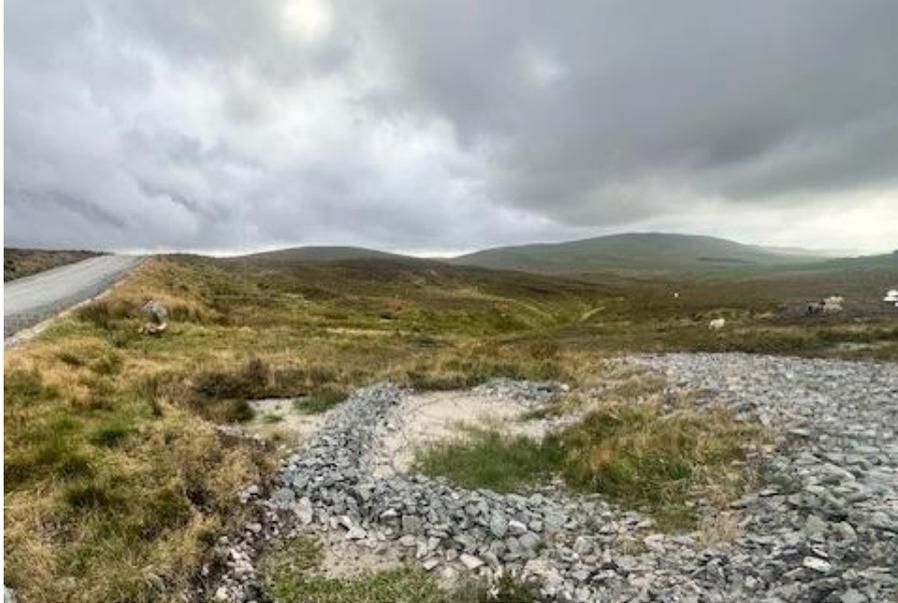
The new design for permanent surface water management to provide attenuation and treatment of surface water draining to the Burn of Droswell from the KAT was observed. The upper retention ponds were dry during the audit visit, and siltation of their base was noted (photo 1). The main retention pond was noted to be full (photo 2). It is understood that SSE Operation are monitoring the ponds, with maintenance undertaken as required. Temporary silt fences remain near the Burn, these will be removed as part of the snagging phase. This area should be visited during the next PMO audit.

Photo 1. Permanent surface water management at the Burn of Droswell

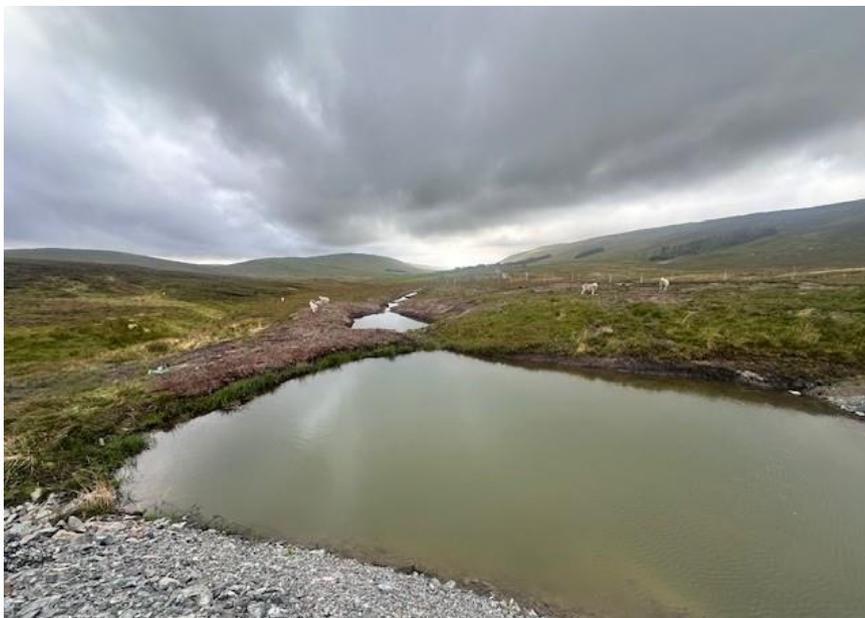
Photo 2. Permanent surface water management at the Burn of Droswell

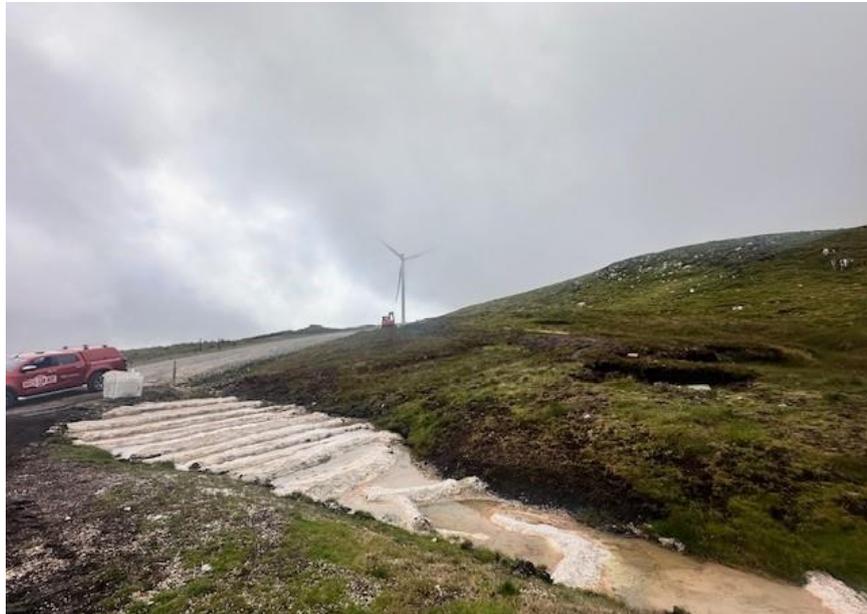
The PMO audit included inspection of the temporary drainage treatment at KBP02 (photo 3). SSER have taken on the monitoring and maintenance of the treatment system, with continued water monitoring and sampling which has shown an improvement of the water quality. A new design for the treatment system has been agreed with subject matter experts and SEPA to further improve the water quality, and pilot trials were in the process of being installed during the audit visit (photo 4 and 5). The pilot trials will be monitoring over the coming months, and the results will help refining the design of the new treatment system.

Photo 3. Temporary drainage treatment at KBP02

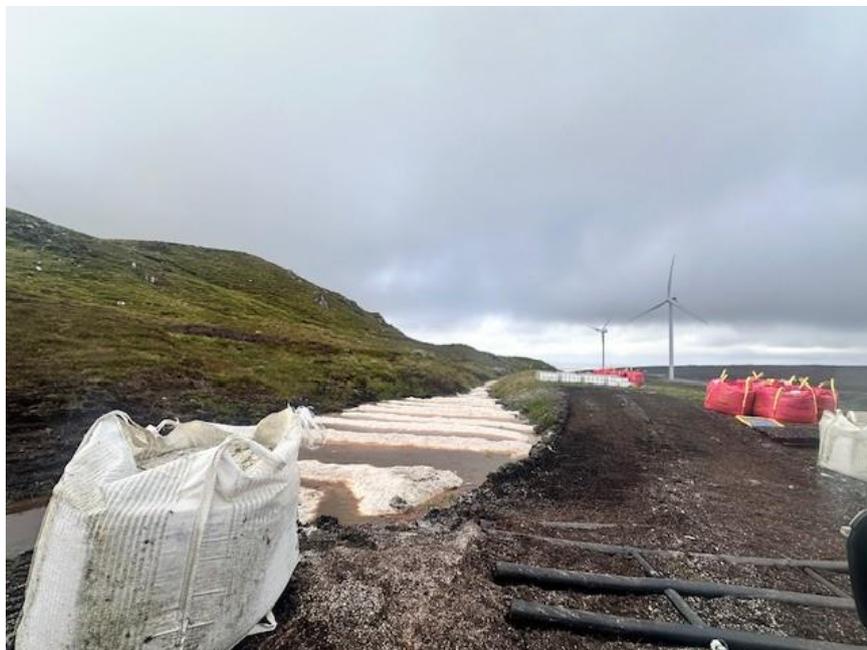
Photo 4. Pilot trials for new design of temporary drainage treatment at KBP02

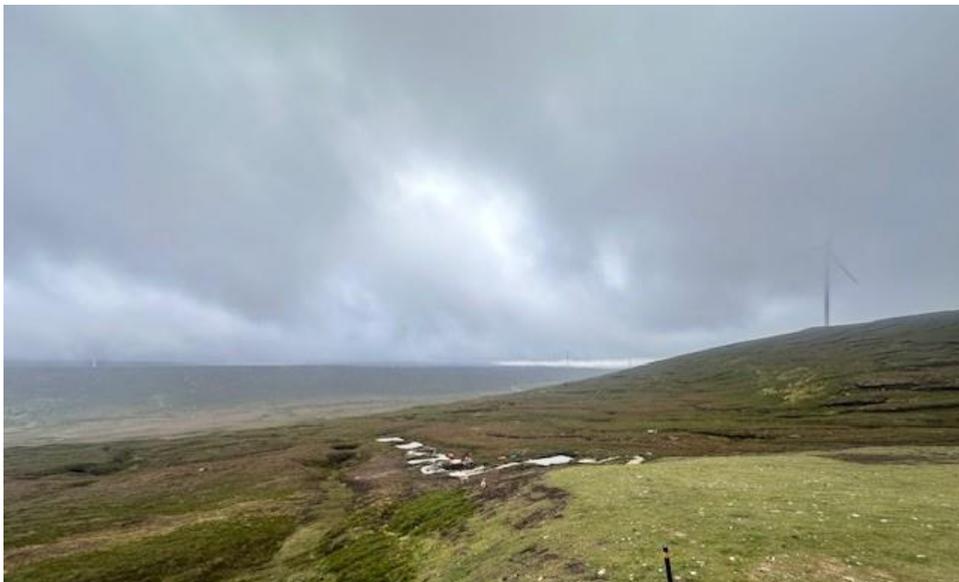
The pond system located down from T026 was also observed and appeared in good condition (photo 6). It is understood that the new treatment design will also be implemented at this location.

Photo 6. Pond treatment system at T026

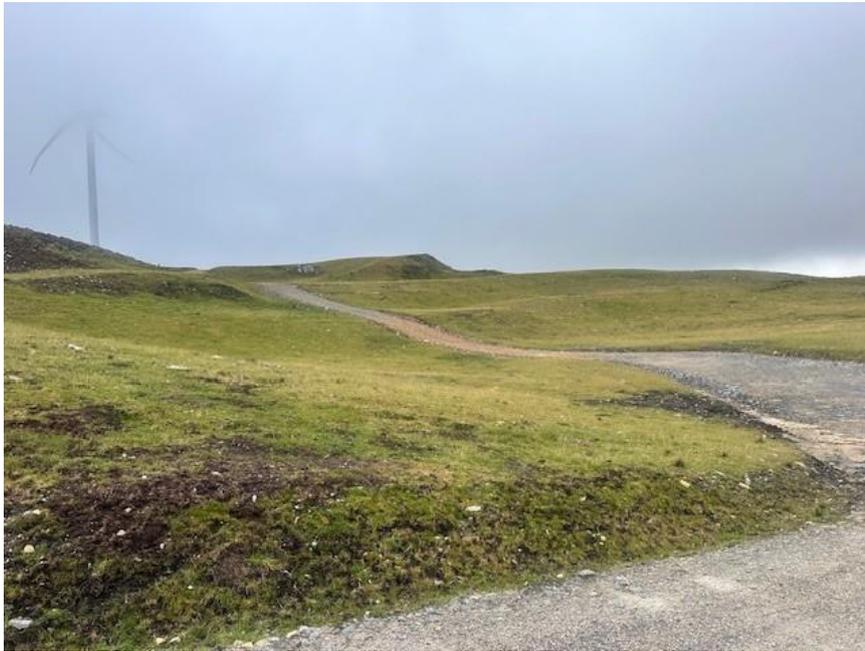
A good state of vegetation was observed on the slopes of KBP02 (photo 7) following the hydroseeding that took place in spring 2024.

Photo 7. Vegetated slopes at KBP02

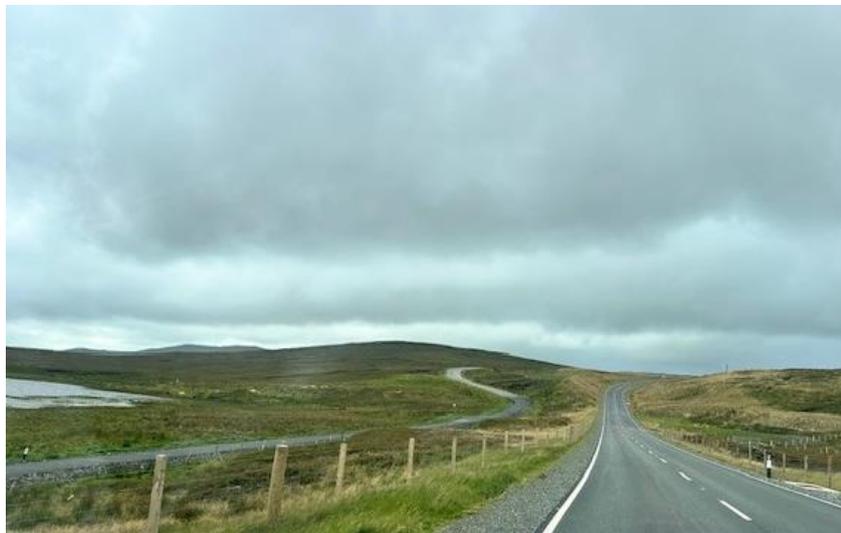
The former B9075 remains closed to public traffic due to the ongoing works (photo 8). Once the road is formally "stopped up" and closed to public traffic, it will become a recreation route for pedestrian and bicycles.

Photo 8. Former B9075 to the left to become recreational route

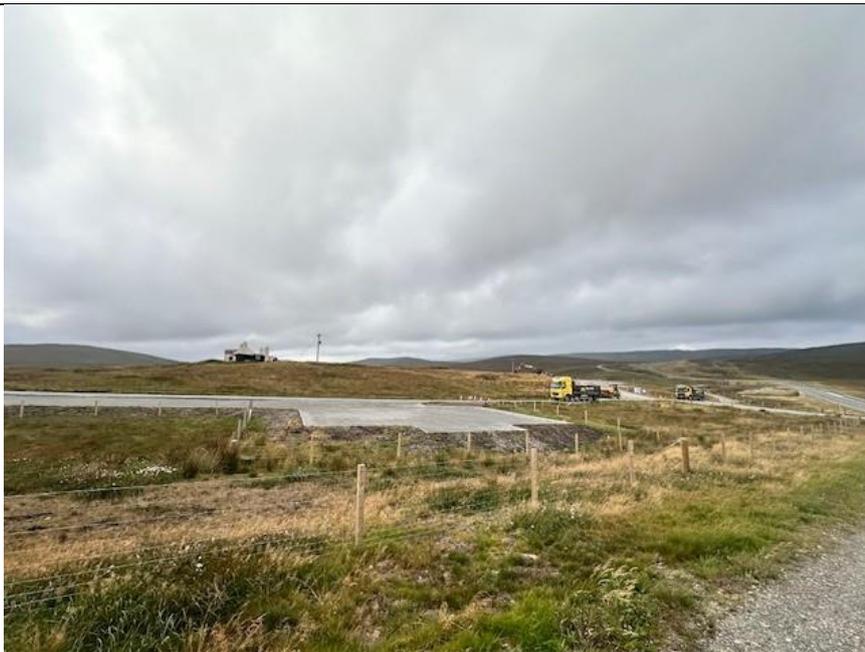
The construction of the Sandwater road carpark is nearing completion, with only surfacing outstanding (photo 9). The construction of the bus layby off the B9070 at the junction with the former B9075 was on-going at the time of the audit visit (photo 10).

Photo 9. Sandwater Road – car park area and future recreational route to the A970

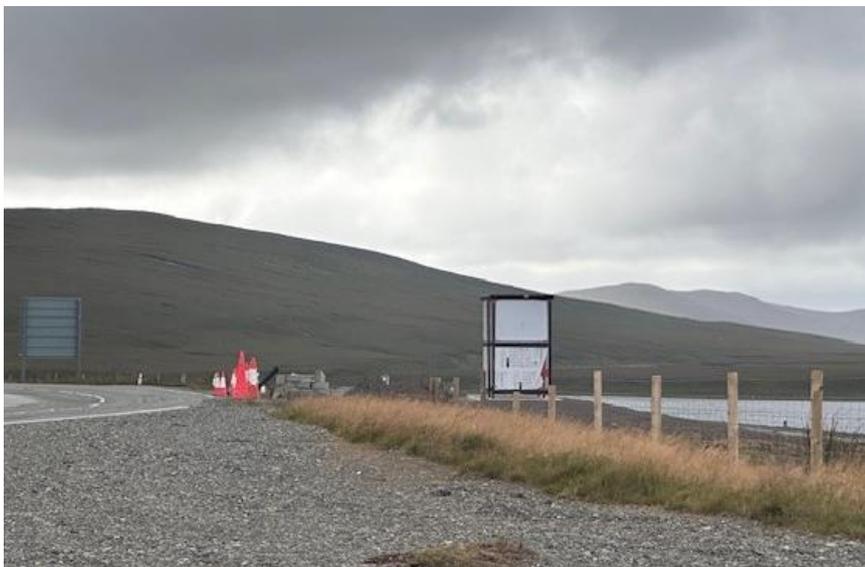
Photo 10. Bus layby off the B9070 under construction

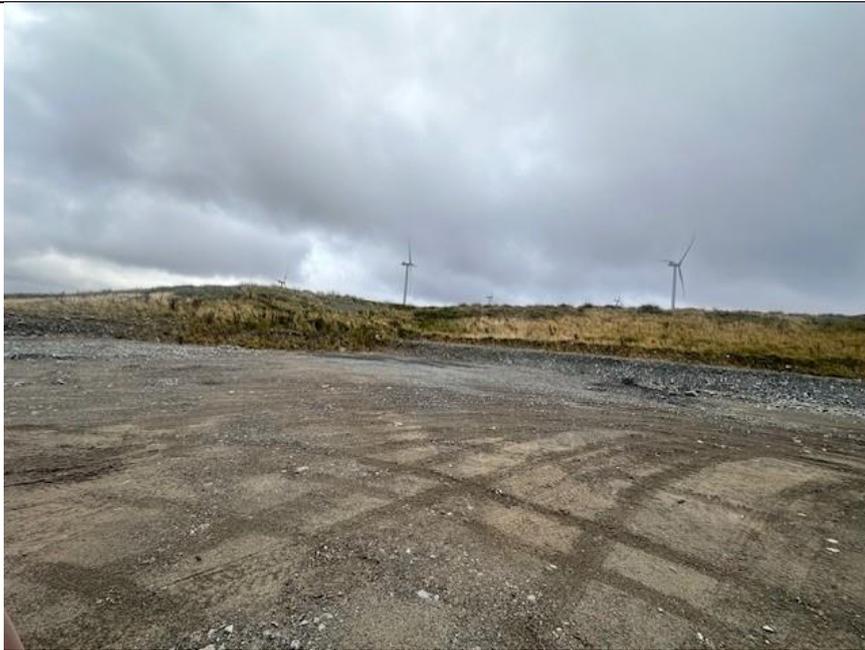
The North Compound was observed during the audit visit (photo 11). SSER is working on discharging pre-commencement conditions relating to pre commencement conditions. It is understood that works will commence when these conditions are discharged by SIC (anticipated Autumn 2025).

Photo 11. North Compound

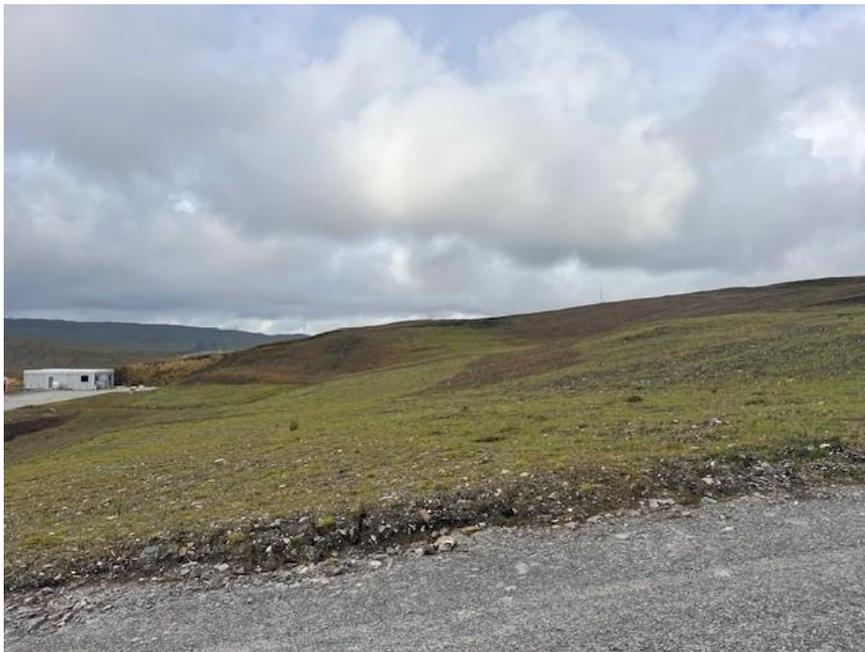
The Main Compound remains in a similar state as during the previous audit visit. Hydroseeding on the reinstated areas appears to have been successful (photo 12). In the centre remains a site office (former visitor centre) to the north, an area of carparking, and two skips (photo 13). The compound appeared tidy.

Photo 12. Vegetated slopes at Main Compound

It is understood that the remainder of the compound will be reinstated in the coming months, with hydroseeding to take place in spring / summer 2026.

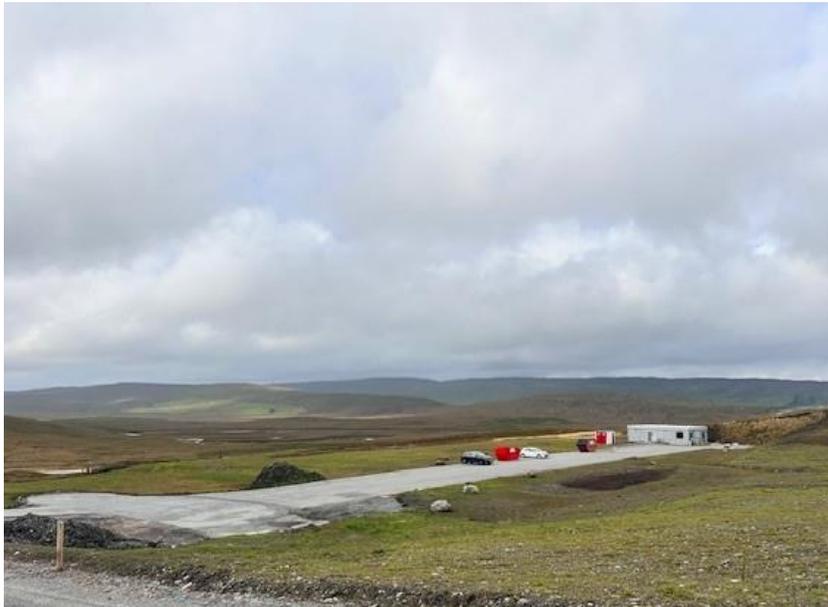
Photo 13. Skips, carparking and office at Main Compound

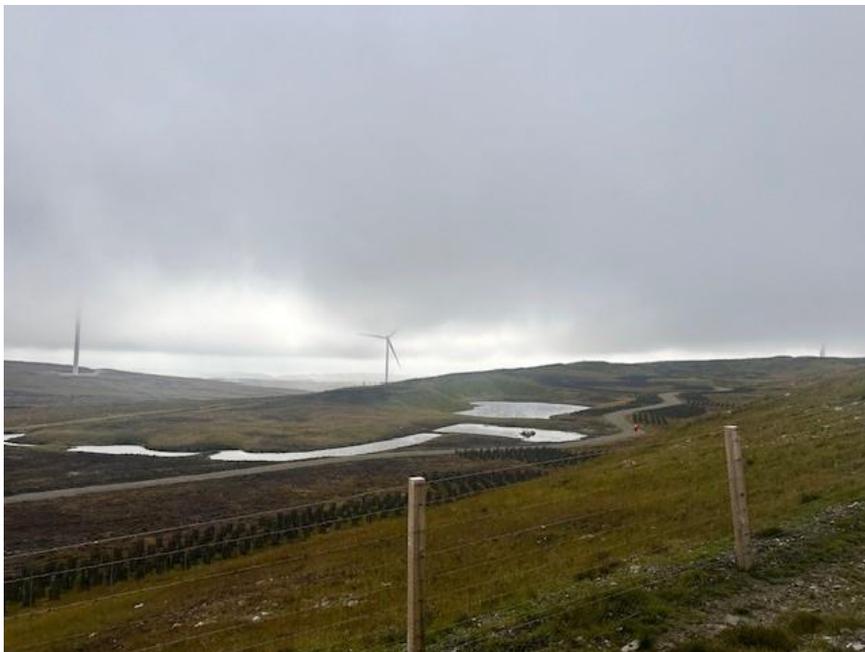
NBP05 was observed during the audit visit. The water features created appeared in good working order with a good state of vegetation on the slopes (photo 14). Tree guards that were placed in June 2025 around the saplings across the south-western part of the restoration area were observed to be in good condition (photo 15). A tree health assessment was undertaken over the summer, and the success of the tree planting will be monitored and assessed again in Spring 2026. Following this, additional measures may be implemented to help tree growth and restoration efforts.

Photo 14. Water features and vegetated slopes at NBP05

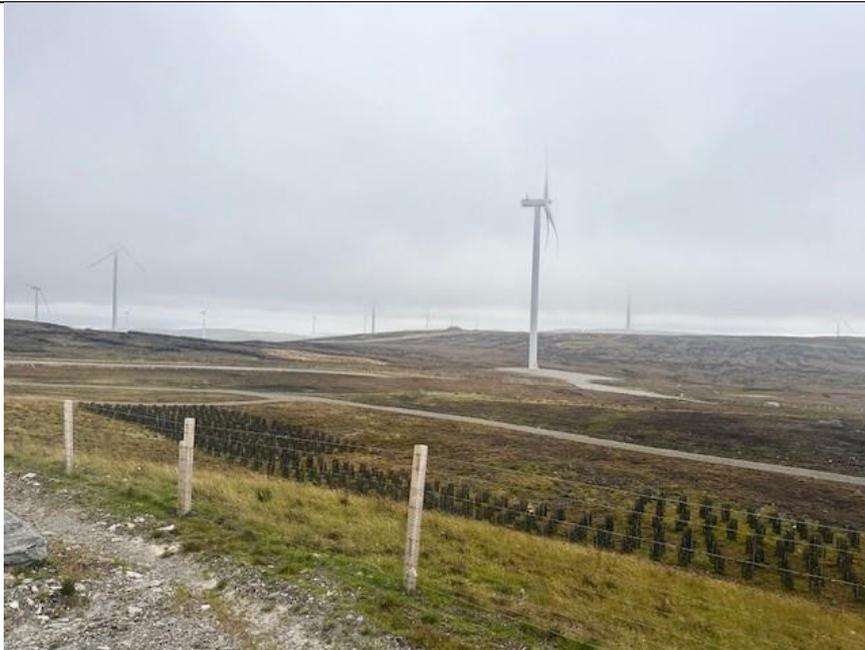
Photo 15. Tree guards placed around saplings at NBP05

The ECoW indicated that a tree health assessment will be undertaken in Spring 2026, with further measures to be implemented to encourage tree growth depending on the results of the assessment. It was also noted that hydroseeding success is variable across the site, and that further hydroseeding will be required in 2026.

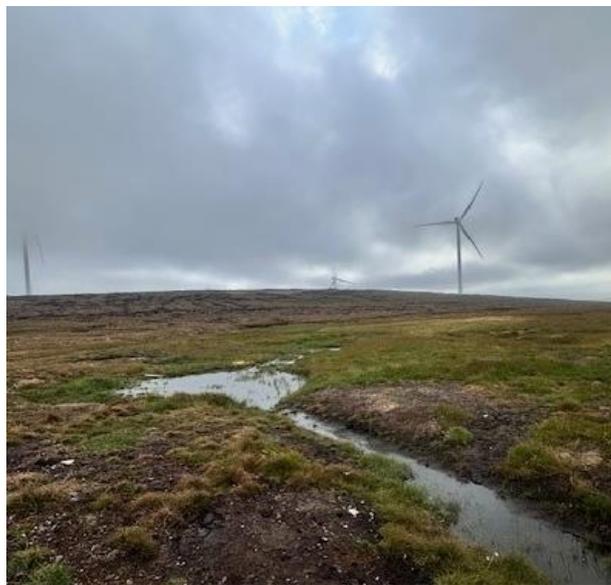
Drainage at T076 was observed (photo 16). The water was noted to run clear close to NBP05 and further downstream across the peat towards the watercourse. Ongoing monitoring of groundwater and surface water levels are continuing in this area. This area should be visited during the next PMO audit.

Photo 16. Drainage at T076
