**Report on  
Archaeological Survey at  
Scord Quarry, East Voe,  
Scalloway, Shetland**

**October 2005**

# **Report on Archaeological Survey at Proposed Extension to Scord Quarry, East Voe, Scalloway**

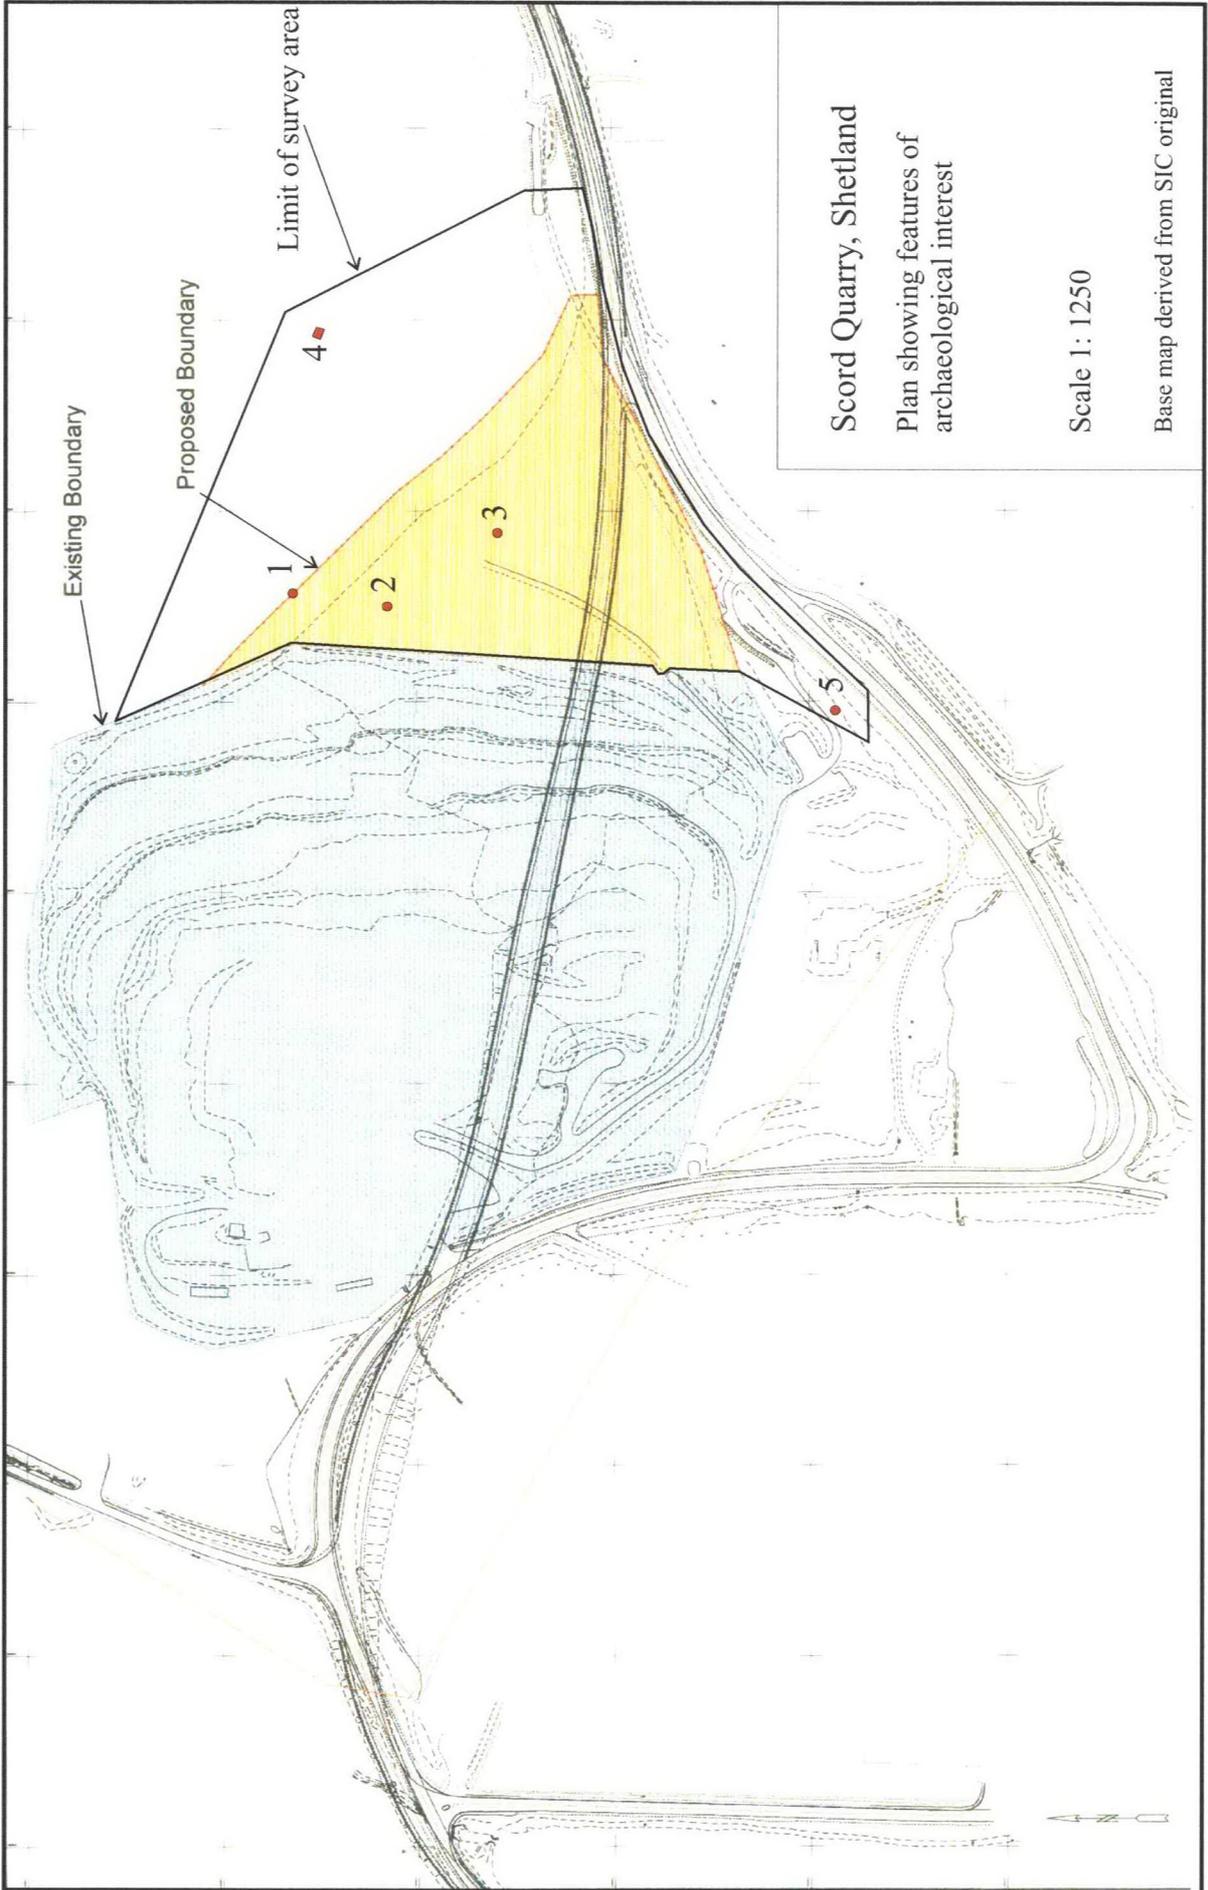
**Scord Quarry, Shetland**

Plan showing features of archaeological interest

**5.1** Five features of interest were noted by this survey. These can be briefly summarised as follows:

- Feature 1: A mounded anomaly located to the immediate north side of the Outnabrake cairn site.
- Feature 2: The remains of the excavated Outnabrake cairn, located on the top of the hill.
- Feature 3: An amorphous stony concentration, located on the southern slope of the hill.
- Feature 4: A probable prehistoric structure, located outwith and to the north east of the proposed extension area.
- Feature 5: An upright slab marking the Road Reconstruction Programme, 1980, erected by SIC.

**7.1** It is recommended that a short programme of intrusive assessment (trial trenching) is conducted to test the findings of the survey. The purpose of this work would be two-fold: (i) to rapidly investigate the nature of features and anomalies identified by this survey and (ii) to randomly sample a proportion of the downhill area in order to ascertain the presence or absence of subsurface features covered by deeper soil/peat cover.

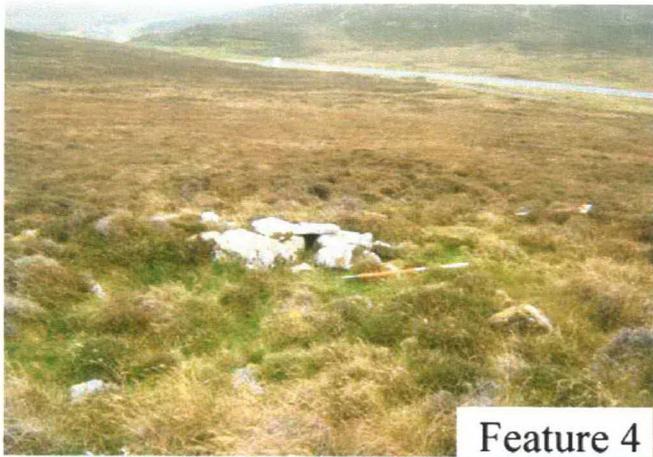
A horseshoe shaped concentration of stone, located towards the base of the hill, includes both upright and coursed elements. The visible dimensions are 7m N-S by 10m E-W. The stone protrudes through peat and it is probable that this feature was once entirely covered in peat. Traces of peat cuttings survive nearby, and it may be that this feature was originally discovered through peat cutting, although it has not been previously recorded as an archaeological monument. It is probable that this feature represents a prehistoric house.

**7.3** Although it lies outwith the proposed extension area, it may prove useful, and ultimately cost-effective, to further assess Feature 4 within the programme of trial trenching. This feature, currently thought to represent a structure of prehistoric date, could be rapidly tested and the findings would serve to inform any future development which might impinge upon this area (i.e. fencing, access roads etc.).

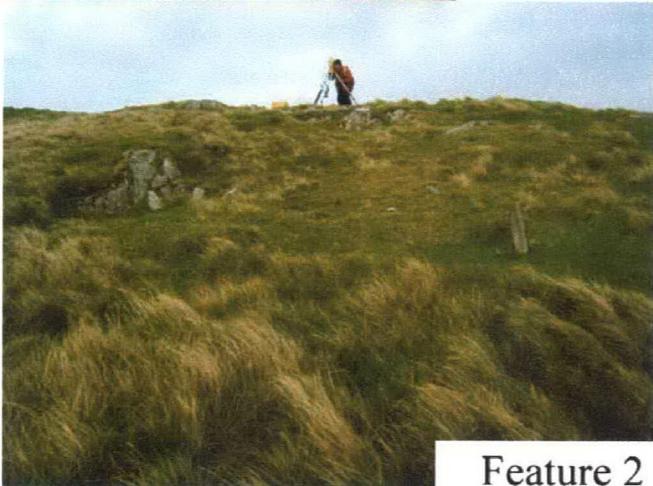
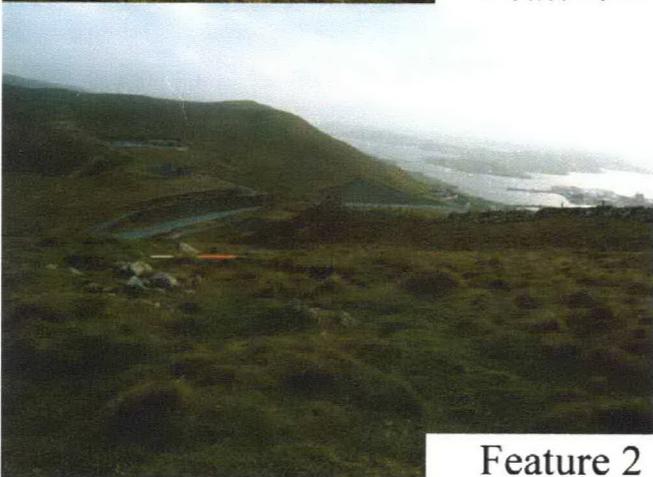
The scanty remains of an excavated cairn are visible in an elevated position behind the current quarry face. The vegetation in this area is locally greener than in the surrounding area. Two grid pegs from the 1990 excavation, situated some 13m apart, remain in situ. In places, bedrock protrudes through the grass.

**7.2** While very little of the excavated Feature 2 remains visible on the ground, it is recommended that a sample of the surrounding area is subjected to trial trenching. This site represents the only verifiable site of archaeological significance located within the proposed extension area and the purpose of this work will be to investigate the possibility that associated features may survive in the immediate hinterland.

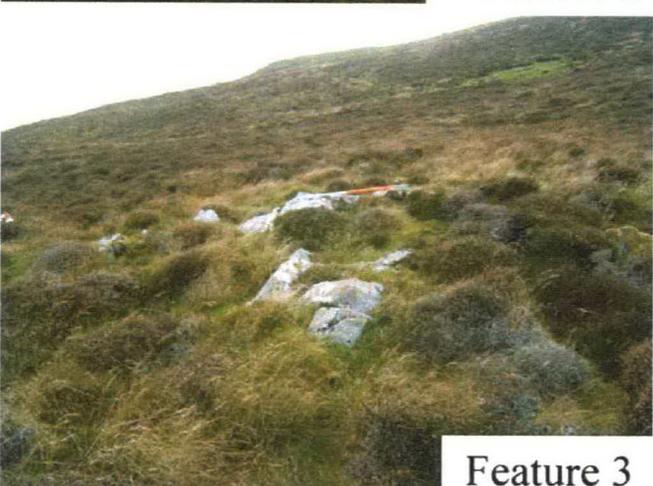
Feature 3

An amorphous concentration of loose and earth fast stone covers an area measuring some 8m N-S by 7m E-W on the slope of the hill. This feature occurs below a rough track and it is possible that at least some of the loose stone may represent material which has been disturbed either by the creation of the track or during its subsequent use. Several earth fast stones, apparently set in an upright position are also present, however, and it is possible that this feature may represent a conflation of rubble covering the remains of a built structure.

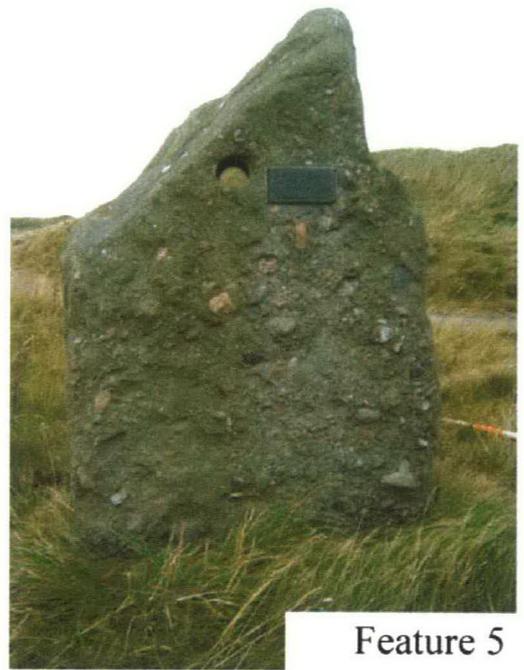
Feature 5

A large sandstone slab has been set up close to the north side of the road. It stands to 1.6m high and bears a bronze plaque bearing the inscription 'Shetland Islands Council Road Reconstruction Programme 1980'.

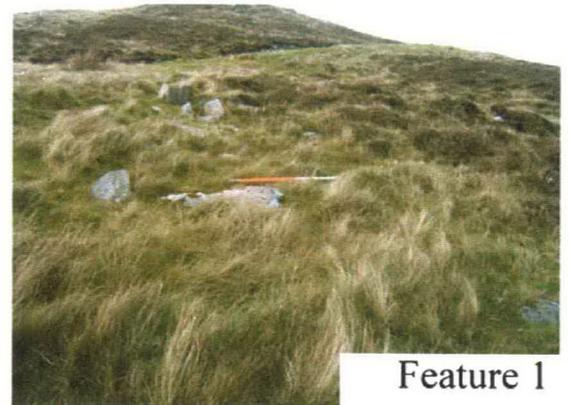
Feature 1

An amorphous grass covered mound is located close to the excavated cairn, in an elevated position behind the current quarry face. It measures some 8m in diameter and stands up to 0.75m high. Several stones, apparently set upright or on edge, protrude from the south side.
