Intended for  
**Viking Energy Wind Farm LLP**

Date  
**July 2026**

# **VIKING ENERGY WIND FARM PLANNING MONITORING OFFICER AUDIT REPORT 052: 4<sup>TH</sup> SEPTEMBER 2025 TO 10<sup>TH</sup> JUNE 2026**

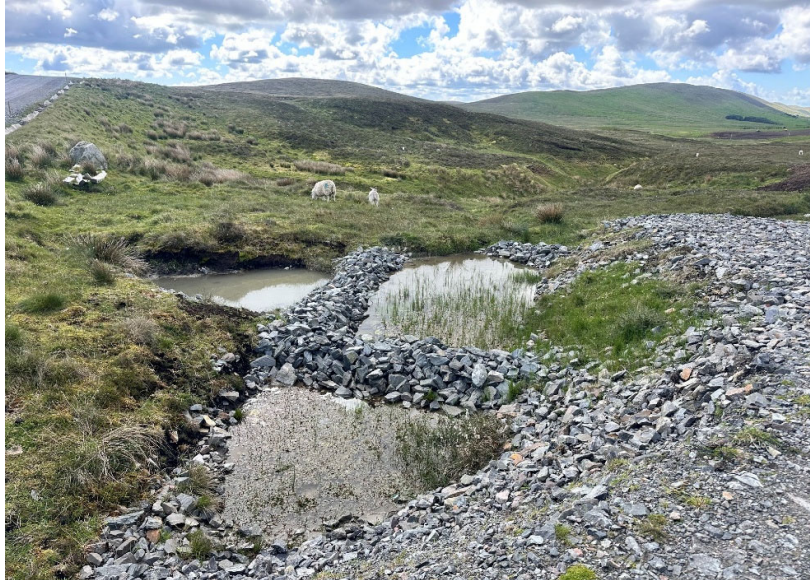
The permanent surface water management system to provide attenuation and treatment of surface water draining to the Burn of Droswell from the KAT was observed. All retention ponds were observed to be holding water during the audit visit, with slight siltation of the upper ponds noted, as well vegetation having developed (photos 1 and 2). Vegetation around retention pond can be beneficial, however excessive silt build up can significantly decrease the total volume of water that ponds can hold, with a risk dirty water overflow. It is understood that this area is being monitored by SSE as part of their routine checks, to ensure that the storage capacity of the ponds remain satisfactory and maintenance undertaken as required. Temporary silt fences have been removed from the area as part of the snagging phase. This area should be visited during the next PMO audit.

**Photo 1.** Permanent surface water management at the Burn of Droswell

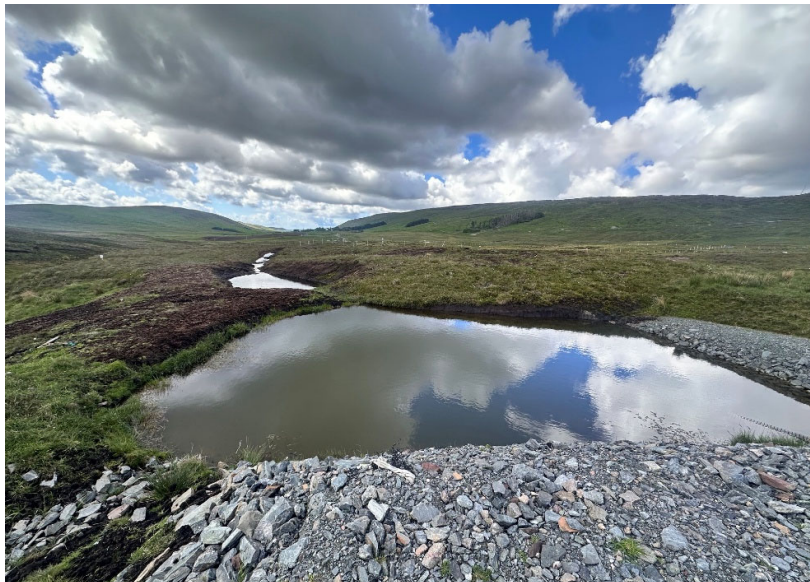
**Photo 2.** Permanent surface water management at the Burn of Droswell

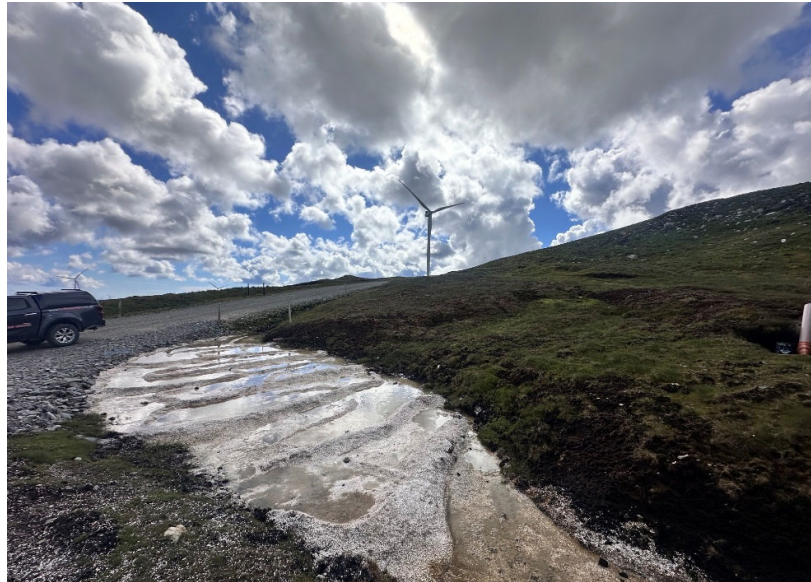
The PMO audit included inspection of the existing temporary drainage treatment system at KBP02 (photo 3). SSER have taken on the monitoring and maintenance of the treatment system, with continued water monitoring and sampling. Pilot trials of a new design for the treatment system are on-going and were observed during the audit visit (photo 4 and 5). The system consists of a series of IBCs providing a succession of nature-based water treatments. The pilot trials are being monitored in close collaboration with SEPA, and the system is in the process of being refined and improved. It is understood that the system will be upscaled for long term water quality management if pilot trials are proven to be successful and suitable. This area should be visited during the next PMO audit.

**Photo 3.** Existing temporary drainage treatment system downstream of KBP02

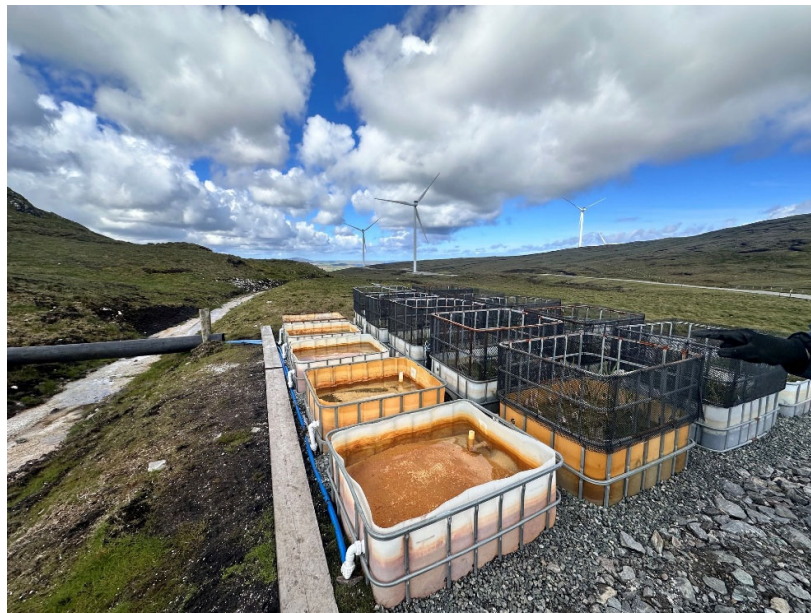
**Photo 4.** Pilot trials for new design of drainage treatment system at KBP02

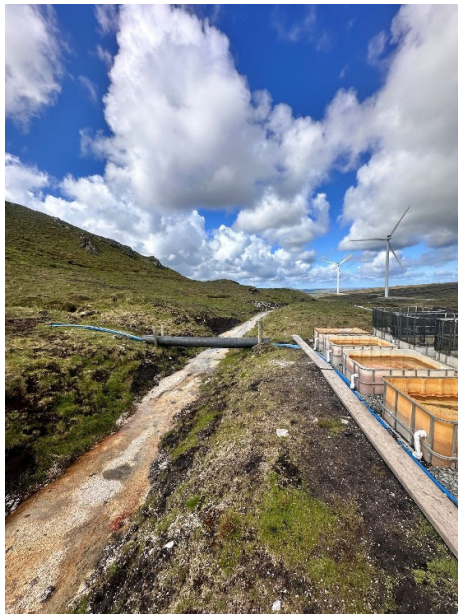
**Photo 5.** Existing drainage treatment system (left) and pilot trials (right) north of KBP02

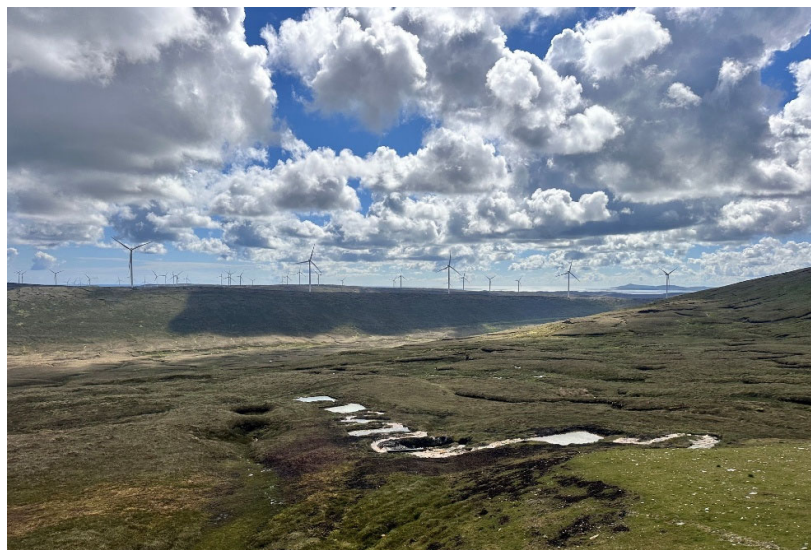
The pond system located down from T026 was also observed and appeared in good condition (photo 6). It is understood that this system will also be improved following the completion of the pilot trials downstream of KBP02. This area should be visited during the next PMO audit.

**Photo 6.** Pond treatment system at T026

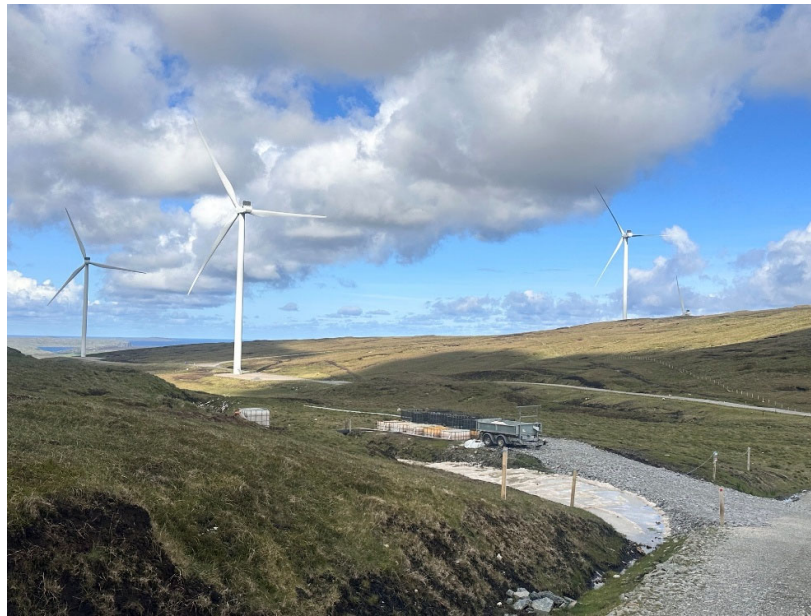
SSE indicated that the back filling of cut off ditches across the site is now complete. Backfilled ditches were observed south of KBP02 (photo 7).

A good state of vegetation was observed during the audit visit following the hydroseeding that took place in spring 2024, as observed north of KBP02 (photo 7). It was indicated however that areas across the entire site require reseeding. This will be taking place during summer 2026. The success of hydroseeding in these areas should be monitored during the next audit visit.

**Photo 7.** Vegetated slopes and backfilled cut off ditches north of KBP02

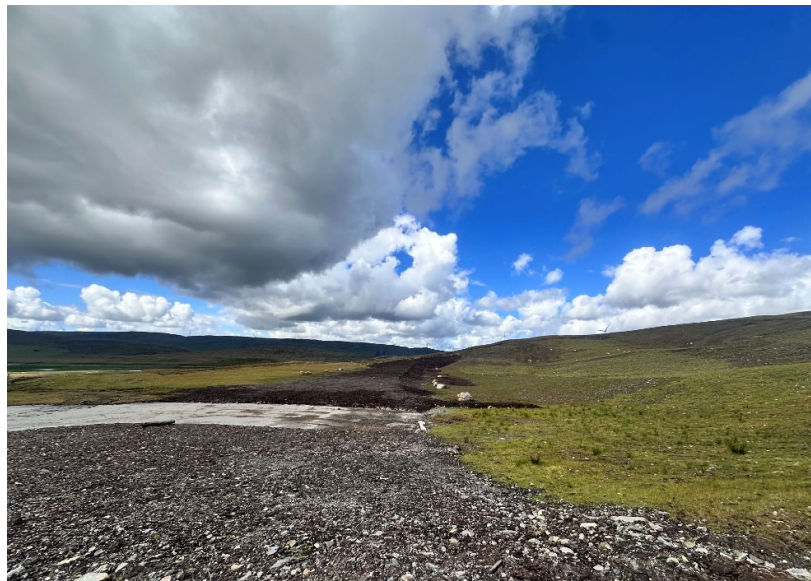
The Main Compound remains has been fully reinstated and partly hydroseeded, with an area of hardstanding left in place (photos 8 and 9). The remainder of the hydroseeding will be completed during summer 2026.

**Photo 8.** Main Compound reinstatement and vegetated slopes

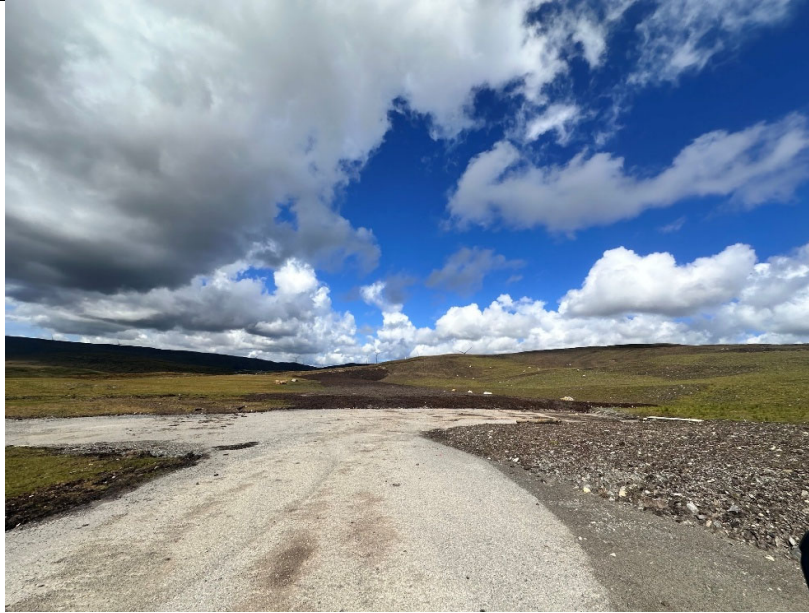
**Photo 9.** Main Compound reinstatement

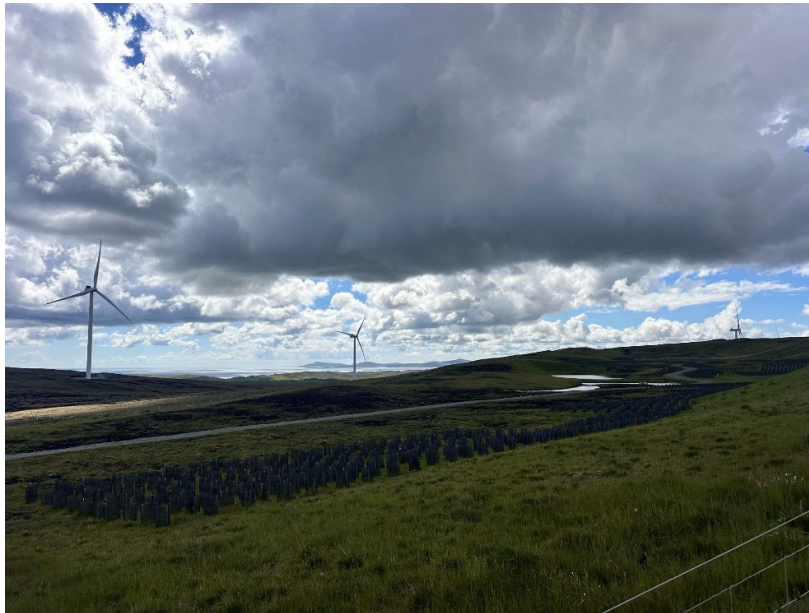
NBP05 was observed during the audit visit. The water features created appeared in good working order with a good state of vegetation on the slopes (photo 10), though some possible water logging during wet period was evident from the poor success of grass growth in some areas (photo 11). SSE are currently assessing the results of a tree health survey that was undertaken in March 2026, with the view of replacing the dead trees with different species. The success of the tree replacement planting will be monitored and assessed again over the summer by the HMP officers. Following this, additional measures may be implemented to help tree growth and restoration efforts. SSE indicated that the peat slip that occurred at NBP05 was assessed by the civil team with a site walkover undertaken in March 2026, with no peat movement recorded.

**Photo 10.** Tree planting area and vegetated slopes at NBP05

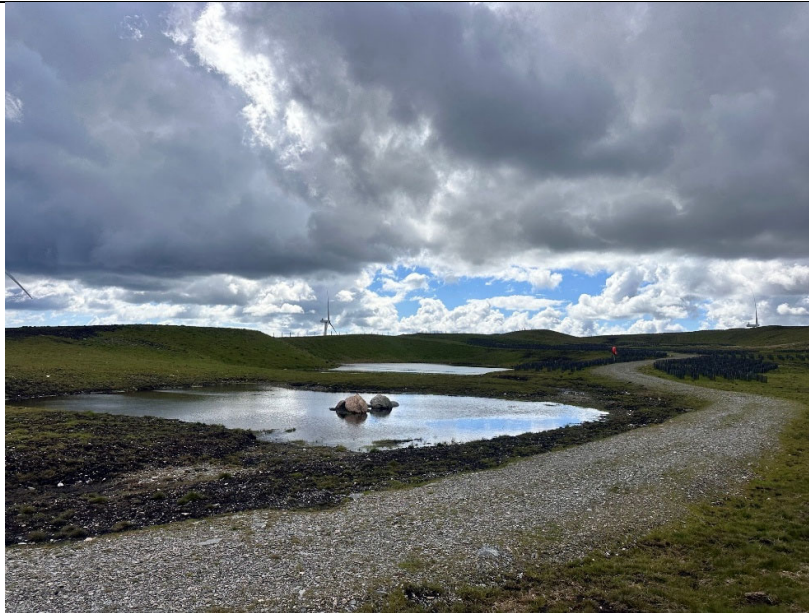
**Photo 11.** Water features, track and vegetated slopes at NBP05

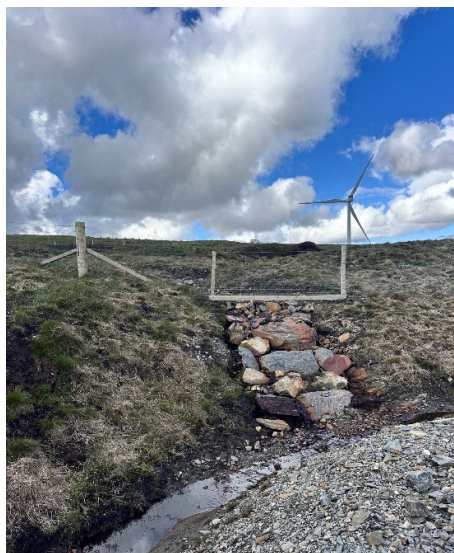
Drainage at T076 was observed (photo 12). The water was noted to run clear close to NBP05 and further downstream across the peat towards the watercourse.

**Photo 12.** Drainage at T076 downstream from NBP05

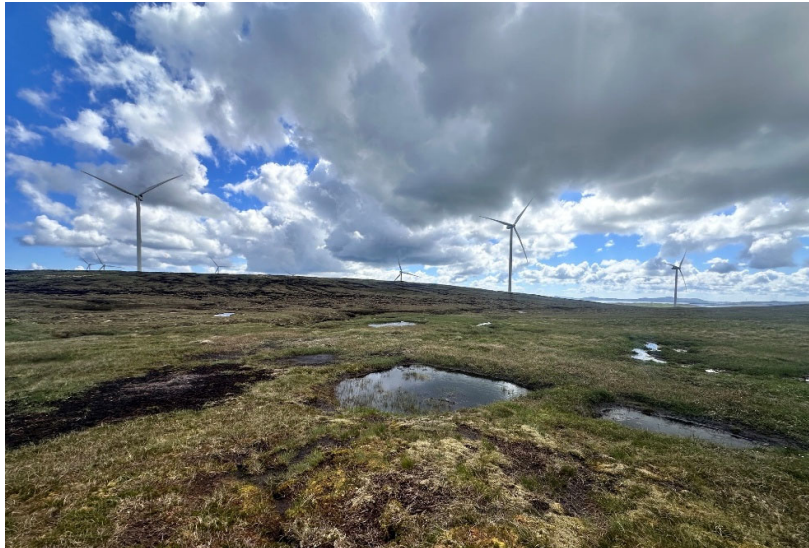
Peat restoration efforts east of T076 were observed during the audit visit to have been successfully completed (photo 13). This consisted mainly in the creation of surface water features such as ponds and lochans, and the enhancement of existing features, to provide sites favourable for wildlife and to increase biodiversity. Similar peat restoration efforts are on-going across Nesting and the wider site. Completed restored areas should be visited during the next PMO audit.

**Photo 13.** Surface water features created as part of peatland restoration efforts east of T076
