Intended for
Viking Energy Wind Farm LLP

Date
January 2021

VIKING WIND FARM PLANNING MONITORING OFFICER AUDIT REPORT 002

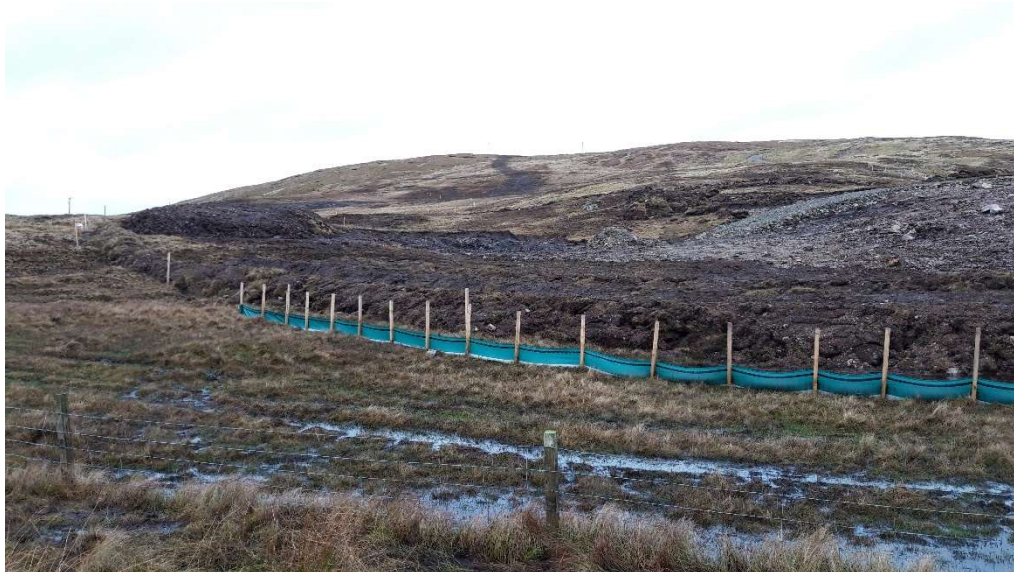
Photo 1. View of location of compound to be constructed at Scord of Sound

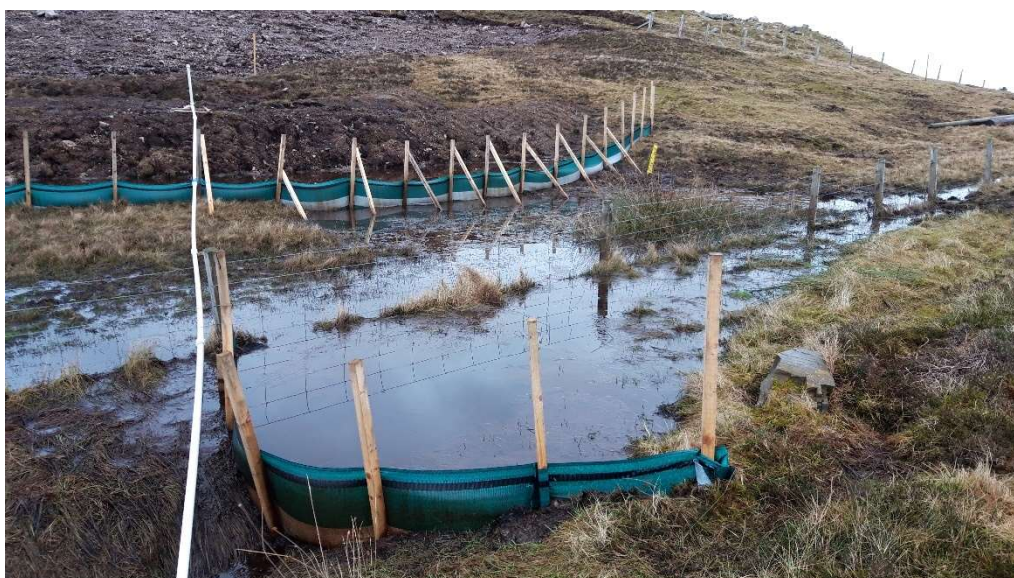
It was reported by the SSE Environmental Advisor that works in this area commenced at the beginning of October which comprised soil stripping and the excavation of drainage ponds. Silt fencing was observed along the southern boundary of the excavated area (i.e. downgradient) and upgradient of the culvert (refer to Appendix 1, Photos 1 and 2). A white pipe (passive syphon system) was also observed in the drainage ponds which is used to divert water in the event of heavy rain. The area drains towards a culvert which passes under the A971 road and then follows a natural drainage channel. There are no active works occurring in this area. Visits are undertaken by SSE's Environmental Advisor; SSE's ECoW and RJ McLeod's Environmental Advisor on at least a weekly basis to monitor the drainage mitigation measures that have been put in place. No issues were reported in relation to the presence of silty water or issues with the mitigation measures.

Photo 2. Silt fencing in drainage channel upgradient of culvert at Scord of Sound

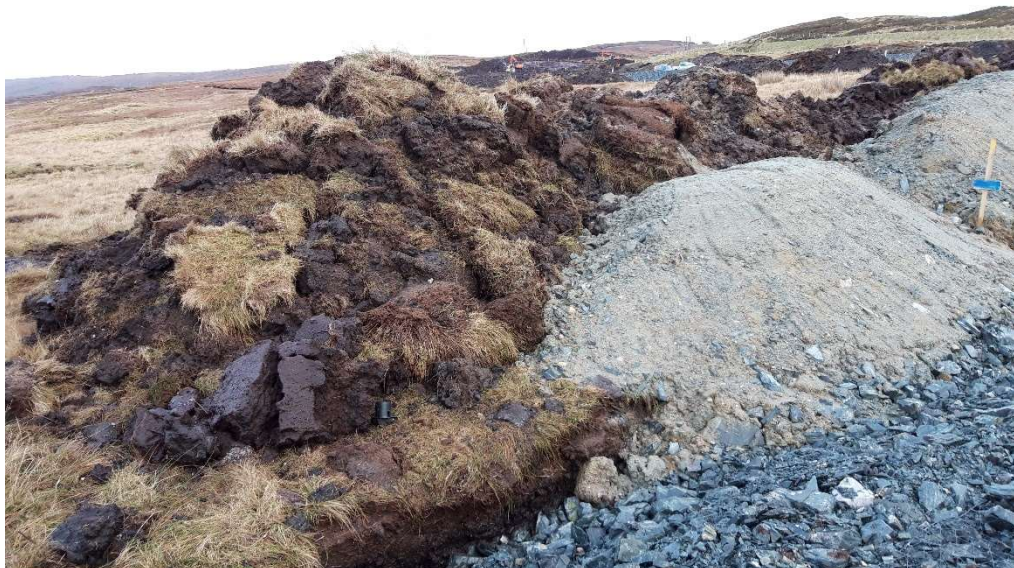
The SSE Environmental Advisor explained that the western end of the road was intended to be a 'floating road', however the recorded ground conditions meant that this was not a suitable solution and that foundations were required. As a result, the volume of soil excavated was more than anticipated. Turves and mineral soils are currently placed in separate stockpiles alongside the road for reinstatement at a later date (refer to Appendix 1, Photo 3). The material was recorded on the excavation log and the stockpiles are monitored for stability on a daily basis by the GCoW.

Photo 3. Turves and mineral soils observed at the western end of Sandwater Road.

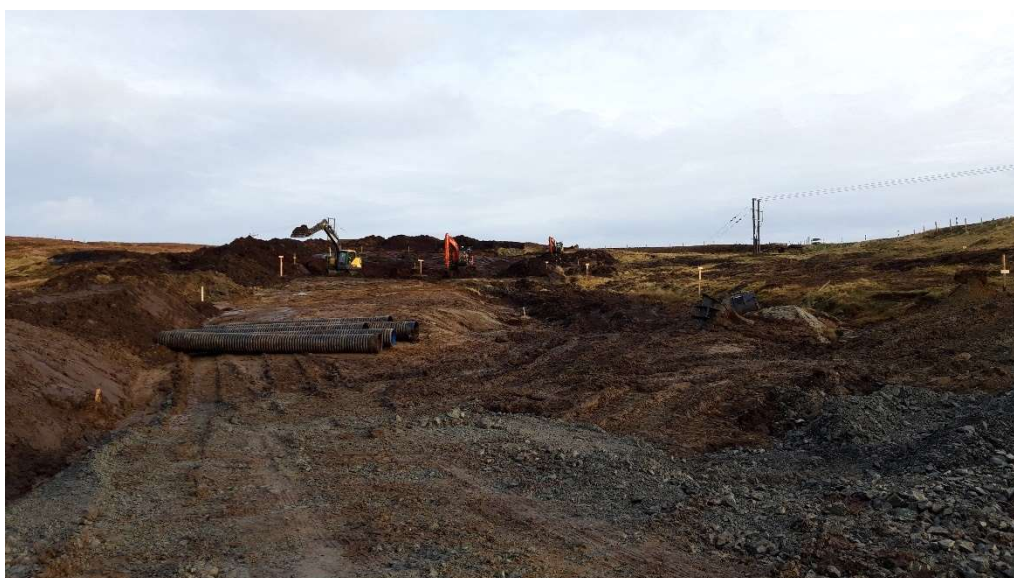
PMO confirmed that this was undertaken by the ACoW. The watching brief was completed on the day on the PMO audit and excavation work beyond this point towards the junction with the Mid Kame Ridge do not require the ACoW to be present full time. Discussions held with the ACoW are summarised in Section 3.5.3. A general view of the on-going construction in this area is shown on Photo 4 in Appendix 1.

Photo 4. General view of western end of Sandwater Road construction, beyond area of Archaeological watching brief

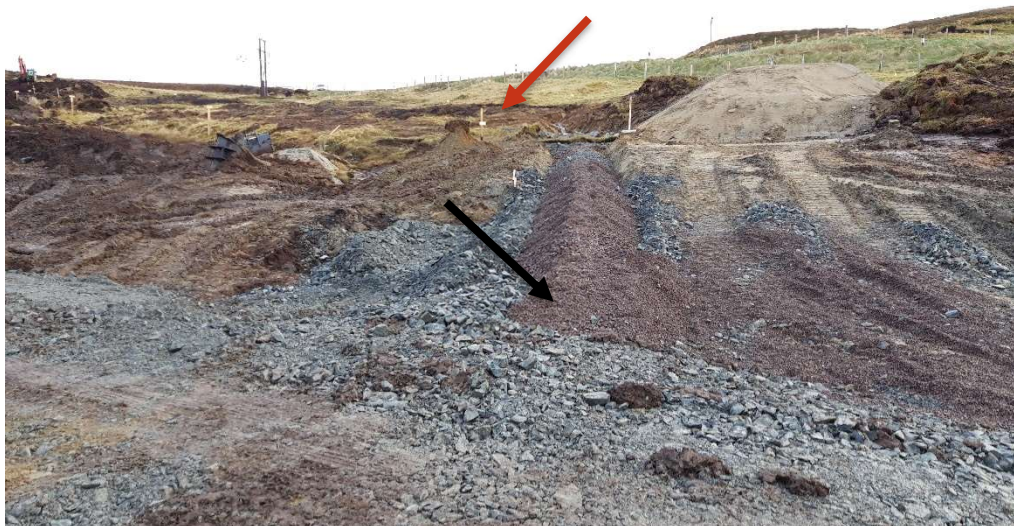
Schedule 3 of the CAR License required a Method Statement to be submitted to SEPA for approval prior to the works and that the works were to be carried out in accordance with the drawings submitted with the license application. A copy of the Method Statement and drawings were provided to the PMO. The realignment works were covered by the Method Statement prepared by the Principal Contractor for the construction of Sandwater Road, dated 5th August 2020, which was submitted to SEPA on 5th October 2020. Email evidence confirming approval of the Method Statement by SEPA on 14th October 2020 was provided to the PMO. The new culvert and realigned channel are shown on Photos 5 and 6 in Appendix 1.

Photo 5. Burn of Swirtars culvert (marked by black arrow) and channel realignment (marked by red arrow) on the upgradient side of Sandwater Road construction.

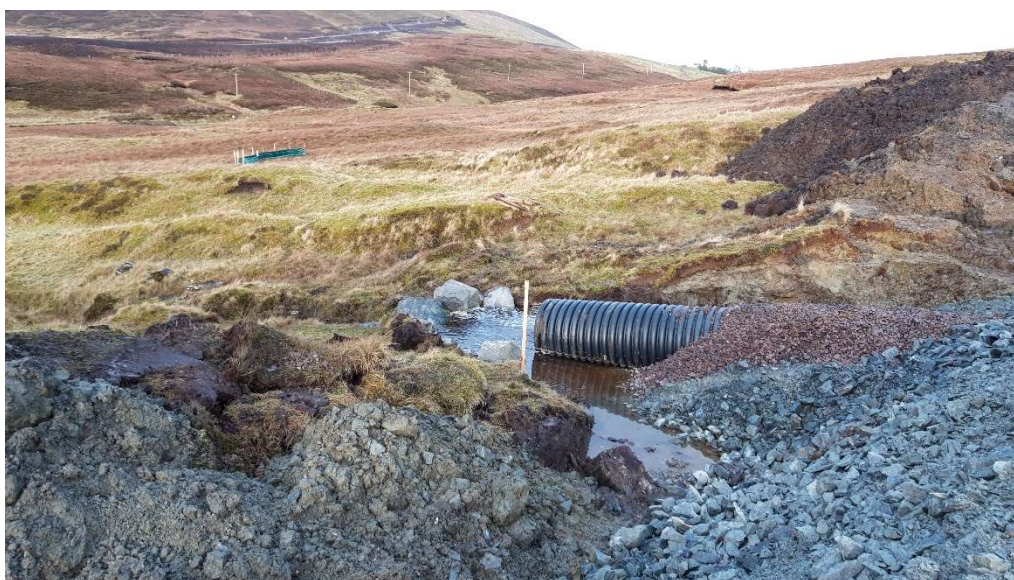
Photo 6. Burn of Swirtars culvert (downgradient side of the new road construction)

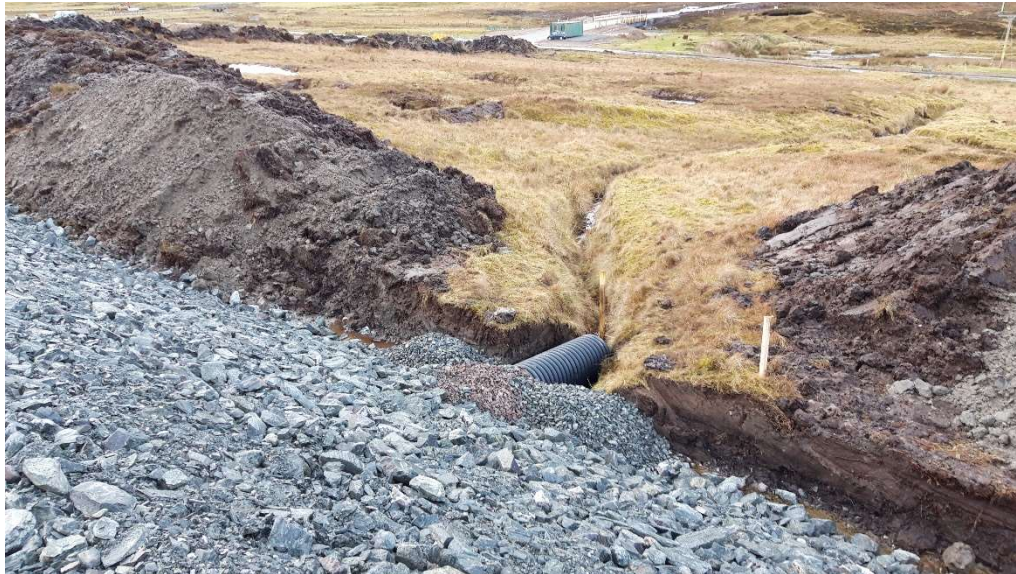
The PMO observed the drainage mitigation measures that have been implemented in this area including culverts under the new road, a ditch excavation, placement of check dams and a sump located adjacent to the western end of the new road (refer to Appendix 1, Photos 7, 8 and 9). The sump collects the water and this is re-routed via the use of a pump and pipework towards the settlement pond.

Photo 7. Example of culverted watercourse beneath new Sandwater road

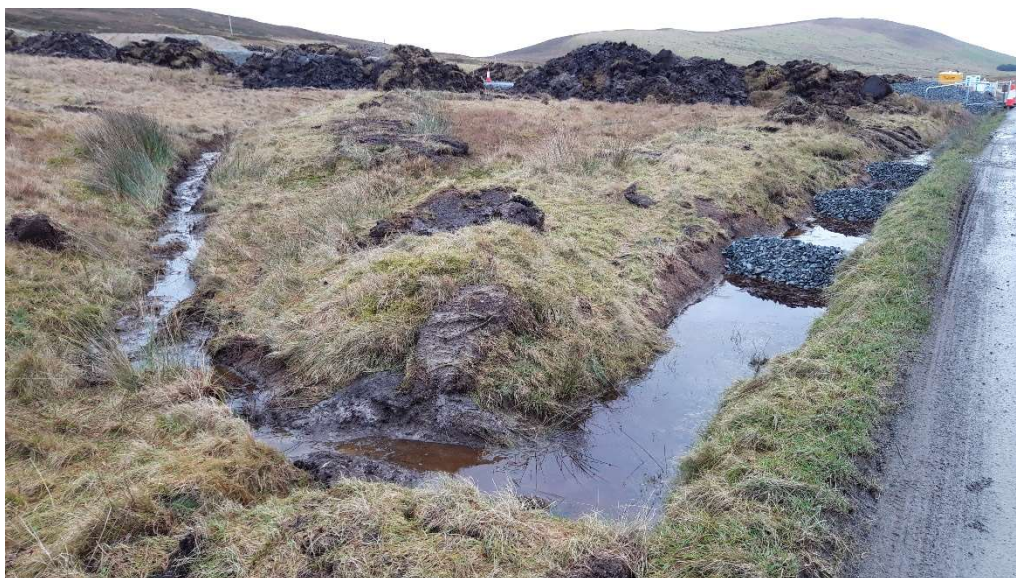
Photo 8. View of drainage channel with check dams diverted towards sump in the distance.

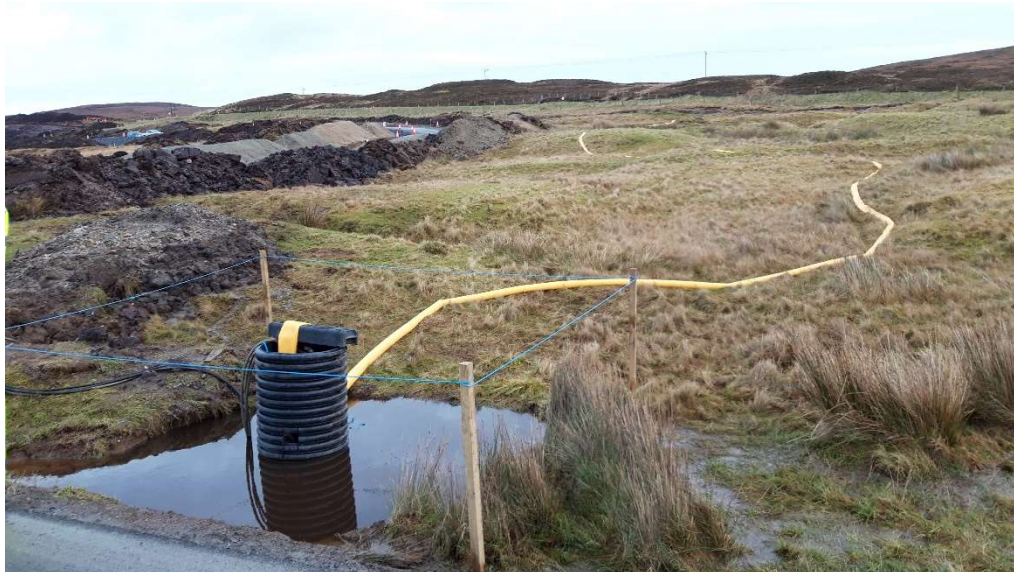
Photo 9. Sump at western end of Sandwater Road with pump and pipe to divert water back to settlement pond

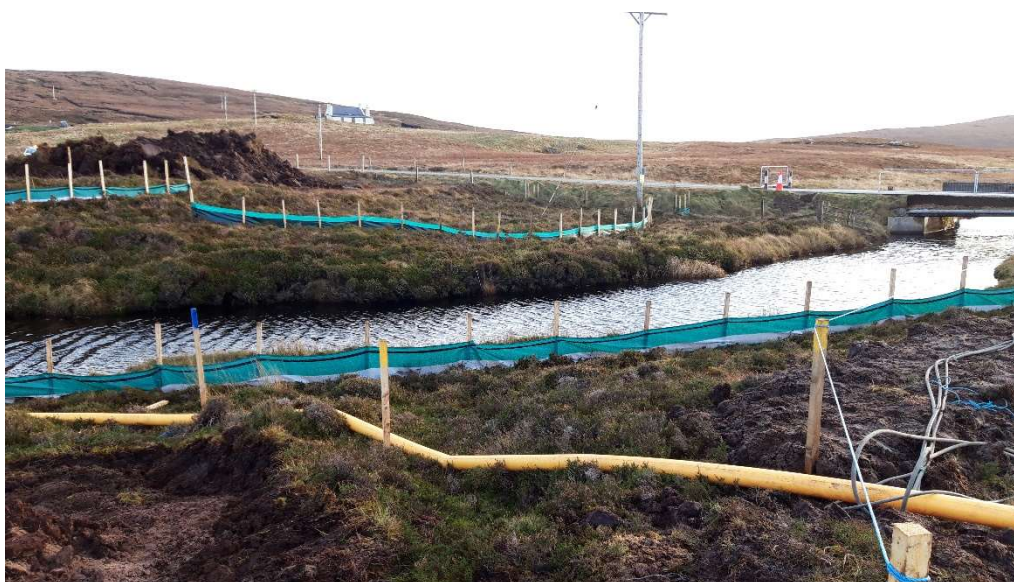
The PMO observed the work area on the western side of the Burn of Pettawater. Silt fencing was in place along both sides of the watercourse and site personnel were in the process of creating a sump to intercept surface water which is then rediverted via a pump and pipework to the catchment area to the north of the work site (refer to Appendix 1, Photo 10).

Photo 10. Western embankment of Burn of Pettawater at Sandwater Road

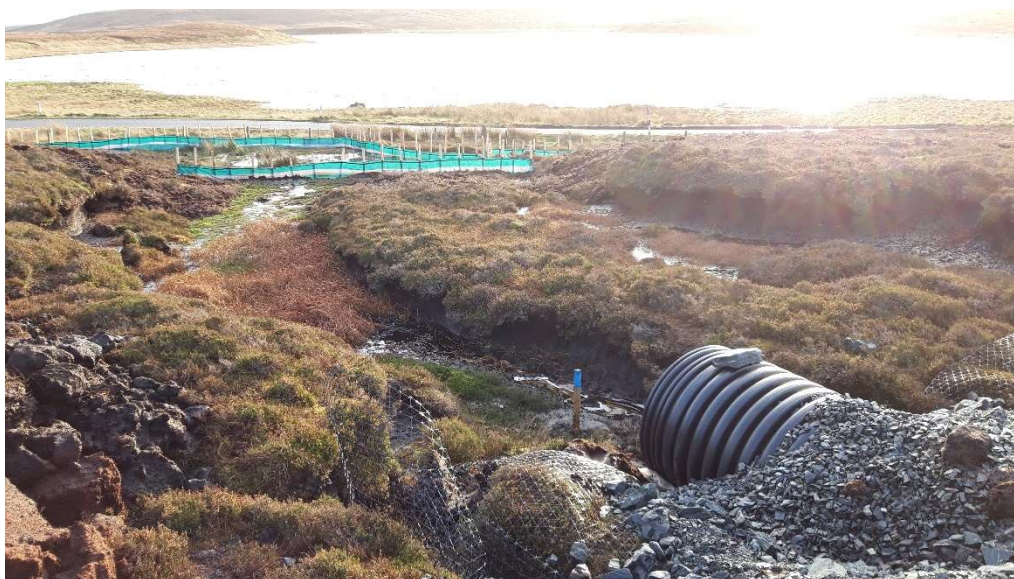
Discoloured water was observed entering Sandwater Loch from Culvert 4 and the source of the water was identified by the Principal Contractor's ECoW as originating from the pump discharge area. The pump was in operation to divert water a distance of 200 m from a blast hole, however the pump was observed to have burst. The incident was identified at 10:30 and the plume in the loch was monitored by the Principal Contractor and SSE ECoWs over a two-hour period. Turbidity levels were reported to have reduced within this time. Water samples were collected from the loch and submitted to a UKAS accredited laboratory for total suspended solid (TSS) analysis. The results confirmed the concentration of TSS to be below the trigger threshold of 100 mg/L⁷.

Revised drainage mitigation measures have been implemented in this area since the last audit due to the construction of the new road. Each of the culverted drainage channels were viewed on both sides of the road by the PMO and surface water was observed to be clear at the time of the audit (refer to Appendix 1, Photo 11).

Photo 11. View of Culvert 4, with existing Sandwater Road and Sandwater Loch in the distance.

Following the incident, the Principal Contractor took action to ensure pump outlets are monitored for the first 30 minutes of operation. Daily check sheets are used, and a toolbox talk was held on 11th November 2020 to highlight the incident and responsibilities of site personnel.

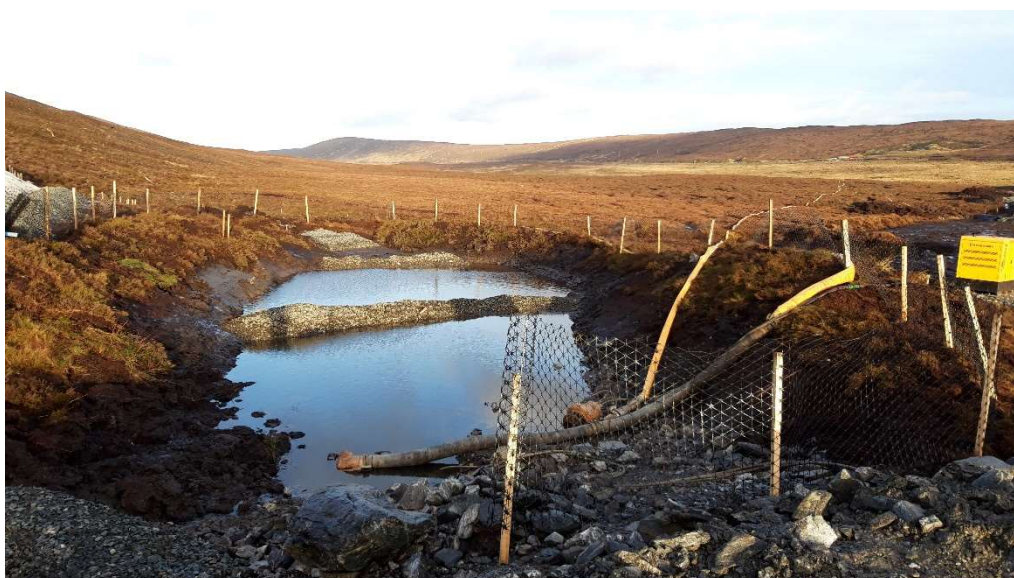
A new settlement pond has been excavated since the previous PMO audit (refer to Appendix 1, Photo 12). Pumps were observed in the pond which are used to divert clean water to the wider catchment area, north of the new road.

Photo 12. Settlement pond at Sandwater Road. Pump and yellow pipes used to re-divert clean water back to the wider catchment area.

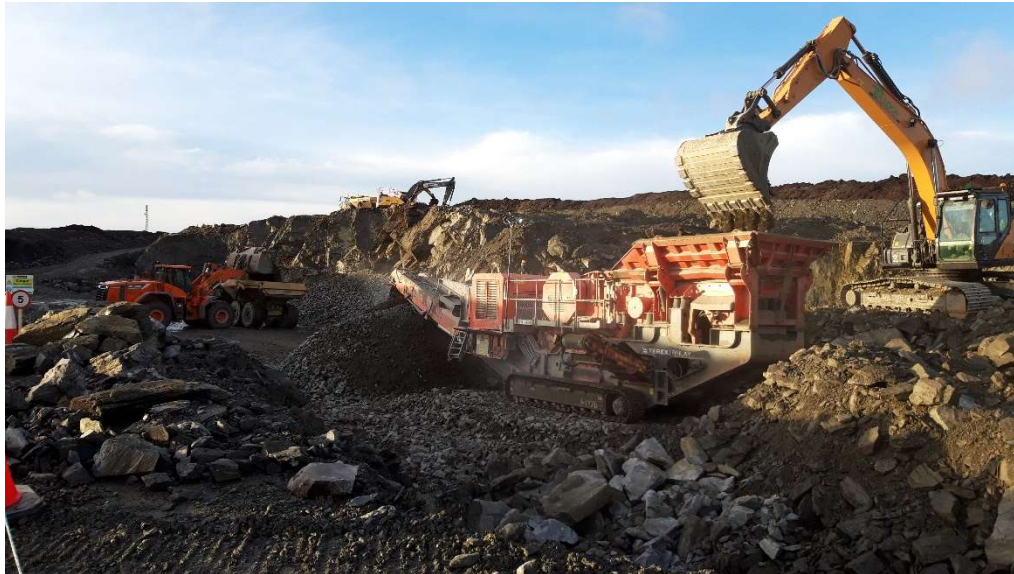
Rock extraction was taking place towards the junction with the Mid Kames Ridge access track. Blasting had been undertaken in the week prior to the audit, and during the visit the PMO observed processing of the blasted rock with the mobile crusher (refer to Appendix 1, Photo 13). The SSE Environmental Advisor confirmed that no issues relating to the generation of dust from the crushing activities had been raised by the public. The PMO observed signage at the entrance indicating that borrow pit works are taking place.

Photo 13. Use of mobile plant for crushing at Sandwater Road.

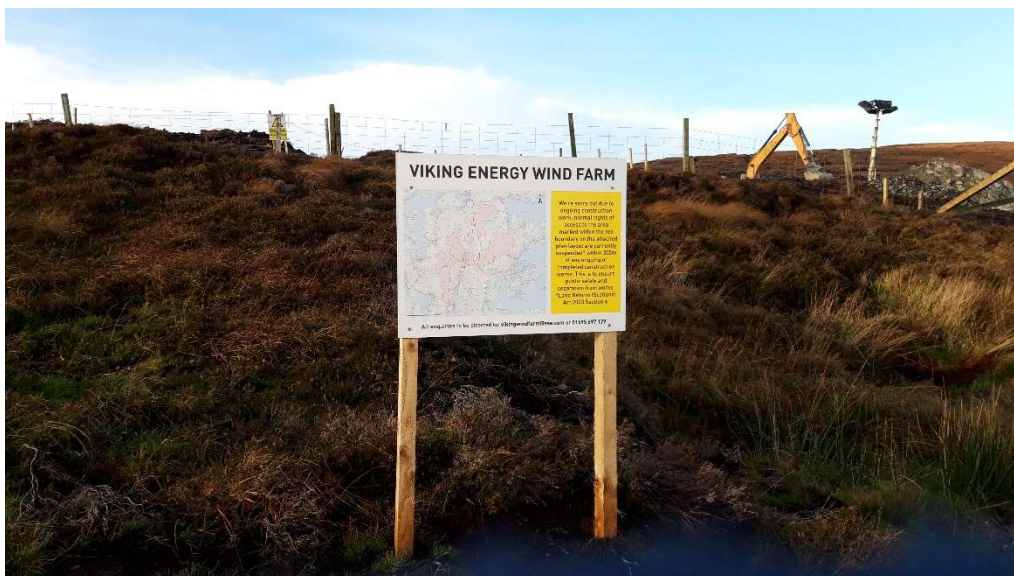
Notice boards were also in place advising the public that normal rights of access are suspended due to the ongoing construction works (refer to Appendix 1, Photo 14). This point is discussed further in Section 3.5.

- A member of the public had requested clarification in relation to the suspension of access rights "*within 300 m of any ongoing or completed construction works*" as noted on signage erected at Sandwater Road (see Appendix 1, Photo 14) and if there was approval in place for this restriction.
- Commitments outlined in the Outdoor Access Management Plan and Sandwater Road Recreational Management Plan relating to the communication of restrictions with the general public had not been carried out.

Photo 14. Example of signage at site access points warning of construction works and restrictions to public access

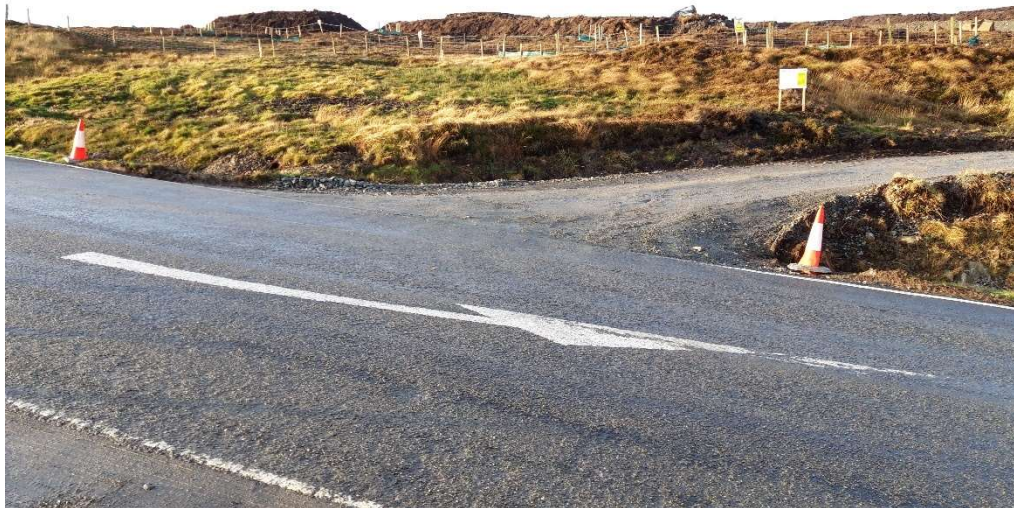
The PMO observed the access point from the existing Sandwater Road following the presence of the silt and mud during the previous audit, and recent public complaint. The road was noted to be clean (refer to Appendix 1, Photo 15). A road sweeper is now available on site as per

Photo 15. Clean road at access point to the new Sandwater Road

Condition 18 of the planning consent which is used regularly to keep the road clear of silty debris that could wash into the drainage network and surface water features.

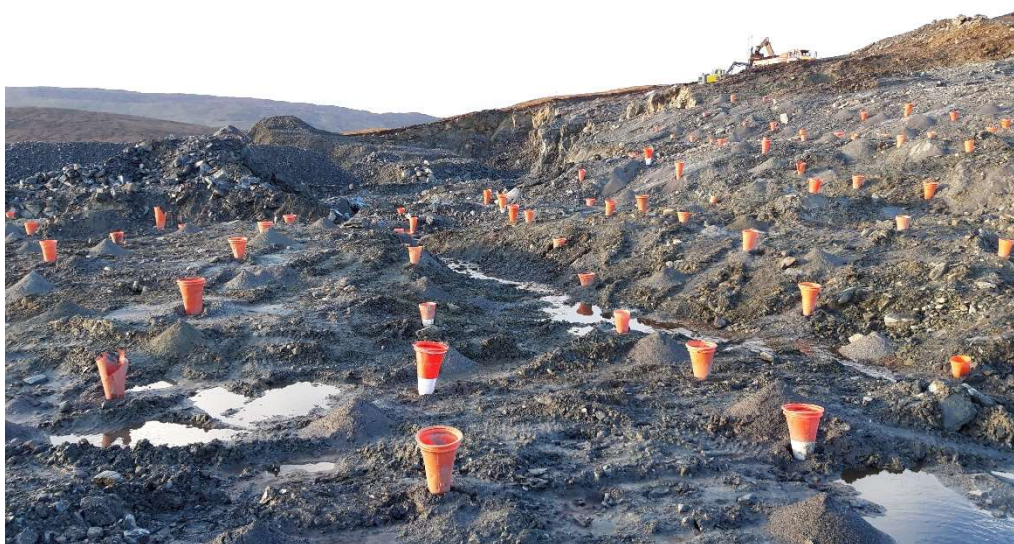
At the time of the audit, preparatory works for blasting on the 3rd December had been undertaken, with the drill holes to be blasted demarcated by traffic cones. An excavator and drilling rig were operating in the area to be blasted on 4th December. A settlement pond was in the process of being excavated, downgradient of the compound area. A labelled spill kit was observed within the work area.

Photo 16. Ground prepared for blasting in Main Compound

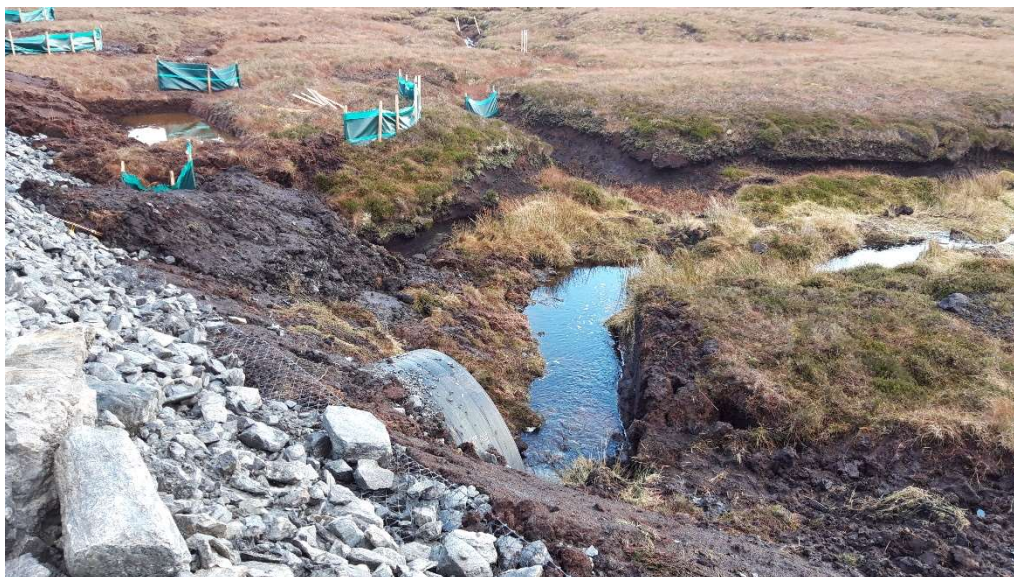
Track construction is progressing from the main compound area towards turbine N111. A water crossing was observed on this track by the PMO (refer to Appendix 1, Photo 17). Silt fencing was observed between the track route and surface water course. Water flowing through the culvert was noted to be clear at the time of the audit.

Photo 17. Culverted watercourse beneath track leading to N111
