Intended for
Viking Energy Wind Farm LLP

Date
July 2021

Project Number
1620009158

VIKING ENERGY WIND FARM PLANNING MONITORING OFFICER AUDIT REPORT 008: 26TH MAY TO 23RD JUNE 2021

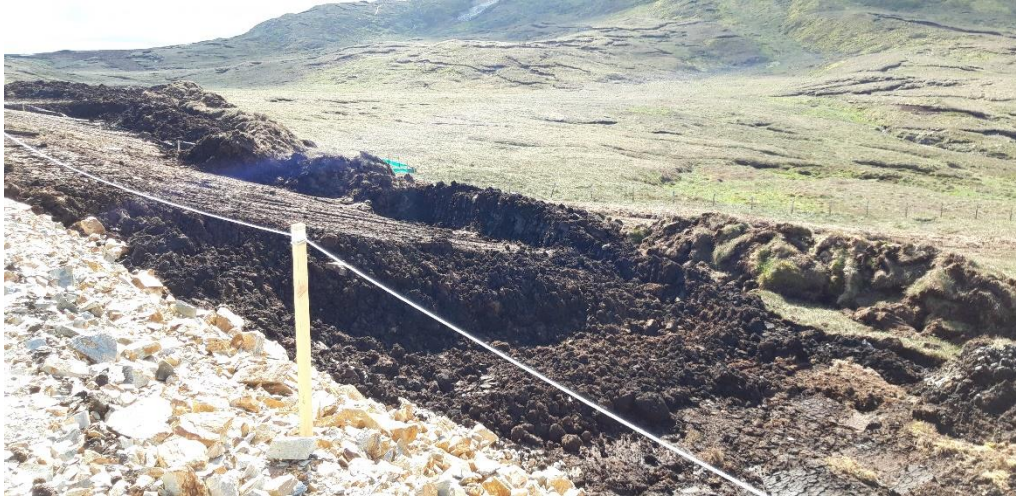
Photo 1.

Construction of Spur 14 had extended towards K48 at the time of the audit; the separation of the peat, soil and turves, ready for reinstatement, was observed to be good. The work in this area is shown in Photograph 1 of Appendix 1.

Looking south from Spur 14 between K50 and K48, the segregation of peat and turves ready for reinstatement was observed to be good.

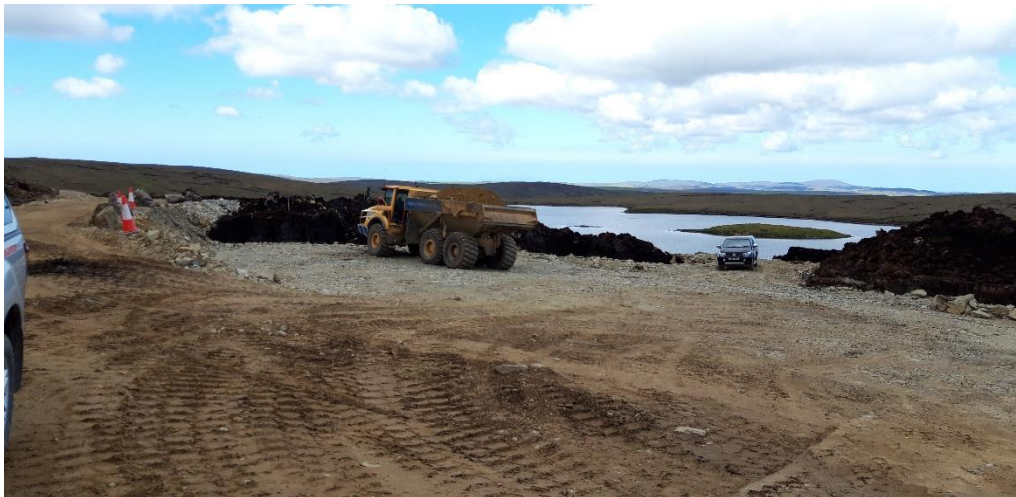
Photo 2.

At Spur 4, construction had progressed to K62, with ongoing capping of the road. A number of unmapped gullies were observed along this track, silt traps had been installed to prevent any runoff entering watercourses. During the audit, dust suppression measures were noted, with a bowser used to wet the track.

View at KBP03 of temporary peat storage. Whilst on Spur 4 dust suppression using a water bowser towed by a tractor was observed.

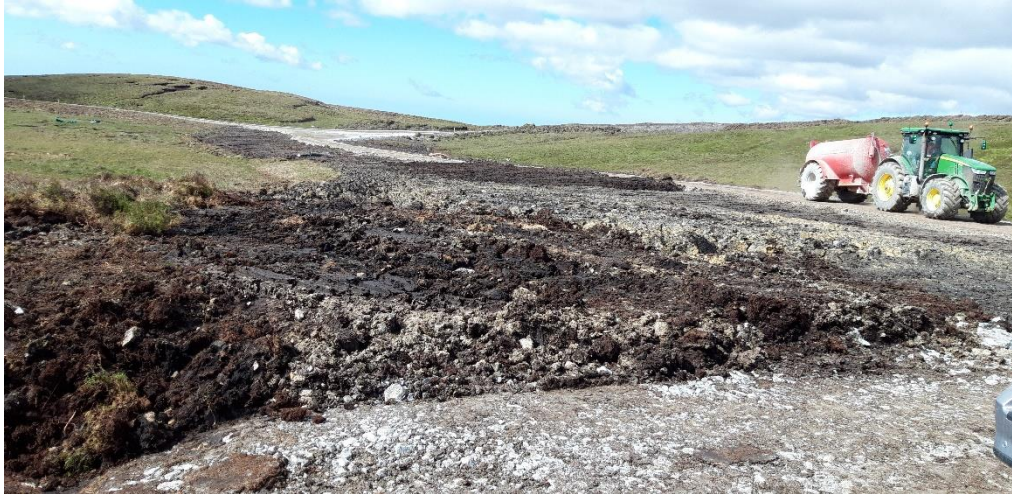
Close to K57, a pond had formed in a depression adjacent to the newly formed track. The pond has been used as a water source for dust suppression. The work in this area is shown in Photograph 3 of Appendix 1.

Photo 3. View from K57 of the peat reinstatement to the edge of the road and a water bowser used for dust suppression.

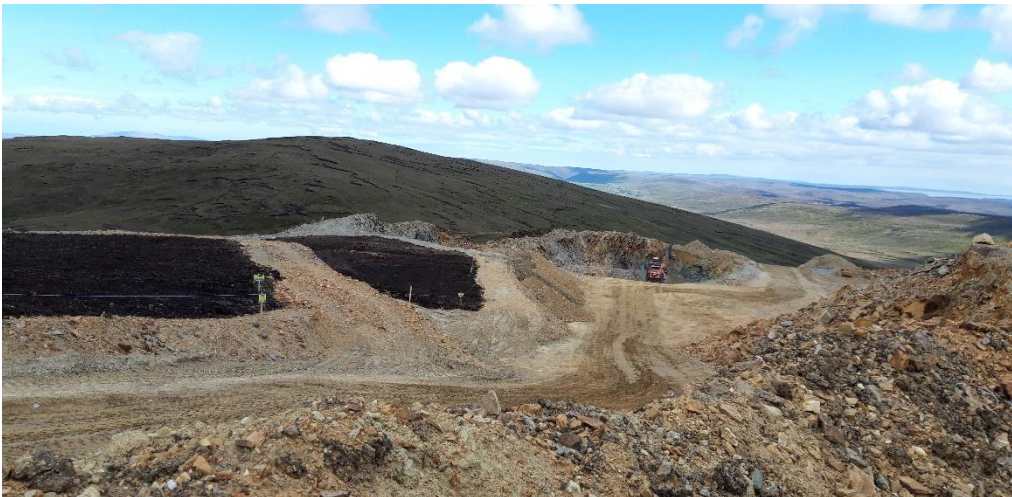
The planned blasting noted in the previous audit had taken place at KBP02 to provide additional material for track and crane hardstanding construction. The peat restoration area in the vicinity of KBP02 had continued since the last audit. The track towards K51 had been extended past KBP02. The work in this area is shown in Photograph 4 of Appendix 1.

Photo 4. View of KBP02 and the adjacent peat restoration areas. Blasting had taken place at KBP02 since the previous audit exposing rock better suited to road capping.

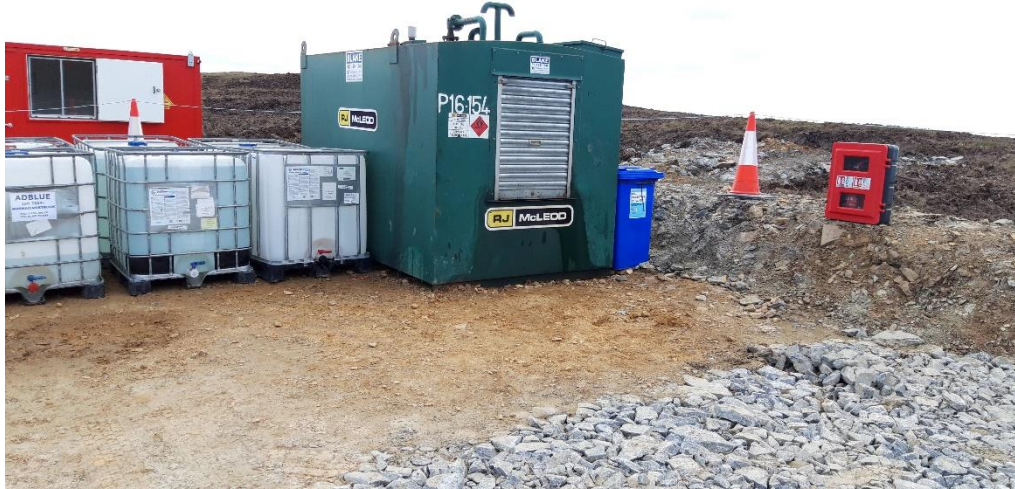
Photo 5.

The refuelling at KBP02 was observed to be well maintained, it was double bunded and underlain with a heavy duty visqueen membrane, as shown in Photograph 5.

View of materials storage at KBP02, the area around the containers was free from staining. The storage is double bunded and underlain with a heavy duty visqueen membrane.

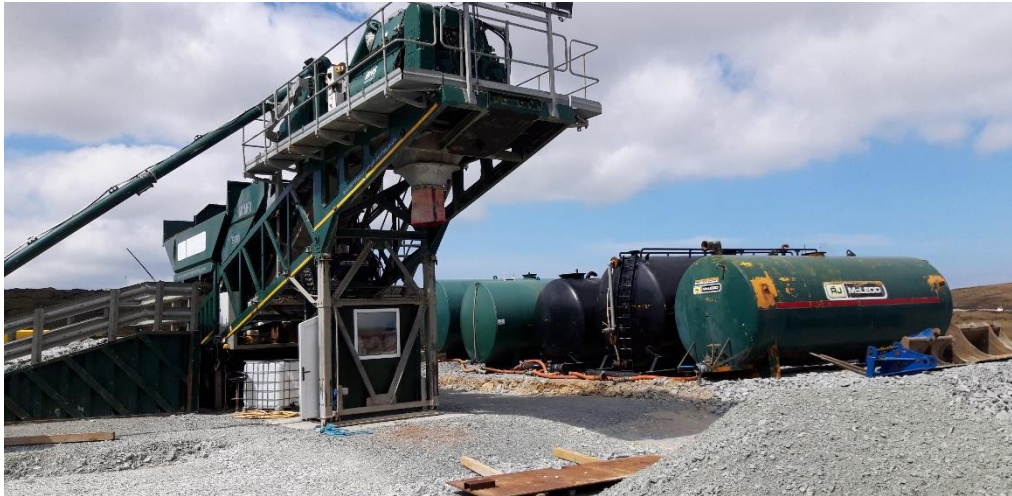
Since the May audit, the first concrete batching plant had been installed and the works for a second unit had started. The water tanks for concrete production will be mains fed due to the proximity of a Scottish Water pipe, the connection to the mains water is being planned with Scottish Water. The work in this area is shown in Photograph 7 of Appendix 1.

Photo 7. The first batching plant installed at the North Compound, the water will be sourced from Scottish Water pipelines.

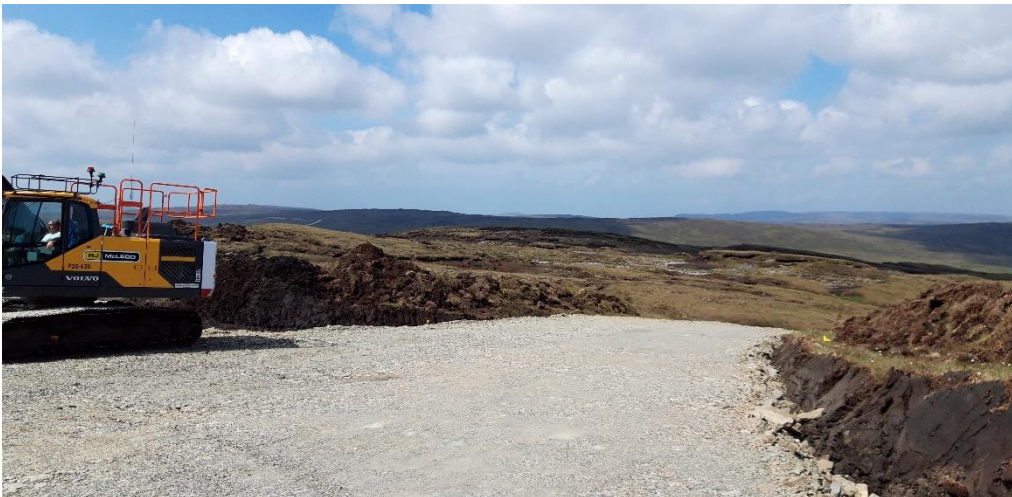
Photo 8. In South Nesting construction had extended to N147.
