Date  
**August 2021**

Project Number  
**1620009158**

# **VIKING ENERGY WIND FARM PLANNING MONITORING OFFICER AUDIT REPORT 009: 24<sup>TH</sup> JULY TO 4TH AUGUST 2021**

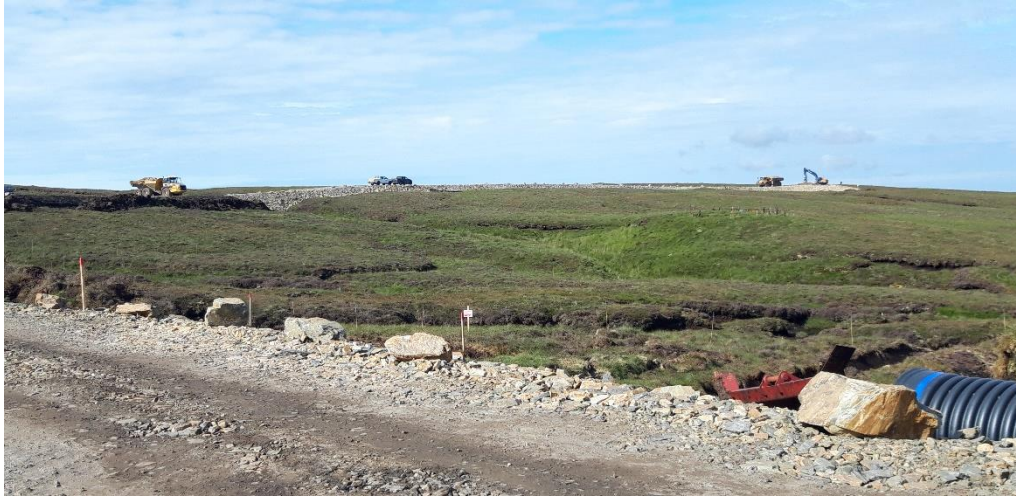
**Photo 1.** View from K62 looking west, construction in Kergord has extended towards K63. Watercourses are culverted under the track.

Construction has extended past K62 to towards K63, with works including track development and the formation of turbine bases. A number of unmapped gullies have been culverted below the track and provided with silt traps to manage sediment runoff. The segregation of turf was observed to be good and peat reinstatement works along the preceding section of Spur 4 are ongoing.

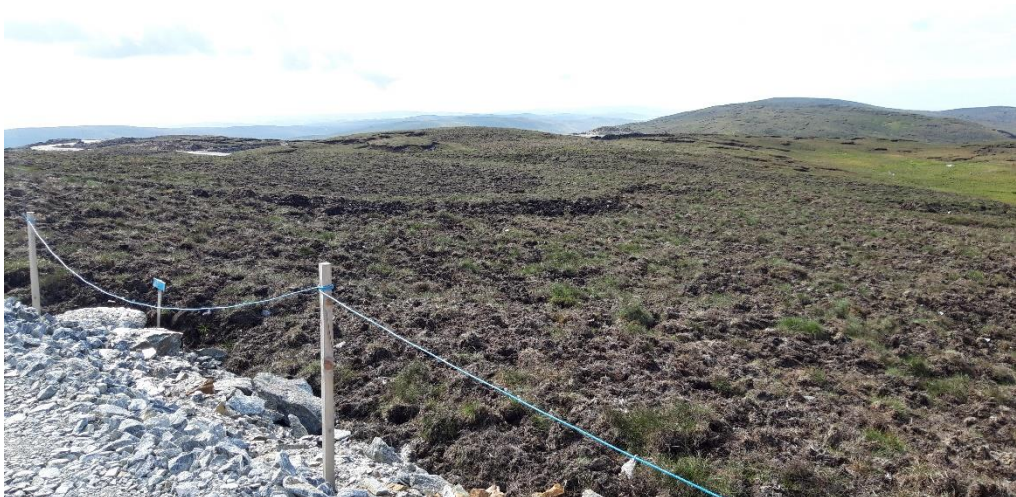
**Photo 2.** View of Peat Restoration 4, peat has been reinstated to the track level.

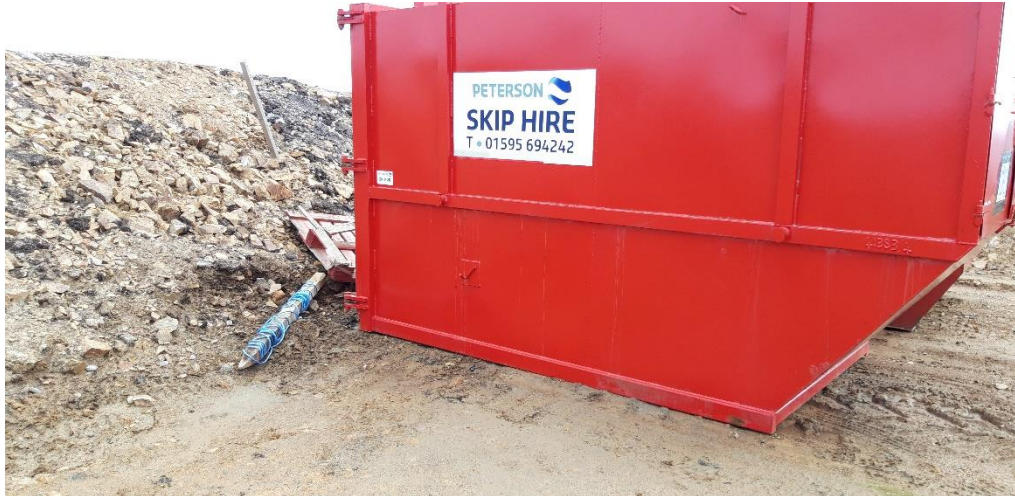
**Photo 3.**

View of waste storage at KBP02, wastes were well segregated with no leaks or stains observed in the area.

Two waste skips were observed at KBP02 where general waste and oily waste are segregated, the skips ordered are based on the anticipated types of waste from the planned works. The waste segregation was good, and no leaks or staining was observed.

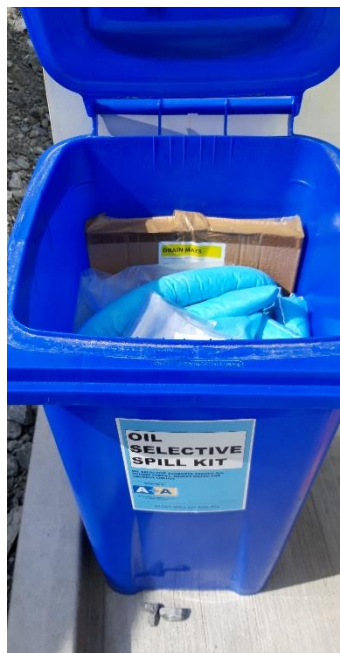
**Photo 4.**

The spill kit locating at the North Compound was well stocked with appropriate equipment and easily accessible.

Since PMO008 a second concrete batching plant had been installed at the North Compound which will provide concrete for the bases along Mid Kames Ridge. The storage of materials in North Compound was generally observed to be good with bunded storage provided for fuels. Minor quantities of oil (5x 5L in sealed containers) had been delivered to the compound and had not been provided with secondary containment, this was quickly identified and addressed by the internal auditing and reporting processes. Additionally, the Principal Contractor will carry out toolbox talks on the best practice for storing liquid materials.

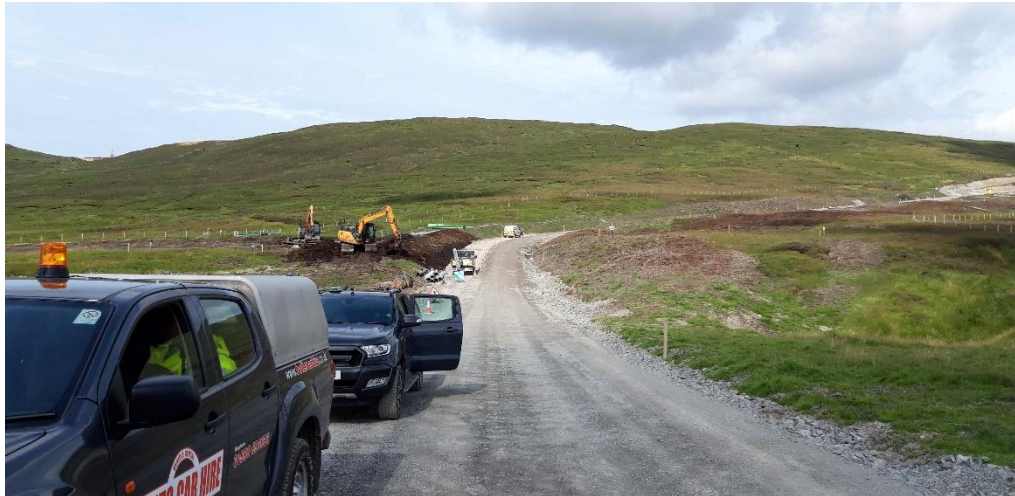
**Photo 5.** View of the works at Drosswell Burn to direct groundwater flow away from the rock armour.

It was reported that a complaint had been received by SIC of silt entering Burn of Droswell from the access track. A previous incident was reported during PMO003 which was identified as silt mobilised by surface water flow. In response to the first event additional silt traps were installed and the surface water flow was diverted away from the track.

Based on the recent reoccurrence of the incident a filter drain is being excavated to direct flow away from the track. Due to the recent dry weather it is considered unlikely that the incident was caused by rainfall mobilising sediment from the track.

During the audit the PMO observed the preparations for the groundwater channel and the existing surface water diversion. Both measures aim to prevent silt being mobilised from the rock armour surrounding Burn of Drosswell.

As described in Section 3.2.2, SIC advised the PMO of a recent complaint that had been received regarding sediment in the Burn of Droswell. The incident was investigated by SSE and identified natural springs under the track. In order to prevent a reoccurrence the construction of a filter drain is planned for the 7<sup>th</sup> August to divert the water from the springs away from the rock armour around the Burn of Droswell. Additionally, the downstream silt traps have been cleaned to improve sediment retention.

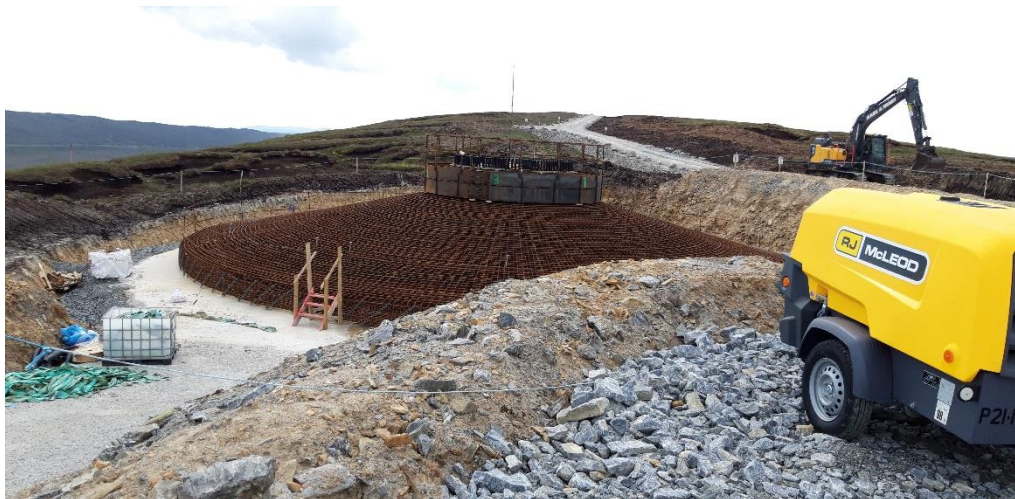
**Photo 6.** View of the base of K82 which is progressing towards concrete pouring.

During the audit the PMO observed preparation for pouring of concrete bases and the ongoing installation of cable ducts. The bases are subject to final checks and sign off before concrete is poured.

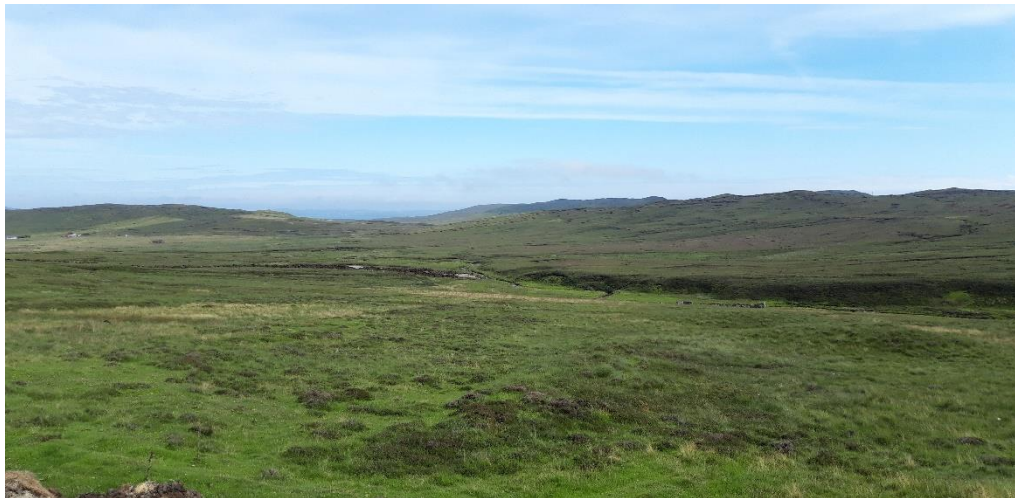
**Photo 7.** View of progress along Spur 34, with the track being developed from N140 and N141.

Construction in the South Nesting array has extended towards N140 with the track Spur 34 being developed from both Junctions 38 and 39. The turf and peat storage along the track was observed to be good, a number of streams have been culverted under the track and silt traps are in place to manage any runoff.

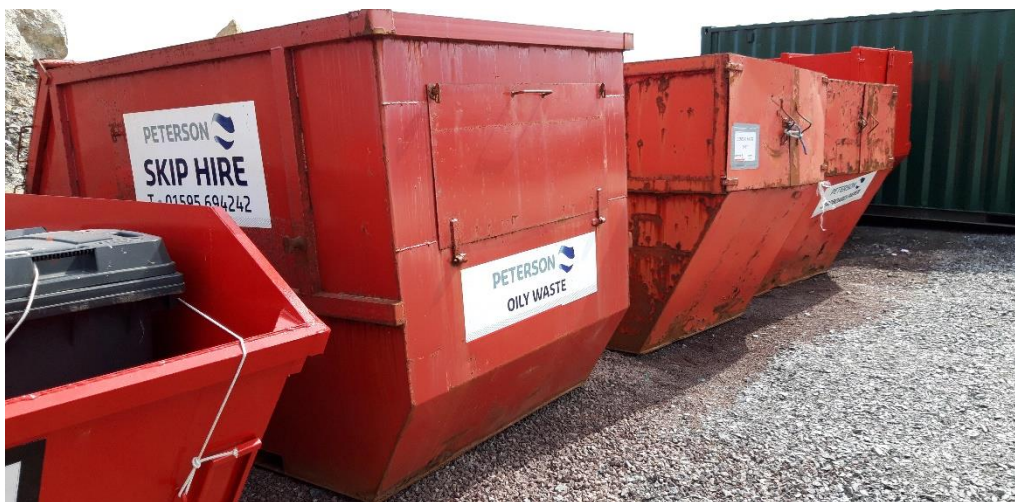
**Photo 8.** View of waste storage at the Main Compound, wastes were well segregated with no evidence of leaks or staining.

The main compound includes the primary waste storage area for the site, these included skips for all waste streams generated on site. The segregation between the wastes was observed to be good, with no leaks or stains observed in the area surrounding the skips. This area included bins for special wastes that were provided with secondary containment. Wastes from this area are uplifted by the waste contractor as and when required.
