Intended for
Viking Energy Wind Farm LLP

Date
August 2021

Project Number
1620009158

VIKING ENERGY WIND FARM PLANNING MONITORING OFFICER AUDIT REPORT 010: 4TH AUGUST TO 1ST SEPTEMBER 2021

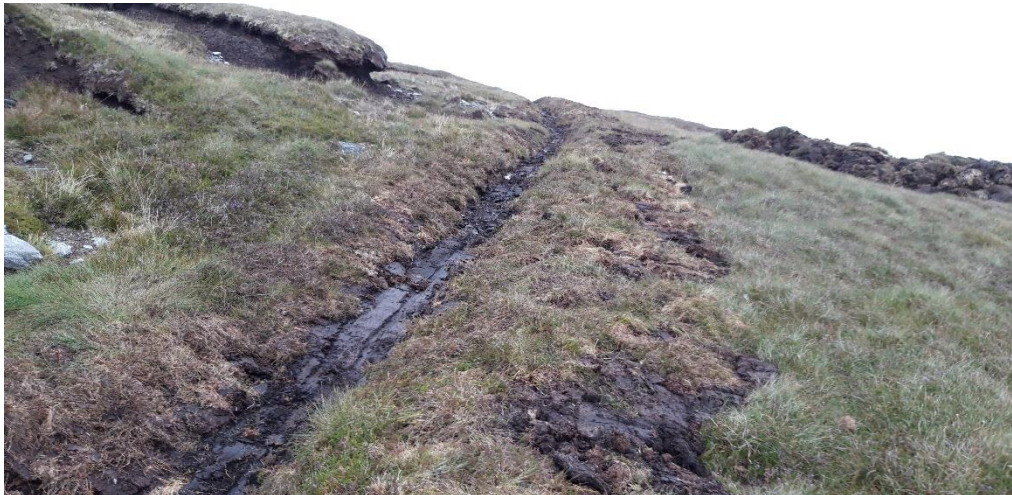
Photo 1. View from K46 of a cut off drain, the drain directs surface water to culverts under the track to minimise sediment transport.

Construction in the north of Kergord has extended towards N46, with ongoing preparation for peat reinstatement works. Surface water flow is controlled by cut off drain (example shown in Photo 1) which direct flow away from construction areas. The ditches are designed to ensure the flow of water towards ecologically sensitive environments is protected. The Principal Contractor and ECoW work together to identify ecological protection areas and micro site the track away from these.

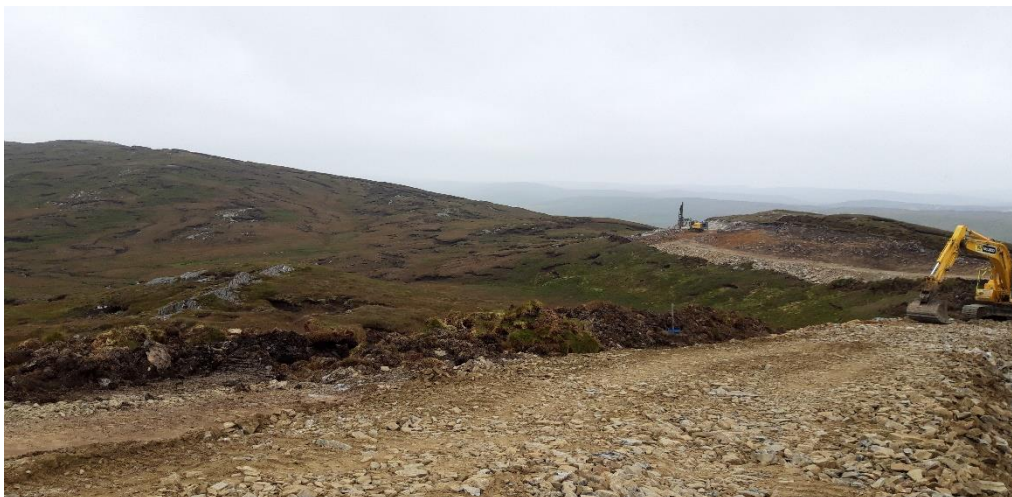
Photo 2. View of peat reinstatement on Spur 14, the peat and turf is built up to the track level as construction progresses.

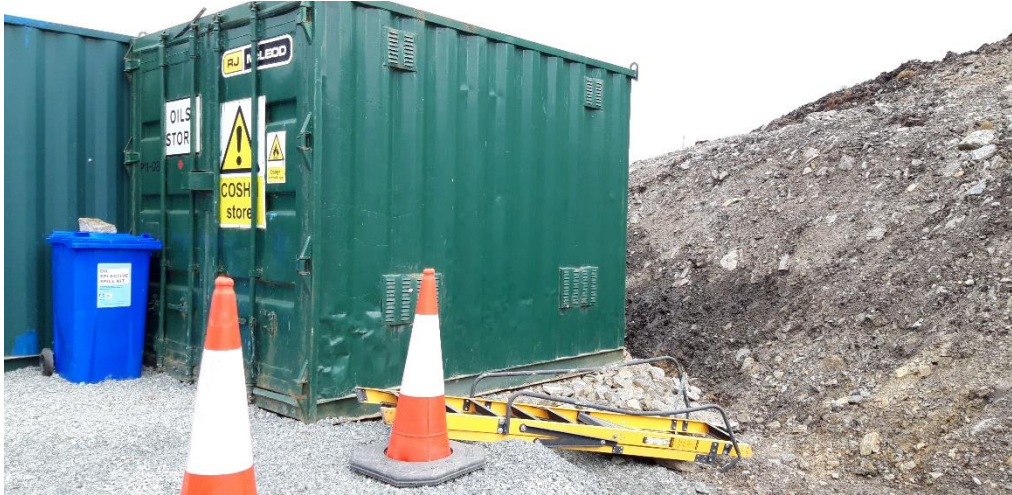
Photo 3. The COSHH store at the North Compound had no evidence of staining in the vicinity and it was provided with a spill kit.

The North Nesting COSHH store (shown in Photo 3) serves the same purpose as the Kergord COSHH store, it is used for the storage of maintenance oils and greases. Access to the store is controlled and the store is bunded. No evidence of leaks or staining was observed in the vicinity of the store, a spill kit and fire extinguishers were available.

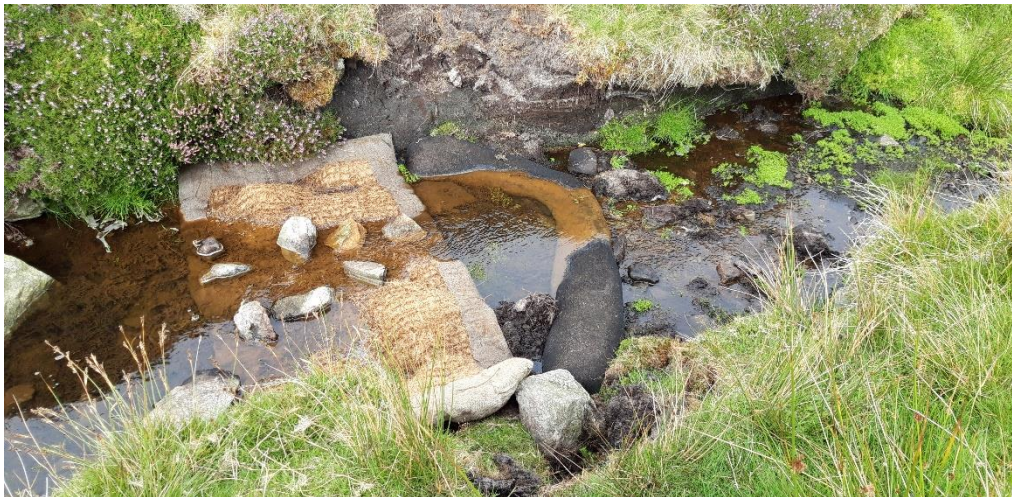
Photo 4. View of the additional silt trapping measures at K93, drainage is designed to prevent silt entering existing watercourses.

A drainage culvert was inspected in the vicinity of N93, the culvert utilised additional sediment retention measures during construction to prevent silt entering watercourses. This comprised a sediment trap and mat to slow the drainage and capture sediment (shown in Photo 4). A cut off drain upslope of the track directs water towards the culvert and minimises the sediment mobilised. The drain was strategically located to ensure a continued supply of water to the groundwater dependent terrestrial ecosystem downslope of the track. A water pump had been used to pump surface water through the culvert, the pump was integrally bunded and located on tertiary spill containment.

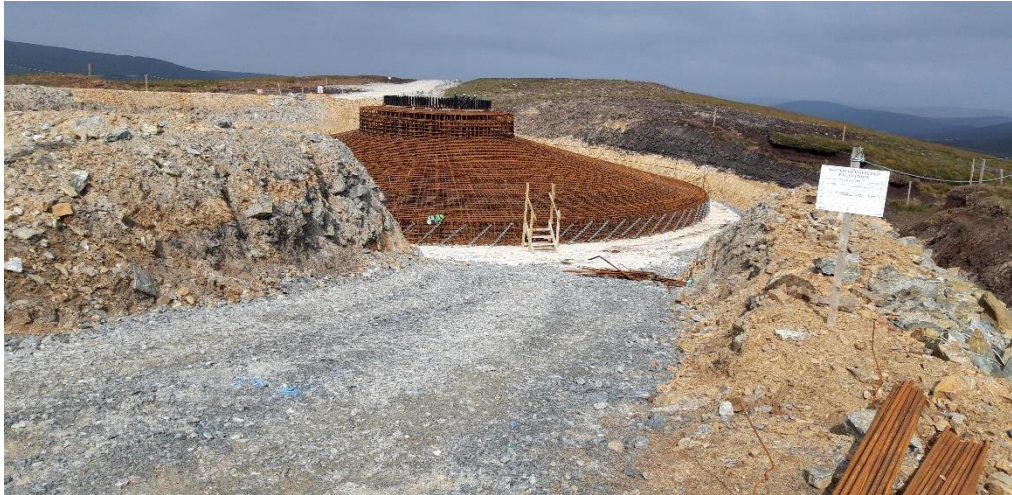
Photo 5.

View of the steel work on Mid Kames Ridge in preparation for concrete pouring, the excavated area will then be backfilled.

The bases in the area are being prepared for concrete pouring with a number of steel cages installed since the previous audit (example shown in Photo 5). The material for backfilling bases after concrete pouring is in place.

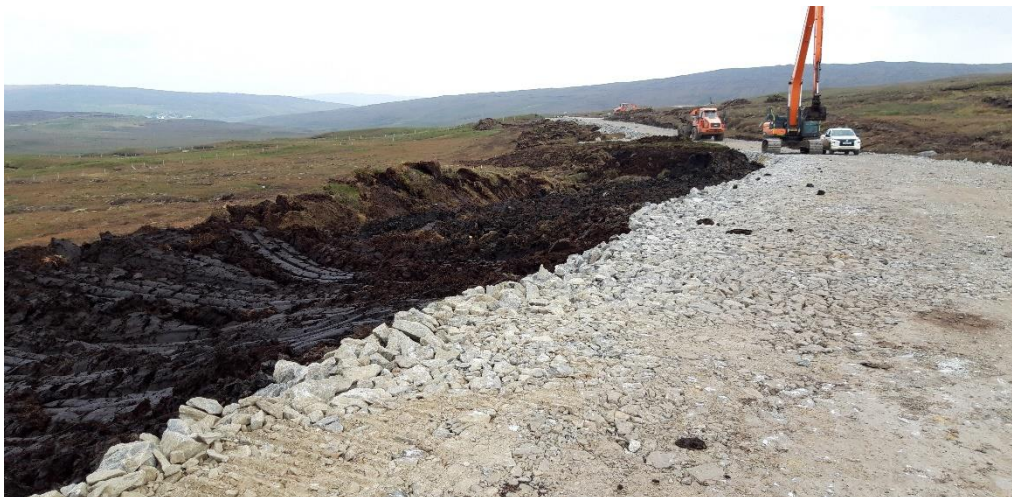
Photo 6.

View of peat reinstatement on Spur 42 where the peat is in place and the turves are laid with a long-arm excavator.

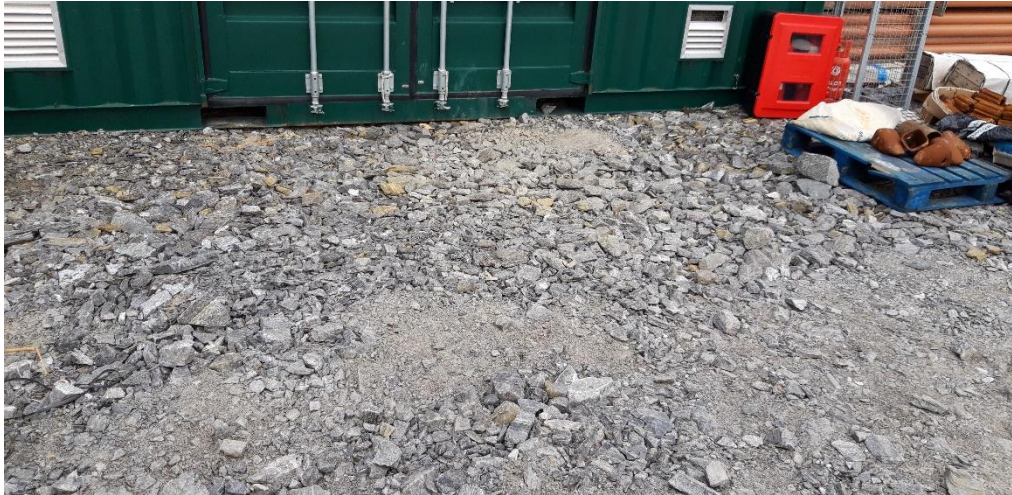
Photo 7. View of the gravel around the Main Compound COSHH store, the area was free from staining and provided with a spill kit.

The Main Compound COSHH store (shown in Photo 7) is the main storage area for substances that have been assessed under the regulations. The stored materials included oils and greases. Access to the store is controlled and the store is bunded. No evidence of leaks or staining was observed in the vicinity of the store, a spill kit and fire extinguishers were available.

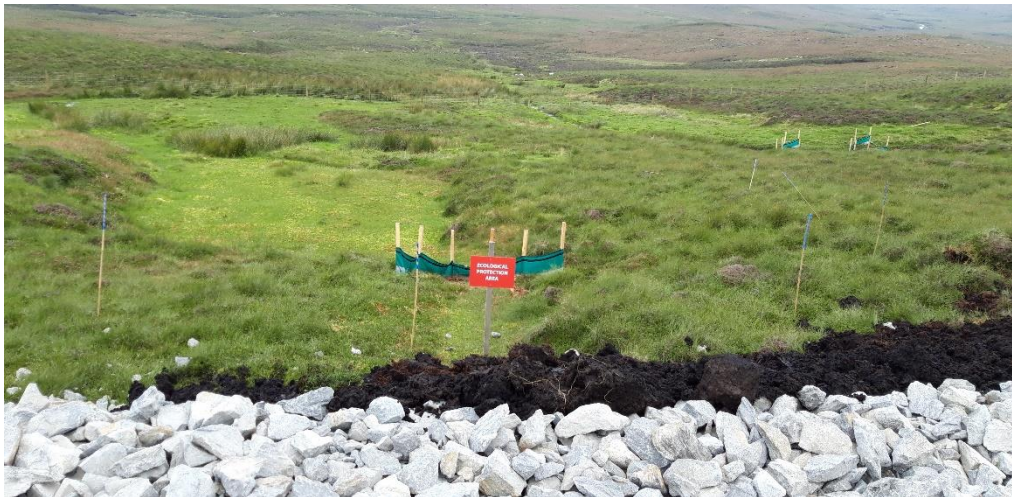
Photo 8. View of a Ecological Protection Area marked out by poles and signage with the track sites outwith the area.

The ECoW continues to discuss micro-siting of the track where ecological features have been identified (example shown in Photo 8), these are raised with the principal contractor through a tracker. Ecological features are also marked out with poles ahead of construction, the lead ECoW has given two toolbox talks on how constraints are marked during the reporting period. It is anticipated the remaining bird constraints will be in place through September.
