Intended for  
**Viking Energy Wind Farm LLP**

Date  
**September 2021**

# **VIKING ENERGY WIND FARM PLANNING MONITORING OFFICER AUDIT REPORT 011: 2<sup>ND</sup> SEPTEMBER TO 23<sup>RD</sup> SEPTEMBER 2021**

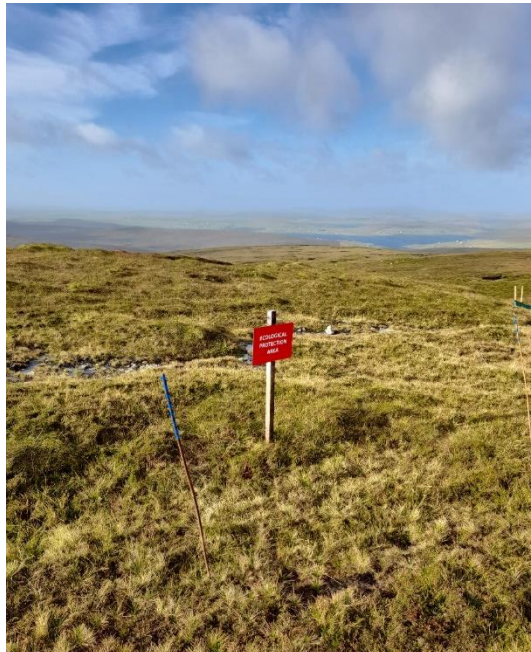
**Photo 1.**

Construction in the north of Kergord has extended towards K42, with ongoing preparation for peat reinstatement works. A crane hardstanding at K43 was noted to have been rotated within the micro-siting boundary in order to minimise peat excavation/ cut and fill. Archaeological areas of interest between K43 and K42 has been marked and avoided. Clean surface water flow is controlled by cut off trenches which direct flow away from construction areas. The ditches are designed to ensure the flow of water towards ecologically sensitive environments is protected. Ecologically sensitive areas near K45 can be seen in Photos 1 and 2. The PMO noted evidence of the Principal Contractor and ECoW working together to identify ecological protection areas and micro site the track away from these, and finding pragmatic solutions for maintaining hydrological connection between areas of wet habitat.

View from K45 of adjacent Ecological Protection Area marked out by poles in red with poles marking edge of hardstanding in blue

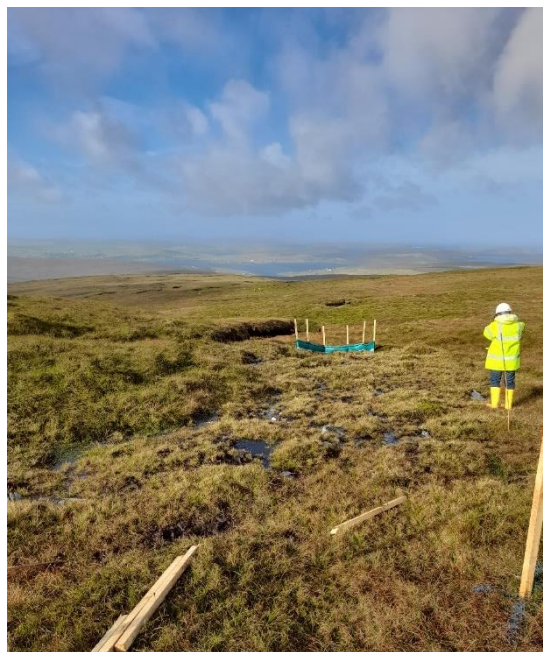
**Photo 2.**

View from K45 of adjacent ecological protection area.

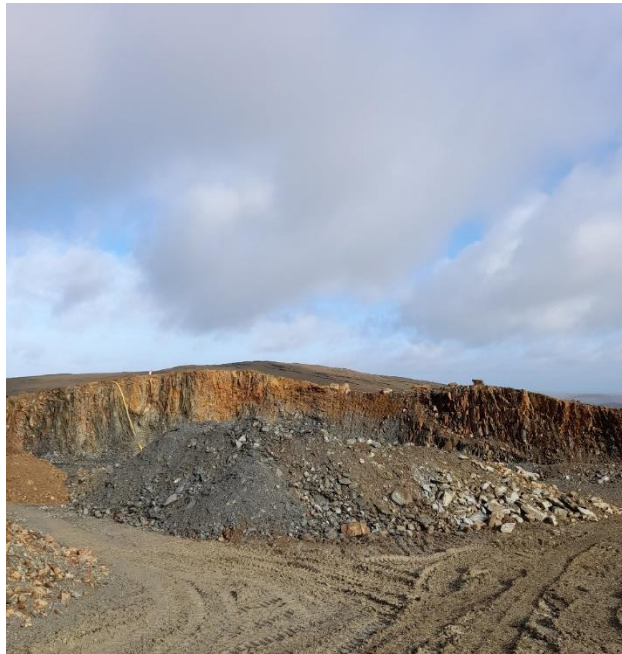
Silt traps are installed throughout the area as construction progresses to manage runoff. A proactive approach to silt traps is being taken in anticipation of higher rainfall in coming months. Part of KBP02 is currently being used as temporary peat storage while the other parts remain active (Photo 3).

**Photo 3.** Active face of KBP02

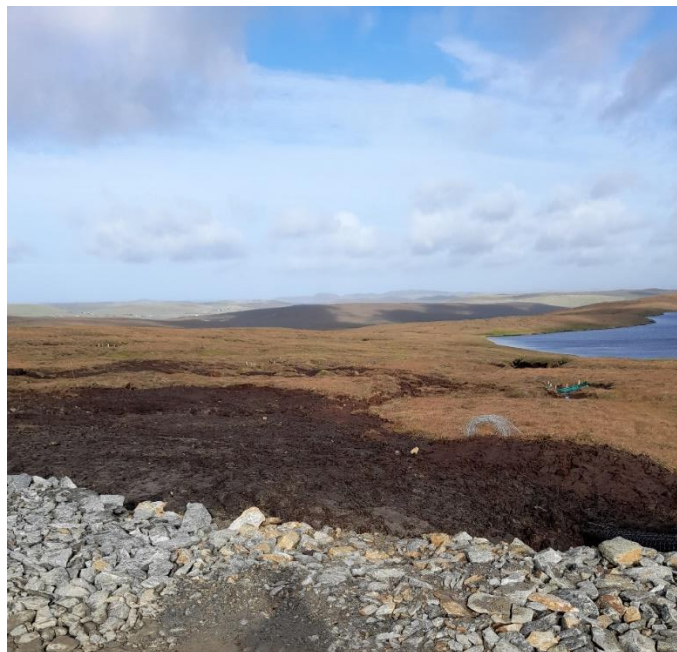
Construction in the south of Kergord has extended towards K74. The PMO observed the reinstatement where peat movements had resulted in additional intervention to restore and maintain stability of the track edge near K63 (Photo 4). The PMO noted discussions held between Principal Contractor and ECoW on best way to maintain hydrological connectivity between sensitive habitat areas between K73 and K74 (Photos 5 and 6).

**Photo 4.** View of reinstatement of a peatslide along track near K63

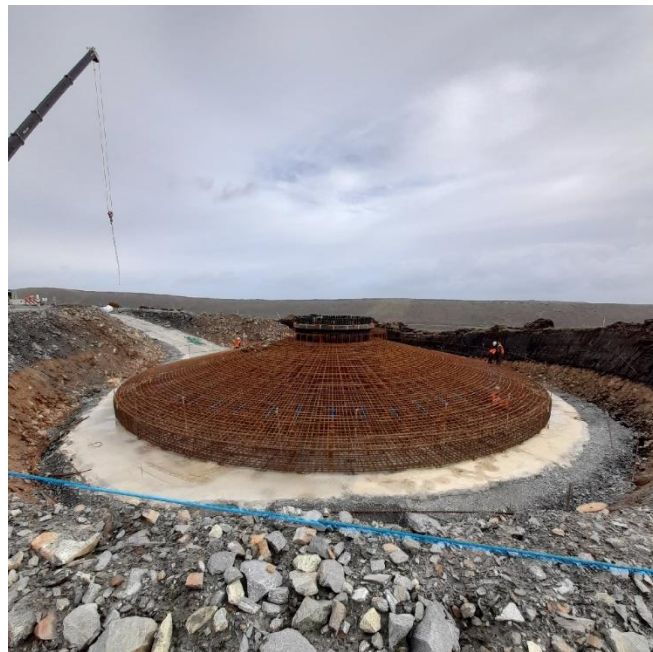
The bases in the area are being prepared for concrete pouring with a number of steel cages installed since the previous audit (example shown in Photos 7 and 8). The stockpiled material at each base will be tested and graded for suitability as backfill for the turbine bases.

**Photo 7.** View of the steel work at K86 in preparation for concrete pouring.

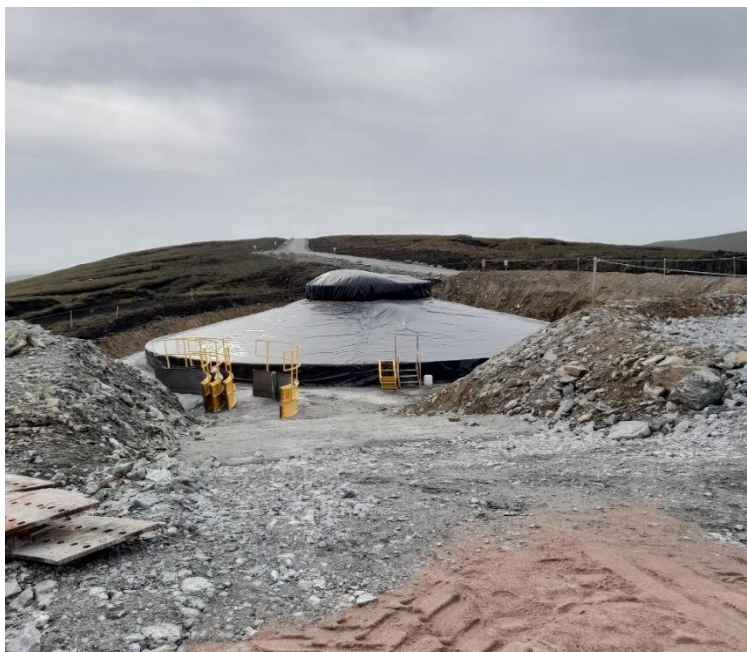
**Photo 8.** View of the completed and covered concrete work at K82, the excavated area will then be backfilled.

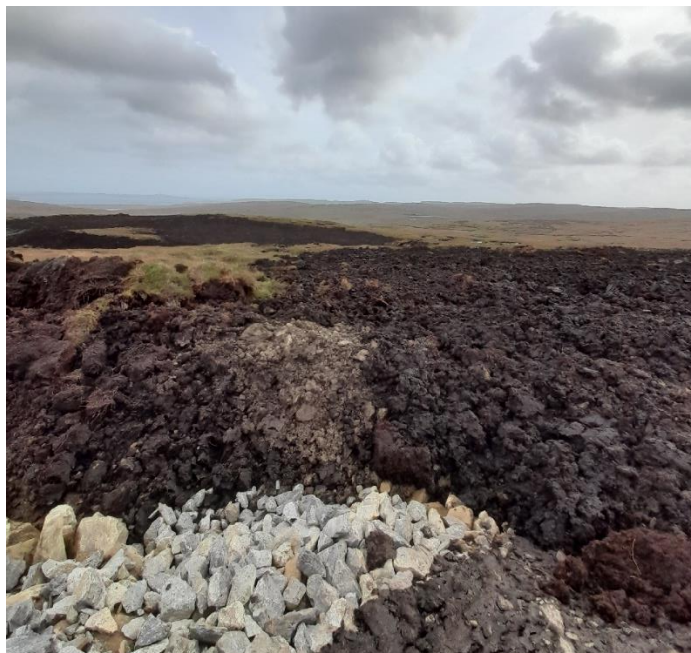
**Photo 9.**

The ECoW and GCoW both noted during interviews with the PMO that some mixing of mineral soil and peat had been observed in peat restoration area P15-P17 and that remedial action had been requested. The SSER Environmental Site Manager confirmed that the Habitat Management Plan Officer (HMPO) has carried out a review of these areas and highlighted where additional work is required. The PMO understands that the HMPO recommendations are in the process of being implemented at P17 (see photo 9) with further work to follow at P15 in due course to ensure that the completed works are satisfactory under the peat restoration criteria. Peat restoration continues to be managed by the SSER Environmental Site Manager and HMPO with a view to providing the revised restoration areas extents by year end. This revision will be presented to SIC and SWEAG.

View of peat restoration area P17 by N102 where the peat is in place.

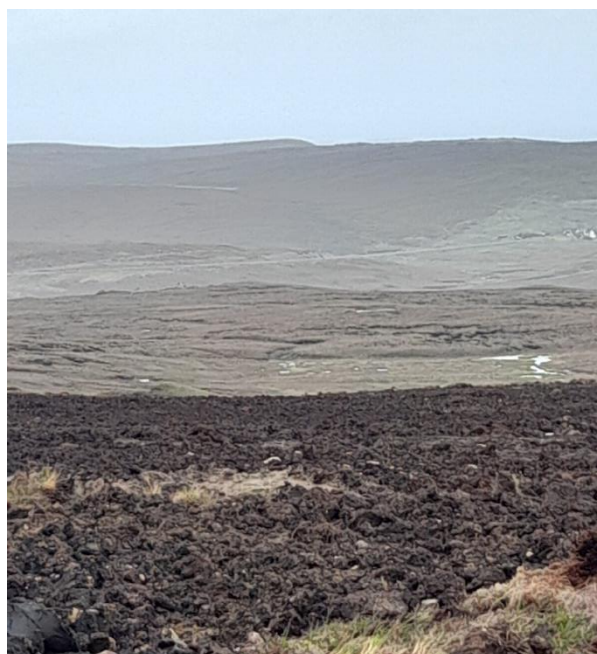
**Photo 10.**

It was noted during the audit that the access track route towards N105 has been modified using the micro-siting tolerances to avoid an area of good quality sensitive habitat (Photo 10).

View towards N105 from N102 where peat basin has been avoided through micro-siting.

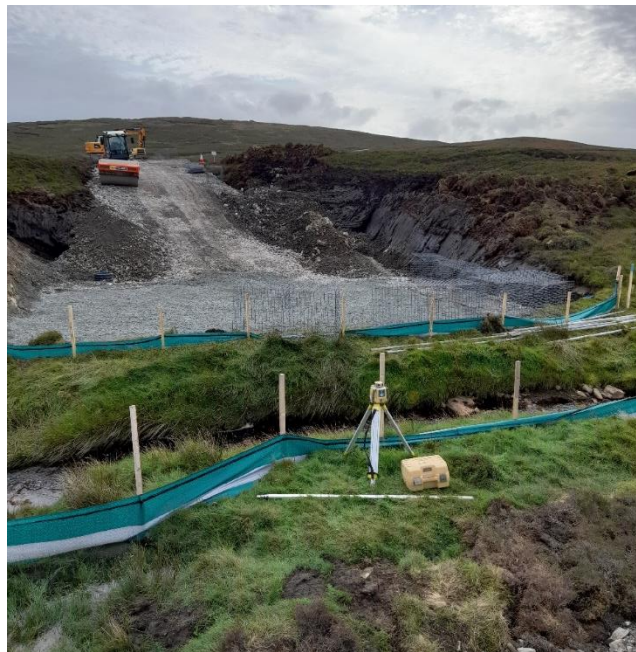
The construction of the track for Spur 34 has been completed and construction of a bridge over the Burn of Grunnafirth (watercrossing 22, between N140 and N141) is ongoing (Photo 11). The tracks are floated where permissible within normal design limits to minimise the volume of peat excavated. A temporary bridge has been installed over the Burn of Forse (watercrossing 19, between N120 and N122) while construction of a permanent bridge is ongoing.

**Photo 11.** Bridge construction at Spur 34 between N140 and N141.

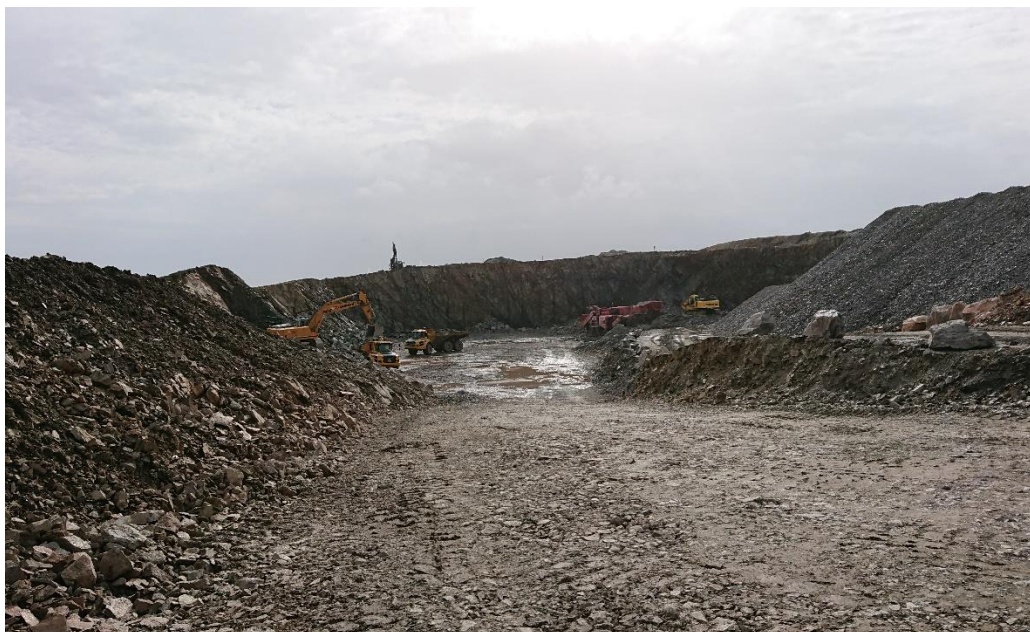
Rock extraction at NBP05 is ongoing, mobile crusher and screening plant for the production of aggregate has been observed at NBP05 (Photo 12).

**Photo 12.** View of active rock extraction at NBP05, mobile crusher and screening plant for the production of aggregate can be seen.
