Intended for
Viking Energy Wind Farm LLP

Date
October 2021

Project Number
1620009158

VIKING ENERGY WIND FARM PLANNING MONITORING OFFICER AUDIT REPORT 012: 24TH SEPTEMBER TO 20TH OCTOBER 2021

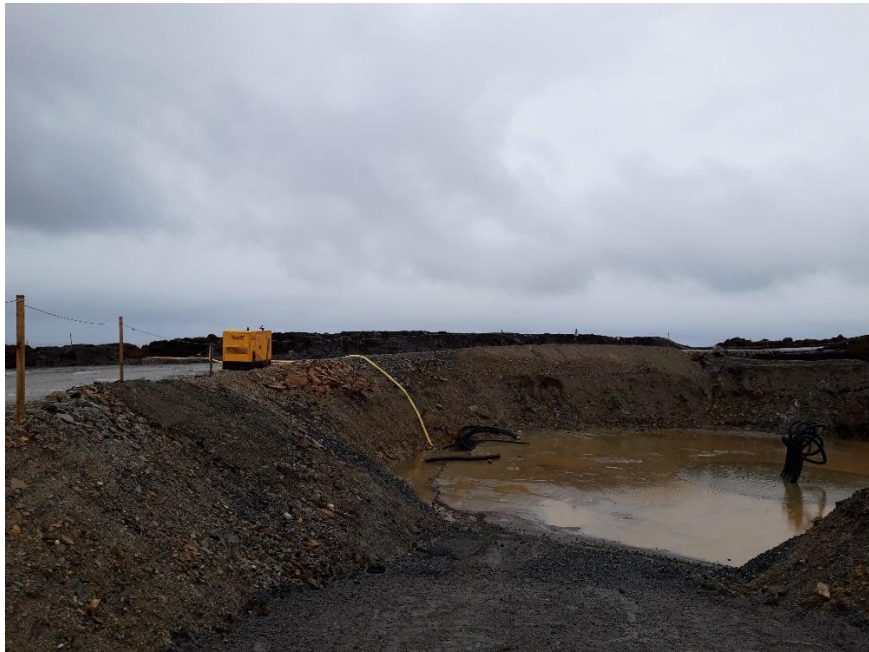
Photo 1. Water pump being used at K47 in preparation for installation of steel cages

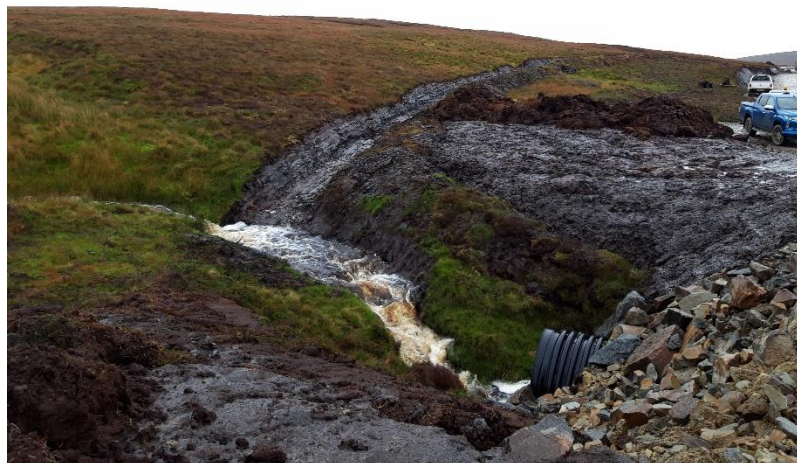
Clean surface water flow is controlled by cut off trenches which direct flow away from construction areas (example shown in Photos 2 and 3). The ditches are designed to ensure the flow of water towards ecologically sensitive environments is protected. Silt traps are installed throughout the area as construction progresses to manage runoff. A proactive approach to drainage, the installation of settlement ponds and the deployment of silt traps and fencing are used in anticipation of higher rainfall in coming months.

Photo 2. Example of cut off trenches that direct clean surface water flow away from construction areas at K64 (inflow)

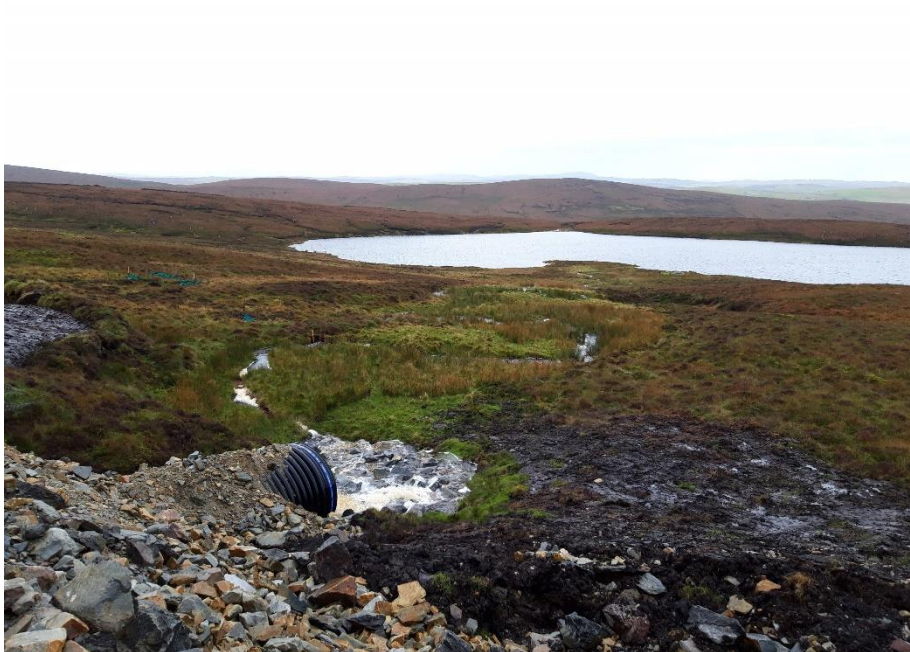
Photo 3. Example of working culvert under track to K64 (outflow)

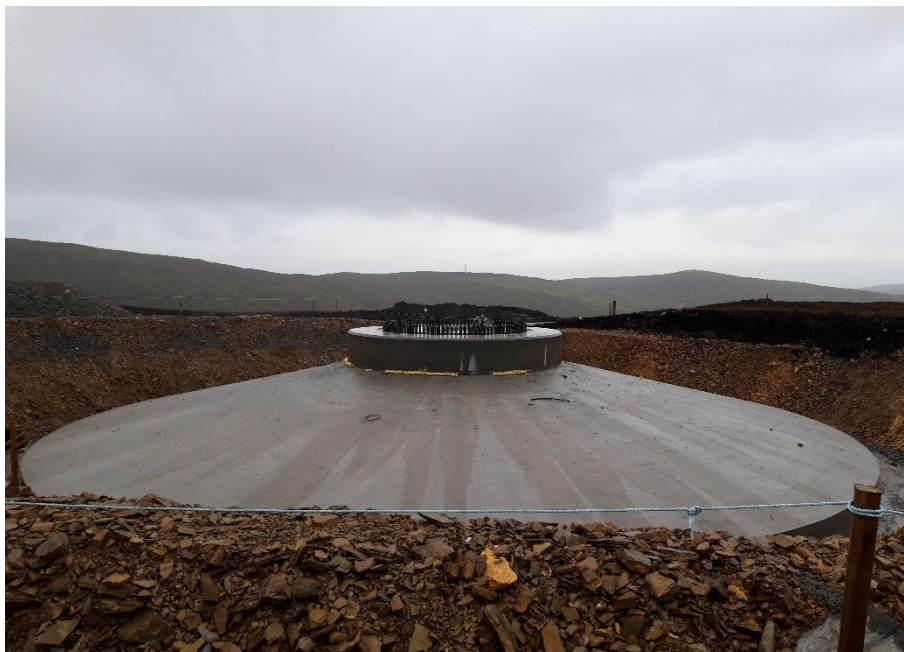
At the time of visit, all of the bases in the area have had concrete poured, except K85 and K88. Bases that have been set and are without temperature restrictions have had their jackets removed (example shown in Photo 4). K85 has been prepared for concrete pouring with concrete being poured at K88 at the time of visit (Photo 5). Vehicles used during the concrete pouring were noted to be washing out residual concrete into a designated concrete wash-out pit, which is appropriately lined with impermeable plastic sheeting (Photo 6). The stockpiled material at each base will be tested and graded for suitability as backfill for the turbine bases.

Photo 4. View of exposed concrete work at K79, the excavated area will then be backfilled

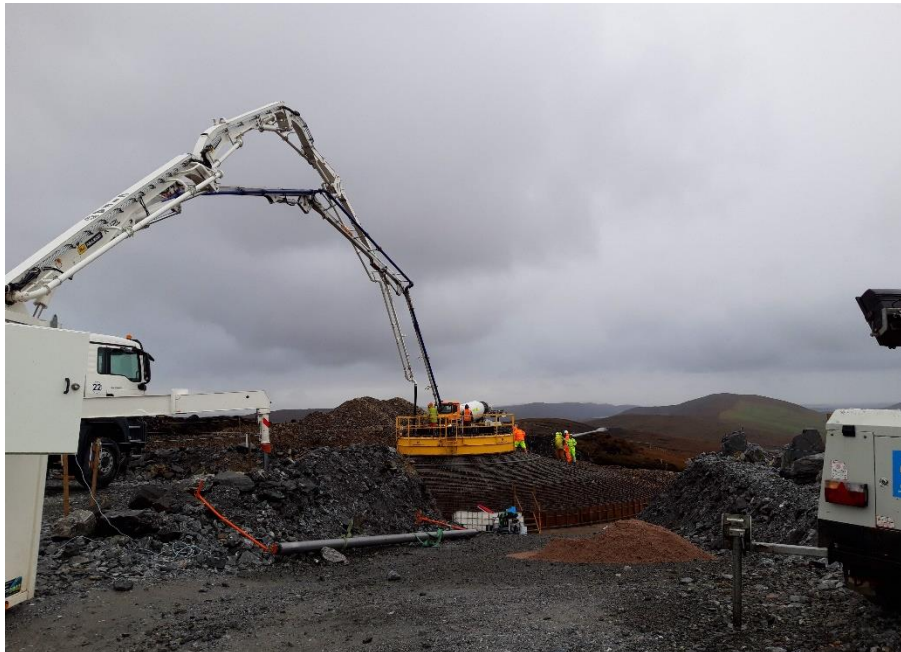
The Mid Kame Ridge (MKR) is accessed from the Sandwater track and stretches northwards to Hamarigrind Scord. Construction personnel were pouring concrete for a turbine foundation/base during the audit at turbine K88.

Photo 5. View of concrete being poured at K88

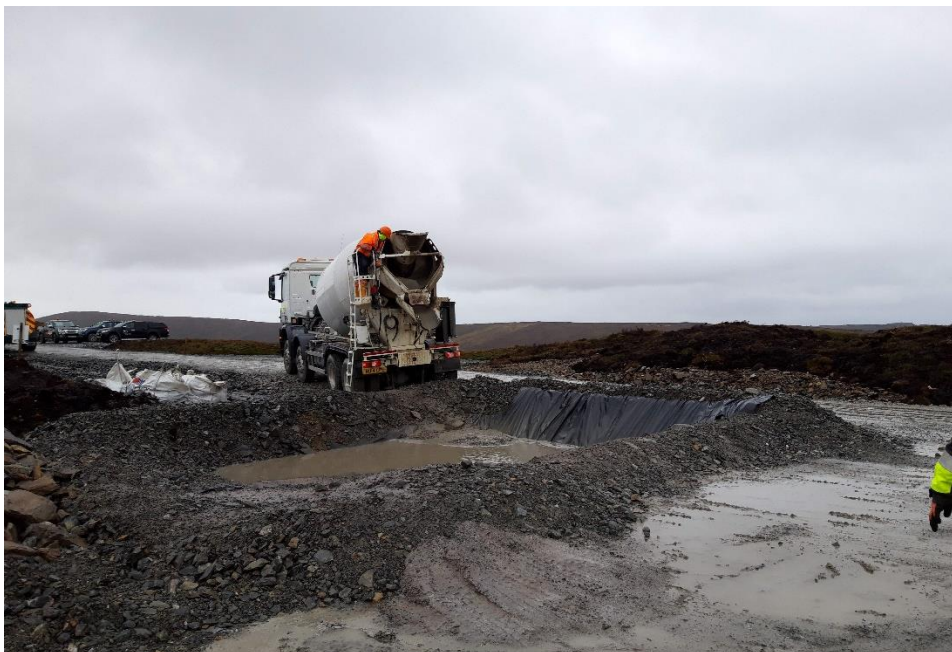
Photo 6. Rinsing of vehicle being used for concrete pouring with mitigation in place to avoid pollution and run offs.

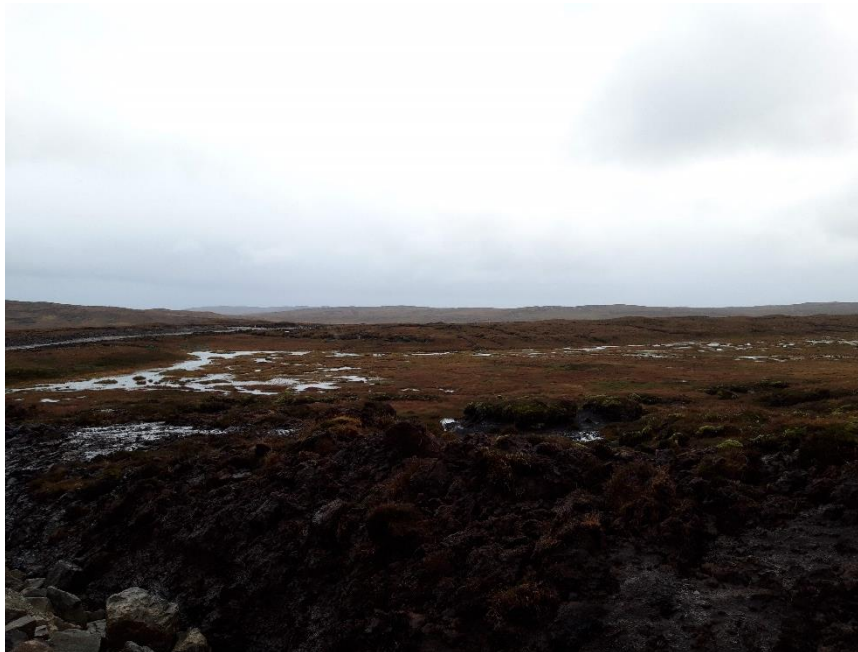
Photo 7.

The construction of a micrositied track route towards N105 has been completed, successfully avoiding an area of good quality sensitive habitat through use of the micrositing process (Photo 7). Construction of the temporary bridge between N95 and N96 (watercrossing 15) has begun (Photo 8), which once completed will allow the track construction of Spur 45, 45A and N97.

View of good quality sensitive habitat avoided with modified track route towards N105, track now on the left of photo instead of through the habitat in the middle

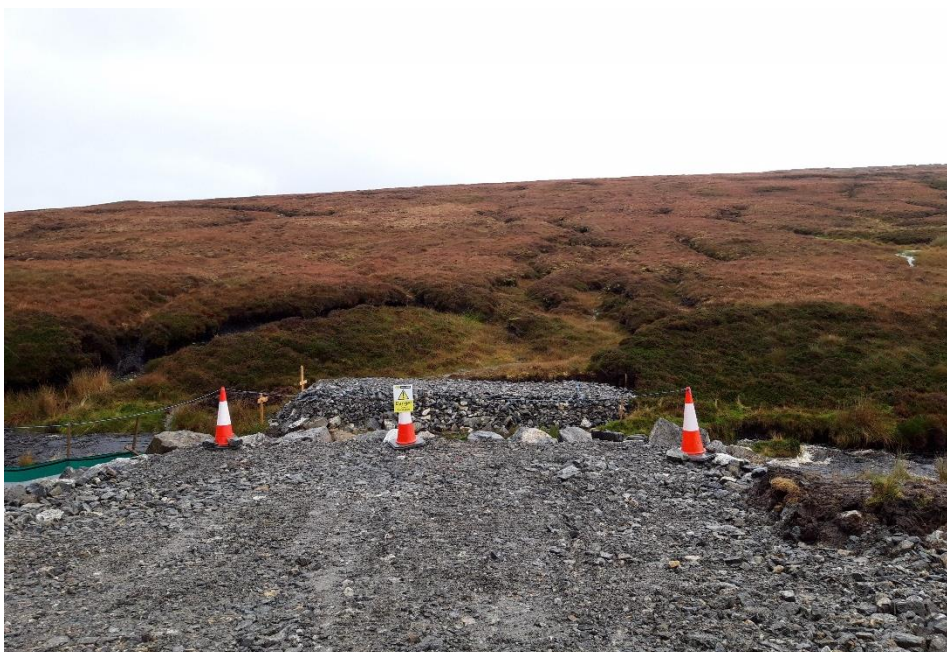
Photo 8.

View of the temporary bridge abutment works for WC15 (Array M)

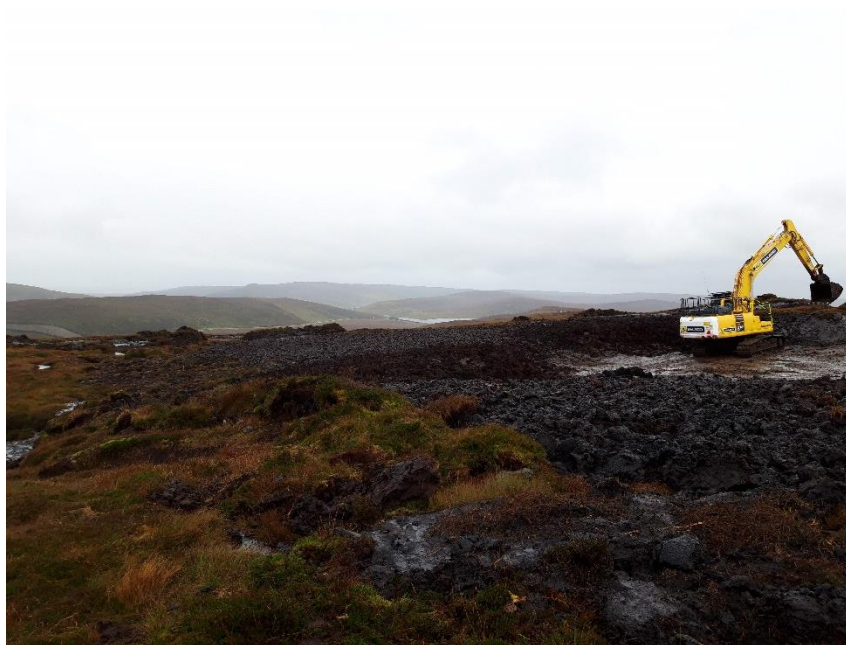
Phase 1 of the peat restoration at P7 and P19 has been completed with ongoing restoration at P11 (Photo 9).

Photo 9. View of ongoing peat restoration at P11

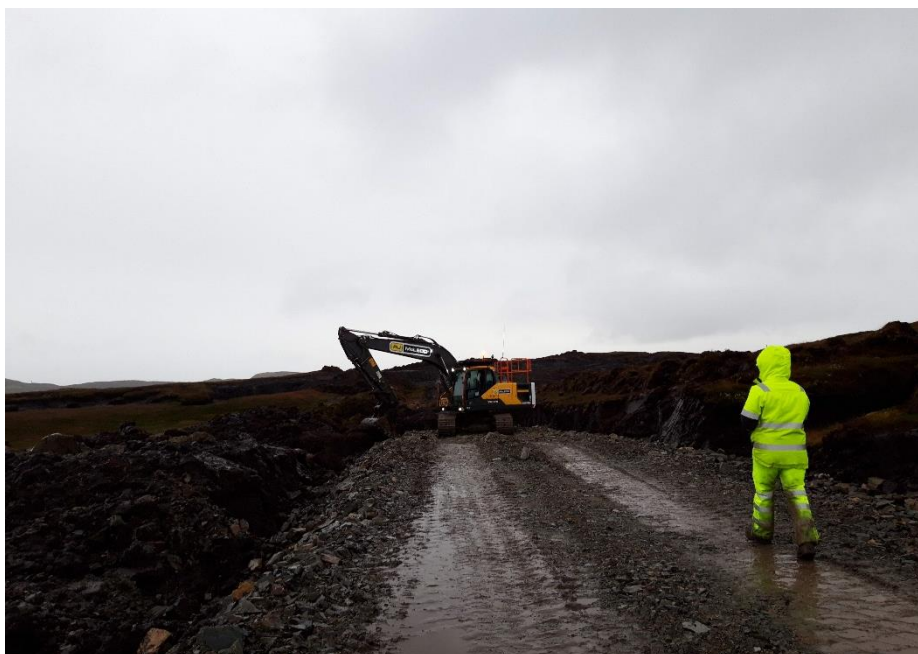
The construction of the track for Spur 35 has been progressed to N128 (Photo 10). The concrete abutment for the permanent bridge over the Burn of Forse (watercrossing 19, between N120 and N122) has been completed, awaiting the arrival of the permanent bridge body (Photo 11).

Photo 10. View of track construction at N128

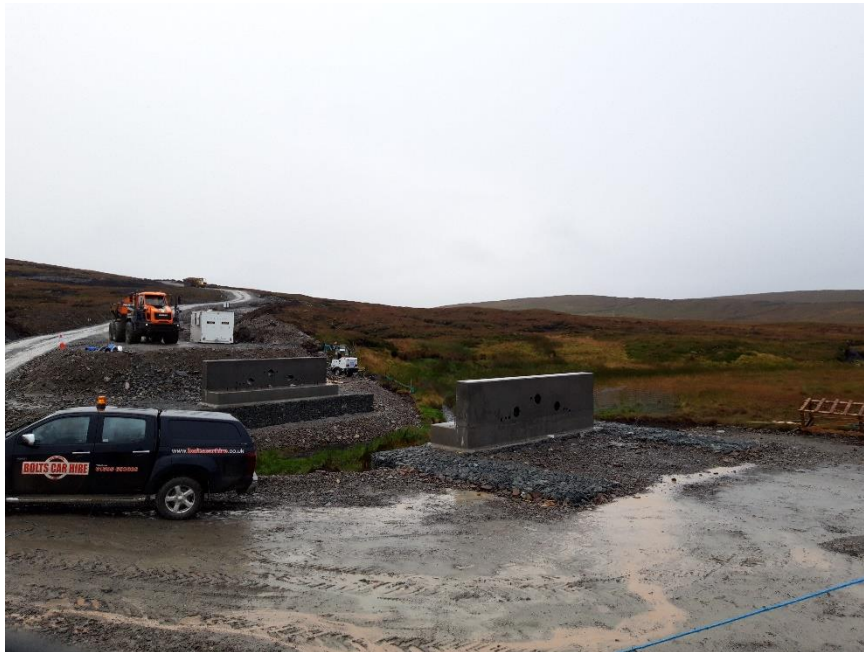
Photo 11. View of completed concrete abutment at watercrossing 19

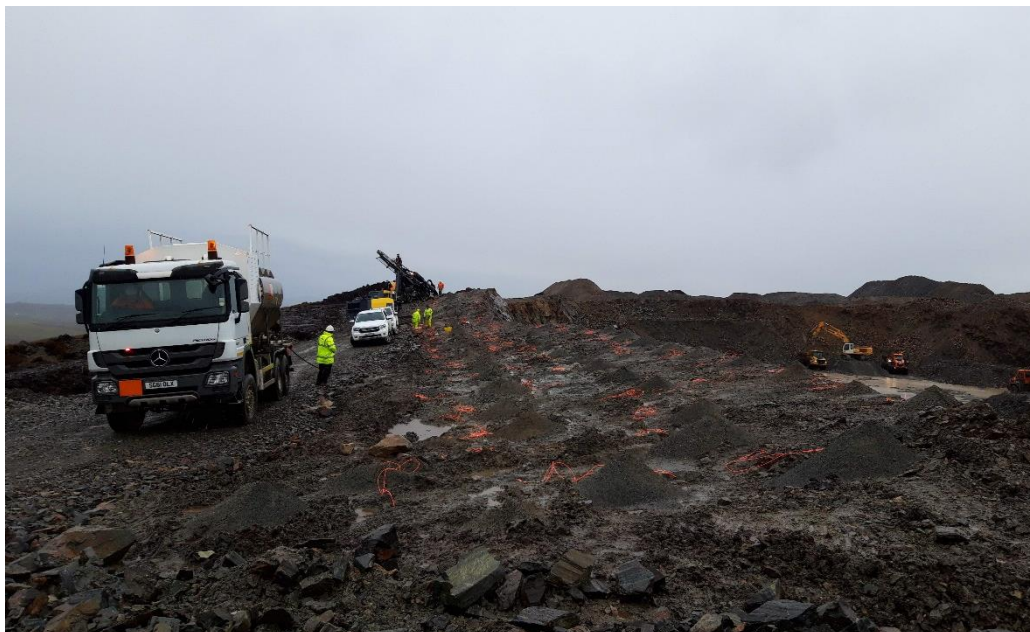
On the day of the visit, there was blasting planned at NBP05 (Photo 12).

Photo 12. View of blasting preparation at NBP05

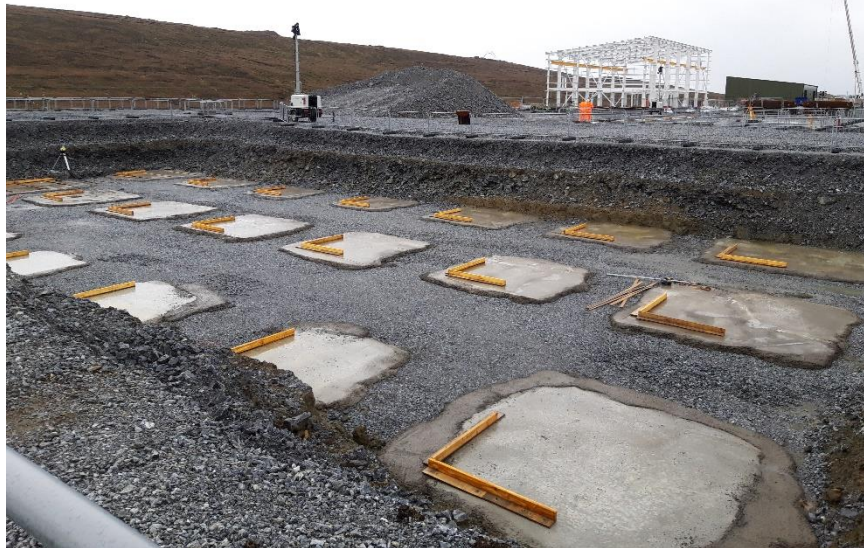
The structure of the temporary site office and welfare facilities has been completed with electricity being connected. Foundation work for buildings within the Substation is ongoing (Photo 13).

Photo 13. View of foundation work for buildings within the Substation

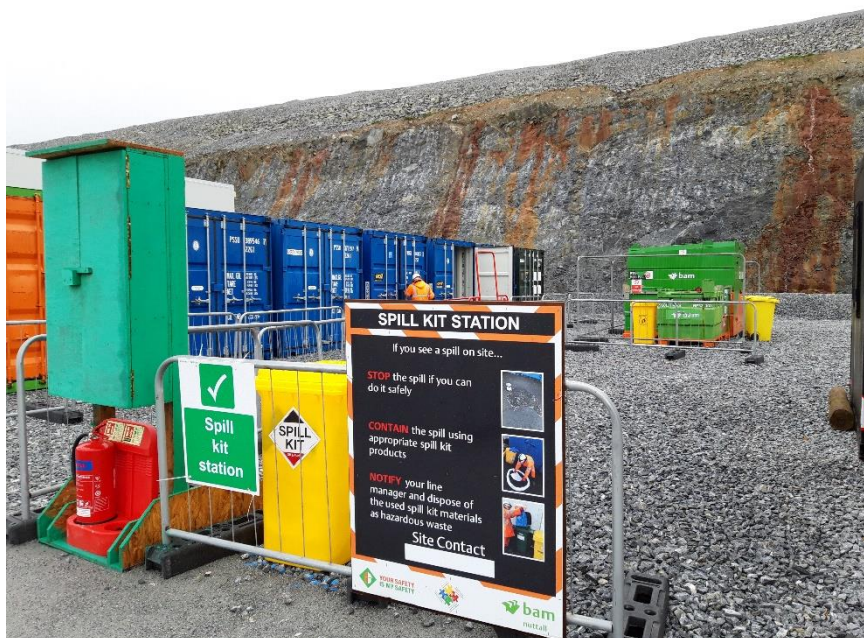
A fuel storage area has been set up and is controlled in keeping with CEMP requirements. Access to the store is controlled and the store is bunded. No evidence of leaks or staining was observed in the vicinity of the store, spill kits and fire extinguisher were available (Photo 14).

Photo 14. View of spill kit and fire extinguisher near fuel storage at Substation

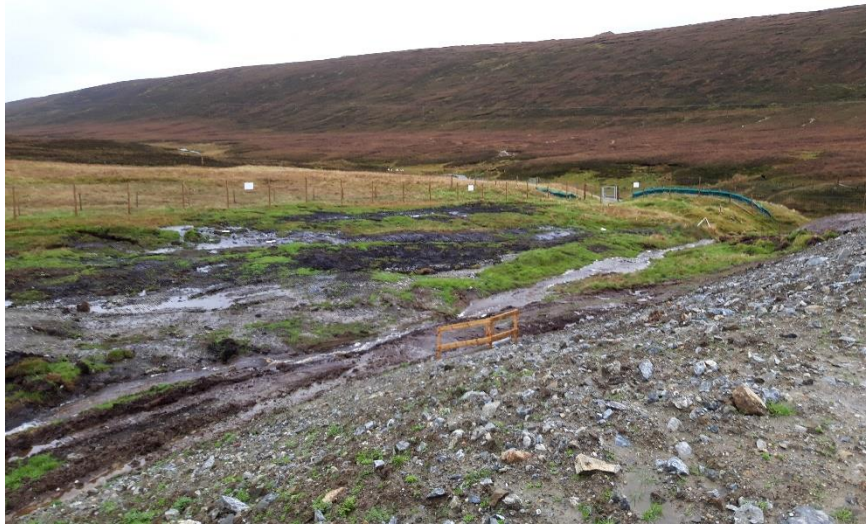
A peripheral drain has been constructed to capture and discharge clean water from the western side of the platform area, PMO observed no discharge during visit (Photo 15).

Photo 15. View proposed clean water discharge point, no discharge observed
