Intended for  
**Viking Energy Wind Farm LLP**

Date  
**November 2021**

Project Number  
**1620009158**

# **VIKING ENERGY WIND FARM PLANNING MONITORING OFFICER AUDIT REPORT 013: 21<sup>ST</sup> OCTOBER TO 12<sup>TH</sup> NOVEMBER 2021**

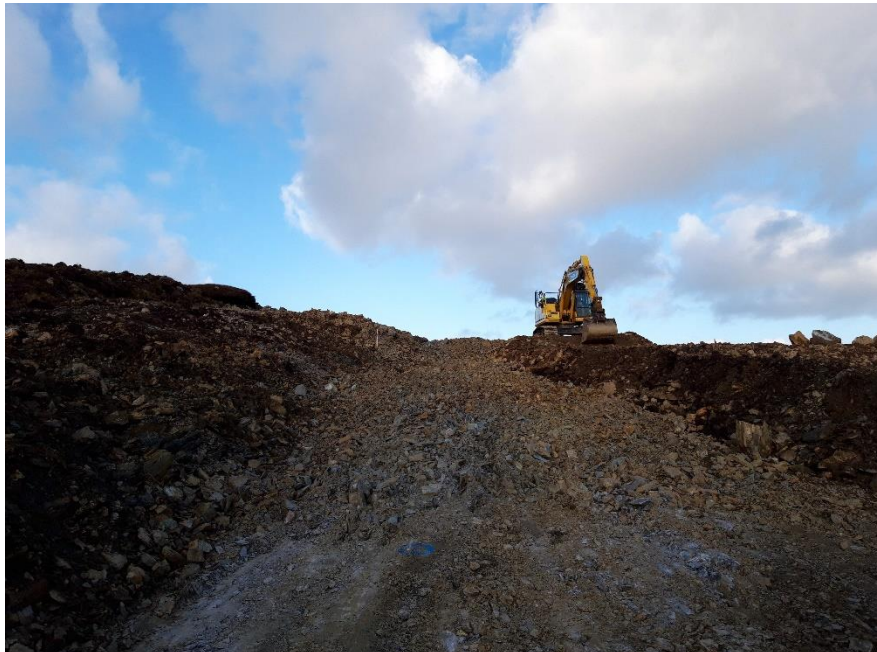
Construction of track in the north of Kergord has been completed and excavation for K42 hardstanding has begun (Photo 1). Construction of track in the south of Kergord has just reached K76 and excavation for K76 hardstanding has begun. Following the dry summer and early autumn periods, rainfall has increased. In response to this, excavation of new turbine bases has stopped and work has focused on turbine bases already excavated and improvement work on built tracks. The installation of the anchor cage has been completed at K44, K46 - K48, K51, K52 and K54 - K60 (example shown in Photo 2); steel rebar has been installed at K46, K48, K52 and K55; concrete pouring has been completed at K52; with K46 being prepared for concrete pouring. At the time of visit, the shuttering at K48 was being lifted (Photo 3) and the steel fix had just begun at K57.

**Photo 1.** View of excavation for K42 hardstanding

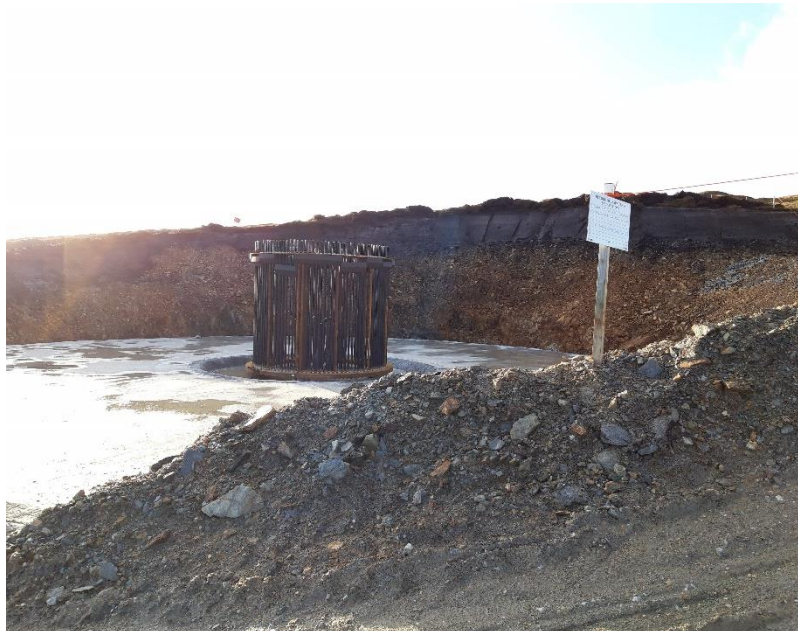
**Photo 2.** Example installed central pillar over concrete blinding at K44, before steel fixing

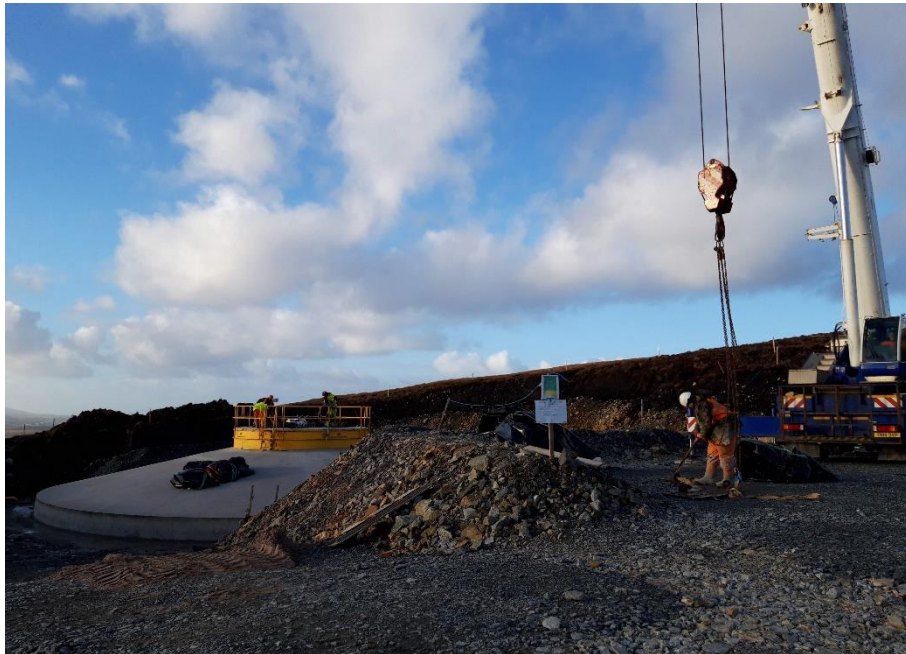
**Photo 3.** Shuttering being lifted at K48 after concrete pour

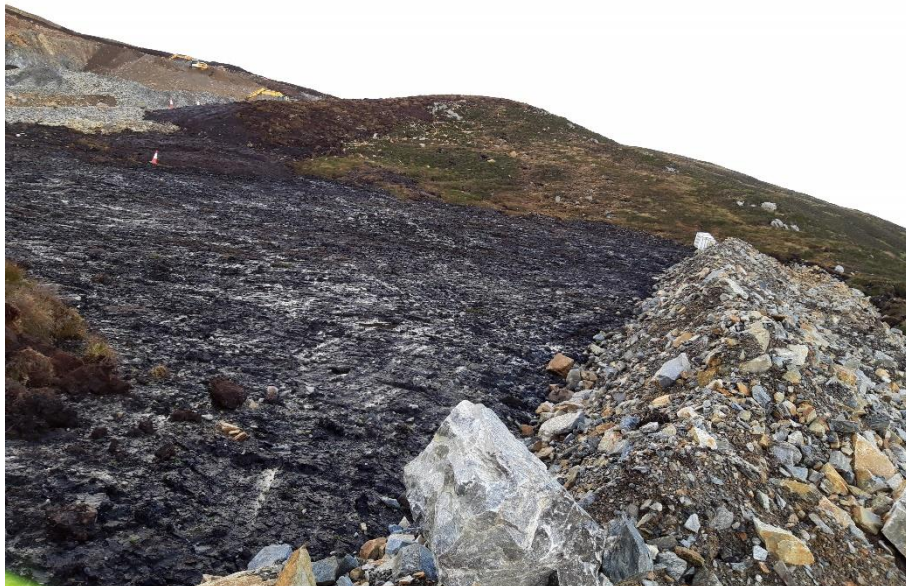
There was no work at KBP02 on the day of visit, rock extraction at KBP03 and KBP05 is still ongoing. Original bunding is still in place at the temporary peat storage area near KBP05 (Photo 4). The temporary peat storage area is compliant with the CEMP specifications and act as temporary storage before peat can be used for future reinstatement purposes. Phase 1 of the peat restoration at P04 and P05 has been completed (Photo 5) with ongoing restoration at P02. The peat reinstatement along tracks is ongoing, although there are sections where the reinstatement of turves is awaiting installation of cabling. Reinstatement of turves on the opposite side of track without cabling is ongoing and has been completed in some sections.

**Photo 4.** View of temporary peat storage area at KPB05

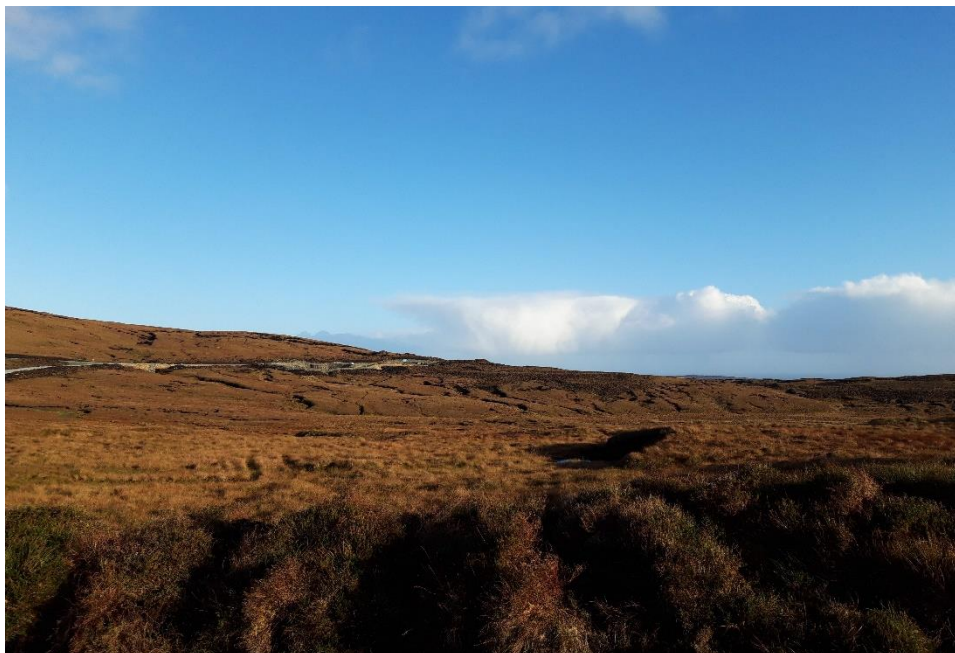
**Photo 5.**

View towards P04 and P05 where phase 1 of the peat restoration has been completed

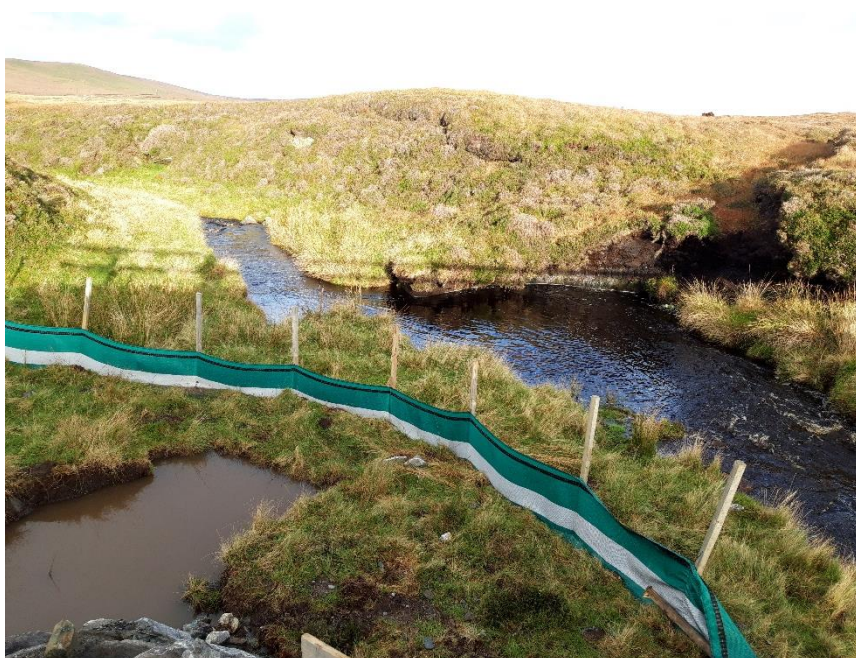
**Photo 6.**

Construction of the temporary bridge between N95 and N96 (watercrossing 15) has been completed, allowing the construction of the permanent bridge and track towards N96 and beyond to begin. As a proactive approach to prevent water pollution and in anticipation of higher rainfall in coming months, settlement pond and silt traps have been installed by the temporary bridge and along tracks (example in Photo 6). Some splash guards are also in place (example in Photo 7), with more to be installed on all active bridges.

Settlement pond and silt trap next to temporary bridge by watercrossing 15

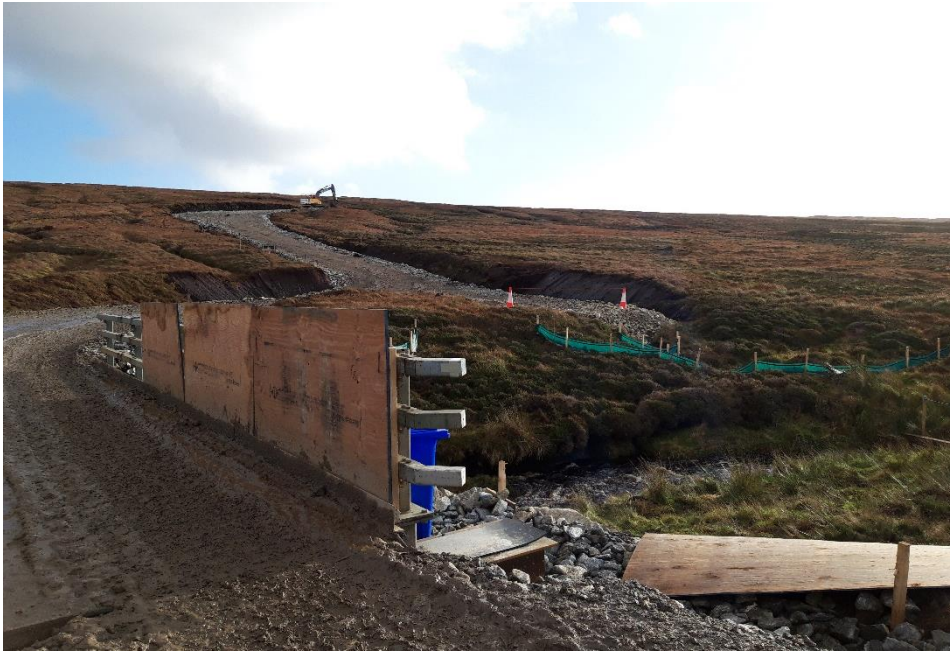
**Photo 7.** Splash guards installed on temporary bridge at watercrossing 15 and view towards tracks onto N96

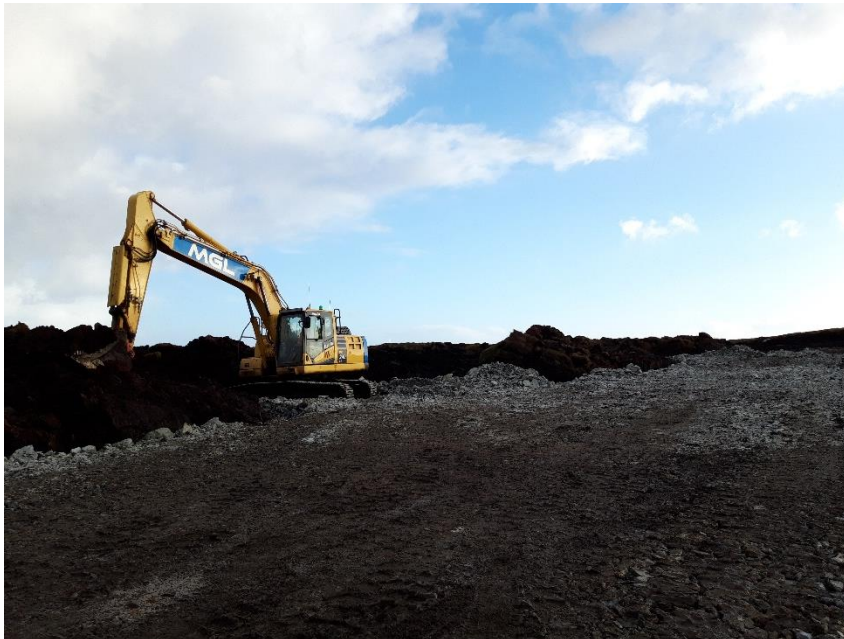
At the south of North Nesting, construction has progressed to N108 (Photo 8).

**Photo 8.** View of ongoing construction at N108

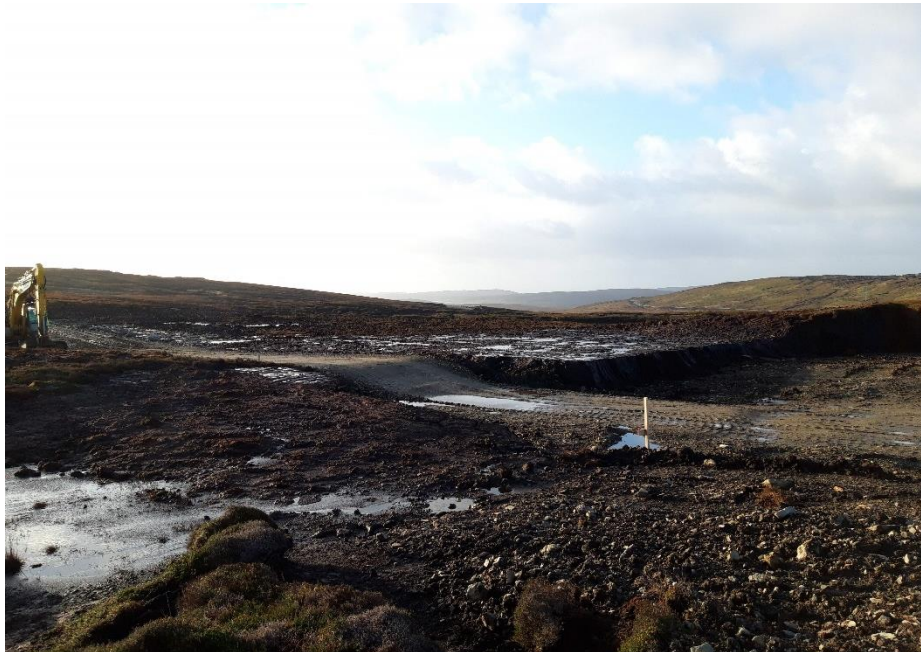
On the day of the visit, there was drilling at NBP05 in preparation for blasting planned later on in the week and ongoing restoration at P22, P24, and near N148 (Photo 9). With higher rainfall and heavy construction traffic, reinstatement of the track surface are underway on tracks near borrow pits.

**Photo 9.** View of ongoing peat restoration near N148

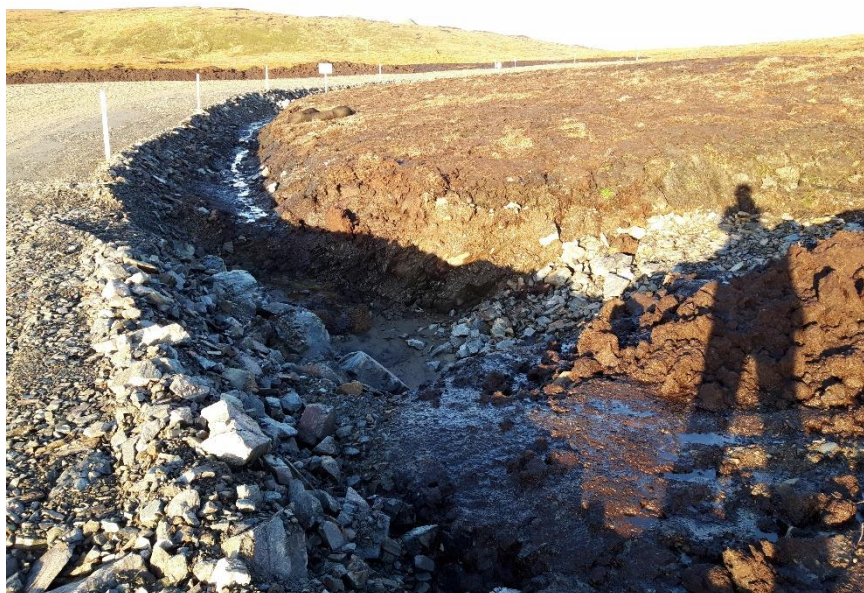
PMO observed the surface water management system installed near N132 where clean and dirty water are separated (Photo 10). Settlement ponds (Photo 11), silt traps and fencing are checked and maintained regularly. Once silt traps are full of silt, they will be cleared as soon as possible.

**Photo 10.** Example of dirty water system near N132

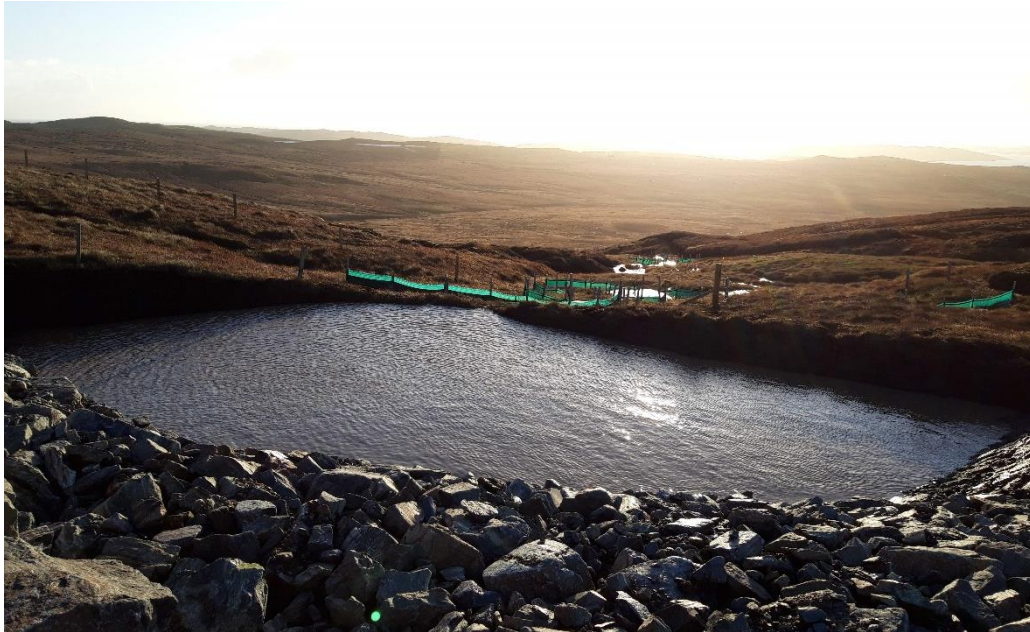
**Photo 11.** Example of track side settlement pond near N132

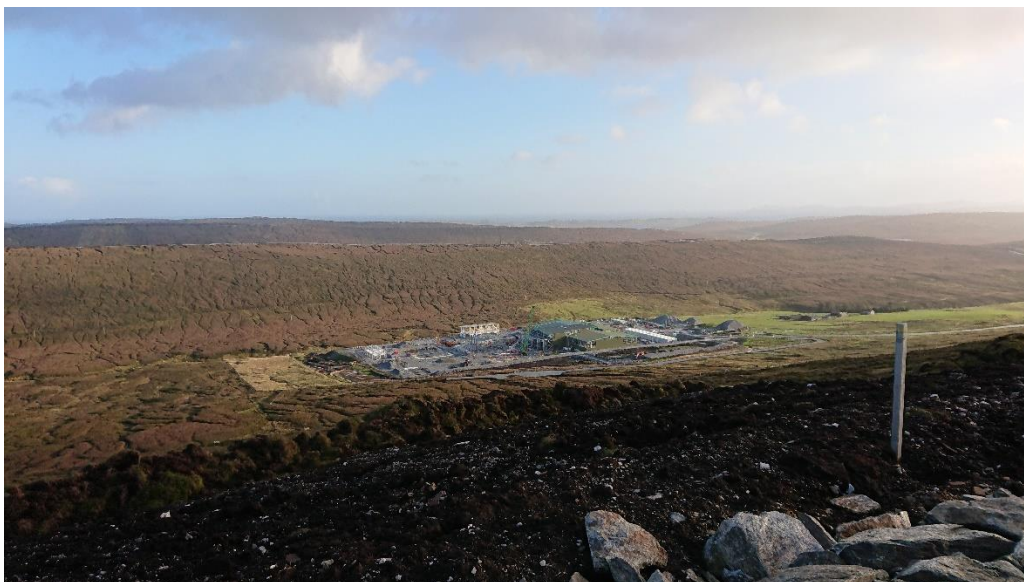
Foundation work for buildings within the Substation is ongoing with frame of the main building being constructed on the day of visit (Photo 12). Construction is in its early stage and activities will be audited in more detail during the future visits.

**Photo 12.** View towards substation under construction
