Intended for
Viking Energy Wind Farm LLP

Date
December 2021

Project Number
1620009158

VIKING ENERGY WIND
FARM
PLANNING
MONITORING OFFICER
AUDIT REPORT 014:
13TH NOVEMBER TO 15TH
DECEMBER 2021

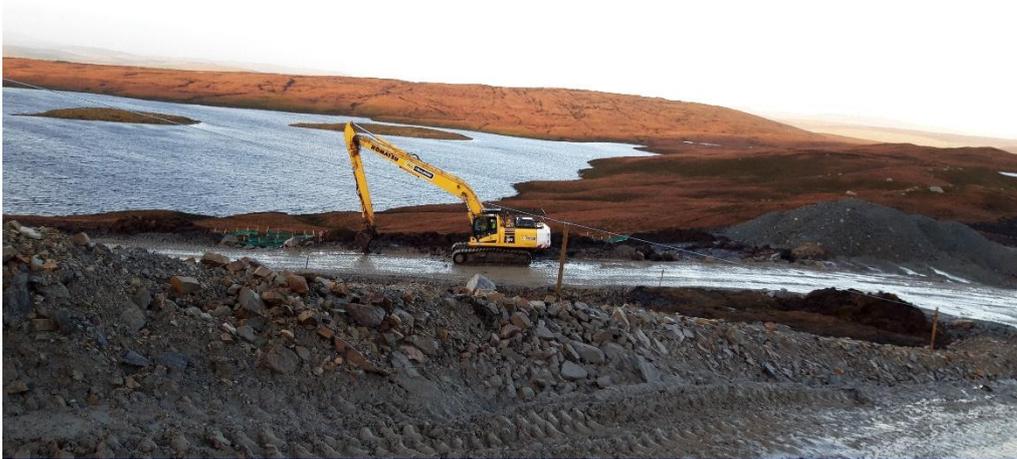
It was reported by the site representative that silty water had been observed as migrating off-site into Maa Water, bypassing existing mitigation measures. Following investigation the primary source of the water was identified to be a subsurface peat pipe. In order to mitigate any flow of silty water additional silt fencing was installed and a potential source for the peat pipe was identified. It is noted that this was not a reportable incident as the concentration of suspended solids was recorded as below the reporting threshold; however the incident has been recorded through the internal project controls. There has been regular contractor-led water quality field monitoring to ensure the discharge does not exceed licensed thresholds.

Photo 1. View of Maa Water from KBP03 and the peat reinstatement works.

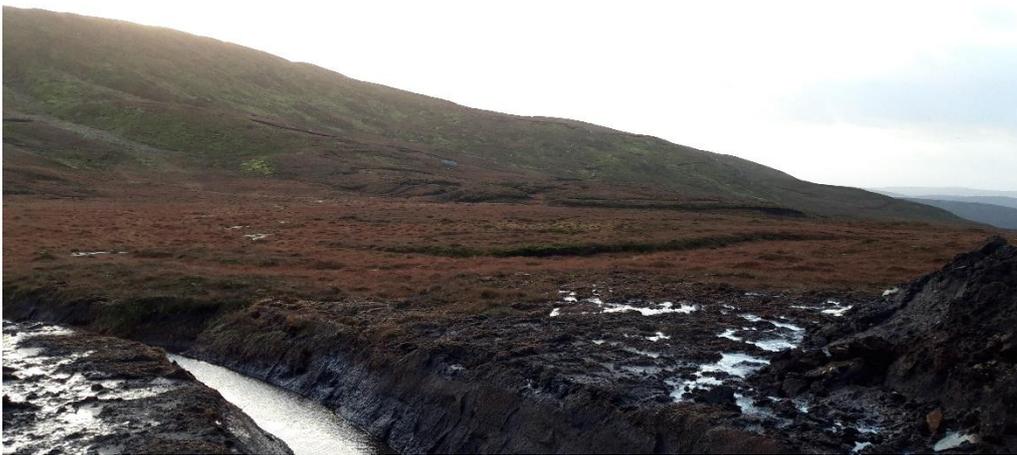
Water monitoring is undertaken across the site to ensure ongoing compliance, the most recent monitoring highlighted a decrease in the pH of water close to K50. The source of the decrease in pH is currently under investigation. Ongoing ECoW led field testing has confirmed that pH levels are normalising to baseline levels. The pH levels continue to be monitored twice per week and consideration is being given to placing soft limestone in the upper regions of Red Burn (a tributary to Burn of Lunklet) should low pH levels persist.

Photo 2. View of the upper catchment of Red Burn.

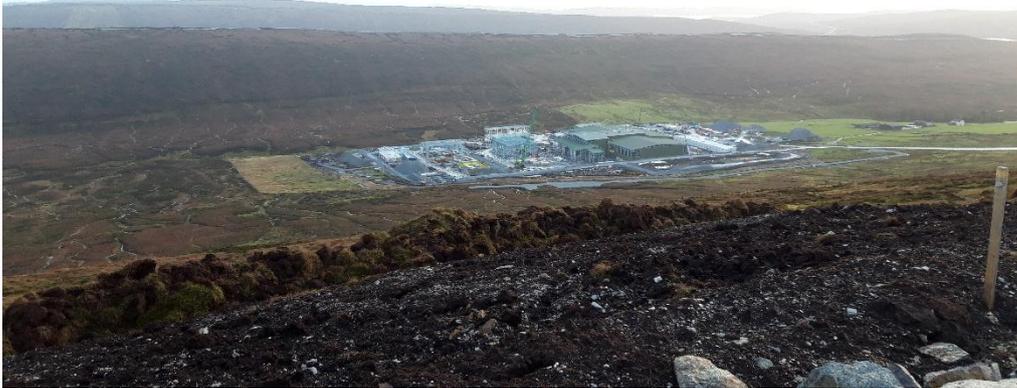
The substation site was not accessible during the audit, however progress was discussed overlooking the area. Construction is ongoing with steelwork installed and preparation for the installation of pre-cast elements.

Photo 3. Overview of construction at the converter station.

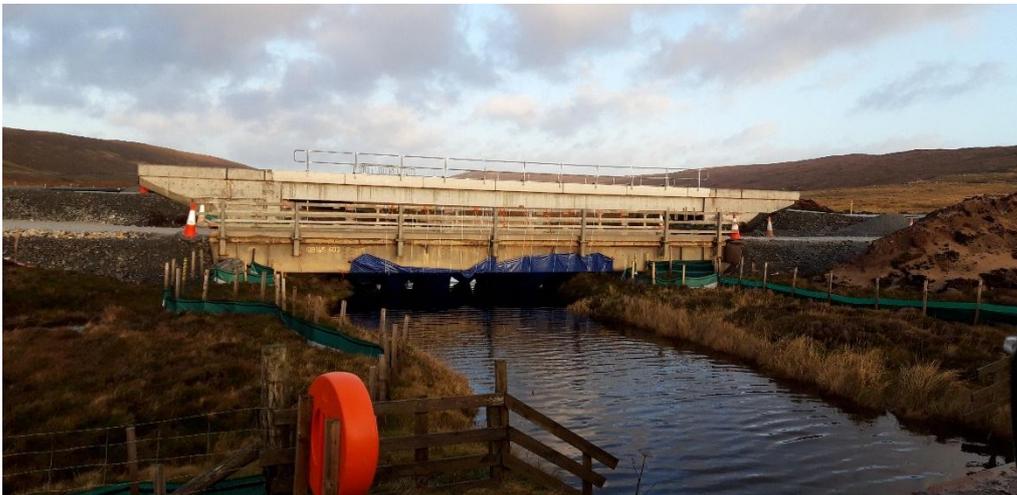
Photo 4. View of the additional sediment containment measures at Pettawater Bridge.

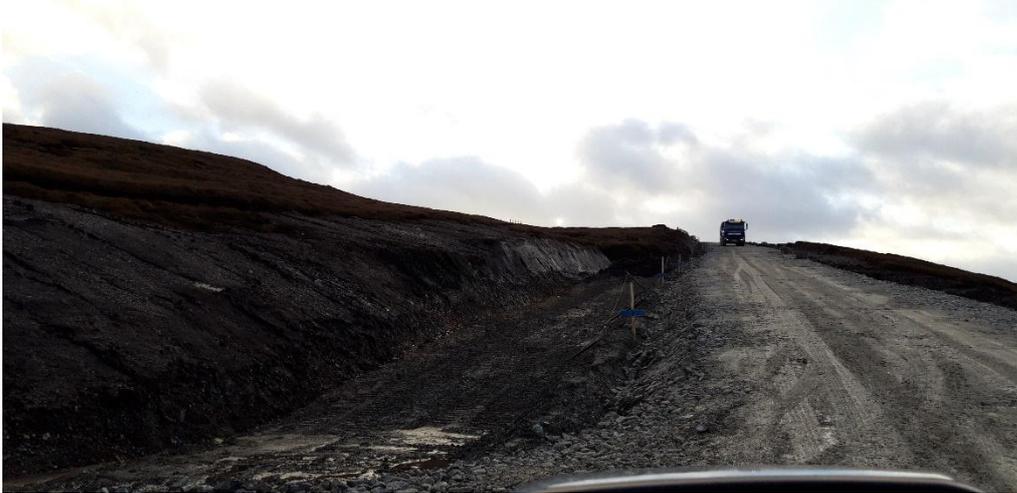
At the north end of Mid Kame Ridge preparatory works for cable installation have begun, with ditches excavated along the track boundary. The reinstatement of peat and turves along the track had been completed to a high standard. Additionally, the backfilling of bases also appeared to be good with K78 particularly noted as positive.

Photo 5. View of the excavation in preparation for cables to be installed on Mid Kame Ridge.

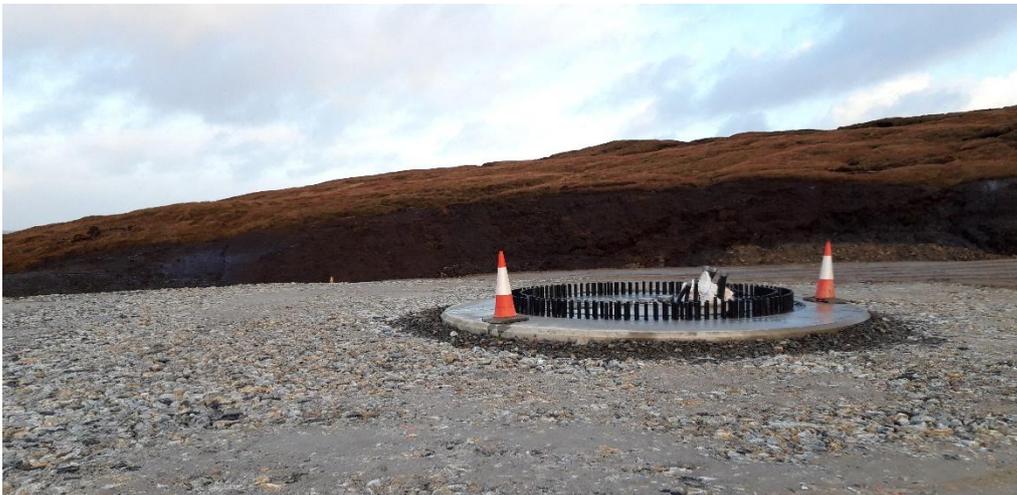
Photo 6. The completed base K78 which has been backfilled.

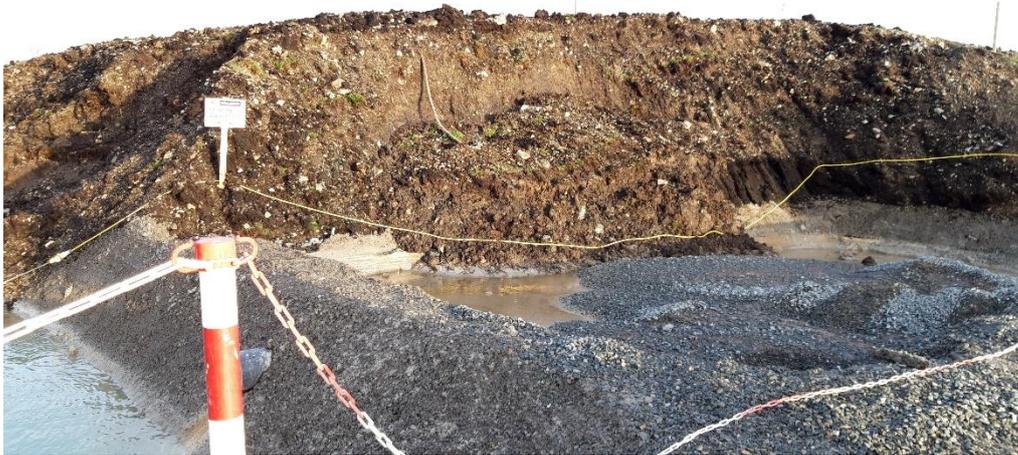
The primary concrete wash out area for the site is located at the North Compound, the area comprises three bunded ponds where solids are settled out of the wash and the pH is balanced to ensure the discharge does not present a pollution risk.

Photo 7. The settlement and balancing bunds used to clean concrete wash out.

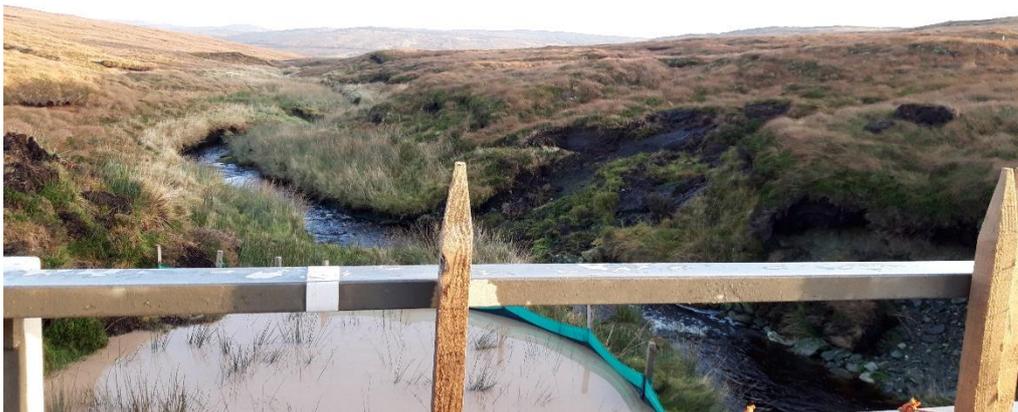
Track development has extended north to N127 and N128, with temporary drainage being installed to manage surface water during construction. The water crossing on Spur 24 (WC 19) was fitted with wood panelling to contain sediment; additionally, silt fencing had been installed around the water course to prevent sediment entering. Due to heavy rainfall on the previous day the silt trap required pumping out (noted to be scheduled prior to the Christmas shutdown), but the containment of silt had been maintained with no evidence of leaking into the water course.

Photo 8. The sediment containment measures around water crossing on Spur 24 are preventing sediment flow into the Burn.
