Viking Energy Wind Farm LLP

January 2022

1620009158

**VIKING ENERGY WIND
FARM
PLANNING
MONITORING OFFICER
AUDIT REPORT 015:
16TH DECEMBER 2021 TO
21ST JANUARY 2022**

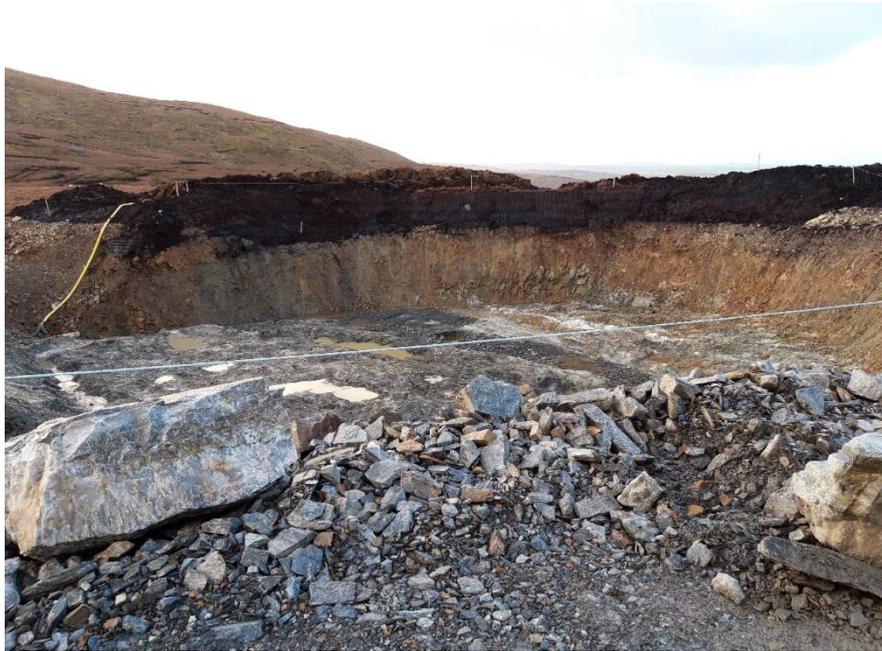
The construction of tracks and bases has continued across the arrays with tracks to K49, K71 and K72 remaining to be completed. The terrain at K49 is steep therefore a slower and more cautious approach has been undertaken to reduce risks. A cut off drain has been installed uphill of tracks towards K49 to provide preventative mitigation as excavation continues. The K50 turbine base has been re-excavated (Photo 1) to address concerns raised regarding drainage. Works will continue once sign off from all parties have been received.

Photo 1. K50 turbine foundation being re-excavated, awaiting approval on drainage system

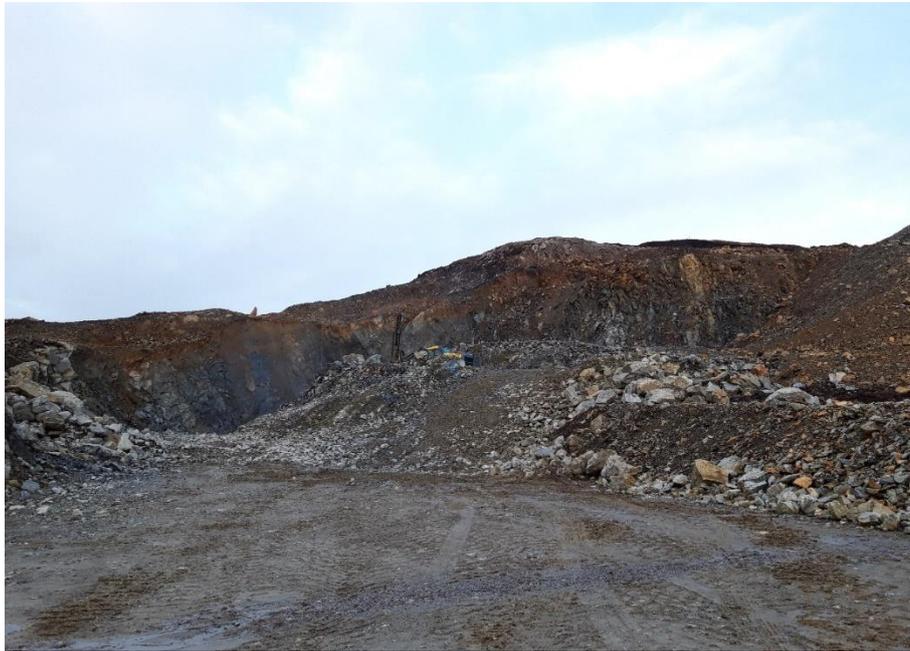
There was no work at KBP02 on the day of visit. Rock extraction at KBP03 and KBP05 is still ongoing. A drilling rig was in operation at KBP05 (Photo 3) in preparation for blasting the day after the visit. Turbine base work at K61 has been delayed as the turbine base is acting as a surface water settlement pond for run off from KBP03 (Photo 4). This is recognised as being evidence of a proactive approach to surface water management.

Photo 3. View of drilling rig in operation at KBP05 in preparation for blasting

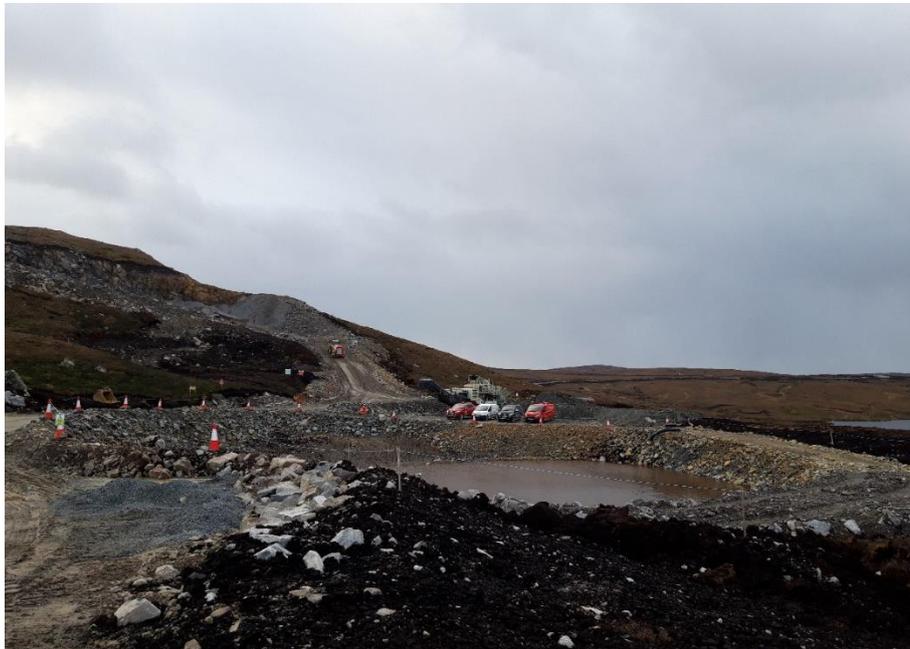
Photo 4. View of K61 turbine base and KBP03

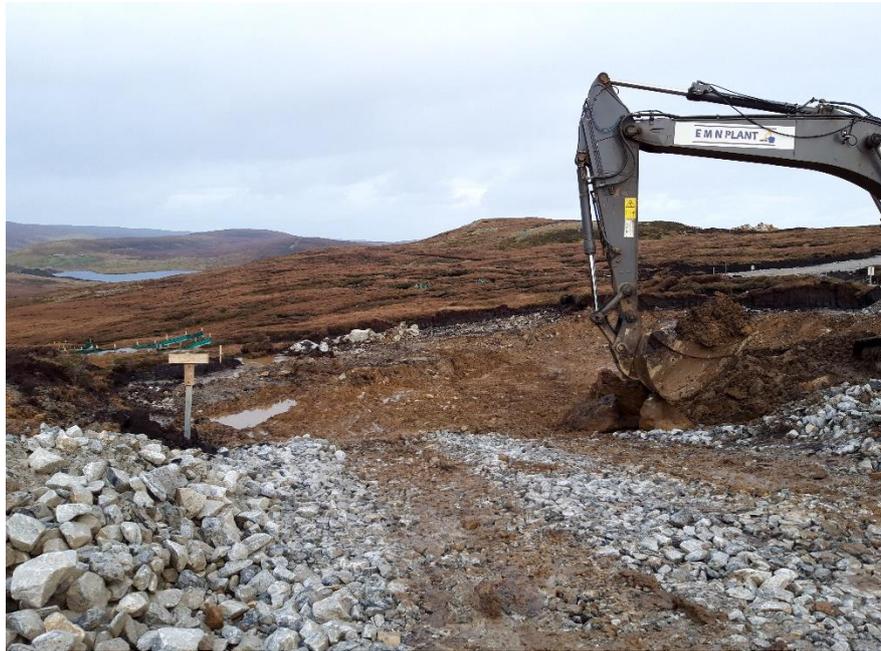
Construction had extended towards both N99 and N98 in the northeast and N109 in the south. Tracks within North Nesting are now all completed with turbine base and hardstanding excavation still to be completed. Excavation at N90 and N91 turbine bases was observed during the site visit (Photo 5). Ground Investigation has been scheduled at N90 turbine base at the end of January before further work can be completed.

Photo 5. View of works being done at N90 turbine base

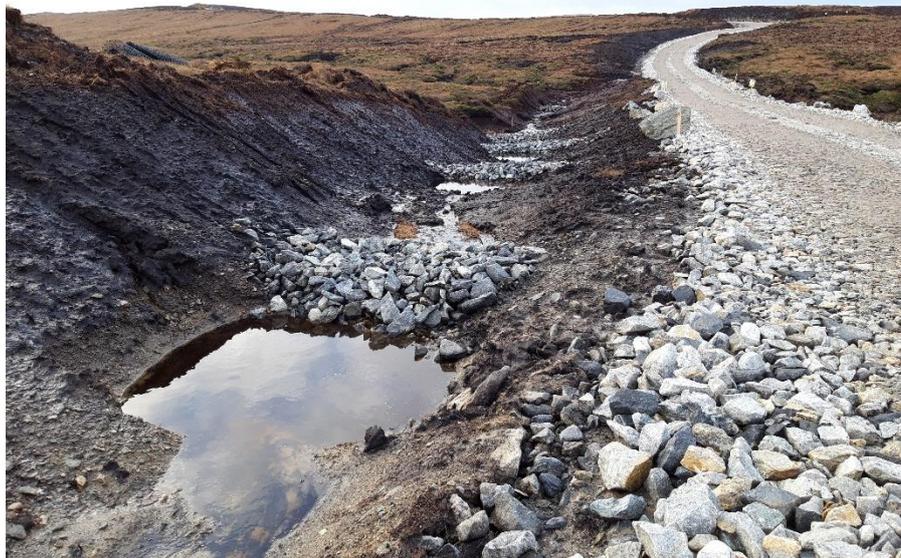
Track side ditches are being installed along constructed tracks. The check dams appear to be effective in slowing down the water and allowing sediments to settle in controlled areas. An example of a track side ditch was observed in more detail near N100 (Photo 6).

Photo 6. Example of roadside drainage system near N100 with check dams

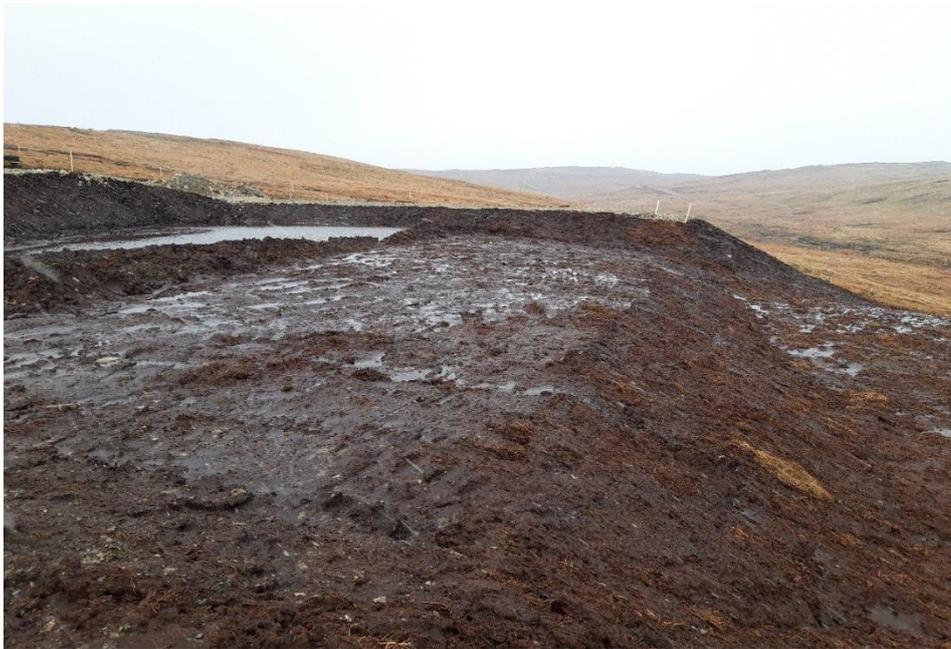
Tracks within Nesting are now all completed with turbine base and hardstanding excavation still to be completed. Additional bunding has been built between the N116 blade fingers to improve stability (Photo 7).

Photo 7. View from N116 southern blade finger onto northern blade finger and additional bunding in between

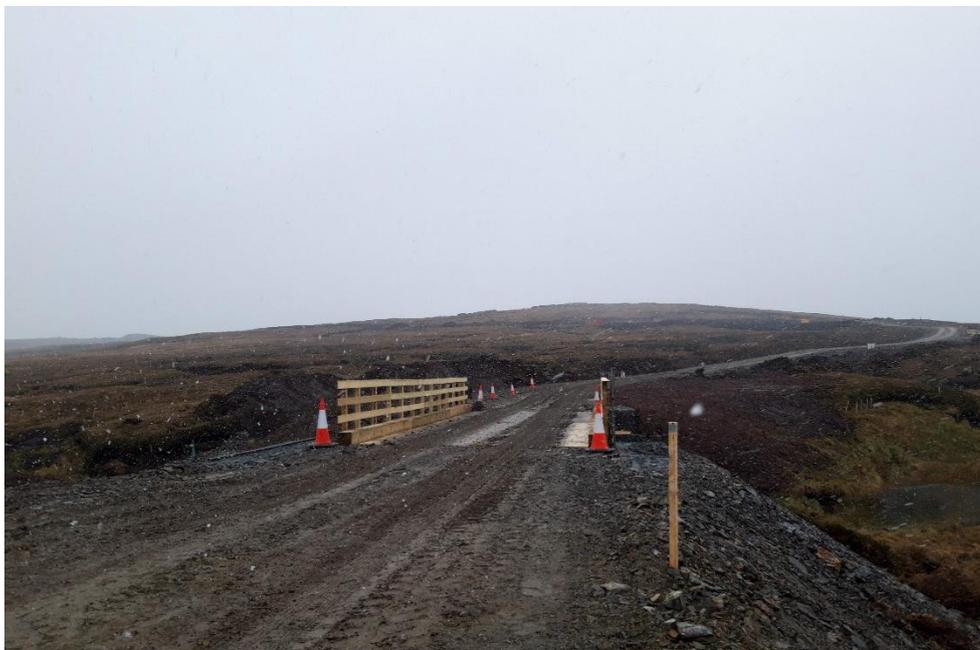
At watercrossing 19, the permanent bridge is now operational (Photo 8) and the temporary bridge decommissioned. During the visit, reinstatement work along the banks where the temporary bridge used to sit were observed. Reinstatement works included building a temporary pond for water run off from the track uphill of the watercourse (Photo 9).

Photo 8. View of permanent bridge at WC19

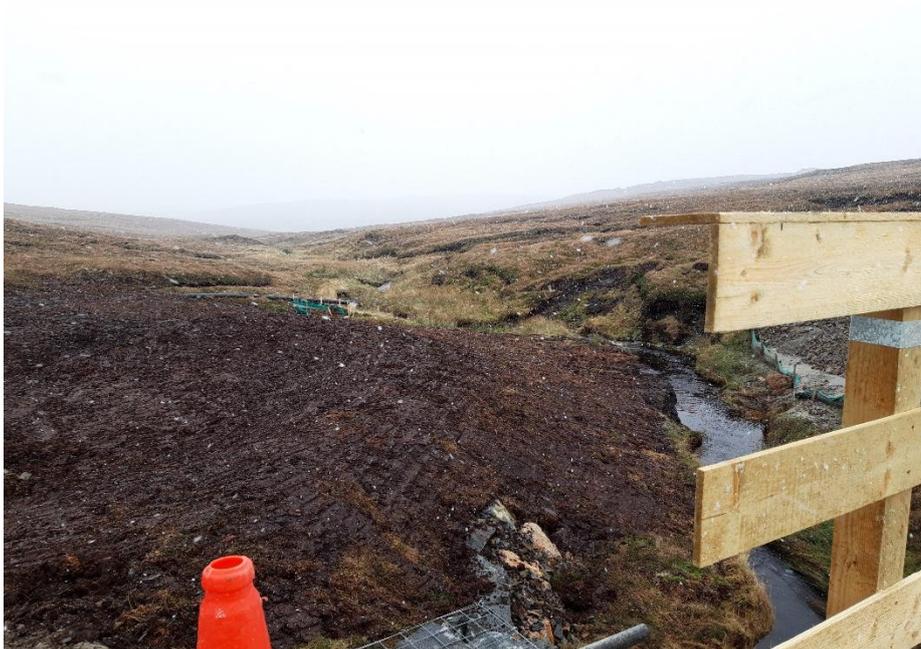
Photo 9. View of landscaping work by WC19 where temporary bridge used to be

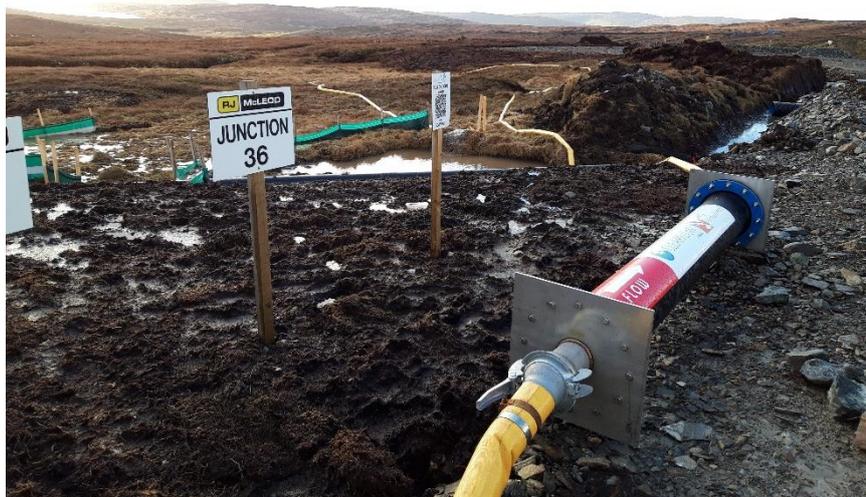
Following the track completion, new drainage has been installed between N132 and N137. To contain the water overflowing from the tracks, additional measures (over and above the typical track side ditch and check dams) have been put in place on Spur 29, Junction 36. Water from the culvert pipe will flow into a settlement pond which is then extracted by a water pump with reactor (Photo 10). The reactor accelerates sediment separation and usage has been approved by SEPA. Water from the water pump reactor will then be released into another settlement pond and then multiple layers of silt fencing (Photo 11).

Photo 10. View of drainage system at Junction 36: Culvert pipe, water pump with reactor and settlement pond

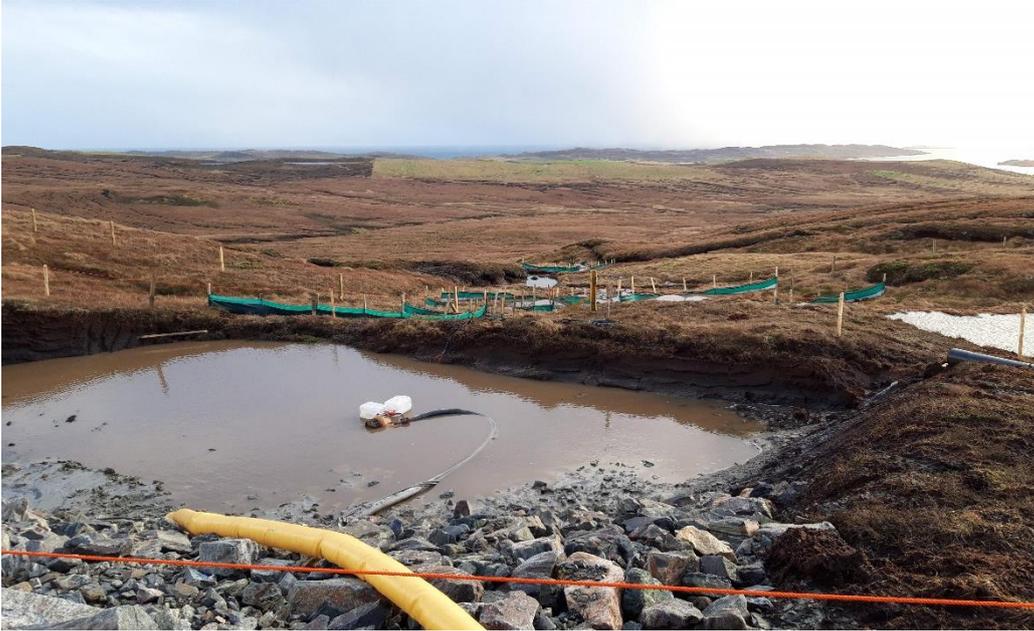
Photo 11. View of drainage system at Junction 36: Settlement pond and silt traps

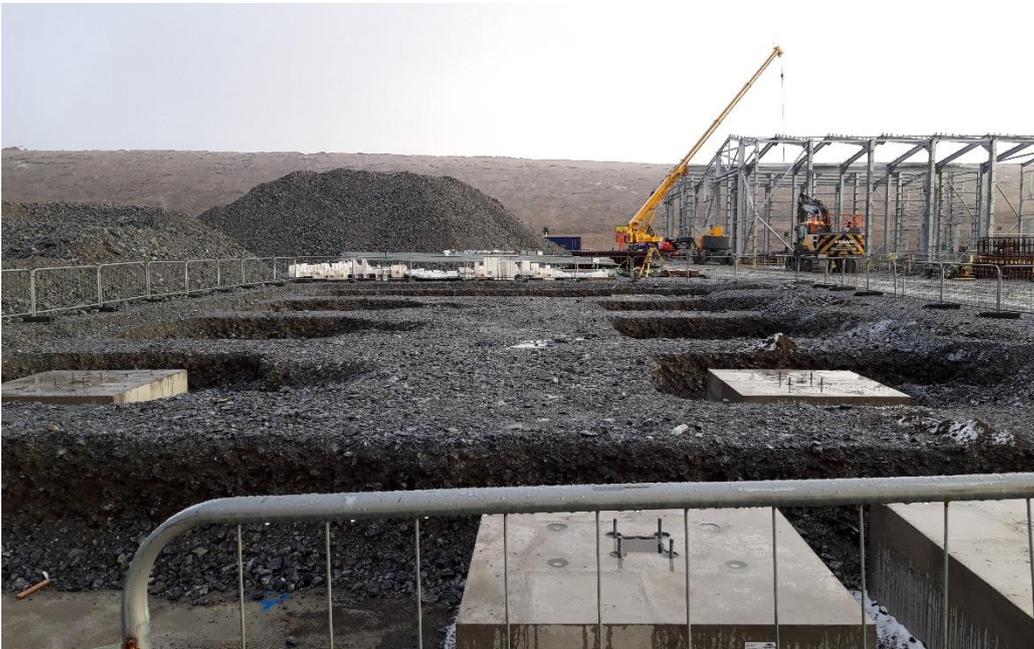
Installation of the steel frame of three buildings (the main substation building, GT1 and GT3) within the substation area has begun. Foundation work for all of the remaining buildings (GT2, GT4 and Welfare Building) is ongoing (Photo 12). On the day of visit, concrete was to be poured into one of the building foundations.

Photo 12. View of substation under construction
