Date
February 2022

Project Number
1620009158

**VIKING ENERGY WIND
FARM
PLANNING
MONITORING OFFICER
AUDIT REPORT 016:
22ND JANUARY 2022 TO
16TH FEBRUARY 2022**

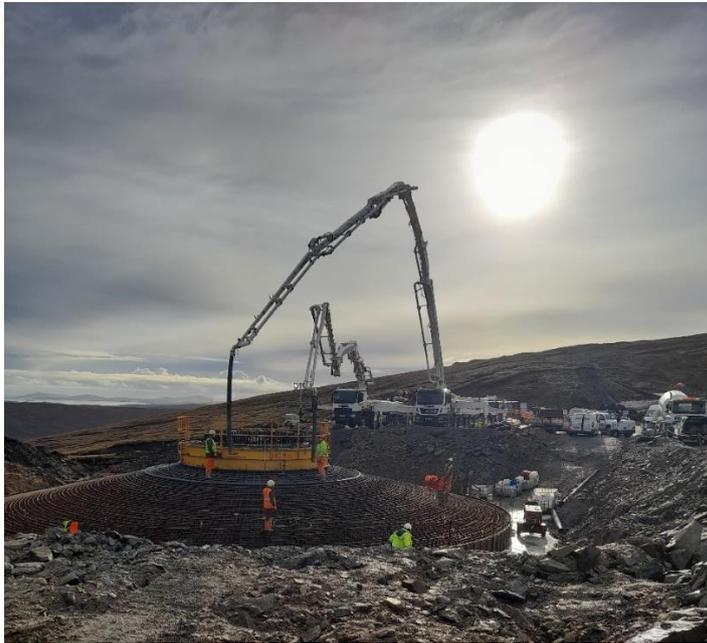
Activities in this area during the audit included progression of access tracks and concrete pouring at turbine base K43 (see photo 1).

Concrete pouring was ongoing at turbine K43 during the audit (photo 1).

Photo 1. K43 turbine foundation concrete pour in progress

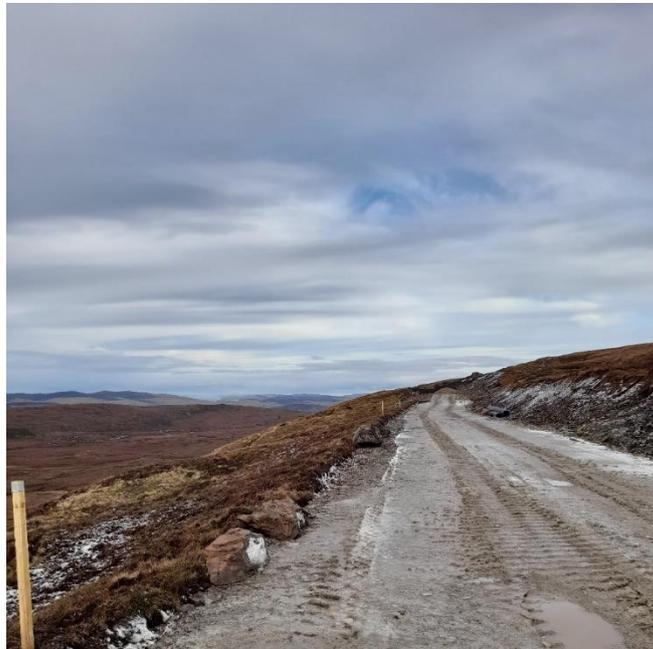
The construction of track to K49 was observed to be underway (photo 2). The terrain at K49 is steep therefore a slower and more cautious approach has been undertaken to reduce risks. A cut off drain has been installed uphill of tracks towards K49 to provide preventative mitigation as excavation continues. Ground and vegetation reinstatement on the low side of the track was noted to have been completed as work progresses (see photo 2).

Photo 2. View of track construction to turbine K49

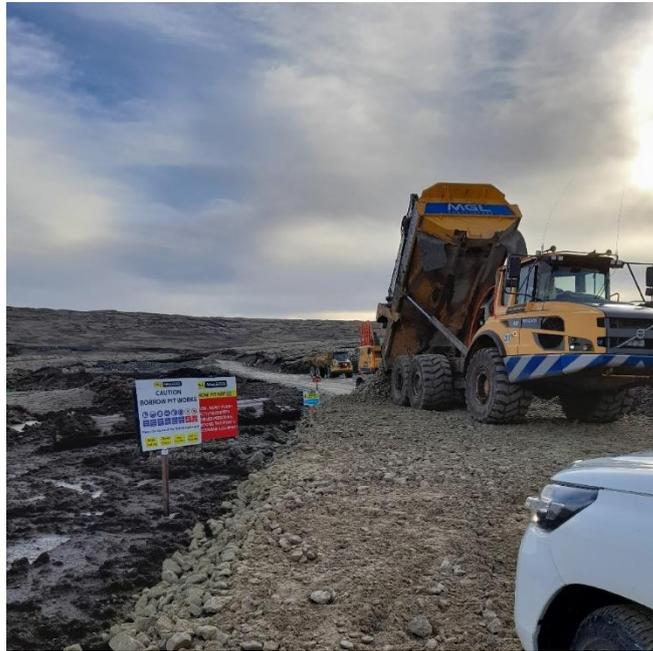
Photo 3. Track construction at N95

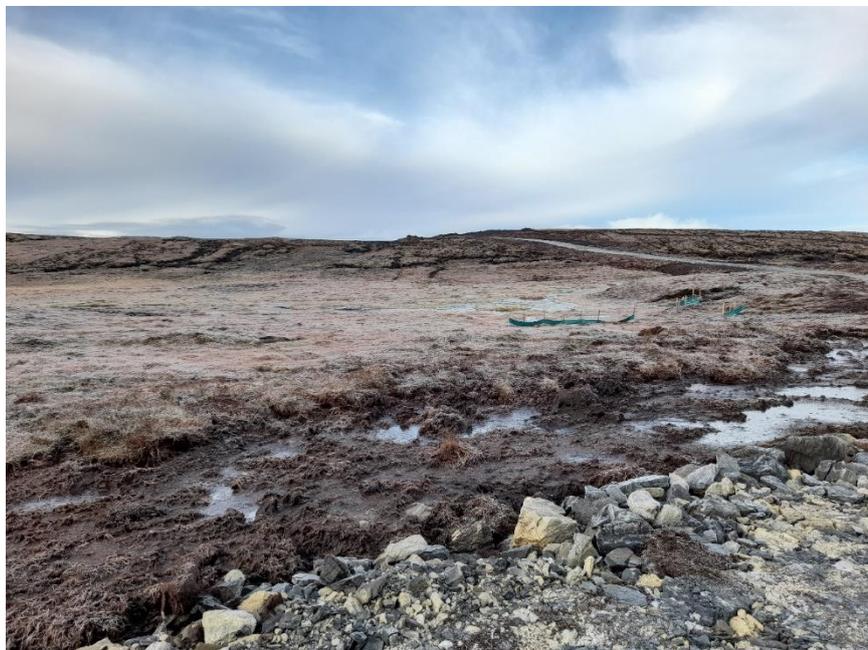
The PMO observed the area of good quality wetland habitat between N104 and 105 which was preserved by micrositing the wind farm track to avoid impacts on this area (photo 4)

Photo 4. Wetland avoidance using micro-siting between N104 and N105

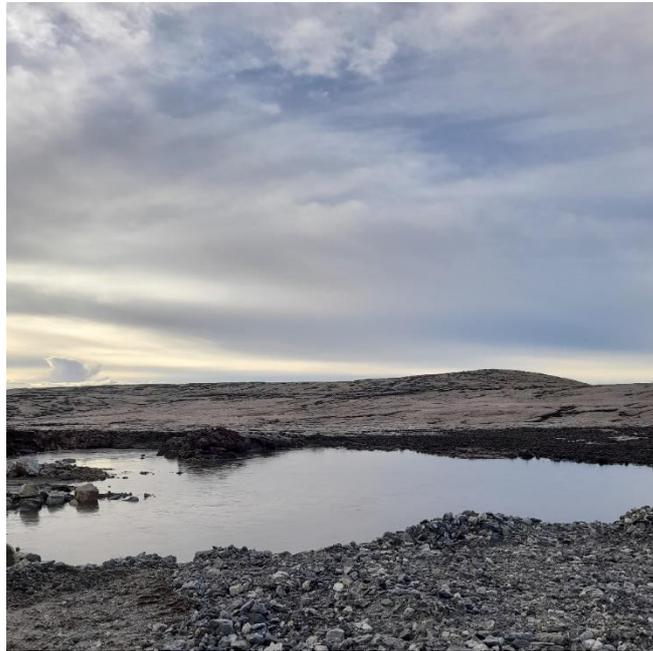
The active peat restoration was observed at P12 (near N101) on the day of visit (photo 5).

Photo 5. View of peatland restoration at P12 (adjacent to turbine N101)

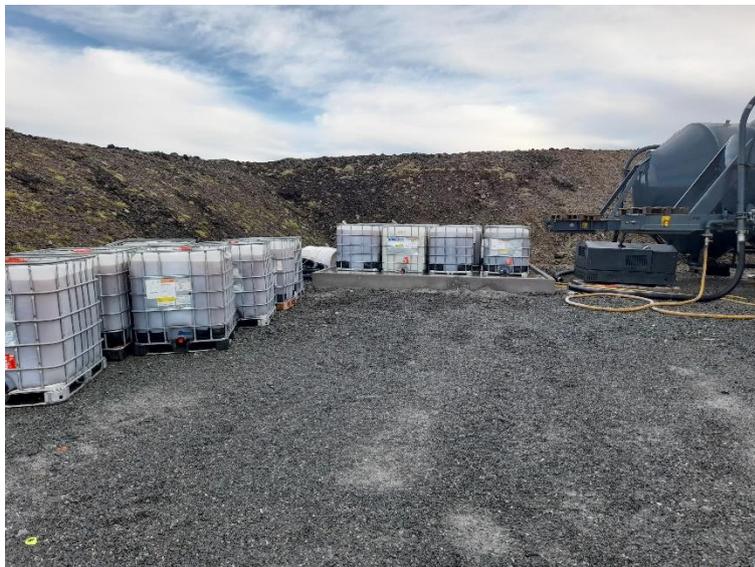
It was noted during the inspection of the batching plant that some IBCs of concrete admixture were stored off the concrete bunded area (photo 6). The PMO understands that since the audit the concrete admixture has been used and moving forward IBCs will be stored on the hardstanding unless in use. Rainwater was noted to have accumulated in the bund, which may compromise the storage capacity for the IBCs stored in the bunded area.

Photo 6. IBCs with concrete admix exceed capacity of storage area

Materials Storage and Handling (e.g. oil/fuel storage and peat/mineral soil storage and handling).	<p>PMO observed some chemicals stored outside of the bunded areas in the batching plant (contrary to the CEMP). The PMO received confirmation following the audit that the issue has now been resolved.</p> <p>PMO observed non-compliance with waste management plan. A special waste skip and/or clearer labelling of skips is required.</p>	Move materials to approved storage location	Principal Contractor	Yellow
Natural and Built Environment (e.g. ecology, biosecurity, protected sites, archaeology and site restoration).	Ecological constraints identified by the ECoW team are communicated to the Principal contractor and Developer to allow mitigation measures to be implemented and rescheduling of preparatory and construction work as required.	No action required.	N/A	Green

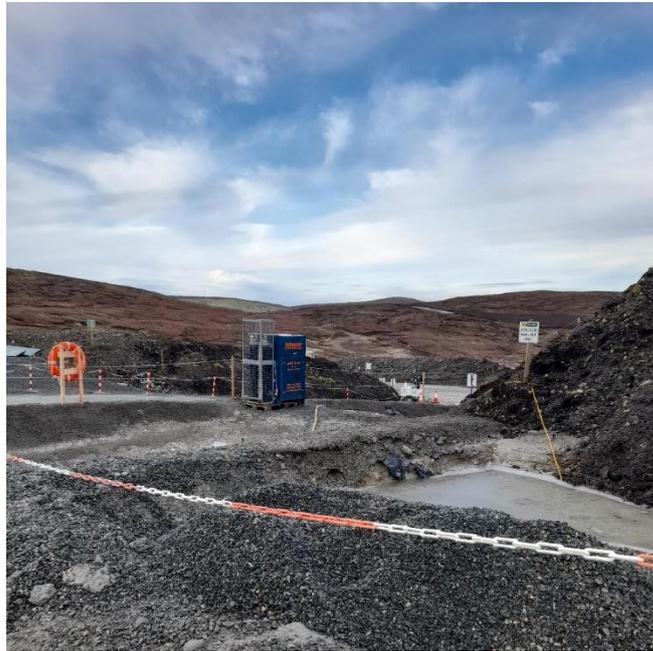
The concrete washout was inspected. It is noted to be provided with an automated 'siltbuster' pHD CO2 pH treatment skid. Water levels in the washout were low on inspection (photo 7).

Photo 7. Concrete washout at batching plant

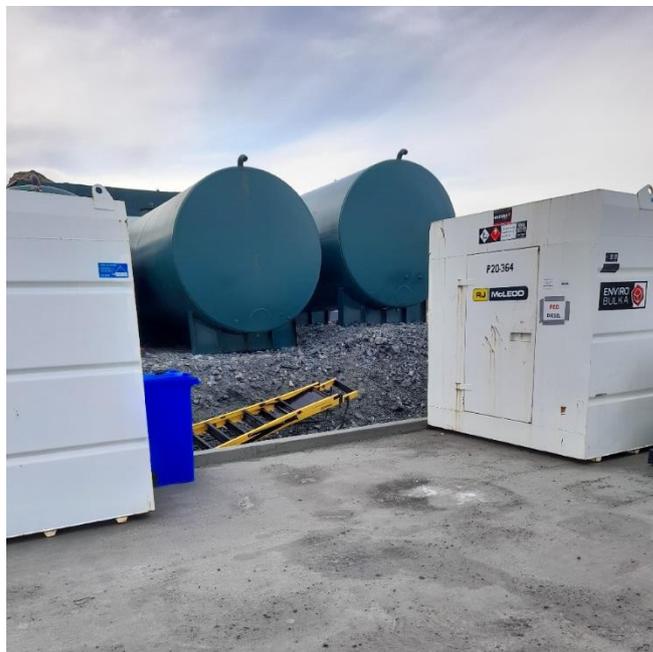
The fuel storage at the compound was noted to be in good order, with spill kit provided (photo 8).

Photo 8. Batching plant fuel storage and spill kit

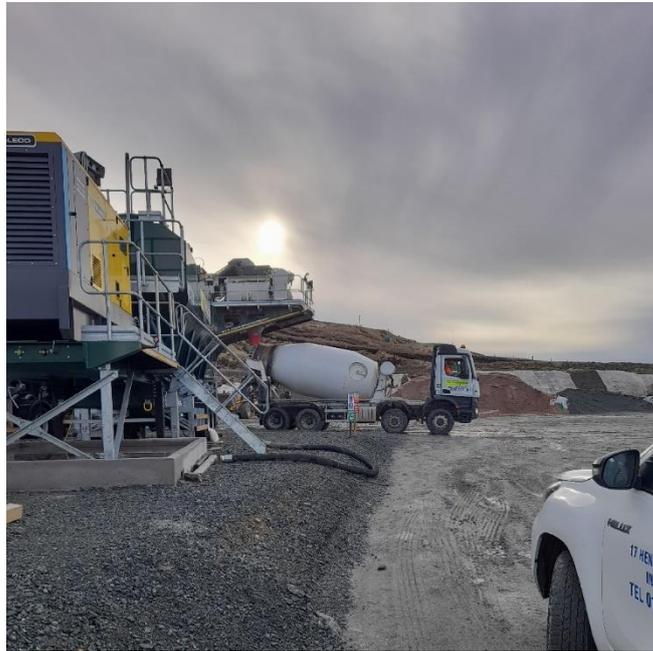
Photo 9. Batching plant in operation

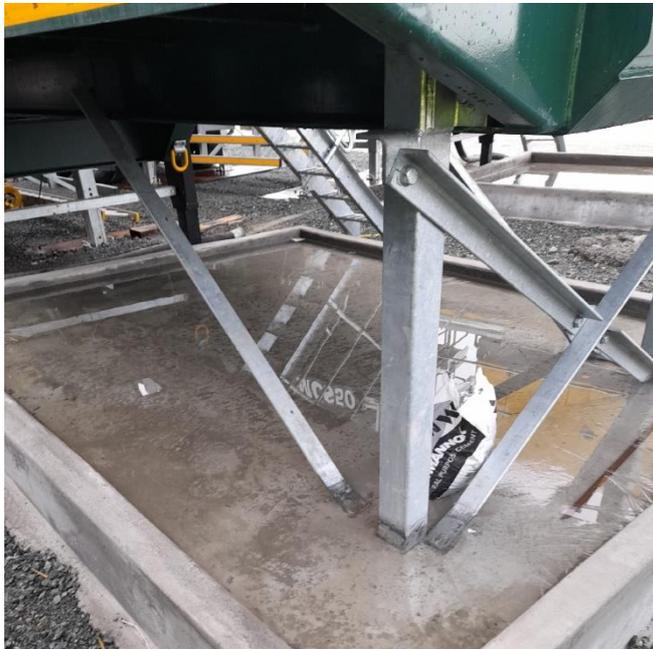
Photo 10. Rainwater accumulation in bund

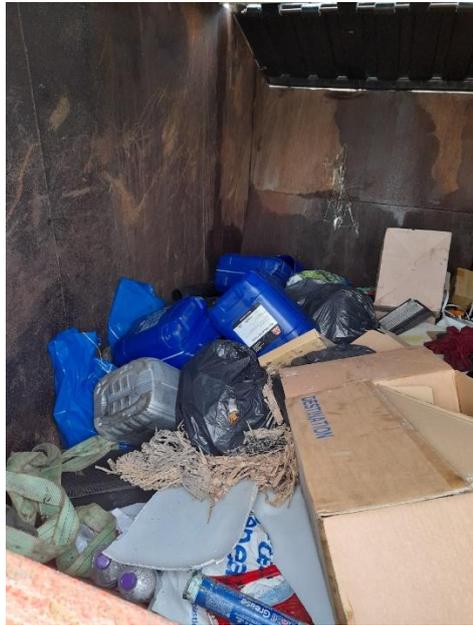
On inspection of the waste skips in the North Compound it was noted that there was no clear labelling of the skips. One of the skips was noted to contain some waste plastic oil containers which would need to be treated as special waste. The RJM representative noted that improved signage to support on-site segregation or a dedicated special waste skip would need to be provided (photo 11).

Photo 11. General waste – require separate skip for oily waste

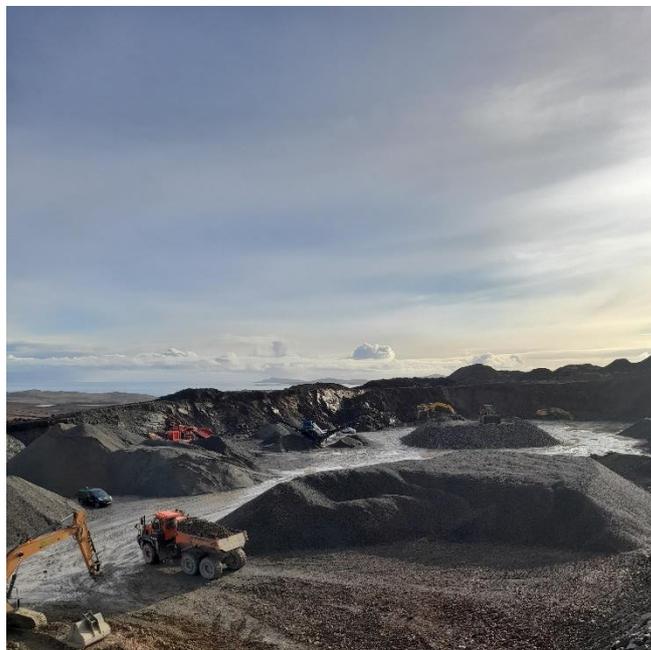
Photo 12.

The PMO observed the continuing rock extraction and crushing at NBP05 (photo 12), with various 'products' being stockpiled for use in cable laying, tracks and concrete production.

Overview of operations at NBP05
