Intended for
Viking Energy Wind Farm LLP

Date
April 2022

Project Number
1620009158

VIKING ENERGY WIND FARM PLANNING MONITORING OFFICER AUDIT REPORT 018: 19TH MARCH 2022 TO 15TH APRIL 2022

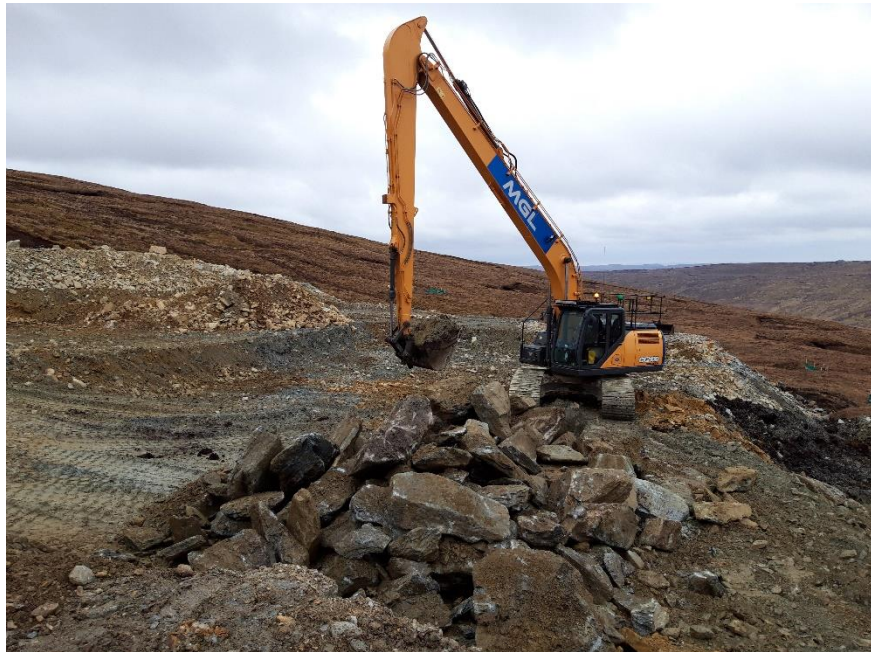
The construction of tracks and bases has continued across the arrays with steelwork and concrete pouring ongoing. Installed drainage measures are of good quality and preventative mitigation will continue to be installed as turbine base and hardstanding excavation continue. Additional bund support is being added between the blade fingers of K51 (Photo 1) and additional culvert installed as preventative mitigation (Photo 2).

Photo 1. Additional bund support between K51 blade fingers.

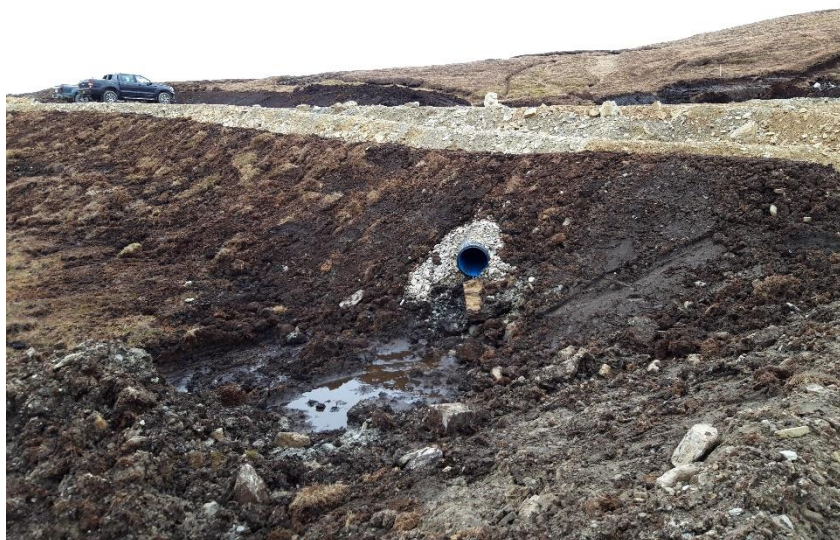
Photo 2. Additional culvert installed at K51

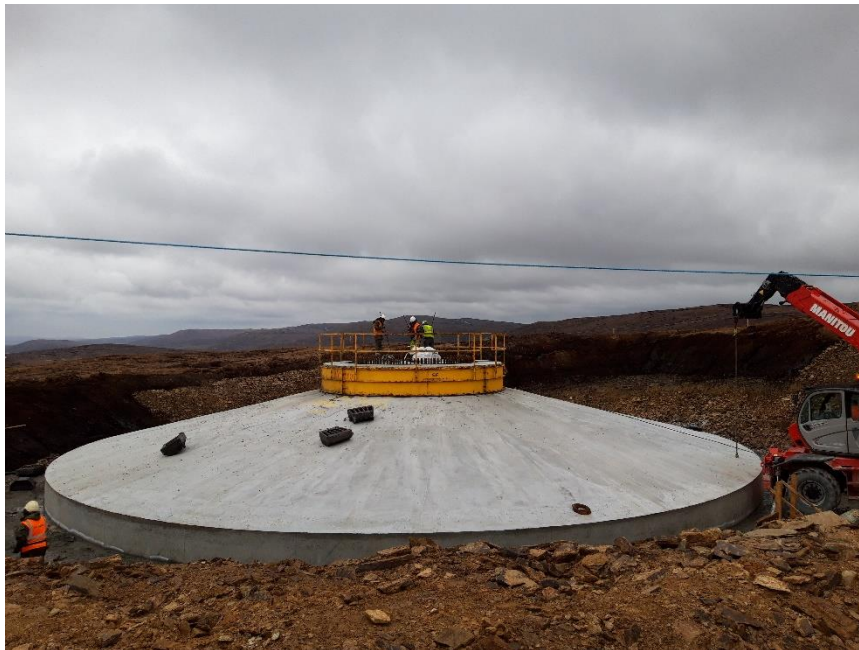
Steel rebar fixing has been completed at K75 and K77 with concrete pouring completed at K50, K63, K64, K66, K69, K70, K73 and K75. The PMO observed shuttering being removed at K75 (Photo 3) after concrete pour and backfill preparation at K52.

Photo 3. View of shutter removal in progress at K75

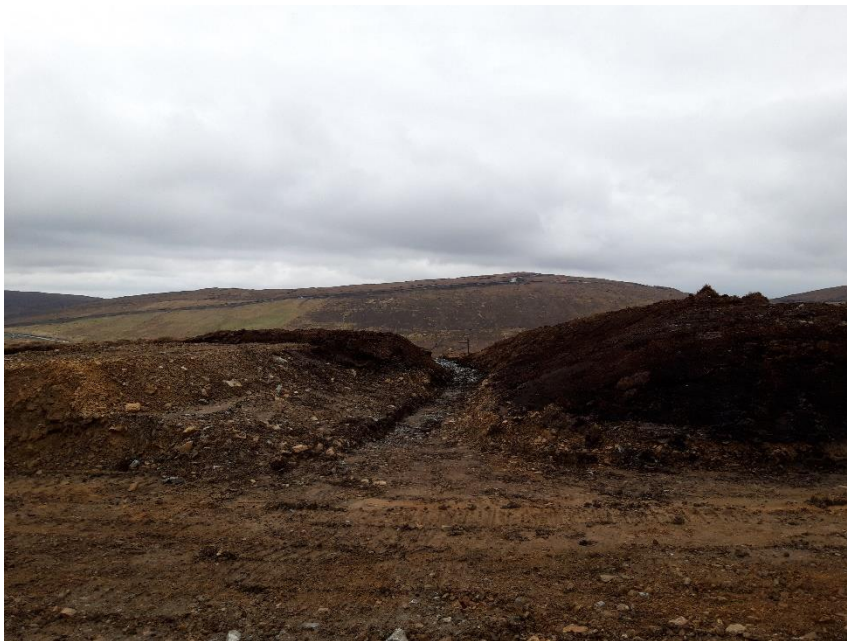
Cable trench excavation on MKR including landscaping and drainage installation (Photo 4) ongoing in preparation for cable laying activities planned for the end of the month. Cable drums and "Whin-Dust" (fine gravel for cable bedding) have been stockpiled along the route.

Photo 4. View of cable trench drainage at K85

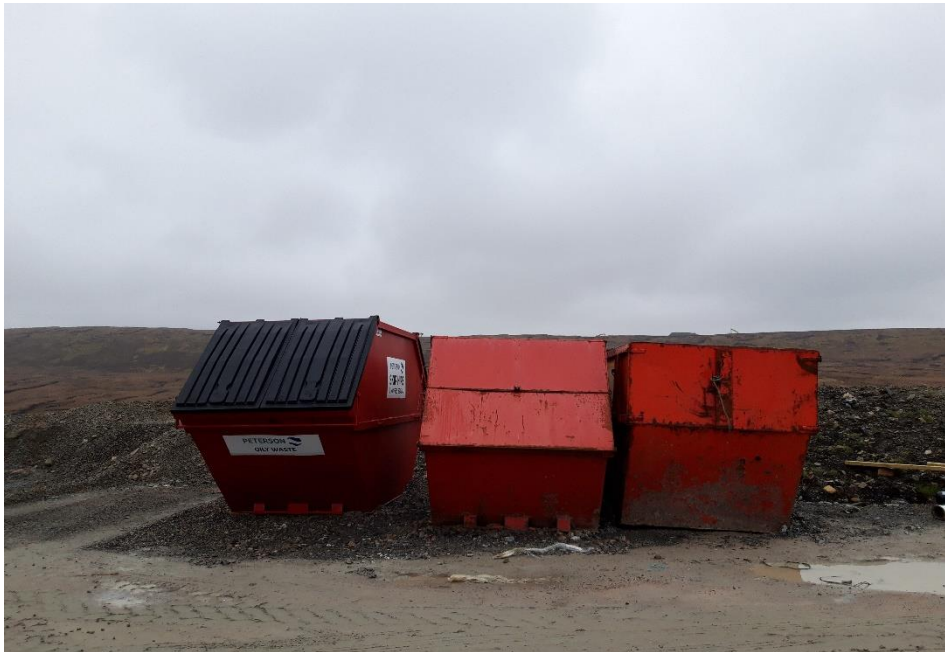
On inspection of the waste skips in the North Compound, it was noted that there was no consistency in labelling of the skips. One of the skips was labelled on the front, one was labelled on the back and one was without a label (Photo 5). Wood was also left on the floor by the skips (Photo 6). The Developer and PMO both agreed that a wood waste skip would need to be provided.

Photo 5. Inconsistent waste skip labelling at North Compound

Materials Storage and Handling (e.g. oil/fuel storage and peat/mineral soil storage and handling).	PMO observed non-compliance with waste management plan. A wood waste skip is required at the North Compound and clearer and more consistent labelling of skips are required in North Compound and Substation.	Move materials to approved storage location and provide clearer labelling	Principal Contractor	Amber
Natural and Built Environment (e.g. ecology, biosecurity, protected sites, archaeology and site restoration).	Ecological constraints identified by the ECoW team are communicated to the Principal contractor and Developer to allow mitigation measures to be implemented and rescheduling of preparatory and construction work as required. These are also marked out by poles on the site and included on ecological sensitive plans issued to the Principal contractor.	No action required.	N/A	Green

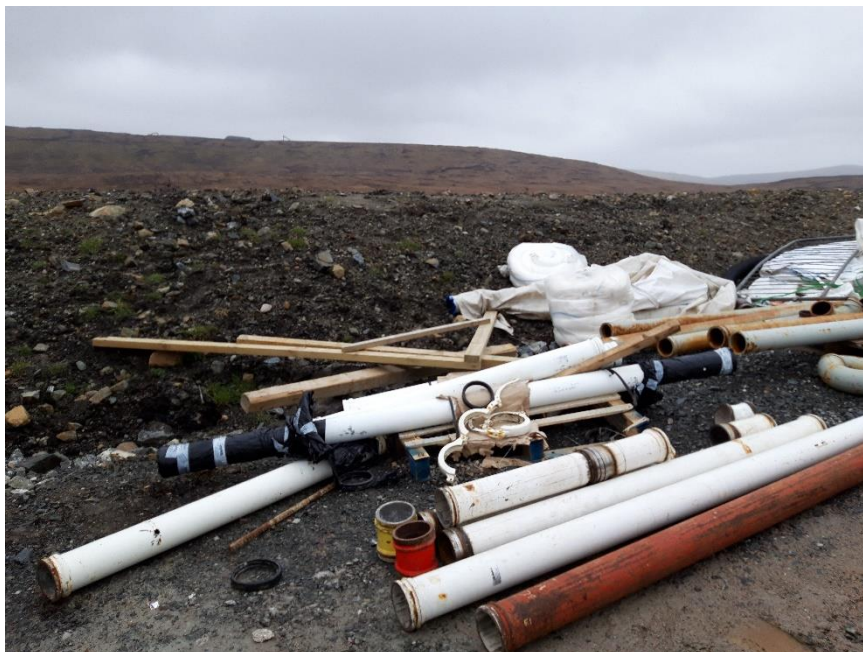
Photo 6. Wood waste between pipe storage by waste skip at North Compound

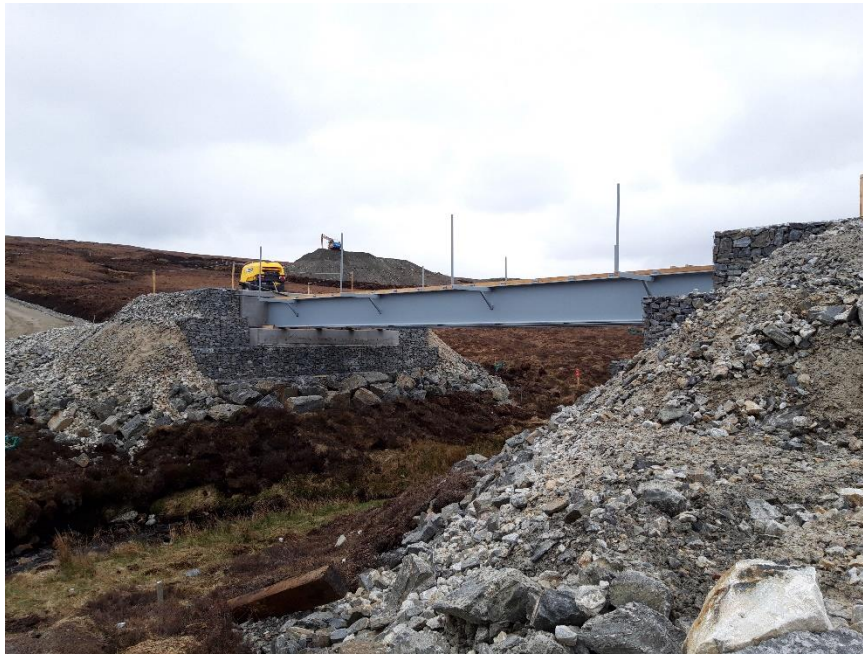
At water crossing 15 (WC15), the permanent bridge construction has continued with the steel base installed (Photo 7).

Photo 7. Permanent bridge steel base installation at WC15

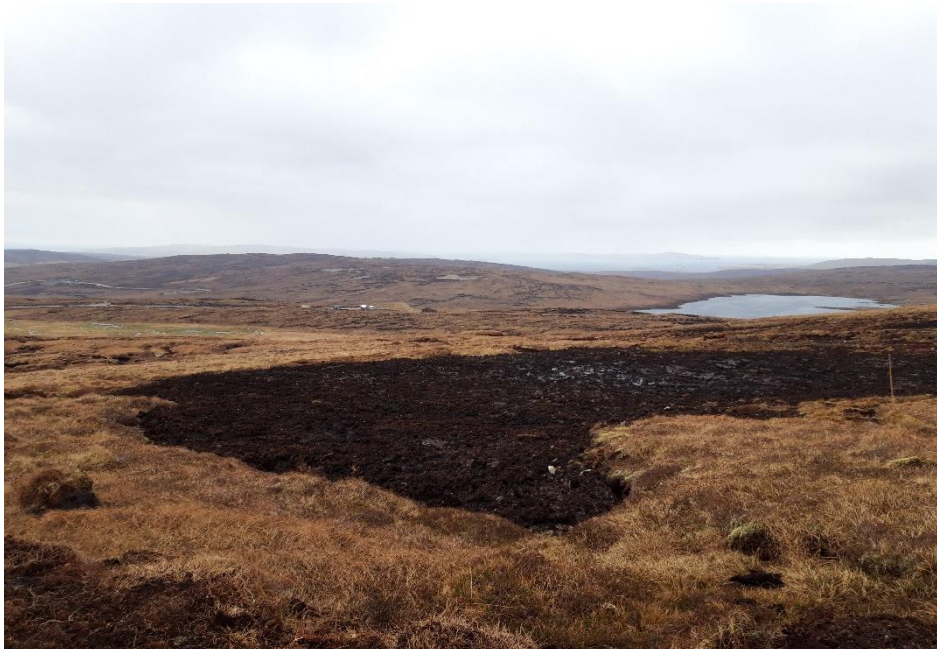
The deposition of peat to area P17 (Phase 1) has been completed (Photo 8) and is being reviewed by the ECoW and GCoW to identify any ecological, drainage or stability issues that are required before Phase 2 and seeding works commence.

Photo 8. View of Peat Restoration Area P17a

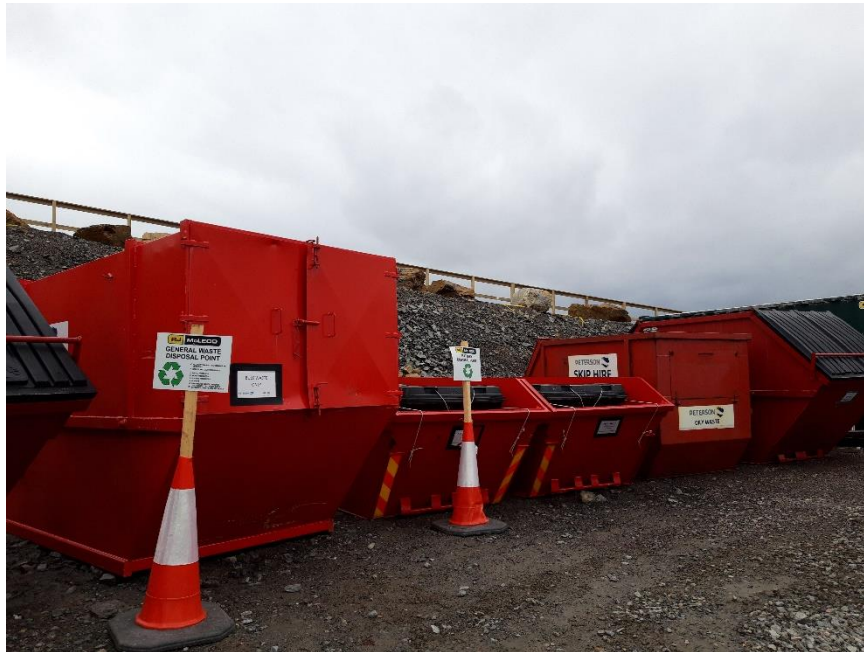
The car parking, site offices and welfare facilities are functioning well. All materials are stored according to regulations. No evidence of leaks or staining was observed in the vicinity of the store. All waste skips are clearly labelled (Photo 9).

Photo 9. Clear waste skip labelling at Main Compound

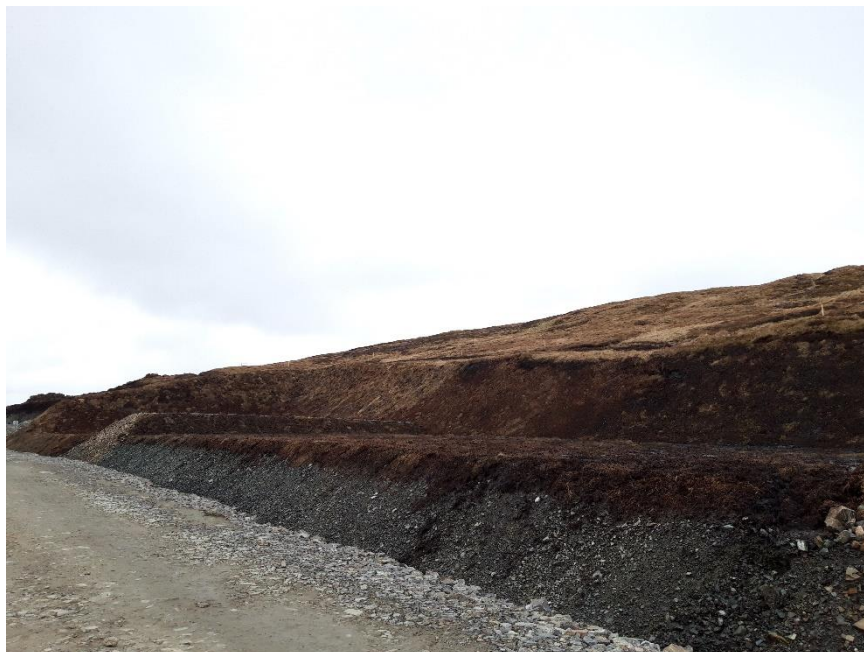
Photo 10. Track side reinstatement near N137 in good condition

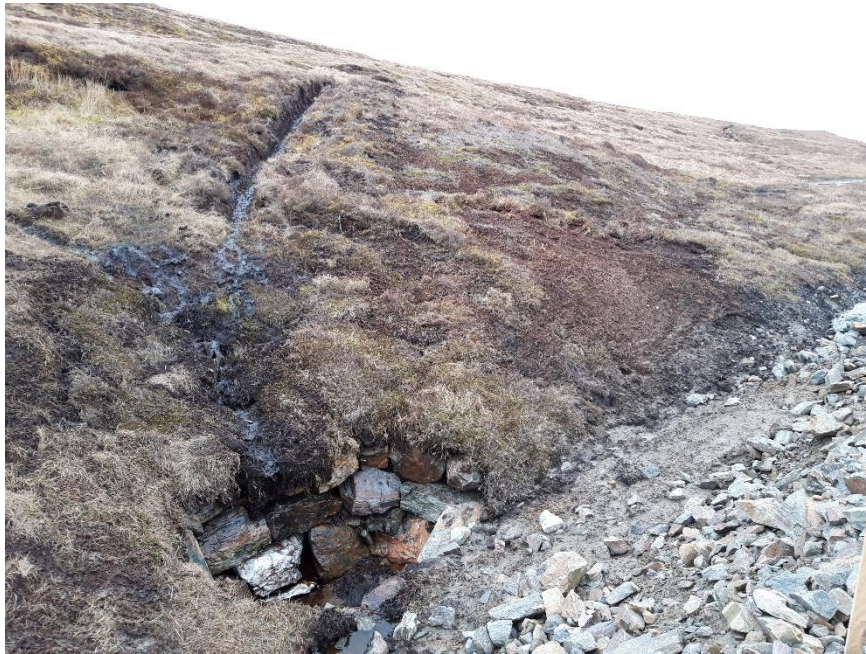
Cable trench excavations are ongoing in Nesting in preparation for cable laying activities. The Principal Contractor is ensuring that permanent drainage is installed prior to the laying of cables and while doing so ensuring that temporary drainage for the open cable trenches does not impact on the permanent systems being installed. N137 was noted as a positive example. The PMO observed that the track side reinstatement near N137 is in good condition (Photo 10). The clean water system installed is also in good condition, with large rocks used to reinforce the stability of the clean water inlet (Photo 12) and outfall channel and silt traps also in good condition.

Photo 11. Inlet of clean water system at N137

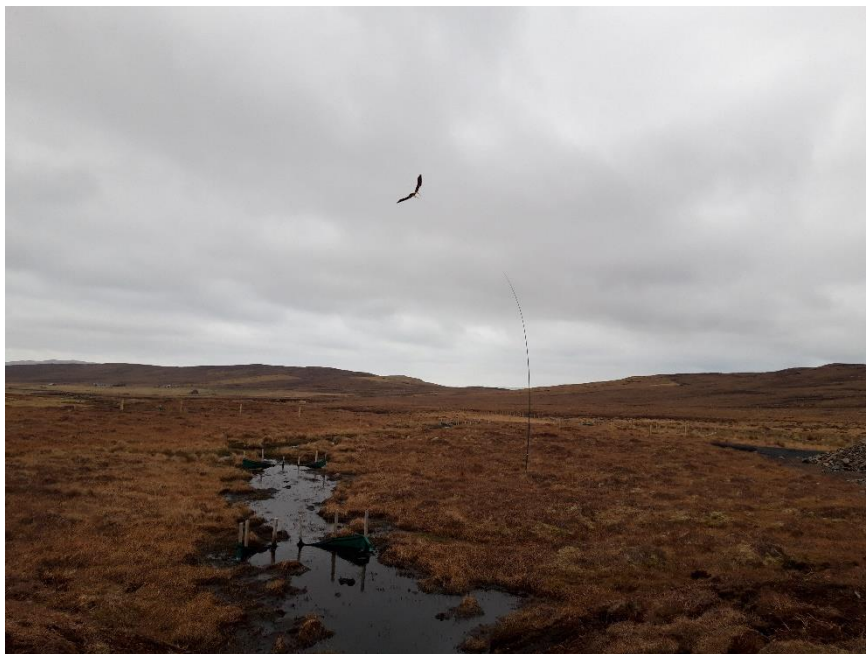
Photo 12. New bird diverter, 'Bird Scarer Kite' installed along tracks

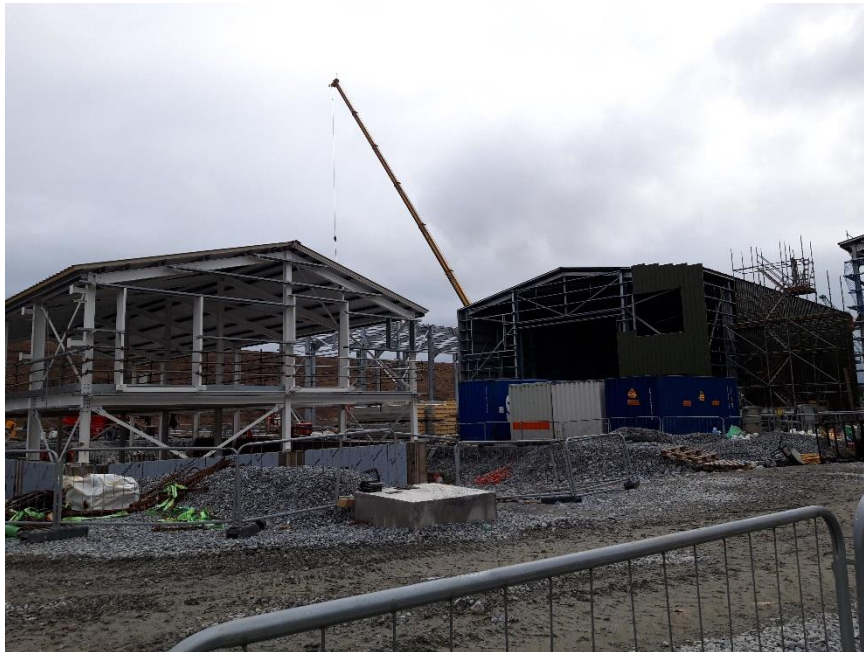
Roof cladding works have been completed on three buildings with wall cladding nearly complete on one of the three (Photo 13). For the remaining three buildings within the substation, secondary steelworks are ongoing for two of the buildings and pre-cast wall are being poured for the final building.

Photo 13. Completed roof cladding on two of the buildings in the substation area

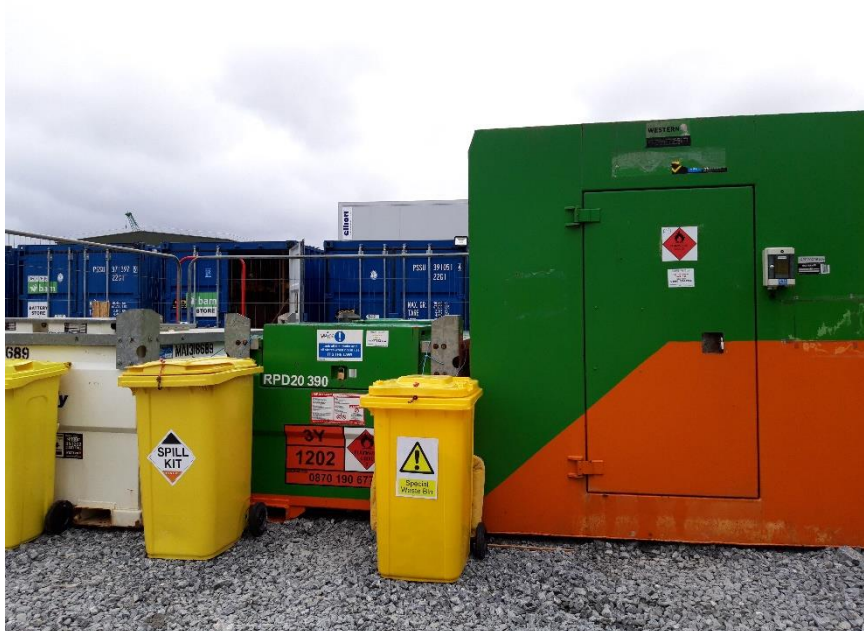
The fuel storage at the substation was noted to be in good order, with spill kit provided (Photo 14). The waste skips at the substation are mostly well labelled with one skip without a label (Photo 15).

Photo 14. Fuel storage at substation with spill kit

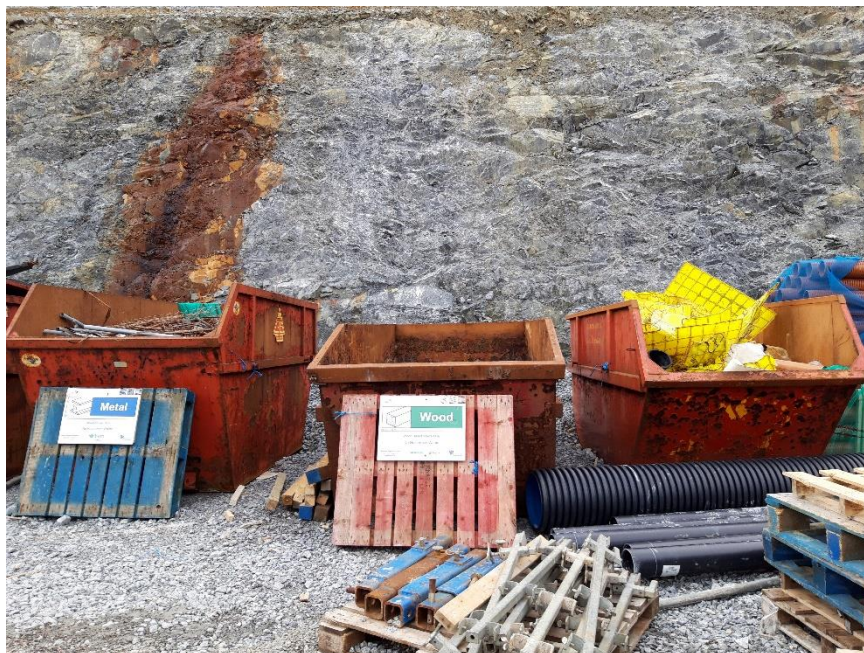
Photo 15. Missing Skip Label (on the right) at substation

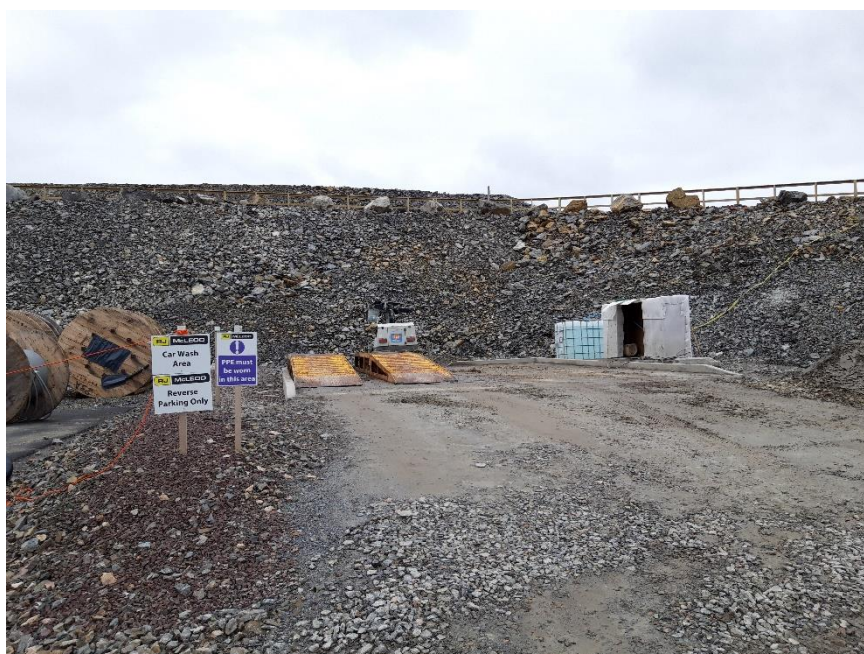
The Developer and Principal Contractor confirmed that wheel washing facilities are provided at the Main Compound (Photo 16) and wash bay is provided at the North Compound on cement pouring days. The Developer reassured that the A970 is constantly monitored and where required the road sweeper is deployed. The Principal Contractor noted that the road sweeper has been recently serviced and is in good working condition.

Photo 16. Washing facilities provided at the Main Compound
