Intended for  
**Viking Energy Wind Farm LLP**

Date  
**May 2022**

Project Number  
**1620009158**

# **VIKING ENERGY WIND FARM PLANNING MONITORING OFFICER AUDIT REPORT 019: 16<sup>TH</sup> APRIL 2022 TO 20<sup>TH</sup> MAY 2022**

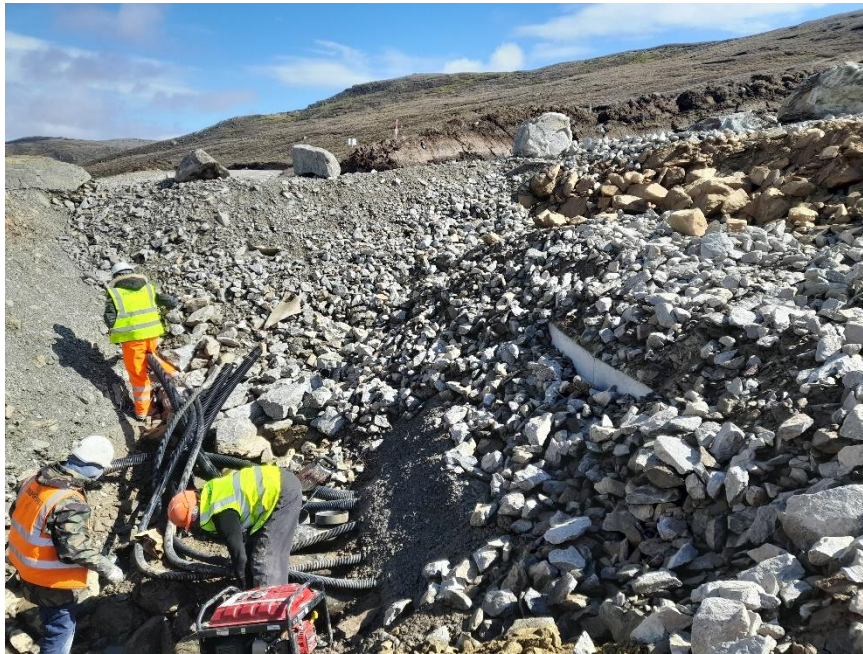
The construction of tracks and bases has continued across the arrays with steelwork and concrete pouring, and the backfilling of bases ongoing (Photo 1). Installed drainage measures are of good quality and preventative mitigation will continue to be installed as turbine base and hardstanding excavation continue (Photo 2). Track construction is progressing towards K68 with peat and turf stripping noted (Photo 3).

The PMO observed the backfilling of the base at K62, including the installation of cable and cable ducting and advancement of the track (including drainage) from Junction 6 to K68.

**Photo 1.** Backfill of base, and cable ducting at K62.

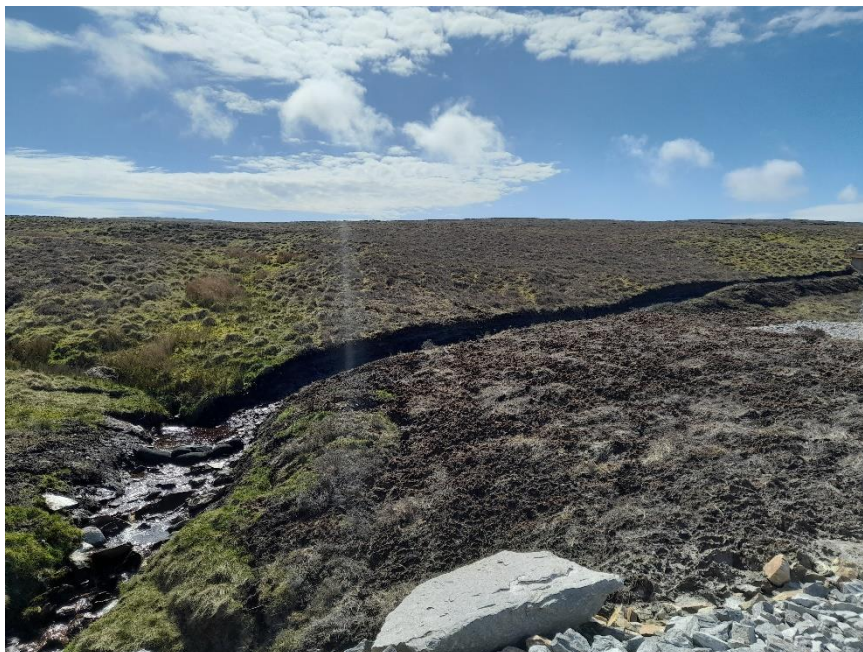
**Photo 2.** Drainage in Kergord.

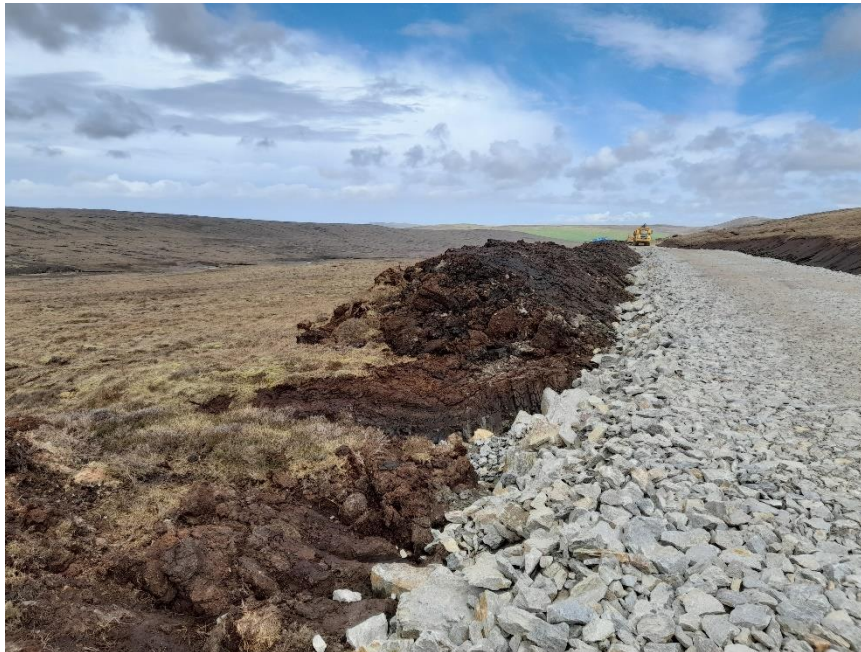
**Photo 3.** Good segregation of turf and peat at the track at Spur 6, towards K68.

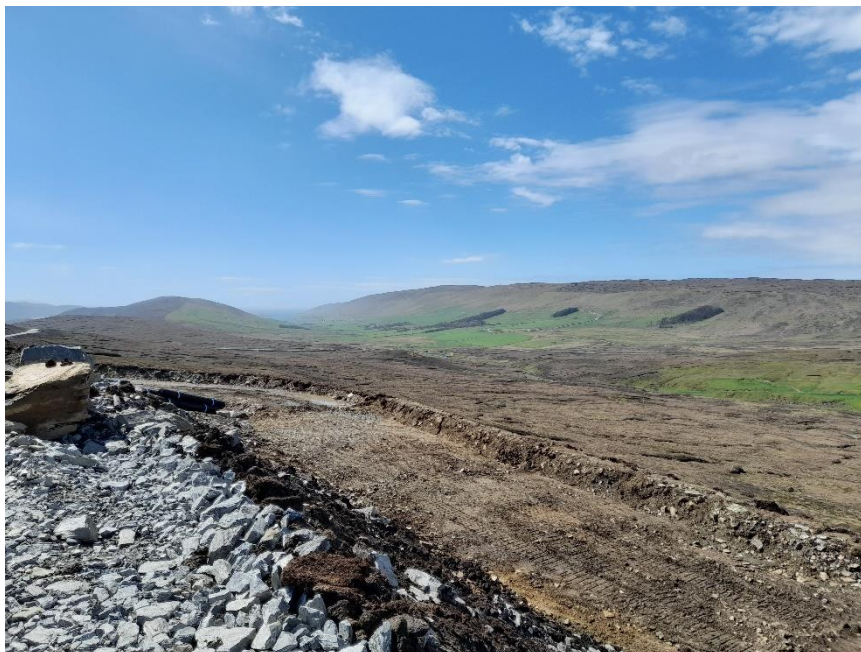
Cable trench excavation on MKR including landscaping and drainage installation (Photo 4) was ongoing to the south of the cable trench. "Whin-Dust" (site-won fine graded dust for cable bedding) was being imported and rolled to create a 75 mm bedding for the cables (Photo 5). The cables (installed in three phase arrays) and the fibre optic cables were being laid and connected to the turbine bases in preparation in the central and north of the cable trench (Photo 6).

**Photo 4.** Cable trench preparation at Mid Kames Ridge.

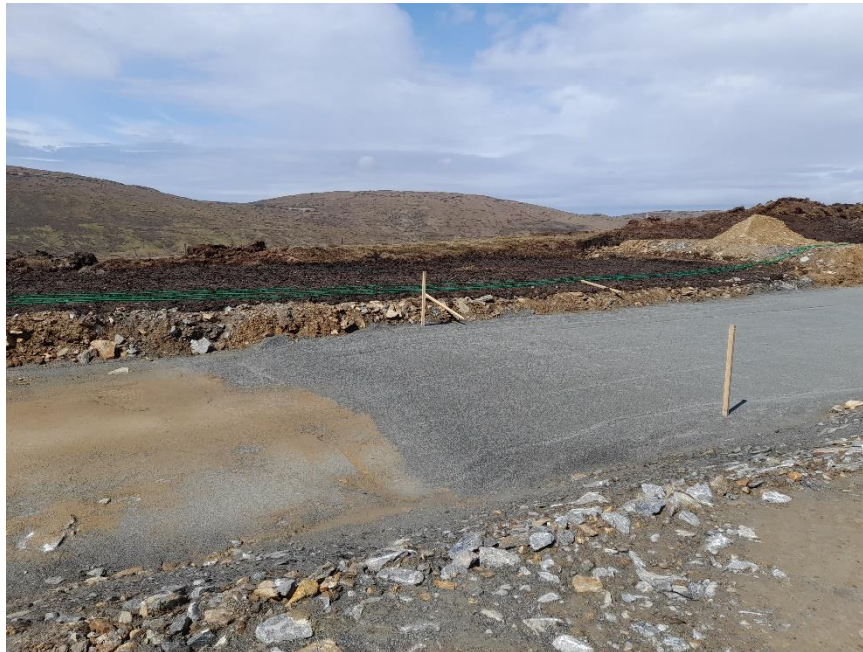
**Photo 5.** 75 m of "Whin-Dust" being laid as cable bedding.

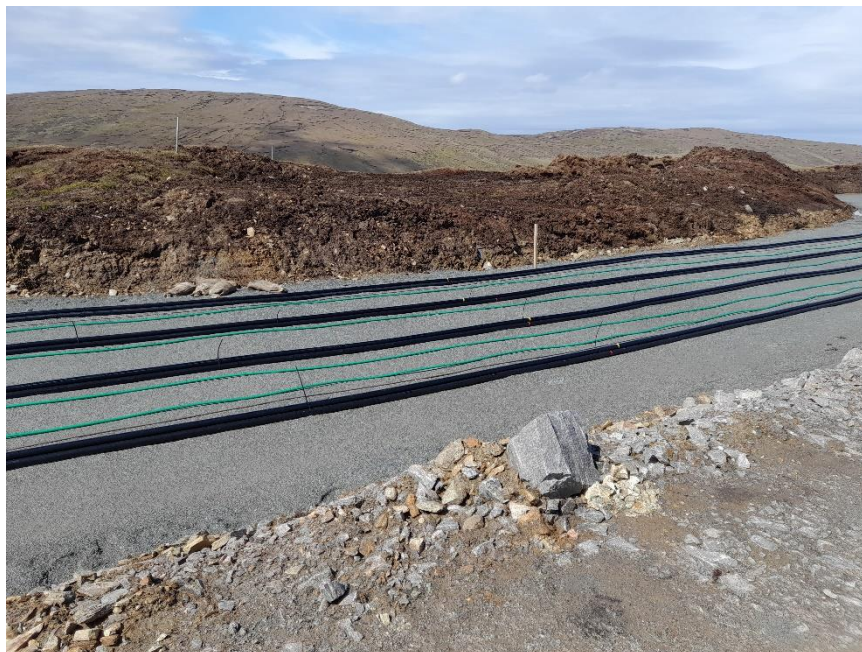
**Photo 6.** Cables being laid in cable trench at Mid Kames Ridge.

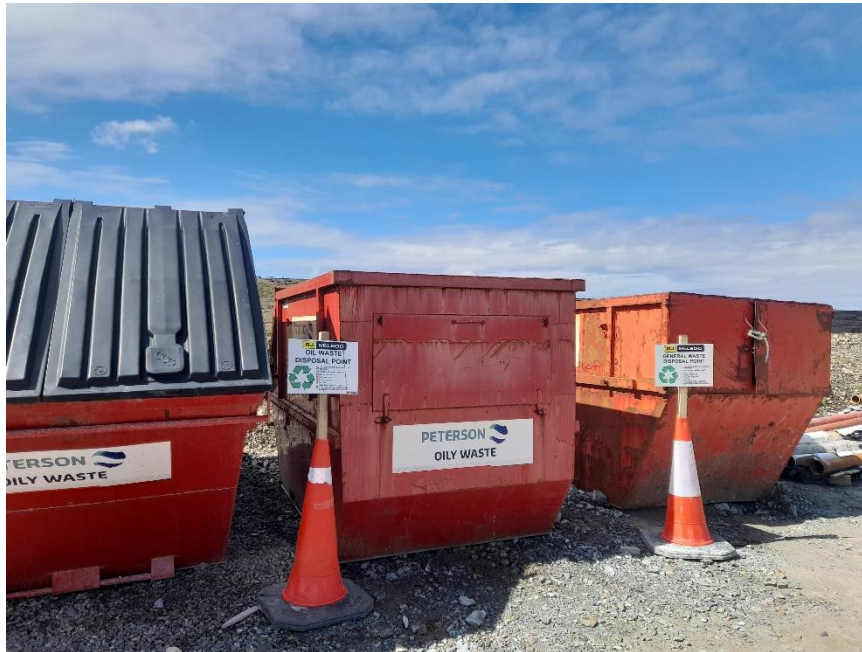
PMO 18 noted that the waste skips within the northern compound were not labelled consistently. During this visit the skips were labelled with labels on the skips themselves, and additional signage on wooden posts in front of the skips (Photo 7).

**Photo 7.** Signage at Waste area in North Compound

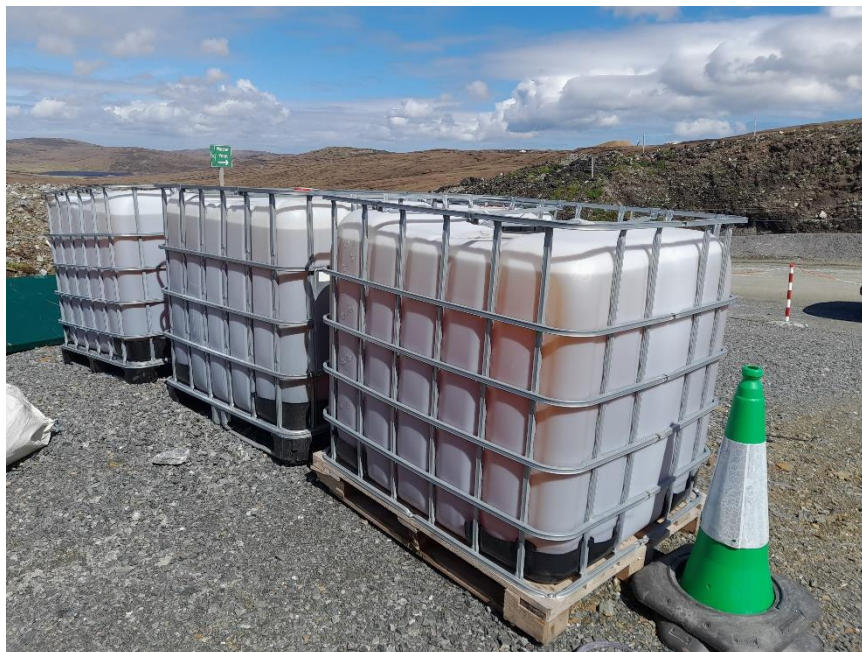
IBCs were being stored on the compacted stone surface, and not on designated hardstanding (Photo 8). The Developer informed that the IBCs were filled with an additive for the concrete mixing. Since there had been limited cement deliveries during the past month (due to production lines being switched off for maintenance by the supplier), the additives had not been used and there was currently a surplus. The Developer and the PMO agreed that temporary bunding would be necessary to mitigate the risk from potential spills from the IBCs reaching the ground.

Materials Storage and Handling (e.g. oil/fuel storage and peat/mineral soil storage and handling).	PMO observed non-compliance with the waste management plan. Approximately 10 no. IBCs were being stored directly on the ground, rather than on an area of hardstanding.	A temporary bund is required whilst the IBCs are being stored off the hardstanding.	Principal Contractor	Amber
Materials Storage and Handling (e.g. oil/fuel storage and peat/mineral soil storage and handling).	During the meetings with the GCoW and during the PMO audit, peat movement was observed at NBP05. A contributing factor was the additional weight being stored on the underlying non-stripped material.. The GCOW noted that peat and other materials should only be stored in areas where additional loading is appropriate.	The movement has been made safe. No further action required.	Principal Contractor	Green
Natural and Built Environment (e.g. ecology, biosecurity, protected sites,	Ecological constraints identified by the ECoW team are communicated to the Principal contractor and Developer to allow mitigation	No action required.	N/A	Green

**Photo 8.** IBCs stored on the ground in the North Compound

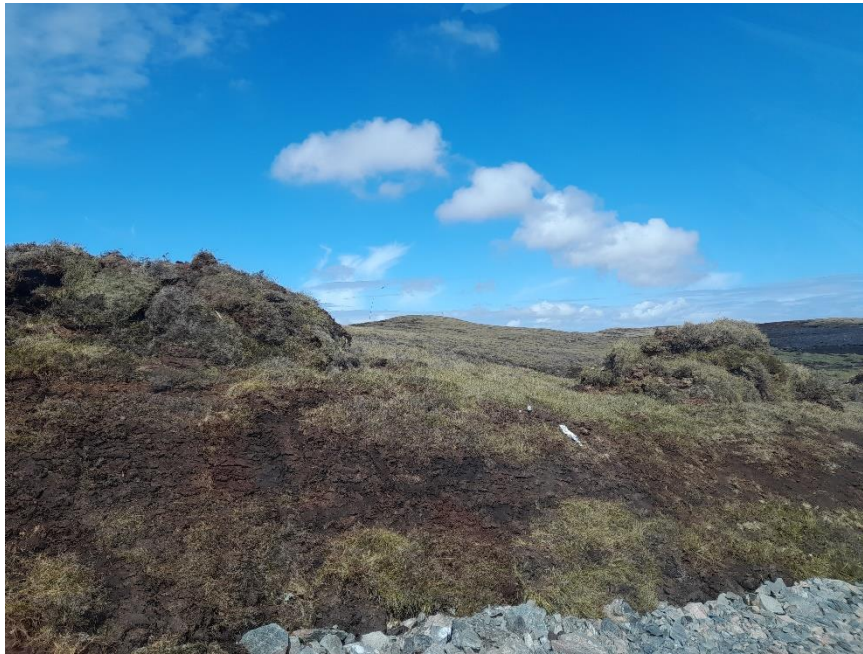
A track had been constructed to access the future cross country cable route that will eventually connect North Nesting to the substation. The turf and peat had been removed and segregated, storing them separately ready for re-use (Photo 9).

**Photo 9.** Turf removed and peat segregated ready for re-use in Nesting

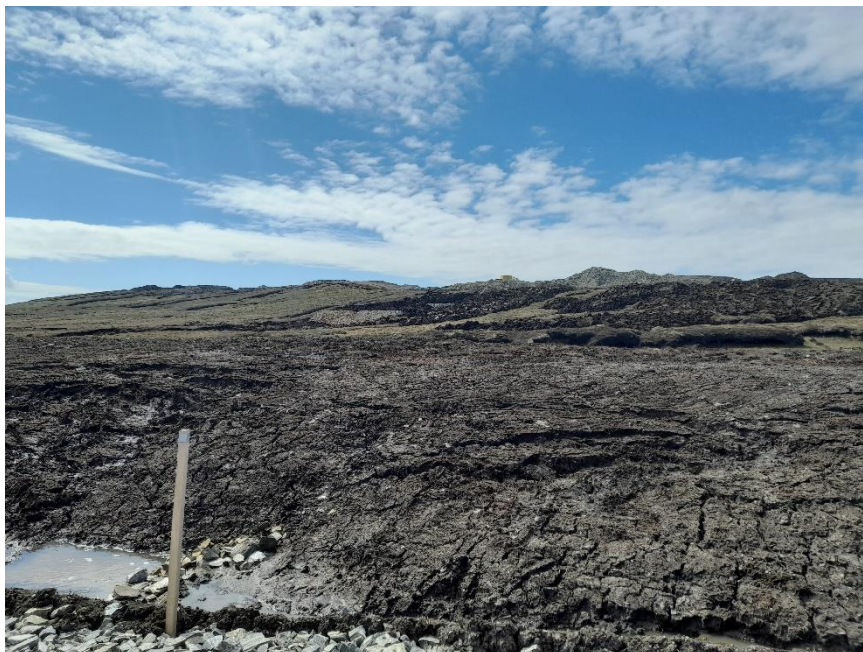
Localised surface movement was observed surrounding borrow pit NBP05 (Photo 10). The movement was believed to have happened during a period of heavy rain after a dry spell. It was also noted that material was placed on top of the edges of the borrow pits prior to the movement, which may also have contributed to additional loading on the peat edges. The movement was made safe and the area will be reprofiled. Internal discussions between RJ McLeod, SSE and the Geological Clerk of Works have established the root cause and agreed measures to ensure a repeat does not occur. This will continue to be monitored throughout the PMO visits.

The monitoring identified a peat movement in the area of NBP05. This is discussed further in Section 3.7.2.

**Photo 10.** Peat movement at NBP05

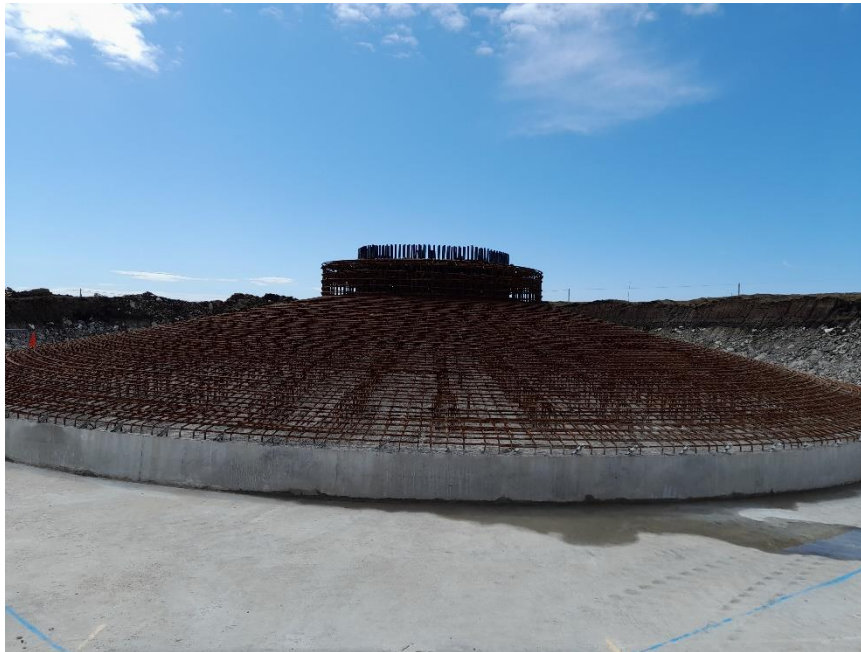
As part of a programme of educational visits to the windfarm, the base at N112 has been partially poured in order to give visitors a view of the construction of a base (Photo 11). This is supplemented with information boards describing why and how Viking is being built. The programme of school visits has had a positive effect with the majority of primary schools taking up the project's invitation to come along and learn all about the project.

**Photo 11.** Show base
