Date
August 2022

Project Number
1620009158

VIKING ENERGY WIND FARM PLANNING MONITORING OFFICER AUDIT REPORT 022: 21ST JULY 2022 TO 21ST AUGUST 2022

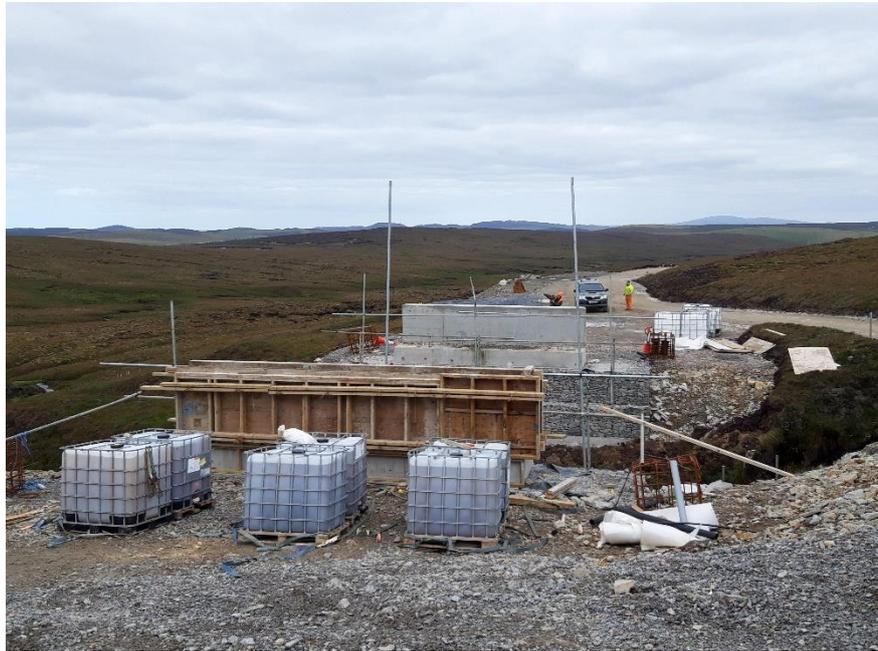
The PMO observed the construction crew in the process of removing the shutters from the concrete abutment at watercourse crossing WC03 (Photo 1), which drains the Truggles Water (between K64 and 66). There was evidence of ground reinstatement around the foot of the bridge foundations, rock filled gabions and silt fencing (Photo 2), which was noted to be good practice, with reinstatement progress in parallel with the work, rather than being left until the end.

Photo 1. Removal of shutters from concrete abutment at WC03

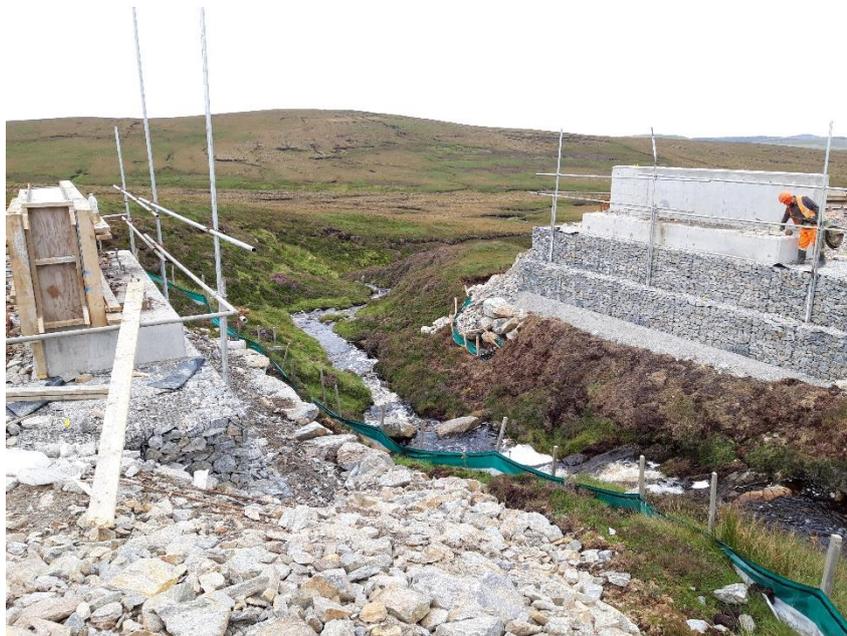
Photo 2. Silt fence at WC03

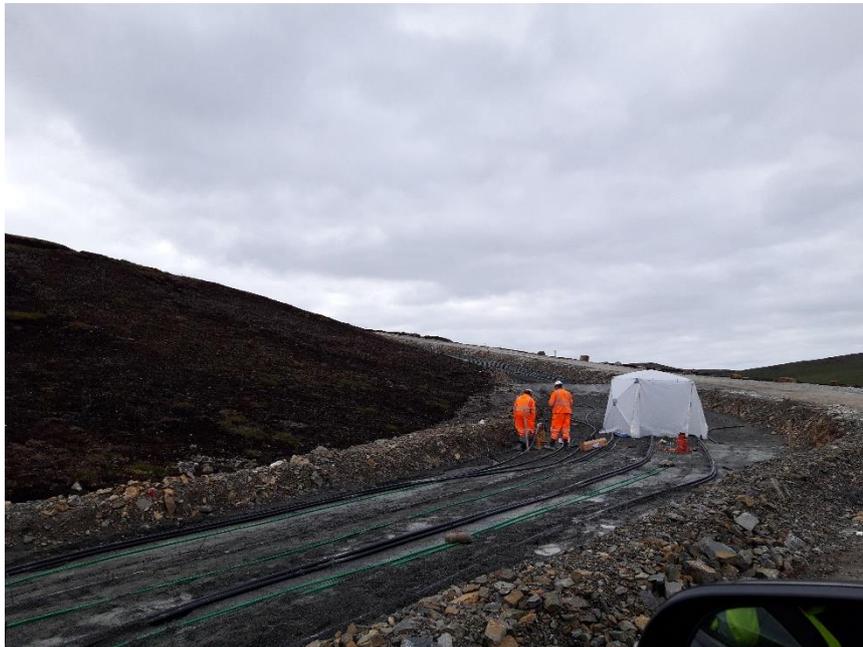
During the visit, construction of cable joint (Photo 3) and backfill of cable trench have been observed in the area (Photo 4). Once cable has been laid the cable is tested and the crushed rock level is checked before backfilling. Backfill consists of a layer of crushed rock, warning tape, a thin layer of peat to hold the tape down before a thicker layer of peat (Photo 5). Concrete cable plugs (Photo 6) have been installed in cable trenches on top of drain outlets (Photo 7) to allow water to flow while preventing flush out of the finer bedding materials.

Photo 3. Construction of cable join near K78

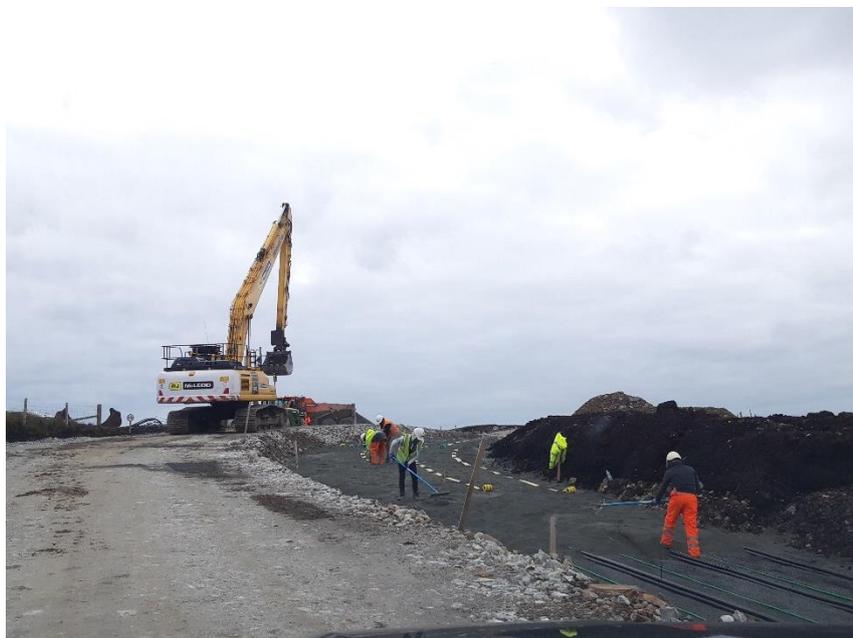
Photo 4. Backfilling of cable trench near K79 in progress

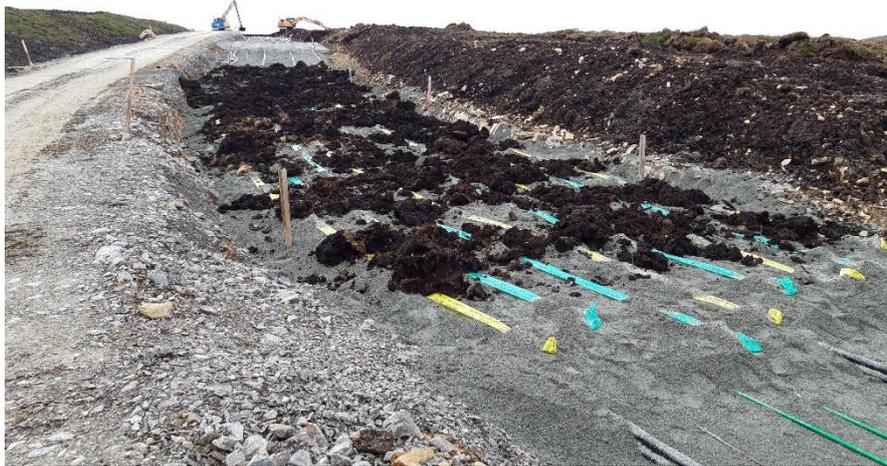
Photo 5. View of layers of cable trench backfill near K80

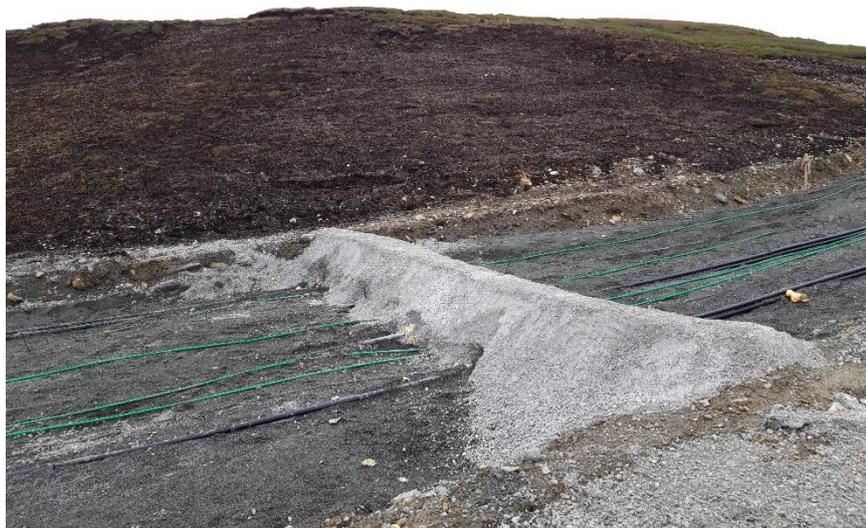
Photo 6. Example of concrete cable plugs in cable trench

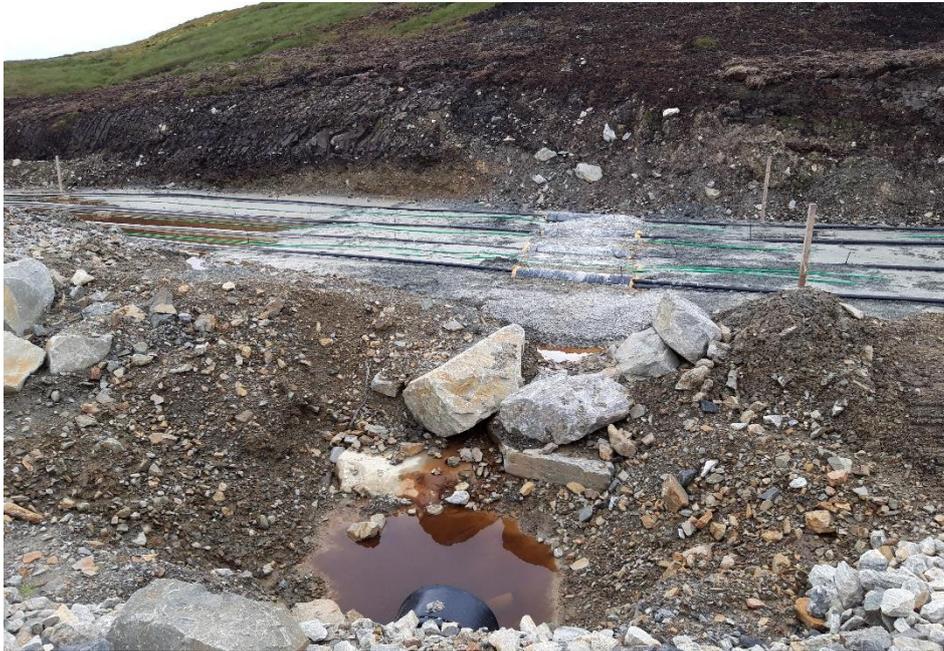
Photo 7. Location of concrete cable plugs to be installed by drainage outlet

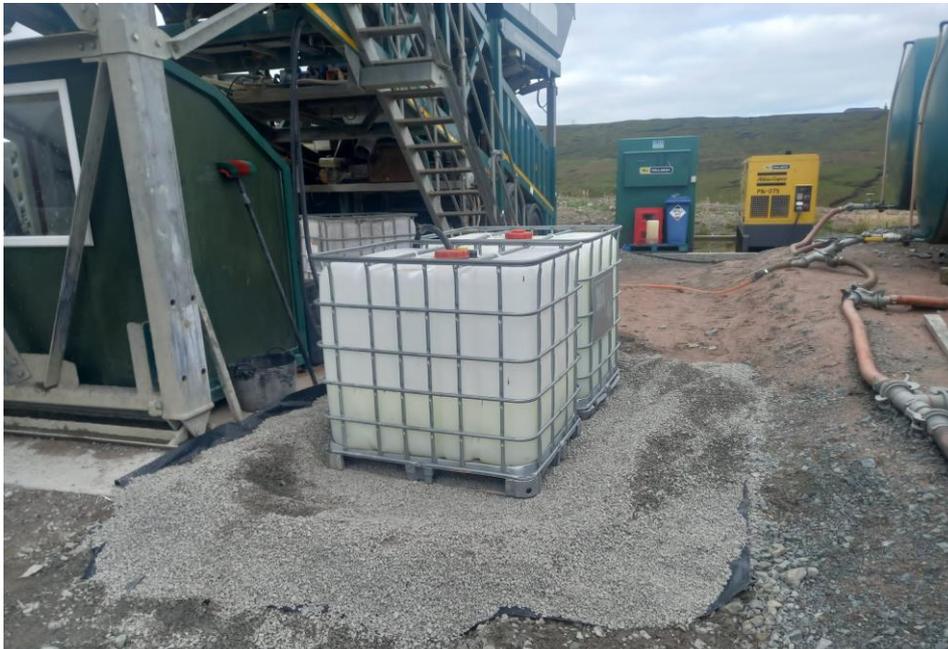
However, the RJM Design Engineer shared photographs from their internal audit showing the IBCs reported in PMO 19-21 are now on temporary impermeable bunding in the form of visqueen sheeting and stone (Photo 8). The PMO will visit the North Compound during the next audit where possible.

Photo 8. IBCs stored on temporary bund (Photo from RJ McLEOD)

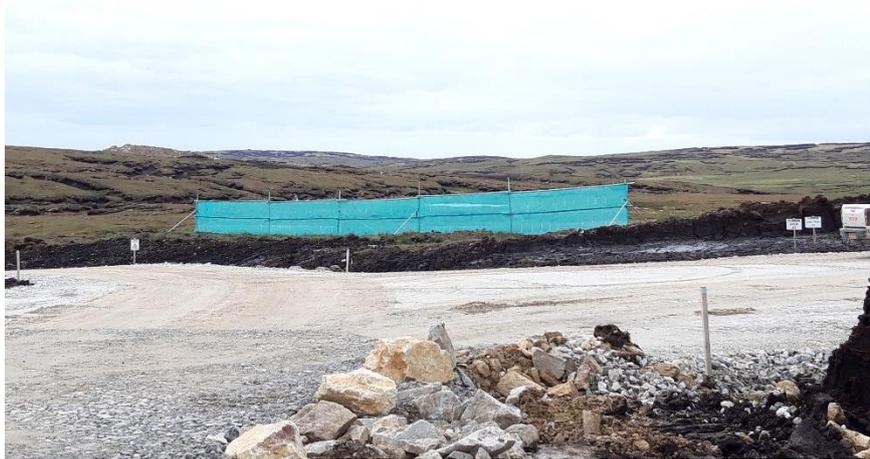
Installed in May, the bird screen at N100, is one of the last remaining bird mitigation measures on site (Photo 9) for this breeding season. Bird screens were installed to screen human activities and minimise disturbance on protected birds. The installed measures have been a significant success as a breeding pair fledged chicks on site, including on the nearby lochan at N100. The road towards the last remaining bird constraints in this breeding season has been restricted to avoid disturbance. Access is only granted for work activities under an ornithological working brief.

Photo 9. Bird screen at N100

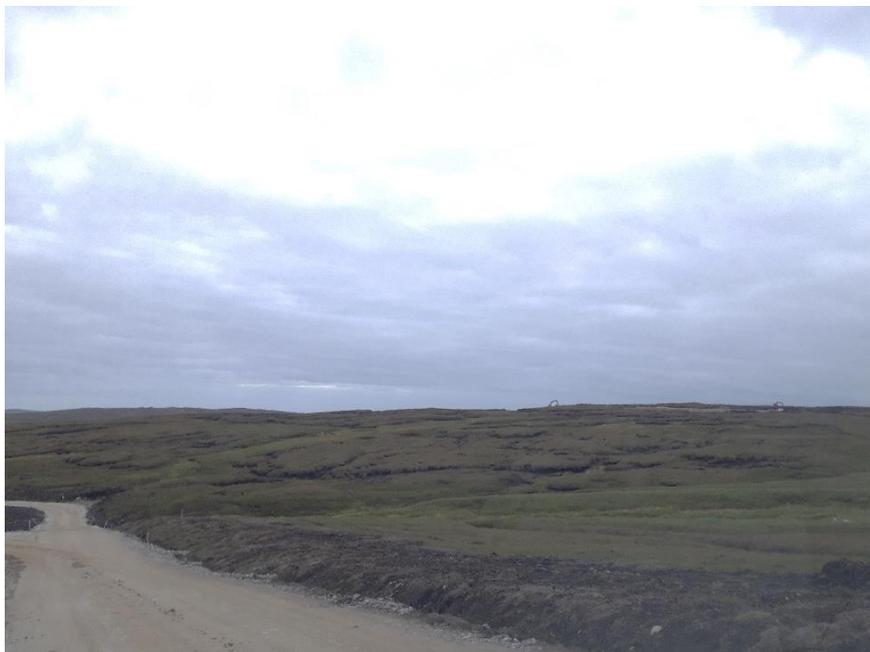
PMO observed activities in NBP01 and Peat Restoration Area P19. Recommendations raised during snagging by GCoW and ECoW are being addressed at P19 with Phase 1 of peat restoration completed at P20 (Photo 10). Phase 1 completion represents the end of peat redeposition and the assurance of stability. Phase 2 works will tie-in adjacent areas to create the overall peat restoration area as specified through the Habitat Management Plan and refined through site works.

Photo 10. View of completed P20 (by track) and improvement on P19 in progress (by horizon)

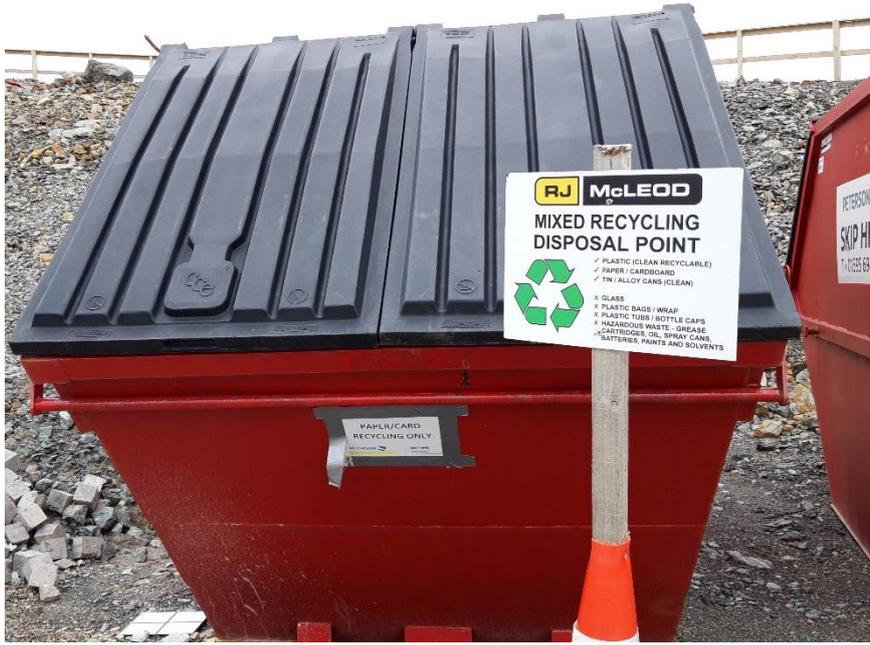
The car parking, site offices and welfare facilities are functioning well. All materials including on the upper level are stored according to regulations. No evidence of leaks or staining was observed in the vicinity of the store. All waste skip labels have been updated for clarity, old labels on skips to be removed to avoid confusion (Photo 11).

Photo 11. New waste skip label on stick with old label on skip to be removed

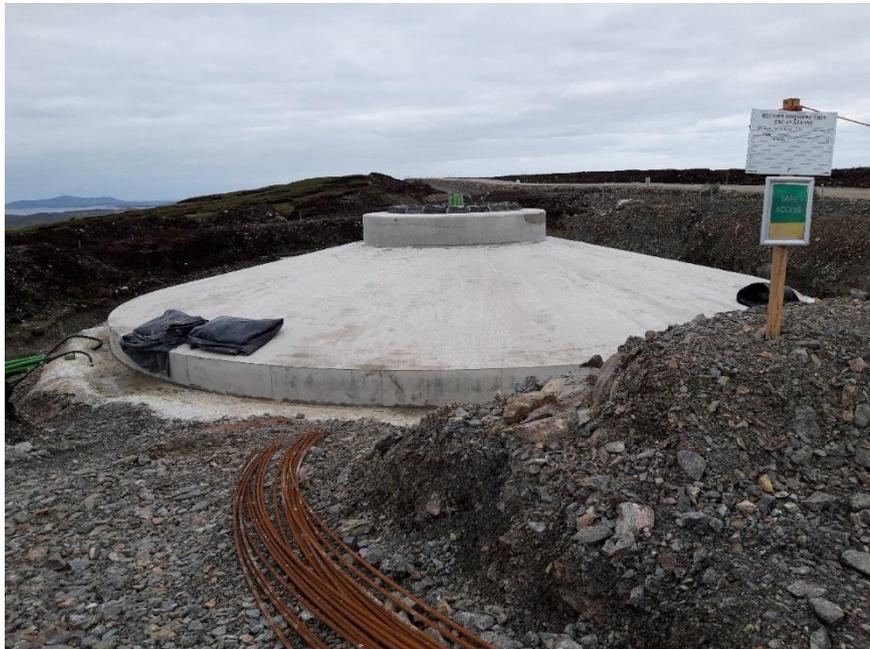
Anchor cage instalment, steelwork fixing and concrete pouring at turbine bases are progressing smoothly in the area with 32 bases left to be poured. Concrete at N130 has been recently poured (Photo 12), and PMO observed N114 being poured from afar. PMO also observed activities in NBP05.

Photo 12. Recently poured base at N130

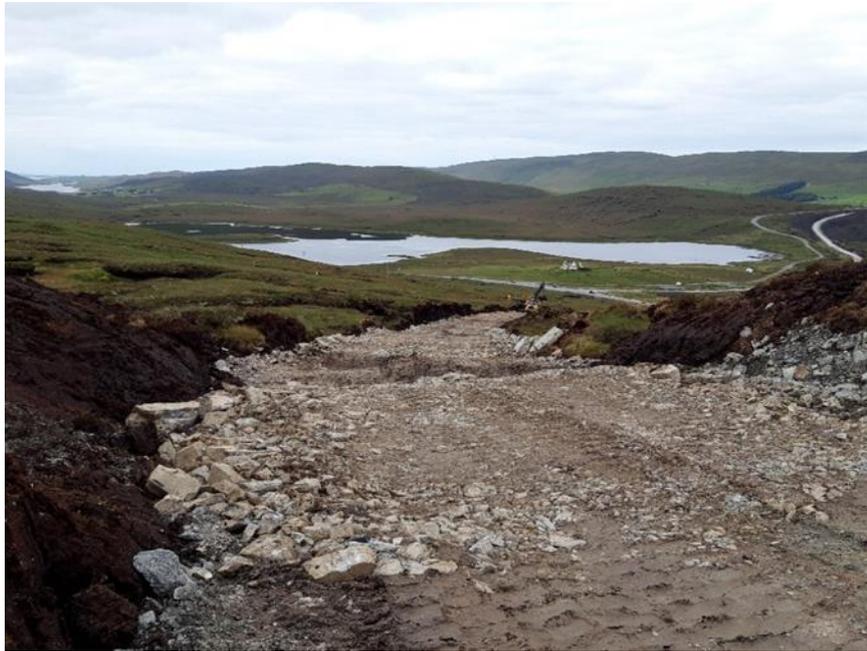
A section of cross-country cable route in the area has been diverted to reduce work on or near A970 to minimise disturbance to road users. Work has begun on the diverted route near Spur 19 (Photo 13).

Photo 13. View of cross country cable construction in progress near Spur 19

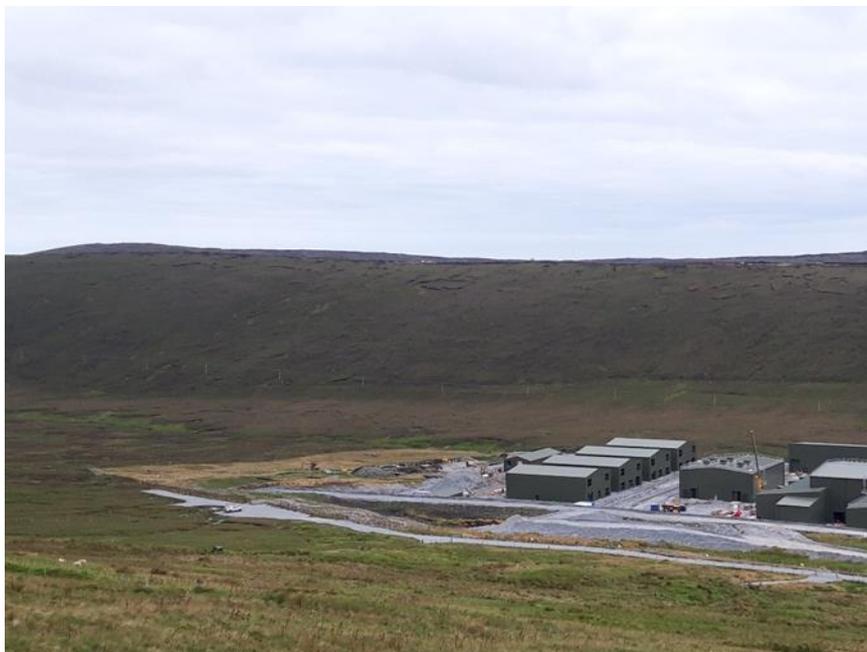
Ecologists have completed surveying the extent of rare bog orchid (Photo 14). Where impacts of cable installation are not avoidable, a small colony of rare bog orchid has been translocated.

Photo 14. Area of rare bog orchid (lighter colour) to the left of substation in photo

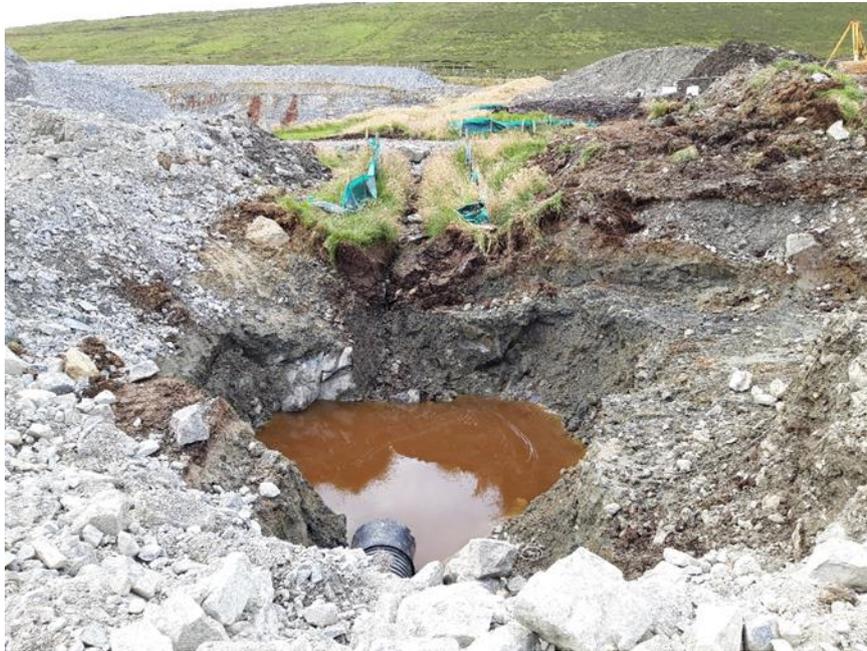
Diversion of the Northern Watercourse as reported in PMO021 has been completed with additional culvert being installed (Photo 15). Construction of substation cable under diverted Northern Watercourse has begun (Photo 16). Once completed, the Northern Watercourse will be restored to its original location, on top of the substation cable.

Photo 15. Additional culvert in diverted Northern Watercourse at substation

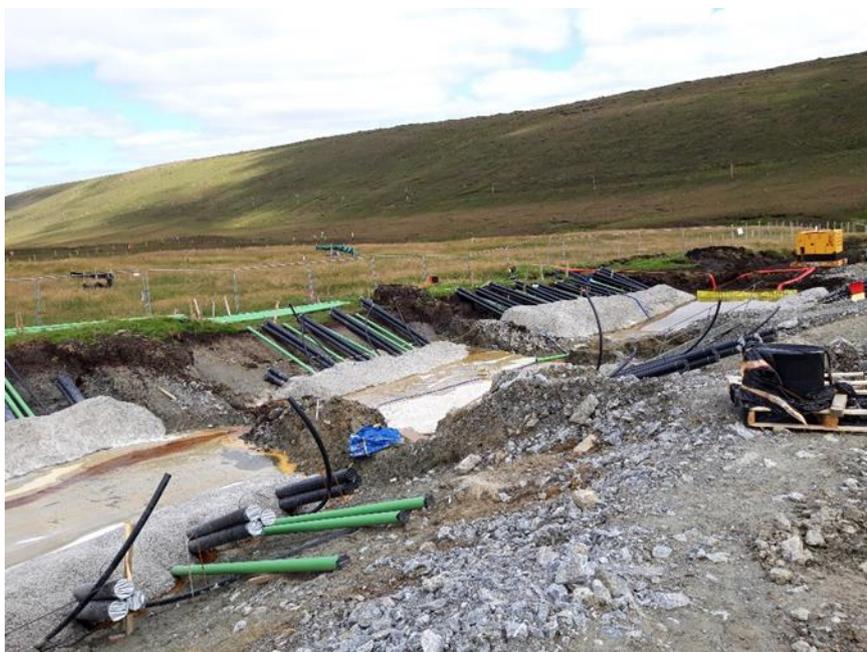
Photo 16. Construction of substation cable under previous location of Northern Watercourse
